| <b>Rolls-Royce</b> | Rolls-Royce Corporation<br>450 S. Meridian Street<br>Indianapolis, Indiana<br>46225-1103, USA | <b>REPORT NO.</b><br>20FAE-014-PR | <b>REV.</b><br>Initial | <b>PAGES</b><br>1 of 135 |
| <b>TITLE</b><br><br><b>METALLURGICAL INVESTIGATION OF A HELICAL POWER TURBINE PINION GEAR, P/N 6893672, INSTALLED IN AN M250-C47B ENGINE, S/N CAE847031, OPERATED BY PANTHER HELICOPTERS</b> | | <b>PREPARED</b><br><br>Signatures on file | | |

| Engine Model: | M250-C47B |
| Evaluations: | Failure Analysis |

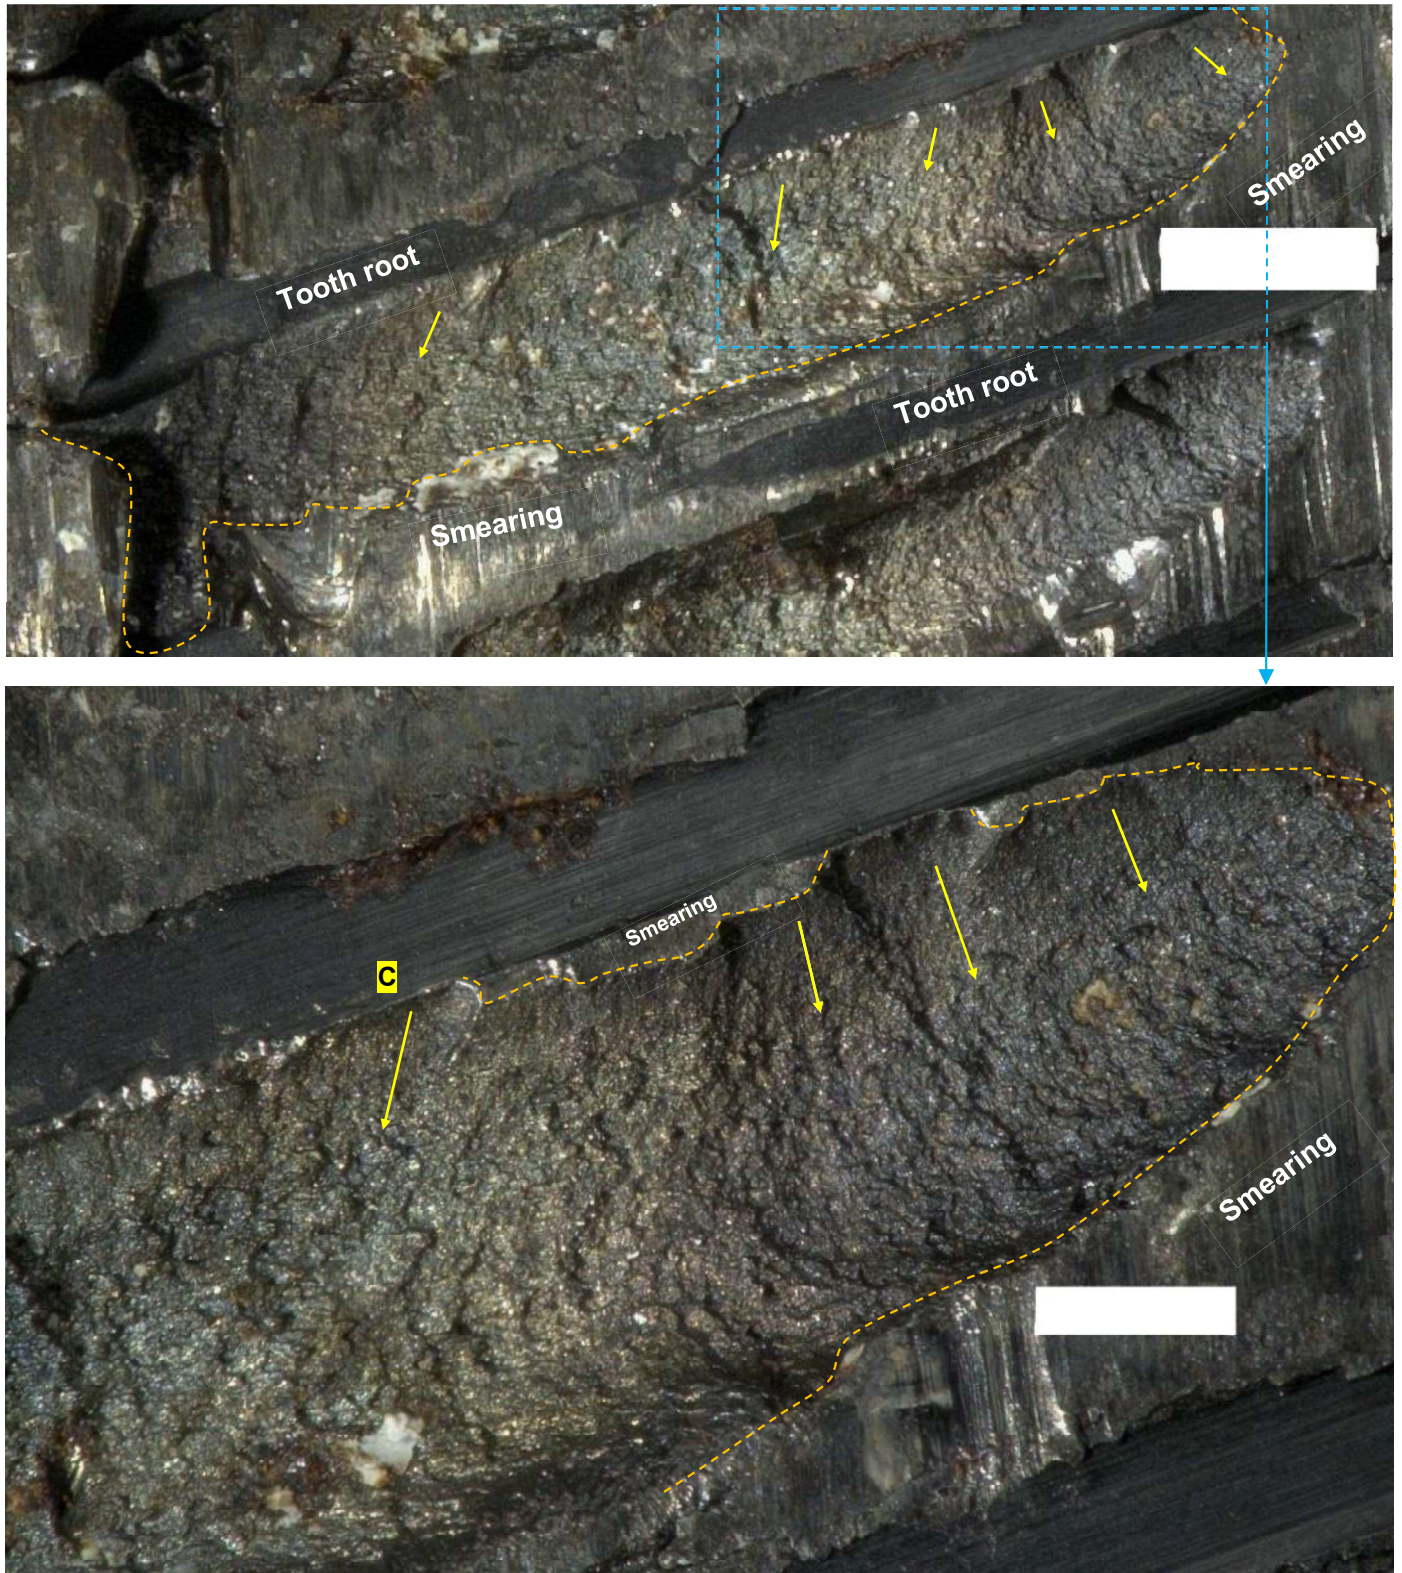
**Figure 16. Detailed views of fracture surfaces at gear tooth number 4 after cleaning. The yellow arrows mark the direction of fatigue progression, the orange dotted line marks the transition from fatigue to smearing damage, and location C is shown in more detail in the following figure.**

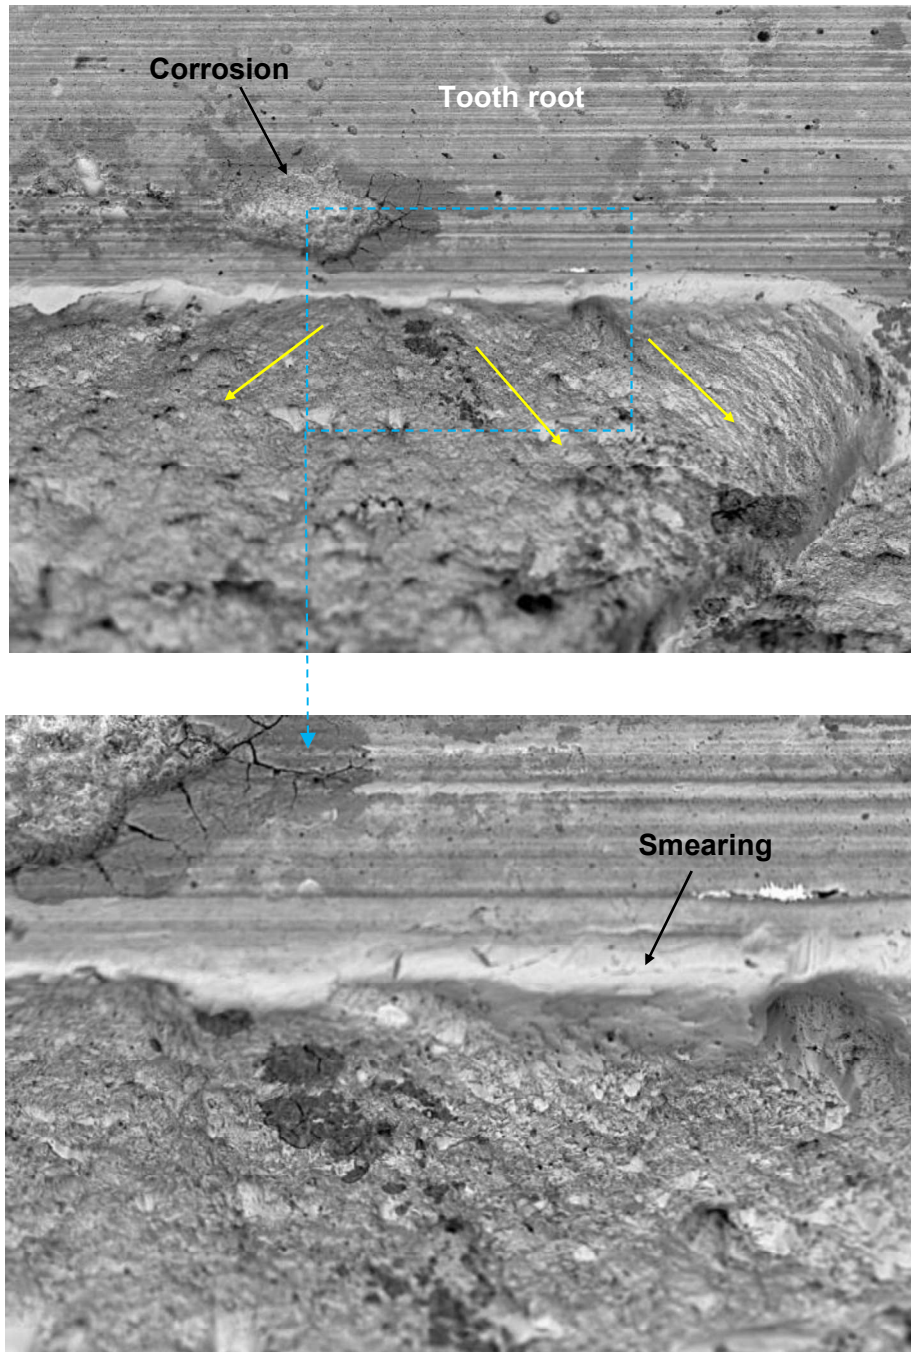
**Figure 17. Backscattered electron SEM image of fracture surfaces at gear tooth number 4 (location C in previous figure). The yellow arrows mark the direction of fatigue progression.**

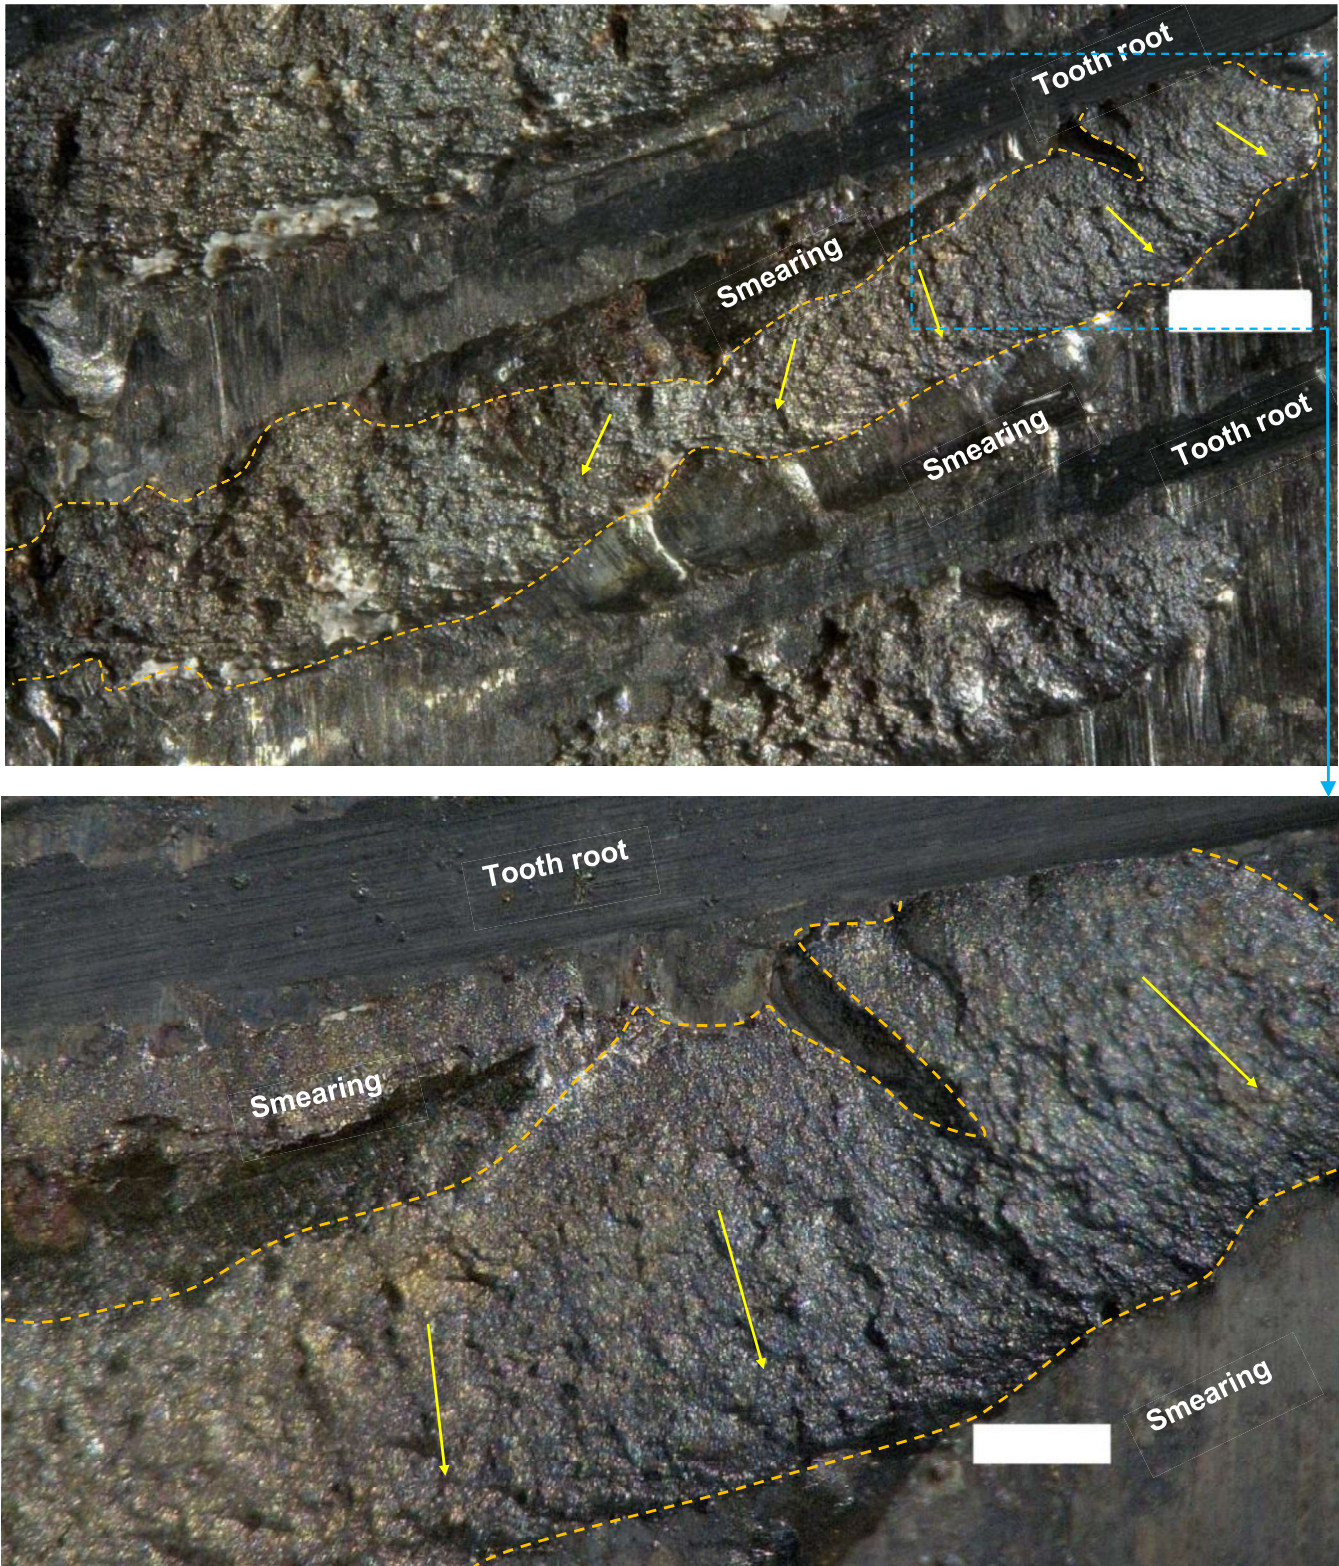
**Figure 18.** Detailed views of fracture surfaces at gear tooth number 5 after cleaning. The yellow arrows mark the direction of fatigue progression, and the orange dotted line marks the transition from fatigue to smearing damage.

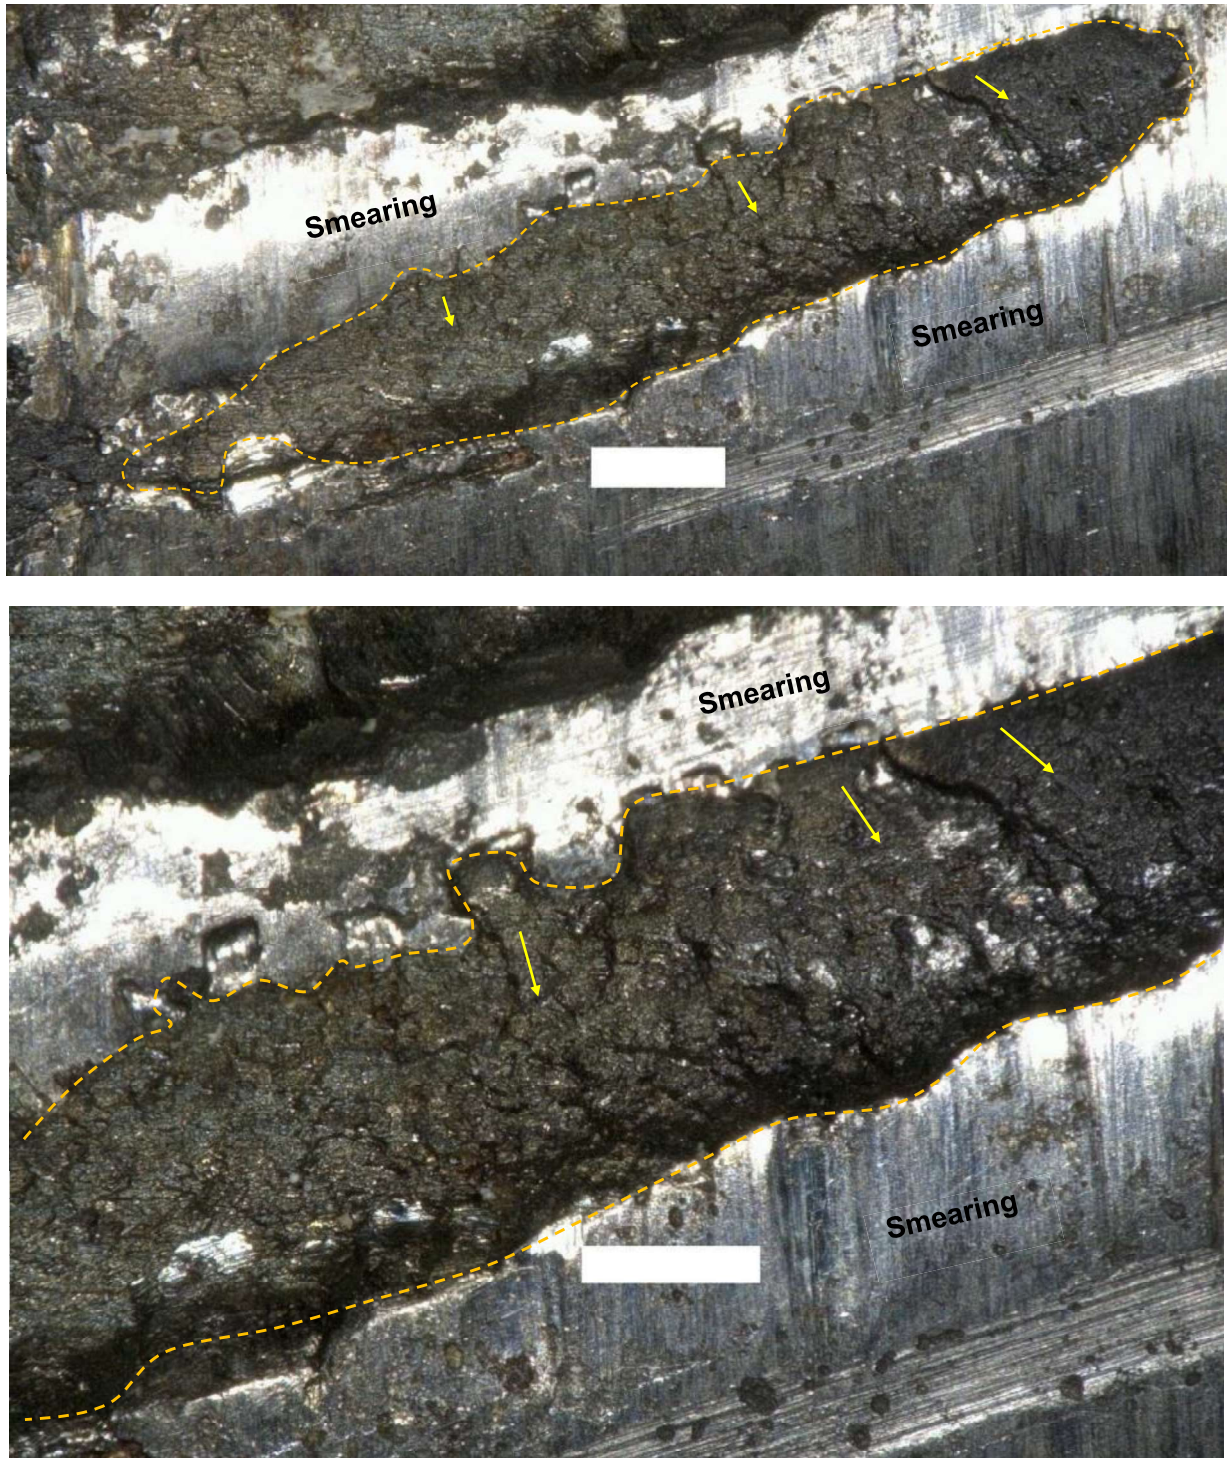
**Figure 19.** Detailed views of fracture surfaces at gear tooth number 6 after cleaning. The yellow arrows mark the direction of fatigue progression, and the orange dotted line marks the transition from fatigue to smearing damage.

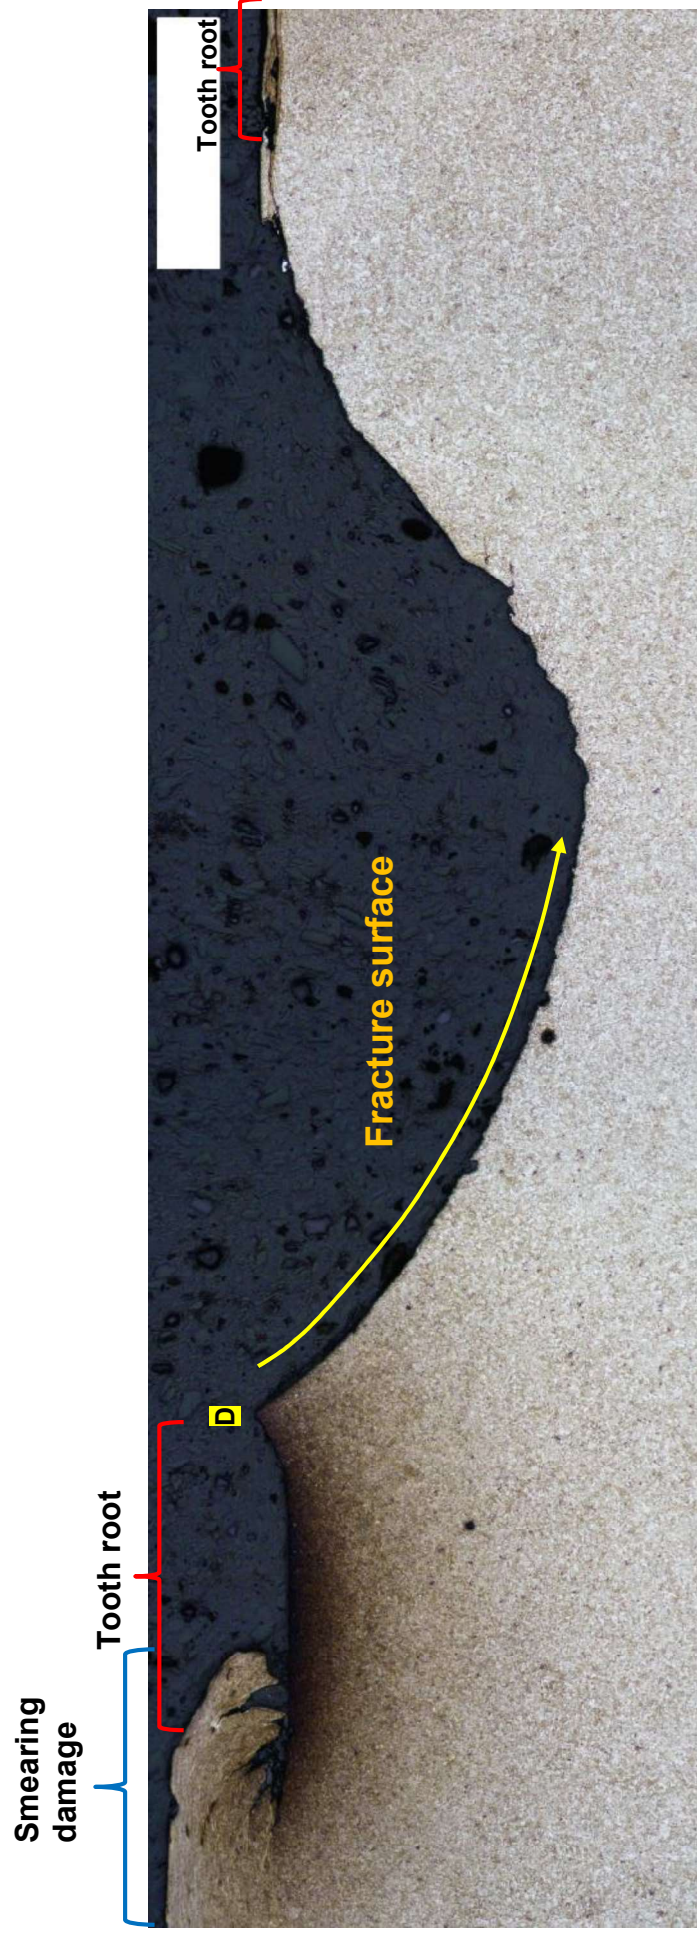
Figure 20 and Figure 21 show a metallographic cross-section through the fracture surface at gear tooth number 3. The fracture origin was located at the tooth root fillet. No material anomalies were observed near the fracture origin, but smearing damage precluded detailed examination of the fracture origin. Figure 22 shows metallographic cross-sections through the No. 3 and No. 4 bearing journals, which both exhibited thermal distress (lighter etched regions). Thermal distress also extended from the No. 3 bearing journal to the gear teeth forward face and the pinion gear inner diameter surface. The core microstructure of the pinion gear away from the thermal distress, as shown in Figure 23, was consistent with the material type required by the component definition.

Figure 20. Metallographic cross-section through the fracture surface at gear tooth number 3 (see red dashed line in Figure 13). Yellow arrow marks the direction of fatigue progression, and location D is shown in more detail in the following figure. Etchant: 5% Nital

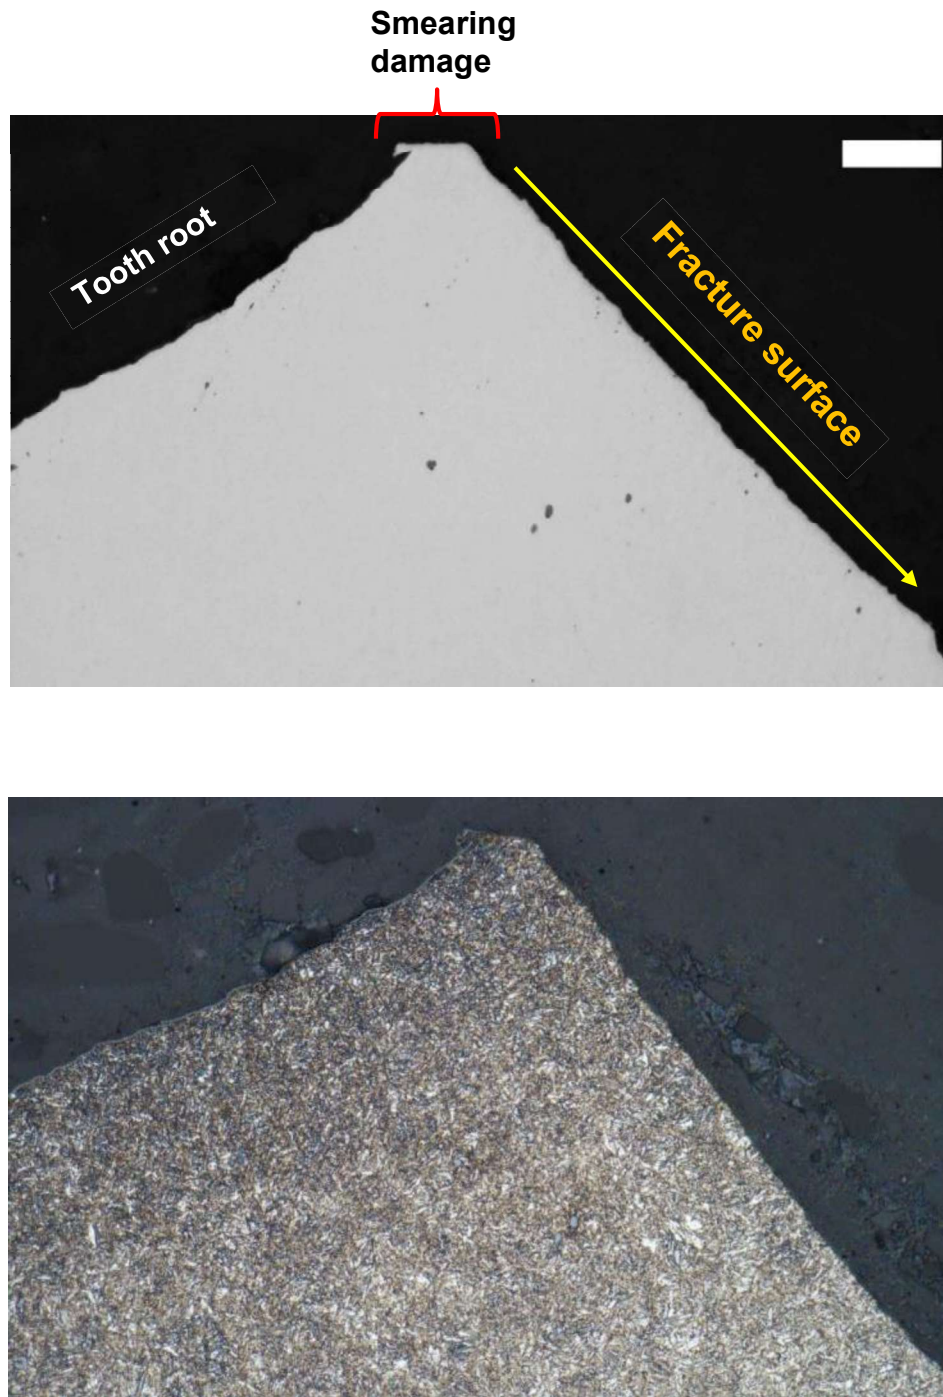
**Figure 21.** Metallographic cross-section through the origin area of the fracture surface at gear tooth number 3 (see location D in the previous figure) in the unetched (top) and etched condition (bottom). Yellow arrow marks the direction of fatigue progression. Etchant: 5% Nital (bottom)

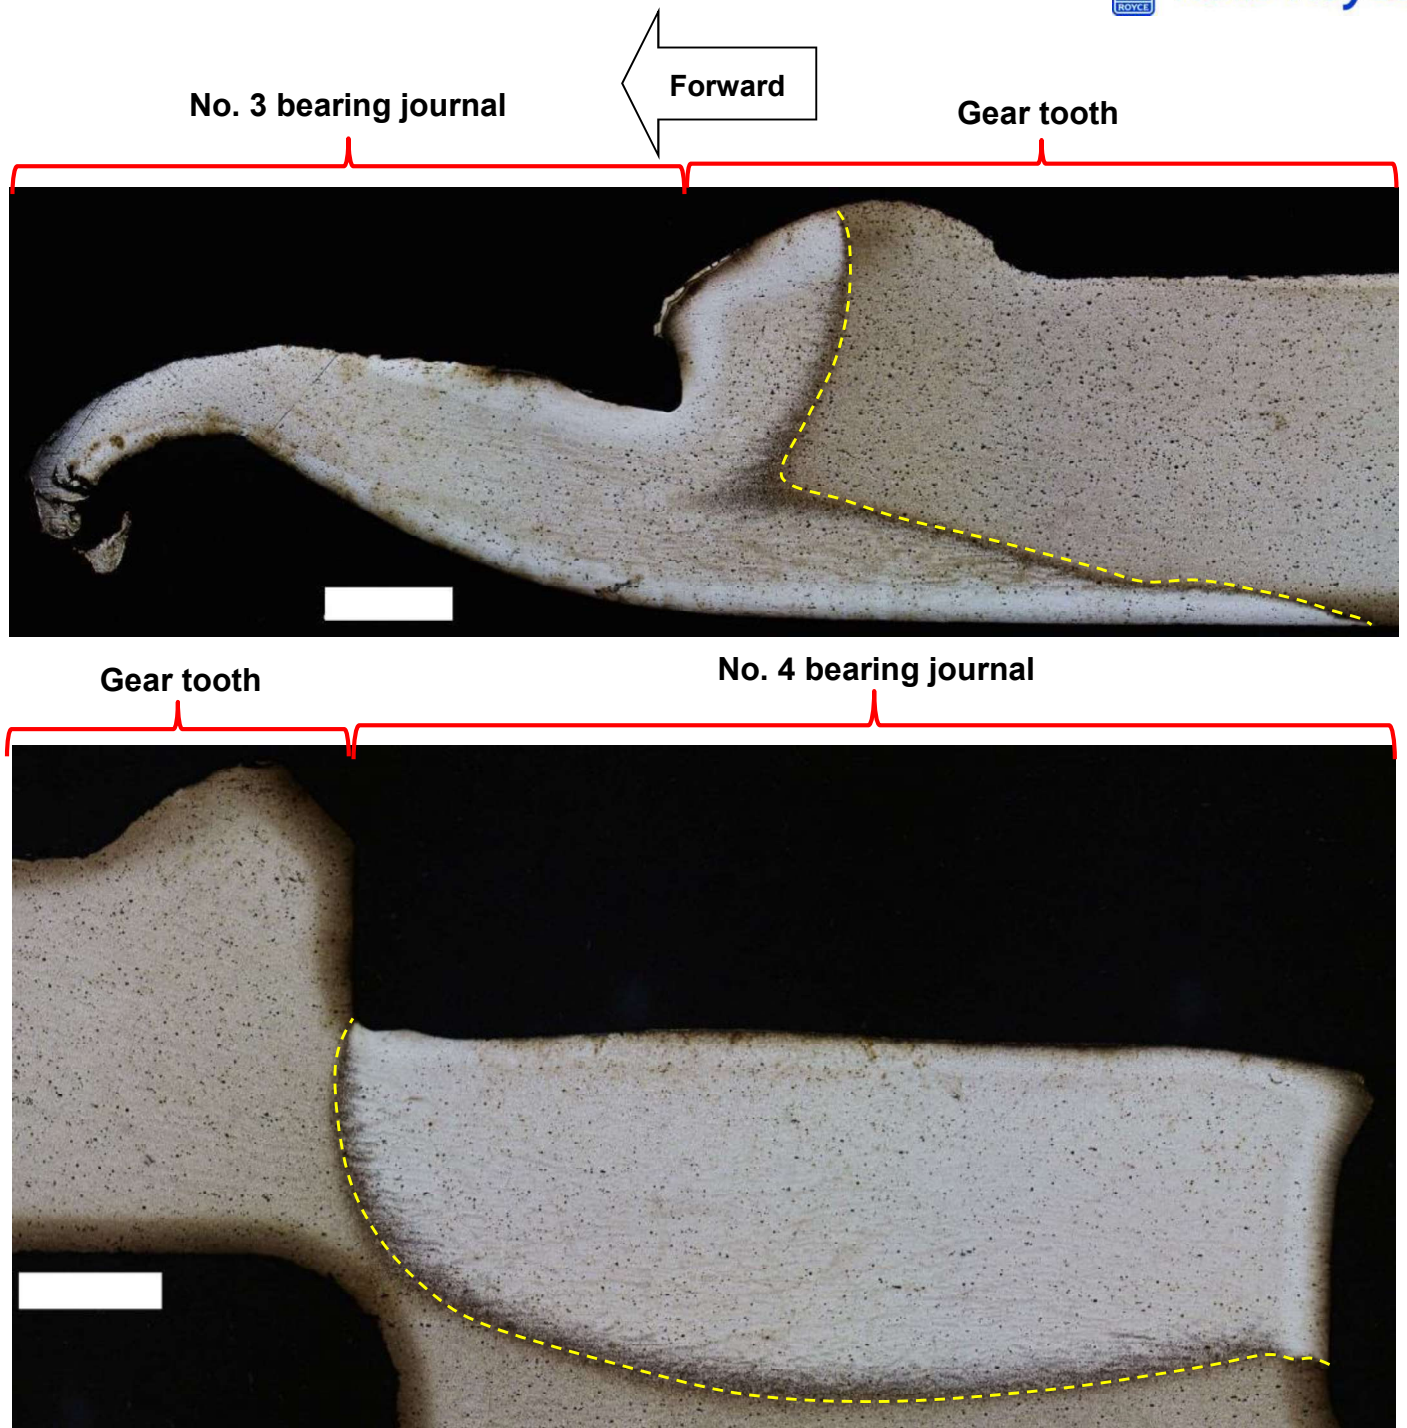
**Figure 22.** Metallographic cross-sections through the No. 3 (top) and No. 4 (bottom) bearing journals on the pinion gear (see yellow and orange dashed lines in Figure 3, respectively). Yellow outlines mark the locations of thermal distress on the journals. Etchant: Vilella's

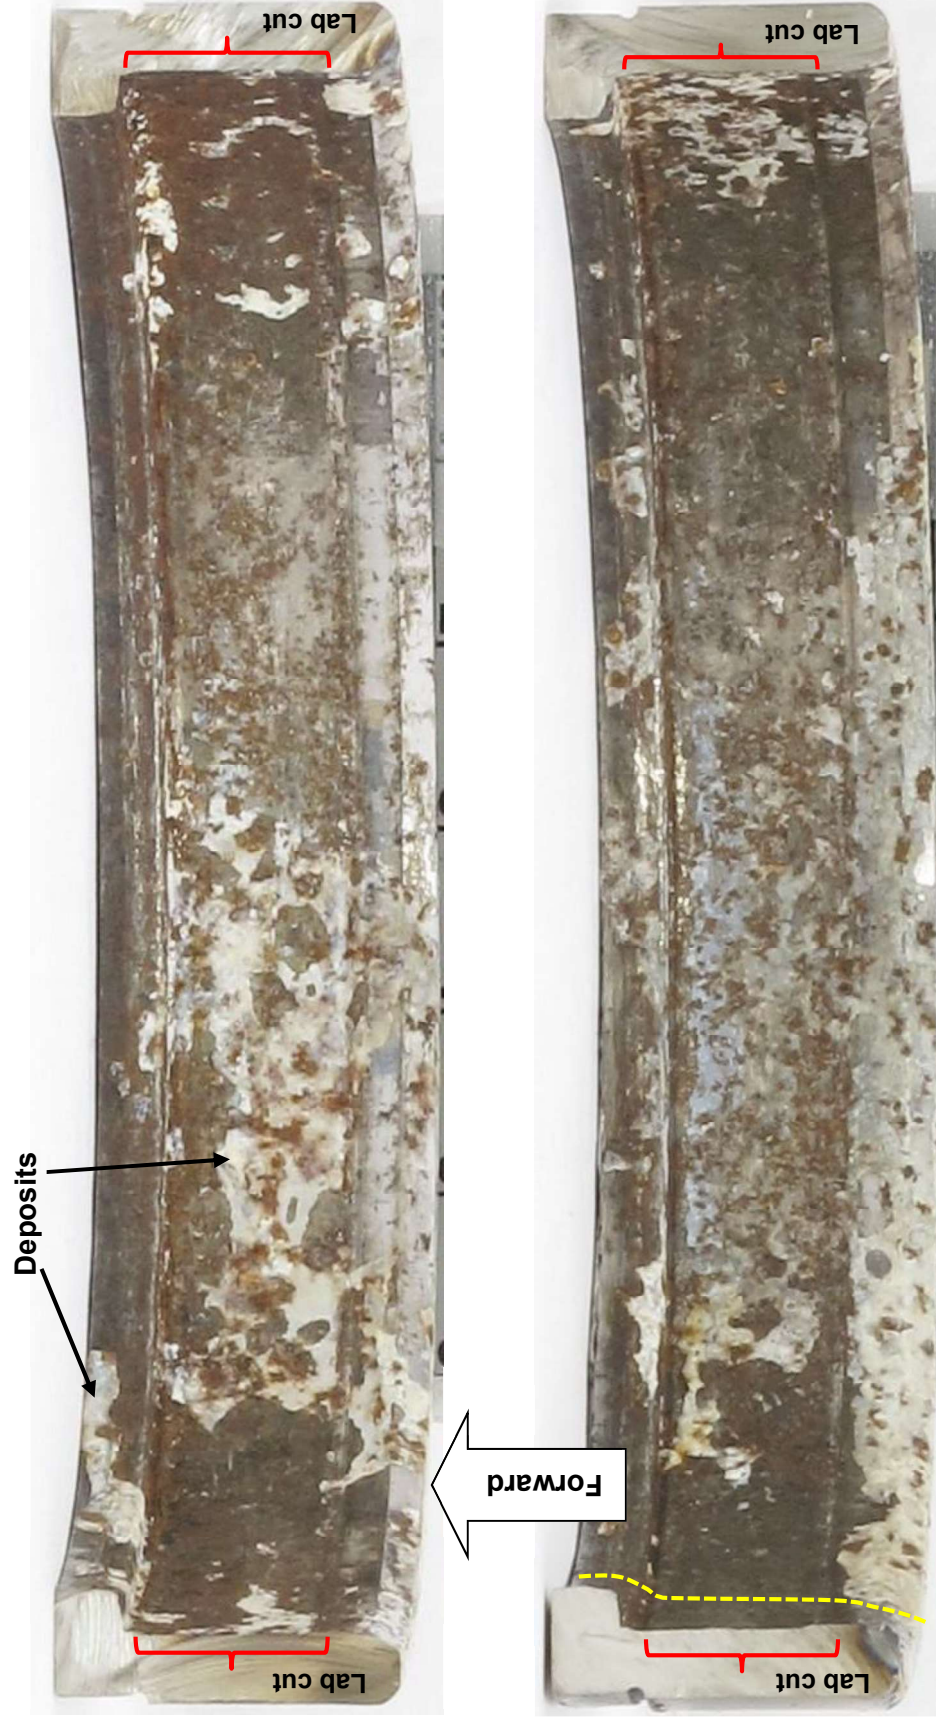
The No.3 bearing outer ring was sectioned out of the bearing-stepped pinion cage in the laboratory, then ultrasonic cleaned and manual cleaned with pumice soap. Figure 26 and Figure 27 shows general and detailed views of outer raceway surface of the No. 3 bearing outer ring, which exhibited material removal at the roller path. Circumferential rub damage was observed on the forward shoulder corner. The outer ring also exhibited oxidation and lighter colored deposits. Figure 28 shows a representative view of outer diameter of the outer ring, which exhibited discoloration.

Figure 26. Two views of the No. 3 bearing outer ring, after it was sectioned and cleaned, showing the condition of the outer raceway surface. Red braces mark the location of material removal at the roller path, and the yellow dashed line marks the plane of metallographic evaluation (see Figure 29).

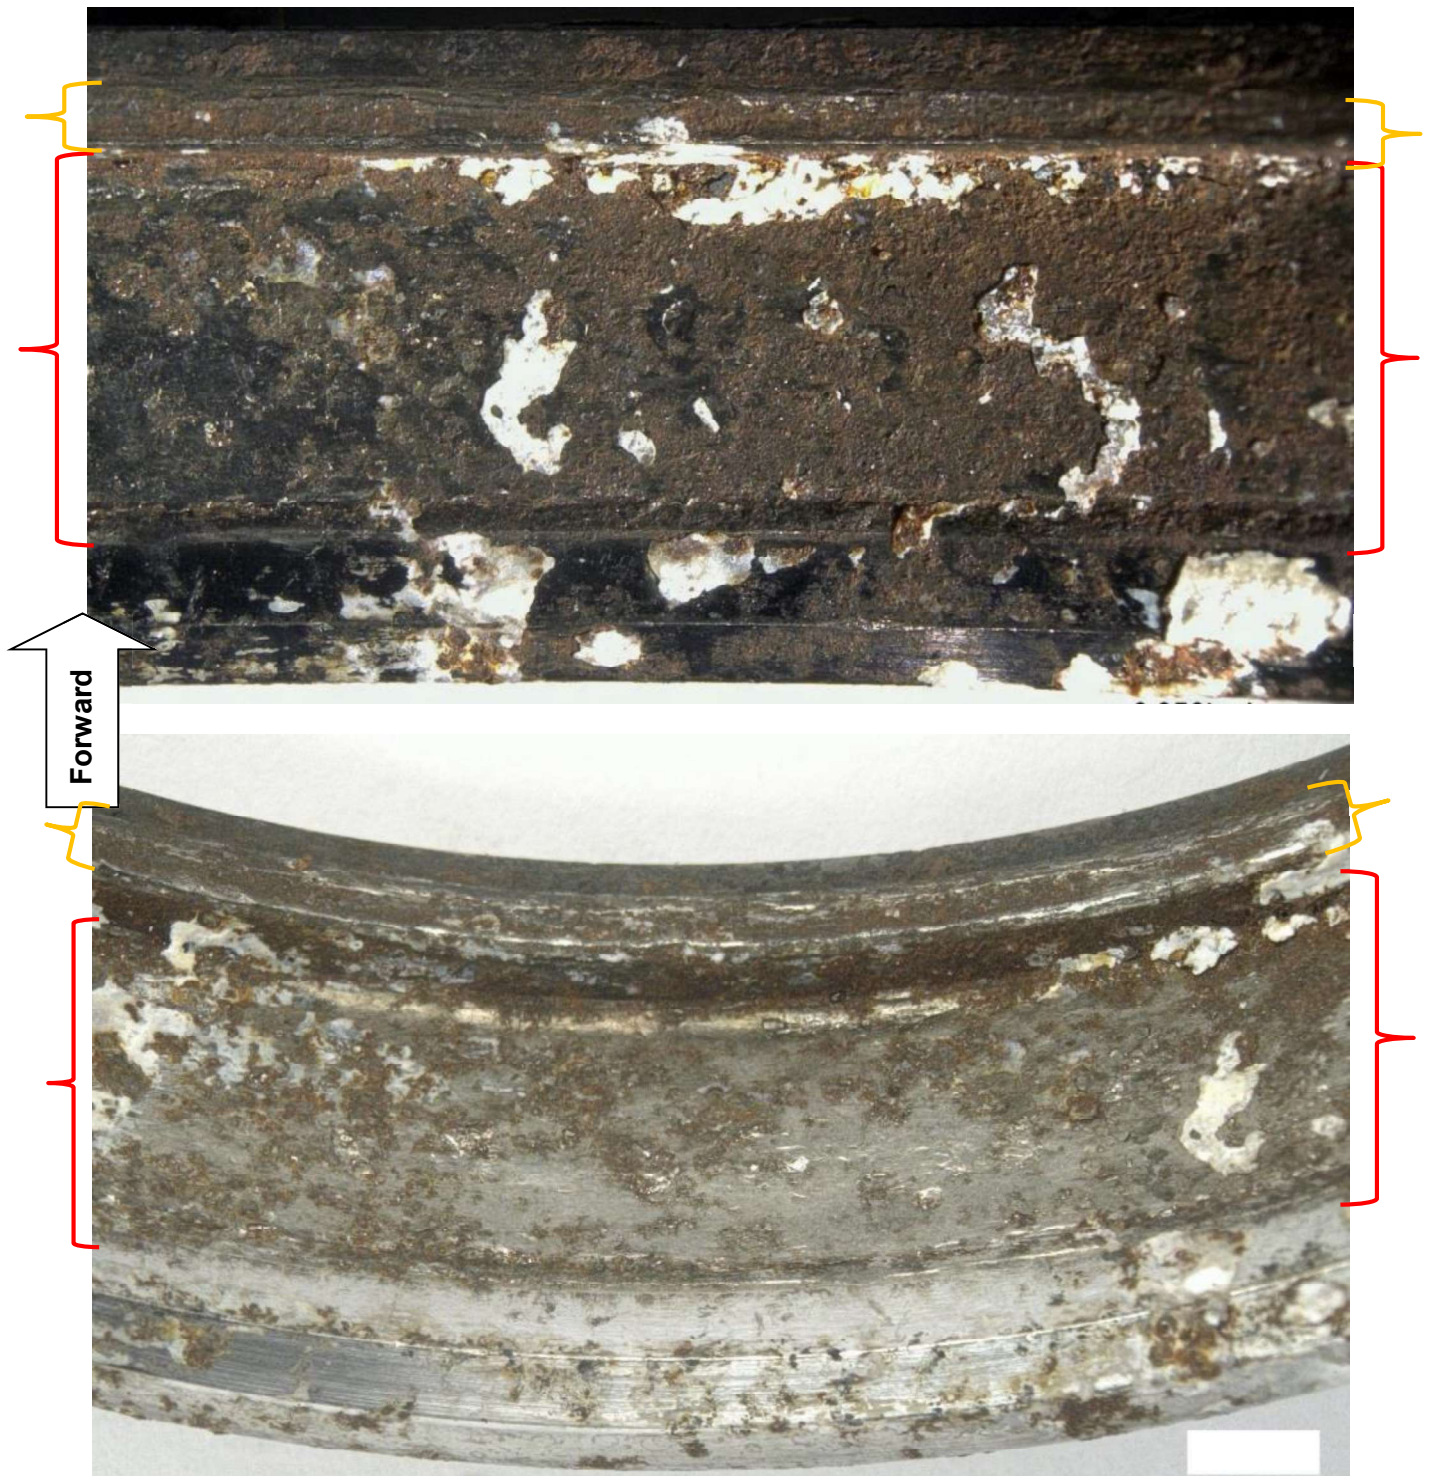
**Figure 27. Detailed inboard looking outboard and oblique views of the No. 3 bearing outer ring raceway. Red braces mark the location of material removal at the roller path, and the orange braces mark rub damage on the forward shoulder corner.**

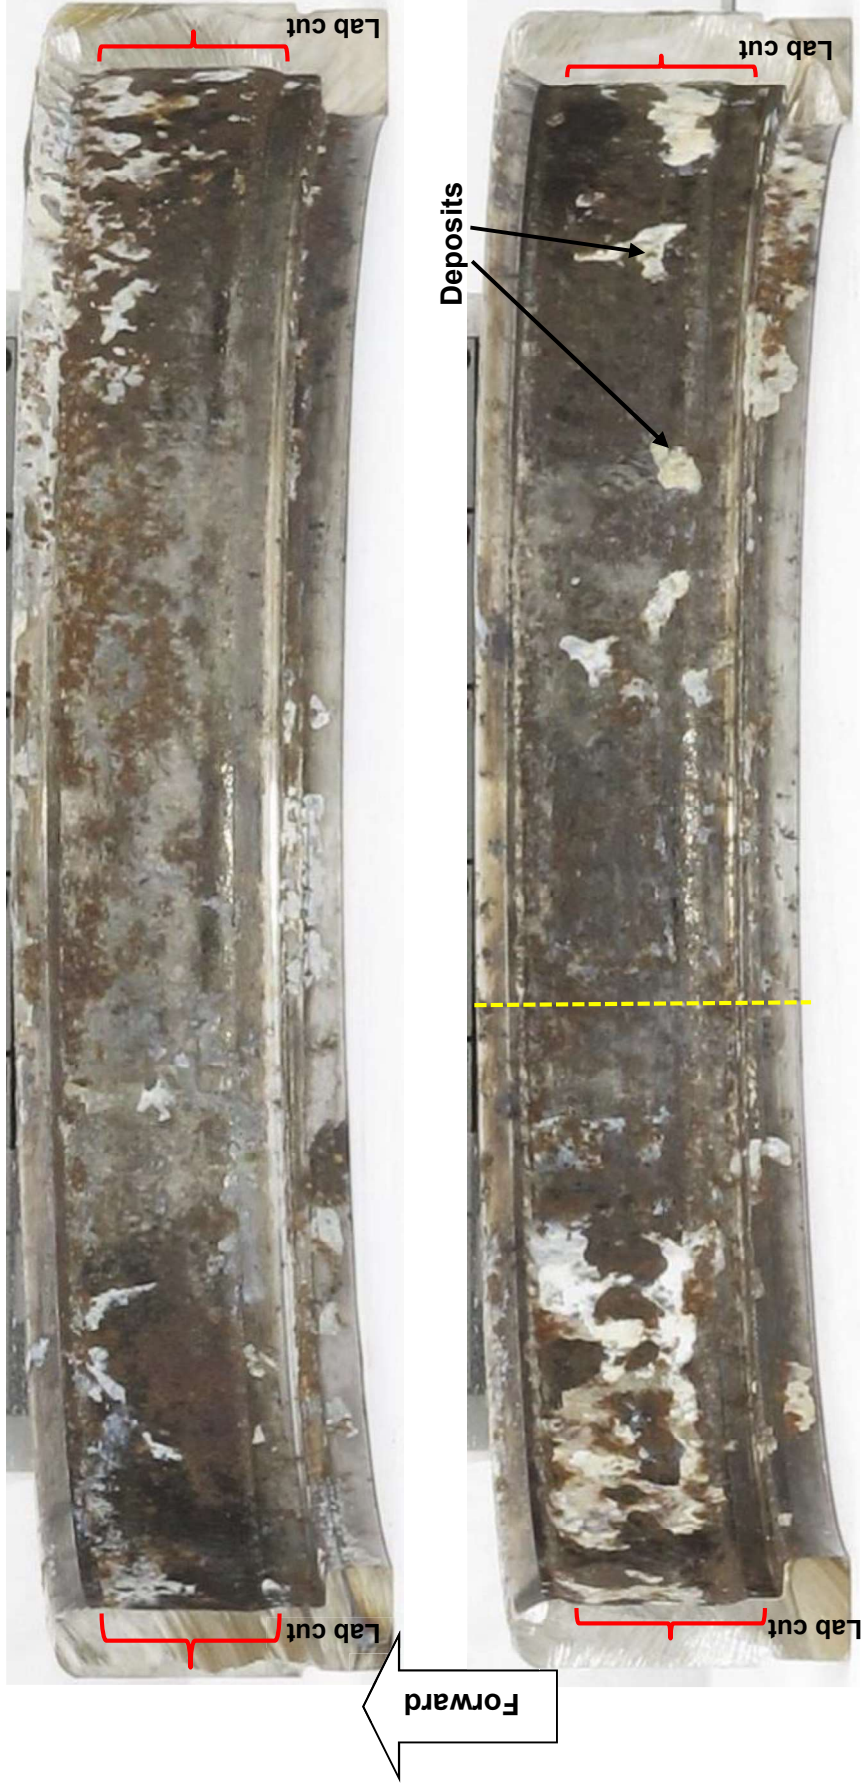
The No.4 bearing outer ring was sectioned out of the bearing-stepped pinion cage in the laboratory, then ultrasonic cleaned and manual cleaned with pumice soap. Figure 32 and Figure 33 shows general and detailed views of outer raceway surface of the No. 4 bearing outer ring, which exhibited material removal at the roller path. Circumferential rub damage was observed on the aft shoulder corner. The outer ring also exhibited oxidation and lighter colored deposits. Figure 34 shows a representative view of outer diameter of the outer ring, which exhibited discoloration.

Figure 32. Two views of the No. 4 bearing outer ring, after it was sectioned and cleaned, showing the condition of the outer raceway surface. Red braces mark the location of material removal at the roller path, and the yellow dashed line marks the plane of metallographic evaluation (see Figure 41).

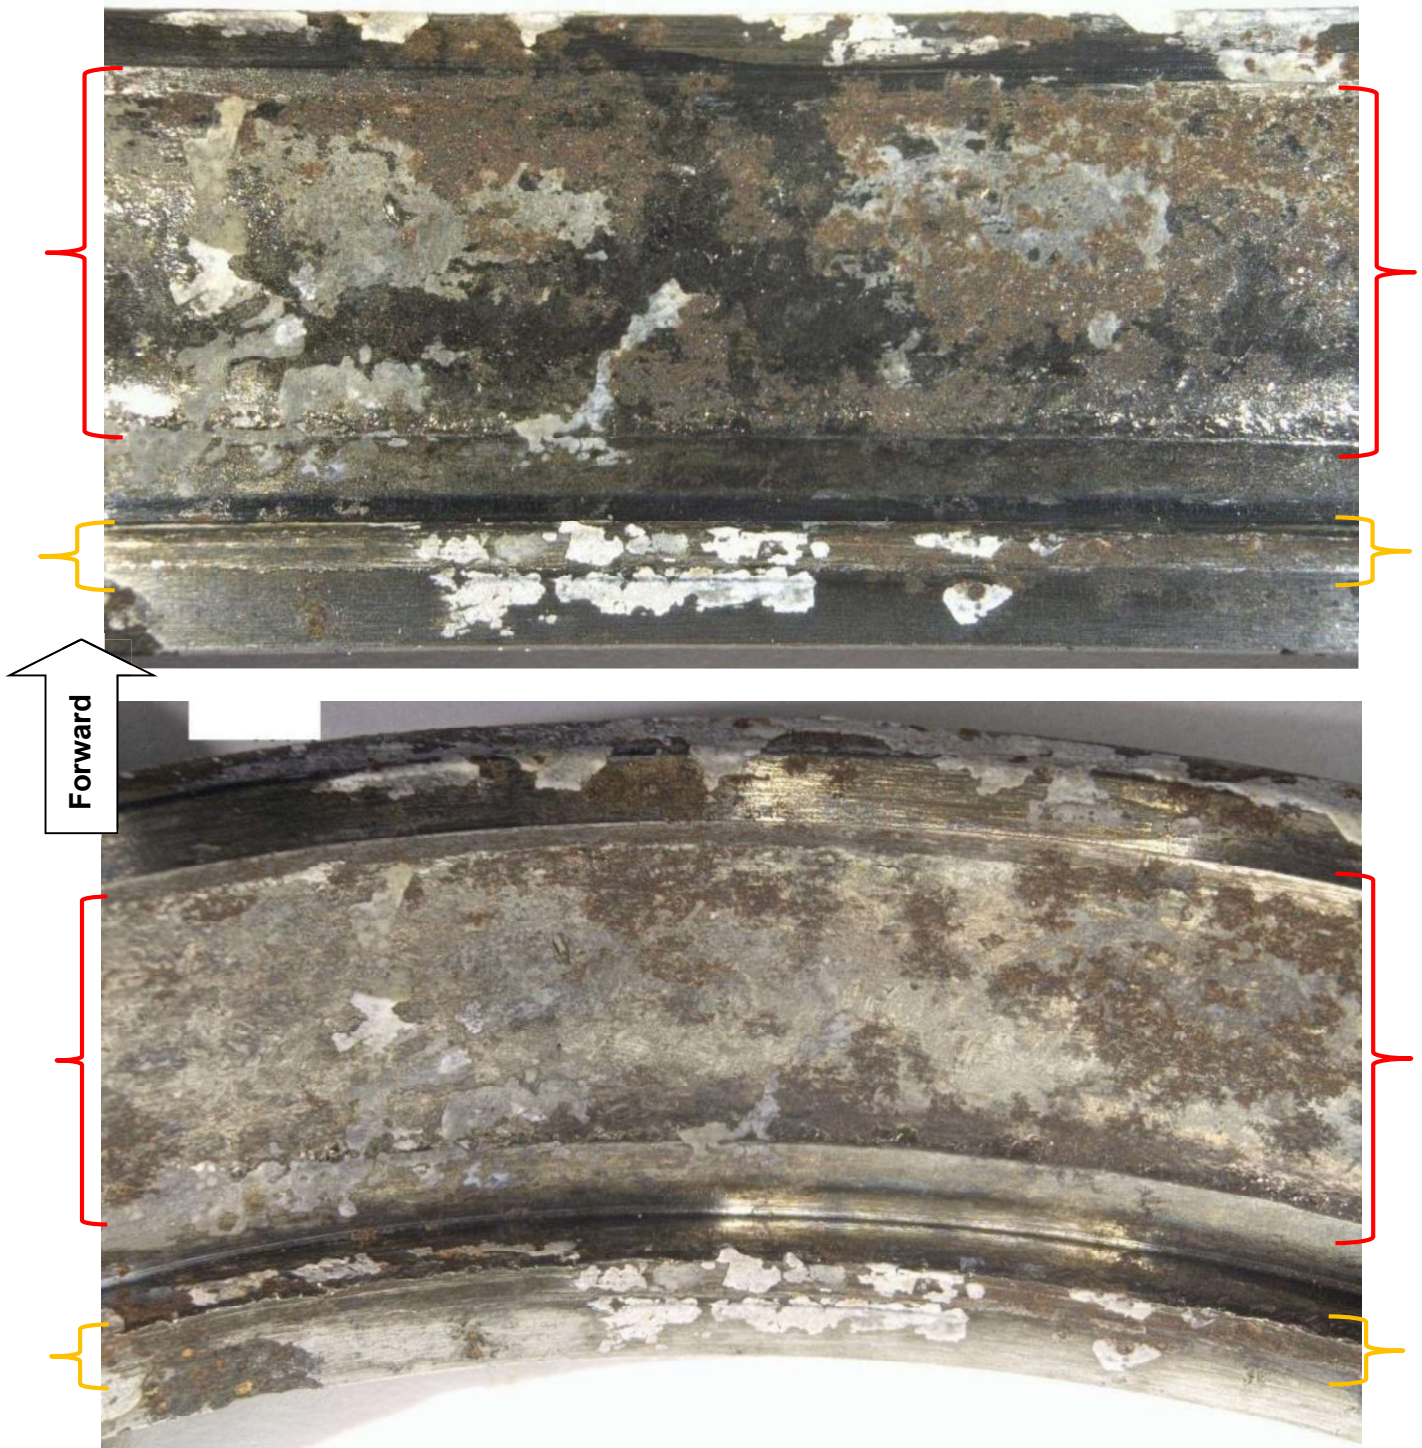
**Figure 33. Detailed inboard looking outboard and oblique views of the No. 4 bearing outer ring raceway. Red braces mark the location of material removal at the roller path, and the orange braces mark rub damage on the aft shoulder corner.**

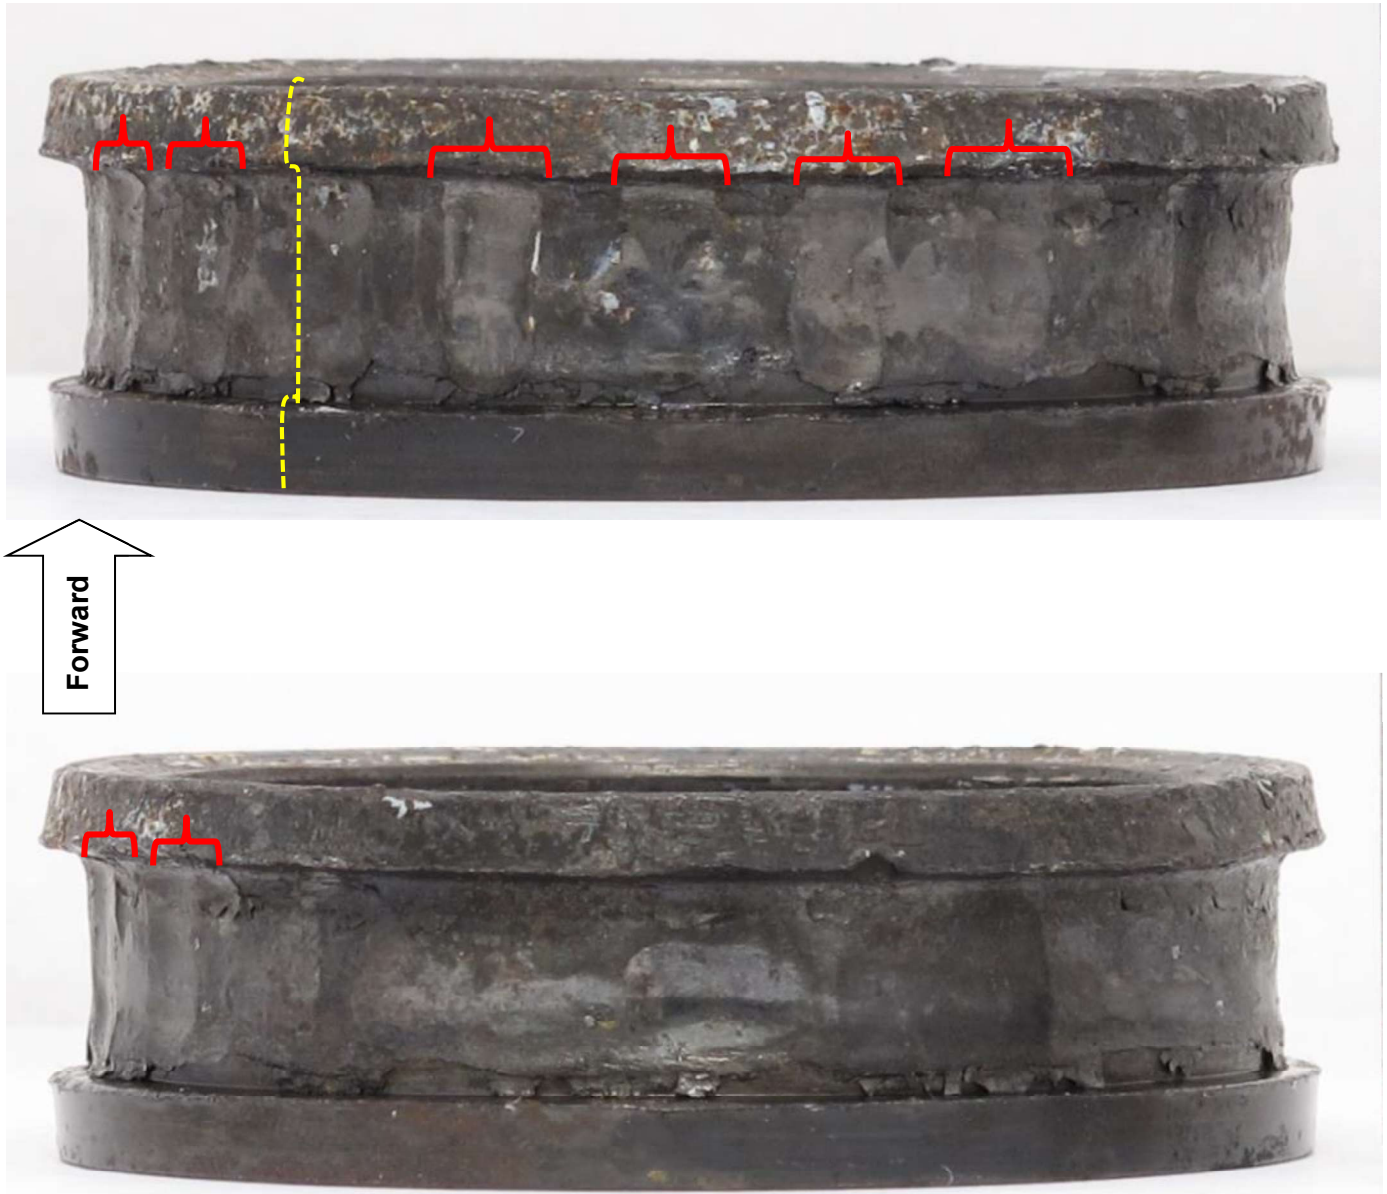
The general condition of the inner ring, after ultrasonic cleaning and manual cleaning with pumice soap, is shown in Figure 35 and Figure 36, which exhibited transferred material on the raceway. Figure 37 shows the profile of the inner ring raceway. Roller impressions were observed on the raceway, and the forward shoulder was deformed forward. The inner diameter of the inner ring exhibited circumferential rub and transferred material (see top image in Figure 38), and the forward face of the forward shoulder exhibited rub damage (see bottom image in Figure 38).

**Figure 35.** General views of the No. 4 bearing inner ring after cleaning showing the condition of the inner raceway surface, which exhibited transferred material. Red braces mark the location of roller impressions, and the yellow dashed line marks the plane of metallographic evaluation (see Figure 41).
