| <b>Rolls-Royce</b> | Rolls-Royce Corporation<br>450 S. Meridian Street<br>Indianapolis, Indiana<br>46225-1103, USA | <b>REPORT NO.</b><br>20FAE-014-PR | <b>REV.</b><br>Initial | <b>PAGES</b><br>1 of 135 |
| <b>TITLE</b><br><br><b>METALLURGICAL INVESTIGATION OF A HELICAL POWER TURBINE PINION GEAR, P/N 6893672, INSTALLED IN AN M250-C47B ENGINE, S/N CAE847031, OPERATED BY PANTHER HELICOPTERS</b> | | <b>PREPARED</b><br><br>Signatures on file | | |

| Engine Model: | M250-C47B |
| Evaluations: | Failure Analysis |

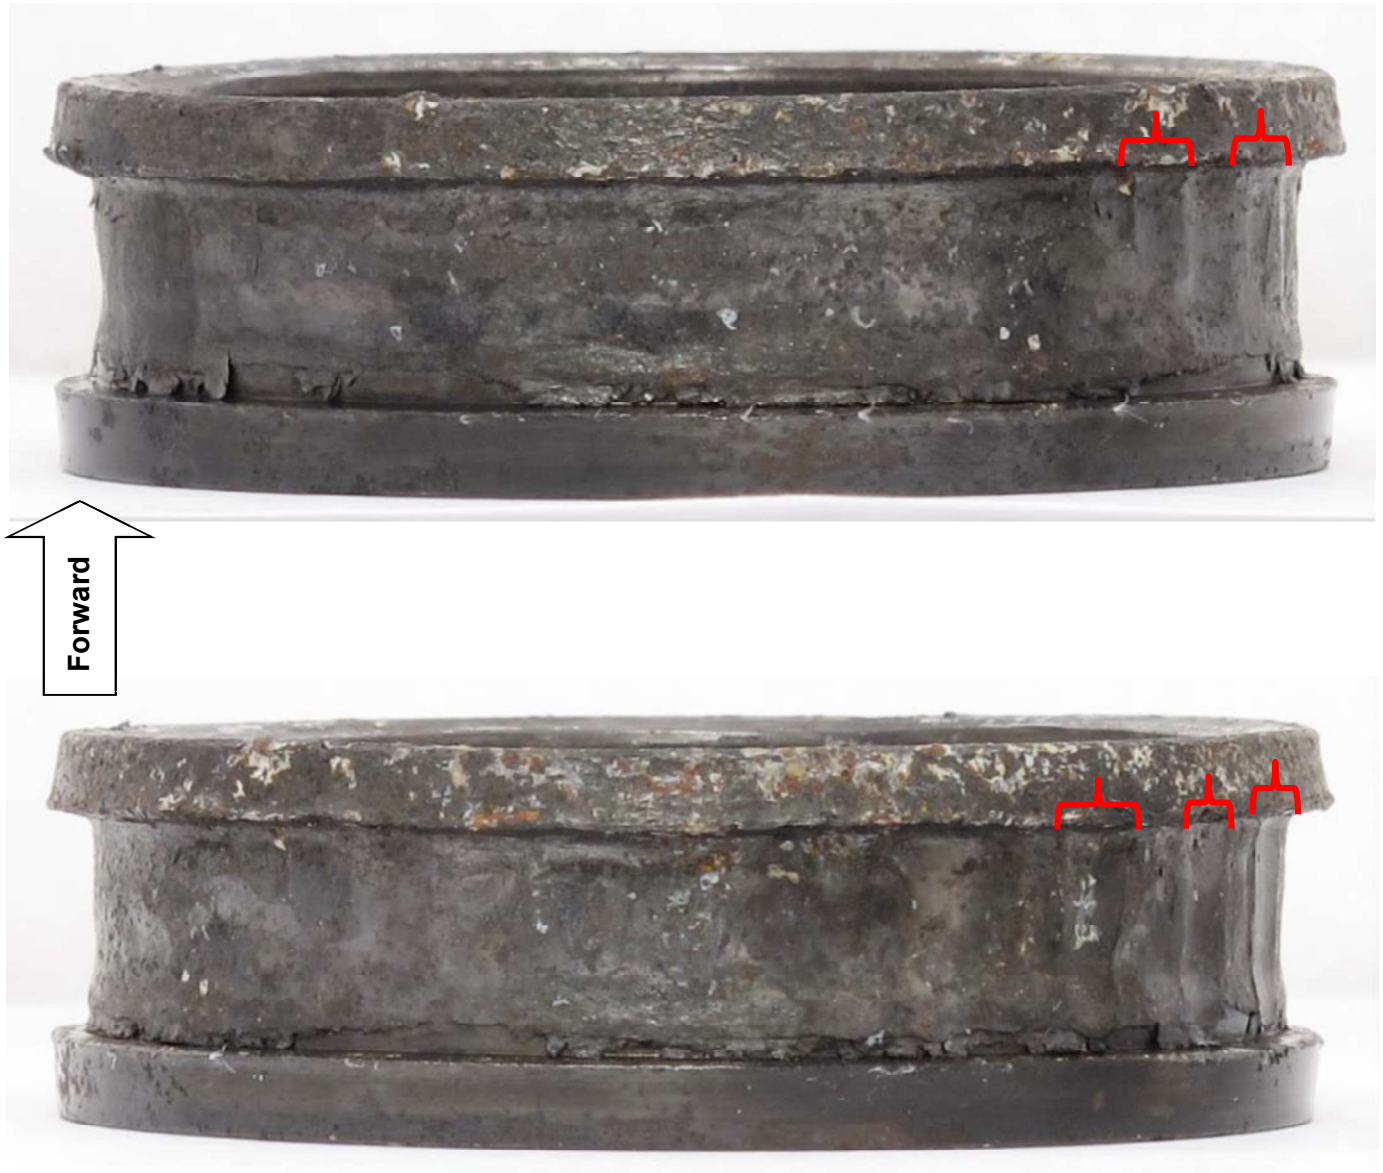
**Figure 36. General views of the No. 4 bearing inner ring after cleaning showing the condition of the inner raceway surface, which exhibited transferred material. Red braces mark the location of roller impressions.**

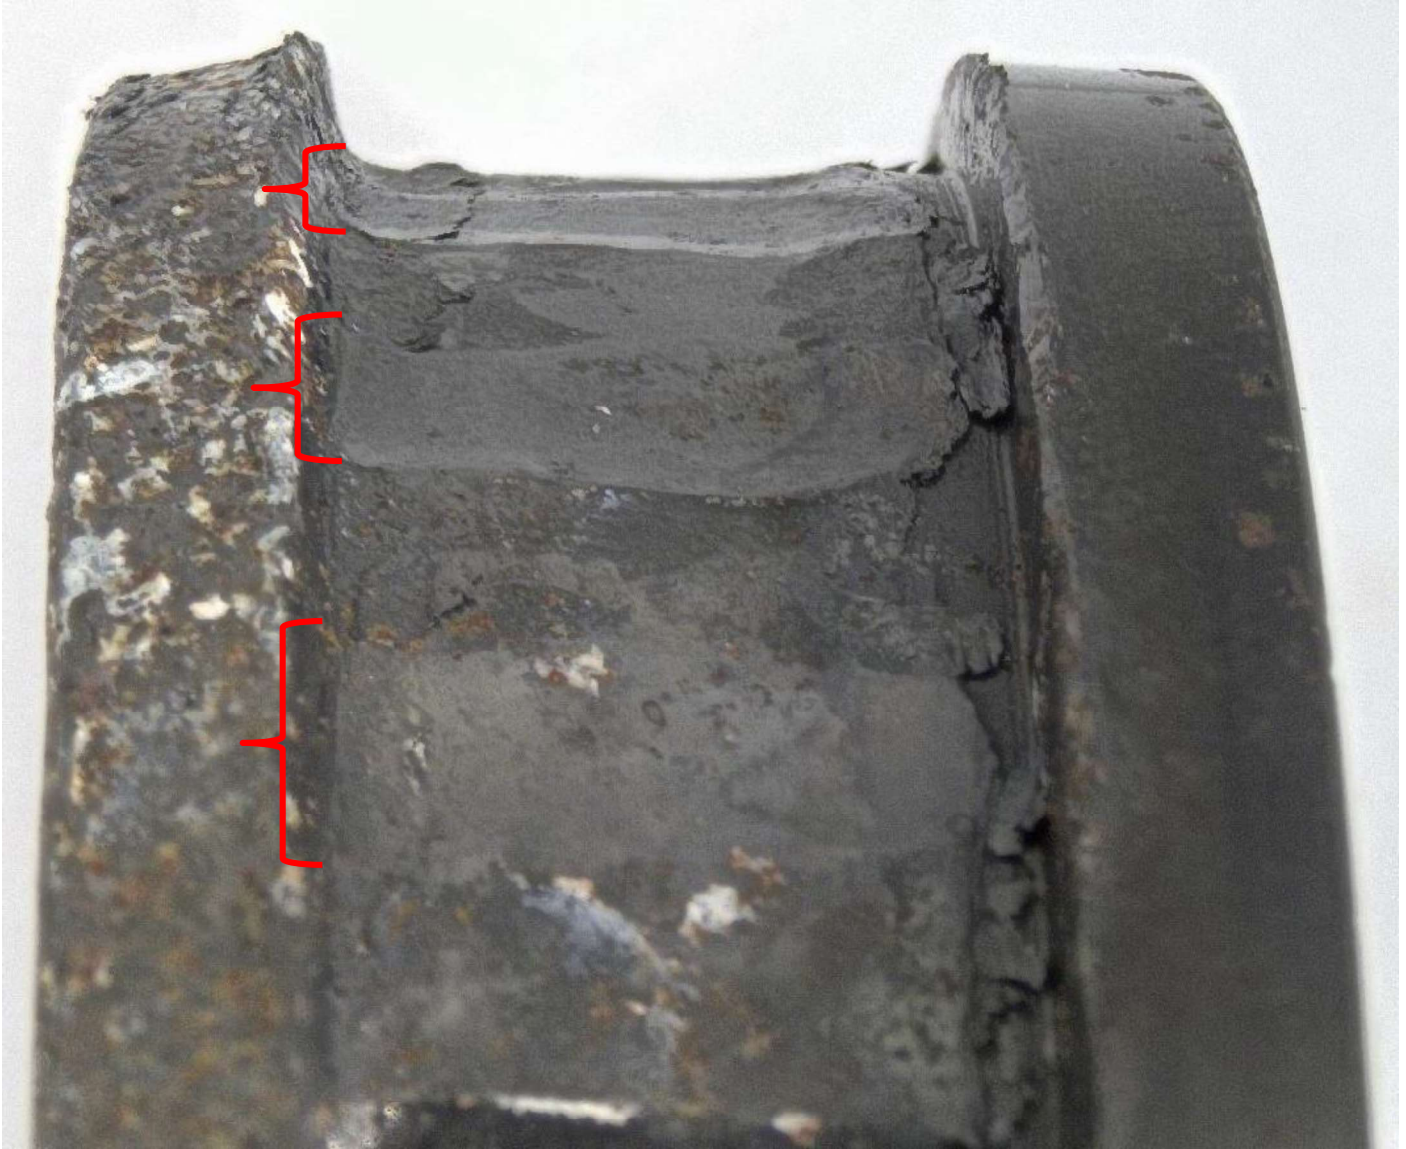
**Figure 37. Detailed view of the inner raceway, which exhibited transferred material. Red braces mark the location of roller impressions. The forward shoulder was deformed forward.**

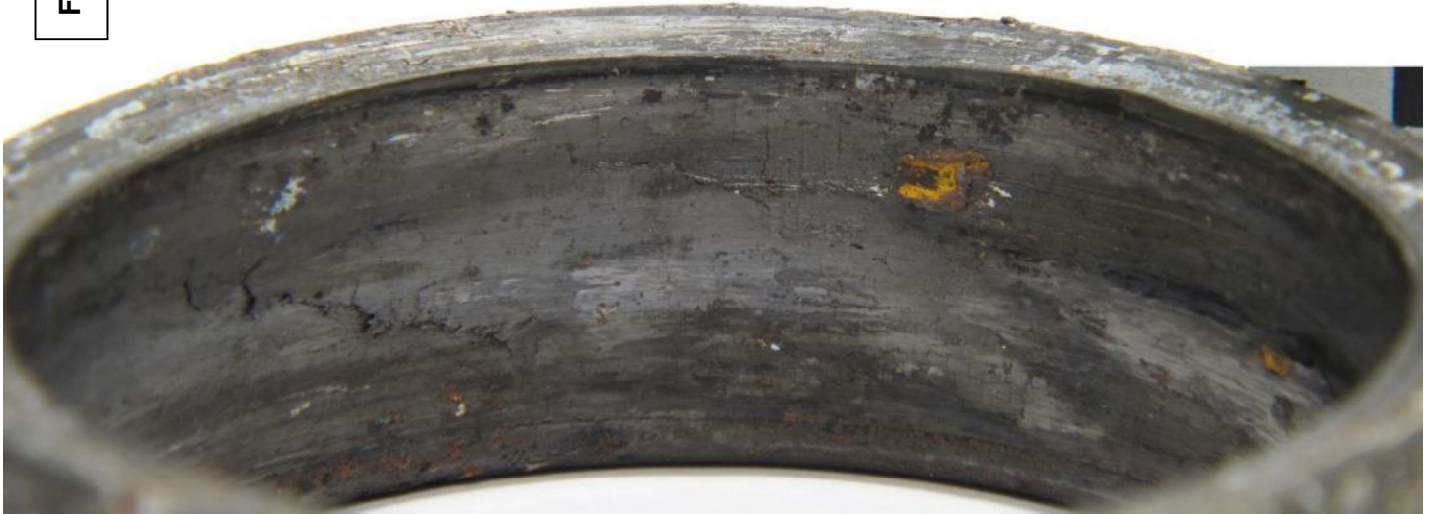
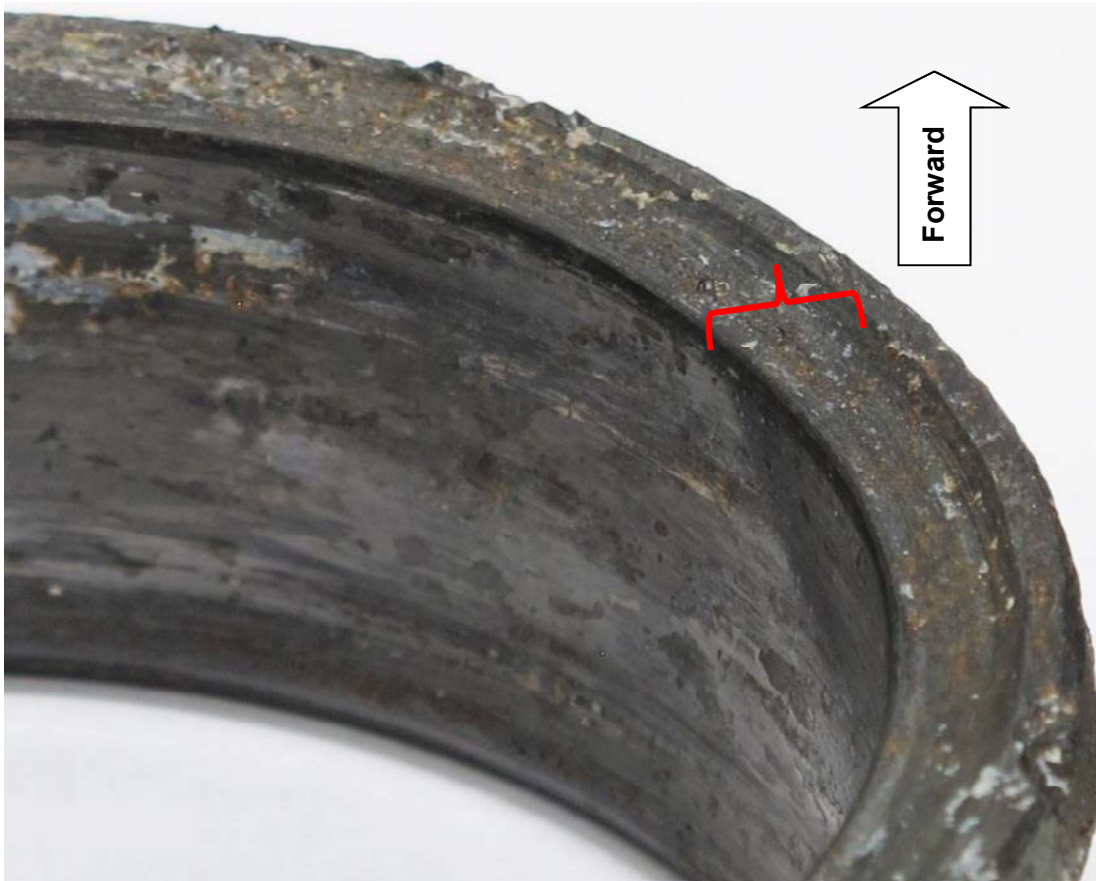
**Figure 38.** Top: General condition of the inner diameter of the inner ring, which exhibited circumferential rub and transferred material. Bottom: Detailed view of the forward face of the forward shoulder, which exhibited rub damage (red brace).

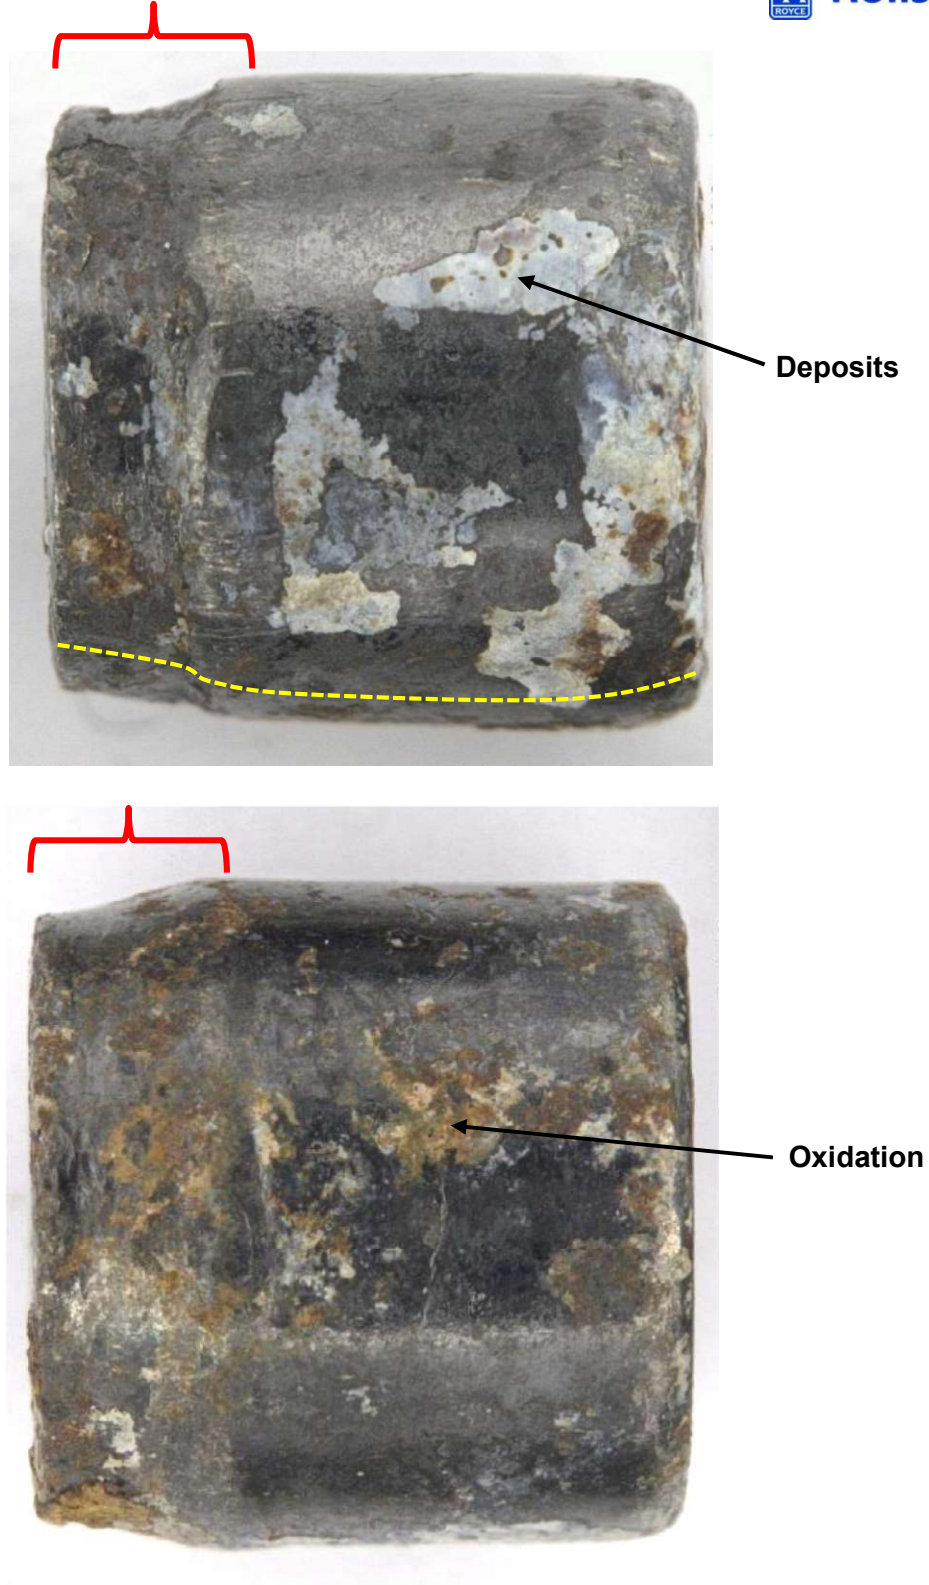
Figure 39 shows the general condition of the No. 4 bearing rollers after ultrasonic cleaning and manual cleaning with pumice soap. Nine out of the twelve rollers were recovered. A circumferential rub step was observed on one corner of the roller diameters (see Figure 40). The rollers also exhibited oxidation and lighter colored deposits.

**Figure 40.** Detailed views of two representative rollers, which exhibited a circumferential rub step (red brace) on one corner of the diameter. Yellow dashed line marks the plane of metallographic evaluation (see Figure 41).

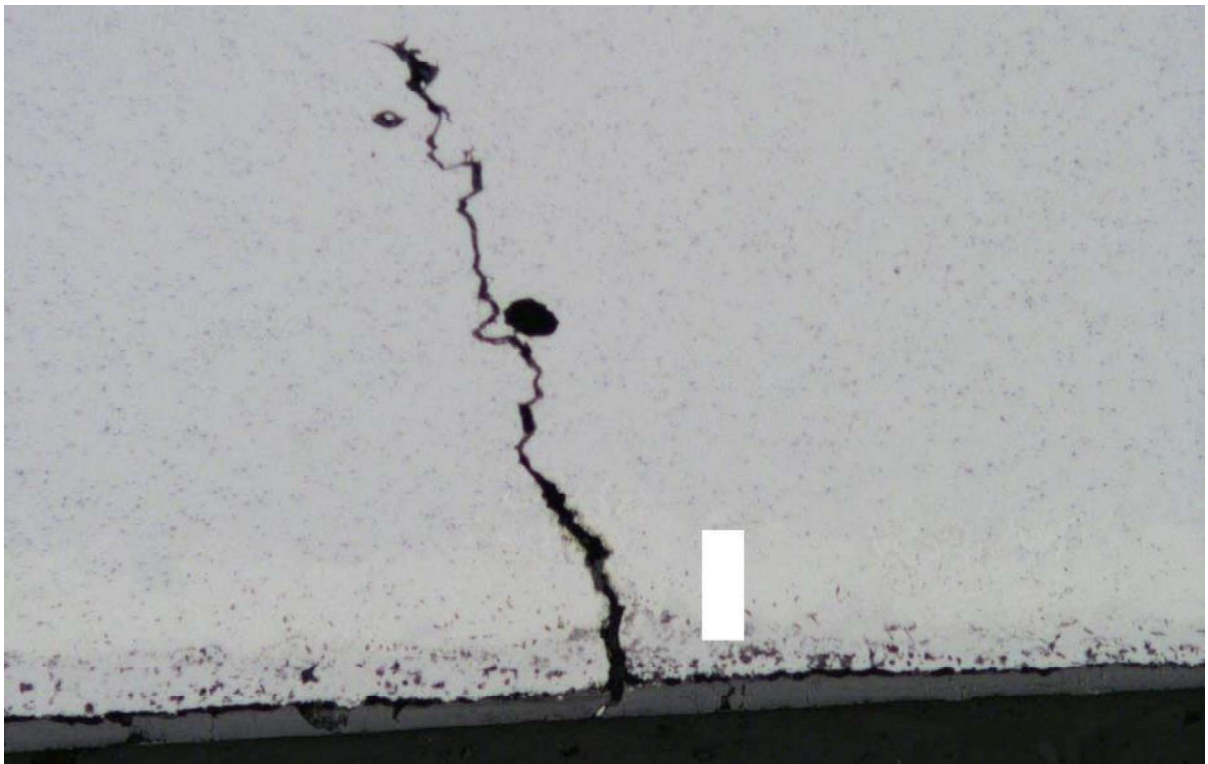
**Figure 43. Metallographic cross-section through the inner diameter of the inner ring (location H in Figure 41), which exhibited cracking. Etchant: Vilella's**

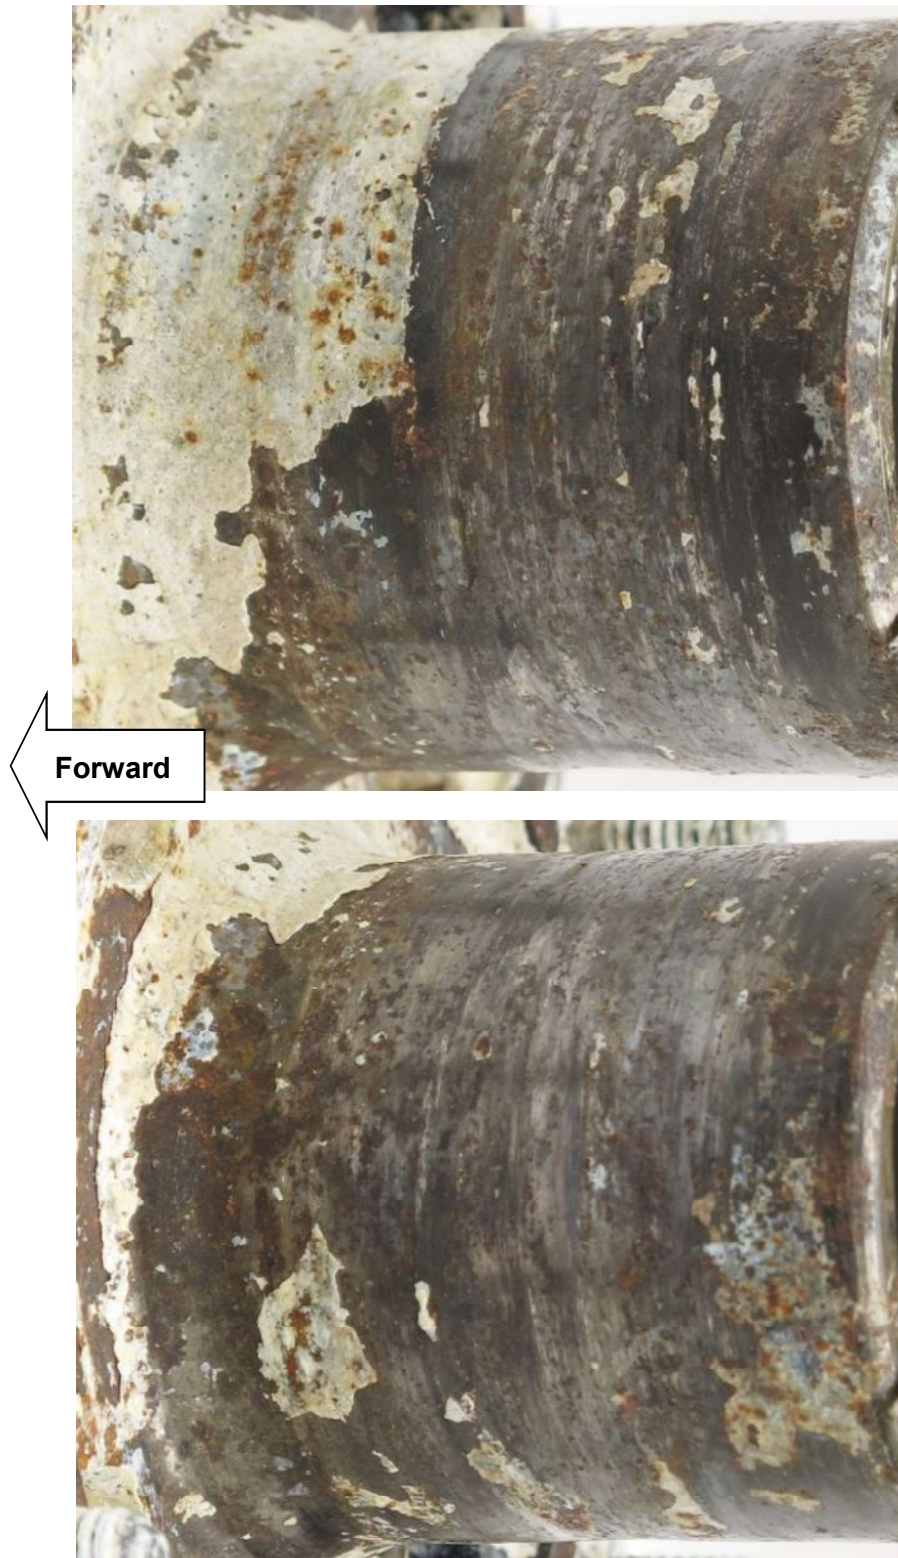
**Figure 47. Detailed views of outer diameter of the flanged No. 2.5 bearing support cage, which exhibited circumferential rub. Each image shows the part rotated  $\sim 90^\circ$  from the previous.**

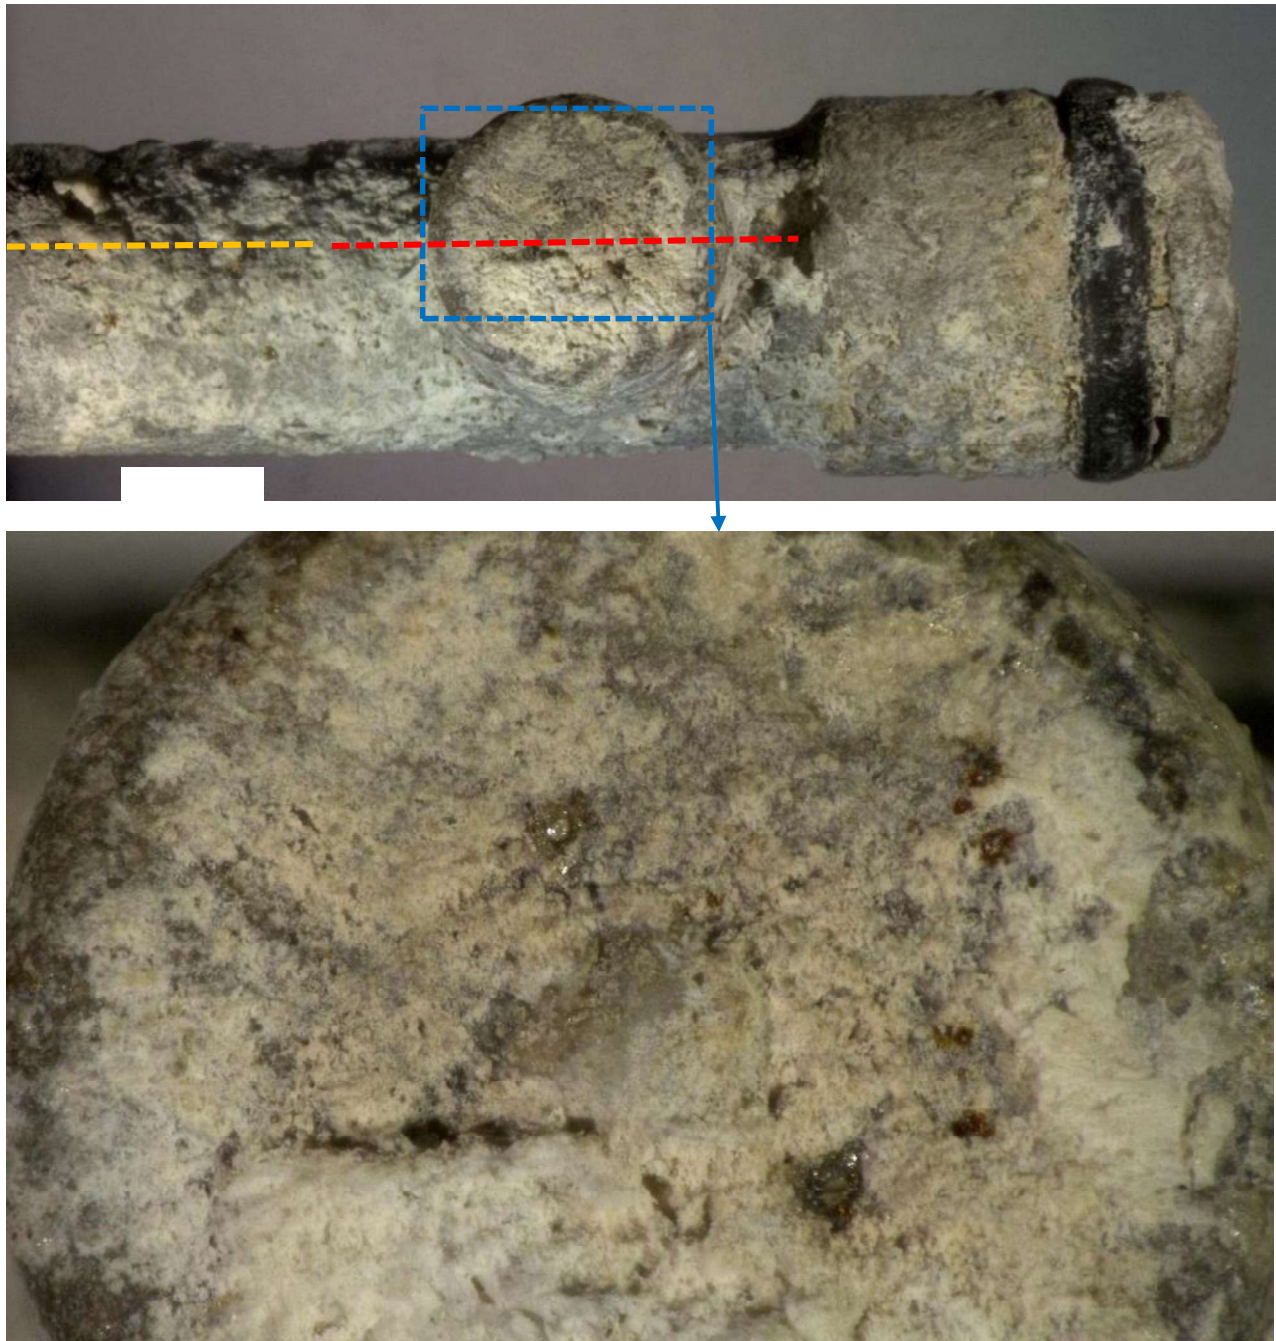
**Figure 54.** Detailed views of the pinion gear oil jet on the oil delivery tube, which was coated in deposits. The red and orange dashed lines mark the planes of metallographic evaluation (see Figure 61 and Figure 62, respectively).

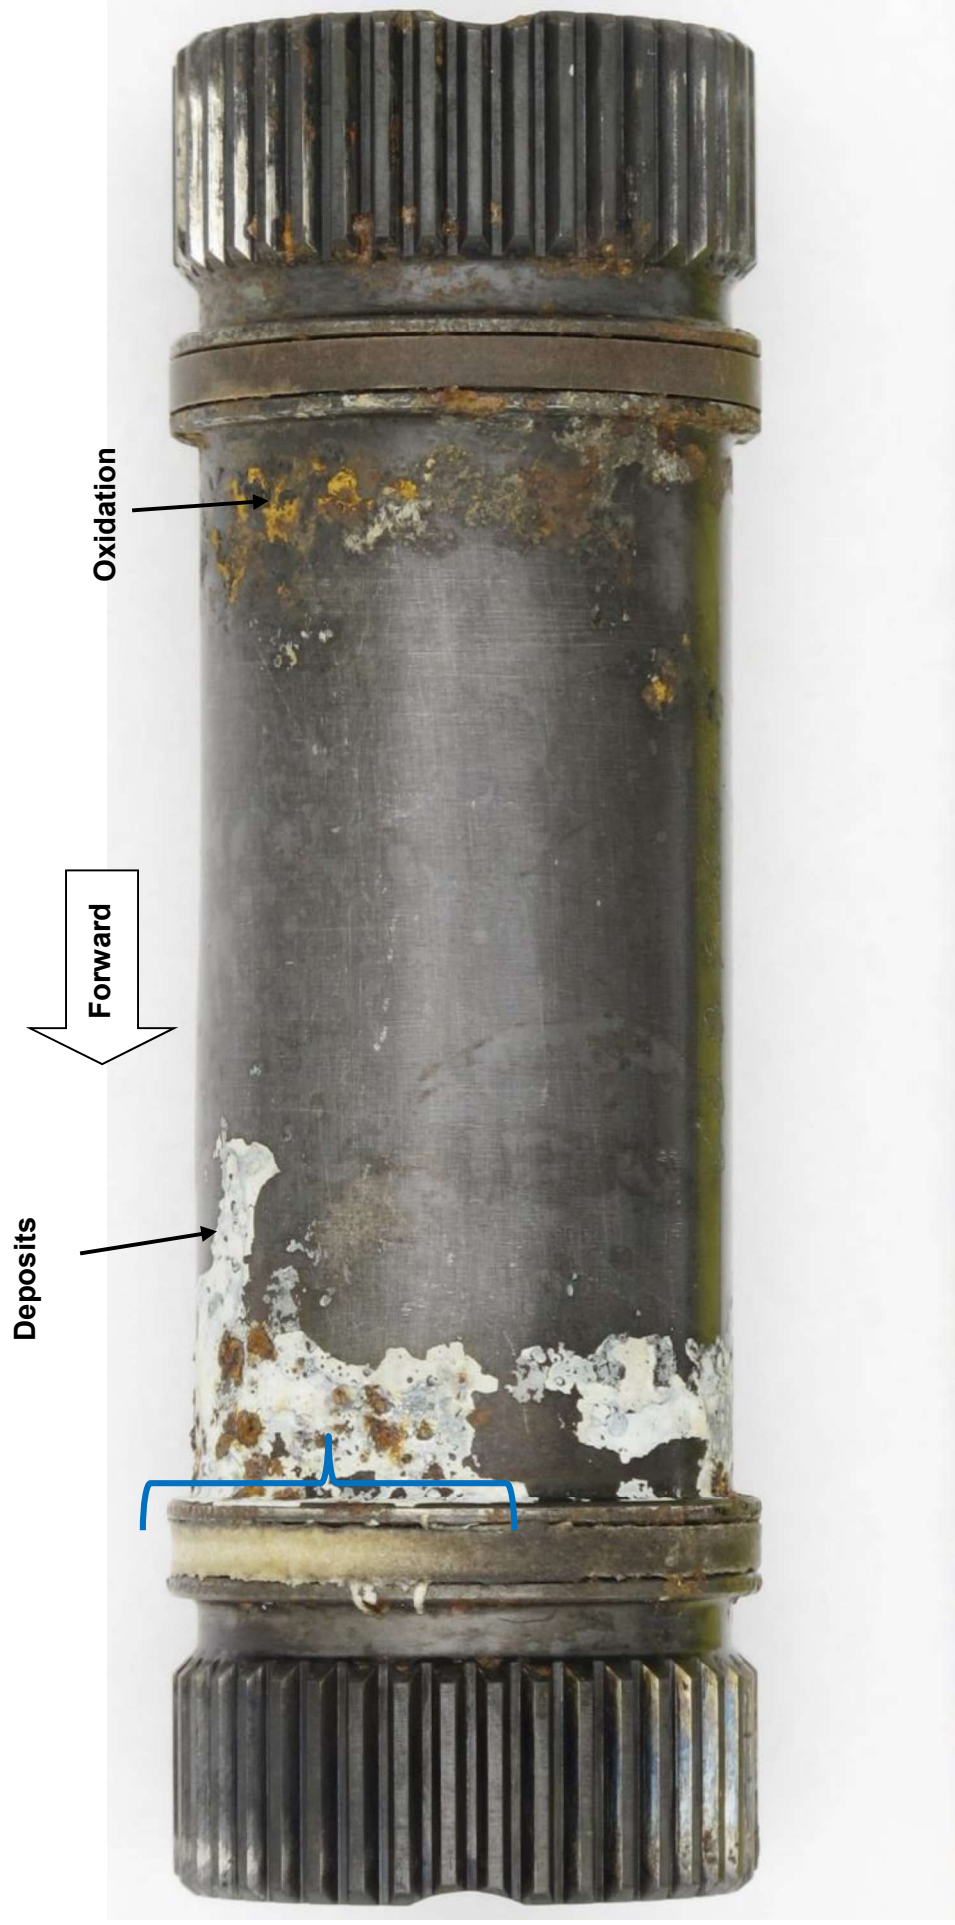
Figure 76. General condition of the turbine shaft to pinion coupling after cleaning. Blue brace marks evidence of thermal distress on the ring seal.

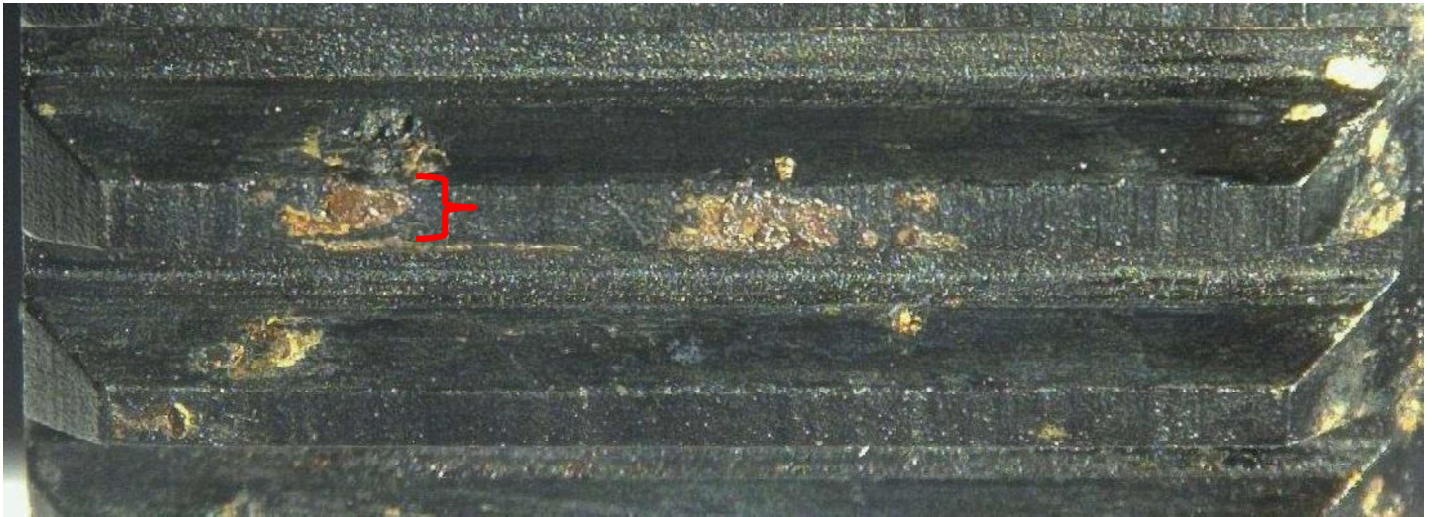
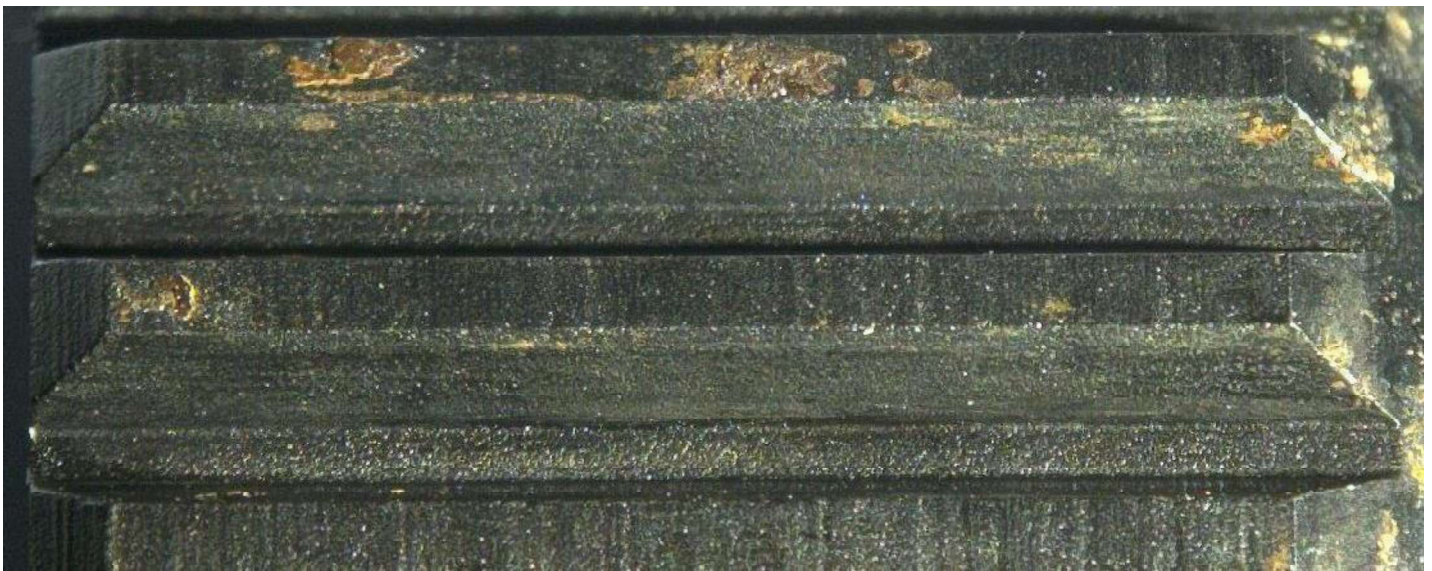
**Figure 77.** Detailed views of the loaded (top) and unloaded (bottom) flanks of the forward splines on the turbine shaft to pinion coupling. Red brace marks a region on the loaded flank on one spline where material fractured away.

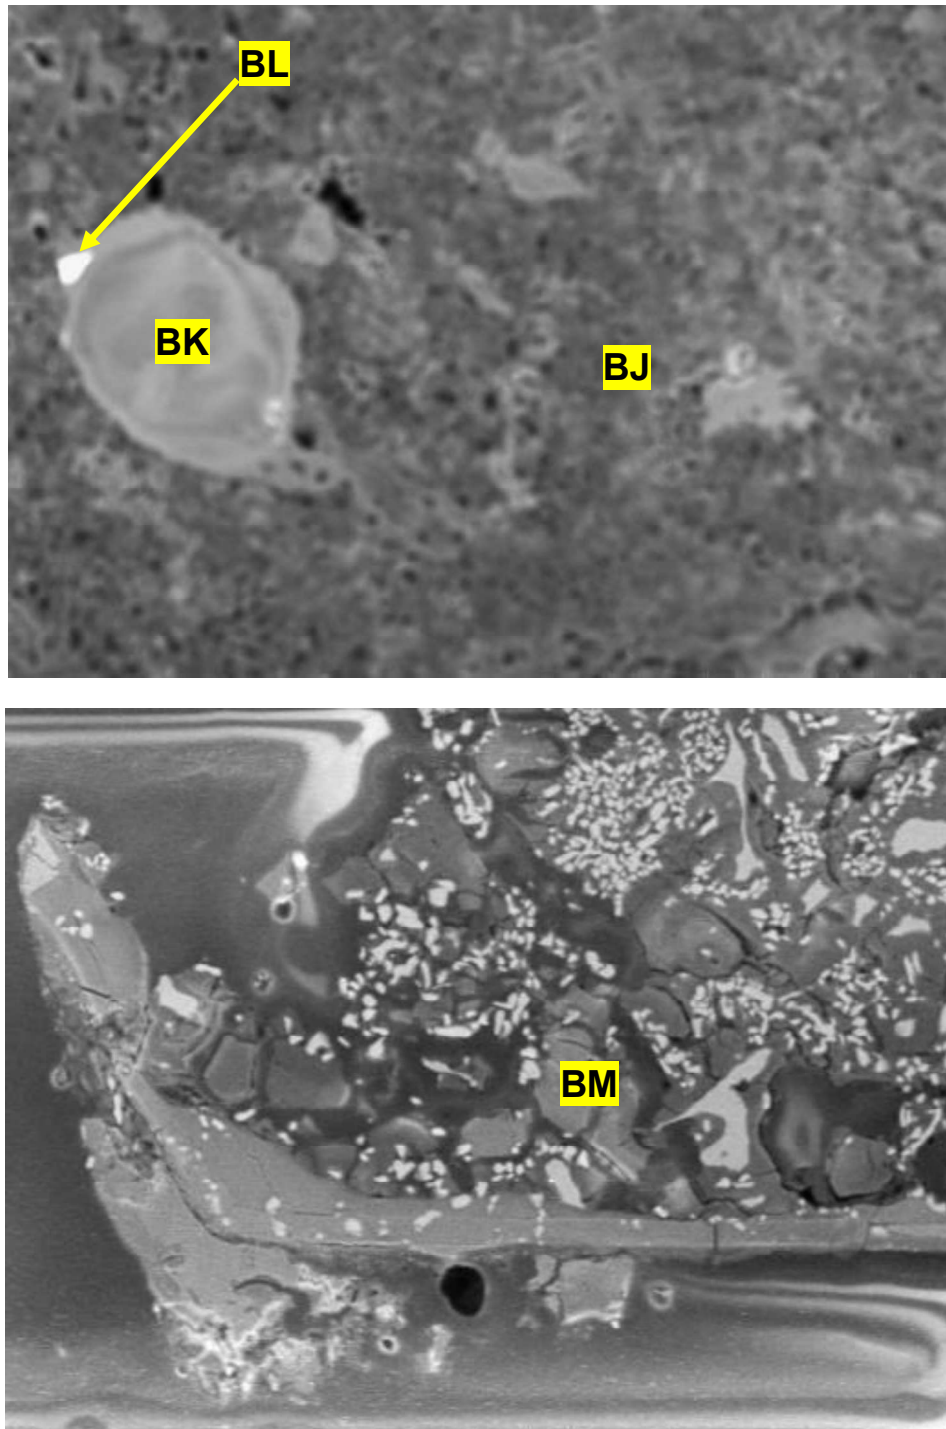
**Figure 116.** Backscattered scanning electron microscope images of the blockage in No. 4 bearing oil jet B of the oil nozzle (top image, see red boxed area in the previous figure) and corrosion in the base material adjacent to hole (bottom image, see blue boxed area in Figure 114). Semi-quantitative EDS results for material at locations BJ through BM are shown in more detail in Figure 118 and Figure 119.

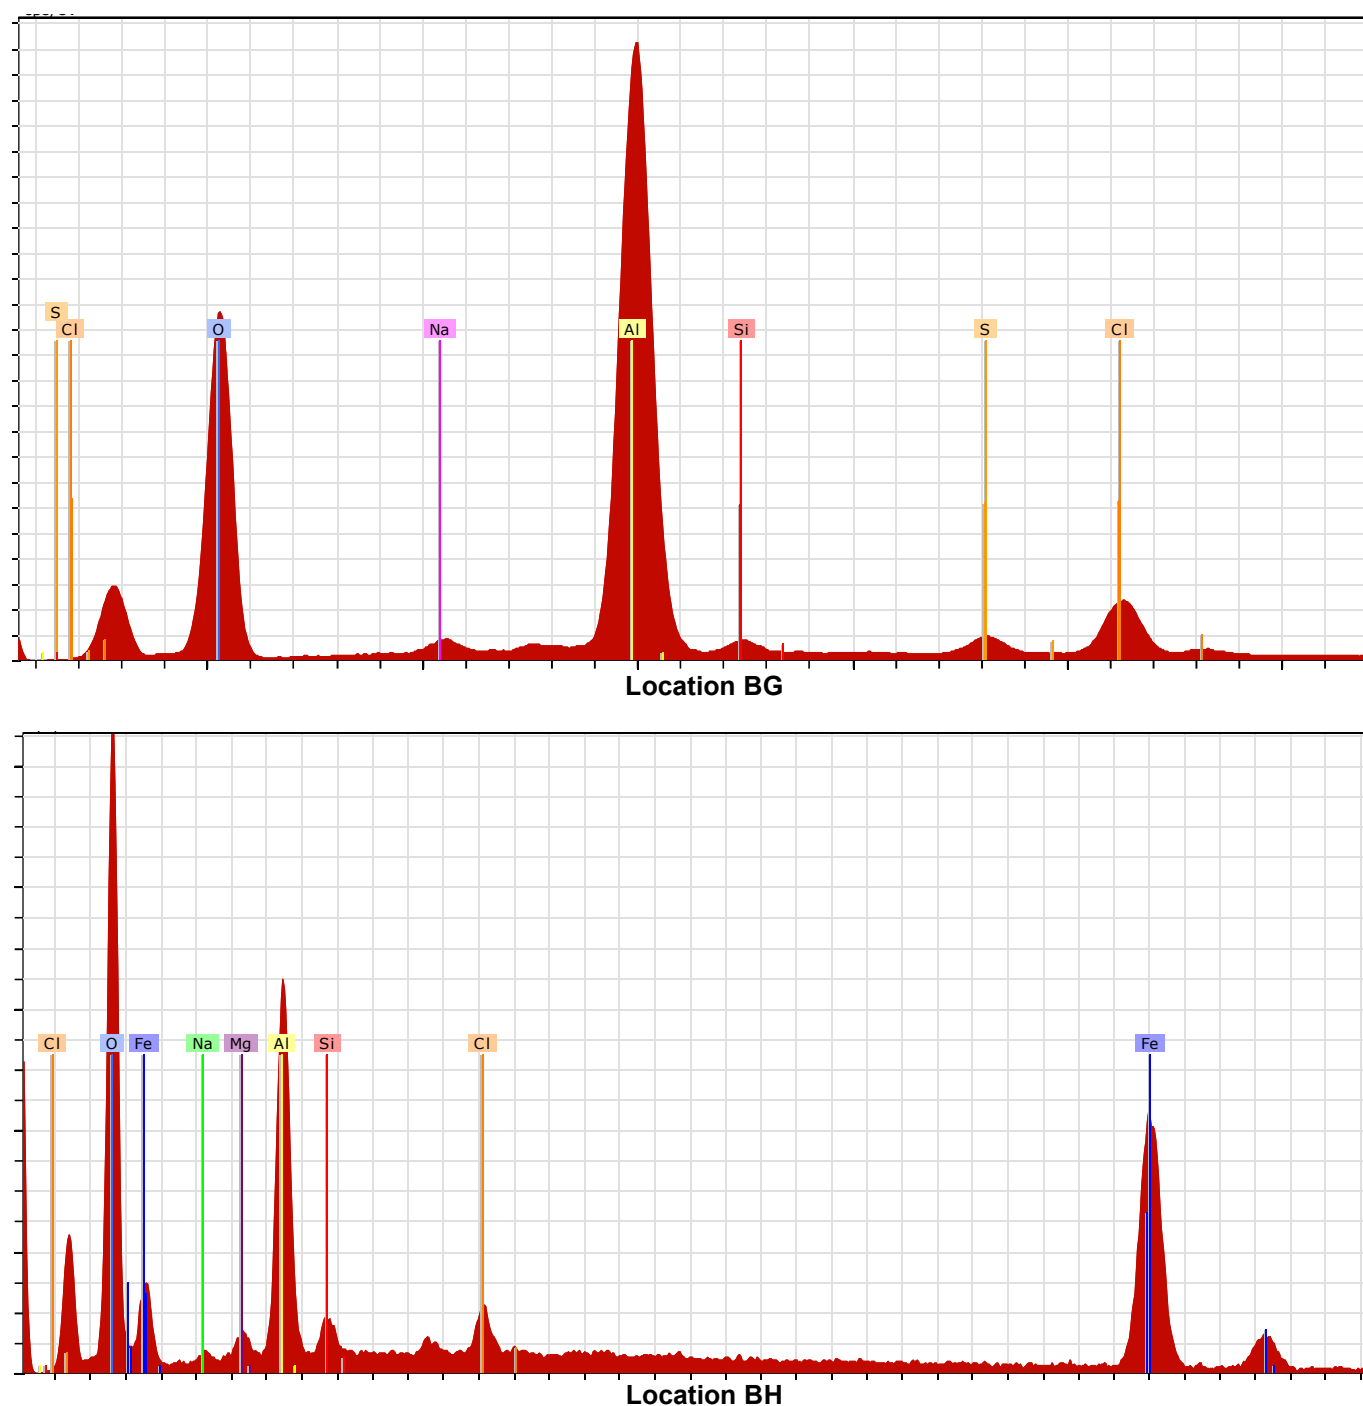
**Figure 117. Semi-quantitative EDS results for blockage material at locations BG and BH in No. 4 bearing oil jet B of the oil nozzle (see Figure 115). The blockage at location BG exhibited concentrations of aluminum, oxygen, chlorine, sodium, sulphur, and silicon. The blockage at location BH exhibited concentrations of iron, oxygen, aluminum, silicon, magnesium, and chlorine.**

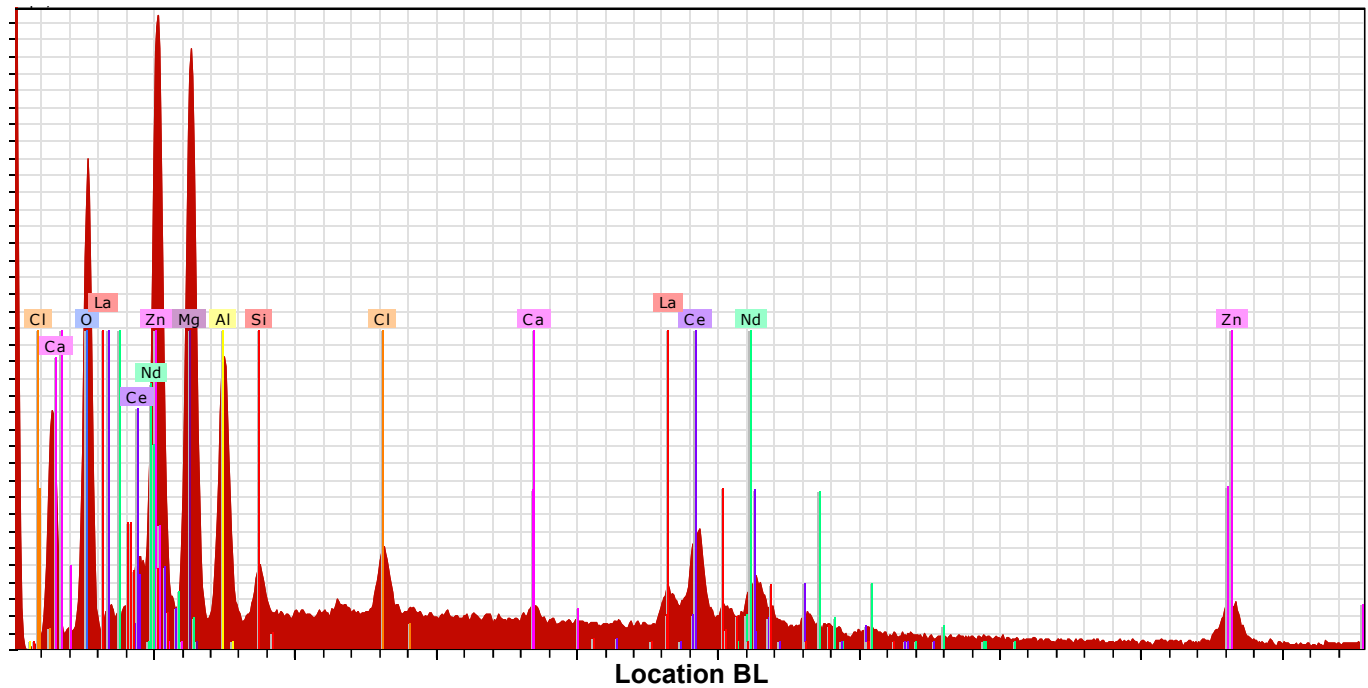
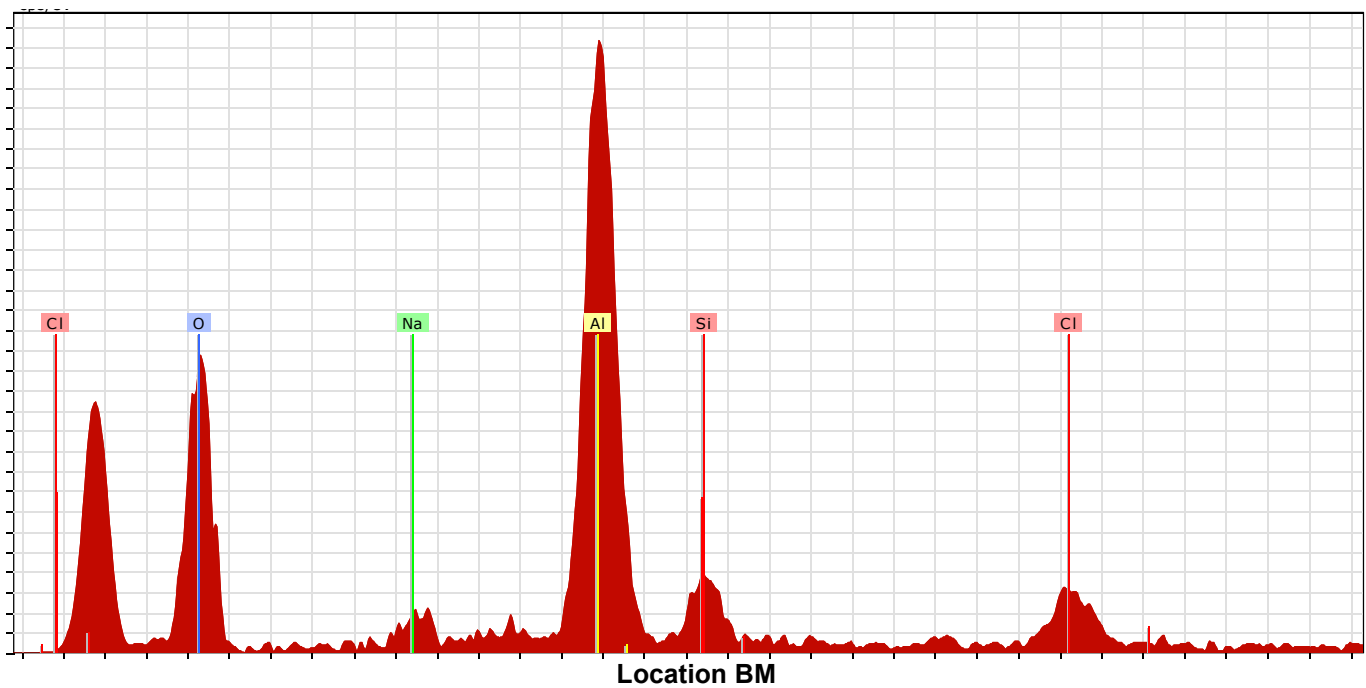
**Figure 119.** Semi-quantitative EDS results for blockage material at locations BL and BM in No. 4 bearing oil jet B of the oil nozzle (see Figure 116). The blockage at location BL exhibited concentrations of magnesium, oxygen, zinc, aluminum, rare earth metals, chlorine, and silicon. The corroded base material at location BM exhibited concentrations of aluminum, oxygen, chlorine, silicon, and sodium.

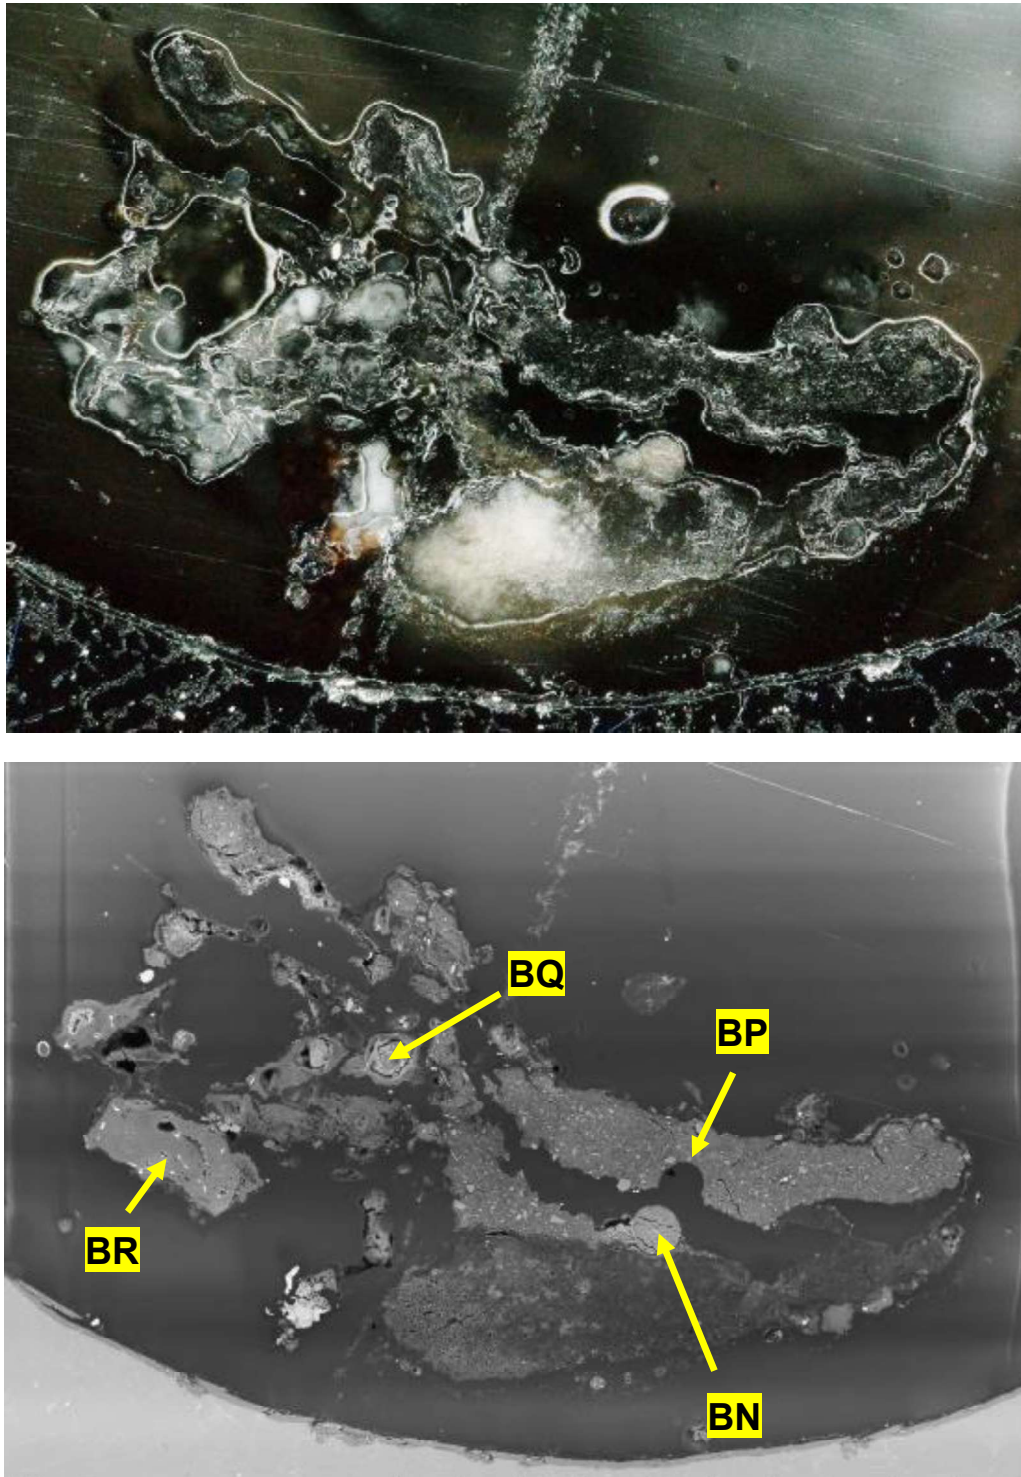
**Figure 120. Optical (top) and backscattered electron SEM (bottom) images of the metallographic section through debris in the oil nozzle main passage (see orange boxed area in Figure 73). locations BN through BR are shown in more detail in the following figures.**
