# National Transportation Safety Board

CEN20FA070

## **WRECKAGE EXAMINATION SUMMARY**

Location: Springfield, Illinois  
Date: January 28, 2020  
Time: 1503 central standard time  
Airplane: Piper PA-60-601P, Registration No. N6071R

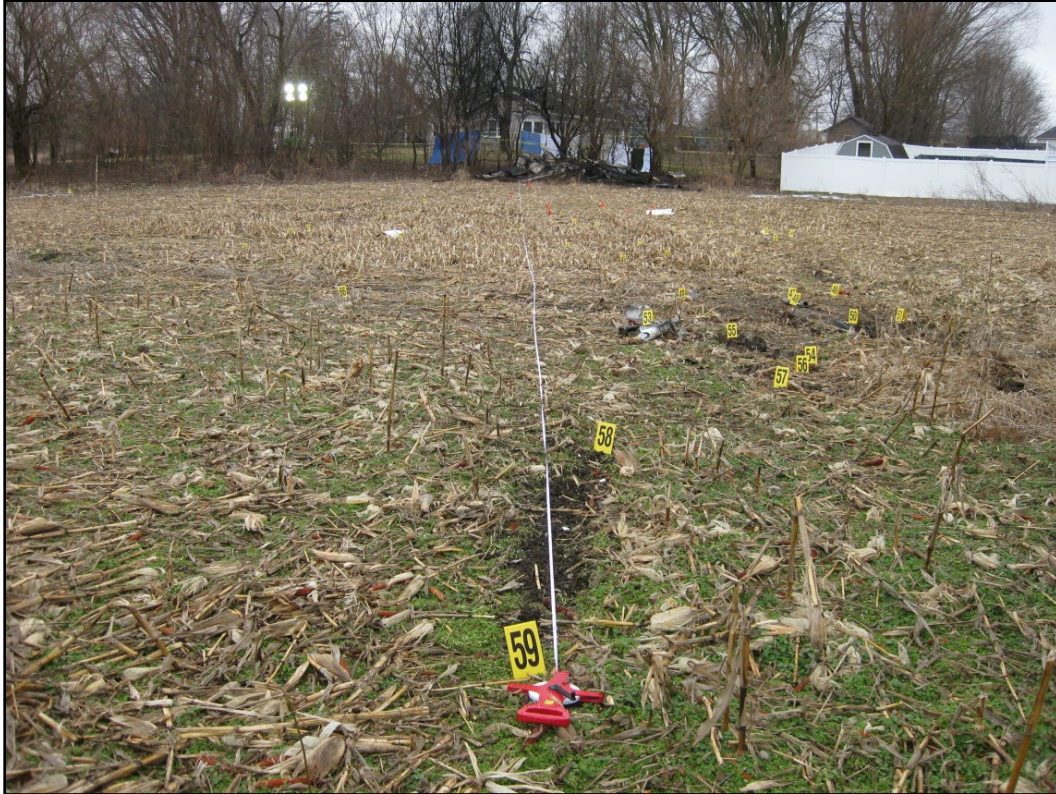
**Figure 1** - Initial Impact Point

The airplane impacted a harvested cornfield about 6.3 nm southeast of the runway 31 threshold, and about 1 nm left of the localizer centerline. A 200 ft long debris path, oriented on a 248° magnetic heading, preceded the location of the main wreckage. The airplane's left wingtip impacted the ground first, followed by the left and right propellers, respectively. The nose landing gear wheel was found separated from the fork assembly about 40 ft from the initial point of impact. The outboard 2.5 ft of the left aileron was found separated from the left wing along the wreckage debris path.

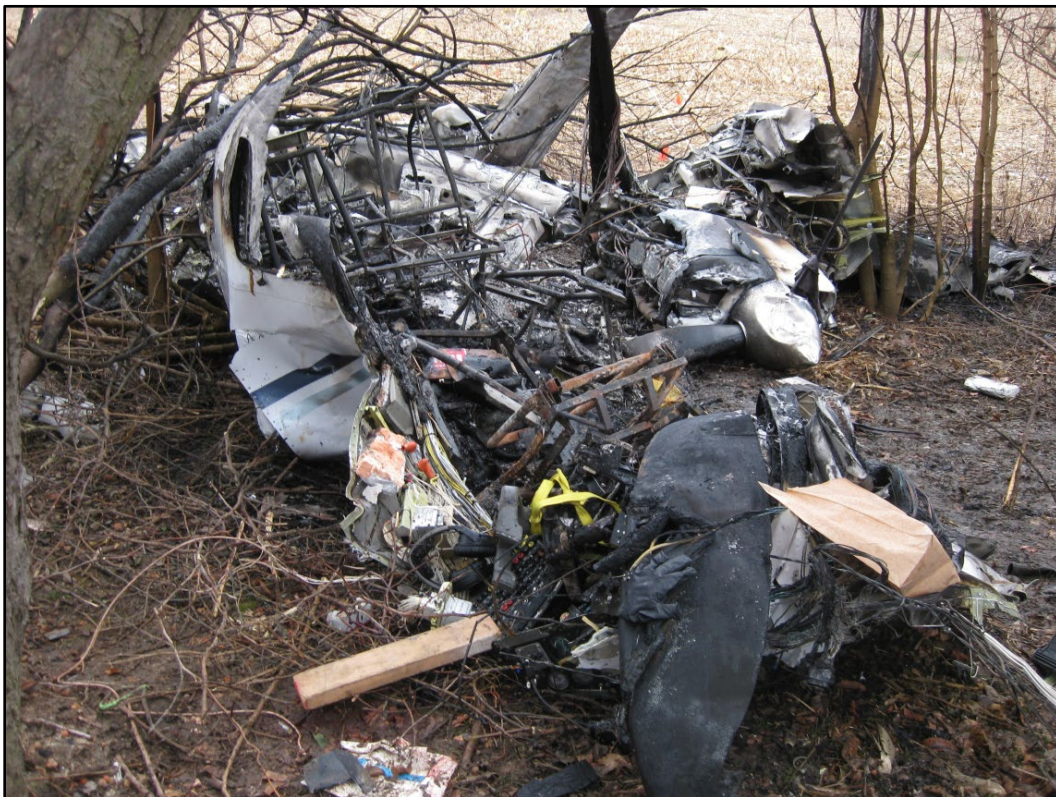
**Figure 2** - Main Cabin

The main wreckage came to rest at the western edge of the cornfield amongst several trees and a wire fence, and consisted of the entire fuselage, both wings, and the empennage. The fuselage cabin and cockpit exhibited extensive damage from the postaccident fire.

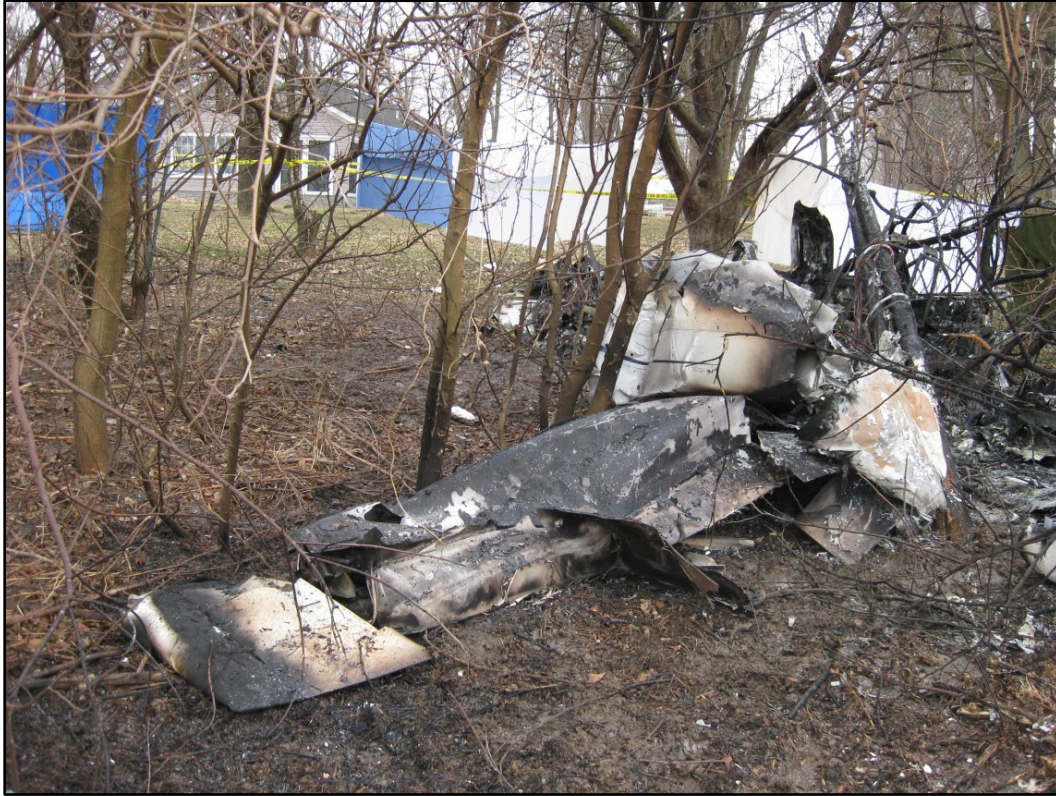
**Figure 3** - Left Wing

Both wing spars were fractured at their wing roots and each wing remained partially attached to the fuselage by engine control cables. Flight control continuity could not be verified because the control push/pull tubes for the ailerons, elevators, and rudder exhibited extensive impact and fire damage. Both ailerons and flaps exhibited impact and fire damage. The hydraulic flap actuators were found extended about 1.5"

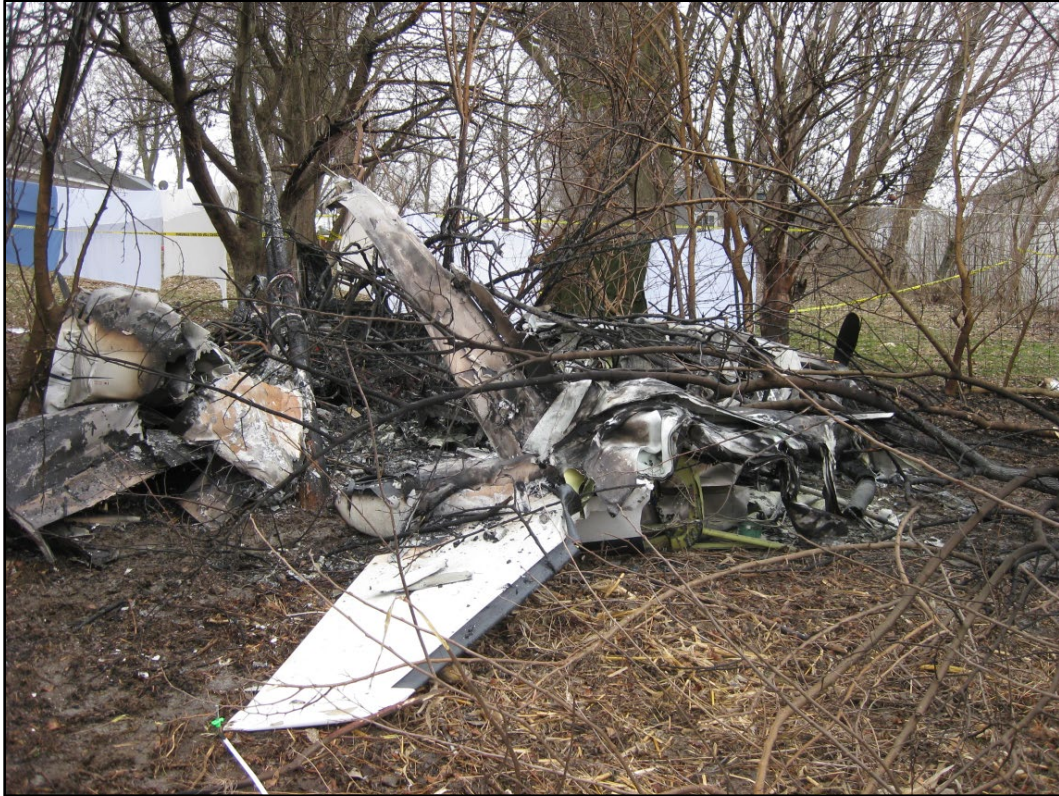
**Figure 5** - Empennage

consistent with about 20° of flap extension. The flap control handle was found in an intermediate position. Both elevators remained attached to the horizontal stabilizer and exhibited fire damage. The rudder remained attached to the vertical stabilizer; however, most of the rudder was destroyed by fire.

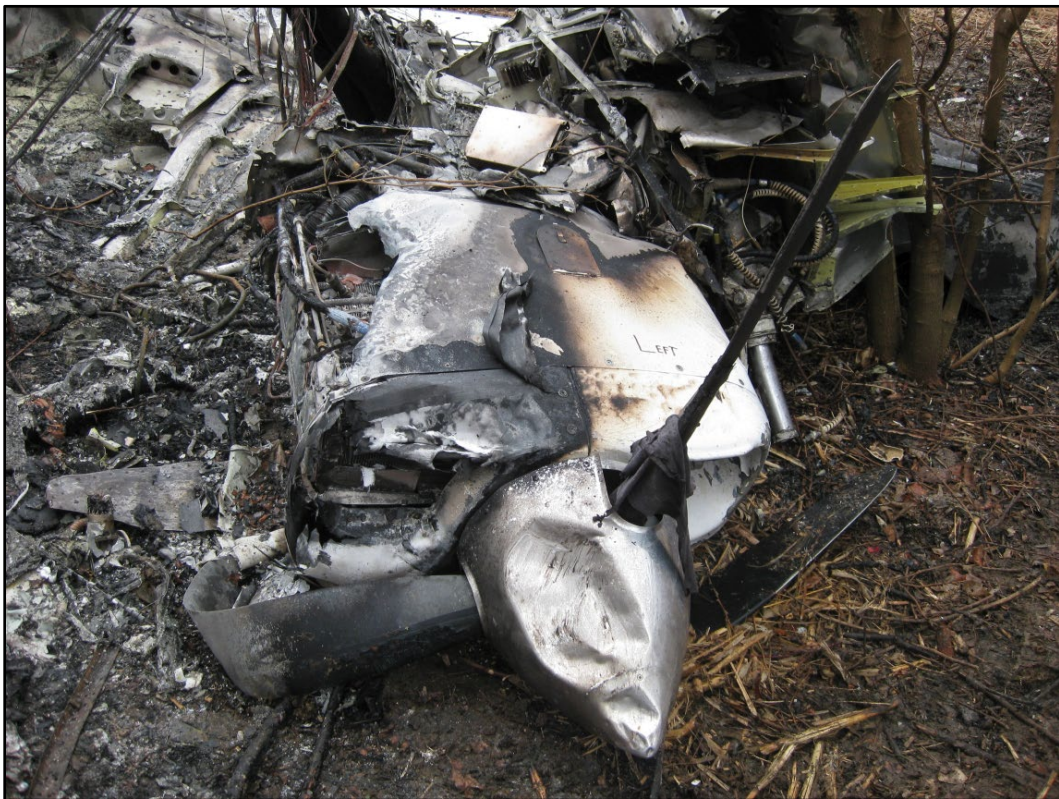
**Figure 6** - Left Engine and Propeller

The left propeller remained attached to the engine propeller shaft flange. One propeller blade appeared to be in the feathered position, and the remaining two blades appeared to be in the normal range of operation. Two propeller blades were bent in the aft direction, and the remaining blade appeared to be slightly bent aft. Two propeller blades had indications of heat exposure such as charring, sooting, and paint blistering. One propeller blade could be partially rotated by hand force. The spinner dome was dented with one counterweight mark on the internal surface in the normal blade angle range of operation. The hydraulic unit remained intact and undamaged, and the piston/pitch change mechanism appeared to be on the start locks. Propeller blade no. 1 was bent aft, bent opposite rotation and twisted towards low pitch. Propeller blade no. 2 was bent slightly aft with no remarkable twisting. Propeller blade no. 3 was bent aft, opposite rotation and twisted towards low pitch. All three propeller blades exhibited chordwise/rotational scoring isolated to the leading edges on both the camber and face side. The low pitch stop had an impact mark consistent with the propeller operating on or near the low pitch stop angle. The preload plate for propeller blade no. 3 had knob impact marks in the range of 26°-31° consistent with a blade angle between 17°-22°.

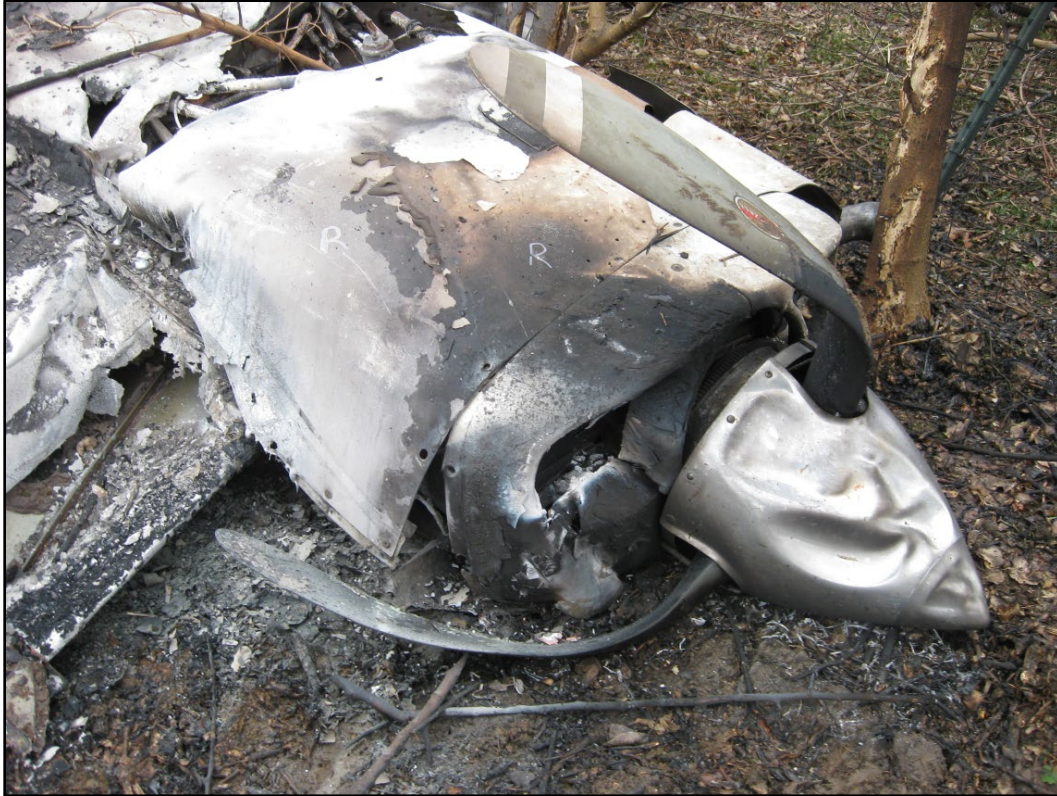
**Figure 7** - Right Engine and Propeller

The right propeller remained attached to the engine propeller shaft flange. All three propeller blades appeared to be in the normal blade angle range. The spinner dome was dented with counterweight impressions that were consistent with normal blade angle range of operation. All three propeller blades were bent aft, opposite rotation in varying degrees and twisted towards low pitch. One propeller blade had indications of heat exposure such as charring, sooting and paint blistering. All three propeller blades could be partially rotated by hand force. The hydraulic unit remained intact and undamaged, and the piston/pitch change mechanism appeared to be in the feathered position. All three propeller blades exhibited chordwise/rotational scoring isolated to the leading edges on both the camber and face side. The pitch change knob on all three blades were fractured. The low pitch stop had an impact mark suggesting the propeller was operating on or near the low

pitch stop angle. The preload plate for propeller blade no. 2 had a knob impact mark in the slot at about 45° consistent with a blade angle of about 3°. The preload plate for propeller blade no. 3 had a knob impact mark in the slot at about 21° consistent with a blade angle of about 27°.

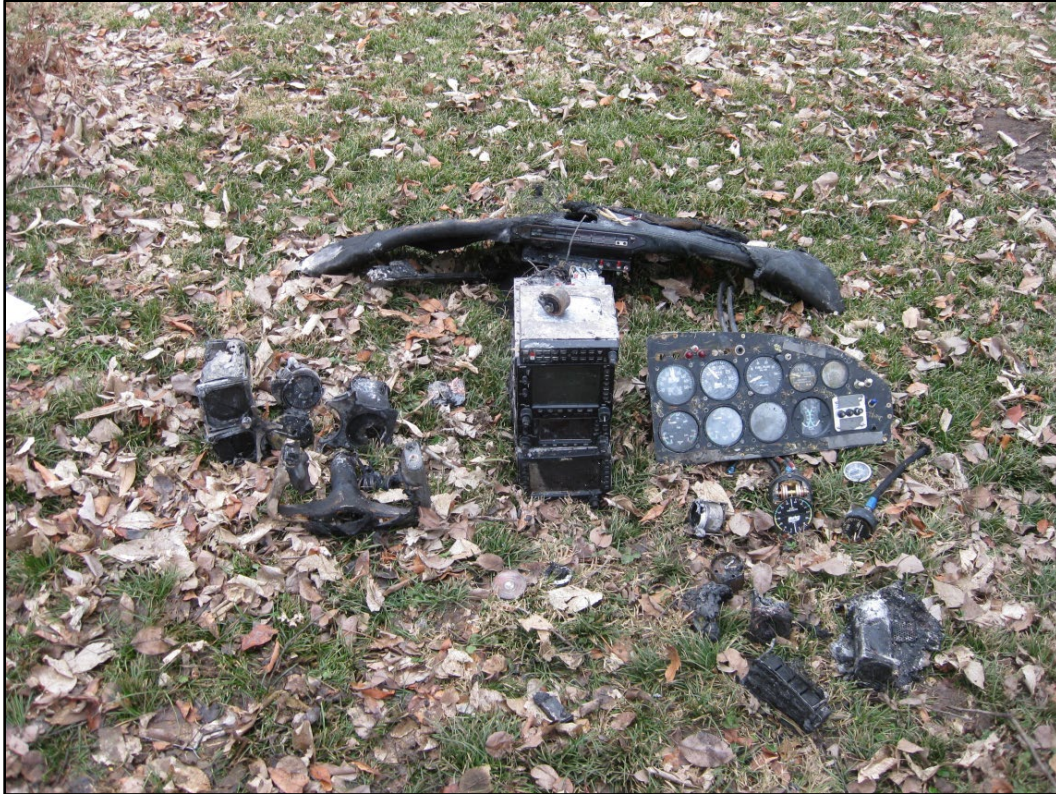
**Figure 9** - Instrument Panel Overview

The instrument panel sustained significant thermal damage during the postaccident fire. The airspeed indicator and altimeter were destroyed by fire. The attitude indicator and horizontal situation indicator (HSI) were extensively damaged by fire and could not be tested. The internal gyros of the attitude indicator and HSI did not exhibit any evidence of rotational scoring. The turn indicator gyro was found separated from its instrument case that was not located during the investigation. The turn indicator gyro did not exhibit any evidence of rotational scoring. The backup course deviation indicator was destroyed by fire. The electronic engine trend monitor was destroyed by fire. The engine tachometer indicated 1,200 rpm for both engines. The manifold pressure gauge indicated 28 and 30 inches of mercury for the left and right engines, respectively.

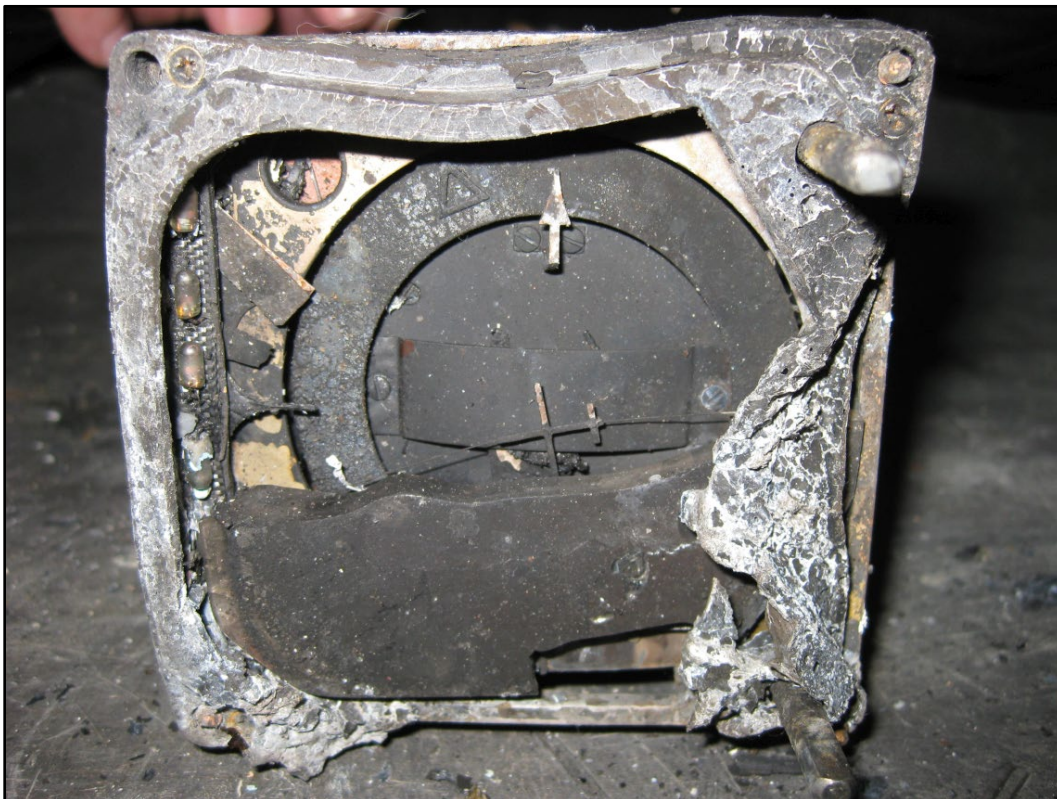
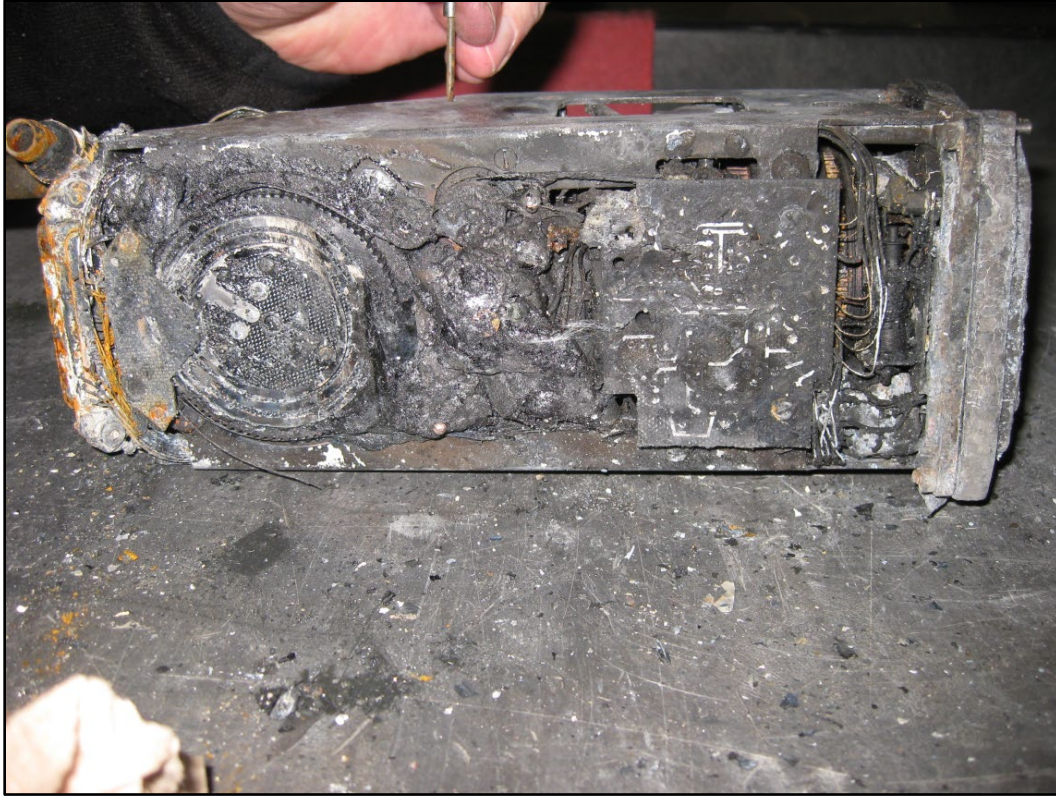
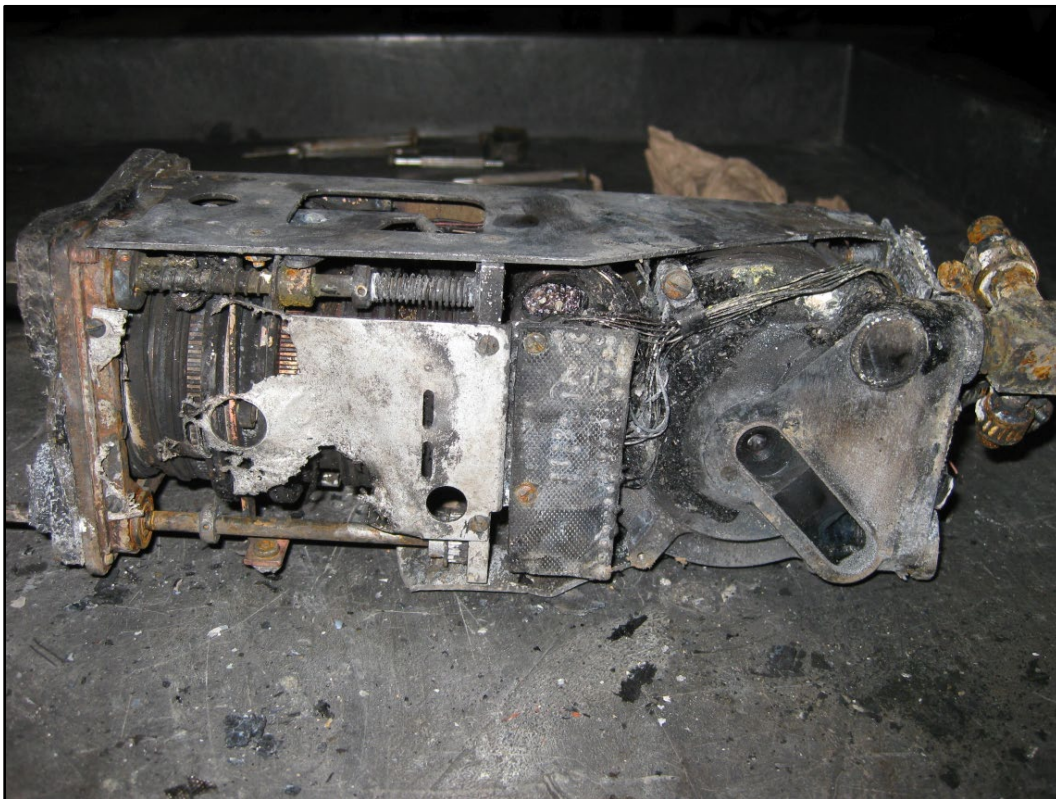
Shortly after the purchase of the airplane in August 2019, the pilot had an issue with the airplane's horizontal situation indicator (HSI) not syncing with the remote compass. According to the airplane's current maintainer, an overhauled HSI was purchased and shipped directly to the pilot to be installed in the airplane; however, a review of available maintenance documentation and a canvassing of several maintenance facilities where the pilot might have contracted maintenance did not establish if the malfunctioning HSI was indeed replaced before the flight. The HSI installed in the airplane at the time of the accident sustained significant thermal/fire damage which prevented testing.
