Aircraft Accident/Incident report No.: 200128

**NTSB File No.:** CEN20FA070

**Aircraft:** Aerostar PA-60-601P (Modified to the "Samurai 350" configuration by Merlyn Products Inc. STC SA4156NM and SE4157NM)

## PROPELLER EXAMINATION REPORT

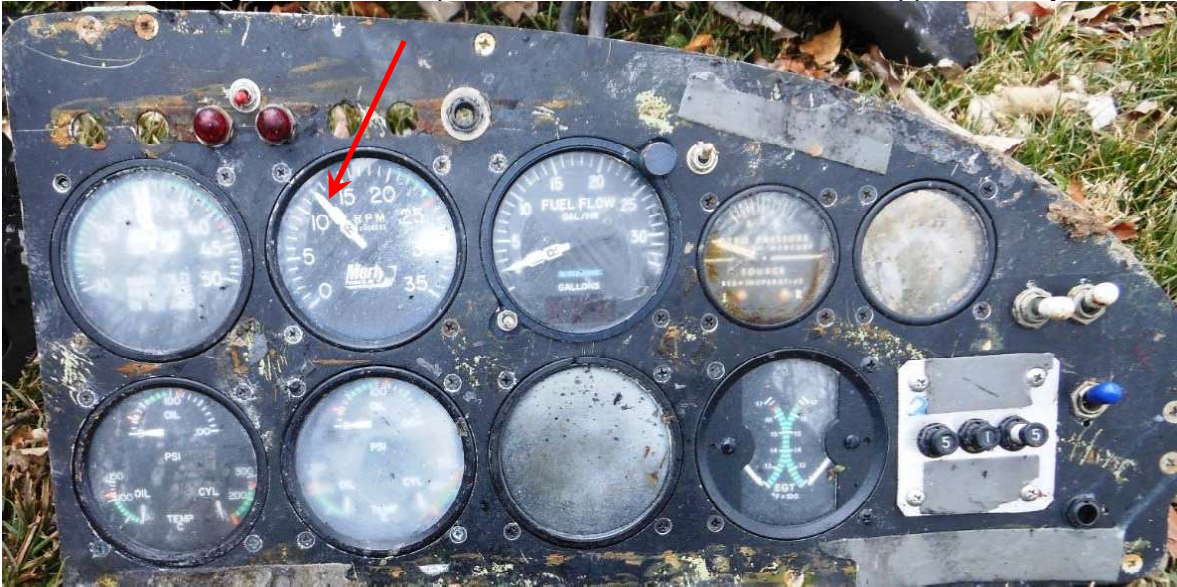
The right instrument panel containing the tachometer was recovered and photographed at the crash scene. The tachometer pointers for the left and right RPM were frozen at approximately 1200 RPM as shown in Photo #1.

Photo #1 – Engine instrument panel with both RPM indicators at approximately 1200

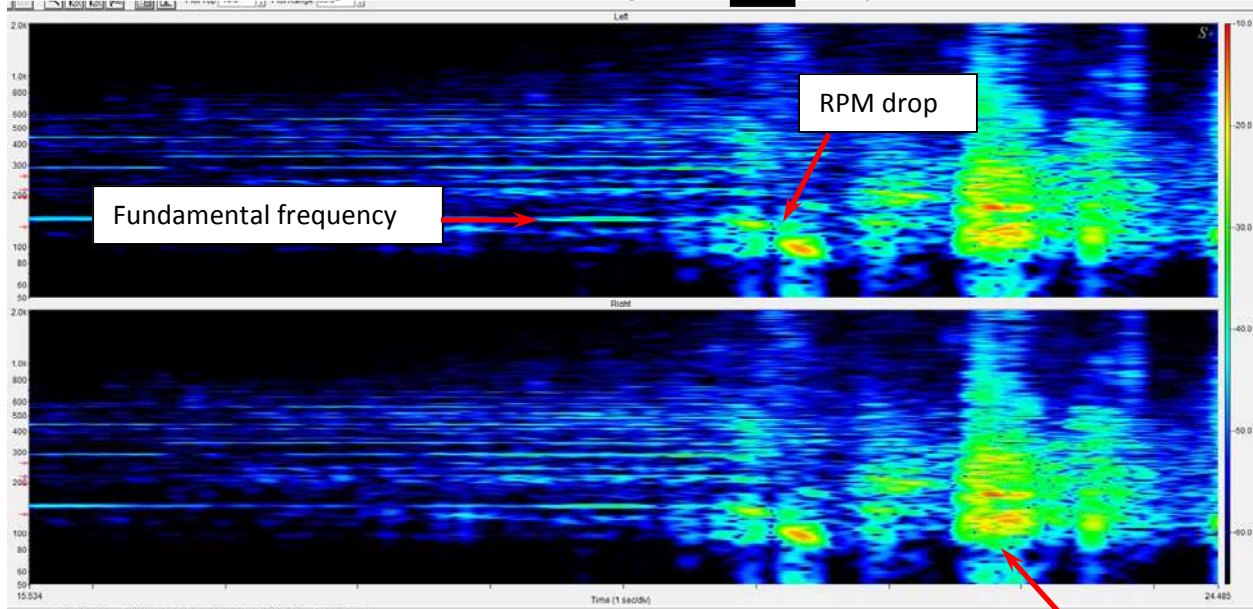
Both spectrums indicate a relatively constant propeller noise signature until approximately two seconds prior to impact. At that time a noticeable “burst” of noise and drop in RPM occurred just before impact.

Figure 2 – Audio spectrogram at [REDACTED] Garry Drive

The spectrogram from the [REDACTED] Garry Drive video captured the visual and audio of the final seconds of flight and the impact sequence. The aircraft flight path was mostly toward, but not directly at the camera during the final few seconds of flight. The initial blade passage frequency recorded in this video was approximately 143 Hz. A Doppler shift in frequency from 125 Hz to 143 Hz represents an aircraft velocity component of approximately 80 knots toward the camera. This spectrogram shows an abrupt drop in propeller noise frequency approximately two seconds prior to impact.

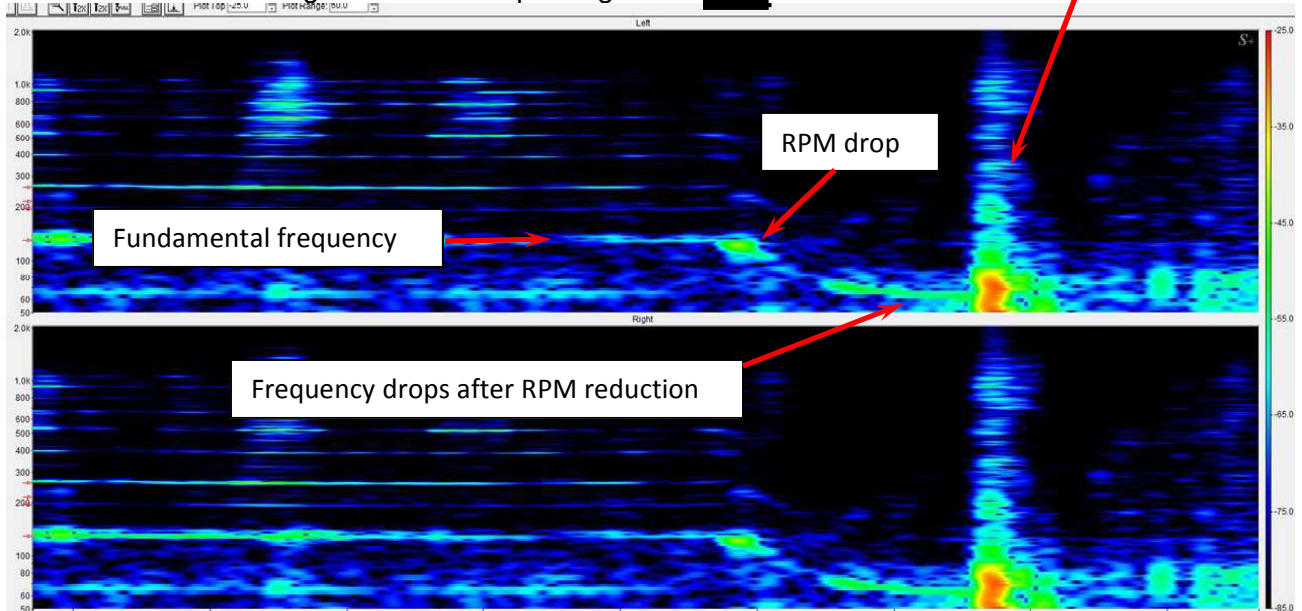
Figure 3 – Audio spectrogram at [REDACTED] Woodhaven Dr.

The spectrogram at [REDACTED] Woodhaven shows a fundamental frequency of approximately 128 Hz until two seconds prior to impact. The difference between 125 and 128 Hz is likely from Doppler shift due to aircraft velocity relative to the camera position. The fundamental frequency drops to approximately 62 Hz just prior to impact which equates to approximately 1240 RPM, or 1180 RPM if adjusted for a 3 Hz Doppler shift.

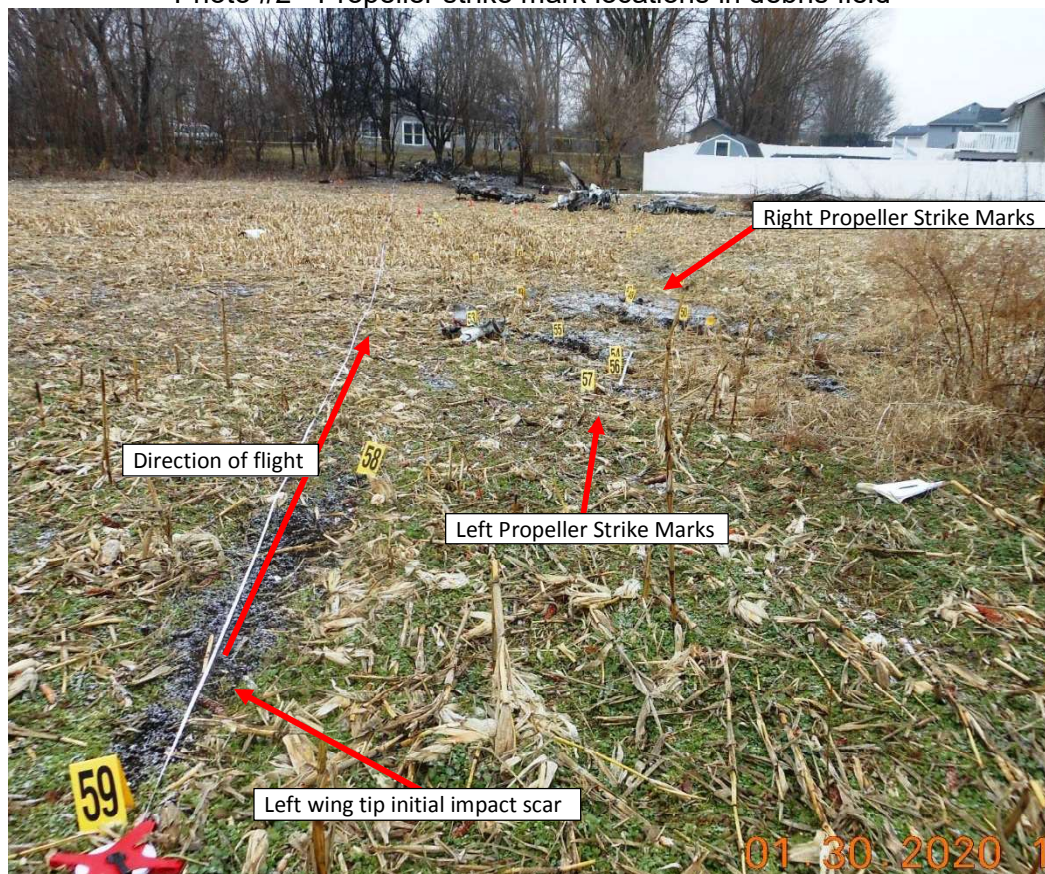
As stated in the NTSB Preliminary Report, the aircraft impacted a harvested cornfield. A flight path angle of approximately  $-22^{\circ}$  was estimated from the doorbell video image at [REDACTED] Garry Drive. Both propellers impacted/cut into cornfield soil that was wet, soft and relatively rock-free. The propellers left slice/strike marks in the locations shown in Photo #2.

Photo #2 - Propeller strike mark locations in debris field

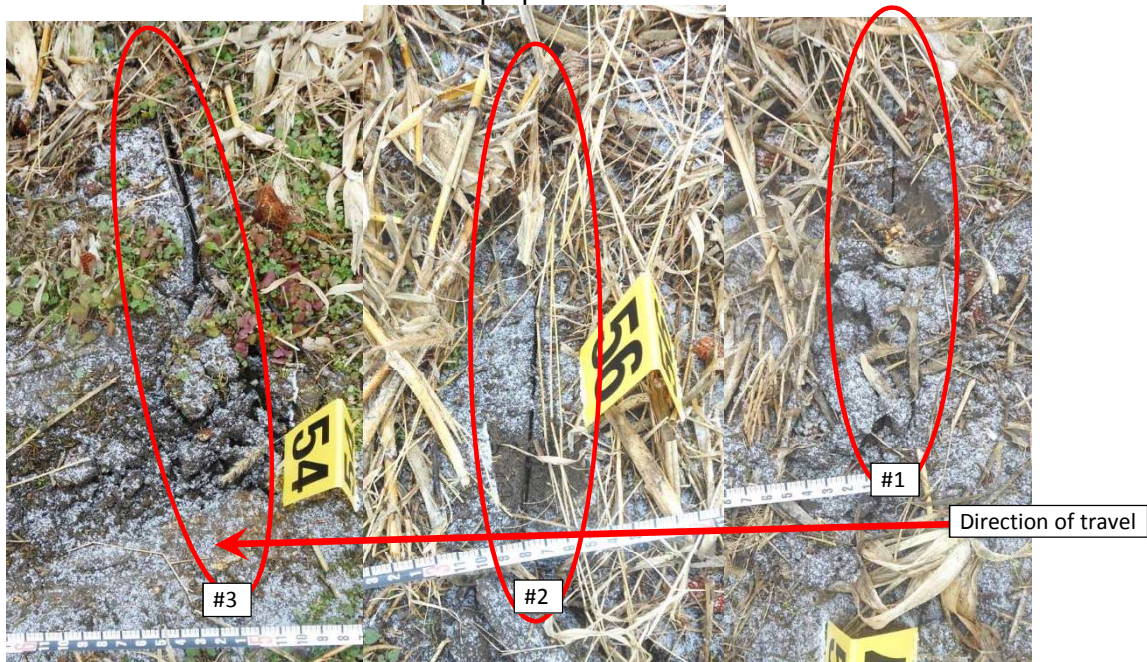
There were three distinguishable propeller strike marks made by the left propeller as shown in Photo #3. The distances between the three marks were as follows:

The average distance between the left propeller strike marks was therefore 2.64 ft. The following equation can be used to estimate either aircraft speed or propeller RPM given the other quantity. If using an RPM of approximately 1200 indicated by two sources; the engine tachometers and the audio spectrums, the estimated ground speed at impact was 94 knots.

Photo #3 - Left propeller strike marks

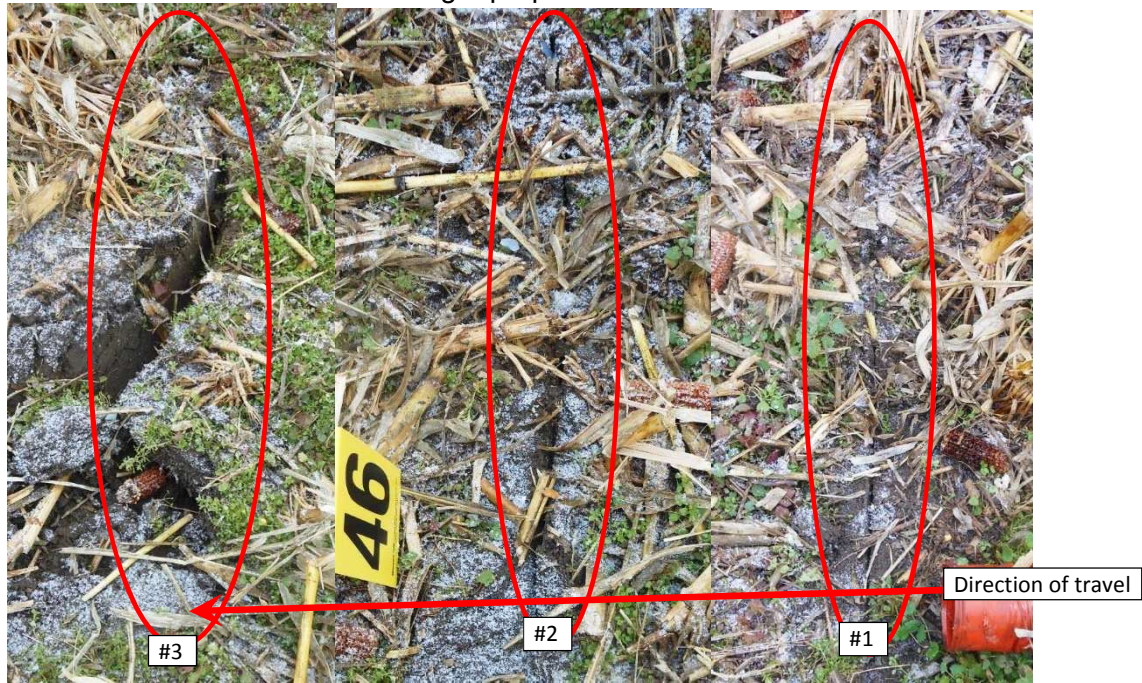
There were three distinguishable propeller strike marks made by the right propeller as shown in Photo #4. The distances between the three marks were as follows:

The average distance between the right propeller strike marks was therefore 2.5 ft. If using the RPM of approximately 1200, the estimated ground speed at impact was 88 knots.

Photo #4 - Right propeller strike marks

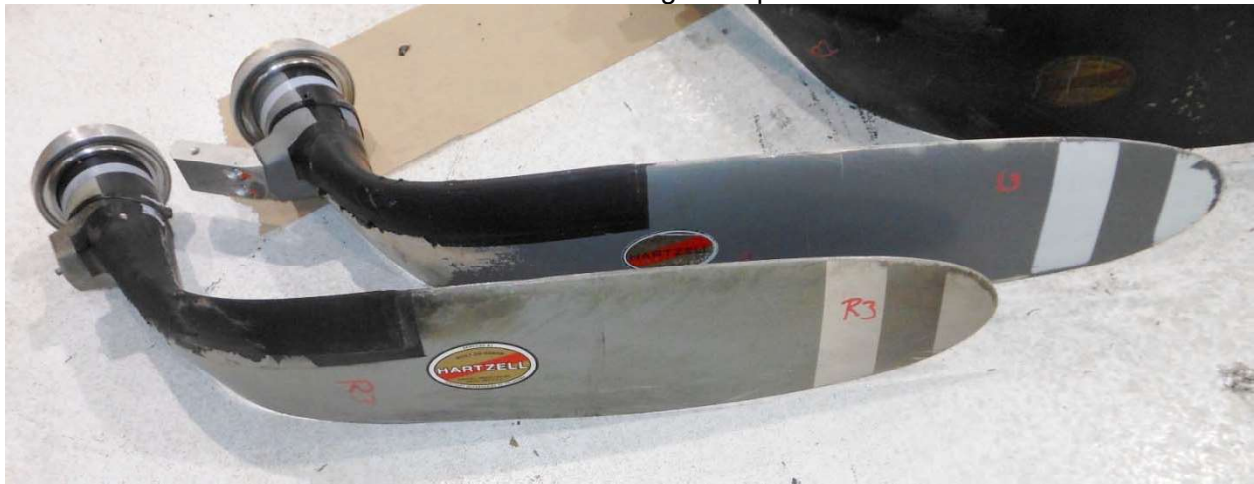
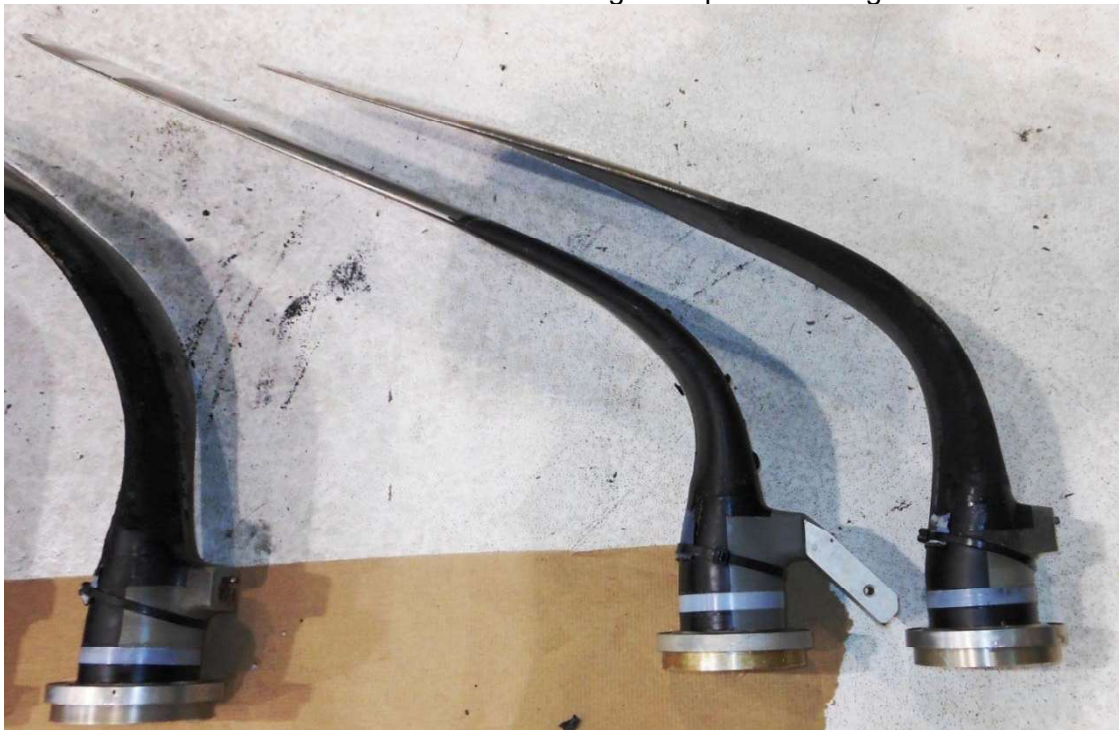
Overall, the degree of damage between the right and left propellers and the propeller strike marks were similar, suggesting a power symmetry. A comparison of blade L3 and R3 damage is shown in Photos #5 and #6. All visual evidence and propeller strike marks indicated that neither propeller was feathered at time of impact.

Photo #5 – L3 and R3 blade damage comparison – camber side

Photo #6 – L3 and R3 blade damage comparison – edge view

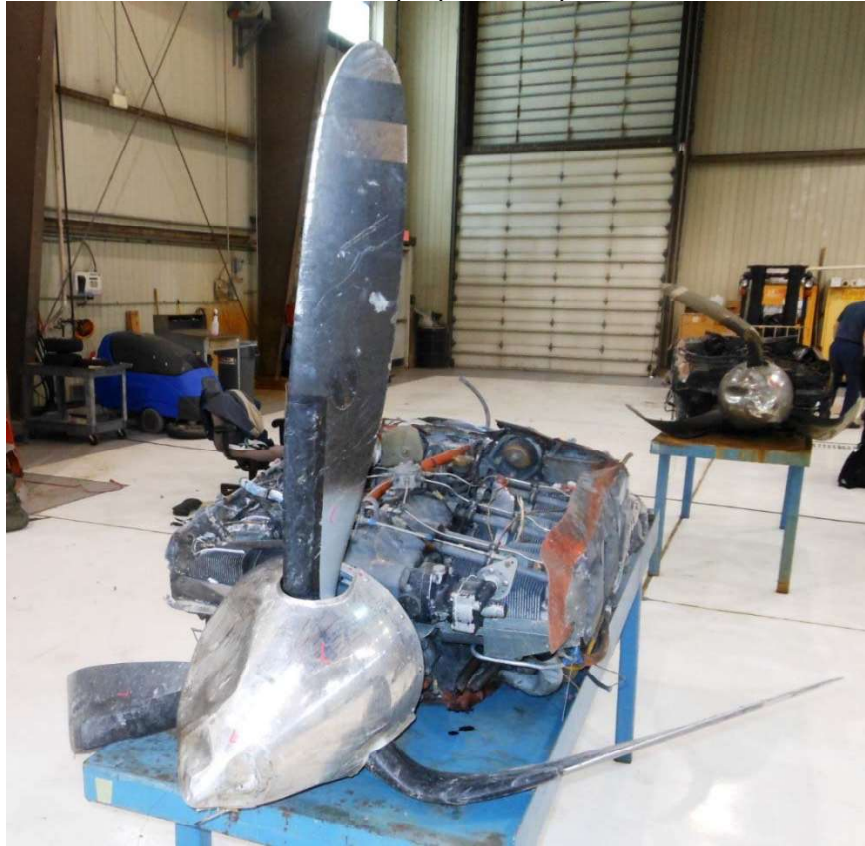
**As Received Condition:** The left propeller remained attached to the engine propeller shaft flange and was presented for examination as shown in Photo #7. One propeller blade appeared to be in the feathered position, two blades appeared to be in the normal range of operation. Two blades were noticeably bent in the aft direction and one blade appeared to be slightly bent aft. Two blades had indications of heat exposure such as charring, sooting and paint blistering. One blade could be partially rotated by hand force. The spinner dome was dented with one counterweight mark on the internal surface in the normal blade angle range of operation. The hydraulic unit remained intact and undamaged and the piston/pitch change mechanism appeared to be on the start locks. Blade L1 was bent aft, bent opposite rotation and twisted towards low pitch. Blade L2 was bent slightly aft and no remarkable twisting. Blade L3 was bent aft, opposite rotation and twisted towards low pitch. All three blades exhibited chordwise/rotational scoring isolated to the leading edges, primarily on the camber side with some on the face side.

Photo #7 – Left propeller as-presented

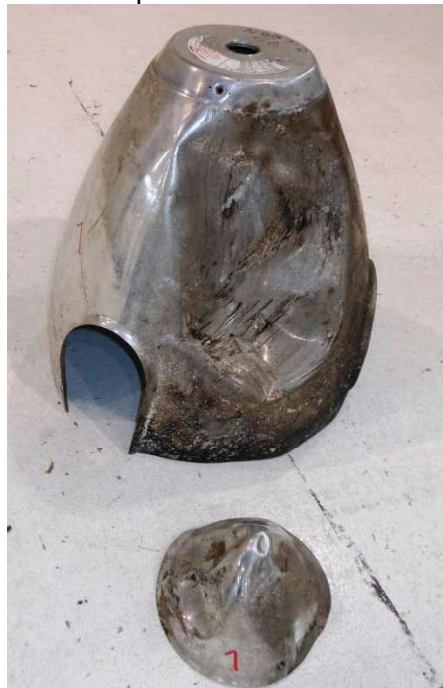
**Spinner Dome:** The spinner dome and dome cap were dented as shown in Photos #7 and #8. There was a counterweight contact mark adjacent to one blade located in the normal range of operation.

Photo #8 – Spinner dome and dome cap

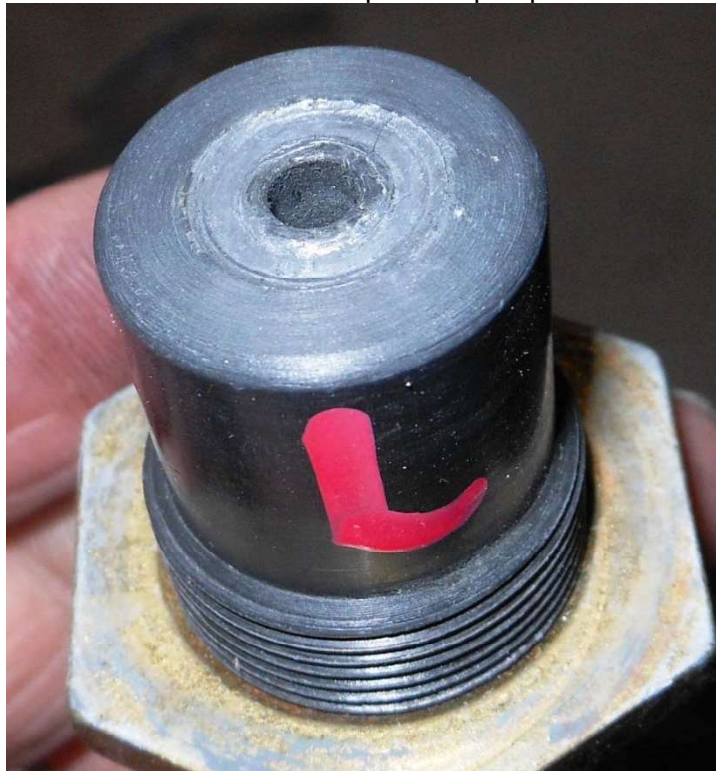
**Low Pitch Stop:** The low pitch stop had an impact impression from the cap screw in the top of the pitch change rod as shown in Photo #10.

Photo #10 – Left low pitch stop impression

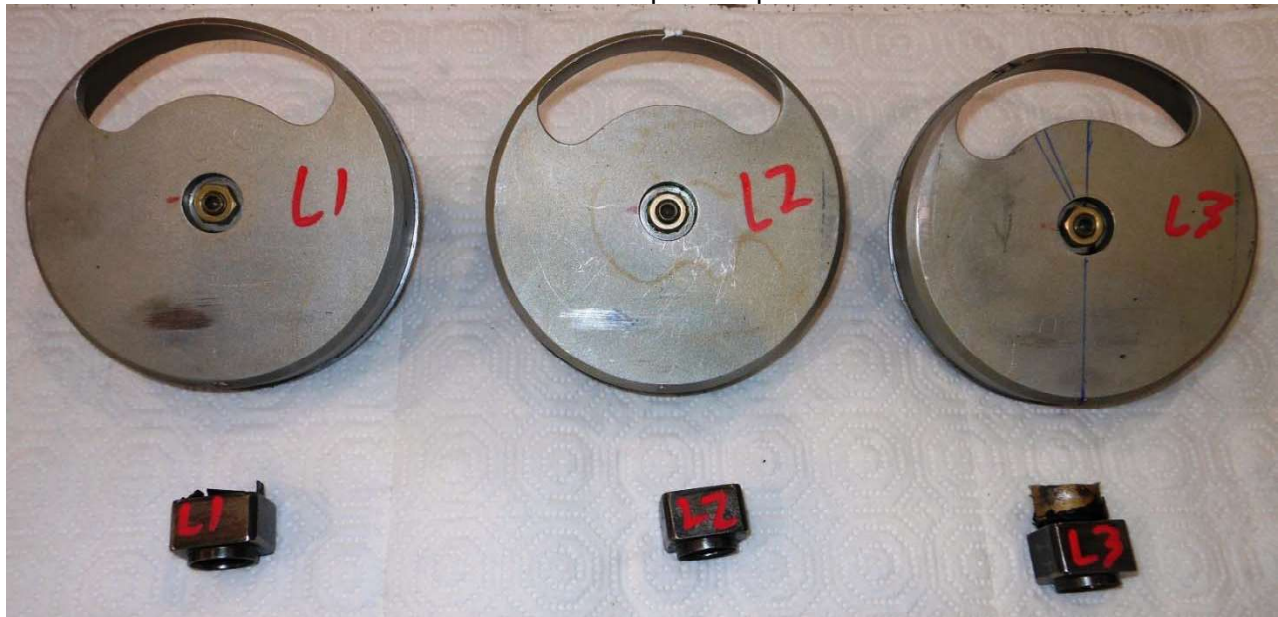
**Preload Plates:** See Photo #16. There were no remarkable fork or pitch change knob impact marks on any preload plate that would indicate a blade angle at impact.

| Preload Plate | Condition |
|---|---|
| L3 | Retention lip sheared in aft quadrant, hub/web impact marks on the forward and aft quadrants. There was a pitch change knob dent in the slot at 26° and 31° representative of blade angles of approximately 17-22°. |

Photo #16 – Left preload plates

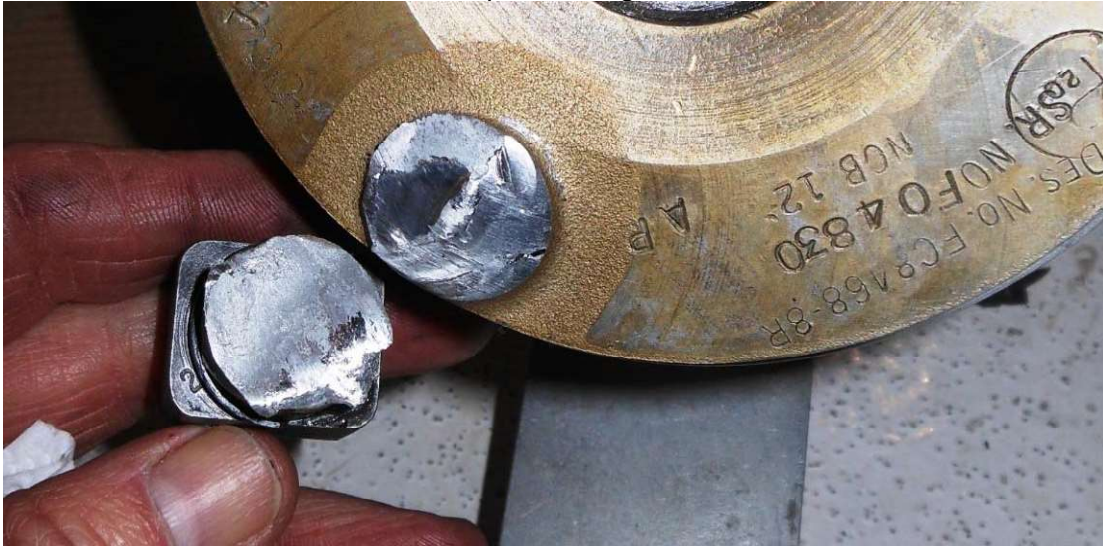
| Knob condition | Fractured, fracture surface indicates overload |

Photo #17 – L3 pitch change knob fracture

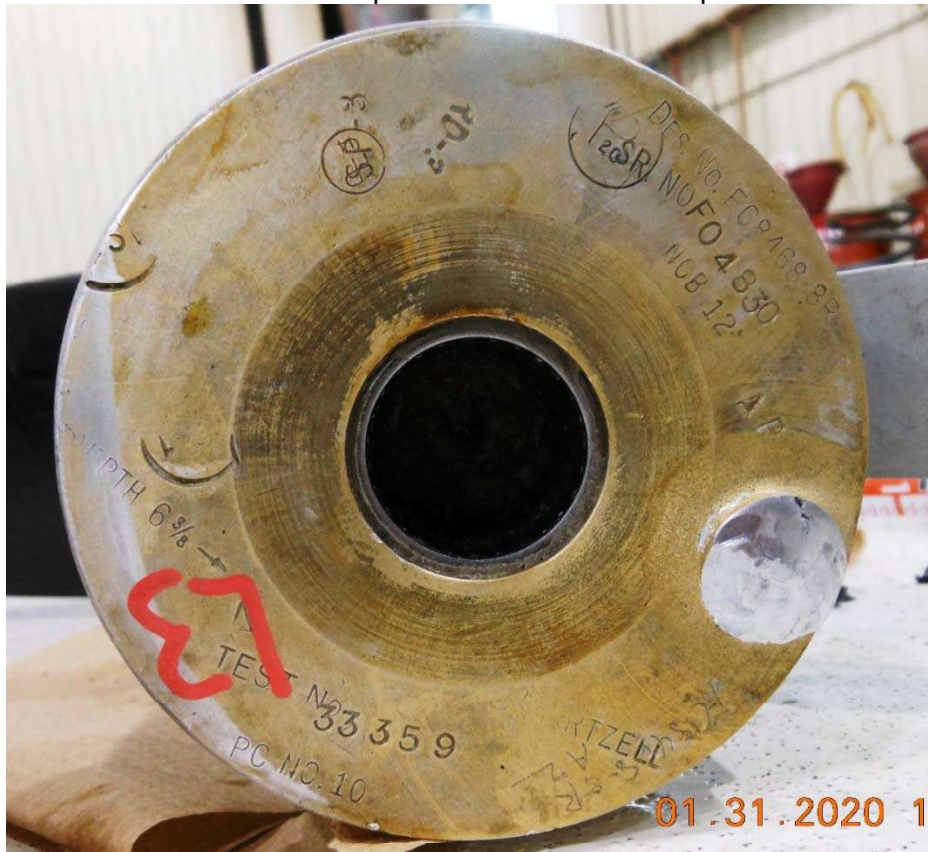
| Butt/shank impact marks | Impact crescent in aft quadrant |

Photo #18 – L3 impact crescent in aft/face quadrant

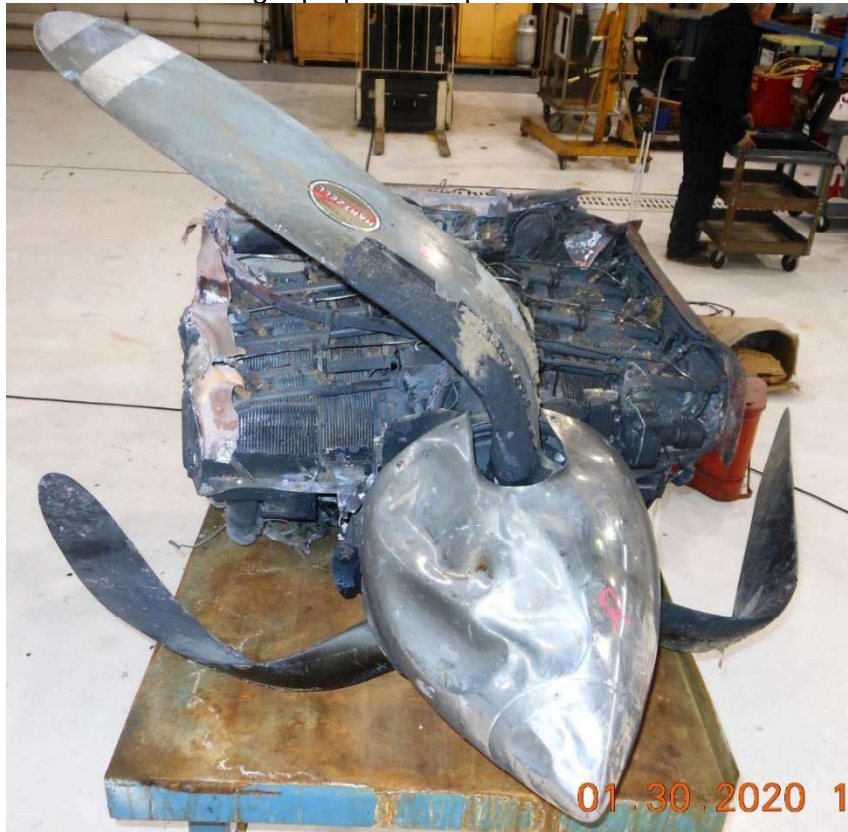
**As Received Condition:** The right propeller remained attached to the engine propeller shaft flange and was presented for examination as shown in Photo #23. The spinner dome was dented with counterweight impressions at blade aperture R1 with angles of 38 and 55 degrees which equate to a blade angle of approximately 25 and 42 degrees respectively. All three blades appeared to be in the normal blade angle range. All three blades were bent aft, opposite rotation in varying degrees and twisted towards low pitch. One blade had indications of heat exposure such as charring, sooting and paint blistering. The hydraulic unit remained intact and undamaged and the piston/pitch change mechanism appeared to be in the feathered position. All three blades exhibited chordwise/rotational scoring isolated to the leading edges on both the camber and face side. All three blades could be partially rotated by hand force indicating a fractured pitch change knob.

Photo #23 – Right propeller as-presented for examination

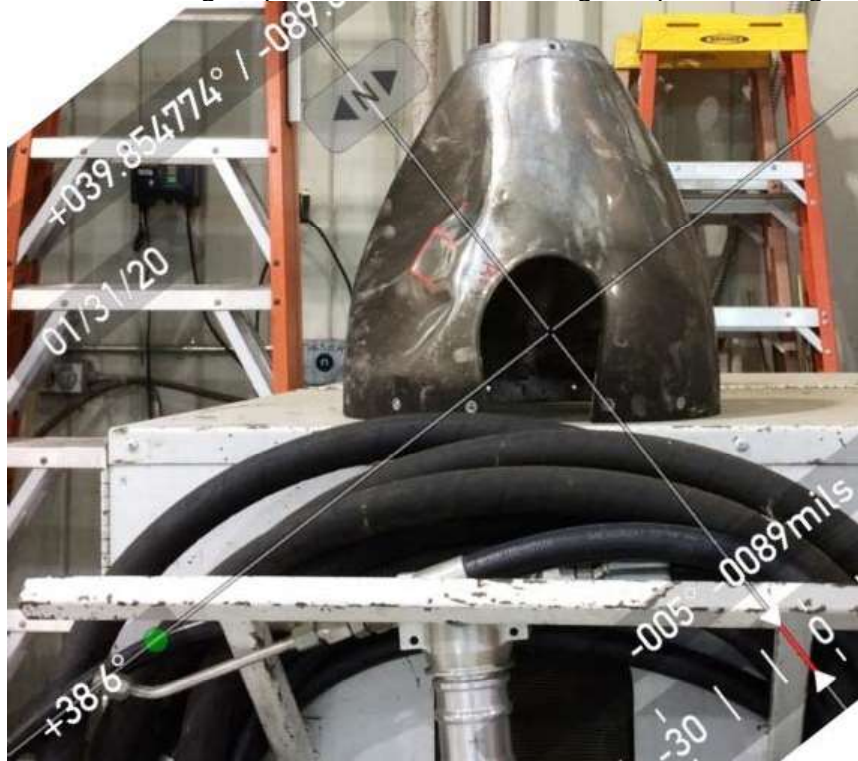
**Spinner Dome:** The spinner dome was dented with counterweight impressions at blade aperture R1 with angles of 38 and 55 degrees which equate to a blade angle of approximately 25 and 42 degrees respectively. The spinner dome and cap are shown in Photos #23 and #24. The measurement of the counterweight impression is shown in Photo #25.

Photo #25 – Right spinner dome counterweight impression angles

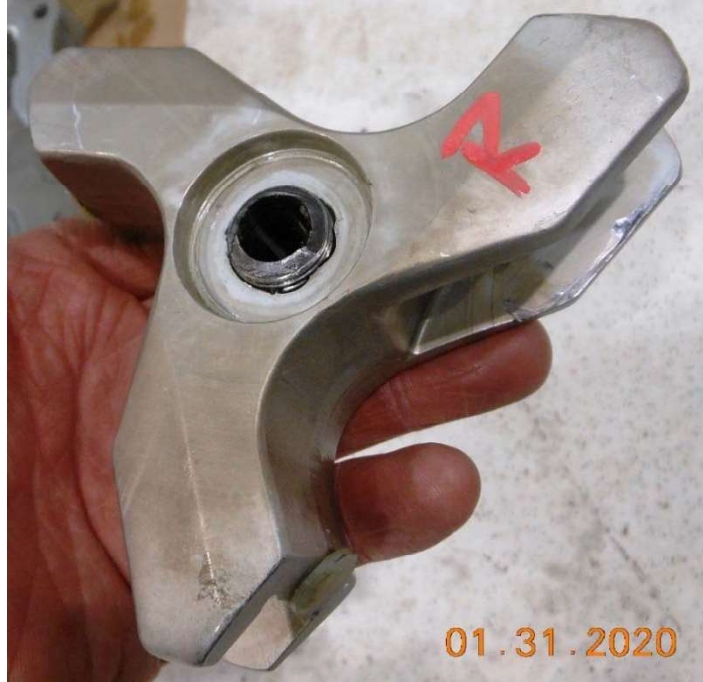
**Pitch Change Rod:** The pitch change rod was fractured forward and aft of the fork attachment threads. The threaded portion of the rod remained in the fork.

Photo #28 – Right fork with pitch change rod segment in threads

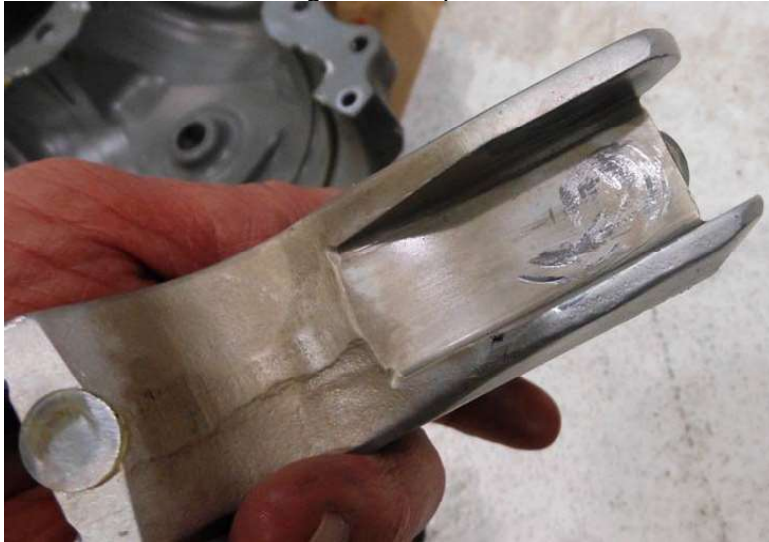
**Fork:** The fork appeared intact (Photo #28). There were knob/block impact marks in the slots as shown in Photo #29. The anti-rotation bumpers appeared intact and not smashed.

Photo #29 – Right fork impact marks in slot

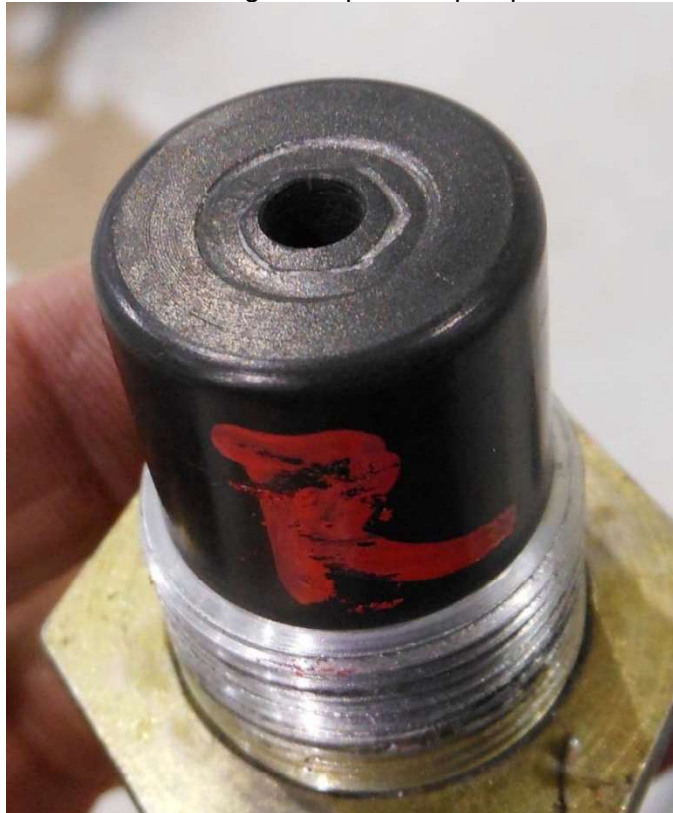
**Low Pitch Stop:** The low pitch stop had an impact impression from the cap screw in the top of the pitch change rod as shown in Photo #30. This suggested the pitch change mechanisms was forced towards the low pitch direction during the impact sequence.

Photo #30 – Right low pitch stop impact mark

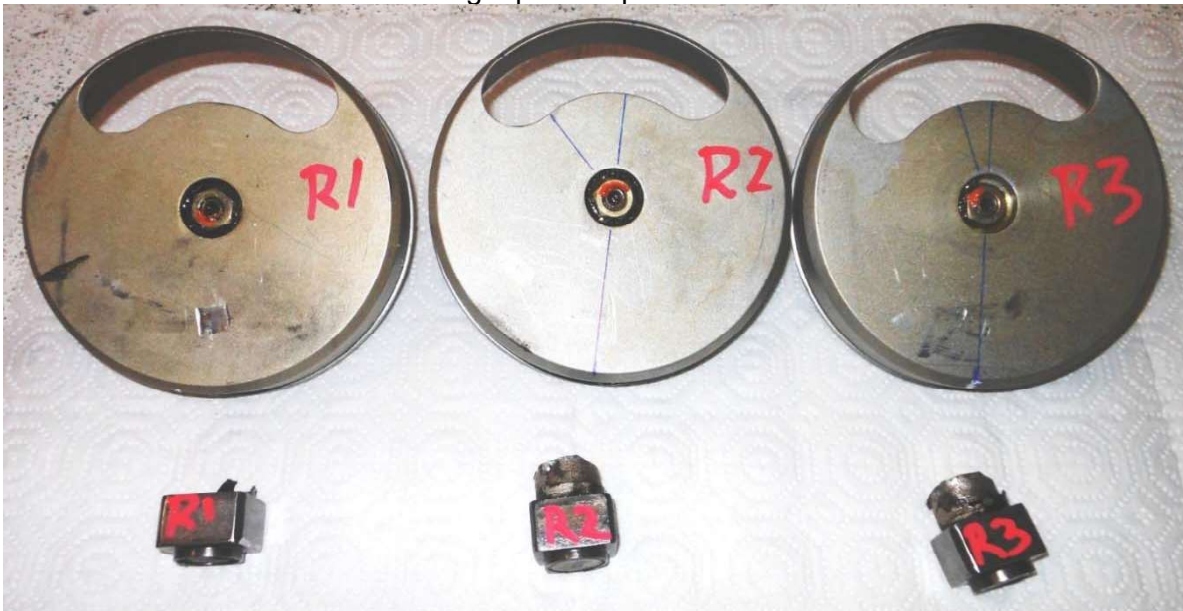
**Preload Plates:** See Photo #34. All three preload plates had varying degrees of retention lip smashing/shearing.

| Preload Plate | Condition |
|---|---|
| R1 | Gouge mark from fork near the hub parting line. Blade butt contact marks in aft/face quadrant. |

Photo #34 – Right preload plates and knob/blocks

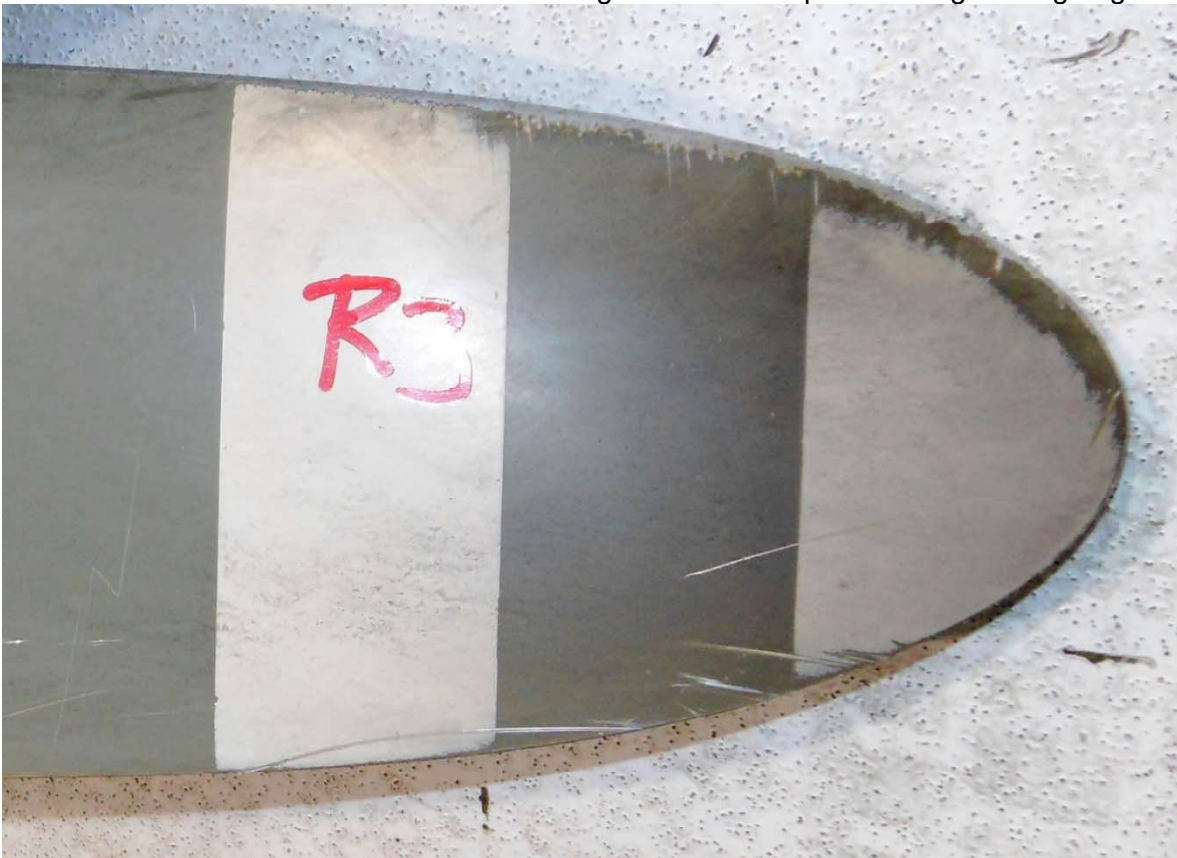
Photo #38 – R3 chordwise/rotational scoring camber side tip area along leading edge
