## CASE FINDINGS

On February 2, 2020, about 1355 mountain standard time, a Piper PA28-150 airplane, N5969W, was substantially damaged when it was involved in an accident near Florence, Colorado. The pilot and one passenger were seriously injured, and one passenger was fatally injured. The airplane operated under the provisions of Title 14 *Code of Federal Regulations* Part 91 as an instructional flight.

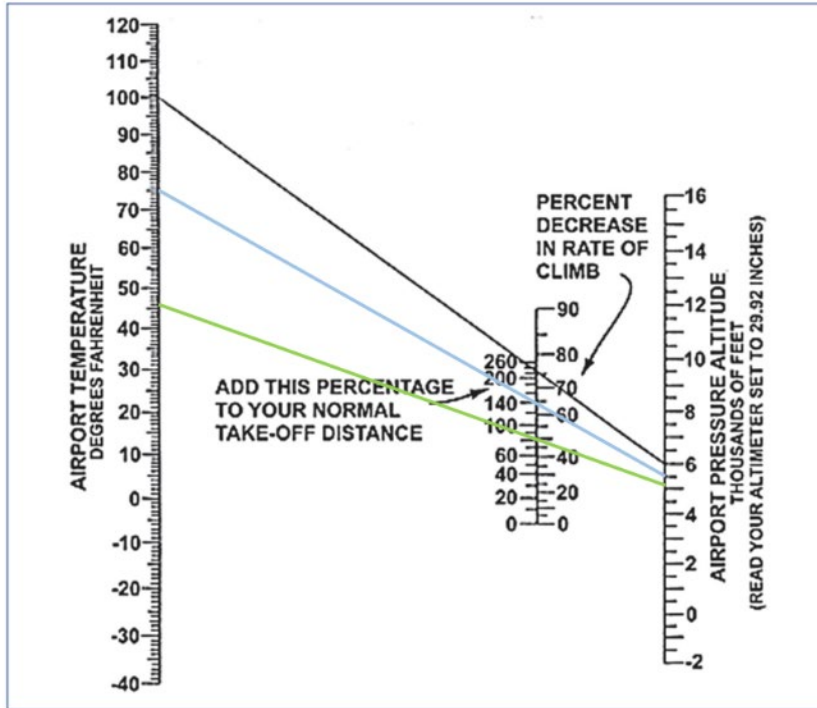
Figure 1 Koch Chart

It also provides a Koch Chart to estimate the effect of altitude and temperature. When charting the information for the accident flight, takeoff distance increases 140%, and climb performance is reduced by 65%.

A student pilot that flew with the instructor in the accident airplane about a month prior to the accident provided a video of the takeoff sequence logged on January 5, 2020. The student reported the flight involved himself, a passenger, and the instructor. He recalled there was 20 gallons of fuel on board for the one-hour flight. In the provided video, the airplane when the airplane is rotated about 72 kts, the stall warning light illuminated and continued to flicker as the airplane climbed and accelerated towards 85 kts. In the video, the student asked if "that" (the stall warning light) was normal. The instructor replied, "Yeah, it's pretty sensitive but we are no where near a stall." Later during the climb out, the instructors remarked that the airplane "is not climbing today." A review of weather information for that flight showed that the temperature was 46.4° F, with a pressure altitude of 5,122 ft. The Koch Chart showed a decrease in climb performance of about 50% (below in green). The accident flight is charted in blue.

Accident Flight: temperature 75.2F, pressure alt 5,528 ft

Previous Flight (video): temperature 46.4F, pressure alt 5,122
