# The National Transportation Safety Board

Office of Aviation Safety  
Central Region  
Memorandum for the Record  
Airframe and Accident Site  
Examination Findings  
CEN20FA075  
Chatham, Louisiana  
February 6, 2020

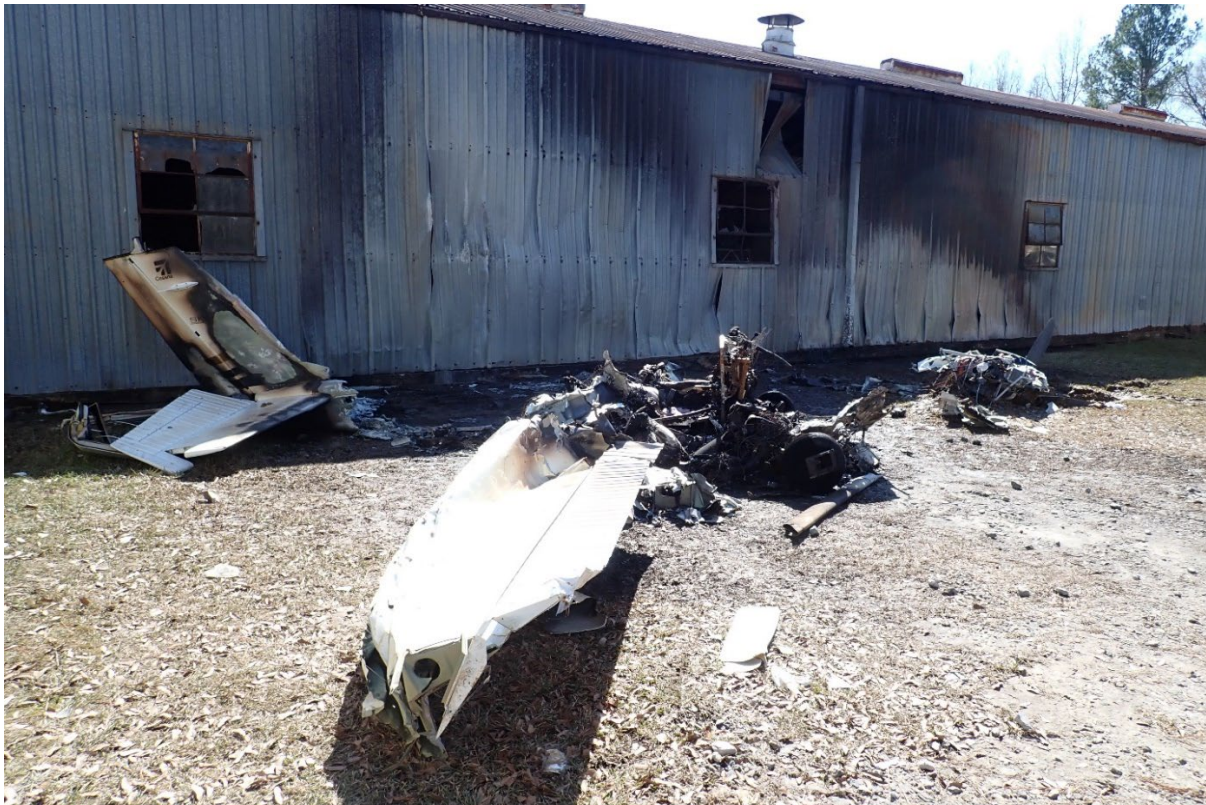
- The aircraft impacted terrain in an almost vertical nose down attitude on a southerly heading next to a commercial building. The engine separated from the fuselage and stayed next to the initial impact crater. Wing leading edge impressions were present in the soft dirt on either side of the impact crater. According to first responders, the aircraft initially came to rest with the left wing against the building and the aircraft sitting tail high. A post-impact fire then occurred which consumed most of the fuselage and the left wing.

Photo: Accident Site and Wreckage
