# The National Transportation Safety Board

Office of Aviation Safety  
Central Region  
Memorandum for the Record  
Engine Examination Findings  
CEN20FA075  
Chatham, Louisiana  
February 6, 2020

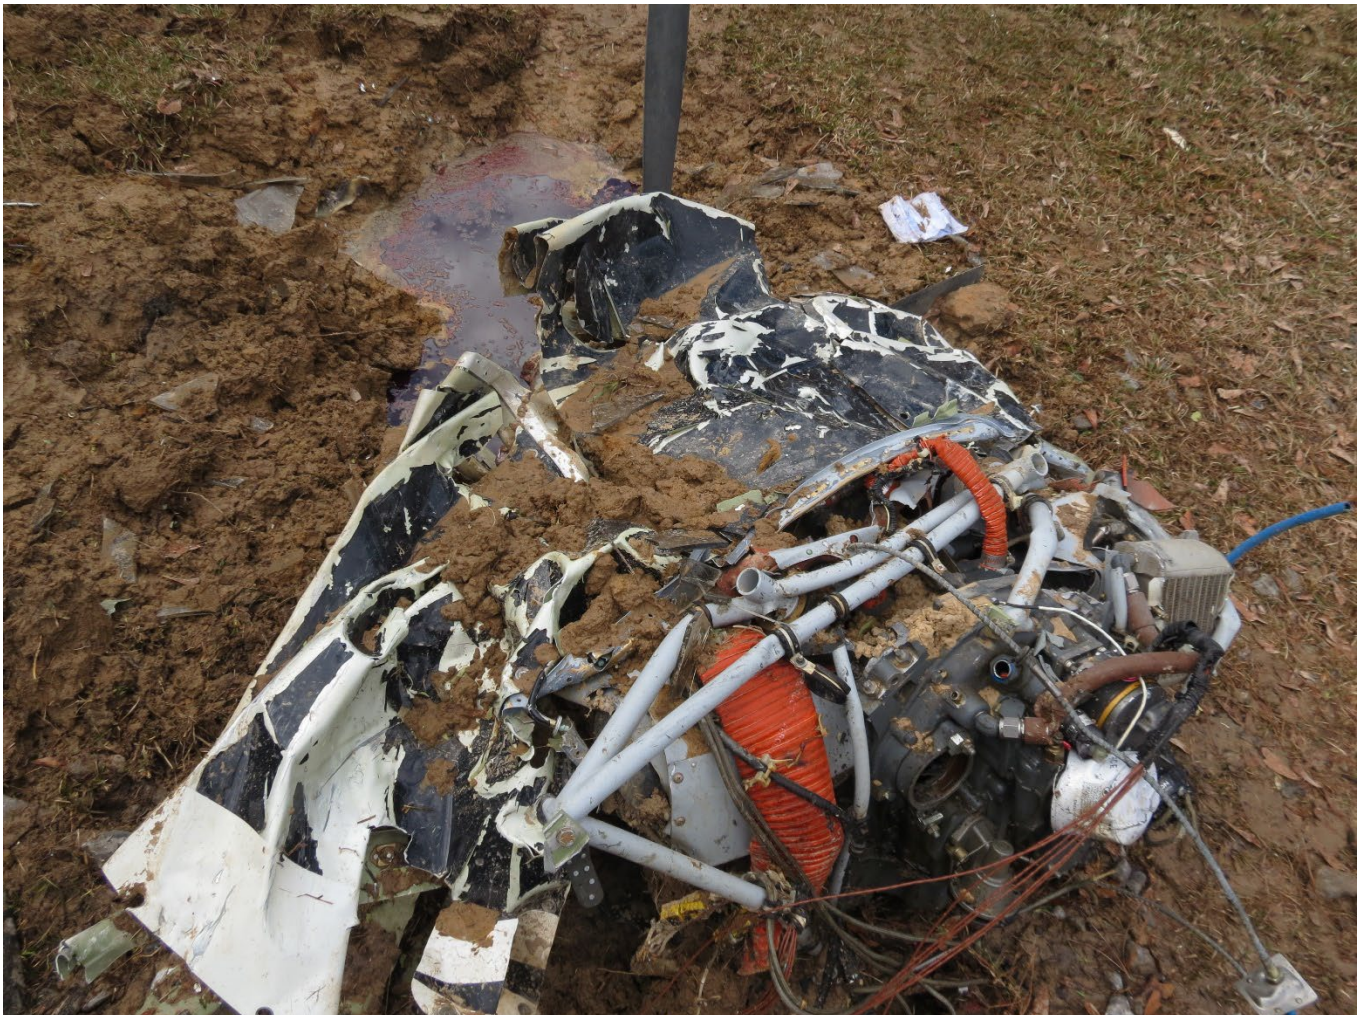
- As first viewed, the engine was separated from the aircraft firewall and laying upright at the edge of an impact crater about 15 feet from the fuselage. The impact crater was about 3 feet wide, four feet long and undetermined depth. The fuel injector servo and the left magneto were separated from the engine and found at the accident site. The lower portion of the engine driven fuel pump was impact separated and not observed. The exhaust tubing was crushed.

Photo1: Engine at Accident Site

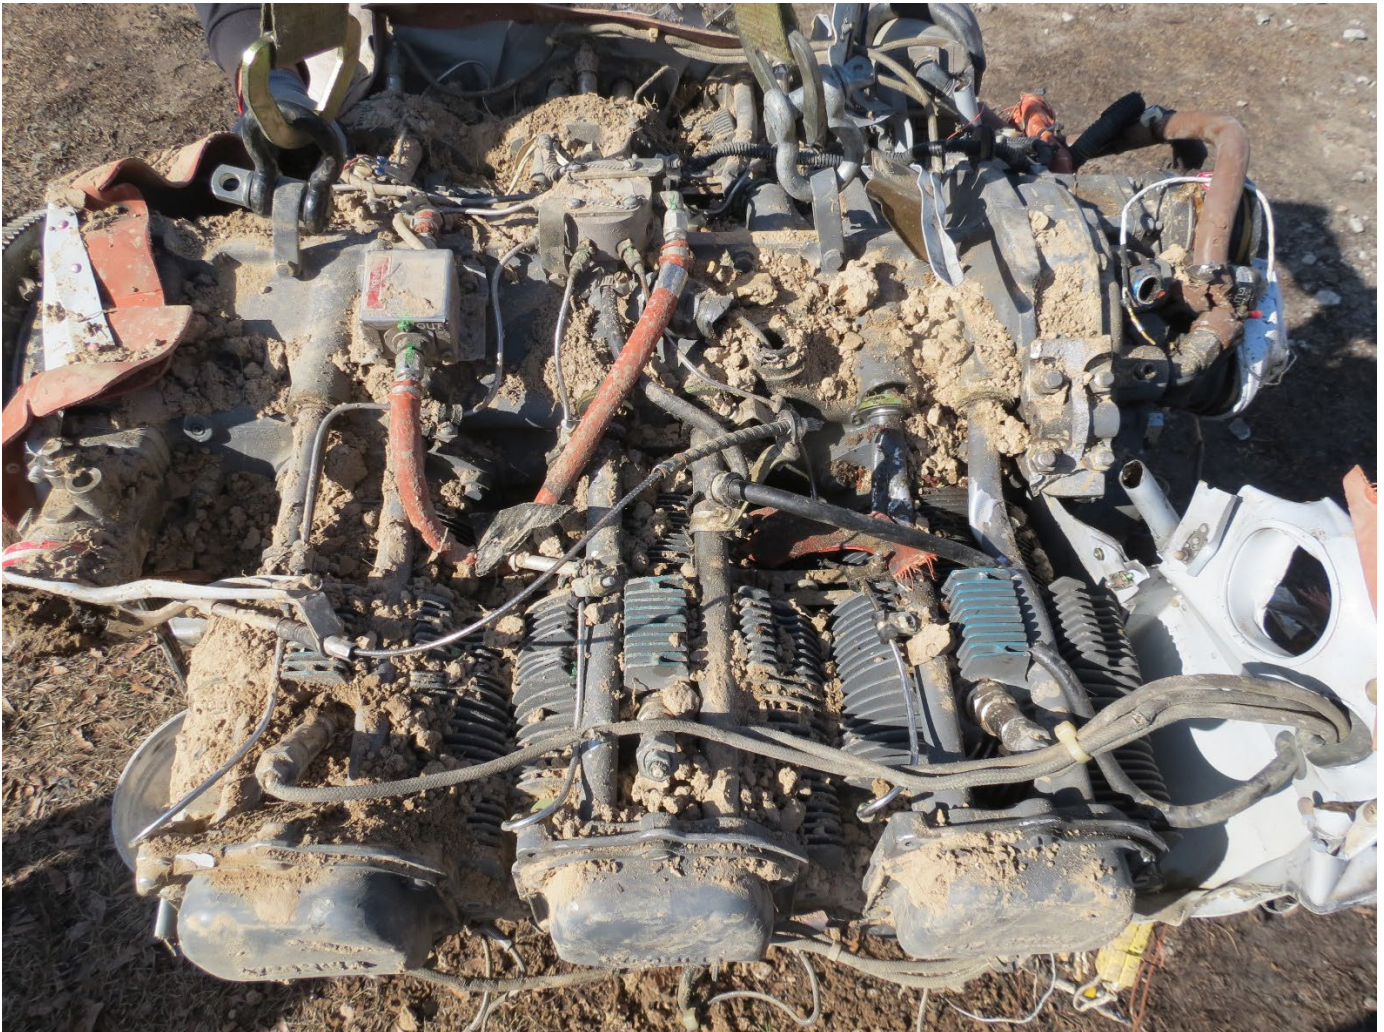
- The engine was suspended from a lift and partially disassembled to facilitate examination. Oil drained from when it was lifted. The oil suction screen was absent of metallic debris. The oil filter was impact damaged and not examined.
