**Examination Summary**  
**NTSB Accident Number CEN20FA076**

Location: Granbury, Texas  
Date: February 8, 2020  
Time: 1317 CST  
Aircraft: Beech F33A Bonanza  
Registration: N6665U

### NTSB Accident Number CEN20FA076

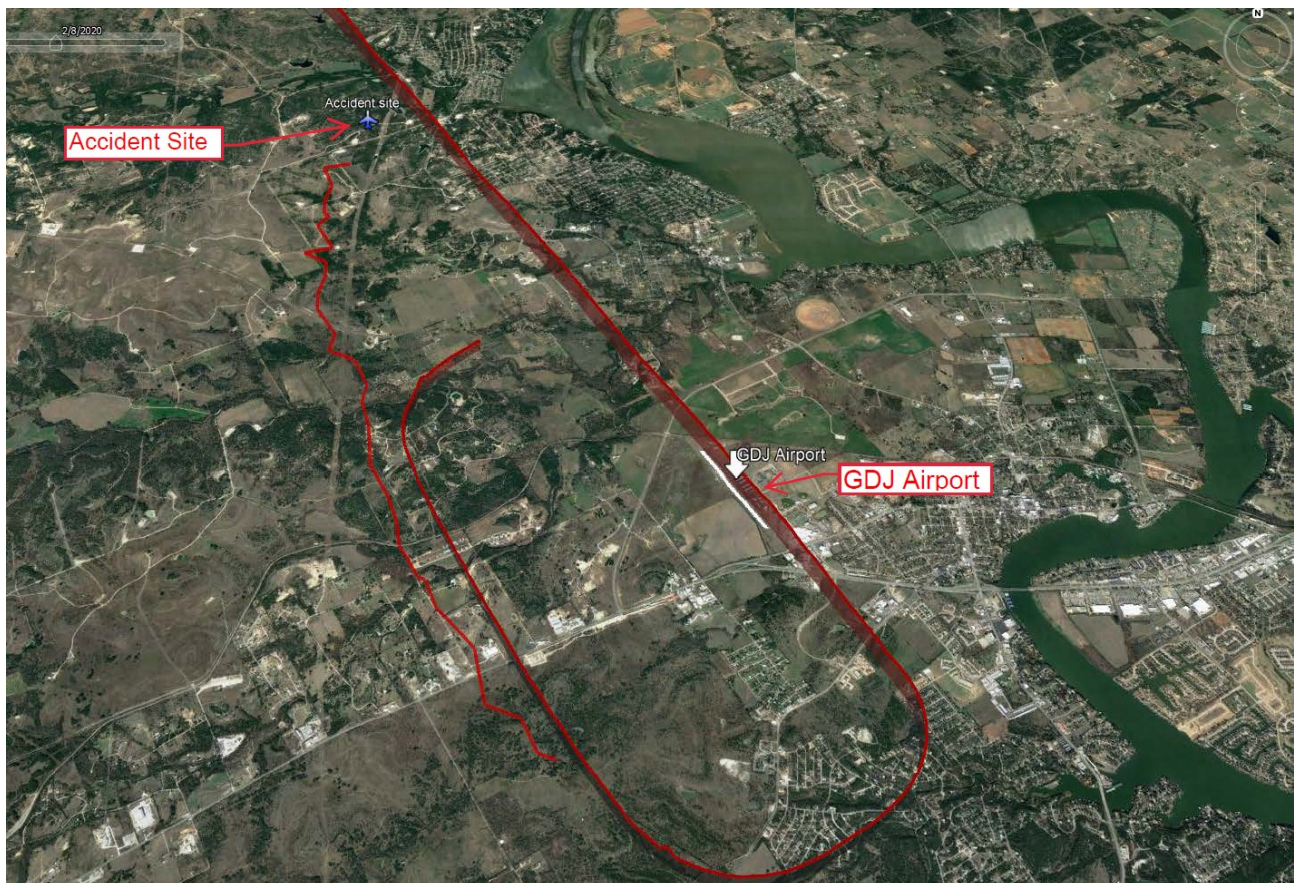
The recorded radar and ADS-B data revealed that the airplane had approached Granbury Regional Airport (GDJ), Granbury, Texas, from the northwest about 1301 and overflowed runway 14 at 900 ft above ground level (agl). After the runway overflight, the track turned right toward northwest on a wide downwind leg and gradually descended to about 400 ft agl. The airplane then made a right base turn where the first set of data ended at 1305:07, about 440 ft agl, and 93 knots groundspeed. At 1314:18, radar data showed a target on the southwest side of GDJ, which proceeded to the north toward the accident site and ended at 1316:51. The accident site was located 0.39 nautical miles north-northeast of the final radar return. Figure 1 shows the recorded flight track with the accident site and GDJ airport labeled.

Figure 1 – Radar and ADS-B track in red with the accident site and GDJ airport labeled

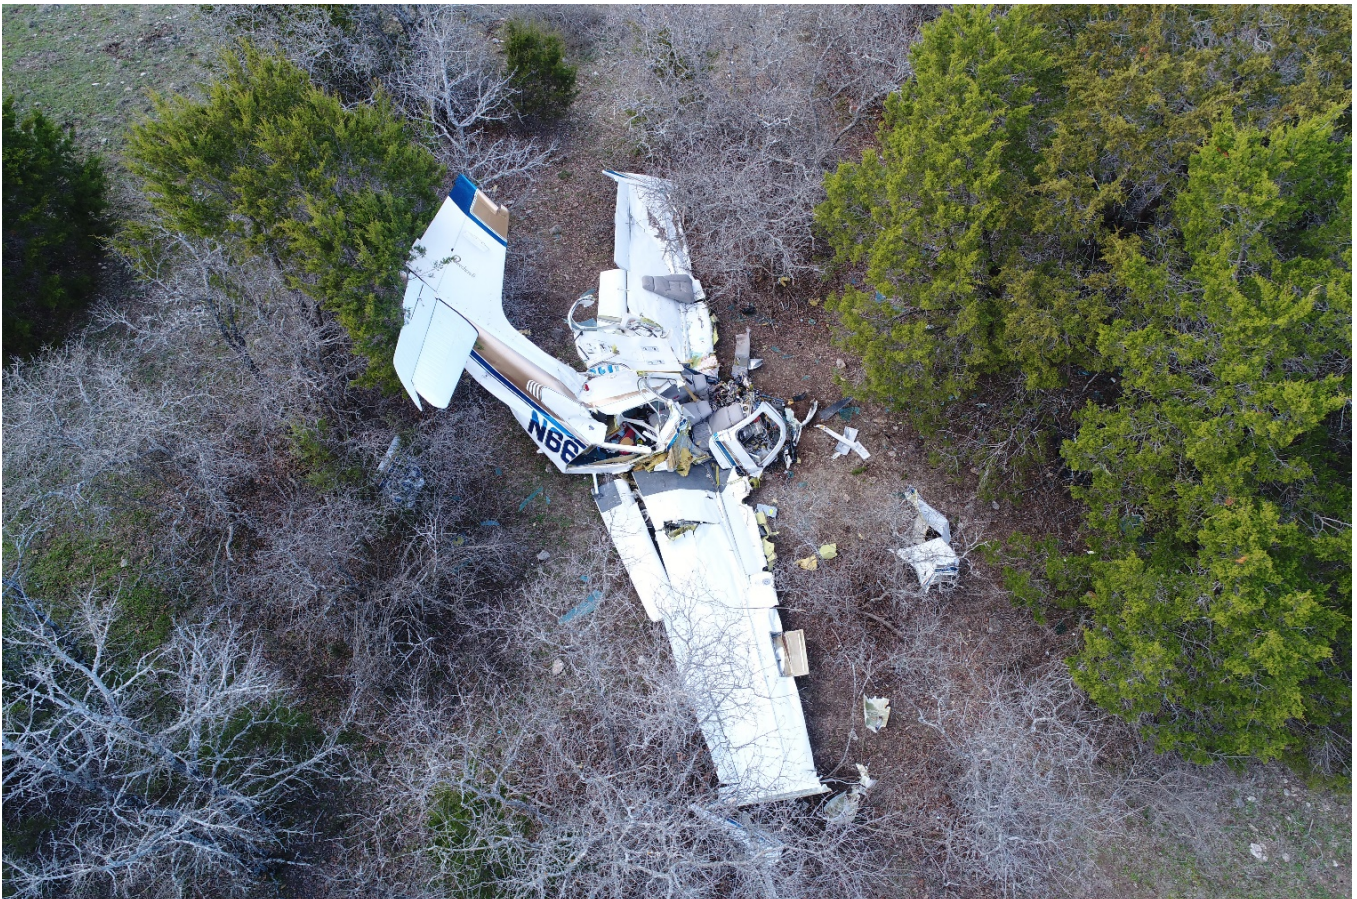
The accident site was located at 32.497067° x -97.861700°, at an elevation about 830 ft msl. The airplane impacted trees and flat, rocky terrain about 2.3 nautical miles northwest (337°) of the final track data point. The airplane impacted the ground with a nose low attitude, estimated about 45° down, and oriented on a 068° true heading. The empennage was bent upward and slightly left and oriented on a 090° heading; the elevators were resting on a tree. The surrounding area was made of up mesquite and spruce trees.
