**NATIONAL TRANSPORTATION SAFETY BOARD**  
Vehicle Recorder Division  
Washington, D.C. 20594

## **Enhanced Ground Proximity Warning System (EGPWS)**

**Specialist's Factual Report**  
**By W. Deven Chen**

Location: Coleman, Texas  
Date: February 20, 2020  
Aircraft: Beechcraft B200  
Registration: N860J  
Operator: Lauren Engineers & Constructors Inc.  
NTSB Number: CEN20FA093

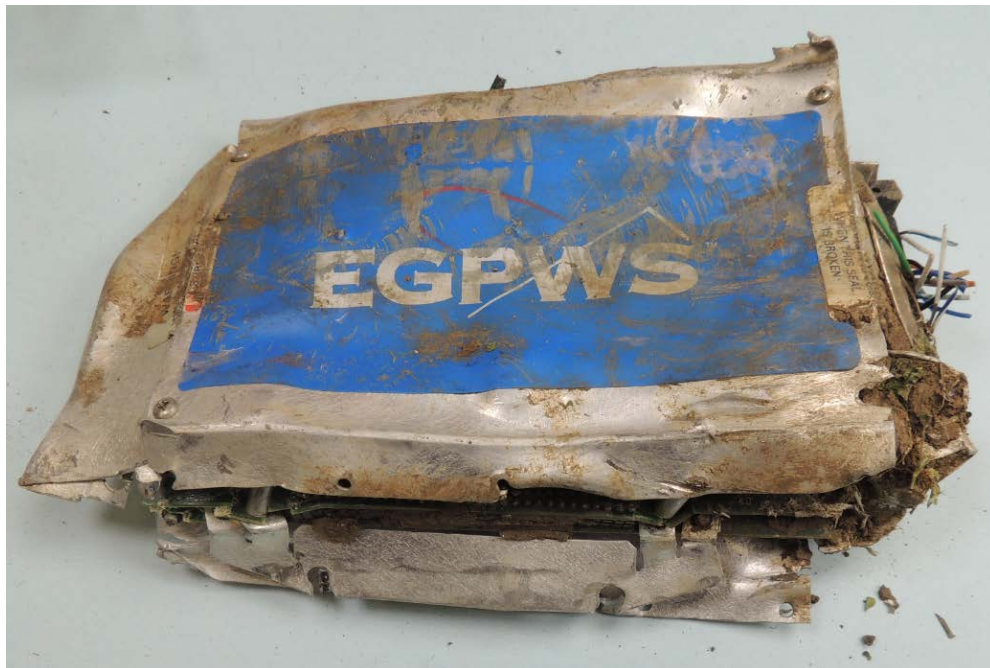
**Figure 1: Honeywell EGPWS KGP 560 as received.**

Upon arrival at the Vehicle Recorder Division, an exterior examination revealed the device sustained severe impact damage, as shown in Figure 1. The circuit board containing the NVM chips was removed from the unit, as shown in Figures 2. The flight data was stored on the NVM chip labeled U24. This circuit board was sent to the manufacturer for data recovery. After removing the NVM chip from the circuit board, the manufacturer discovered cracks on the chip due to impact from the accident and could not read data from it. The manufacturer advised to have a chip manufacturer perform a raw data reading on the damaged NVM chip and recommended a chip manufacturer. However, the chip manufacturer did not believe they could successfully recover information from the chip and declined the work after reviewing the photos of the damaged NVM chip. The damaged NVM chip then was sent to the Integrated Electronic Engineering Center of Binghamton University for damage evaluation and repair. The tests found cracks in the silicon die inside the chip. The evaluation concluded that no data recovery from the chip was possible due to cracks in the silicon die and that the NVM chip could not be repaired. Thus, no data were recovered from this device. Figure 3 shows a screenshot of the damage evaluation on the NVM chip from the Integrated Electronic Engineering Center of Binghamton University. The full report of the chip damage evaluation is provided as Attachment 1 to this report.

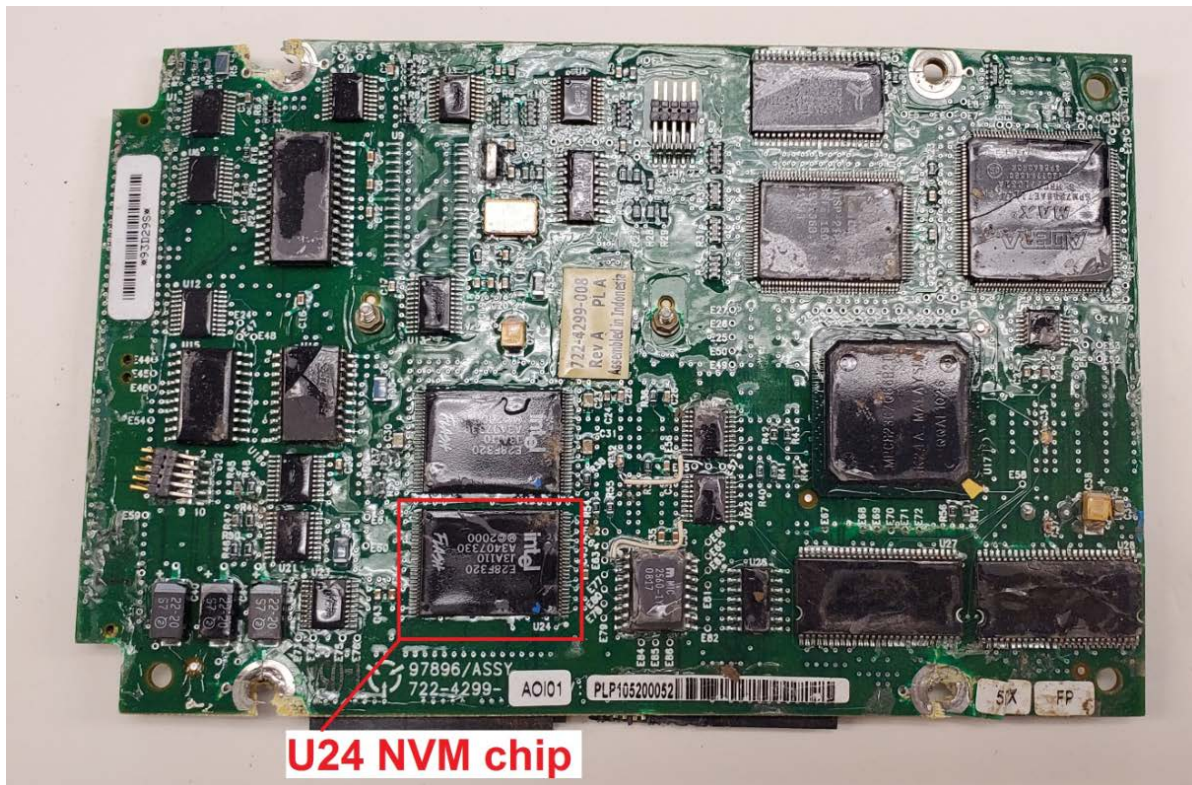
Figure 2: Circuit board containing NVM chip of the Honeywell EGPWS.

- Optical inspection revealed multiple cracks on the back side and a long thin crack on the front side of the module.
  - Side view showed one of the cracks to have propagated along the package thickness, and that the package is slightly bent.

- X-ray imaging revealed that the memory module consists of a wire-bonded, rectangular die with a leadframe.
  - Package cracks could be easily discerned in the x-ray images. They also revealed possible cracks in the die. No anomalies were detected in any wire bonds. There were inhomogeneities in the die-attach.

- X-ray images from the side showed a slight bowing of the package
  - Acoustic images show cracks in the silicon die, mold as well as the leadframe. Voids and delaminations were detected in the die attach.

- Conclusion: No data recovery is possible due to cracks in the Silicon die. This module can not be repaired.
