# **Non-destructive evaluation of a memory module from incident CEN20FA093**

Prepared for the National Transportation Safety Board

September 11, 2020

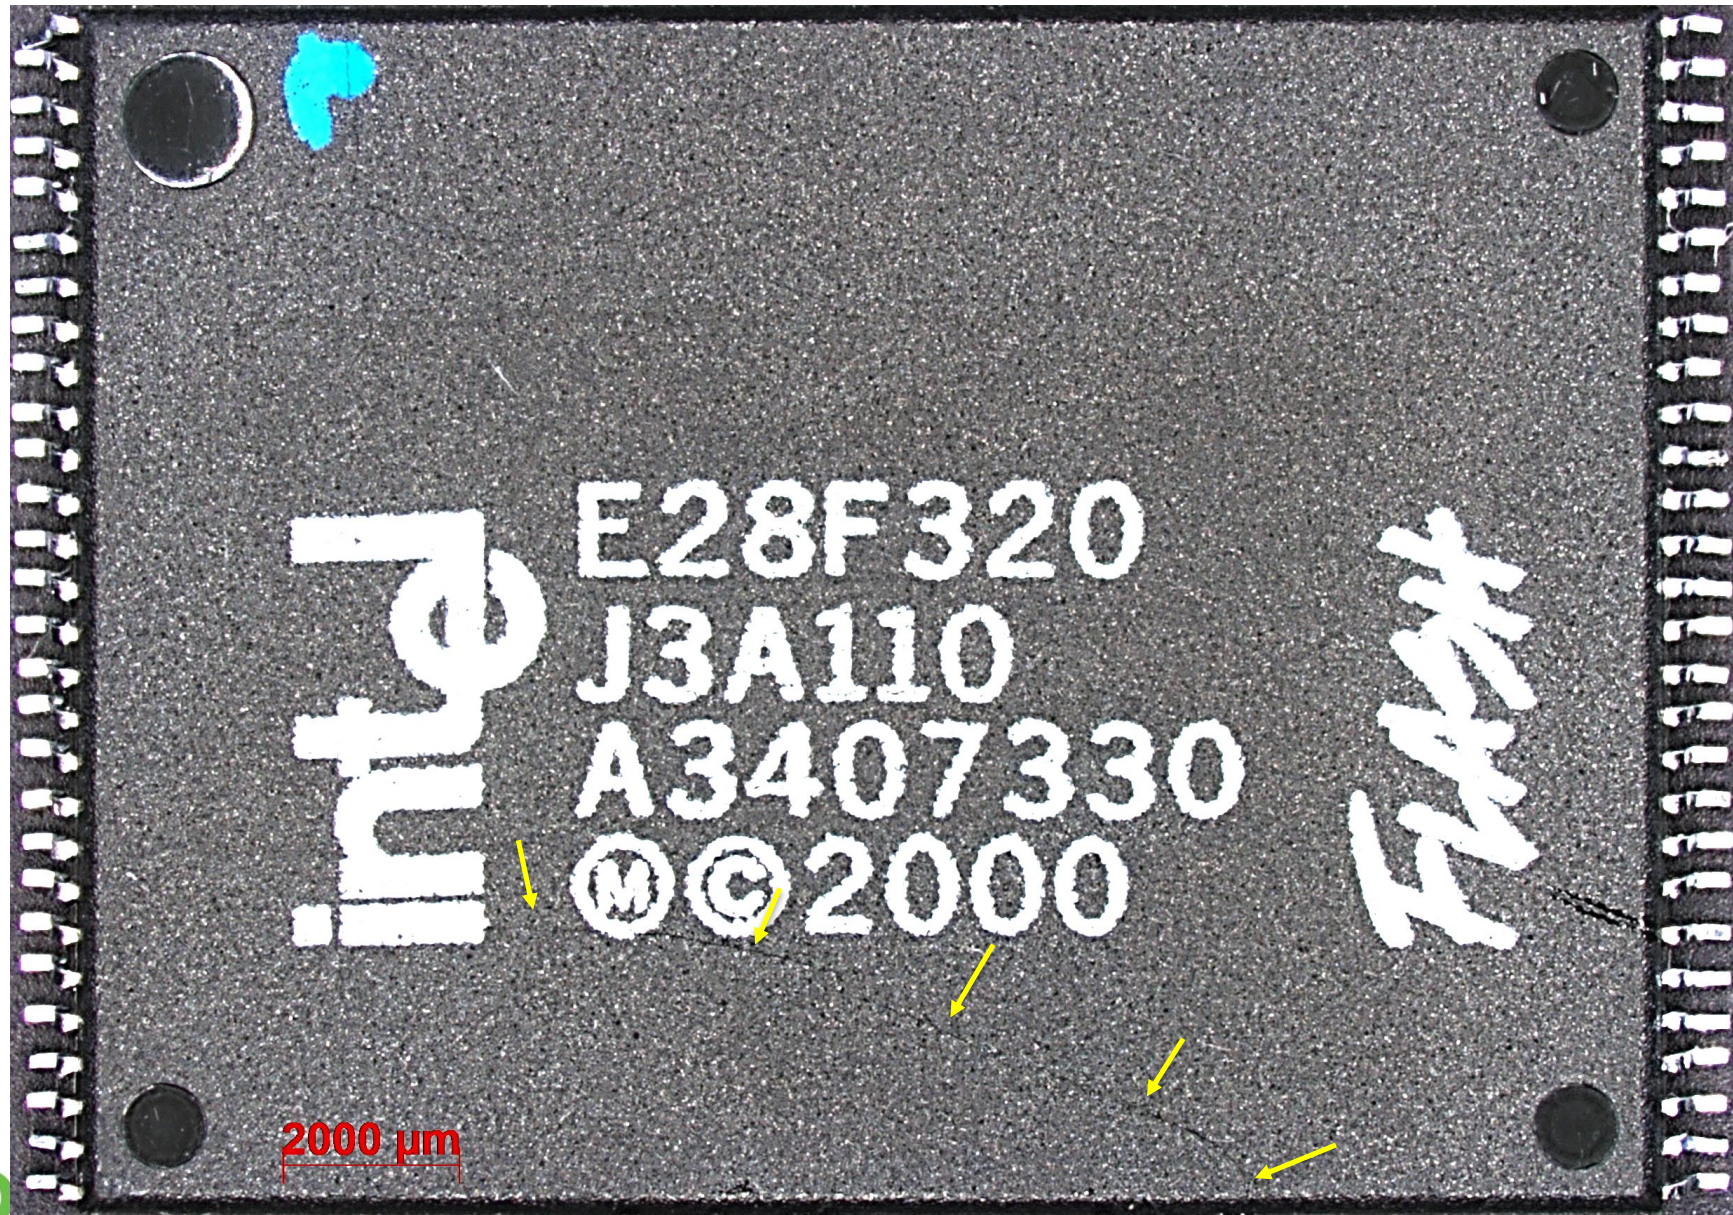
## Front-side of the module

Module has a long thin crack in its front side

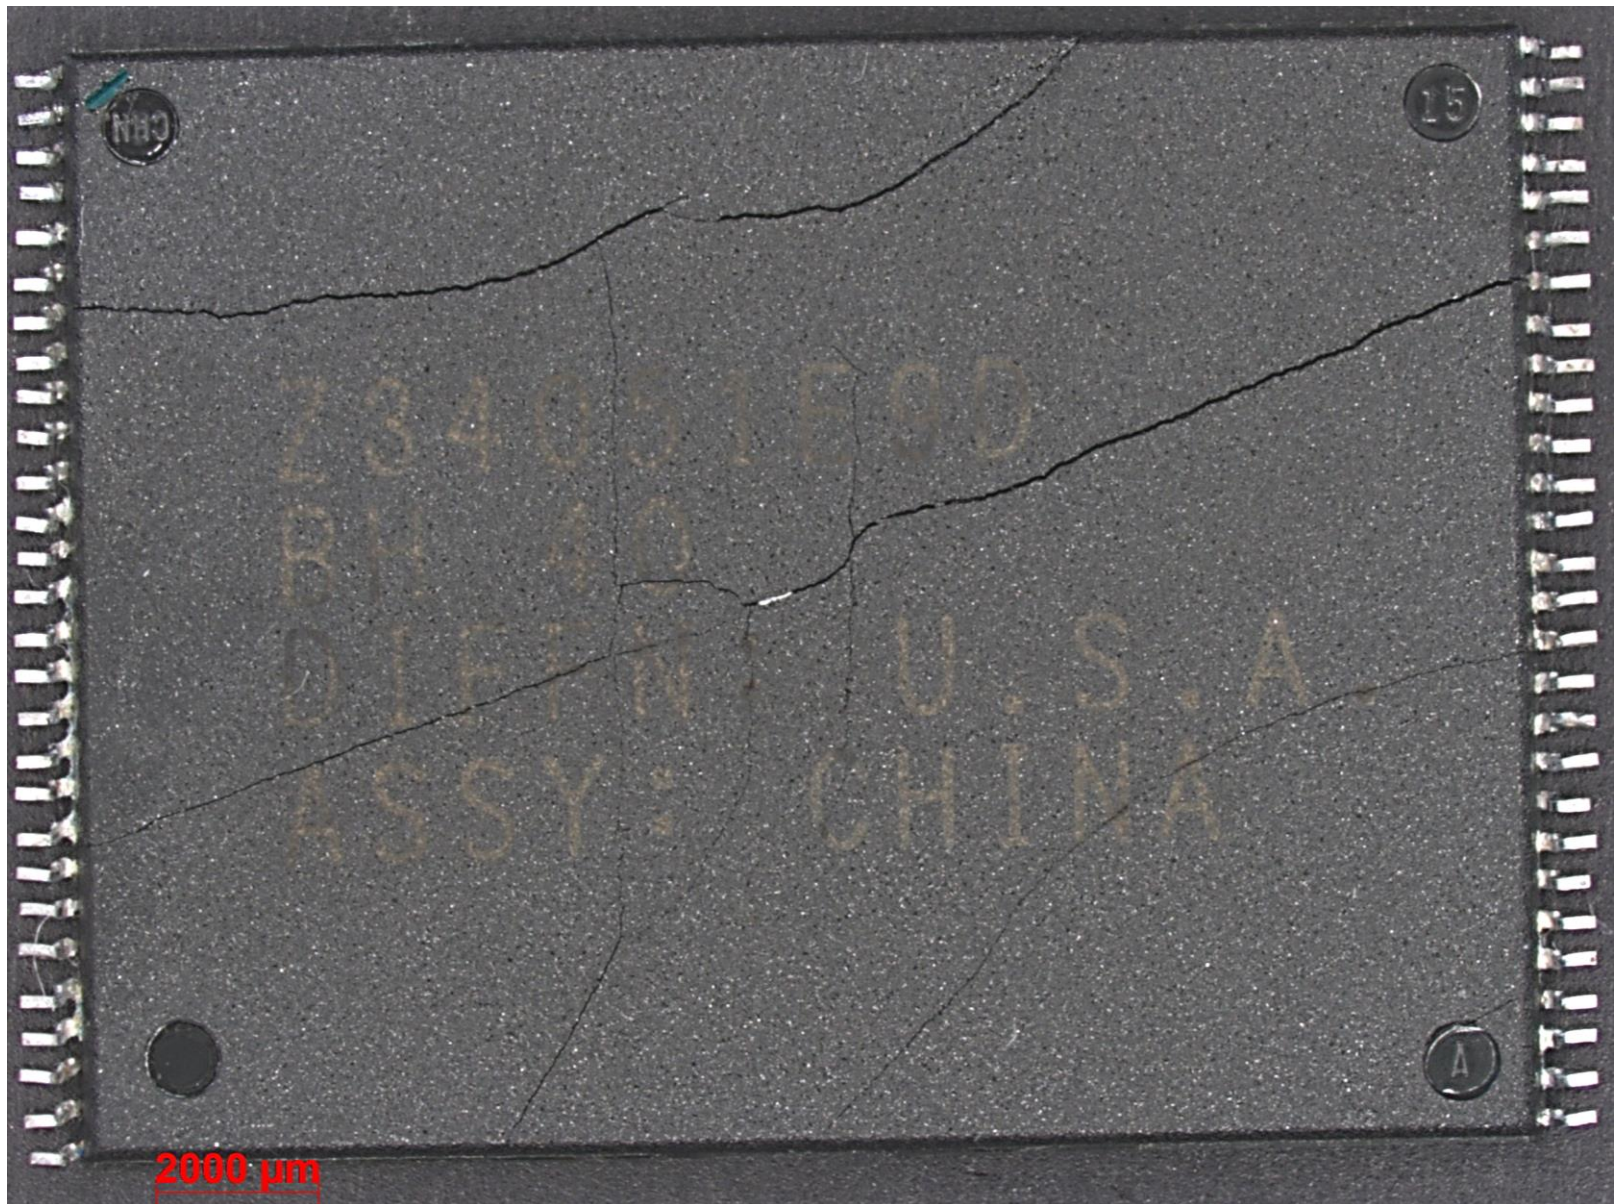
## Backside of the module

Package is severely cracked from its back side

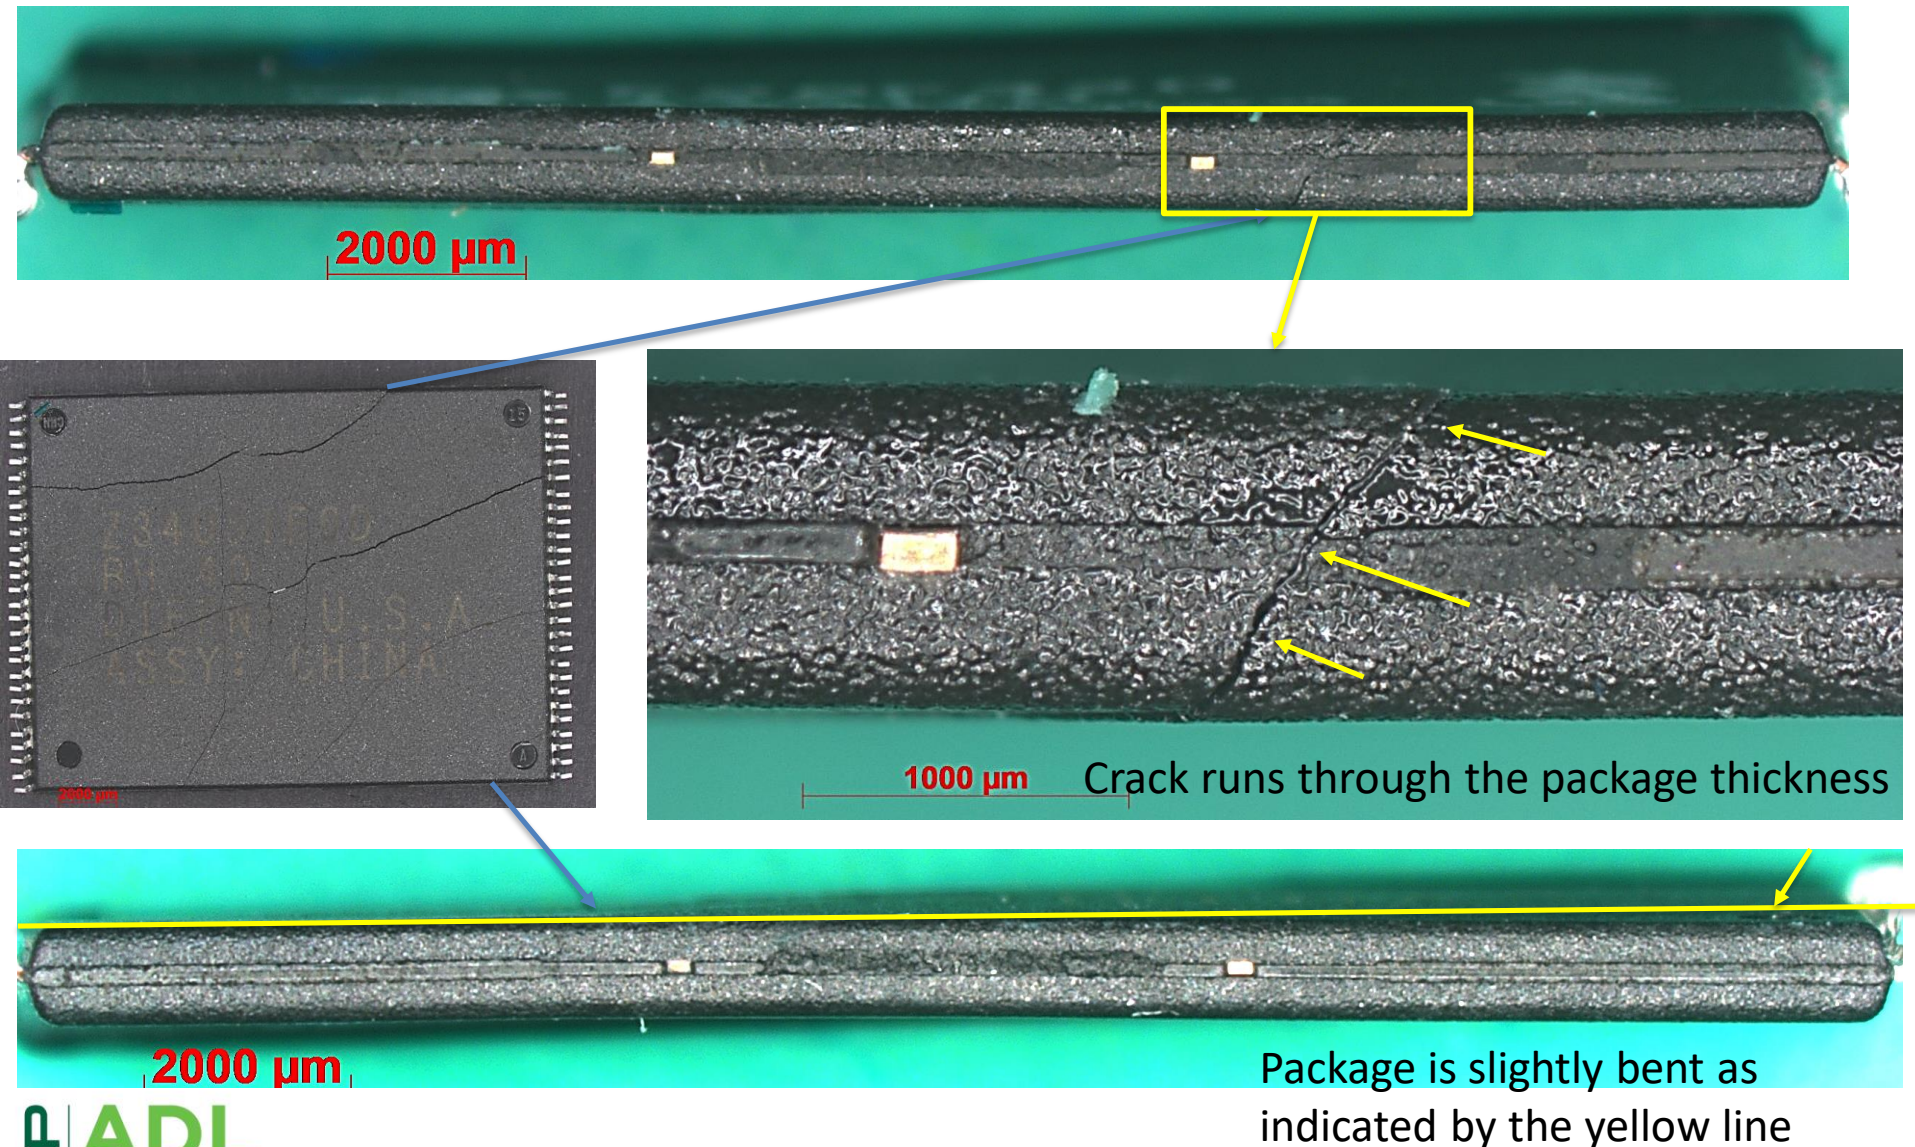
## Side views of the module

- Optical inspection revealed multiple cracks on the back side and a long thin crack on the front side of the module.
  - Side view showed one of the cracks to have propagated along the package thickness, and that the package is slightly bent.

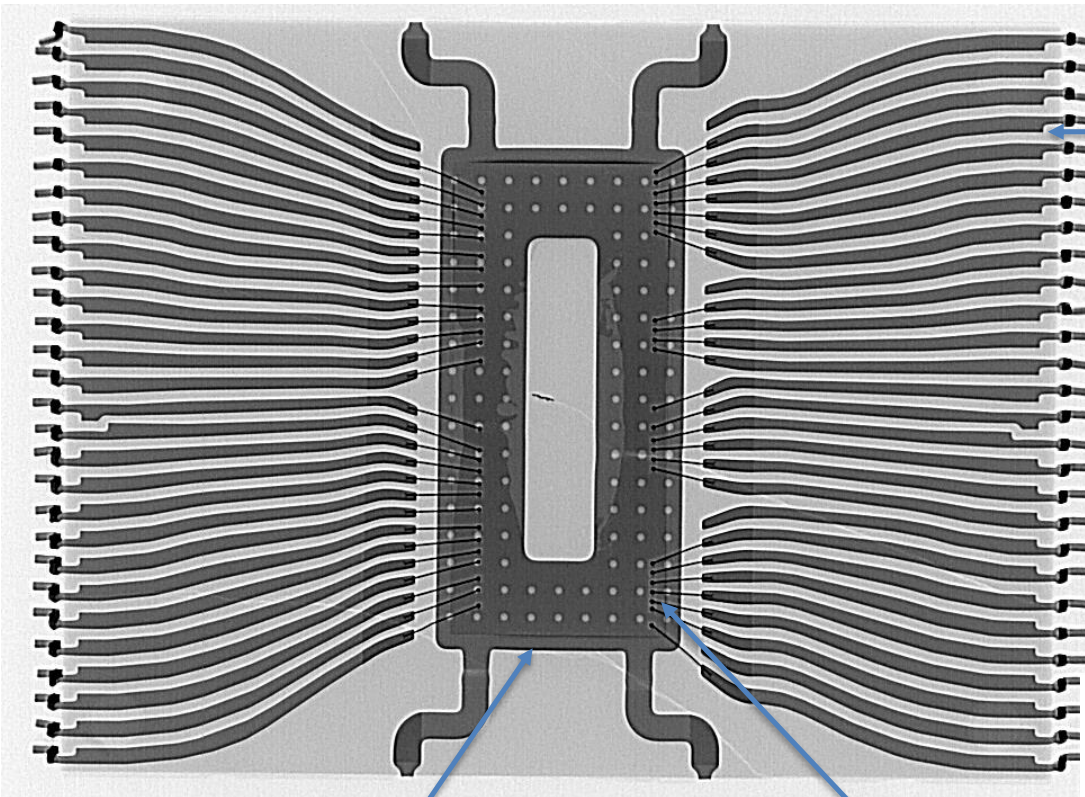
## X-ray image of the module

Leadframe

Lead frame  
with die paddle

Die with  
wirebonds

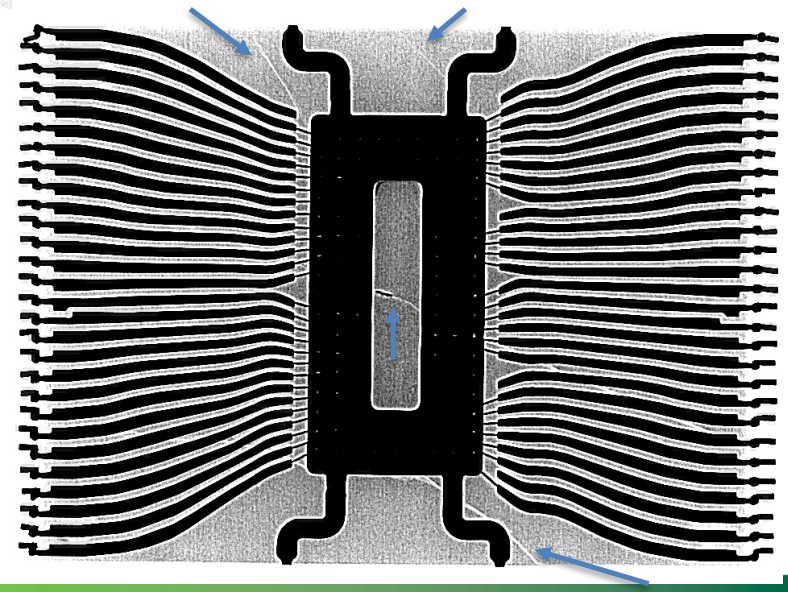
The image below with adjusted  
contrast shows package cracks

The package has a die with  
wirebonds on two sides

- Multiple cracks in package shown with blue arrows
- Some cracks pass through the die area
- The die attach shows inhomogeneities such as voids
- Some kind of metal debris is trapped in the crack in the middle (red arrow)

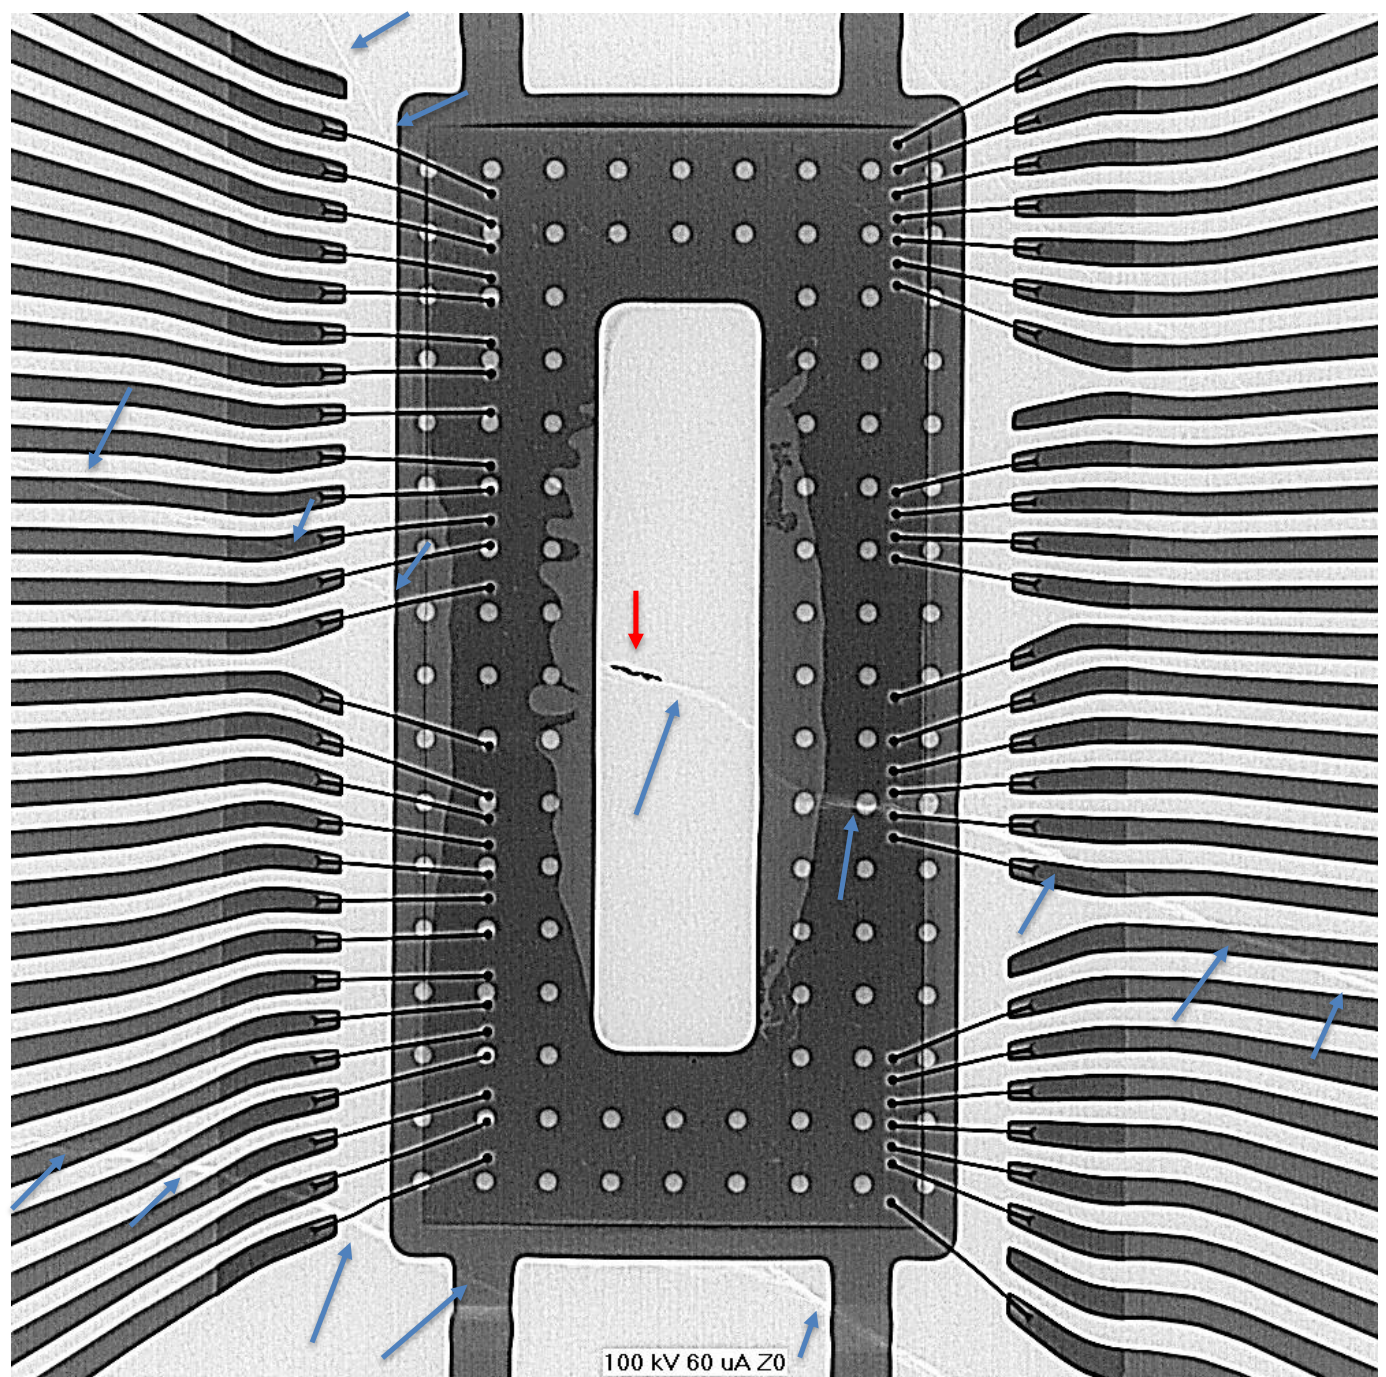
Wire bonds look OK

Blue arrows pointing to  
cracks in the package

Possible cracks in the die as  
indicated by shift in its edge

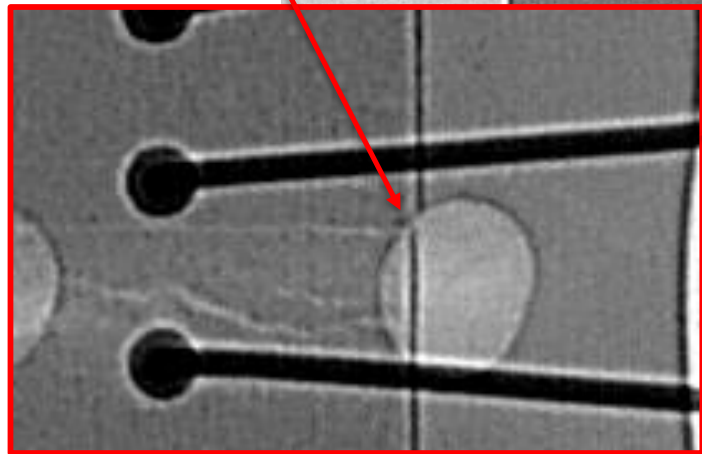
Wire bonds look OK

Possible cracks in the die as indicated by shift in its edge

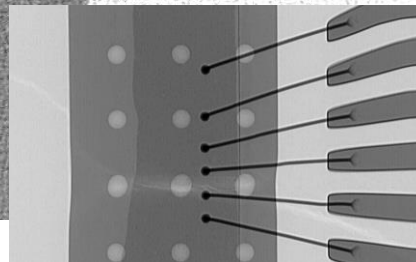
wire bonds looks OK

Possible cracks in the die as indicated by shift in its edge

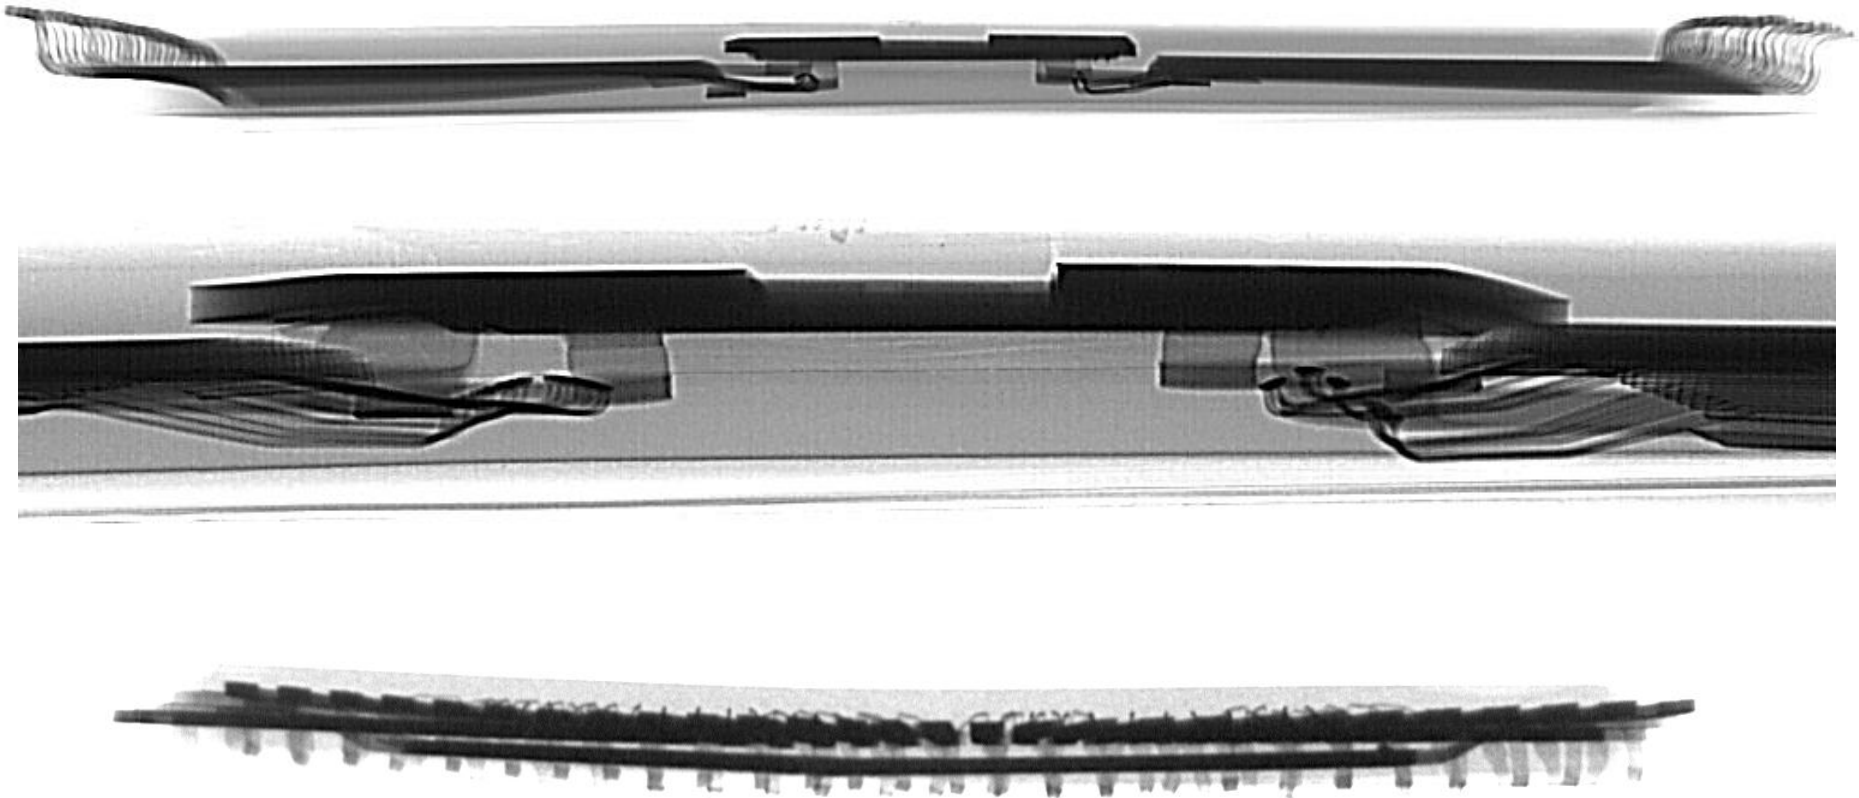
## Side view of the module

Side view of the package shows that it is bent.

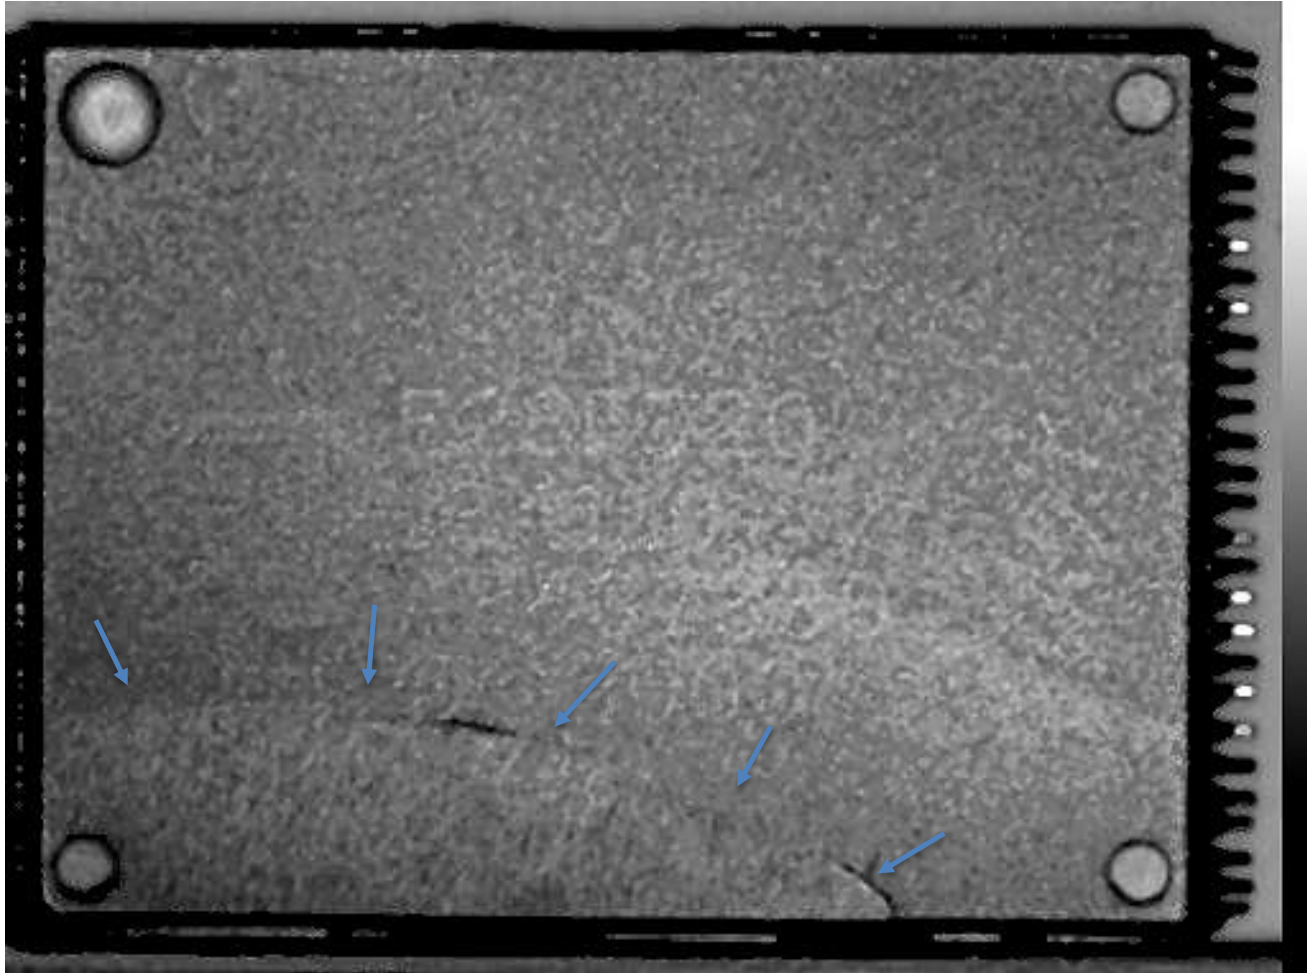
## Top surface of the module

C-SAM image from the top surface shows a long crack in the mold surface

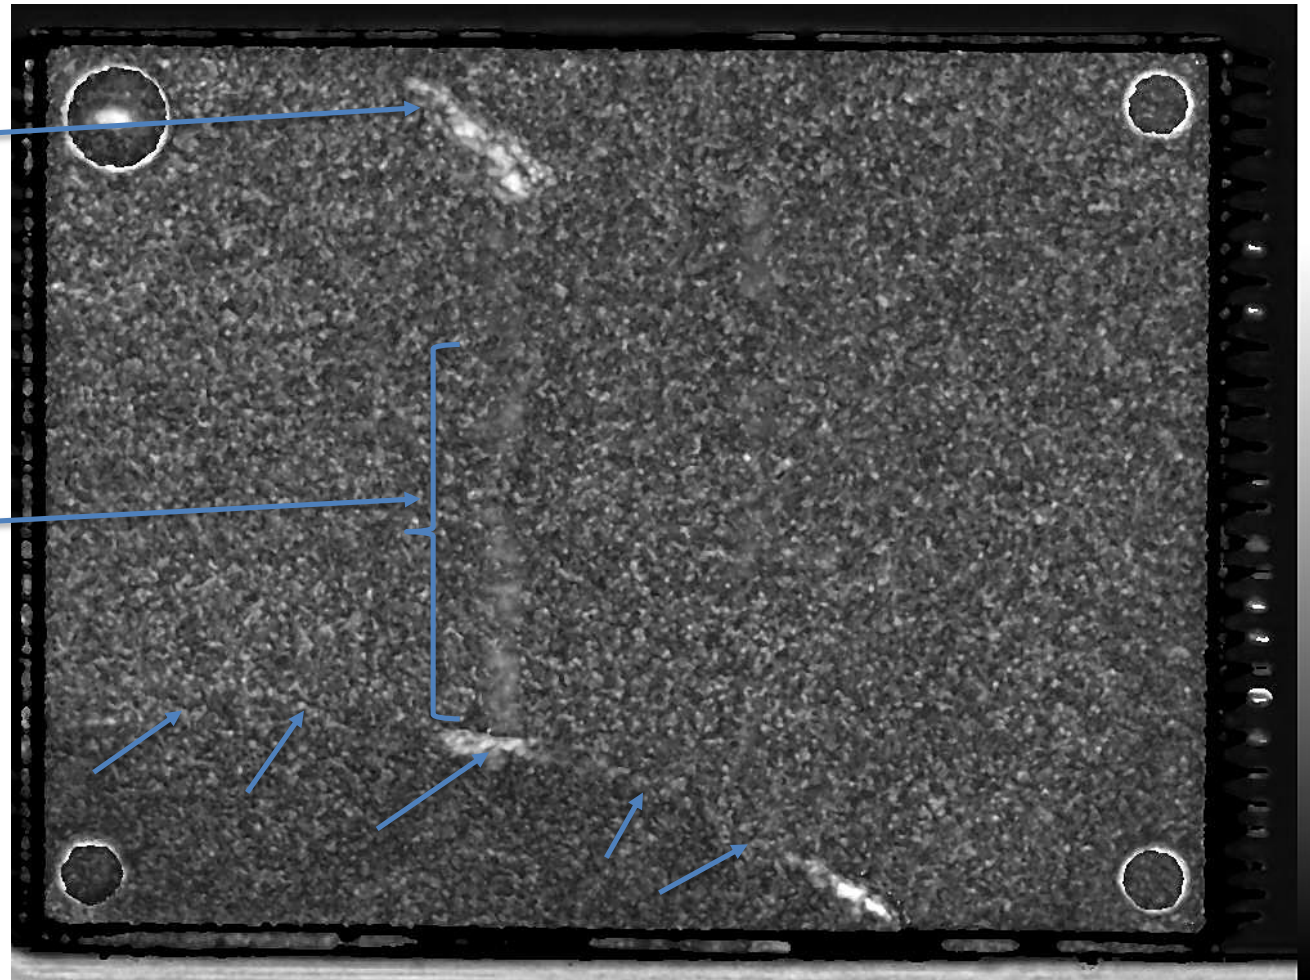
## C-SAM image from the mold compound

Crack in the mold

Die wire bonds  
within the mold

Shadow/propagation of  
the mold surface crack

There are cracks on the top package surface as  
well as within the mold

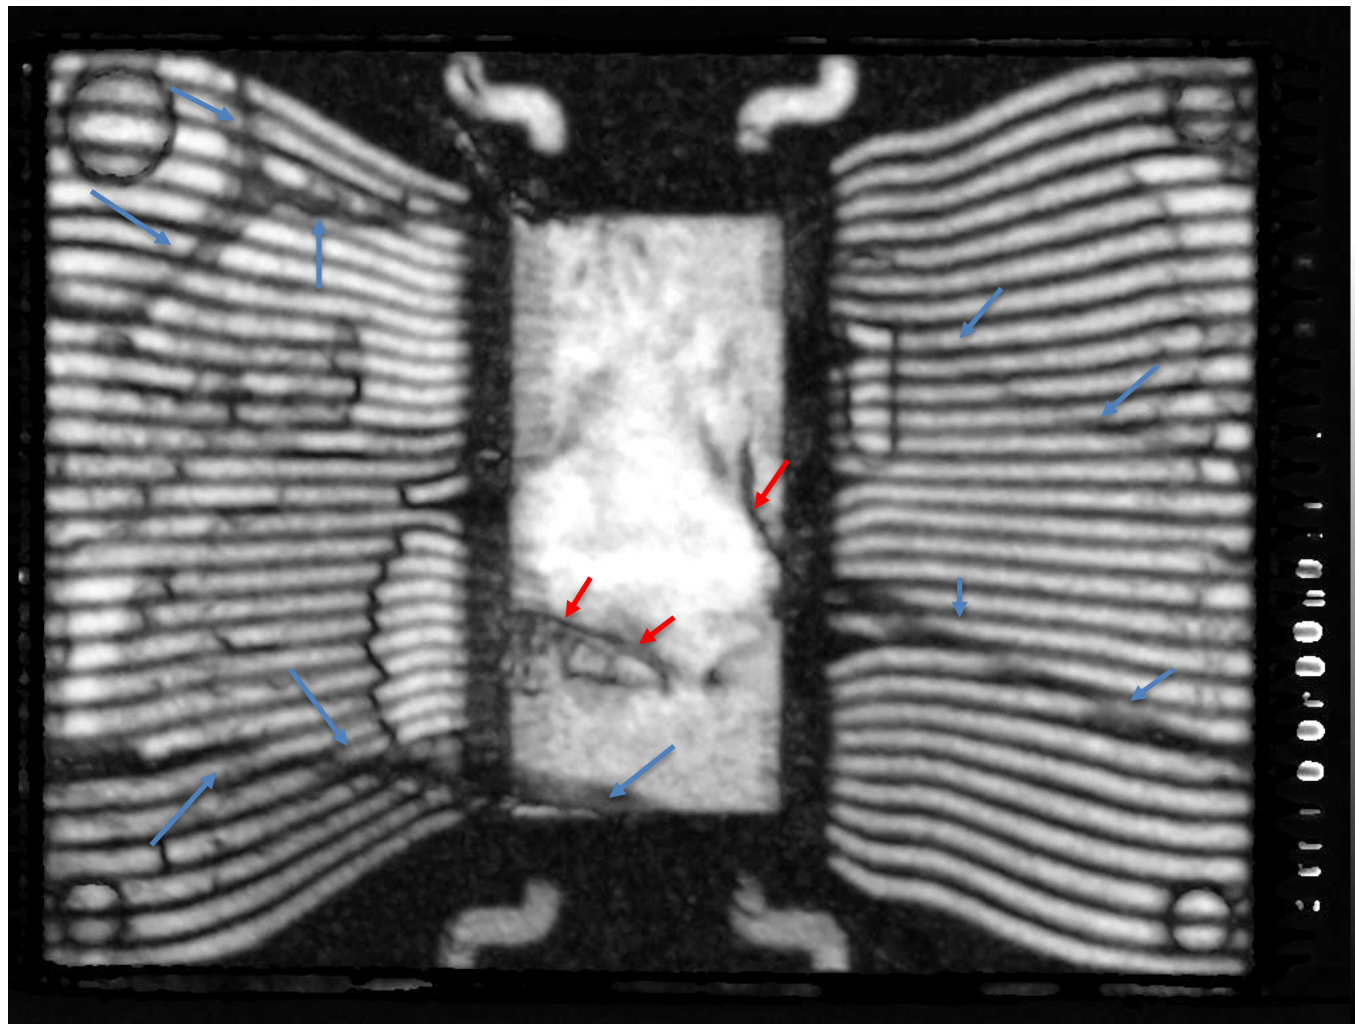
## C-SAM image from die top and leadframe

- Die cracks pointed with red arrows
- Leadframe cracks pointed with blue arrows

C-SAM images show that there are cracks in the die.

- Conclusion: No data recovery is possible due to cracks in the Silicon die. This module can not be repaired.

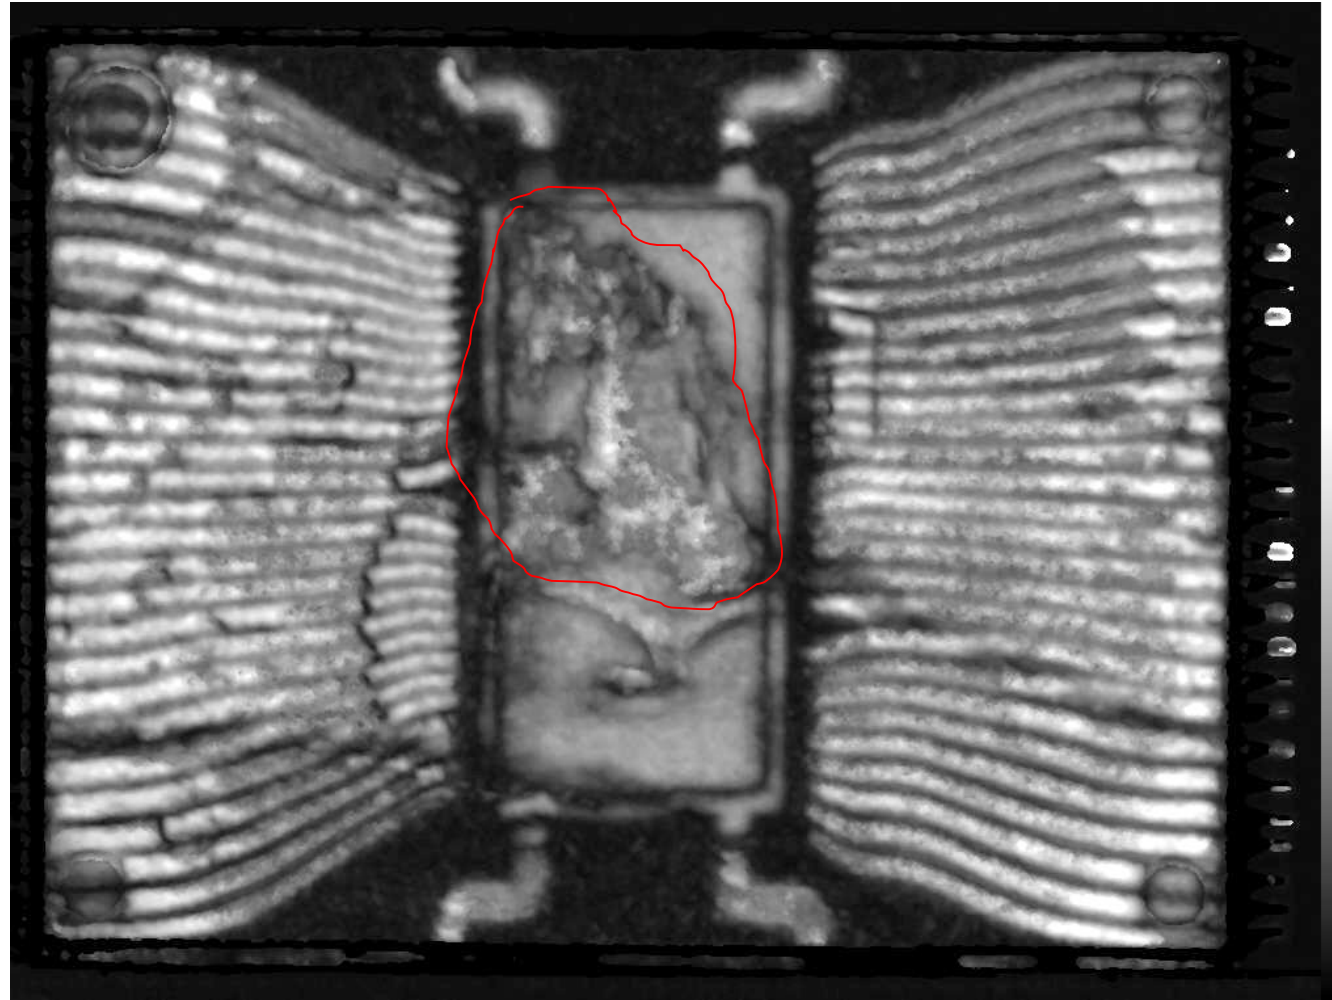
## C-SAM image from the die attach

C-SAM images show delaminations and voids in the die attach.

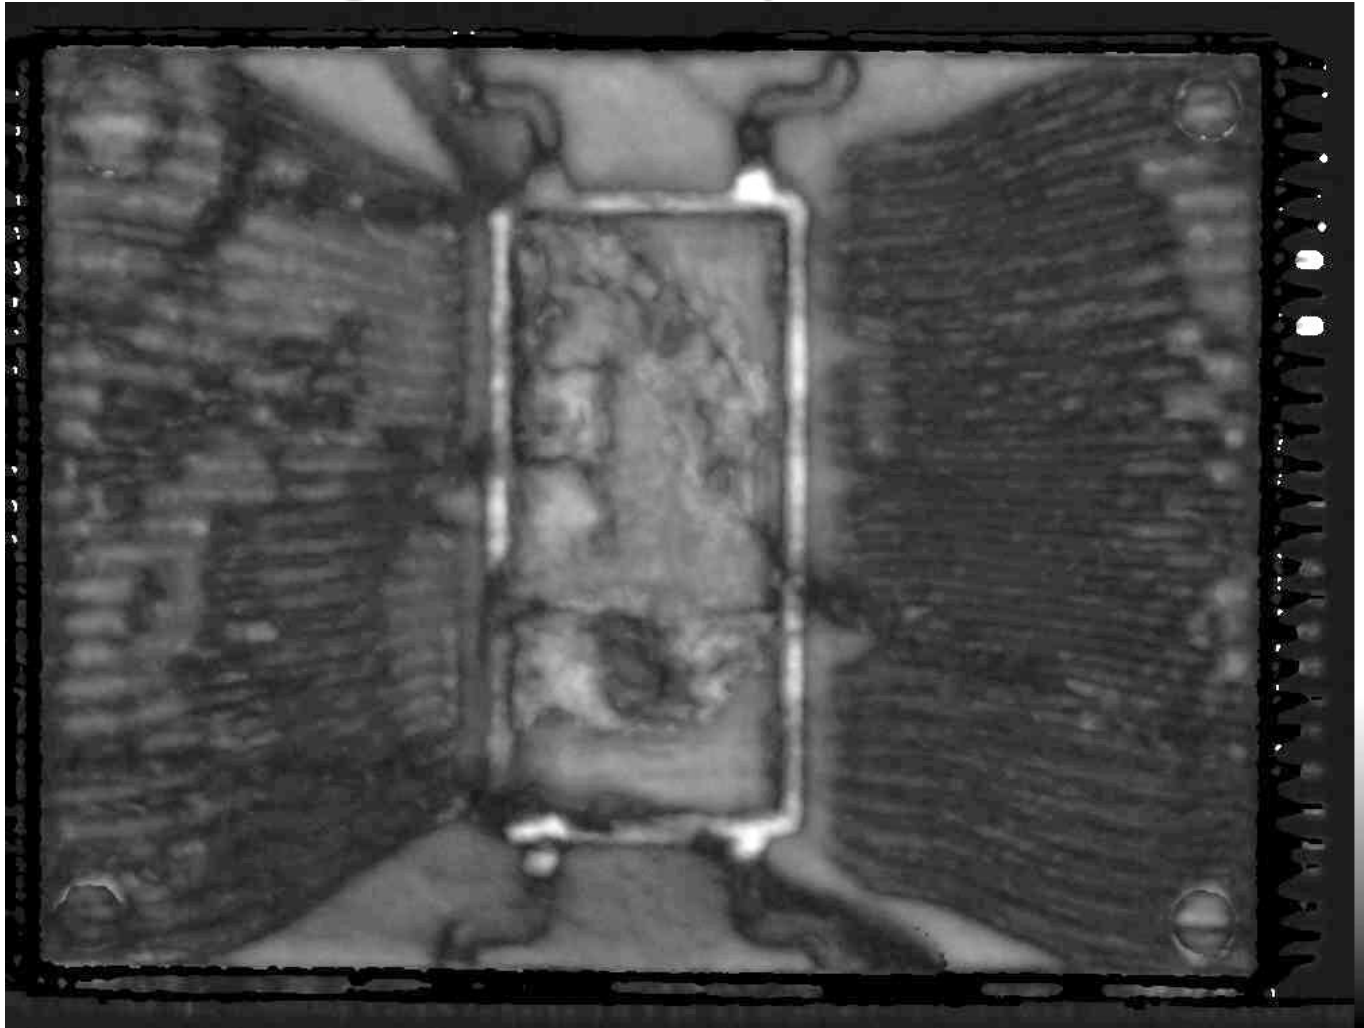
## C-SAM image from the die paddle and leadframe

The image shows package cracks and their shadows.
