#### SUMMARY OF AIRCRAFT EXAMINATIONS

-- CEN20FA096 --

Location: Rogers, Minnesota  
Date: February 22, 2020  
Time: 1111 central standard time  
Aircraft: Beech A36, N3266Q, serial # E-2966  
Engine: Continental IO-550R (6B), serial # 1037555

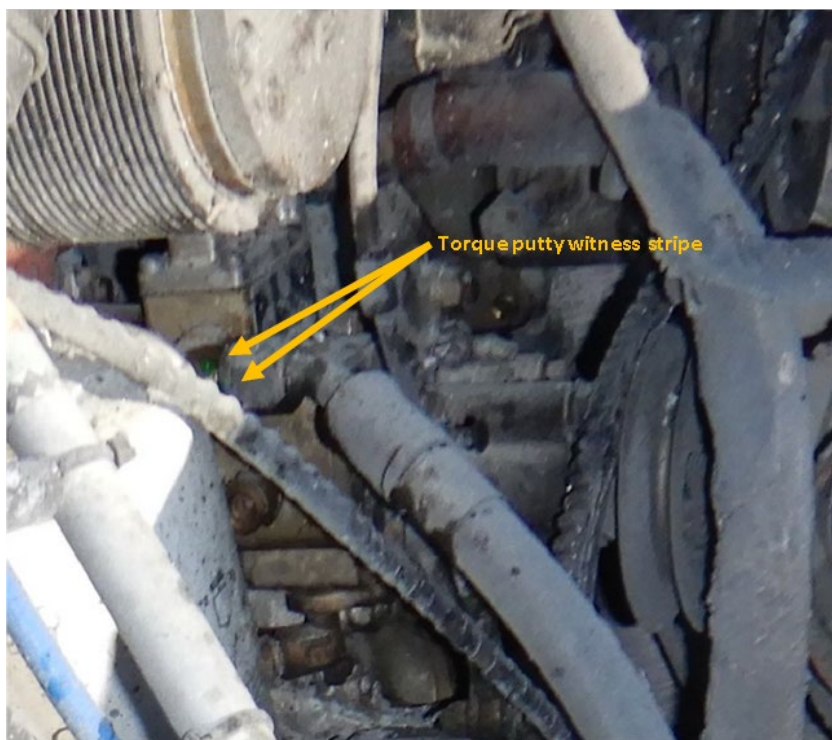
The flexible fuel hose b-nut connecting the firewall fuel-outlet fitting to the fuel inlet-fitting located on the engine-driven fuel pump was found to be only finger tight. The green torque putty placed on this b-nut did not align between the fuel fitting on the fuel pump and the b-nut shoulder, which was consistent with movement between the fuel fitting and

the fuel b-nut shoulder.

Photo 1 – Fuel inlet b-nut fitting at accident Site

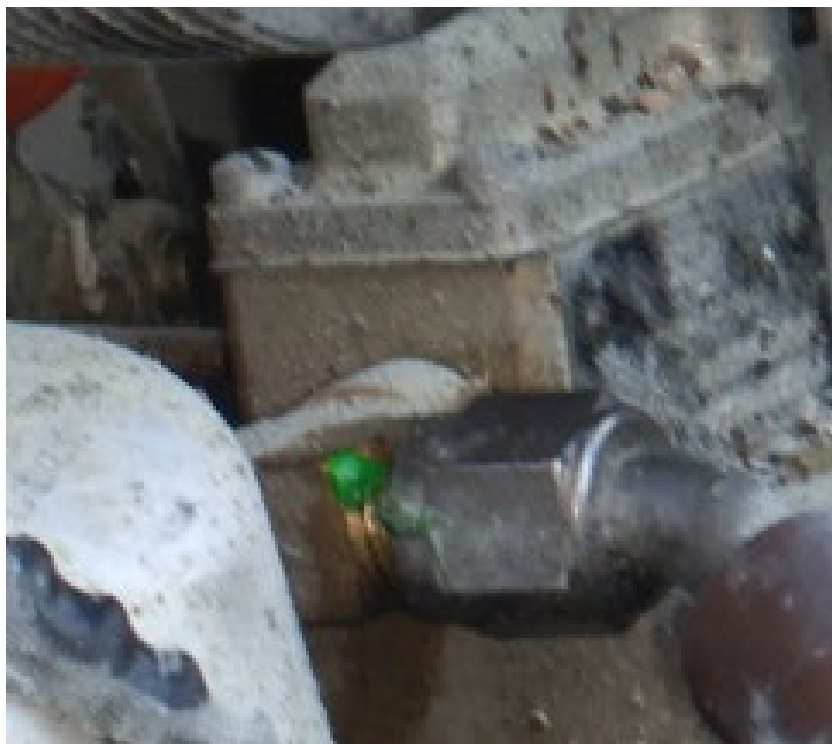
Photo 2 – Close up view of fuel inlet b-nut fitting

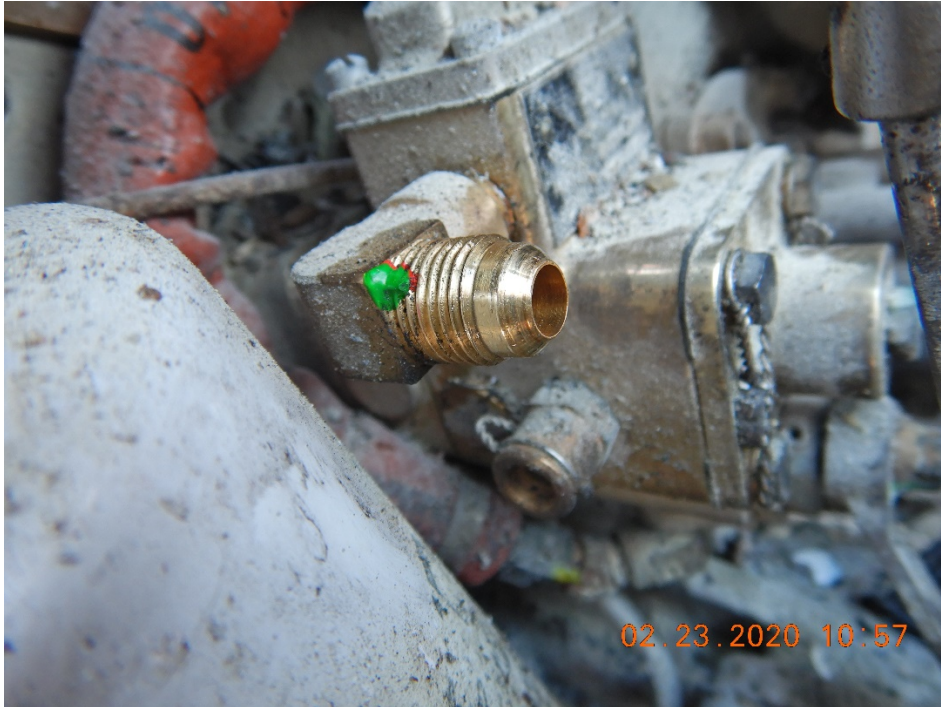
The fuel inlet b-nut fitting was disassembled. No anomalies were noted with the inlet fitting or the b-nut shoulder.

Photo 3 – Fuel pump inlet fitting

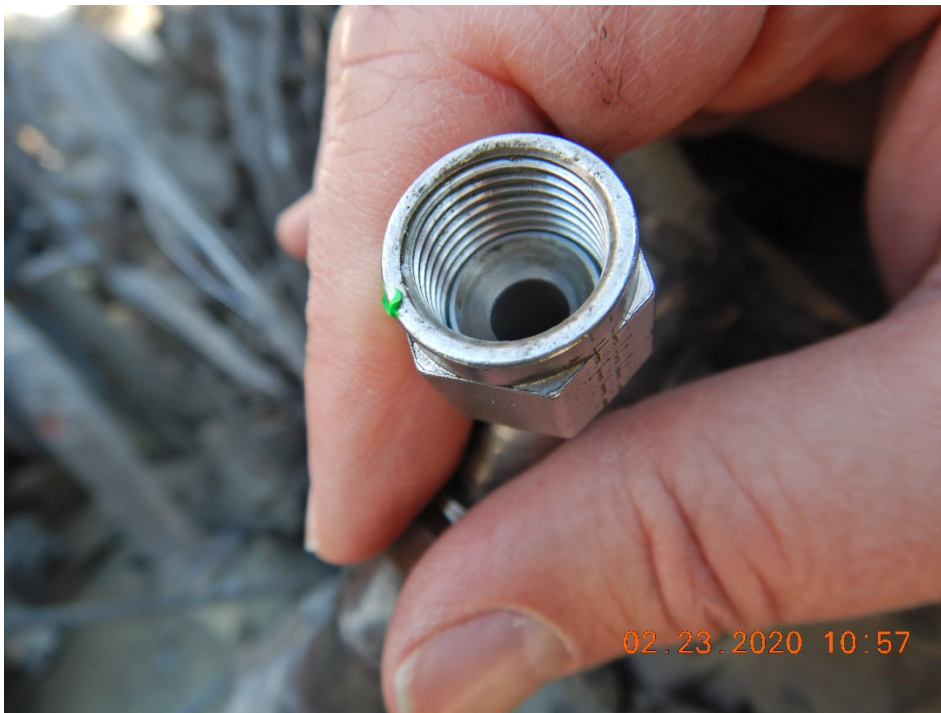
Photo 3 – Fuel pump inlet – shoulder of b-nut
