## Memorandum for Record

**Subject:** CEN20FA098 Wreckage Examination

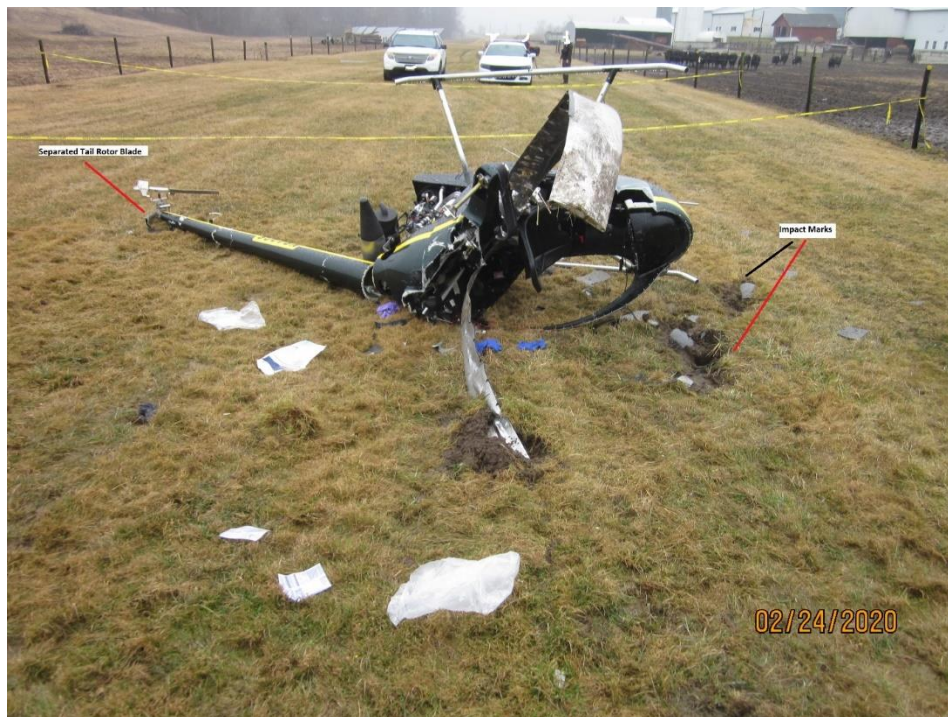
Figure 1.

An examination of the wreckage was conducted by the NTSB IIC on 2/25/2020. The accident site was located on the east end of a private grass airstrip located about three miles west of North Manchester, Indiana. The helicopter wreckage came to rest on its right side. Both aluminum main rotor blades (MRB) remained attached to the rotor mast. One MRB was partially imbedded into the ground and displayed some bending and deformation along its entire length. The second MRB was bent about 70° and exhibited deformation throughout its length. Two impact marks were located on the ground within 3 ft of the nose of the helicopter, one of which was linear. (Figure 1)
