**From:** Fox Matthew  
**Sent:** Friday, February 21, 2020 1:57 PM  
**To:** Williams Shaun  
**Cc:** Budinski Michael  
**Subject:** CEN20LA020 - Tyler, TX - Materials Laboratory Examination  
**Attachments:** IMG\_9849.JPG; IMG\_9959.JPG; IMG\_9962.JPG; IMG\_9963.JPG; IMG\_9964.JPG

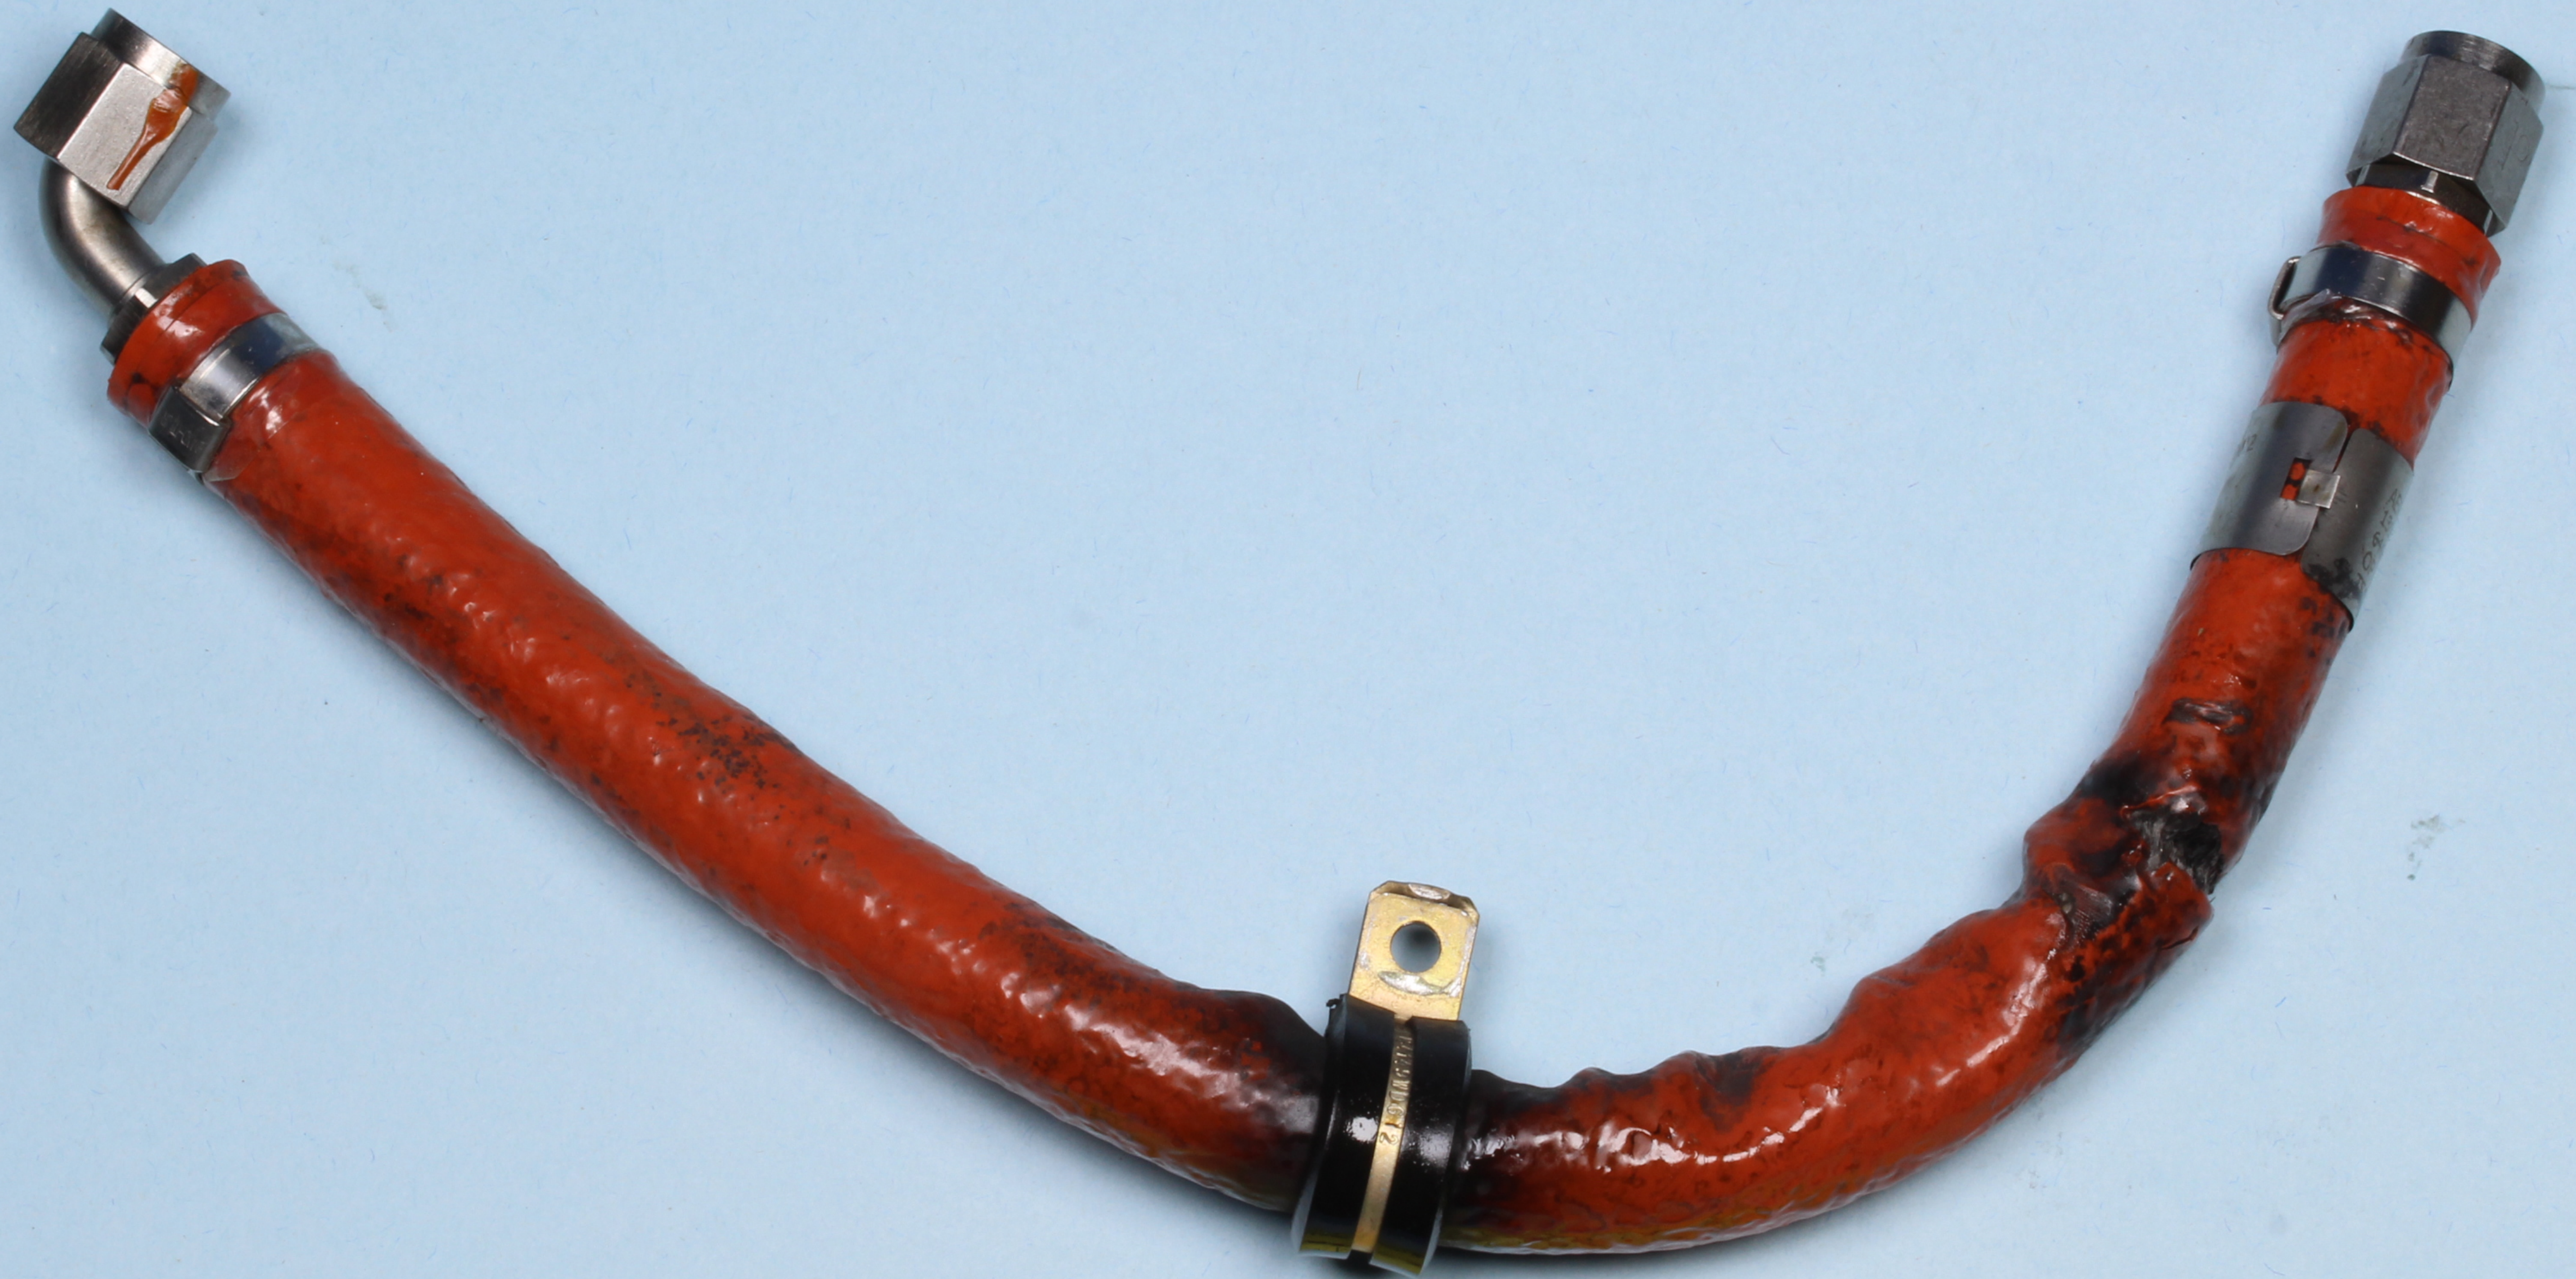
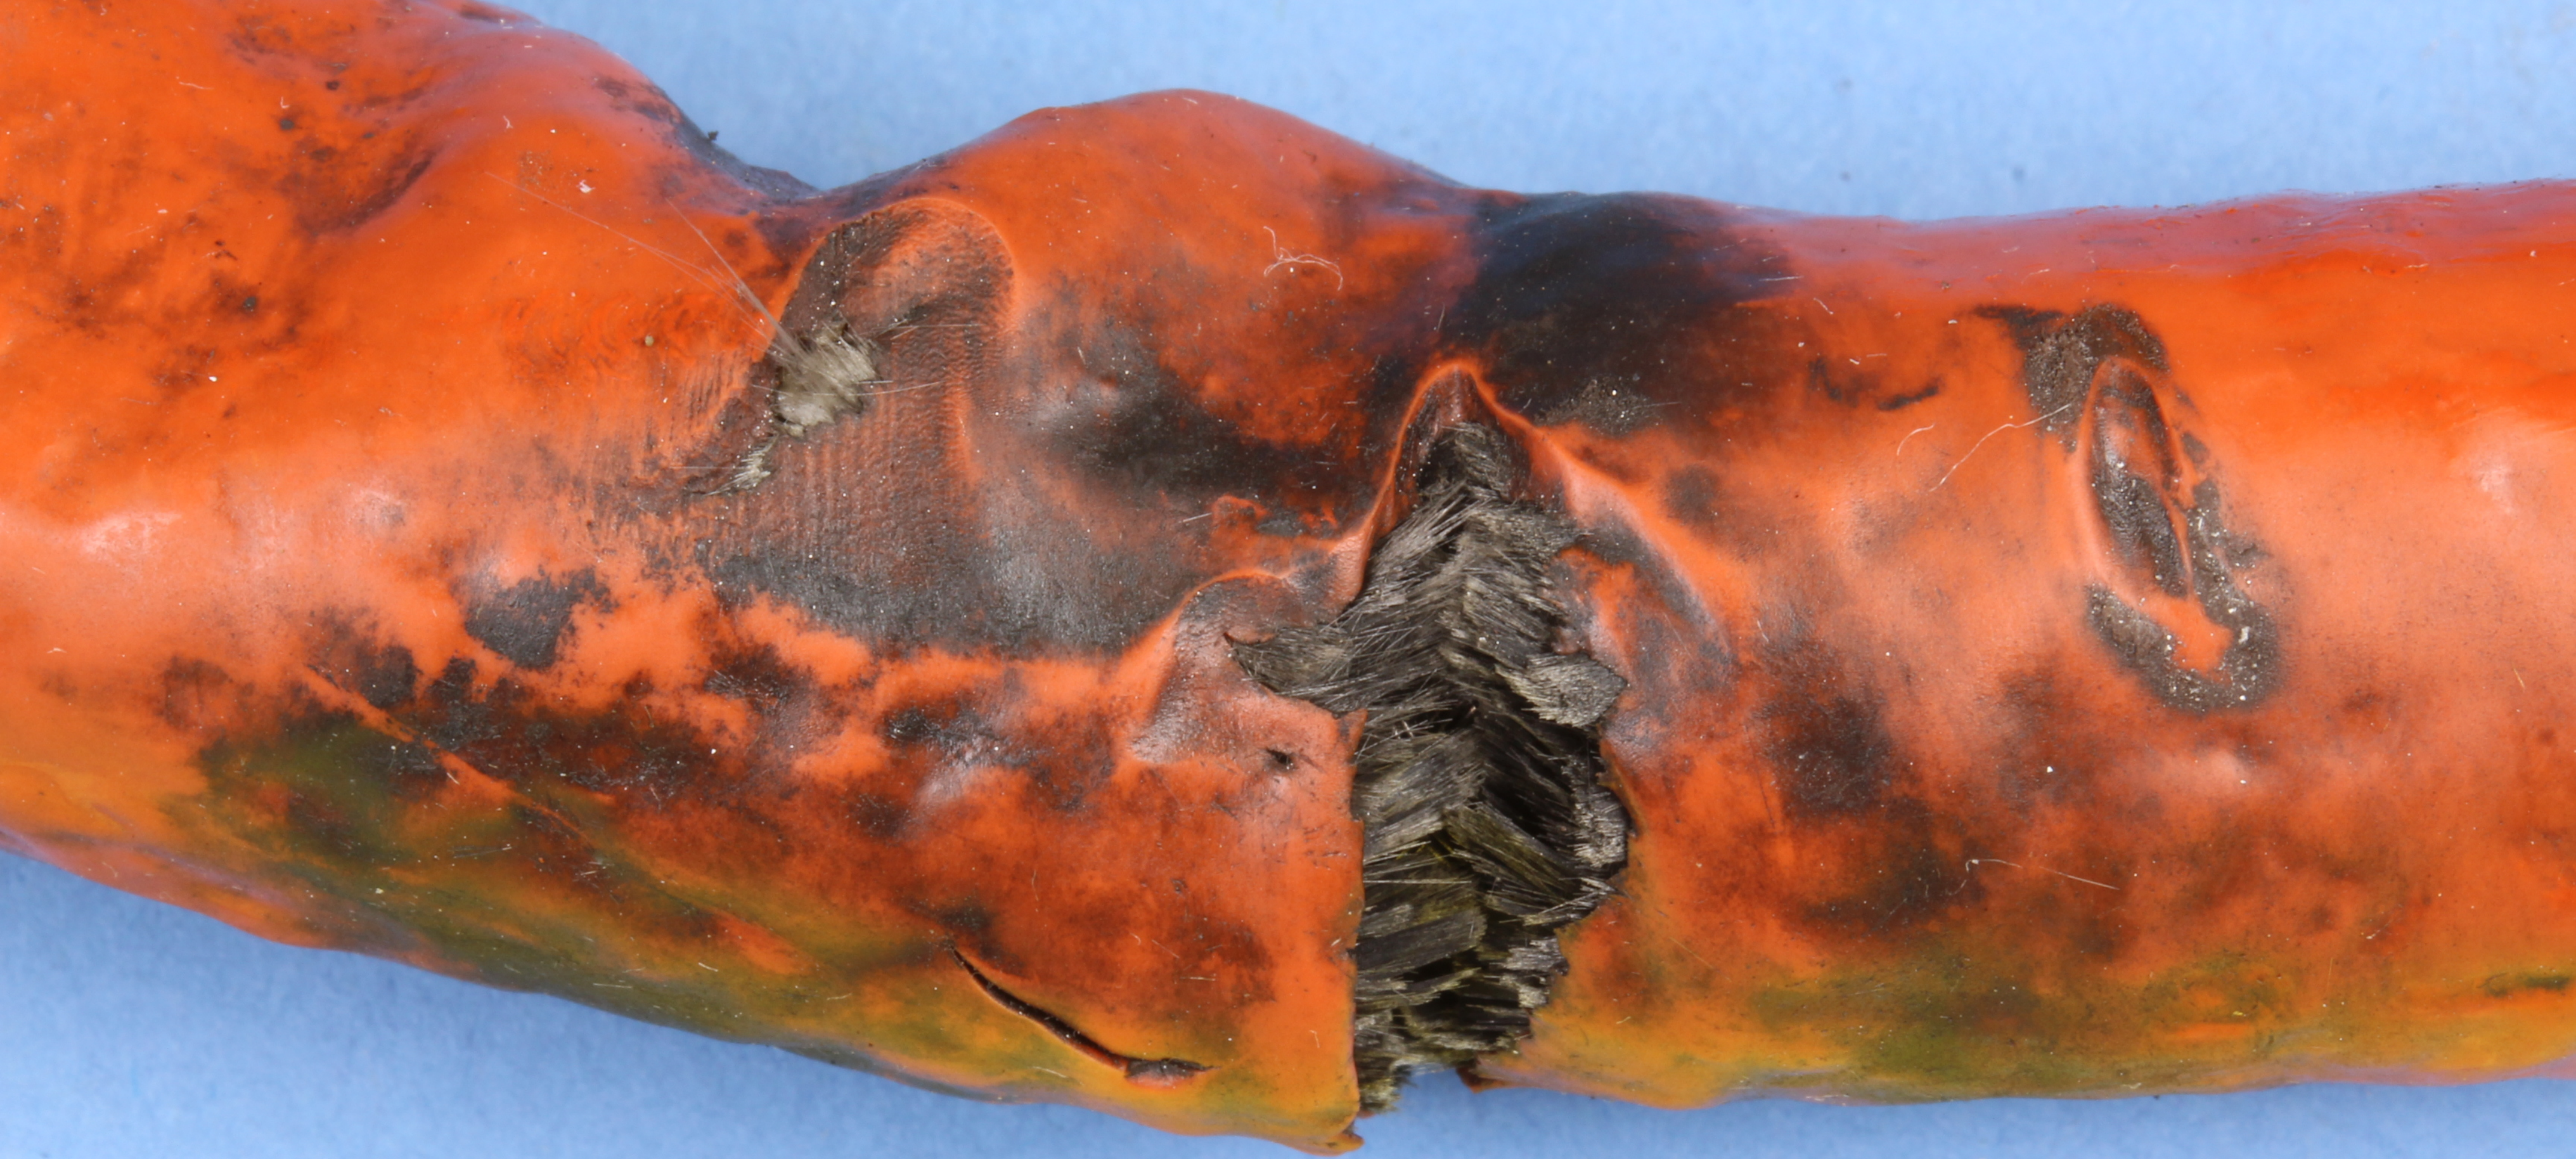
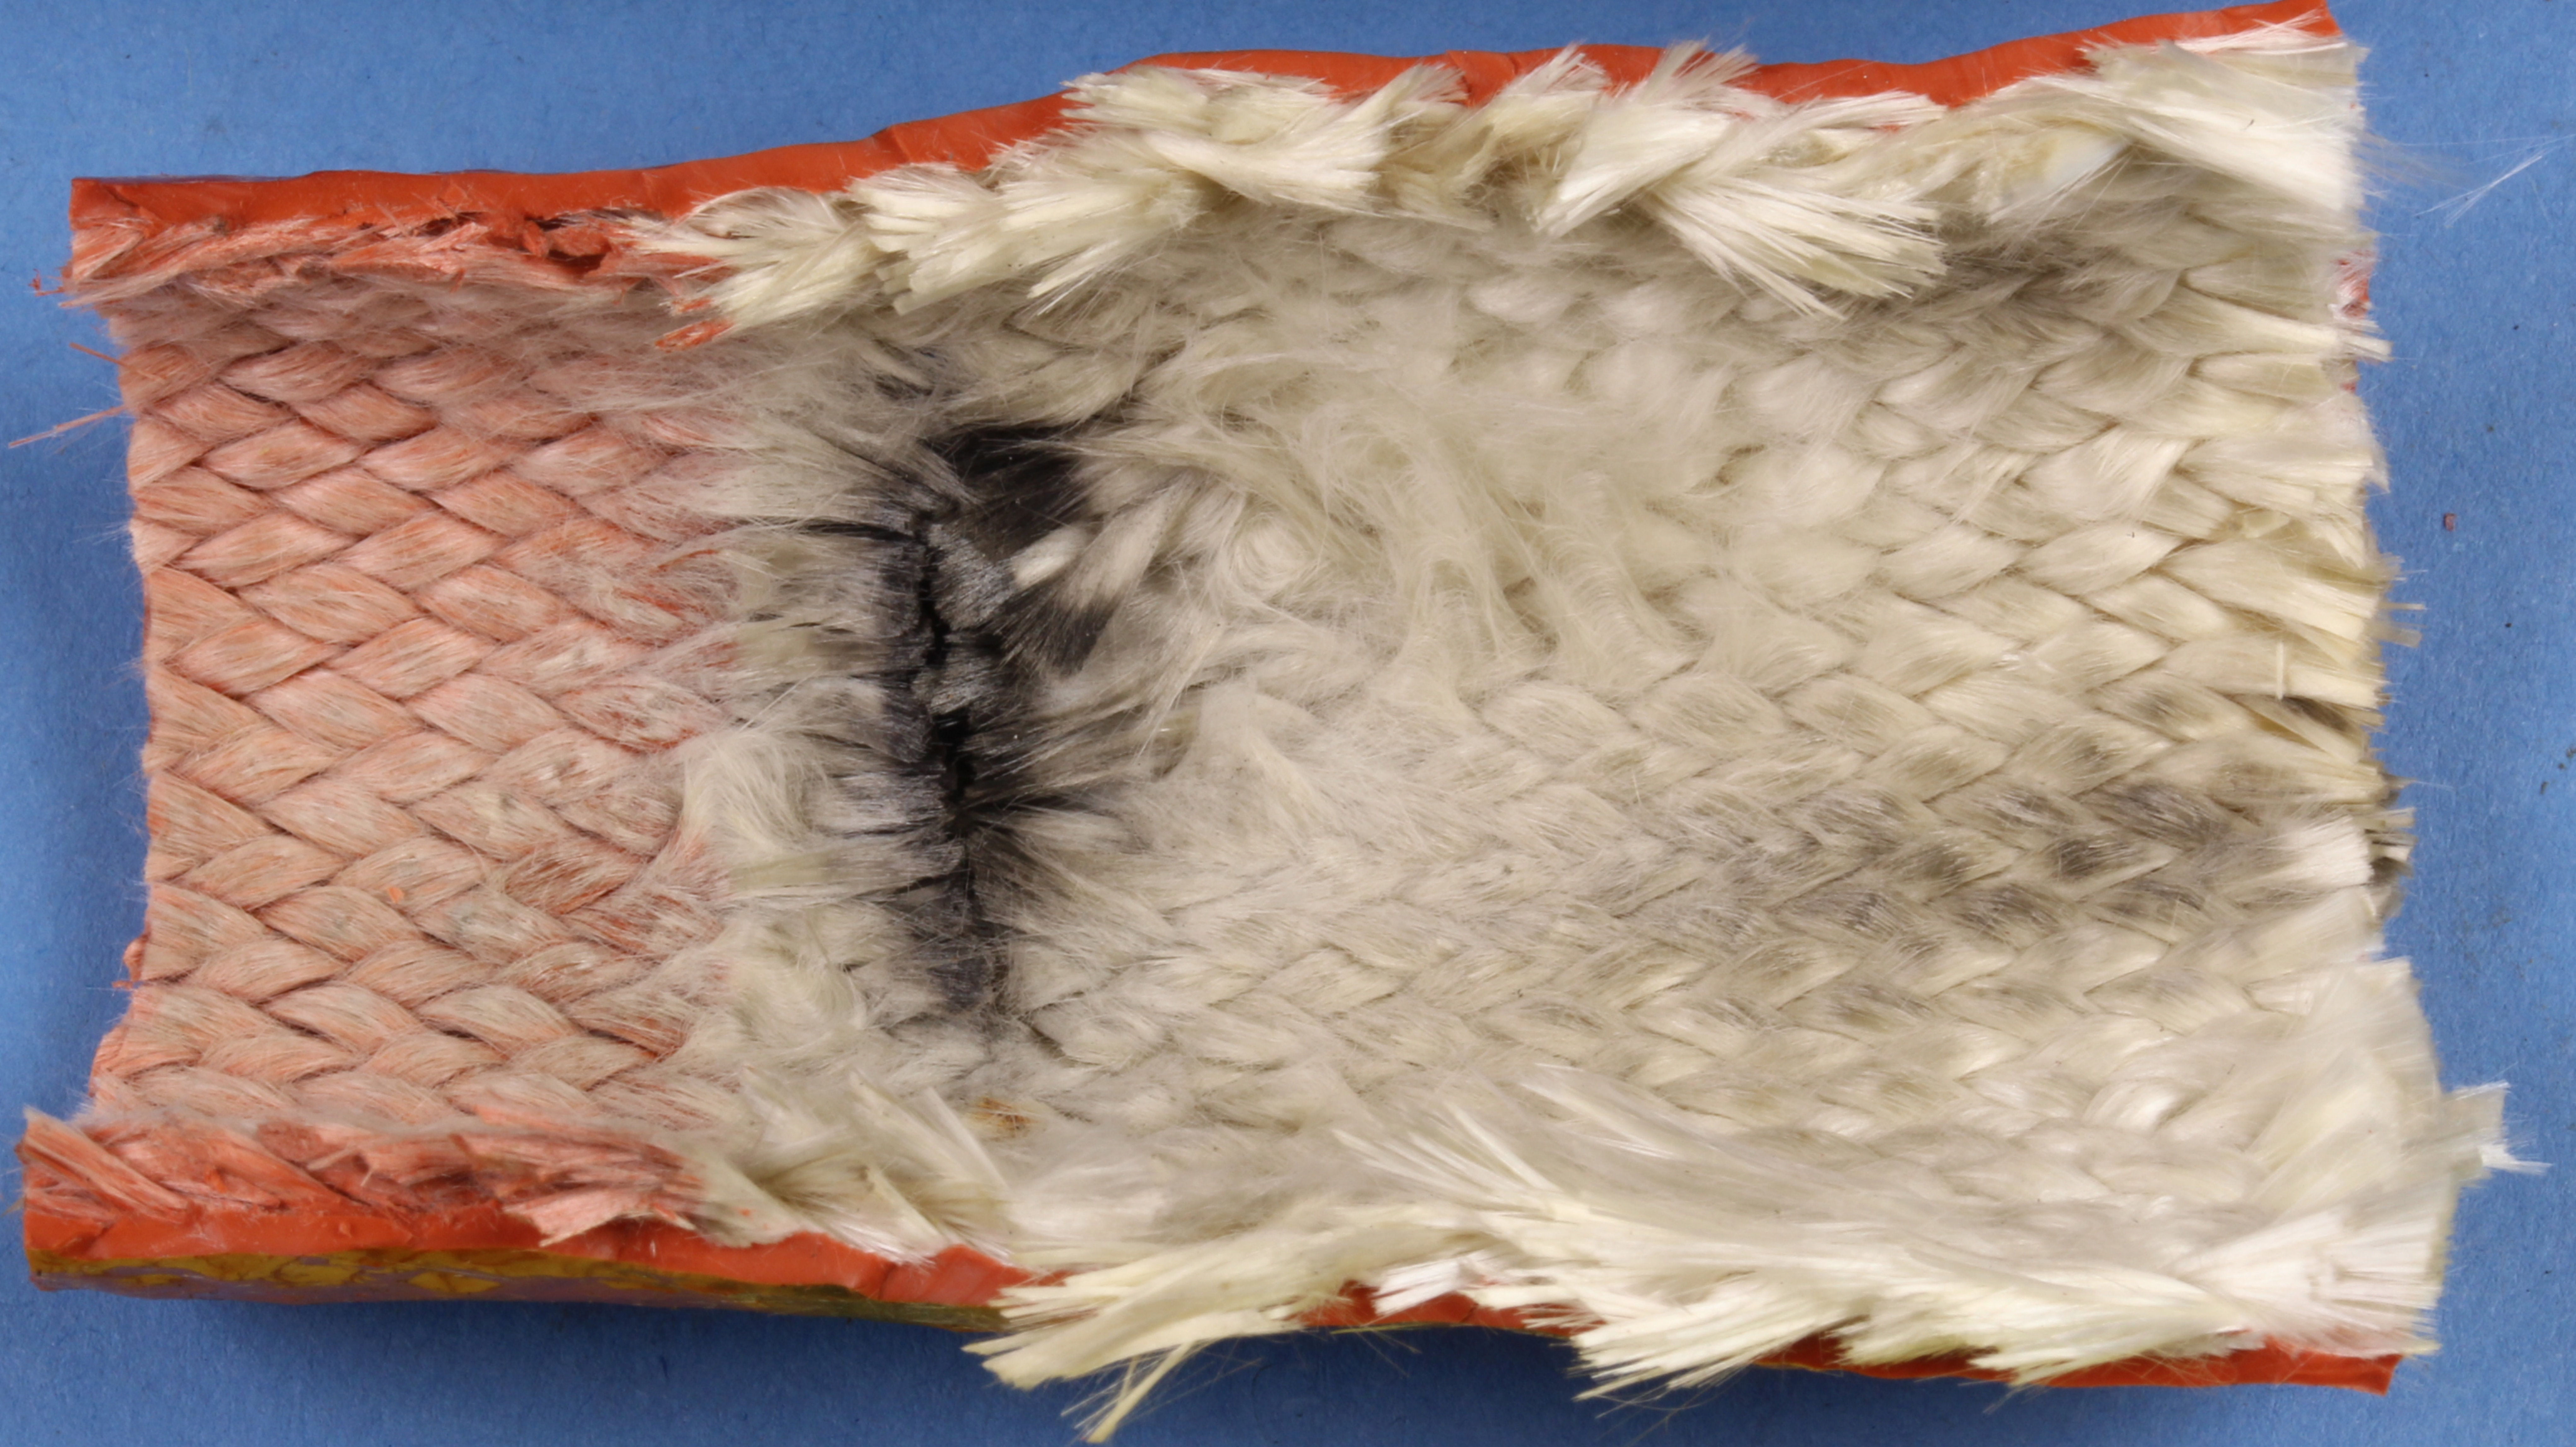
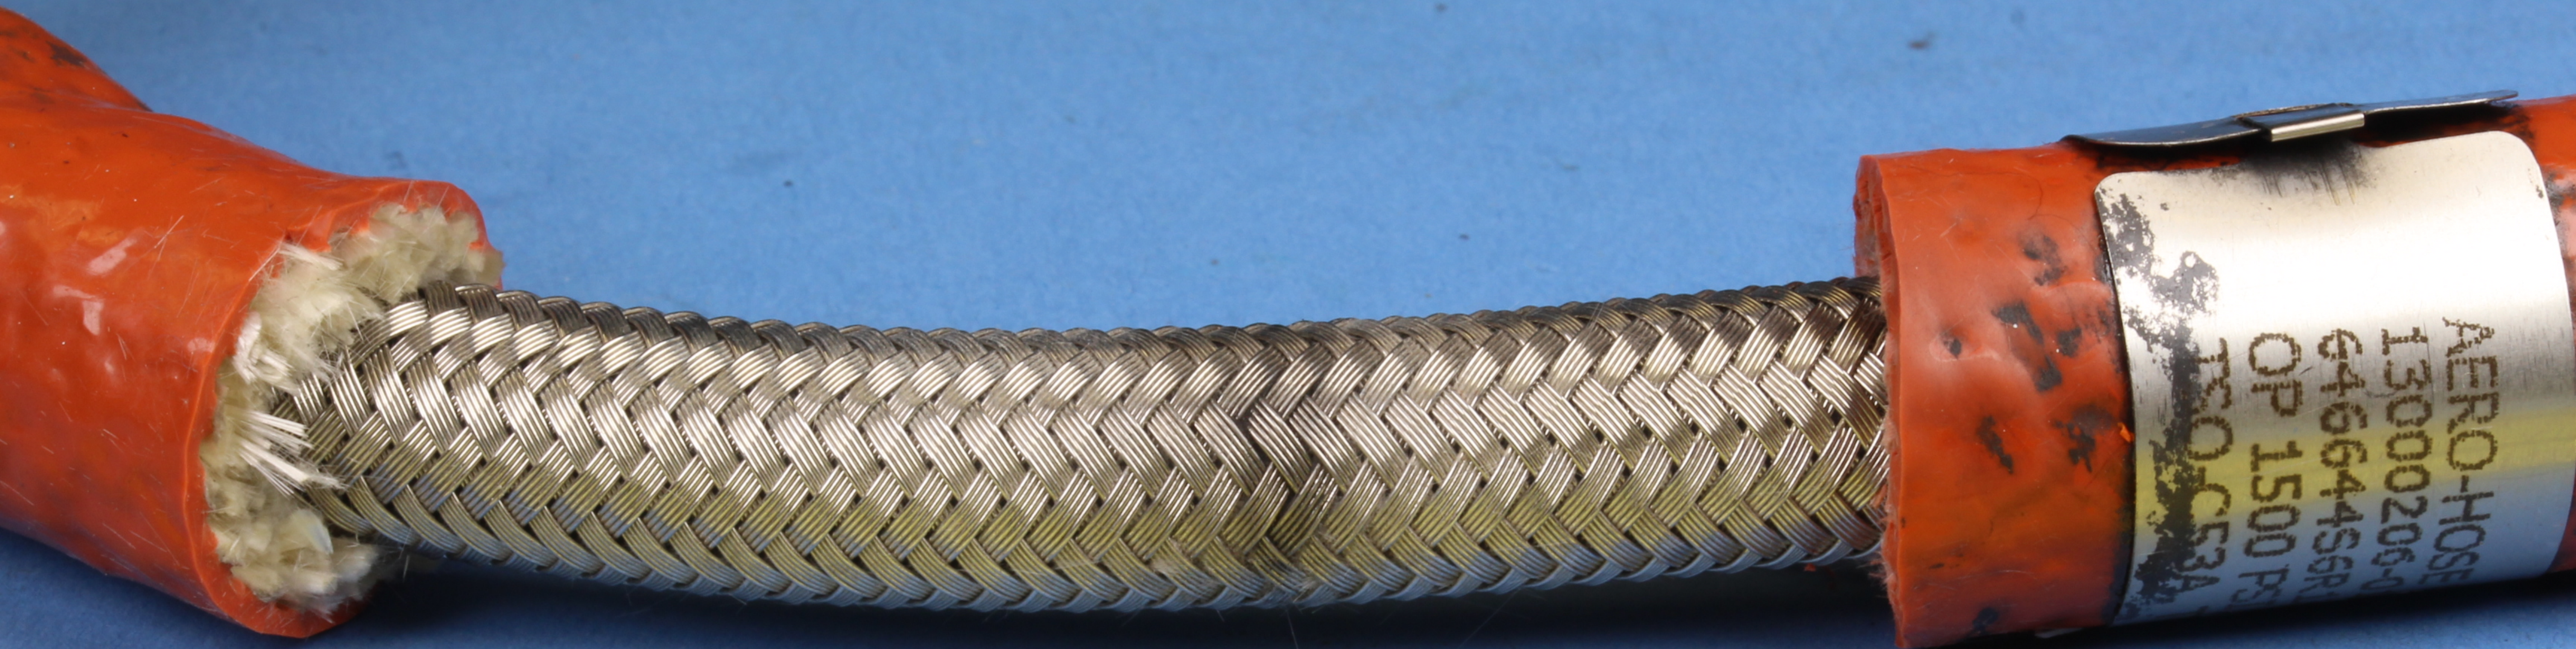
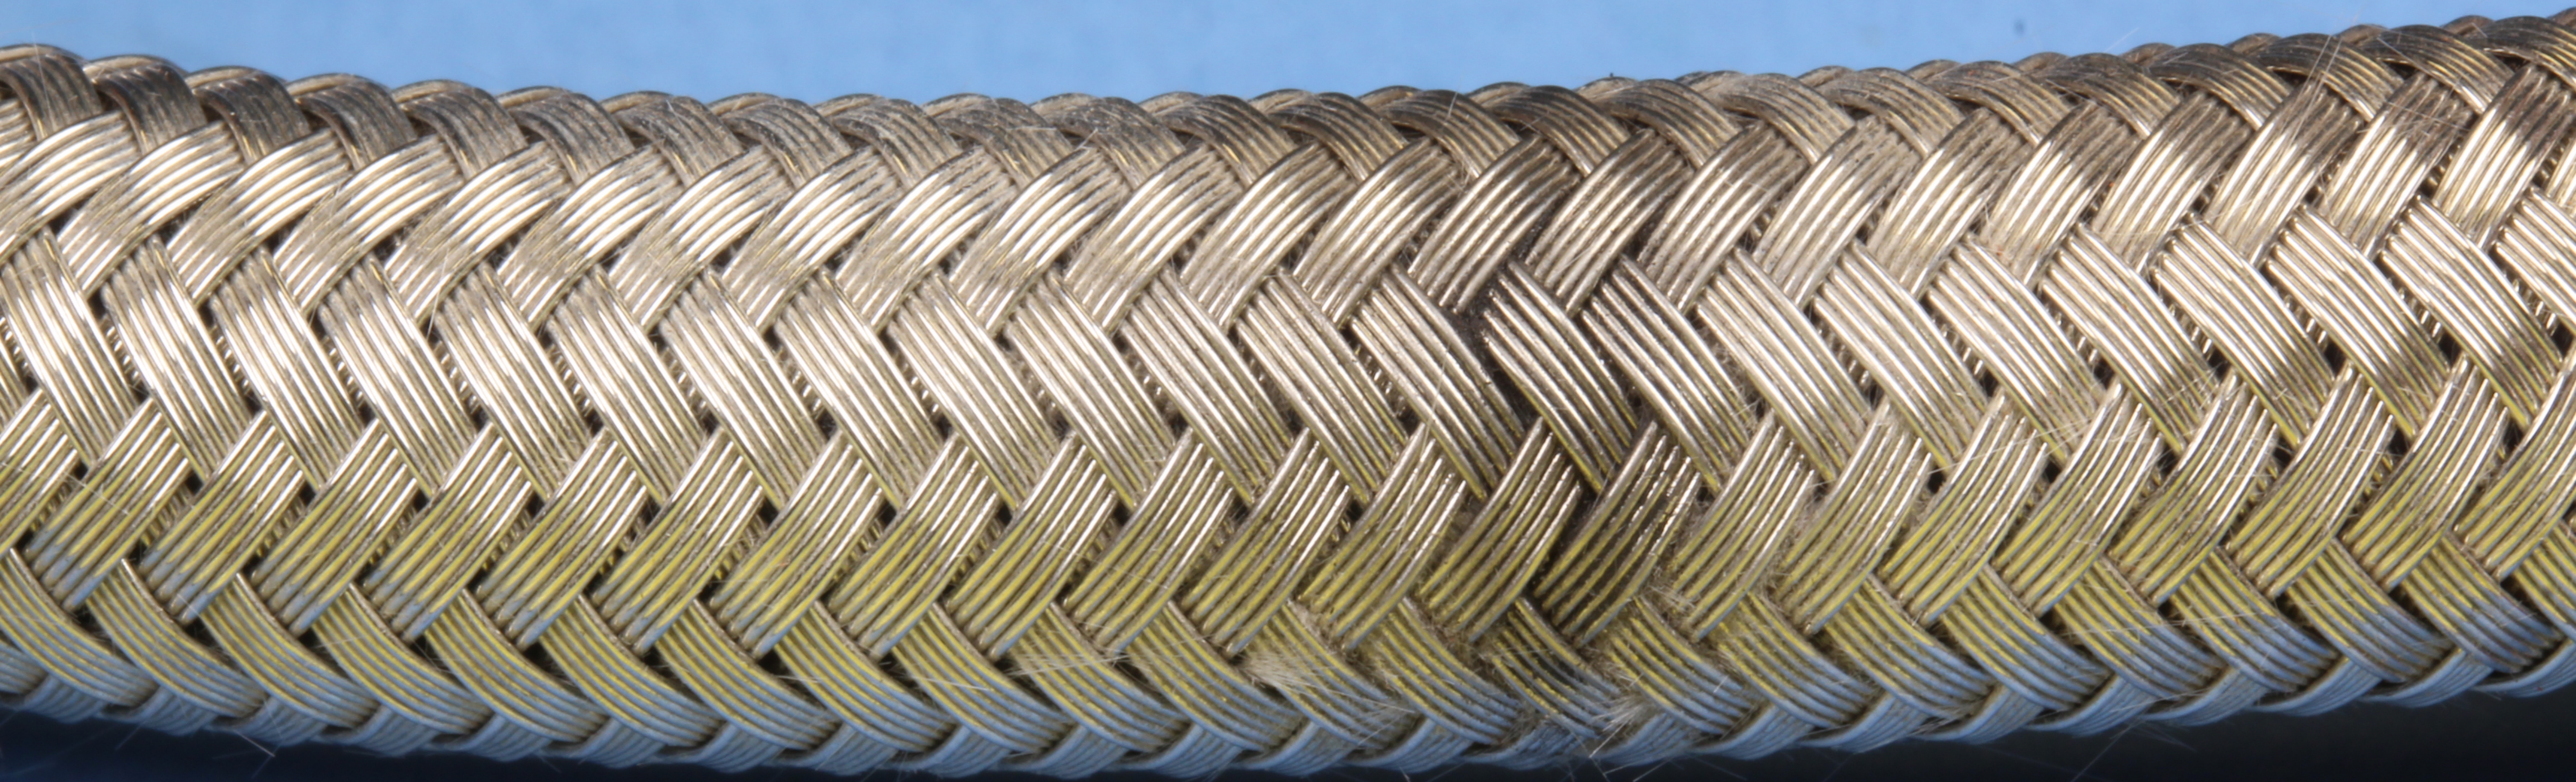
Pictures of the submitted oil line from the subject investigation are attached. The external sheath was damaged near one end, exposing the underlying stainless steel braided reinforcement. The sheath was removed from the damaged area, and no damage to the braided reinforcement was observed. Oil stains on the interior surface of the exterior sheath were limited to the area around the crack, consistent with an external source for the oil stains. A plug was threaded onto the fitting near the damaged area, and the damaged end was submerged in water while holding an air hose to the fitting at the other end. No bubbles emerged from the submerged portion of the hose. Subsequently, the plug on the submerged fitting was loosened, and bubbles emanated from the fitting with the loose plug, thereby confirming the test pressurization of the line was sufficient to cause bubbles to form if there had been a leak in the damaged area. Additionally, a borescope was inserted into the oil line, and no damage to the liner was detected visually up to the area of external sheath damage. As a result of the exam, no evidence of a leak from the damaged area of the oil line was detected.
