**National Transportation Safety Board**  
Office of Research and Engineering  
Washington, D.C. 20594

## Radar Performance Study

### Specialist Report Timothy Burtch

**Location:** Detroit, Michigan  
**Date:** December 3, 2019  
**Time:** 1334 GMT (0834 EST)  
**Airplane:** BAE 125 Series 800A, N469RJ  
**NTSB Number:** CEN20LA028

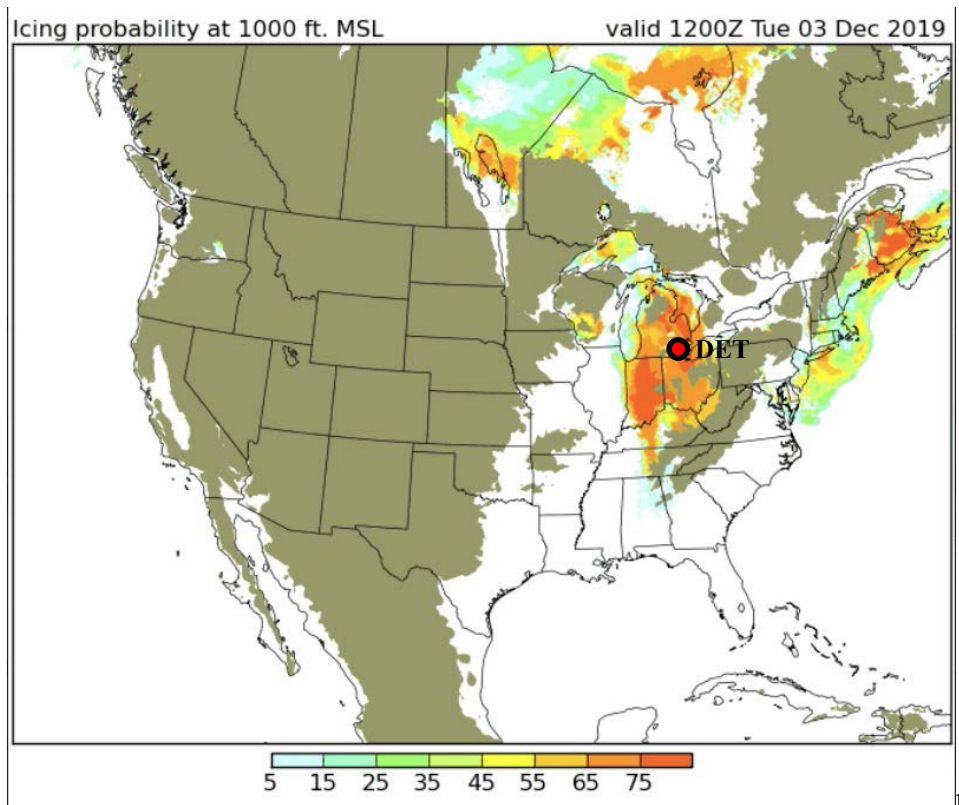
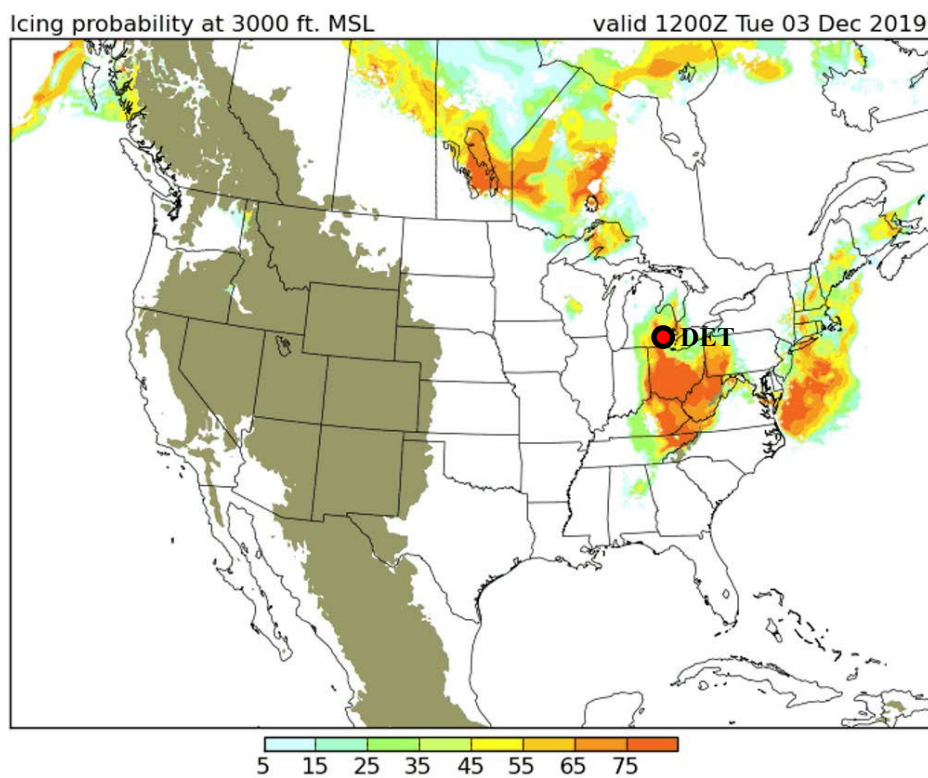
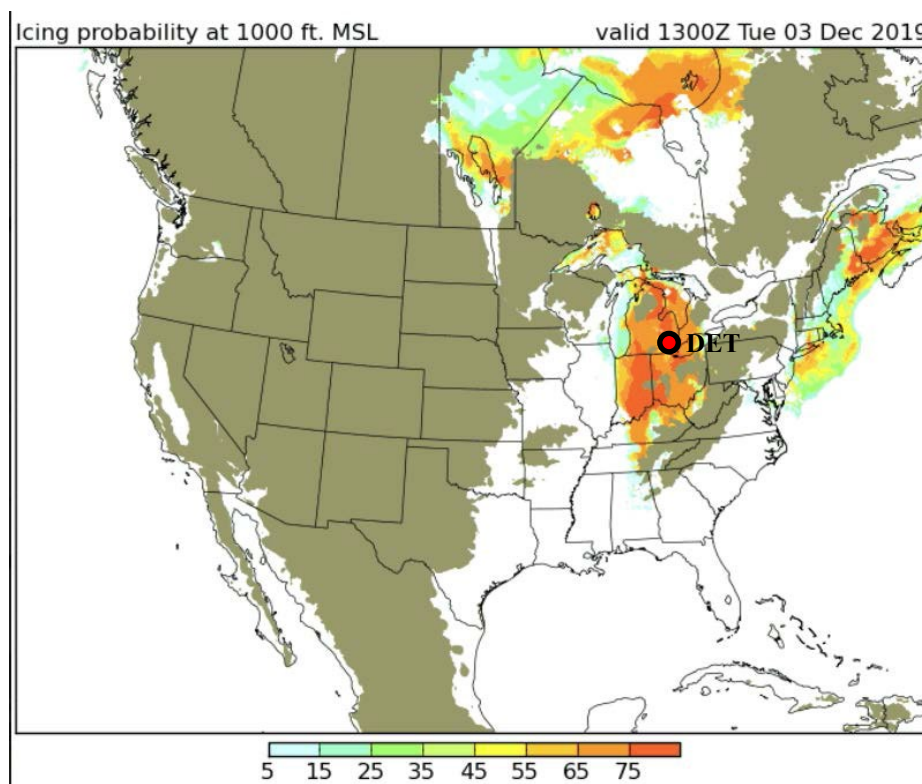
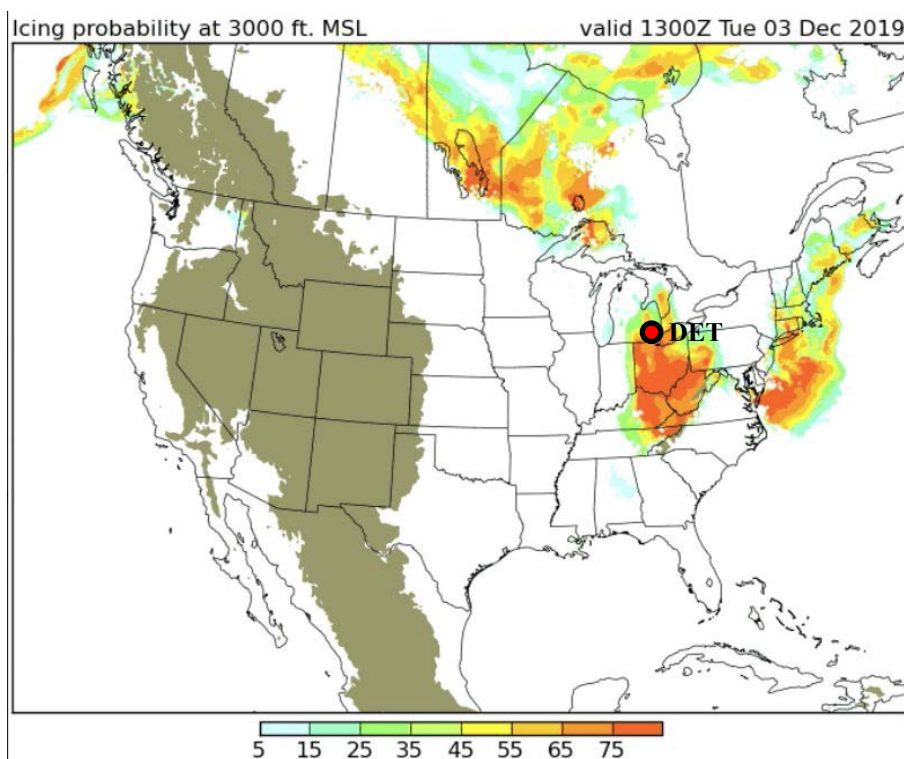
Images provided by the National Center for Atmospheric Research included the Current Icing Product (CIP) valid for 0700 EST and 0800 EST on the day of the accident. The CIP are shown in Figures 2 through 5. The figures indicate a greater than 65% probability of light icing conditions at altitudes of 1,000 ft and 3,000 ft over eastern Michigan in the vicinity of the accident. No icing was forecast at 6,000 ft.

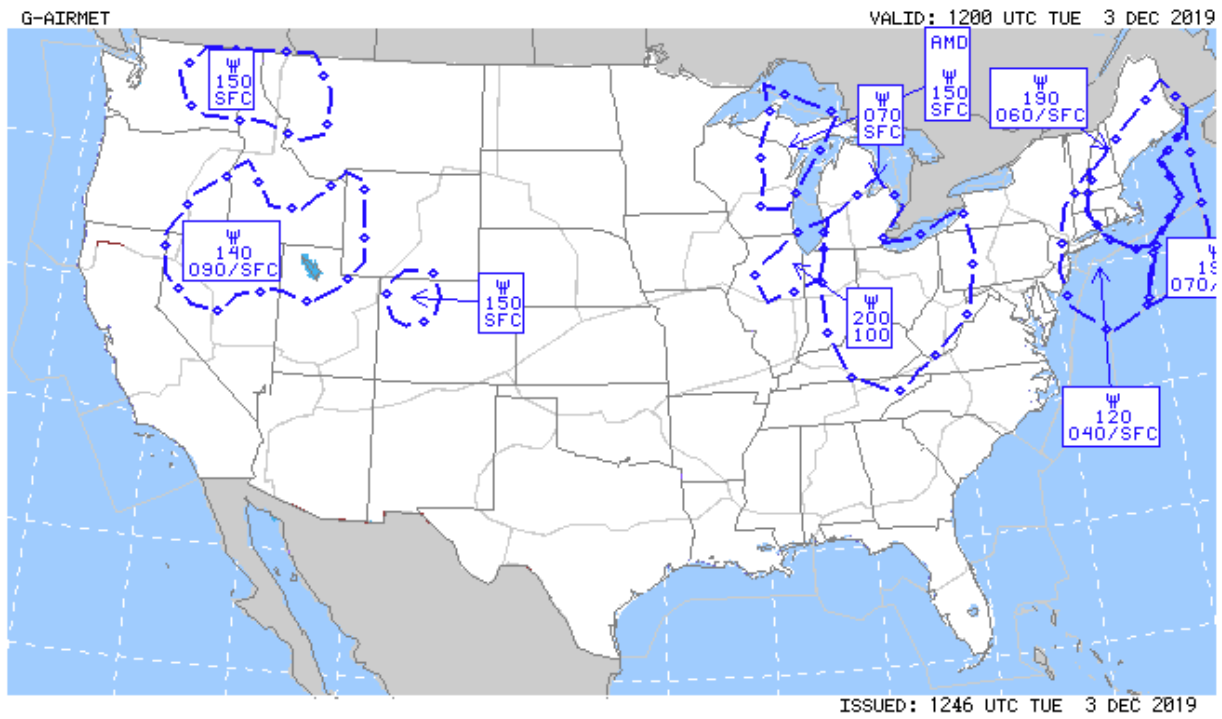
Figure 6 depicts an AIRMET for moderate icing from the surface to 7,000 ft around the time of the accident. See the NTSB Meteorology Weather Study for more details about the accident weather conditions.

**Figure 6: G-AIRMET Zulu for Moderate Icing from the Surface to 7,000 ft at 0700 EST**

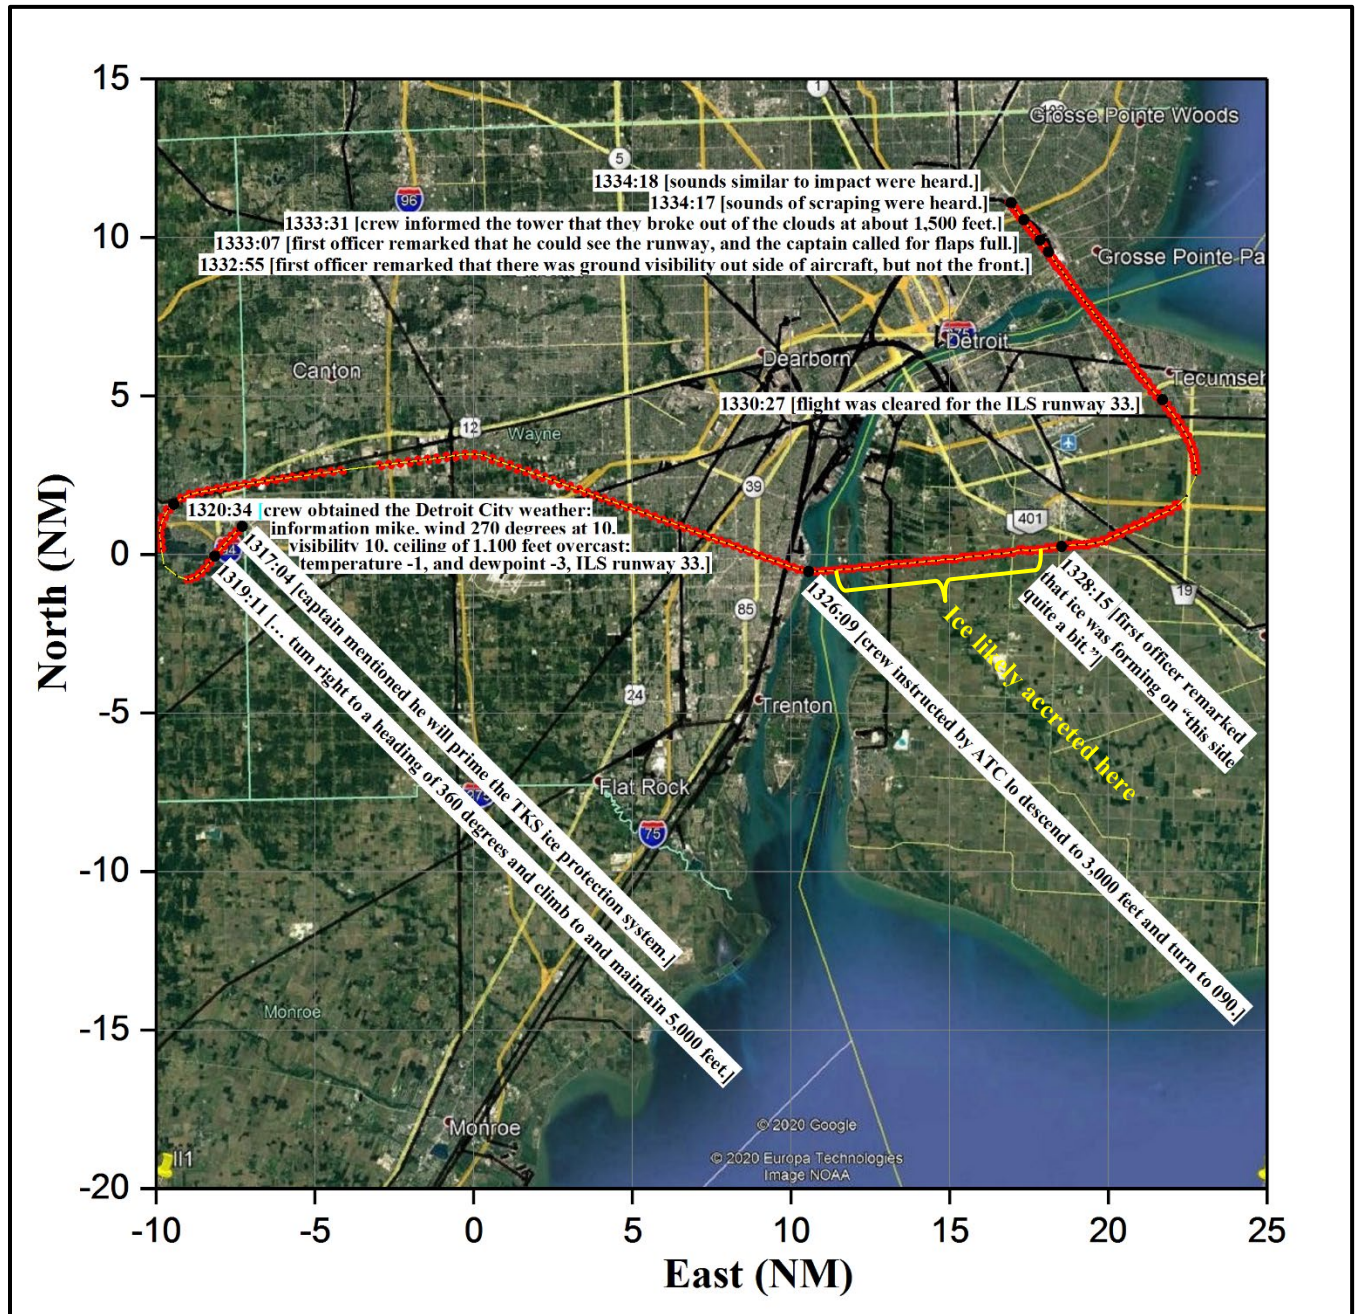
An overview of the accident airplane's radar ground track from Willow Run to Coleman Young Municipal airport with paraphrased CVR comments and approximate GMT is shown in Figure 7. The airplane approached DET from the west and flew an extended left base to runway 33 while receiving radar vectors from air traffic control and capturing the instrument landing system (ILS) signals to runway 33.

**Figure 7: Radar Ground Track from YIP to DET for N469RJ  
 with Paraphrased CVR Comments in GMT**

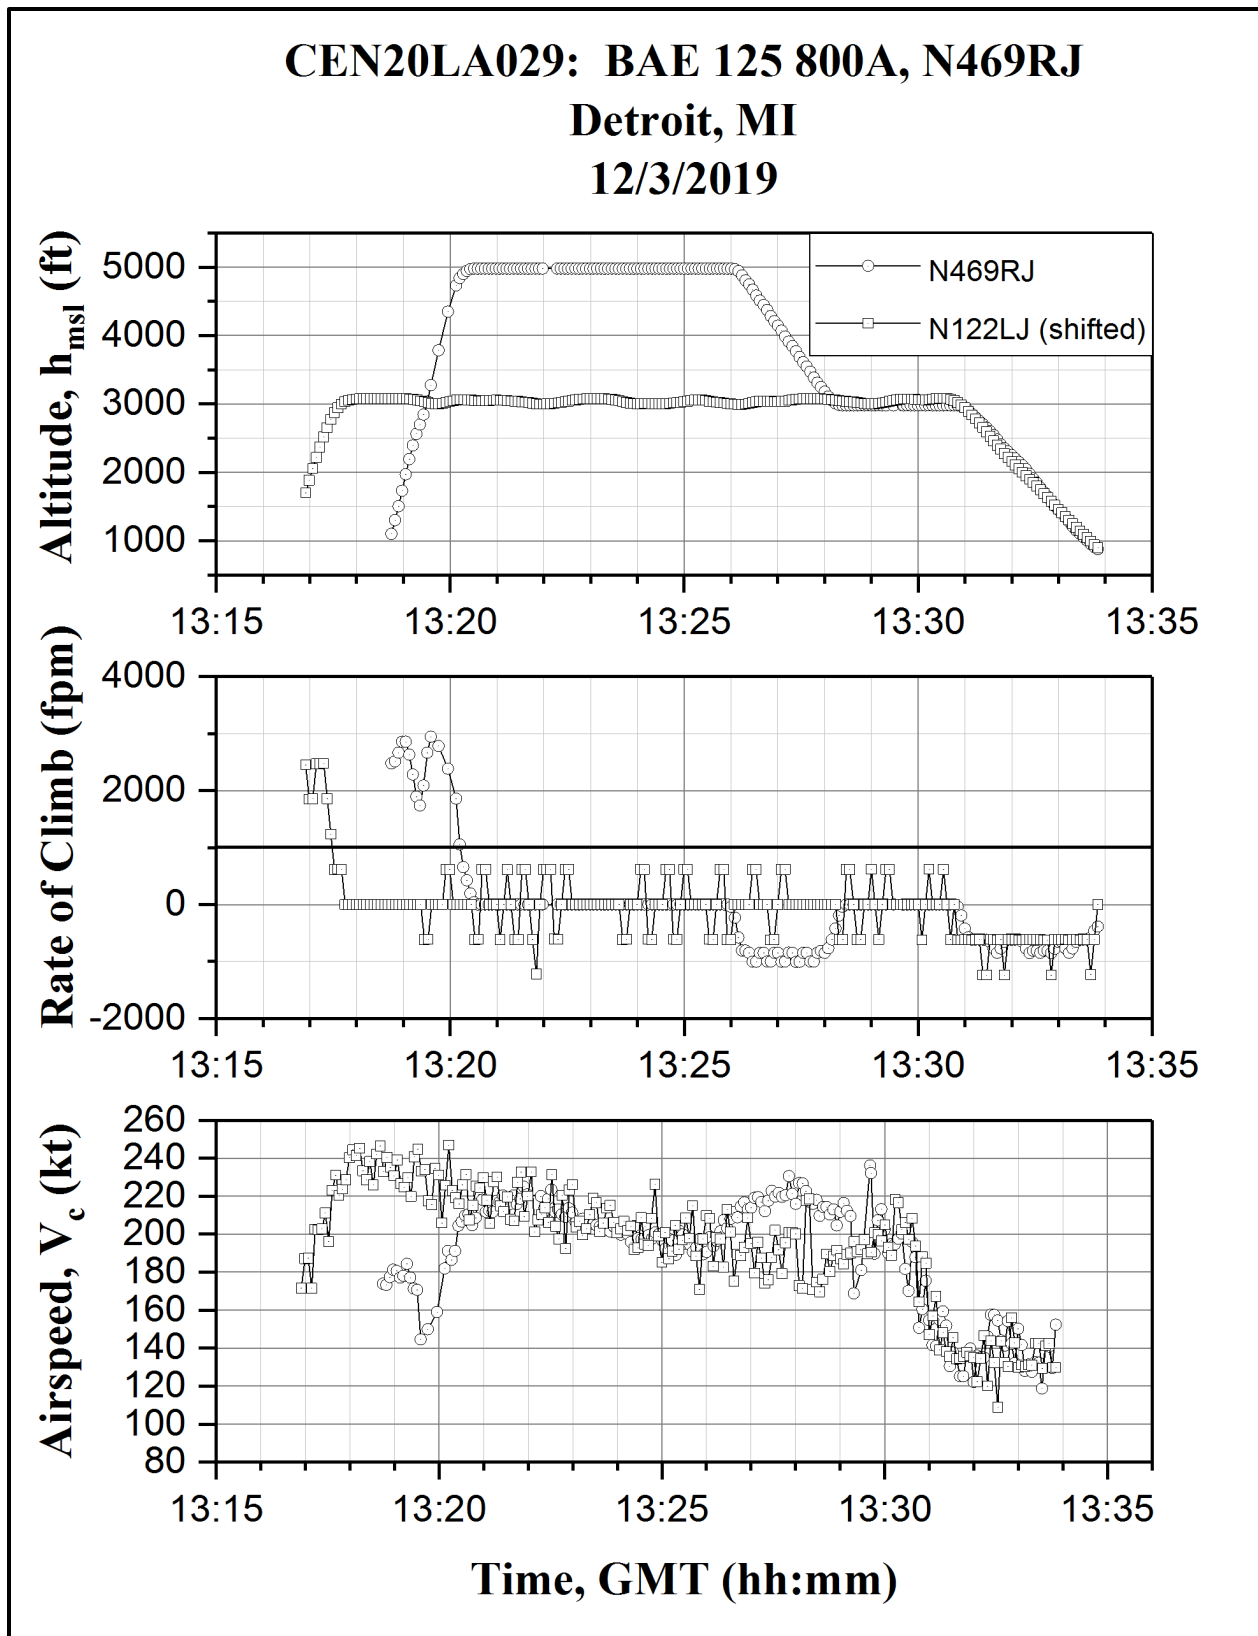
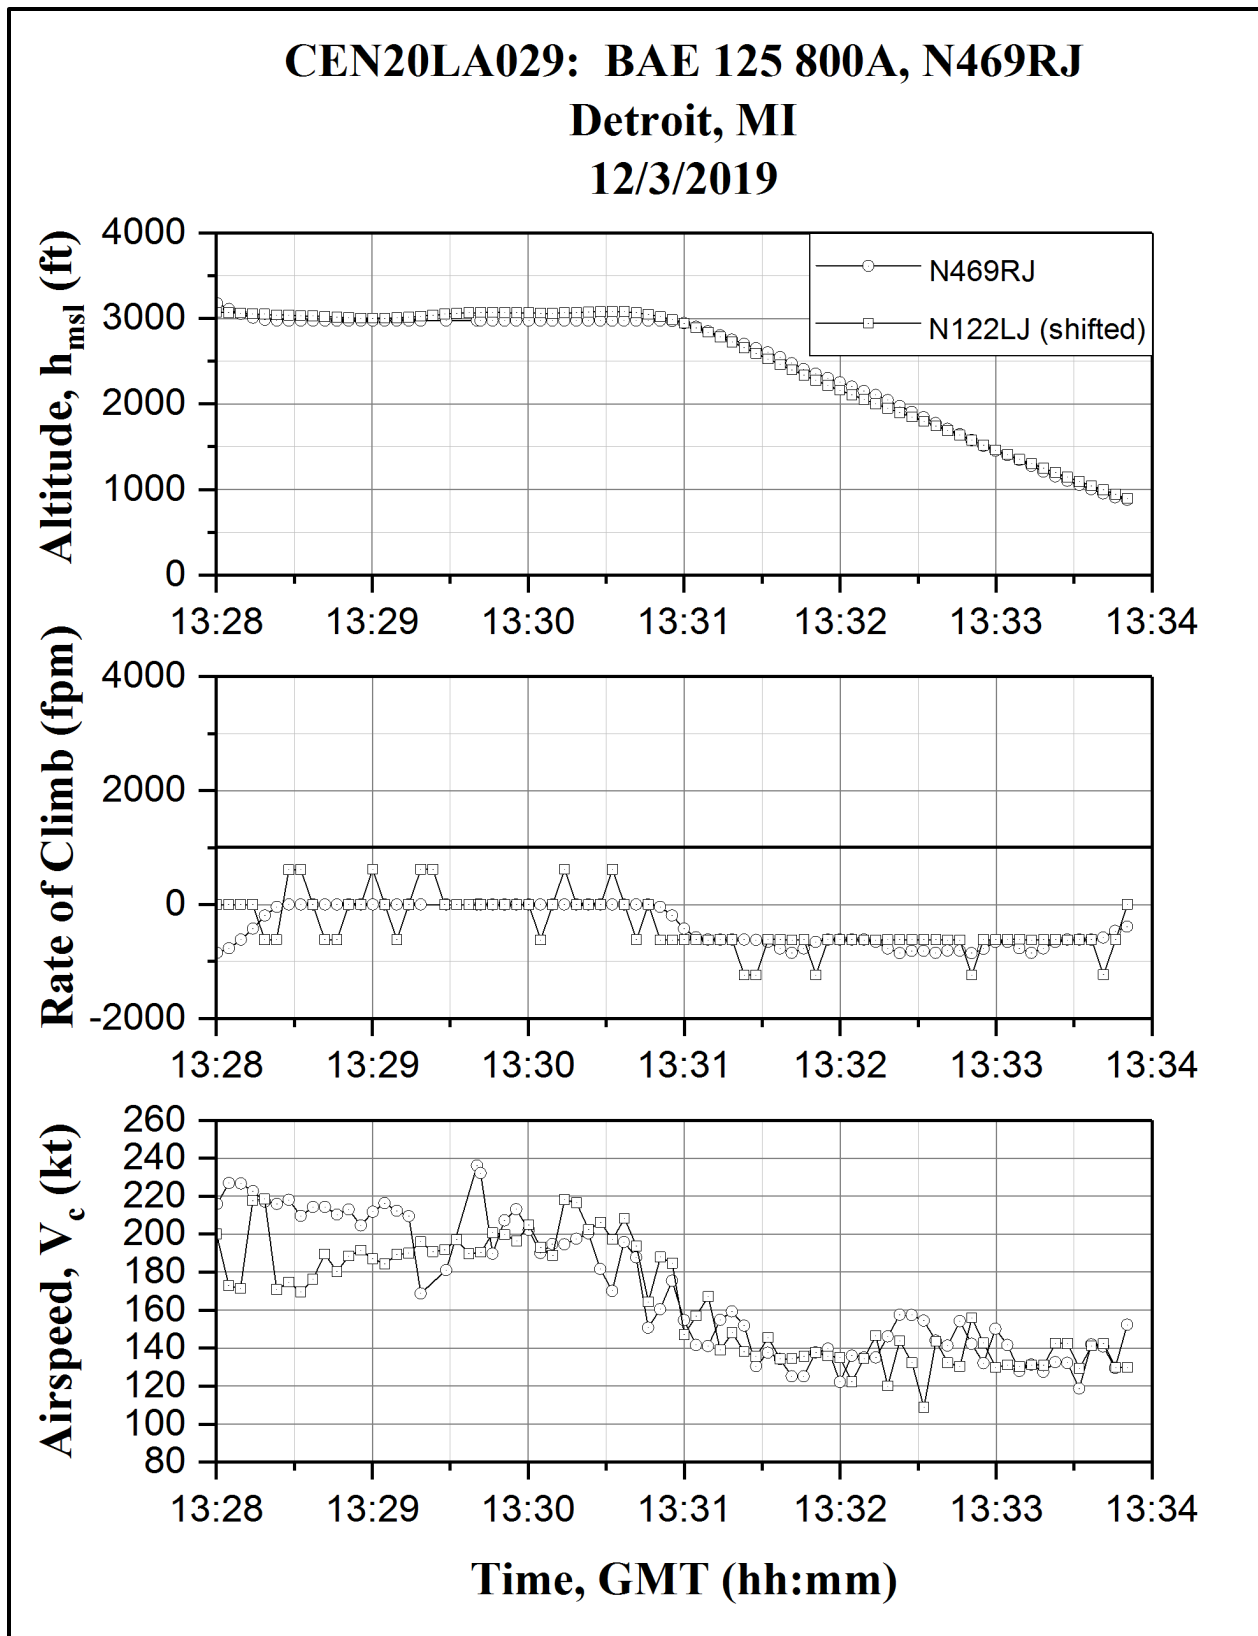
The flight progressed without incident according to radar and CVR data. Altitude and radar-derived airspeed for the short 15-minute flight are shown in Figure 8. Figure 9 highlights the final 6 minutes of the flight. (Note: Figures 8 and 9 also contain data from a second airplane, N122LJ, that will be discussed later.) However, at 0834:04, airport security video captured N469RJ over the runway 33 threshold and entering an abrupt right-wing-down roll that resulted in the right wingtip striking the runway at about 0834:06. See Figure 10.

Vref was calculated by the flight crew to be 128 KIAS based on a landing weight of 22,300 lb. According to the AFM, the normal approach speed is Vref + 10 kt. This results in a minimum normal approach speed of 138 KIAS for the accident flight; however, since ice was observed on the airframe, an approach speed of 148 KIAS was appropriate as per the AFM. After the accident, the flight crew reported flying approach speeds between 140-145 KIAS<sup>3</sup>.

Figure 8: Airspeed and Altitude Derived from Radar for N469RJ

Figure 9: Airspeed and Altitude Derived from Radar for the Final the Minutes of Flight

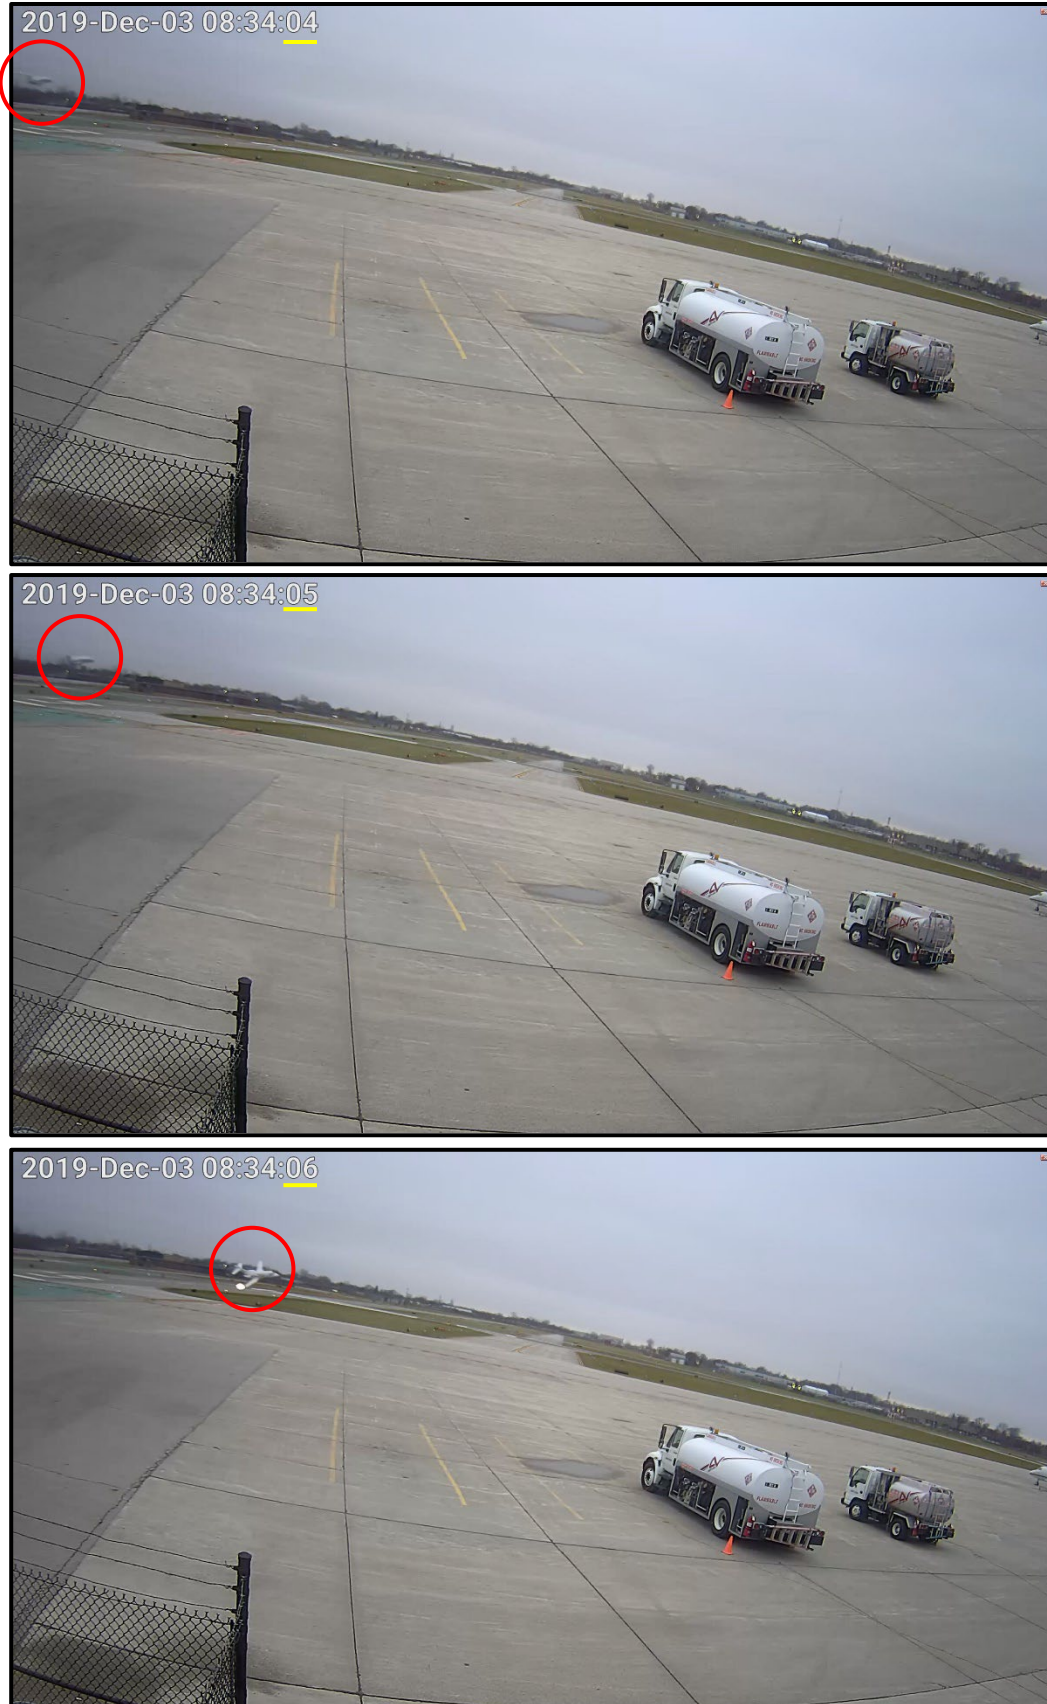
N469RJ was not equipped with a flight data recorder. However, airport security video shows the airplane entering an abrupt right-wing-down roll over the runway threshold that resulted in the right wingtip striking the runway.

**Figure 10: Video Stills from Airport Security Camera**

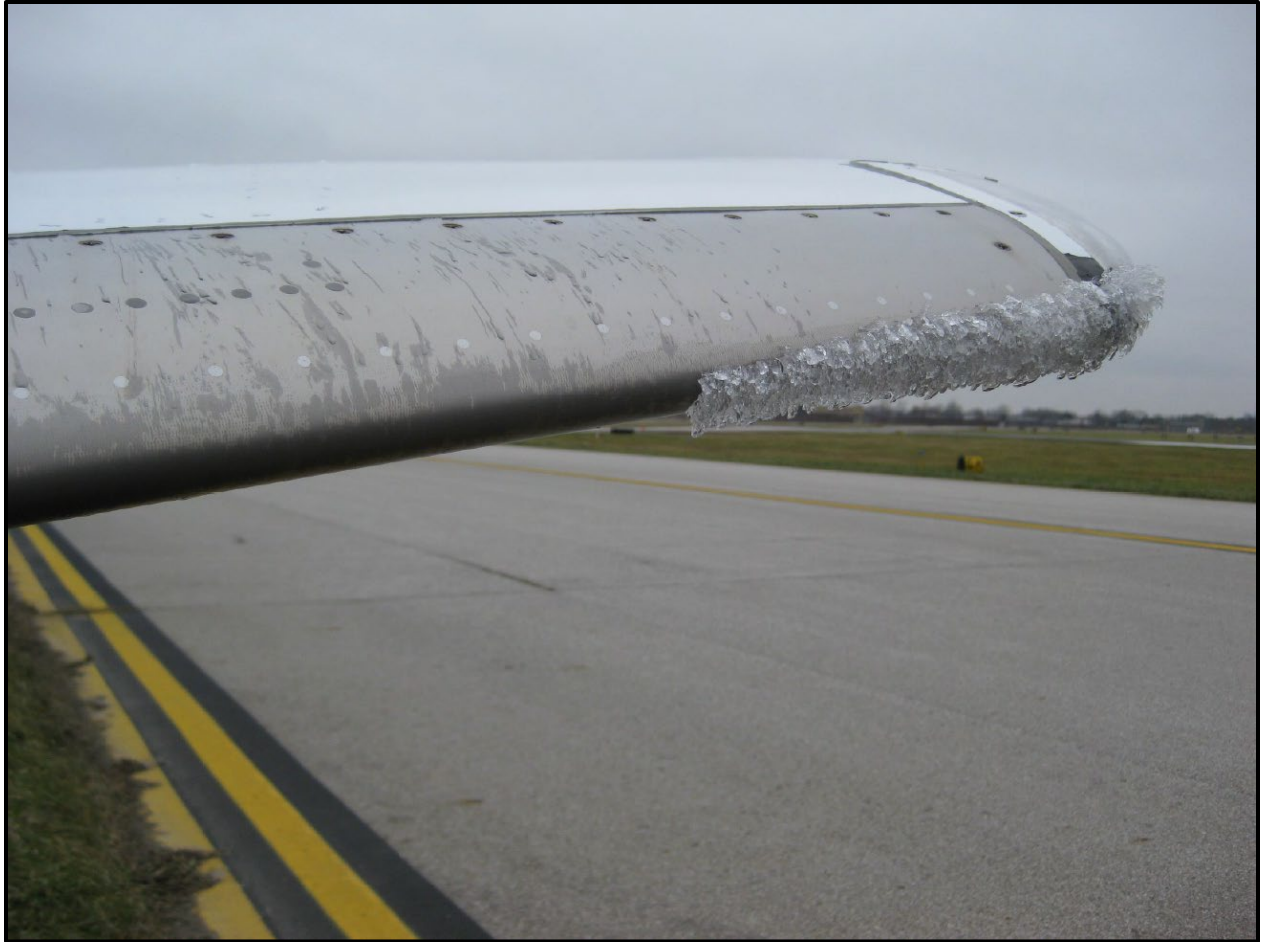
Pictures of the airplane's left wing taken as the airplane sat on the grass infield adjacent to runway 33 after the accident are shown in Figures 11 and 12. In addition to the ice on the ground underneath the left wing (that had broken off), ice accretions still attached to the left wing leading edge can be seen. The ice on the right wing likely broke off when the wing struck the runway<sup>1</sup>.

<sup>4</sup> Textron reviewed the photographs in Figures 11 and 12 and the ice accumulation for the 15-minute flight. Textron assessed the ice accretion as appearing to be in the moderate range. They also stated that the TKS system on the BAE 125-800A, if operating properly and turned on at the appropriate time, should have been sufficient to clear the ice. Textron reiterated that the AFM instructs flight crews to increase the approach speed to account for icing conditions.

**Figure 11: Photo of Ice on Left Wingtip after the Accident (source: FAA)**

The right roll was likely due to the right wing angle-of-attack (AOA) exceeding the critical AOA as a result of ice. Adding 10 kts to the normal approach speed for ice as recommended by the airplane manufacturer would have provided N469RJ with additional stall margin.

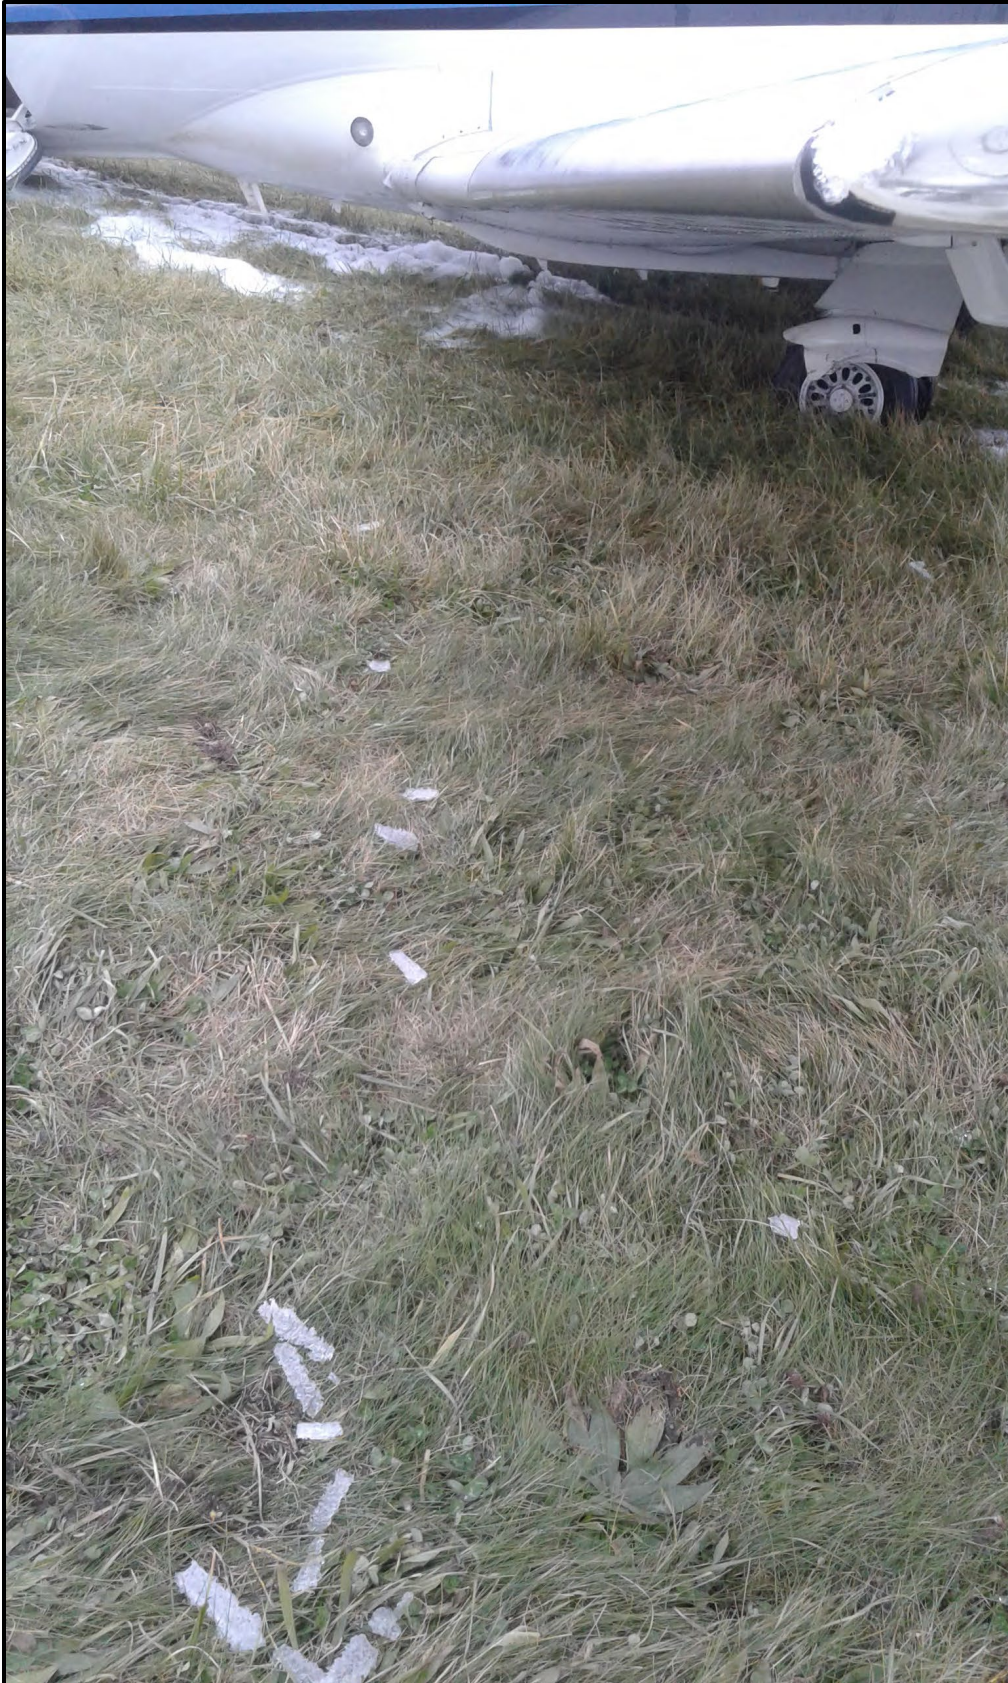
**Figure 12: Photo of Ice on Ground after the Accident (source: FAA)**

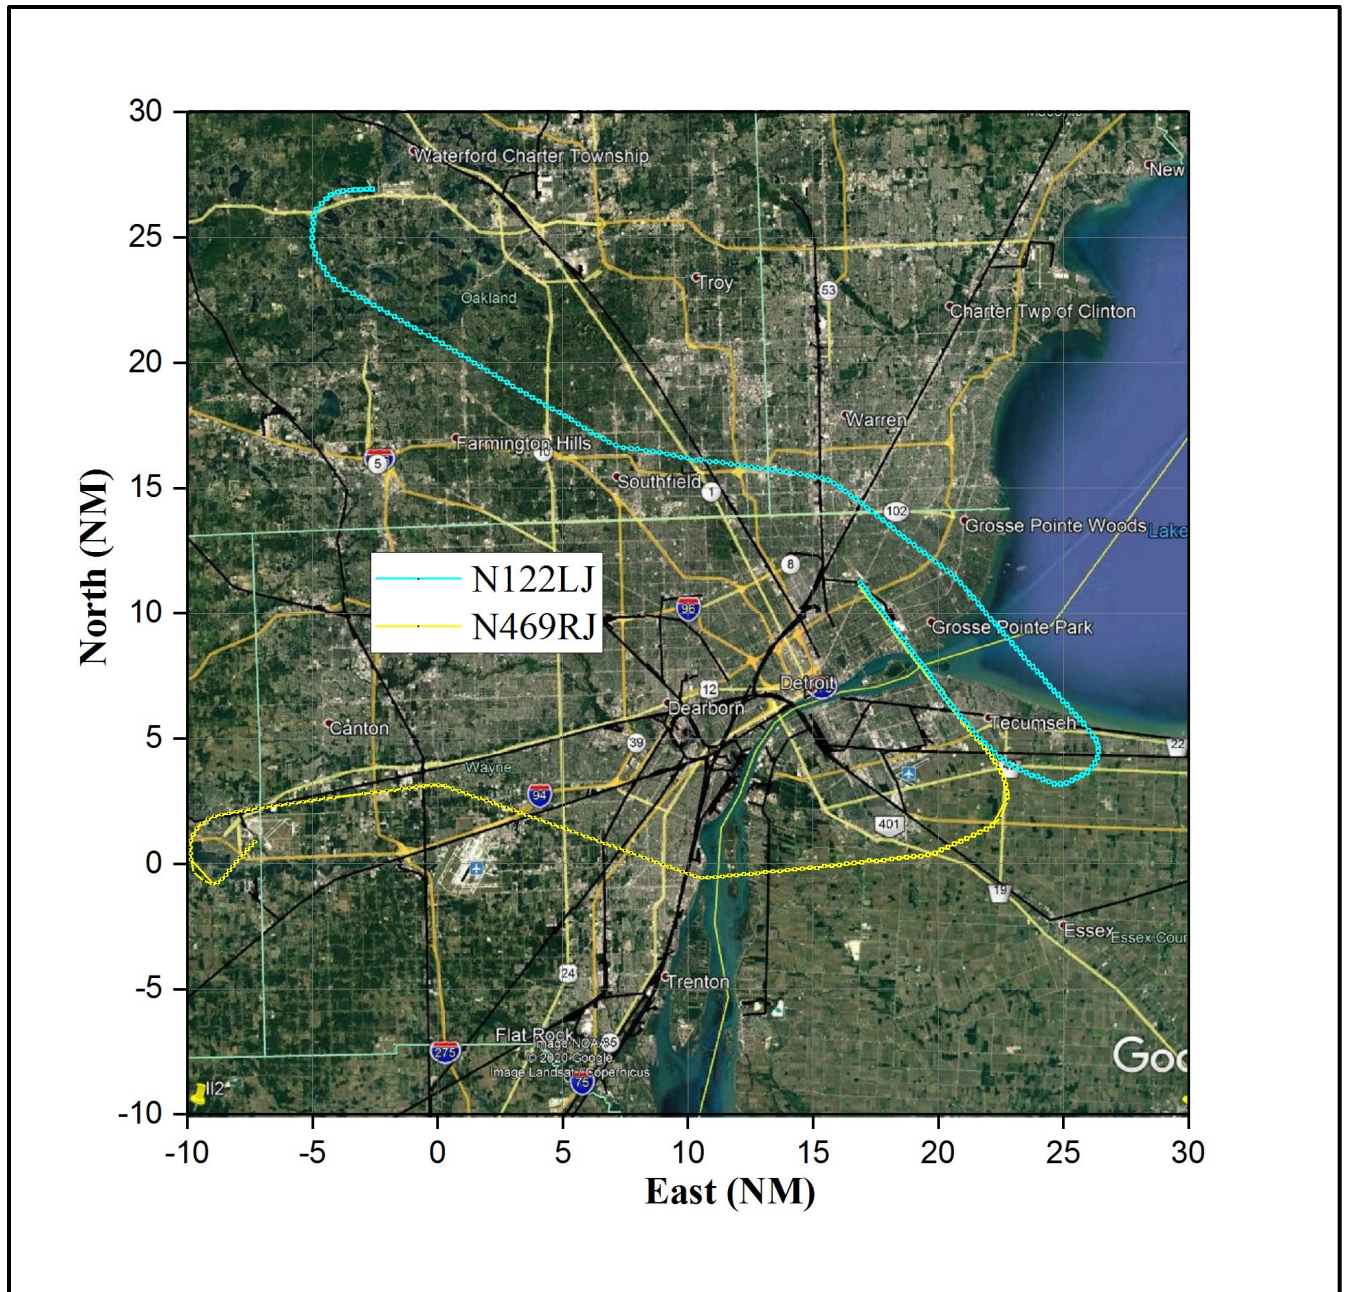
Figure 13 shows the radar ground track of a second BAE 125-800A, N122LJ, that landed at DET 26.5 minutes before N469RJ (in cyan). As previously mentioned, altitude and radar-derived airspeed for N122LJ are also shown in Figures 8 and 9. After shifting the data to account for the 26.5 minute time difference, the altitude and airspeed during approach for the two flights are similar.

The pilot of N122LJ stated that they too conducted a normal approach (based on a landing weight of 23,000 lb) with full flaps using a reference speed of 130 KIAS. The recommended 10 kt additive for ice was not applied. However, after landing, the flight crew noticed some ice on the unprotected surfaces. A combination of the slightly earlier flight time and the approach made from the east may explain the better outcome for N122LJ<sup>4</sup>.

**Figure 13: Radar Ground Track of N469RJ and N122LJ**  
**N122LJ, also a BAE 125-800A, Landed 26.5 Minutes Before N469RJ without Incident**
