**NATIONAL TRANSPORTATION SAFETY BOARD  
Office of Aviation Safety  
Washington, DC 20594**

**SUMMARY OF ENGINE DEEC EXAMINATIONS**

**CEN20LA028**

Location: Detroit, Michigan  
Date: December 3, 2019  
Time: 0833 eastern standard time  
Aircraft: BAE 125 800A, N469RJ

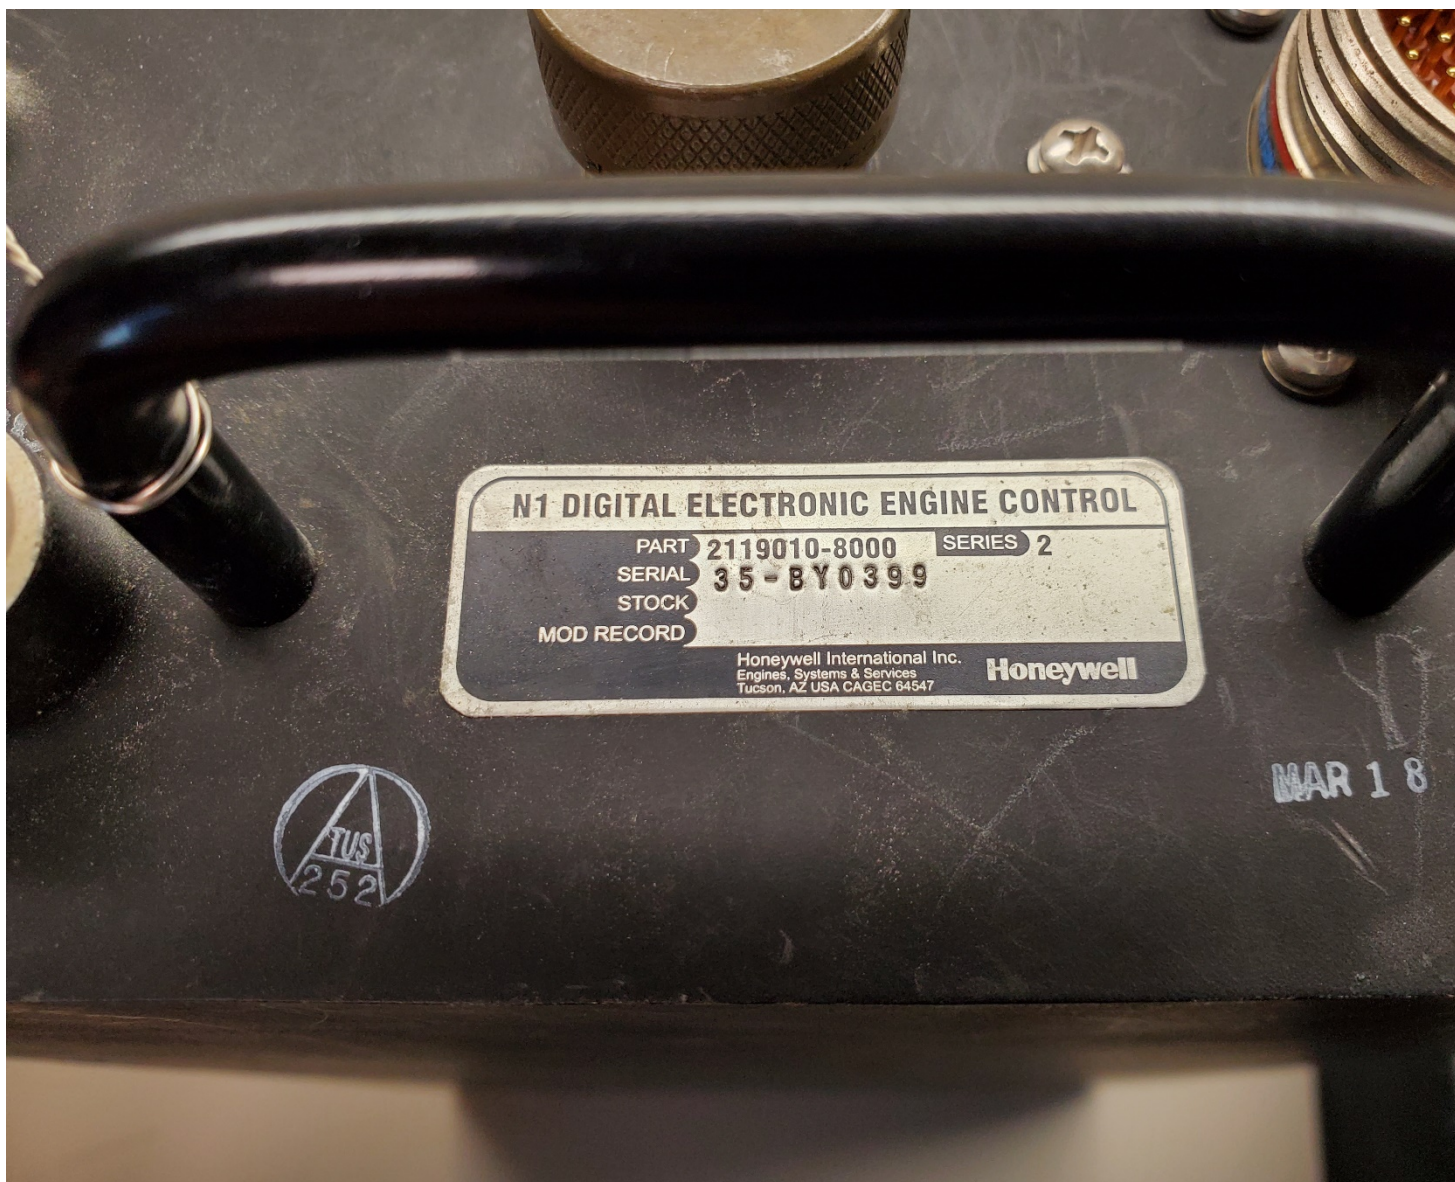
**Photo 1 – DEEC s/n 35-BY0399**

The download of the incident recorder data and fault history data from both N1 DEECs was completed successfully. Review of the data revealed that both engines were rotating, operating, and responding to power lever inputs throughout the approach and accident sequence. About 130 seconds after the accident sequence, power was removed from the DEECs.
