# The National Transportation Safety Board

Office of Aviation Safety  
Central Region  
Memorandum for the Record  
Electrical System  
Examination Findings  
CEN20LA058  
Bandera Texas  
January 11 2020

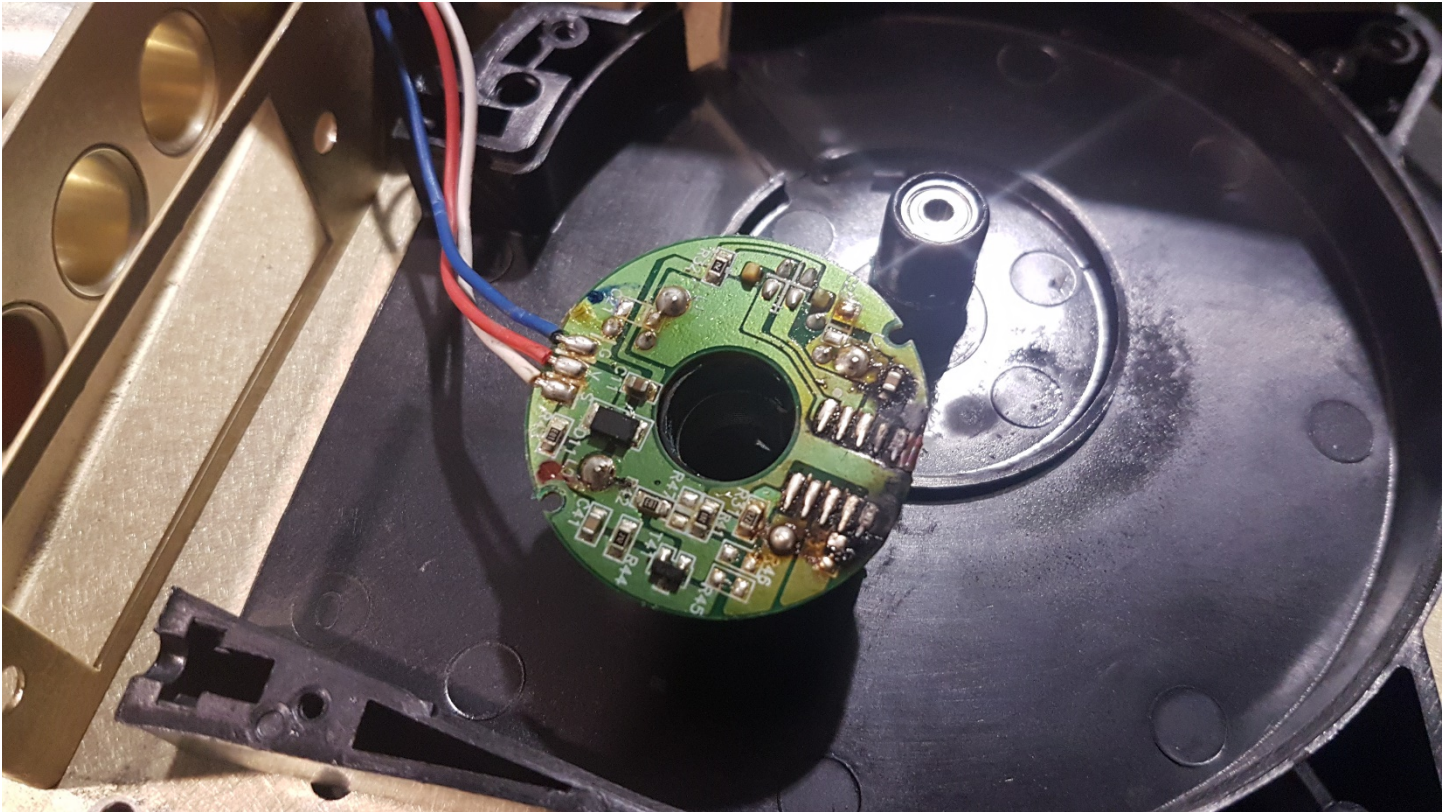
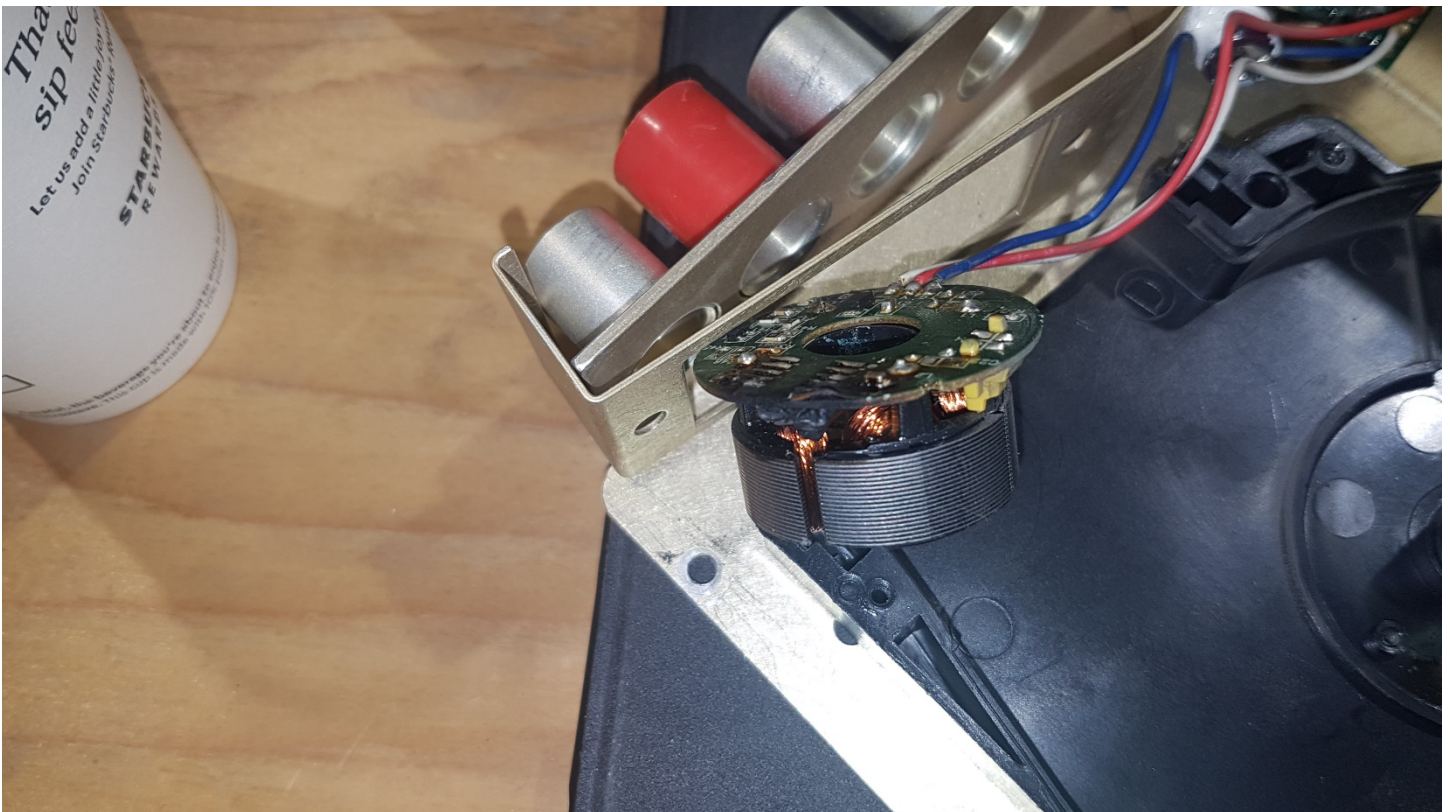
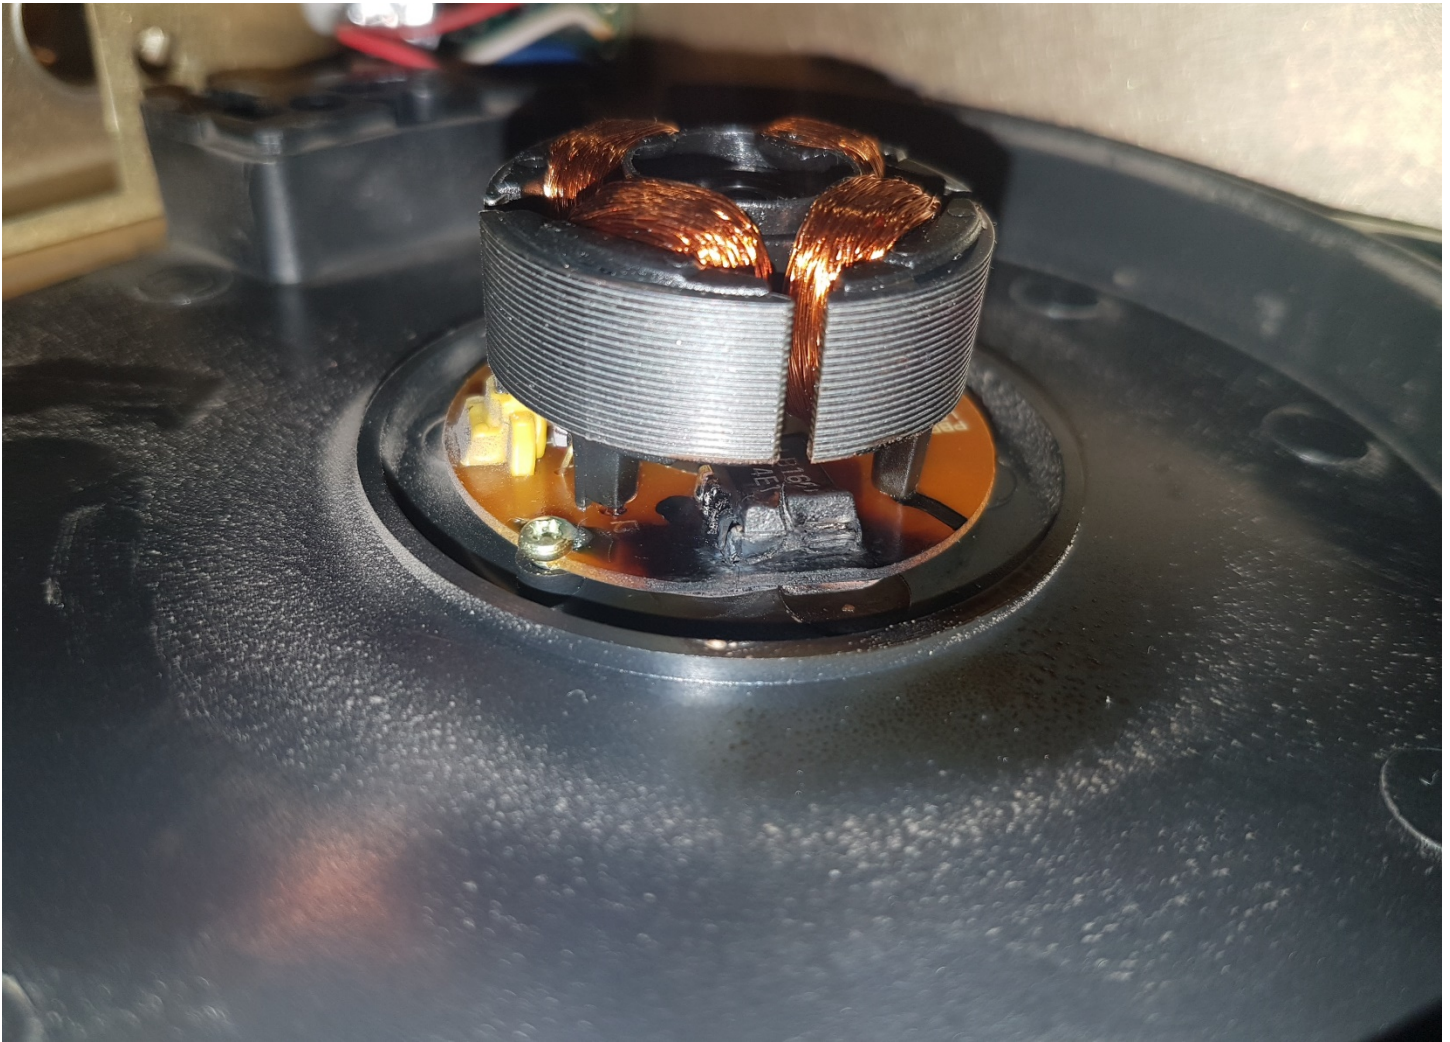
- After confirming that the pilot's side fan would not operate when connected to an electrical power source, the fan was disassembled. After removing the fan blades from the motor assembly, an area of thermal damage and discoloration were observed on the circuit board.

- Photographs of the fan assembly and thermal damage of the fan circuit board were sent a NTSB Fire Specialist. The Fire Specialist stated that the damage to the fan circuit board would likely have produced smoke, and the smoke would probably be irritating to the eyes, which is consistent with the pilot's account of the flight.
