# Rolls-Royce Engine Investigation Report

Aircraft Type: Hiller UH-12F (Soloy)  
Aircraft Reg: N7173S  
Engine Model: M250-C20B  
Engine S/N: 823398  
Engine Rating: 420 shp (takeoff)

9 February 2021

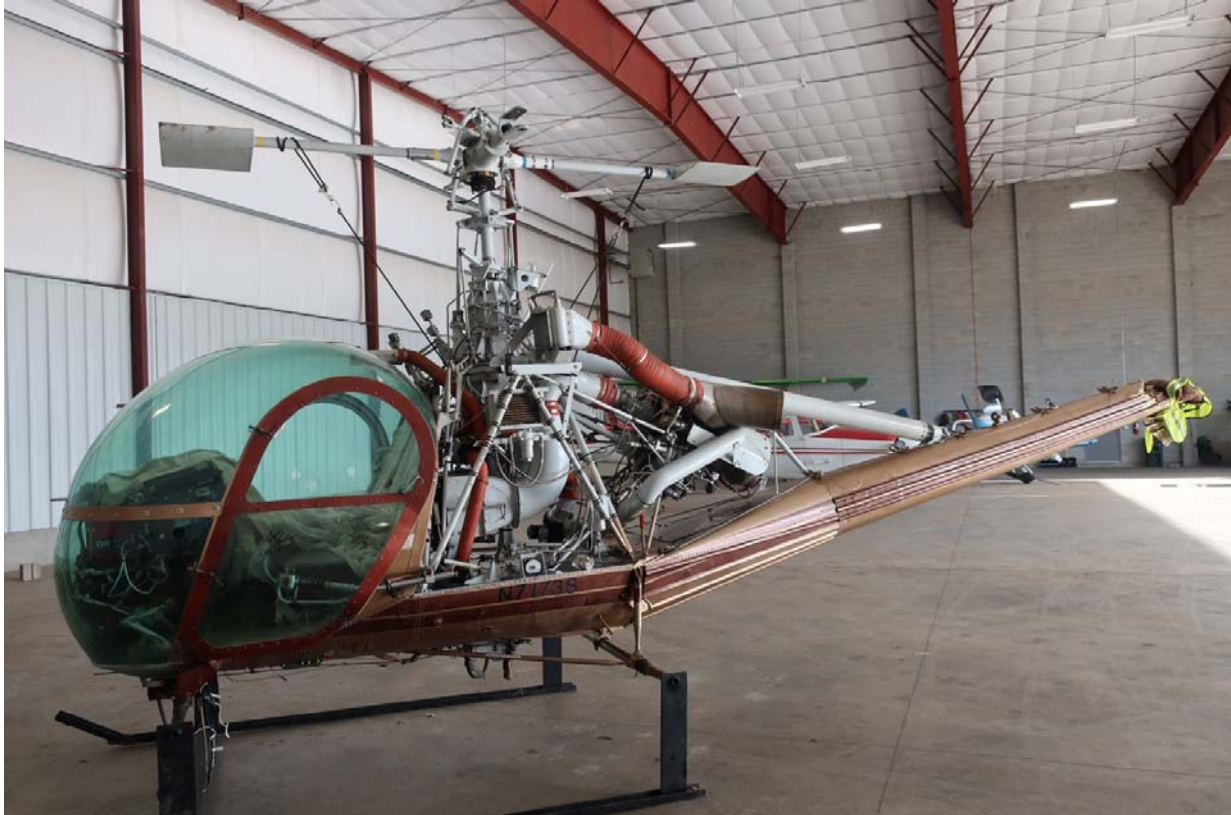
The aircraft was recovered to a rented hangar at the Vernal airport and was positioned on makeshift skids. The main rotor blades were removed for transport and not observed. Impact damage was noted to the tail boom and the tail rotor assembly was not present.

Figure 1. Aircraft after recovery to hangar on makeshift skids.

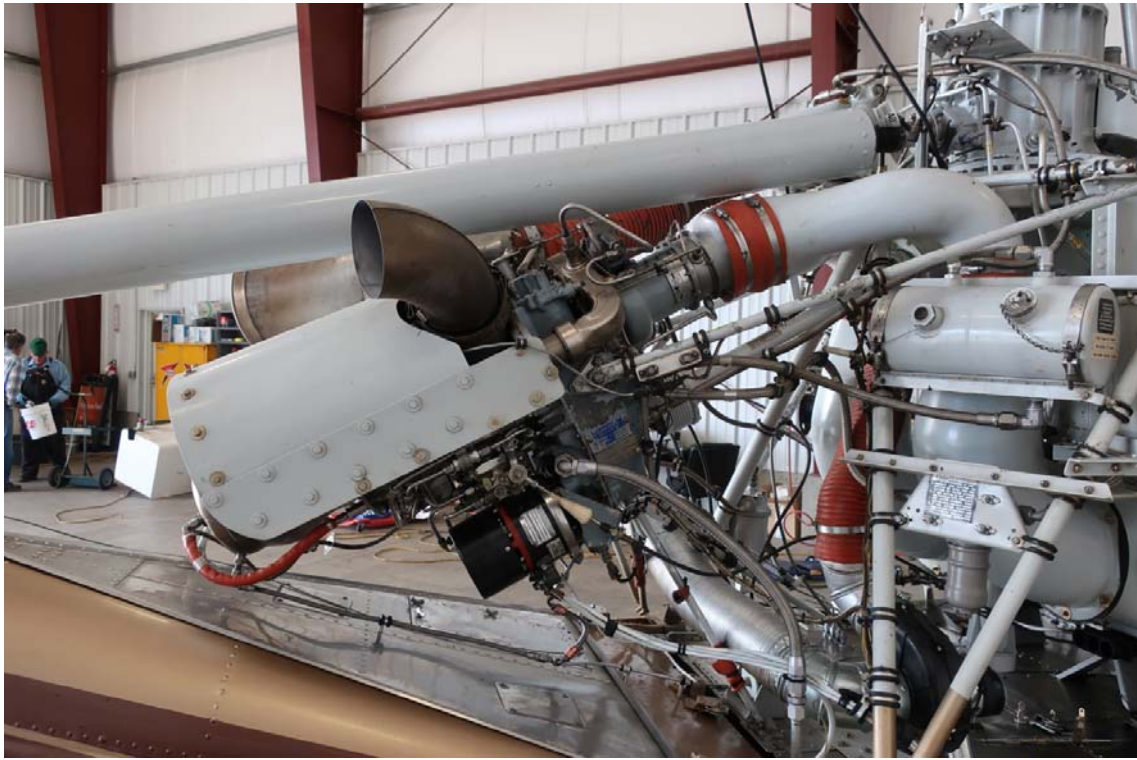
The engine was secure and in place with no damage to the mounts. External engine damage consisted of small dents on the left compressor discharge tube consistent with internal debris travelling outward. The engine N1 system was locked while the engine N2 system turned and was connected to the aircraft power train. No Foreign Object Damage (FOD) was noted on the first stage compressor blades or compressor inlet and the inlet barrier filter system was intact and free of debris. The fourth stage turbine wheel was normal in appearance when viewed from the exhaust collector.

Figure 2. Engine in-situ prior to field examination

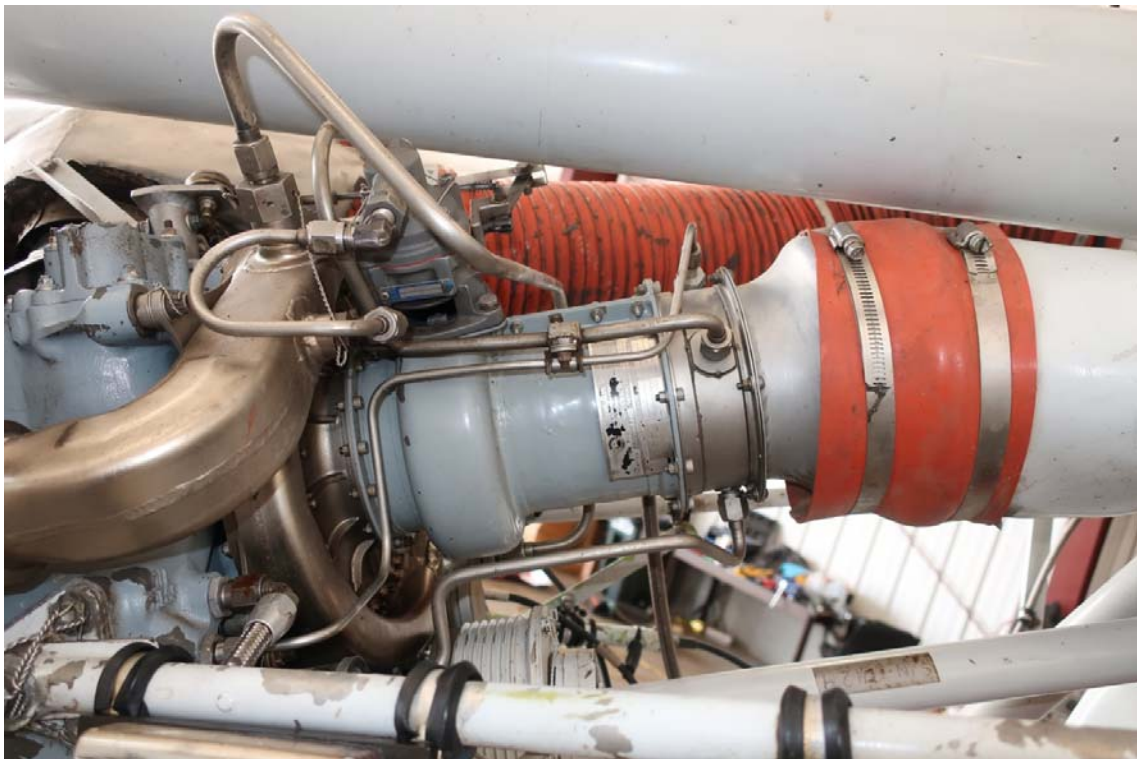
The compressor case was not penetrated but downstream internal damage could be seen when viewed from the inlet. The compressor bleed valve was removed and normal in appearance. The plunger extended with the appropriate resistance and retracted under spring force. Metallic debris, consistent with liberated compressor material, was log-jammed in the compressor bleed valve manifold which is located adjacent to the fifth stage compressor wheel.

Figure 3. Compressor in-situ prior to field examination

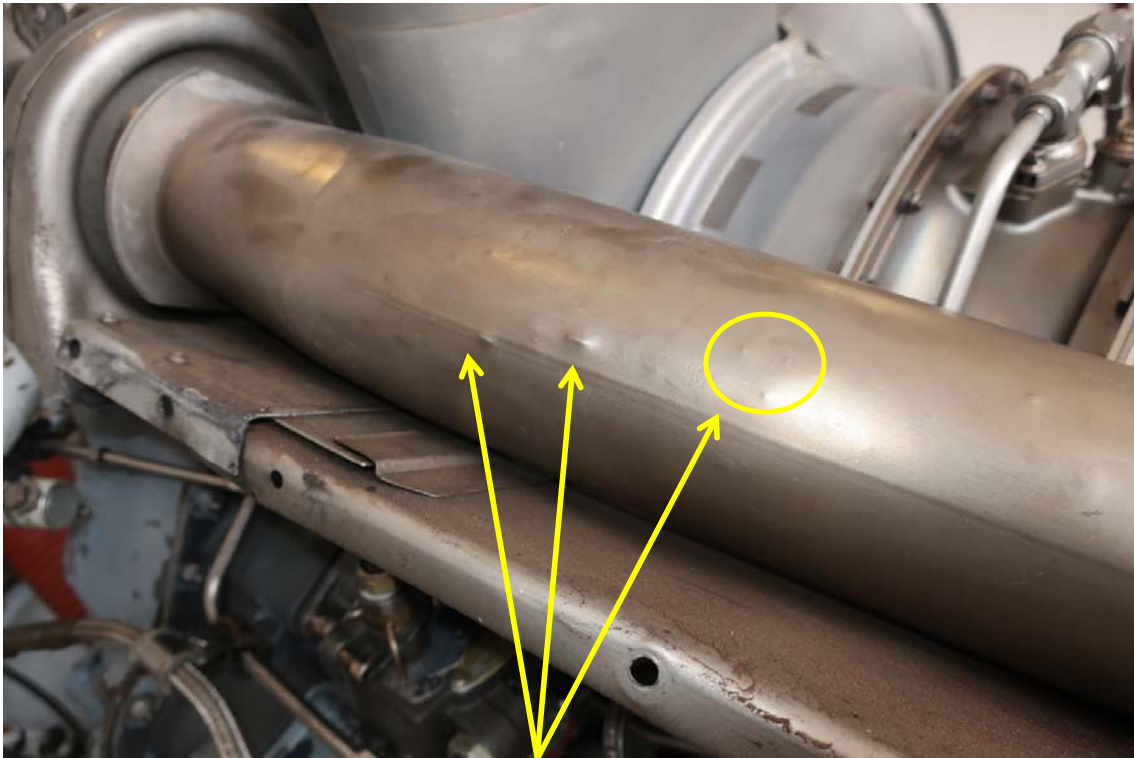
The outer combustion case, combustion liner, and compressor discharge tubes were removed for inspection. The left compressor discharge tube exhibited impact damage on

the interior of the tubes. No noticeable damage was noted to the right discharge tube. Loose metallic debris was noted within the outer combustion case, which was otherwise undamaged. The combustion liner was normal in appearance. The first stage nozzle shield and first stage nozzle airfoils were coated with a gray powder-like substance. The gas producer turbine rotated freely once the compressor was removed and all of the first stage turbine wheel blades were intact.

Figure 4. Left side compressor discharge tube peening damage

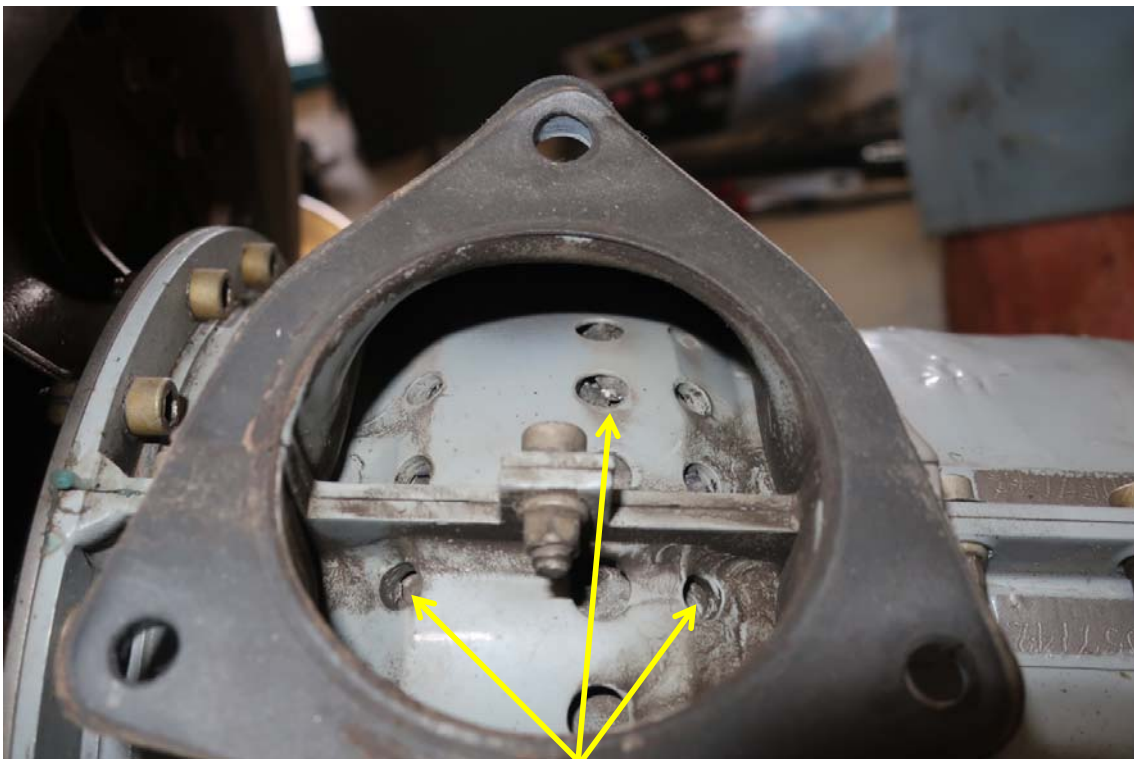
Figure 5. Liberated debris log-jammed in bleed valve manifold
