Rolls-Royce Corporation

Date: 12 February 2021

Subject: Findings of the Series II Fourth Stage Compressor Wheel from Dynamic Aviation

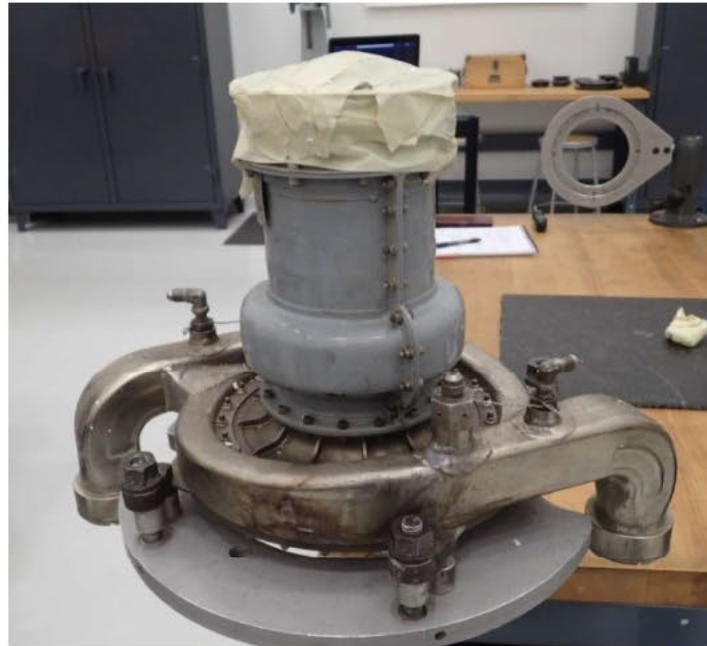
Figure 1: As-received compressor module

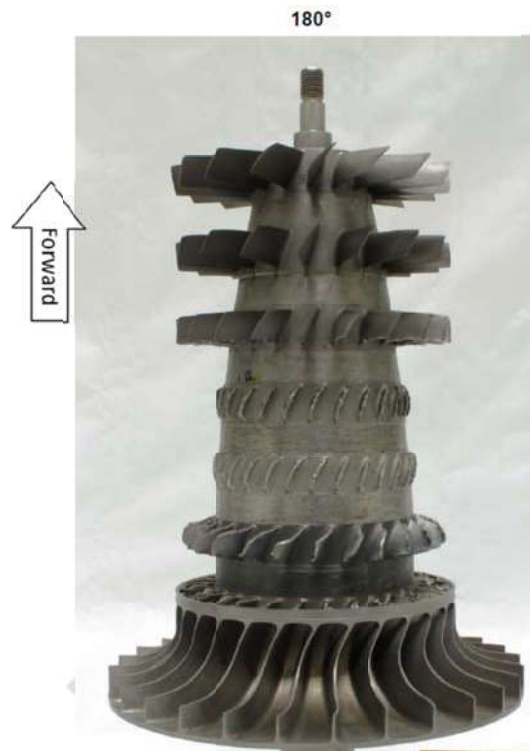
The as-received condition of the compressor rotor following teardown is shown in Figure 2. All the stage 4 and 5 blades were fractured and liberated near the root, and all the fracture surfaces exhibited some amount of smearing damage. The stage 3 blades exhibited impact damage on the trailing edges. The stage 6 compressor blades exhibited tip deflection against the direction of engine rotation. The damage to the stage 3 and 6 compressor blades was consistent with impact damage from the liberated stage 4 and 5 compressor blades.

**Figure 2:** As-received compressor rotor

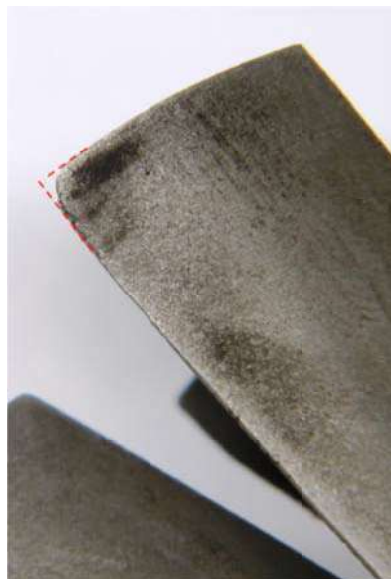
**Figure 3:** Representative leading edge tip erosion found on the stage 1 compressor blades. The red dashed line shows the approximate original profile of the leading edge tip.

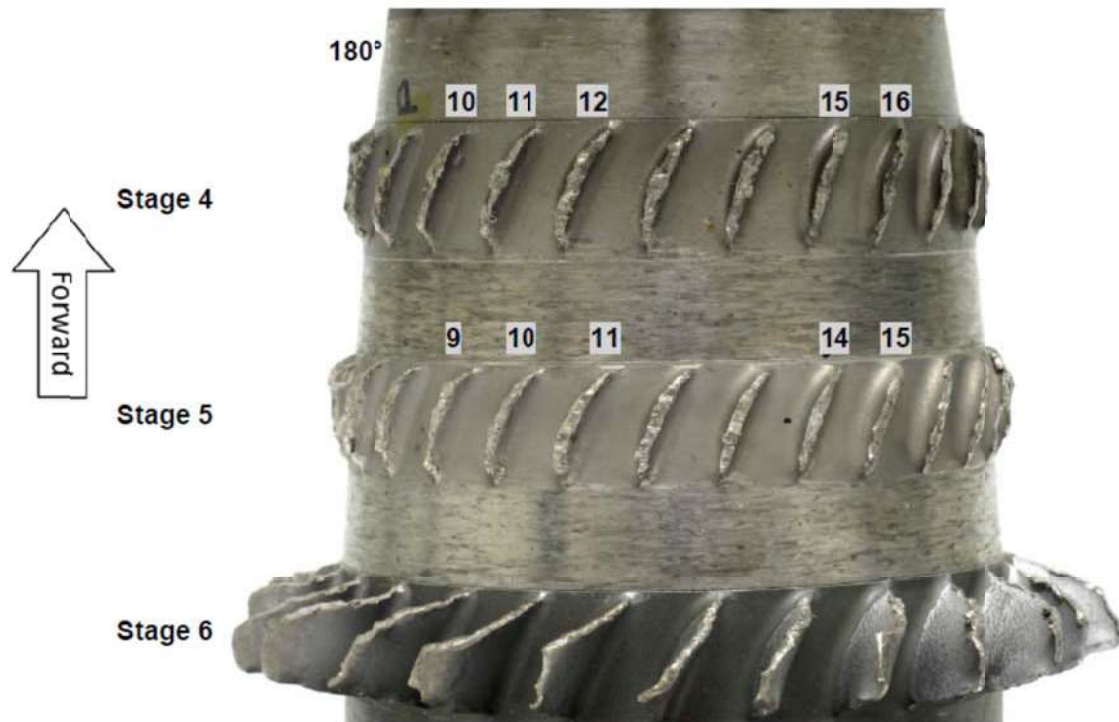
**Figure 4:** Close up view of the stage 4, 5 and 6 compressor wheels

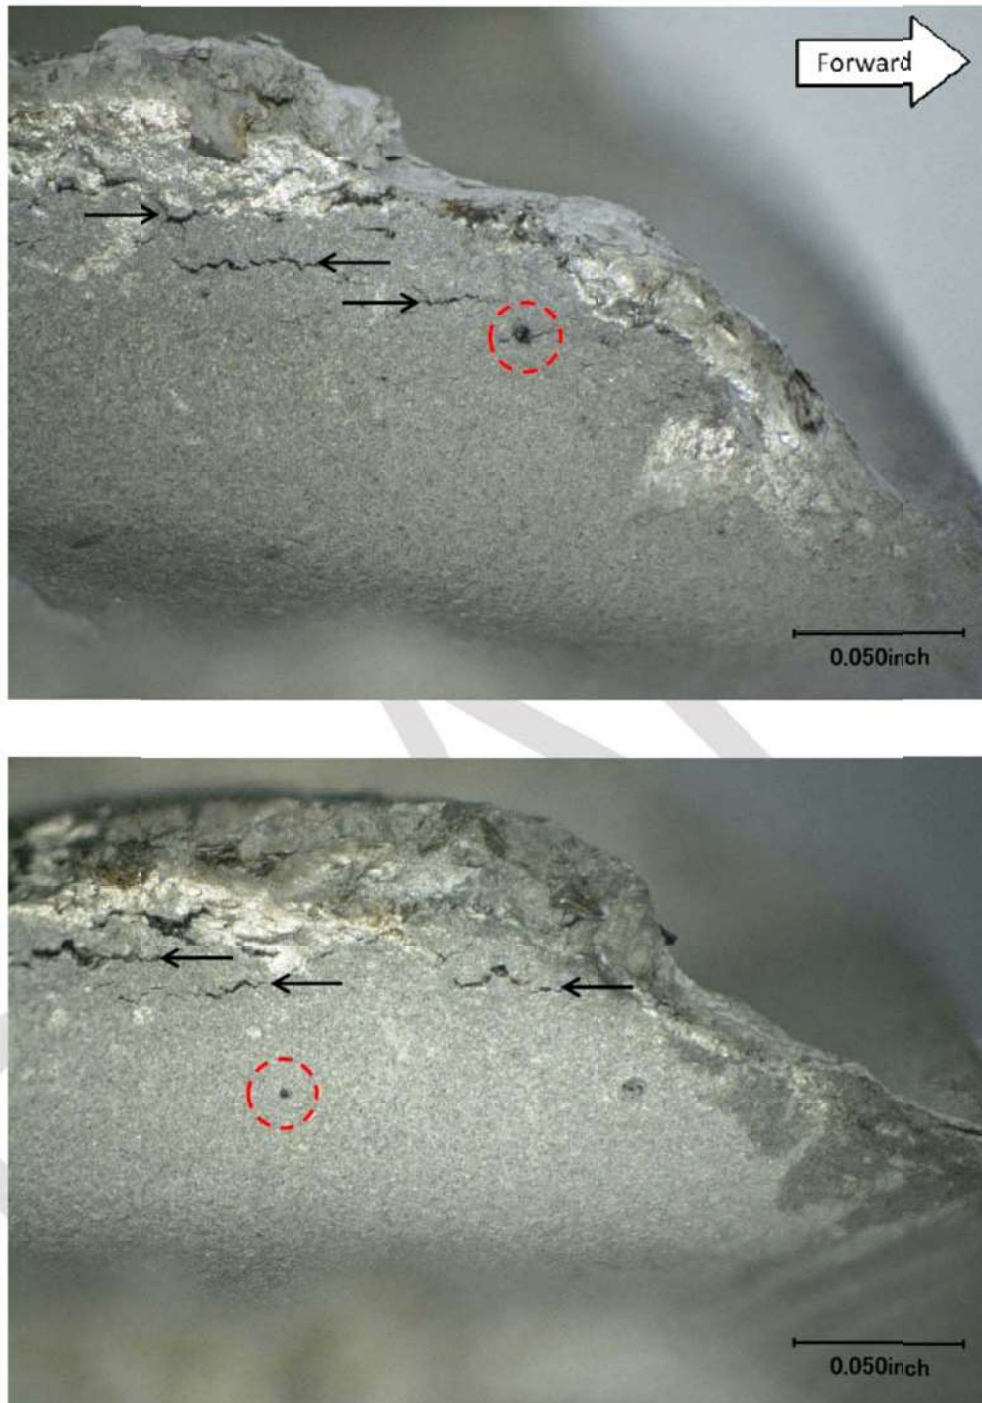
- The stage 4 compressor rotor exhibited corrosion damage on the airfoil and rim surfaces. Both of the blades that fractured in fatigue from the suction side crown had corrosion damage near the middle of the fatigue fractures.

**Figure 5:** Detailed pressure side views of stage 4 blade #5 (top) and #23 (bottom) (randomly numbered) showing representative corrosion damage (red dashed circles) and pressure side cracking (arrows) found on the stage 4 blades. Not all instances of damage are annotated.

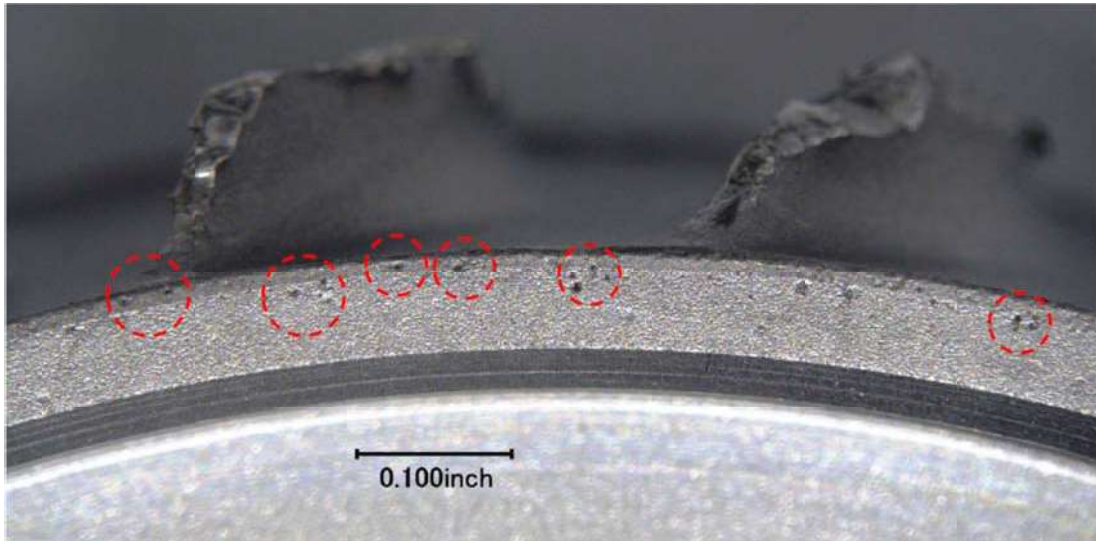
**Figure 6:** Representative corrosion pitting (red dashed circles) found on the forward rim face of the stage 4 compressor wheel.

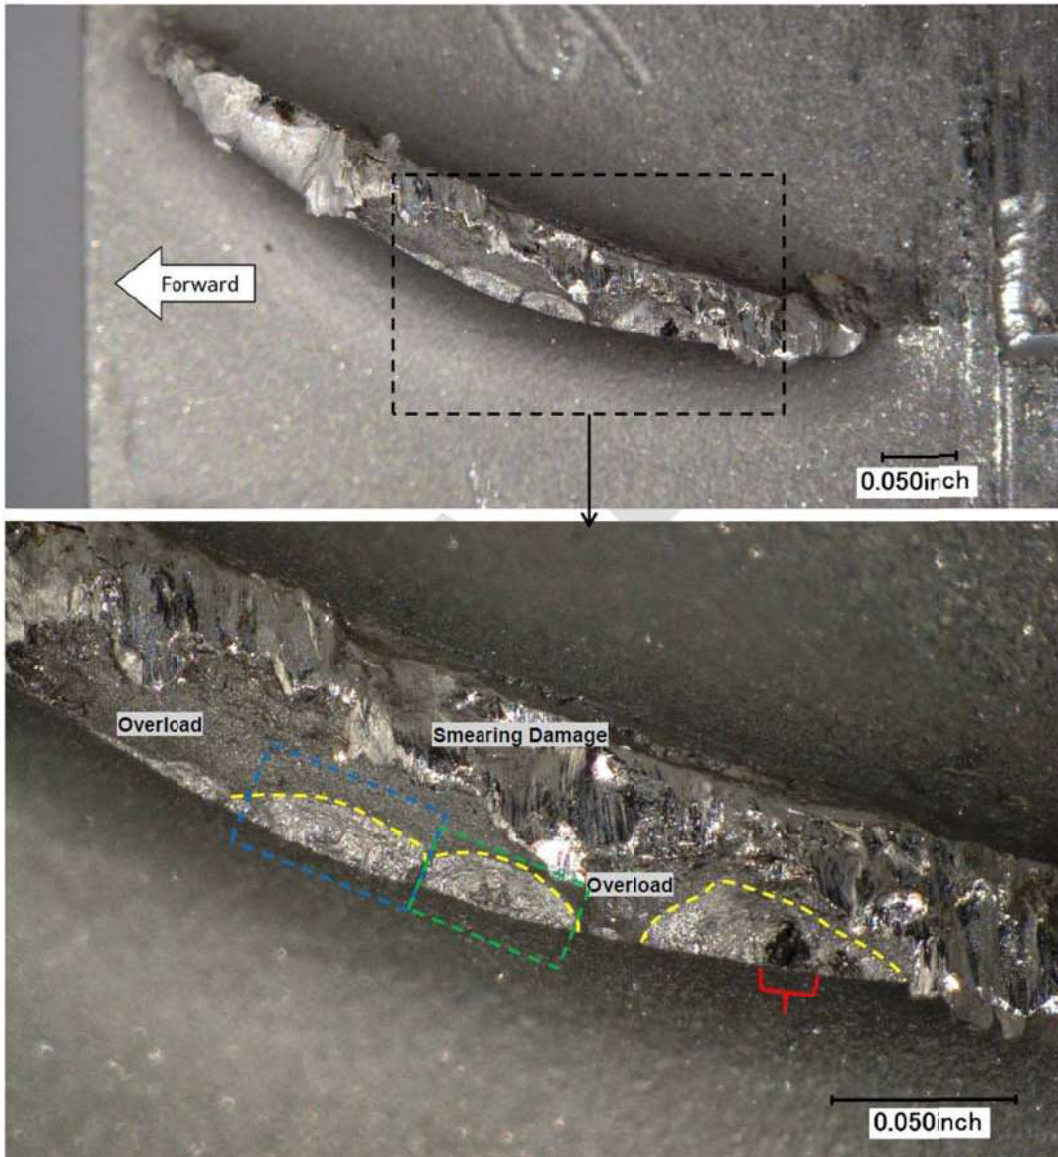
- At least three stage 4 compressor blades exhibited fracture features consistent with fatigue. Two of the blades exhibited fracture features consistent with fatigue progression from the suction side crown and one blade exhibited fracture features near the suction side crown location that were consistent with fatigue progression aft from the leading edge area.

**Figure 7:** Detailed views showing the fracture surface on a representative stage 4 compressor blade (#5). Multiple fatigue fractures propagated across the airfoil from the suction side surface near the crown. The yellow dashed lines show the ends of the fatigue fractures. There was a corrosion pit (red brace) near the center of one of the fatigue fractures.

The investigation concluded that the direct cause of this event was the liberation of the 4<sup>th</sup> stage compressor blades due to corrosion pitting from being operated for some time in a corrosive environment.

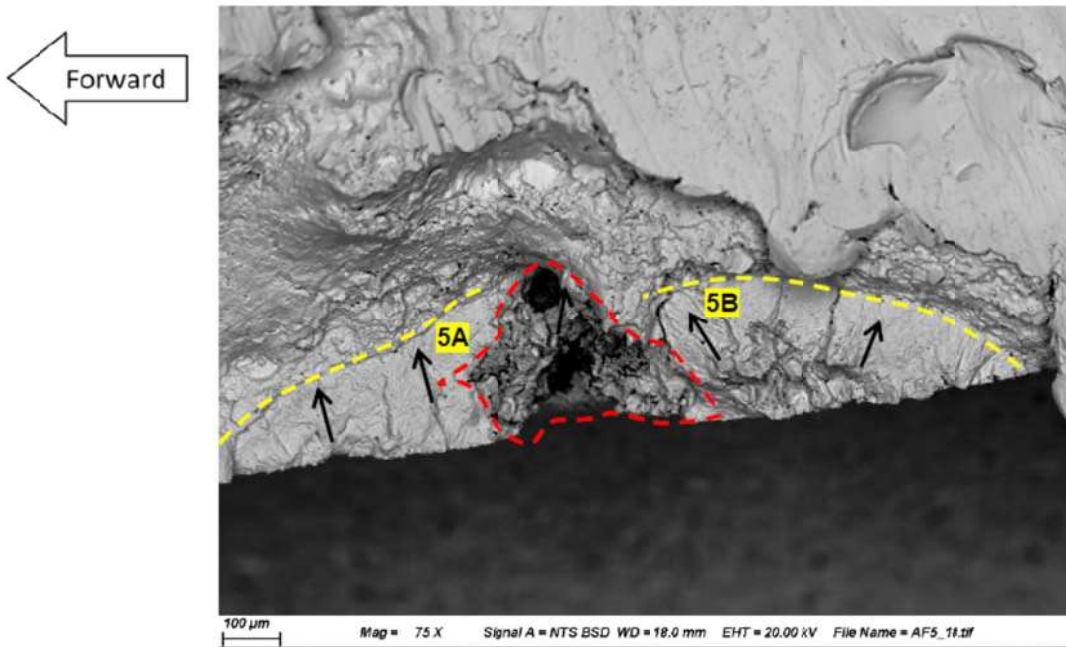
**Figure 8:** Backscattered electron SEM image of the corrosion pit area shown in Figure 7. The yellow dashed line shows the end of the fatigue fracture. Arrows show the local direction of fatigue progression.

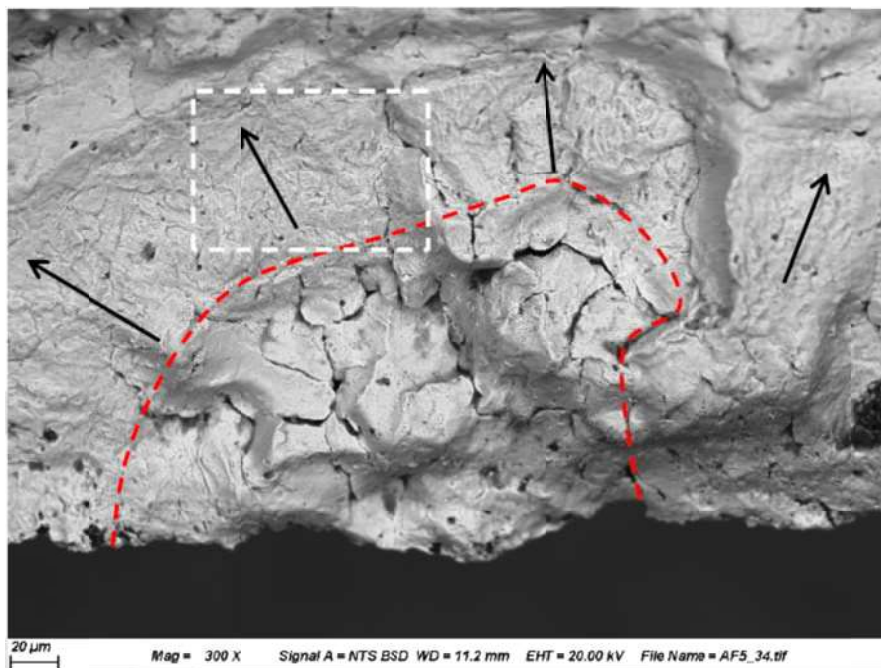
**Figure 9:** Backscattered electron SEM images showing the forward-most fatigue fracture thumbnail on stage 1 blade #5 (area noted as 5A in Figure 3). The fracture features emanated away (black arrows) from an area of intergranular damage and a relatively smooth intergranular surface morphology (red dashed outlined area) consistent with corrosion damage.

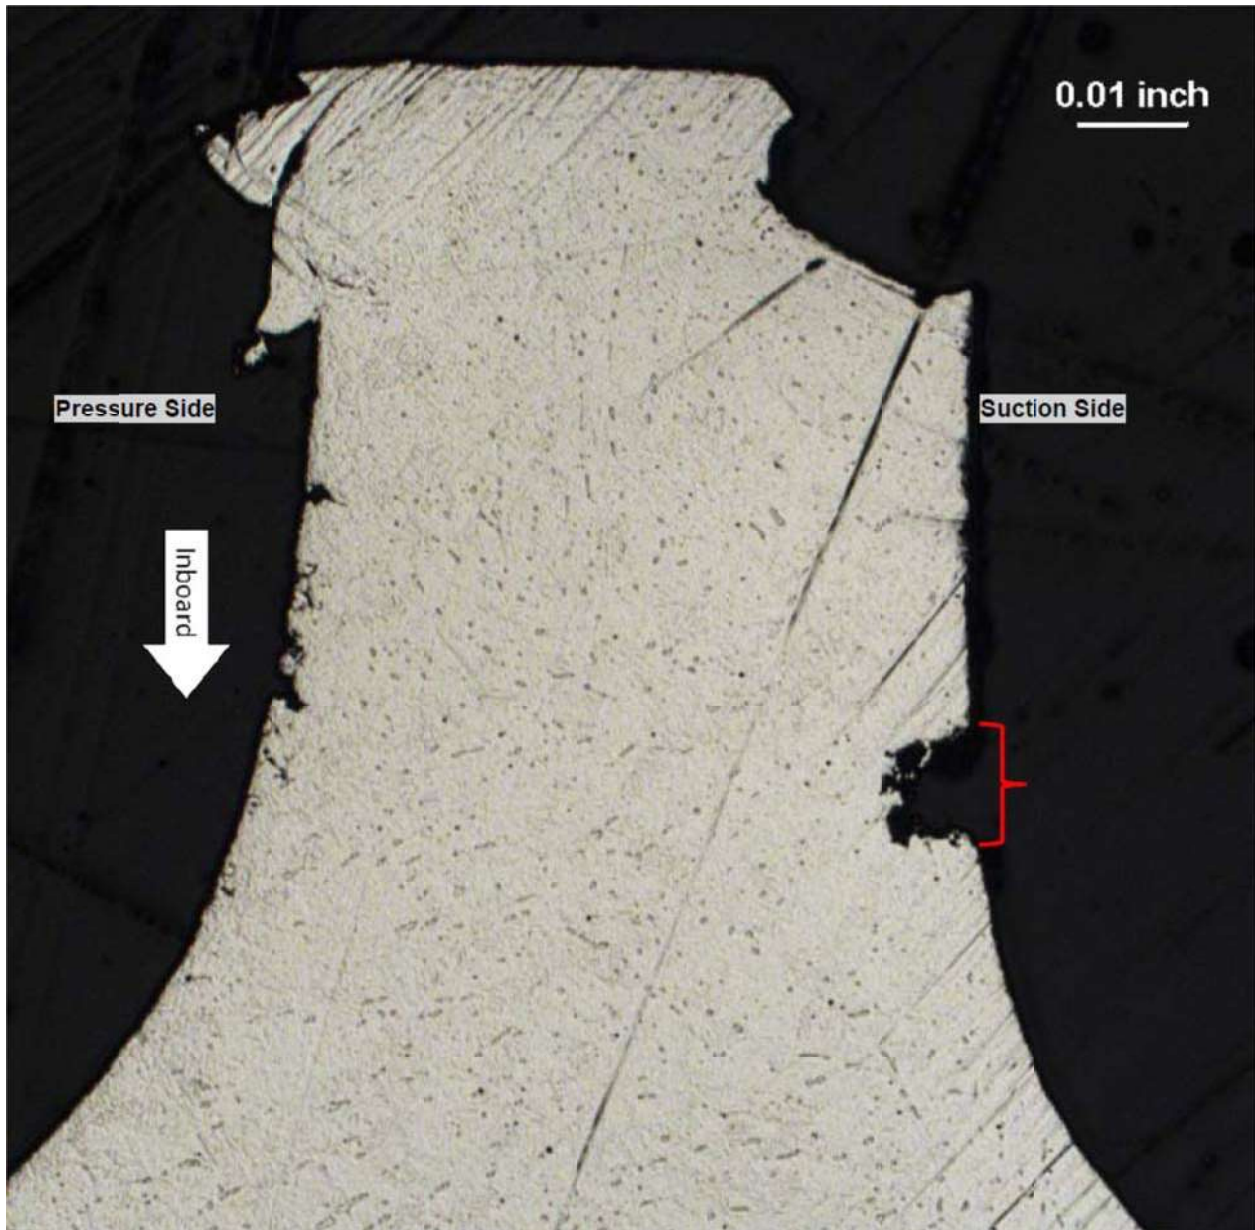
- The stage 4 and 5 compressor blades did not have a diffused aluminide coating on the gas path surfaces.
- The remaining stage 4 compressor blades exhibited a combination of overload fracture features and smearing damage.

**Figure 10:** Overall view of the cross-section through the suction side corrosion pit on stage 4 compressor blade #9. The linear features on the surface of the mount were scratches from specimen preparation. There was no coating apparent on the cross-section.

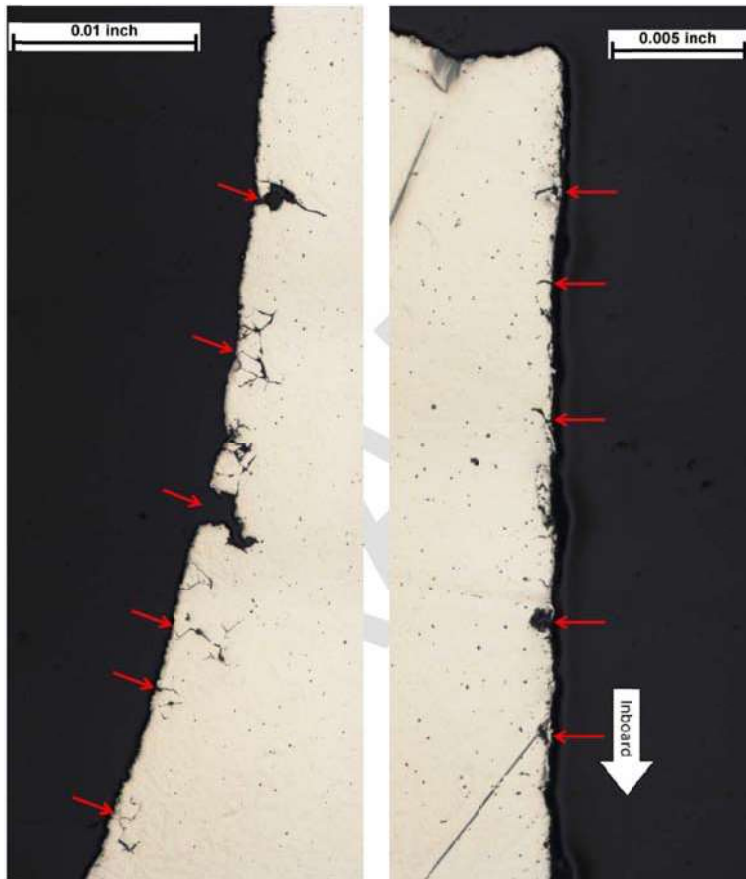
**Figure 11:** Pressure (left) and suction (right) side detailed views showing corrosion damage and surface damage (red arrows, not all instances are annotated) on Stage 4 blade #9, inboard of the fracture surface.
