# NATIONAL TRANSPORTATION SAFETY BOARD

## MATERIALS LABORATORY FACTUAL REPORT

Report No. 21-104

Place : Lumberton, Mississippi  
Date : 03/14/2020  
Vehicle : Cessna 182 (N20847)  
NTSB No. : CEN20LA123  
Investigator : Josh Lindberg

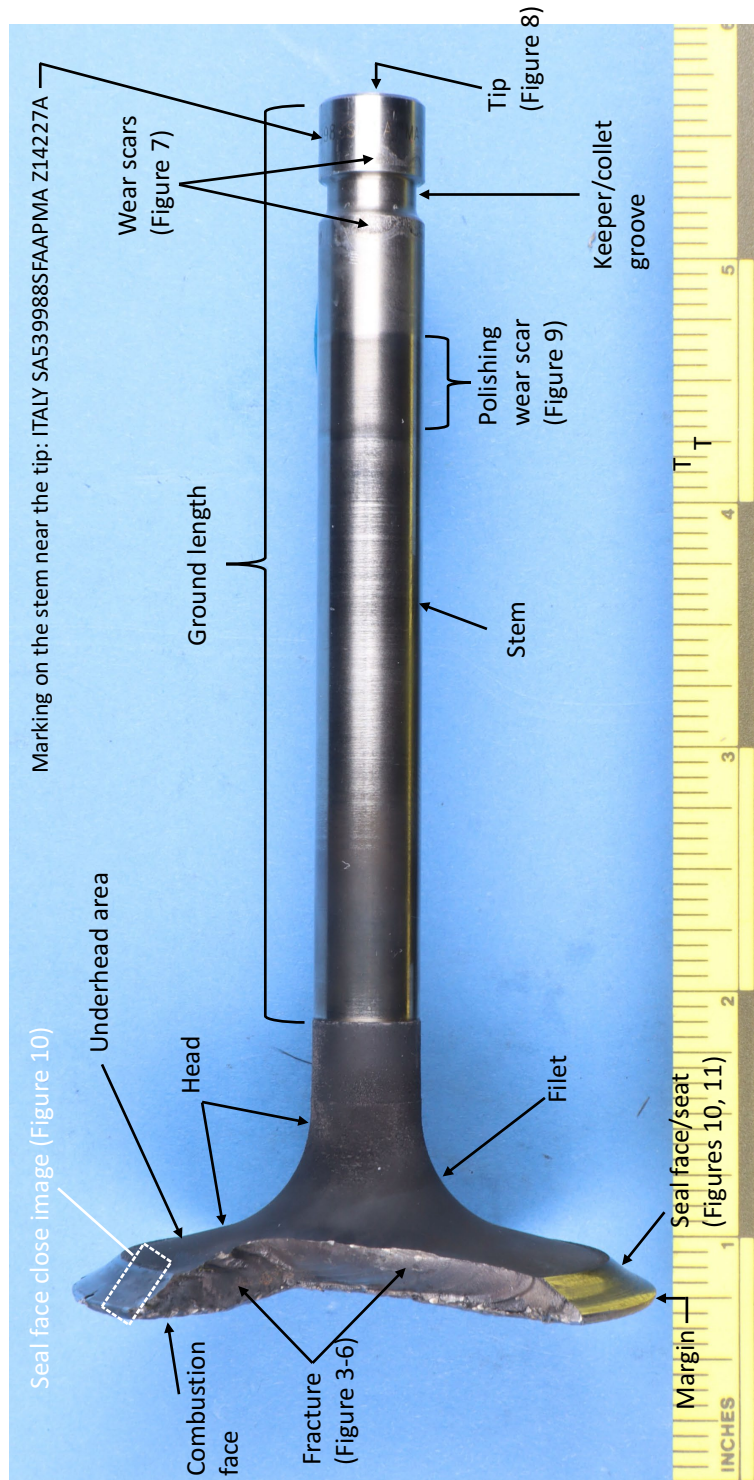
The as-received intake valve is shown in Figures 1 and 2. The images are annotated to identify key features of the valve. As indicated in the figures, a portion of the valve head is missing, consistent with the inward propagation of a radial rim fracture and the initiation and propagation of a chordal fracture in the fillet area perpendicular to the axis of the stem (see Figures 2b and 3). As documented in Figures 4-6, crack progression marks are indicative of fatigue crack propagation. The initial crack developed at the valve margin or rim (biased to the combustion face side) and propagated inward toward the center of the valve head as a radial rim crack and when the crack front reached the fillet region of the head, a second crack initiated and propagated in fatigue as a chordal fracture. As indicated in Figure 3, a final overstress fracture occurred near the valve's rim or margin.

Adjacent to the keeper/collet groove, there are fretting wear scars (also known as chafe marks) around the circumference of the valve stem (See Figure 1 and 7). These scars or marks can be indicative of valve floating.

The tip of the valve (Figure 1) exhibited parallel grinding lines across the face and a faint radial wear pattern consistent with rotational contact with the rocker pad as documented in Figure 8.

The valve stem exhibited fine circumferential grind lines along the ground length (see Figure 1 and 9). A faint but defined polishing wear scar was observed as indicated in Figures 1 and 9. The length of the wear scar was approximately 0.42 inch (consistent with valve lift).

Figure 1 Side view of the fractured number 1 intake valve with key details annotated.

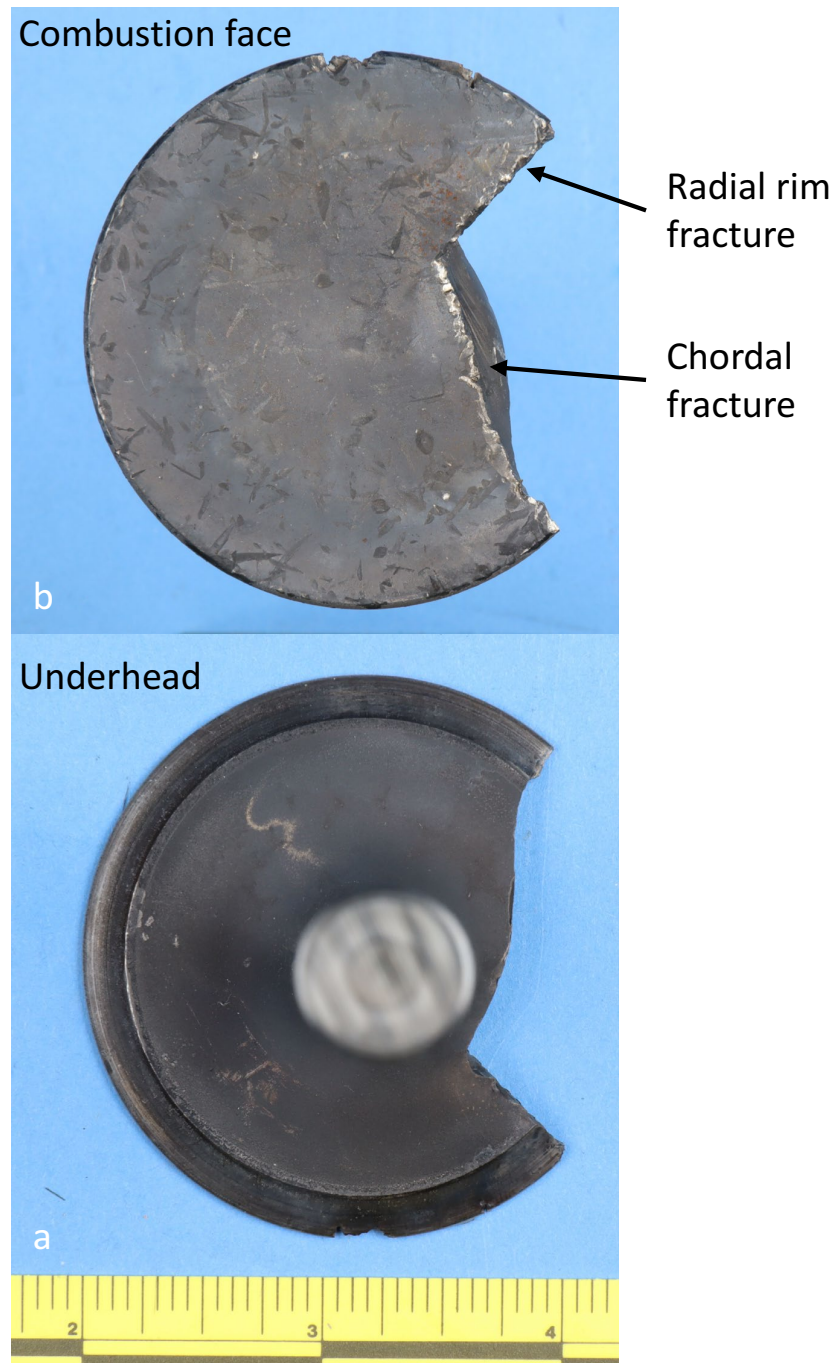
Figure 2 Views of the number 1 valve combustion face and underhead.

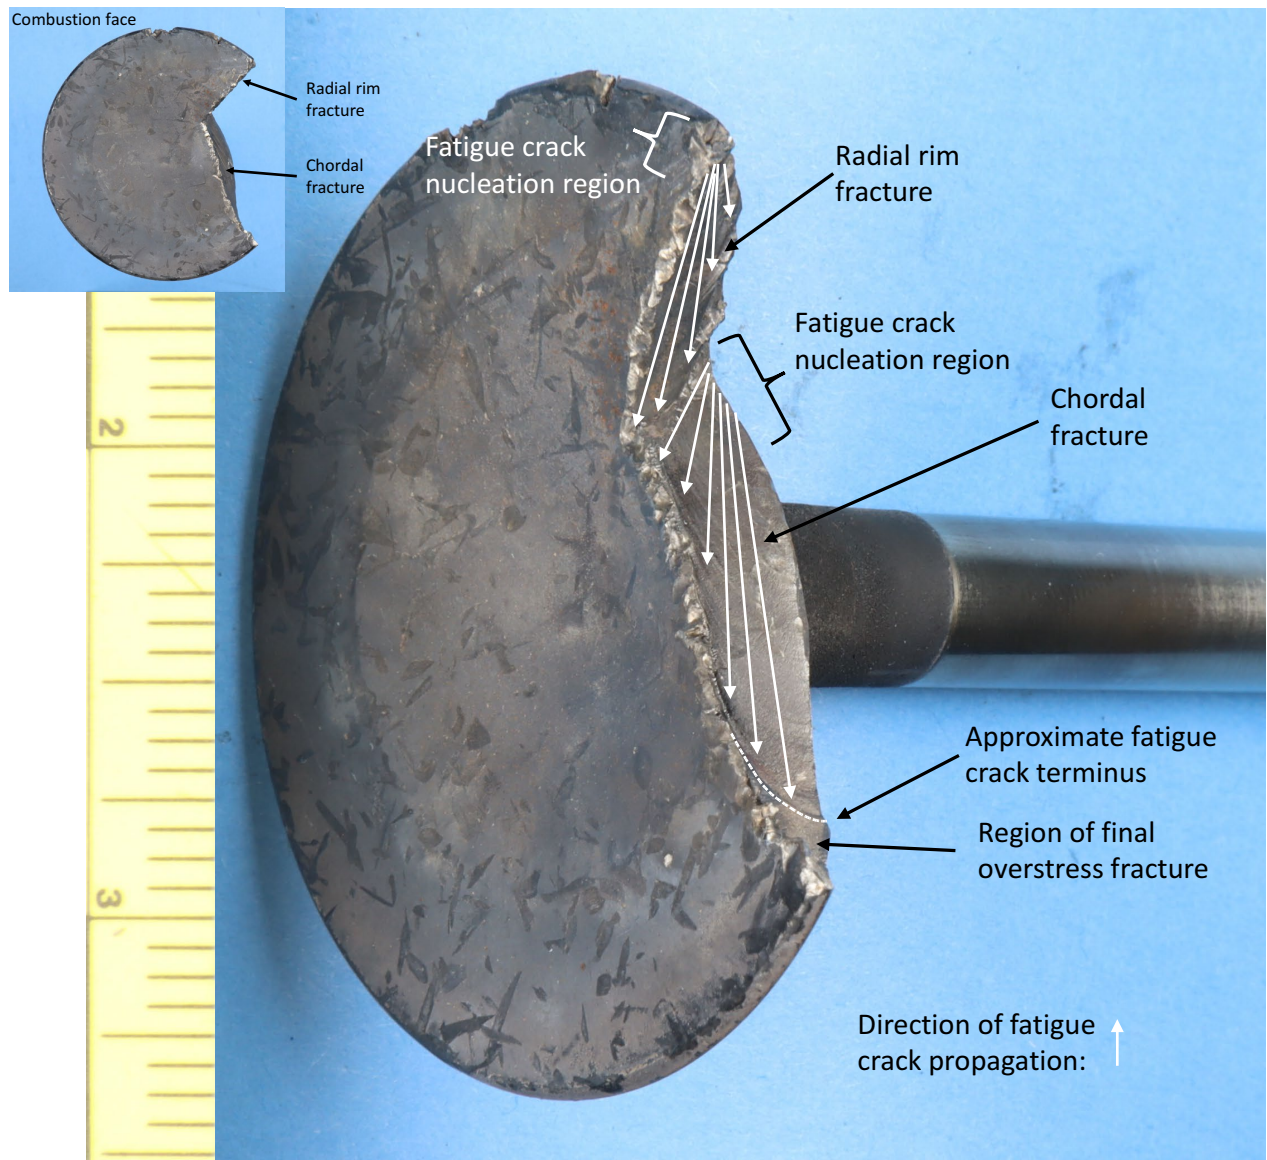
Figure 3 Oblique image of the number 1 intake valve head. The fracture initiation (nucleation) and crack propagation directions are annotated.

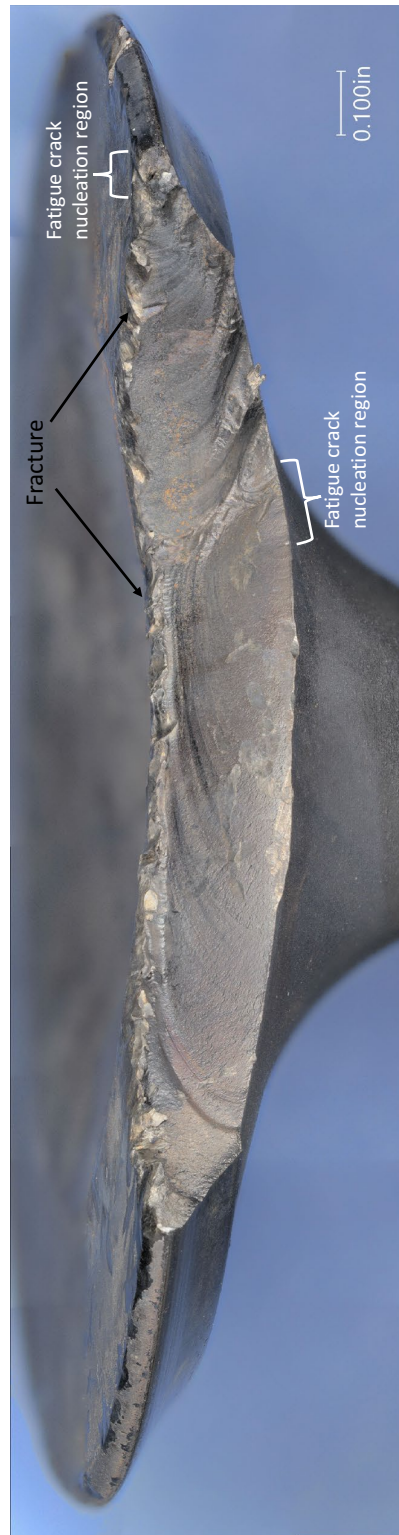
Figure 4 Overall digital microscope image of the number 1 intake valve fracture surfaces with the initiation or nucleation regions identified.

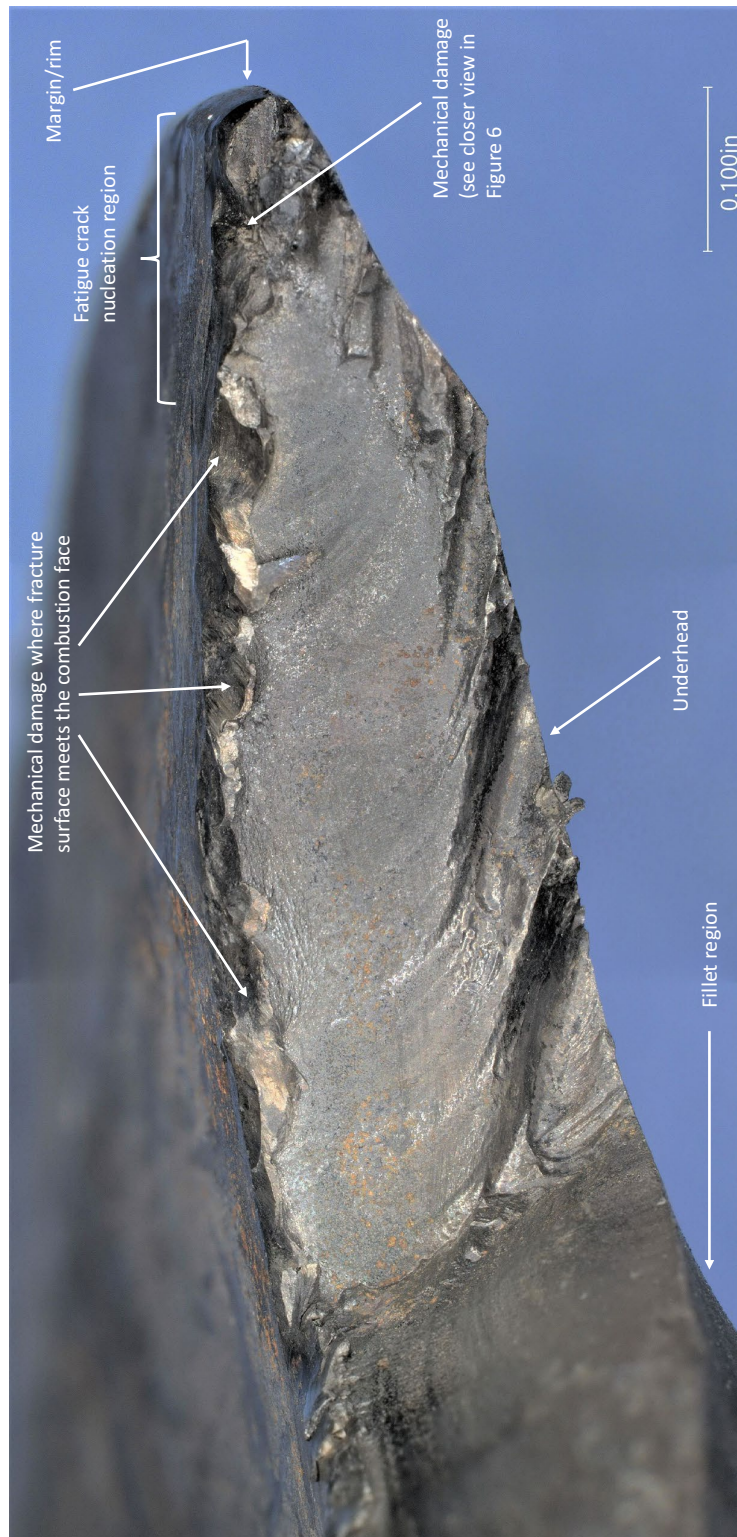
The combustion face of the valve exhibited impact marks uniformly across the face. The edge of the fracture as it intersects the combustion face was damaged by impact along its entire length. Such impact damage is indicated in Figures 5 and 6 and precluded the documentation of the origin region for the radial rim fracture as indicated in Figure 6.

Figure 5 Digital microscope image of the fracture surface of the radial rim crack with key features annotated. Mechanical damage at the origin or nucleation region is noted.

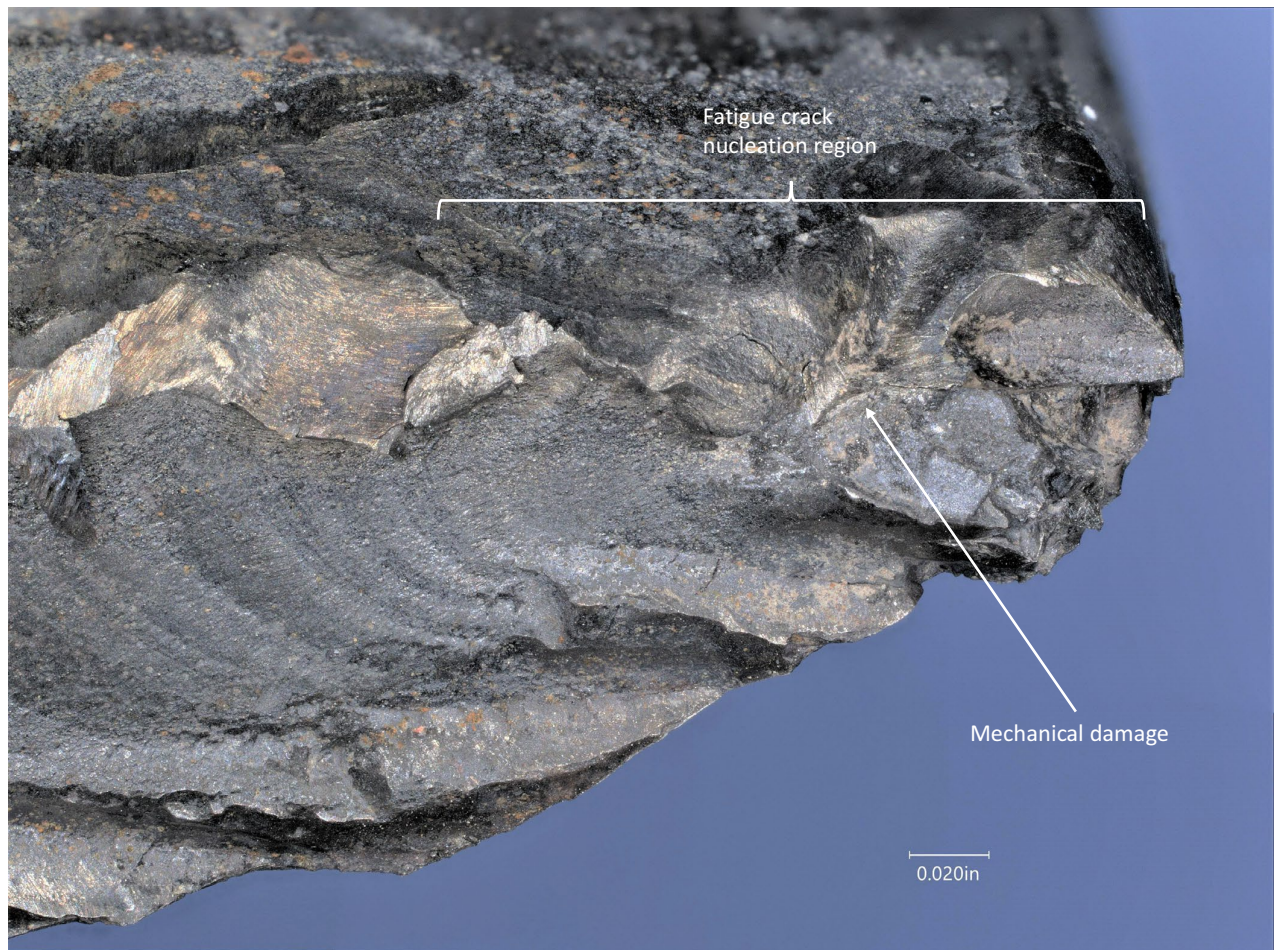
Figure 6 Close digital microscope image of the fracture origin or nucleation region of the radial rim crack. Mechanical damage obscures the fatigue crack origin area.

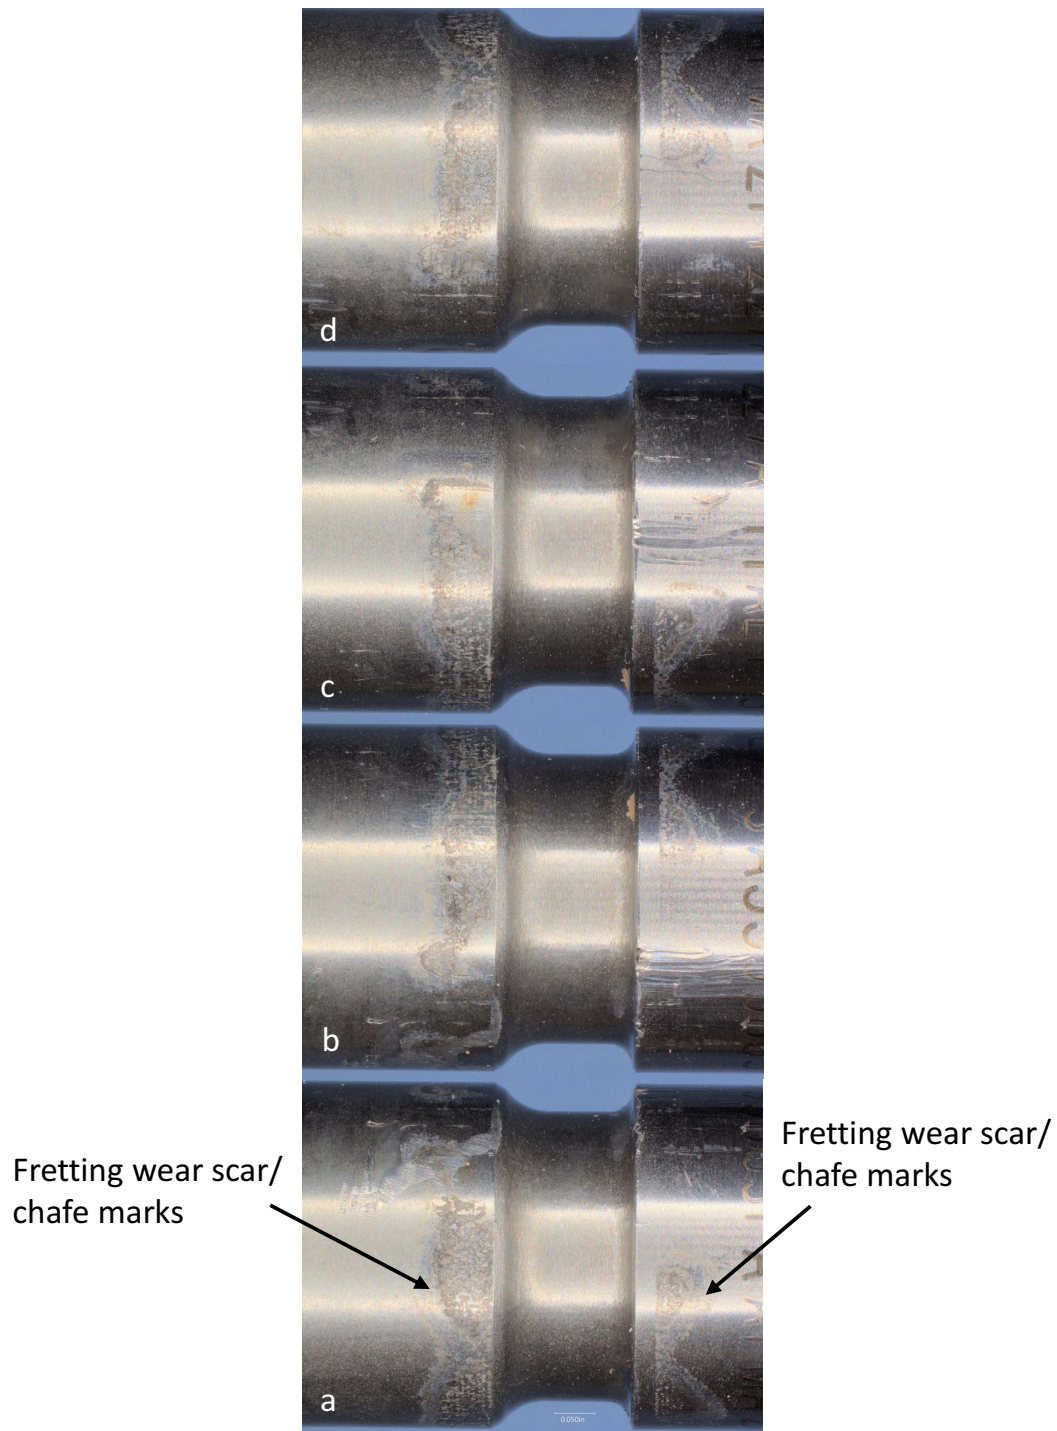
Figure 7 Images of the stem surface near the keeper groove showing fretting wear scars (or chafe marks). Views a-d were taken by digital microscope every 90°.

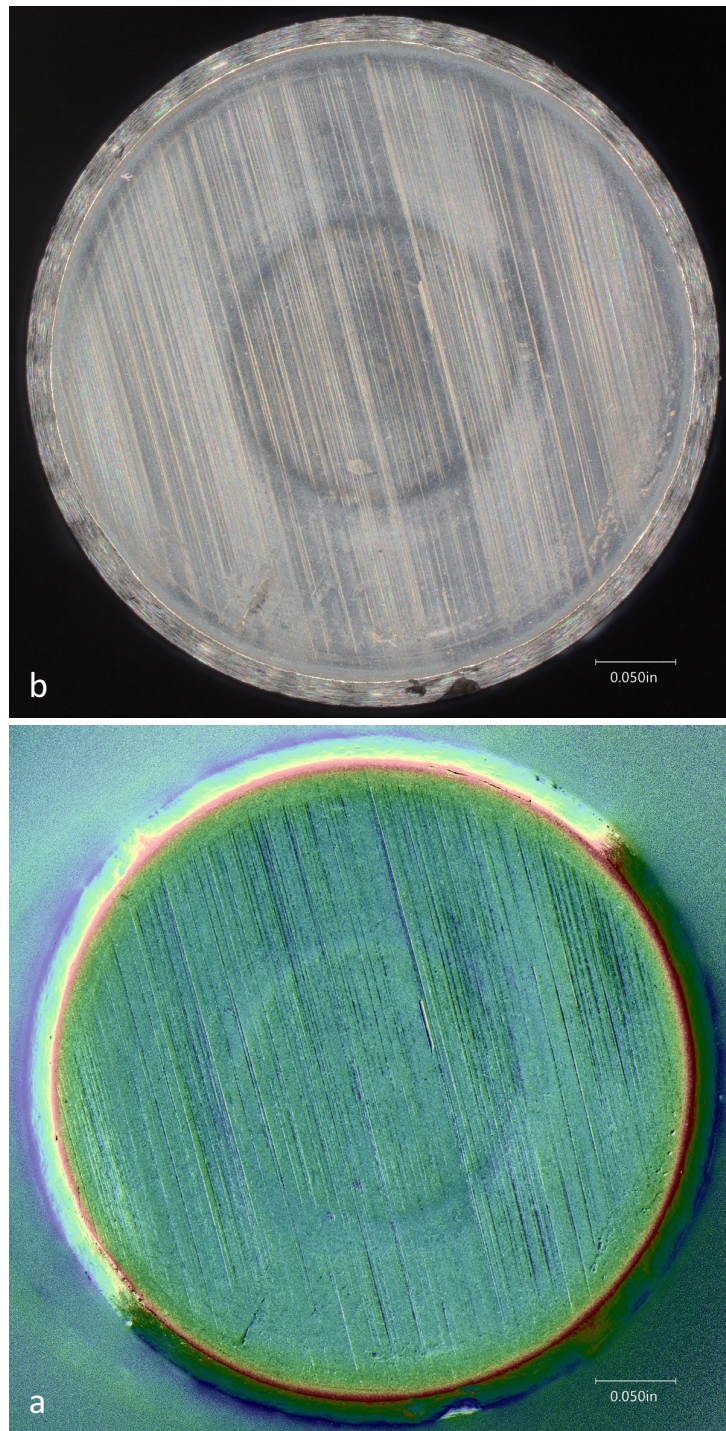
Figure 8 Digital microscope images of the valve stem tip. Parallel grinding lines and a faint circular impression are present.

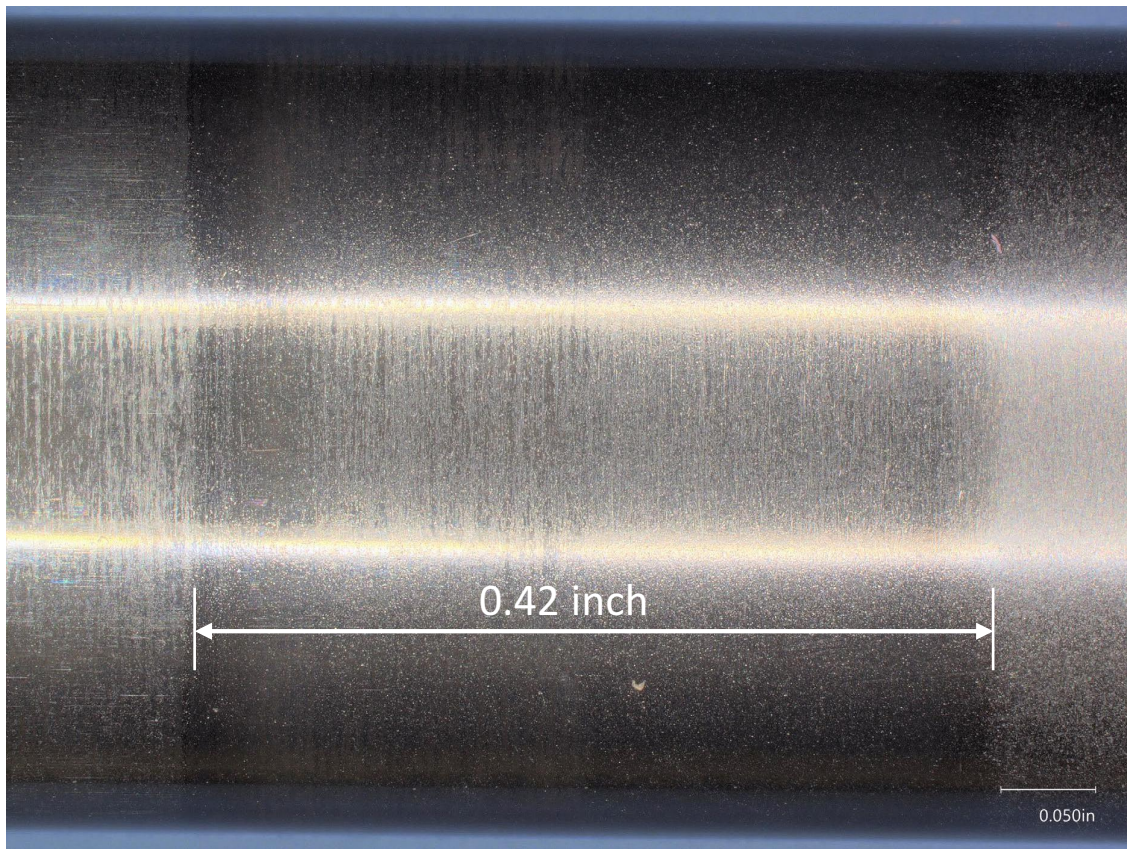
Figure 9 Digital microscope image of the outside surface of the stem in the vicinity of a 0.42 inch polishing wear scar (see Figure 1 for the location).

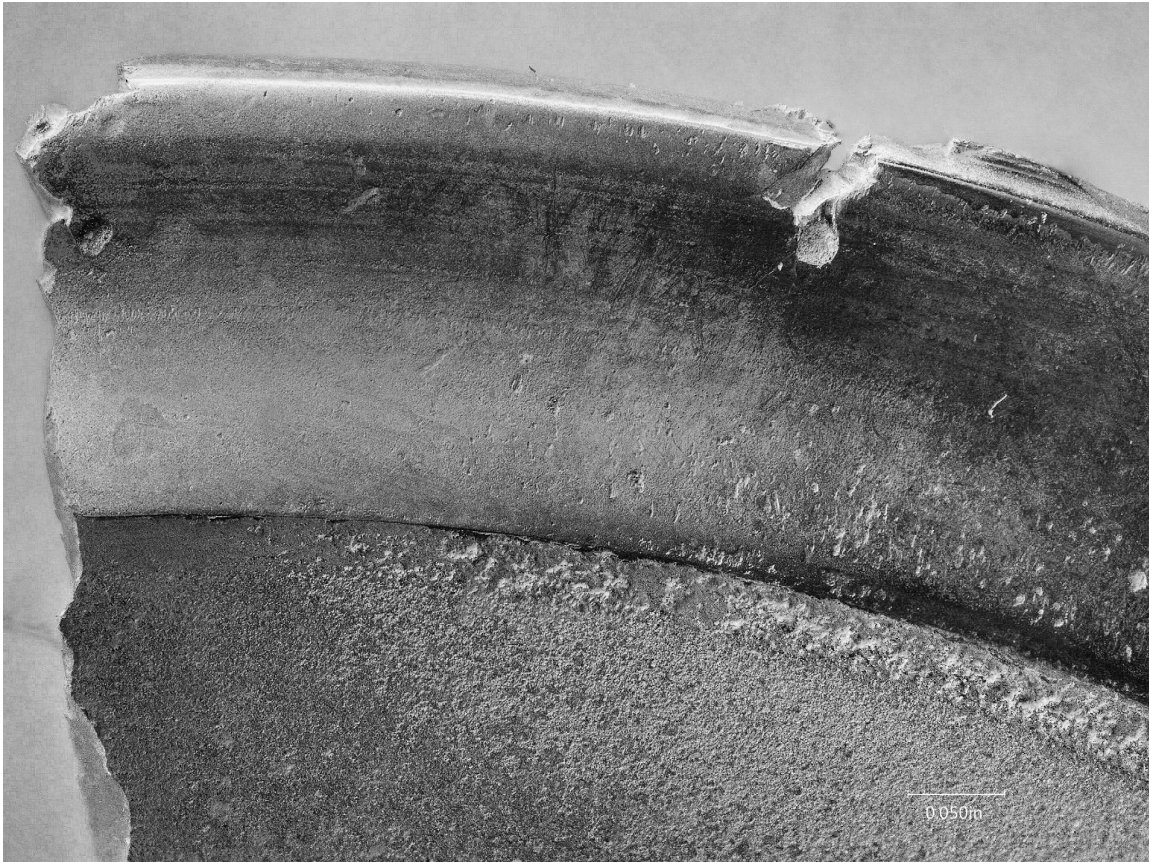
Images of the valve seal face or seat are shown in Figures 10 and 11. Impact marks and rim damage documented in Figure 10 are consistent with foreign object damage. A closer view of the seal face in Figure 11 reveals impact wear scars and deformed machining marks. No indications of seal face erosion were noted.

Figure 10 Digital microscope image of the seal face or seat of the valve near the origin of the radial rim crack.

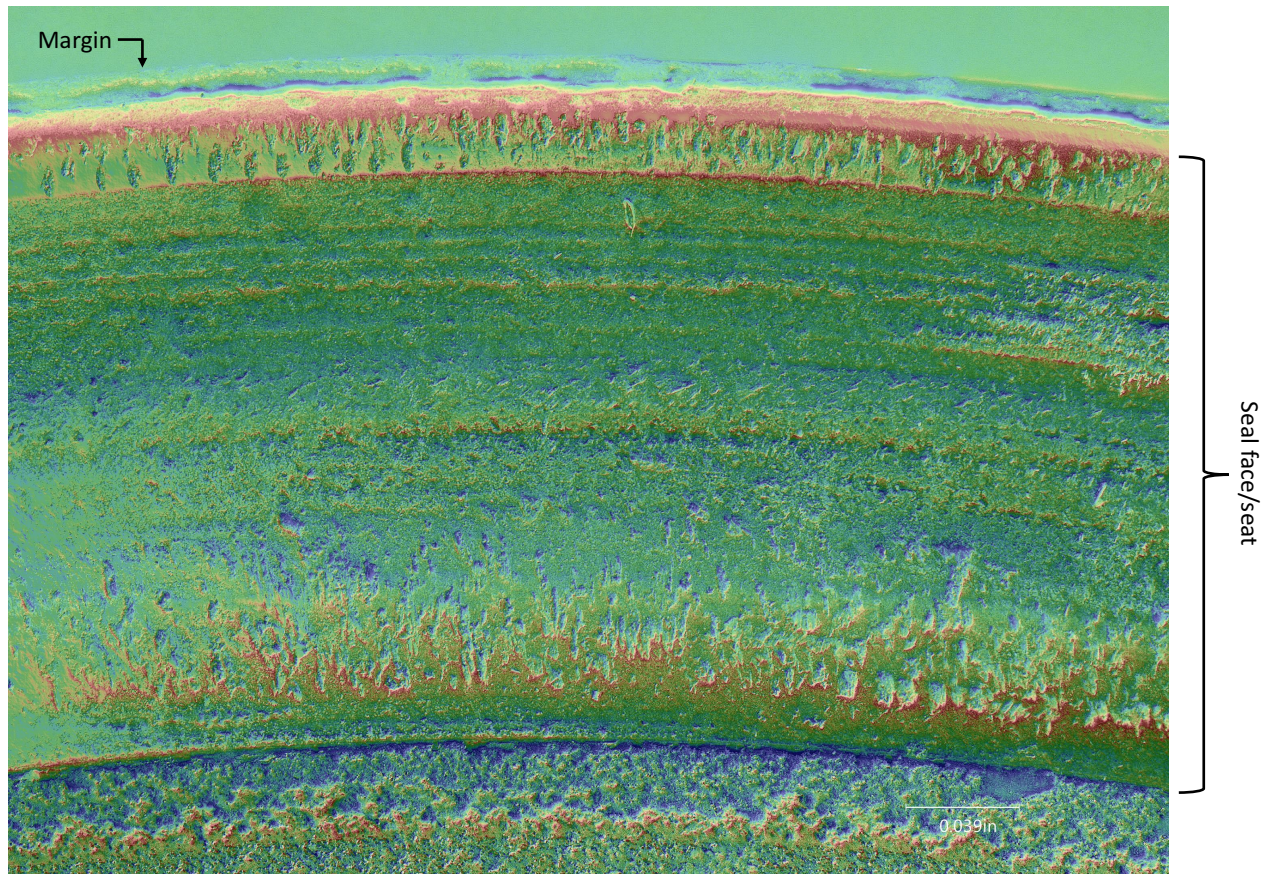
Figure 11 Digital microscope image of the valve seal face or seat approximately 90° from the radial rim crack. Shading and colorizing have been used to highlight the surface texture. This surface texture is representative of the remaining seal face present on the valve. No indications of erosion were observed.
