# The National Transportation Safety Board

Office of Aviation Safety  
Central Region  
Memorandum for the Record  
Airframe and Engine  
Examination Findings  
CEN19FA127  
Pleasant Prairie, Ohio  
March 18, 2020

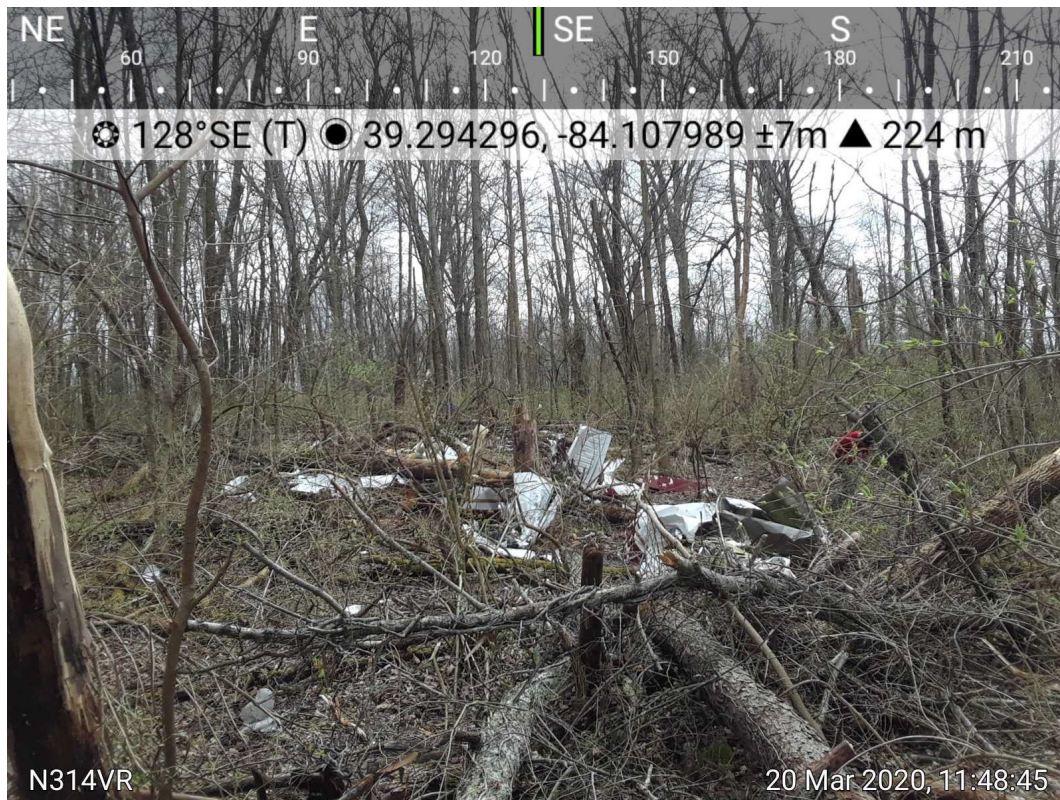
- The fuselage was mostly fragmented from impact forces. A large semi-circle impression was noted to the upper fuselage area, consistent with contact with a tree. The cabin door and baggage door were impact damaged and separated from their attach points.

Photo 1 Accident Site and Airplane Wreckage

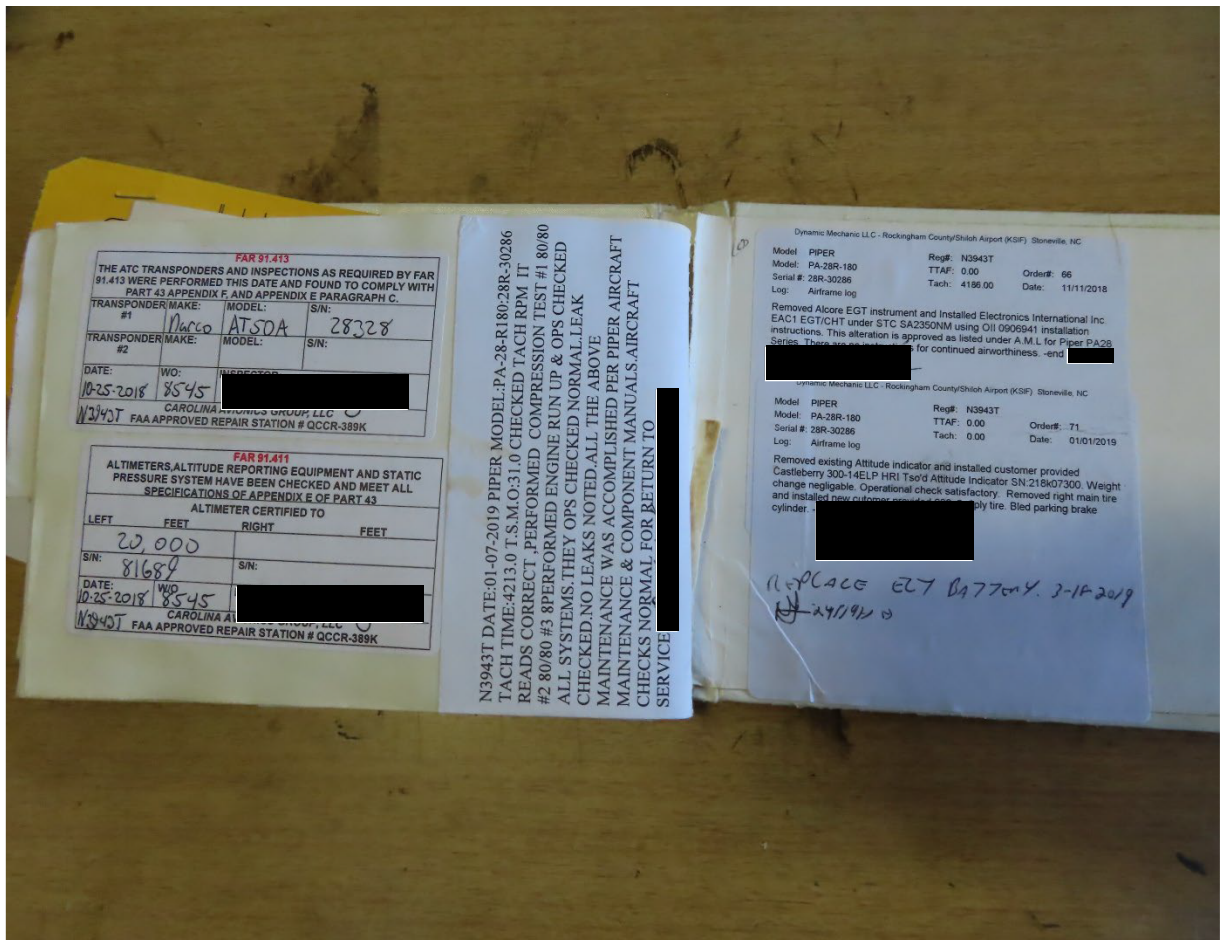
- Impact damage precluded a functional check of the electronic attitude indicator (EAI). The EAI was disassembled, and its internal gyro and housing revealed no obvious rotational scoring or scuffing. There was no vacuum driven attitude indicator observed within the recovered wreckage. Review of maintenance records showed that on January 1, 2019, the existing attitude indicator had been replaced with an owner supplied EAI.

Photo 2 EAI Logbook Entry
