**NATIONAL TRANSPORTATION SAFETY BOARD**  
Office of Aviation Safety

**POSTACCIDENT AIRCRAFT EXAMINATION**

**A. ACCIDENT      CEN20LA136**

Location:      Audubon, Iowa  
Date:      March 31, 2020  
Time:      1626 Central Daylight Time (CDT)  
Operator:      Ride the Sky Helicopters  
Aircraft:      Robinson R44  
Registration:      N107EH

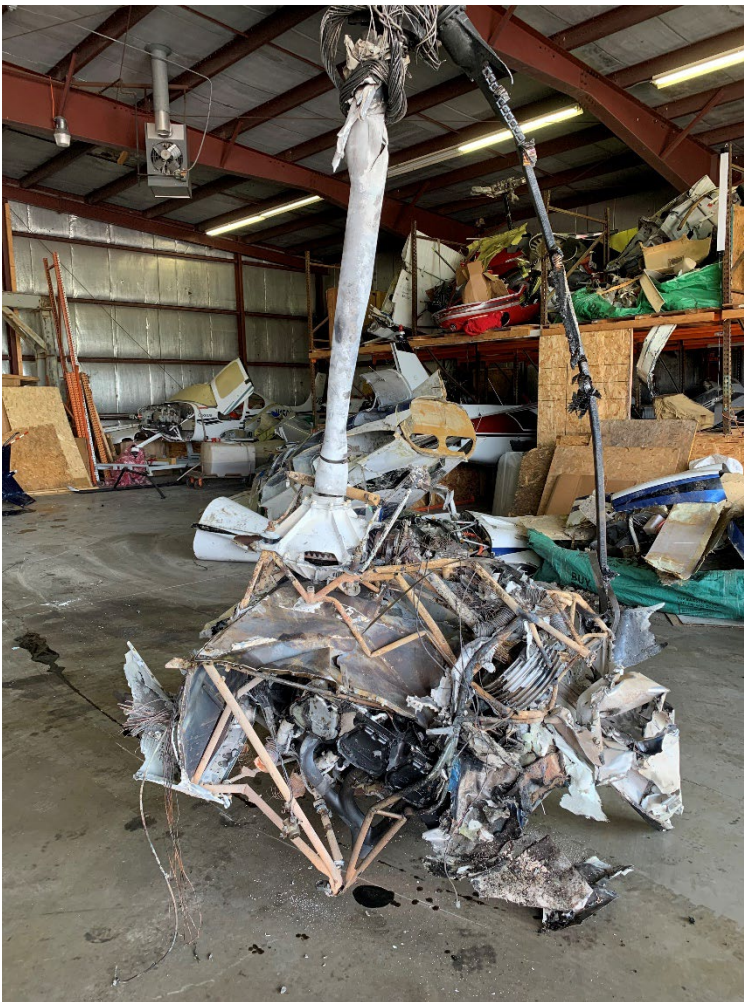
The main wreckage was composed of the engine, main rotor gearbox, steel tube frame structure and the remains of the cabin section. The entire structure that remained exhibited evidence of impact and fire damage. The cabin section was almost completely missing/consumed by fire. Of the components that remained, no evidence of pre-impact deficiencies were found, but the extent of the damage precluded an extensive examination. The main rotor mast and the main rotor blade grips remained attached. At the top of the mast, just below the rotor head, was a large wire, consistent with a powerline, wrapped around the mast about 2 complete turns. The helicopter tailboom was separated from the forward structure but remained predominately intact with the tail rotor still attached. There was evidence of fire damage to the forward portion of the tailboom.

*Figure 1: Overall view of the main wreckage*

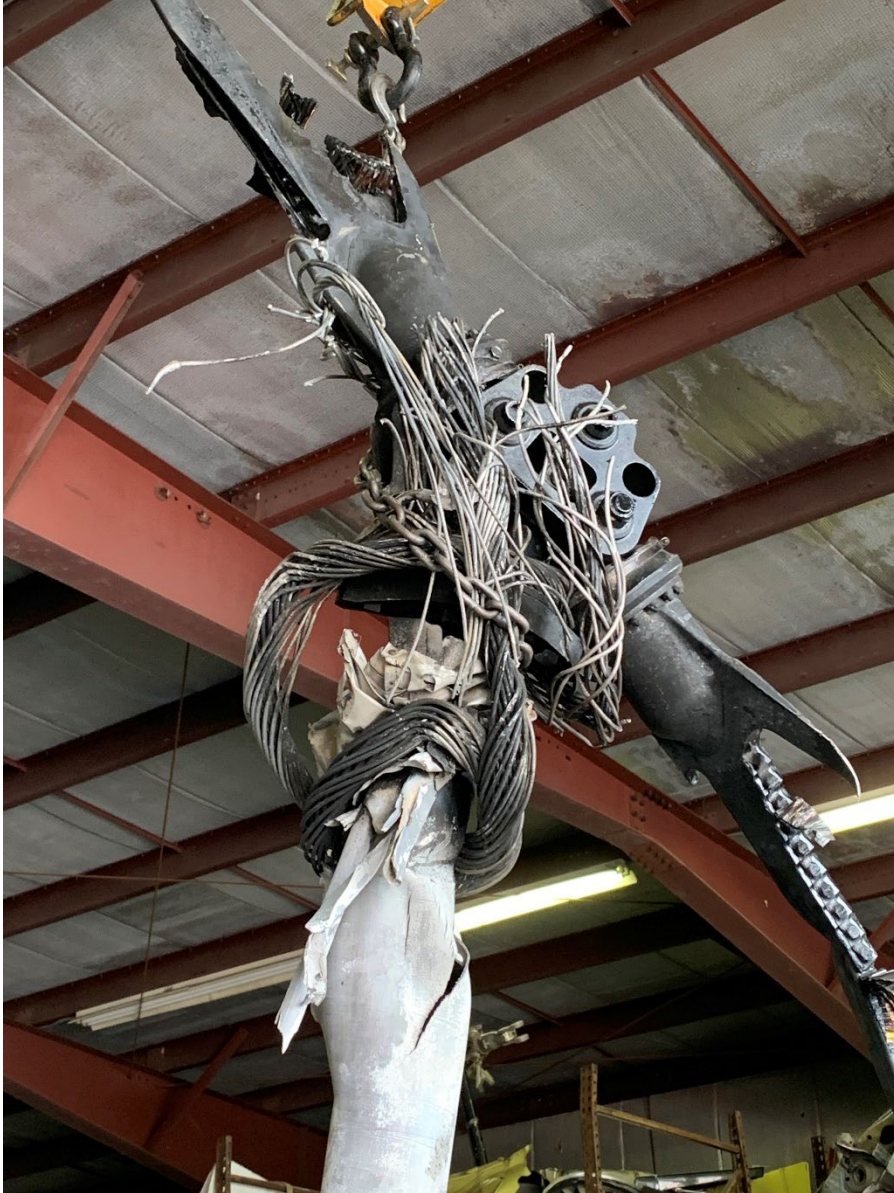
*Figure 2: View of powerline wires wrapped around rotor head*

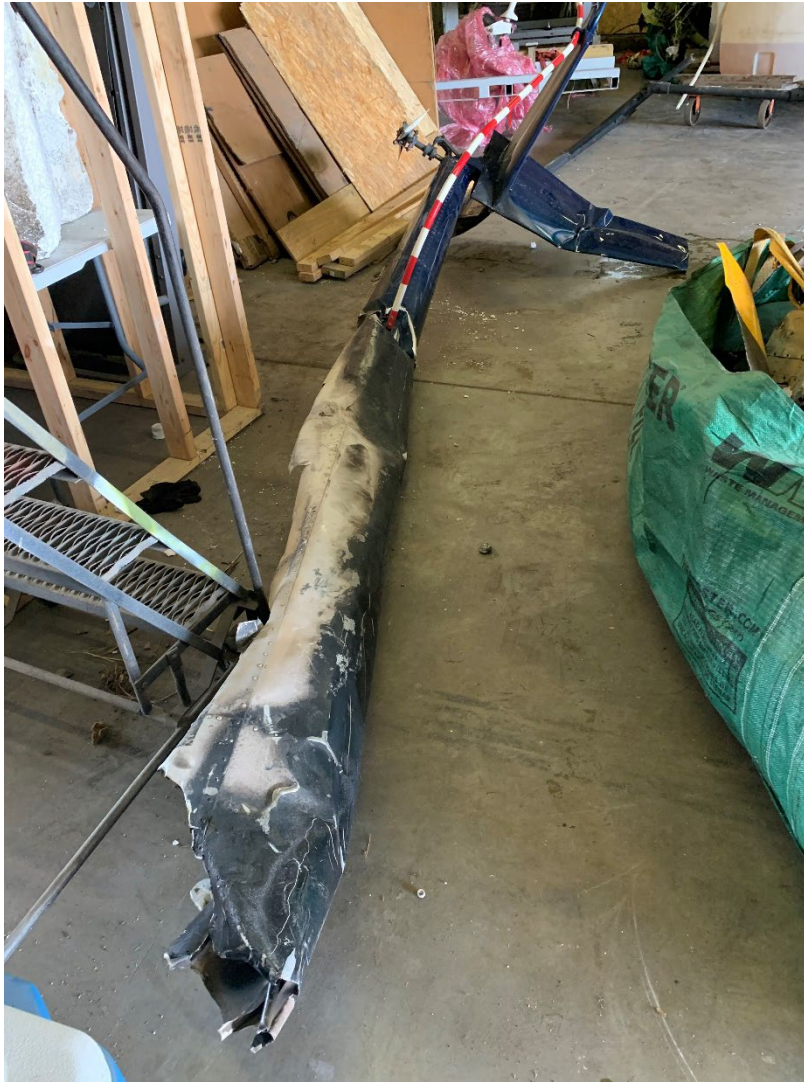
Figure 3: View of the helicopter tailboom during examination.

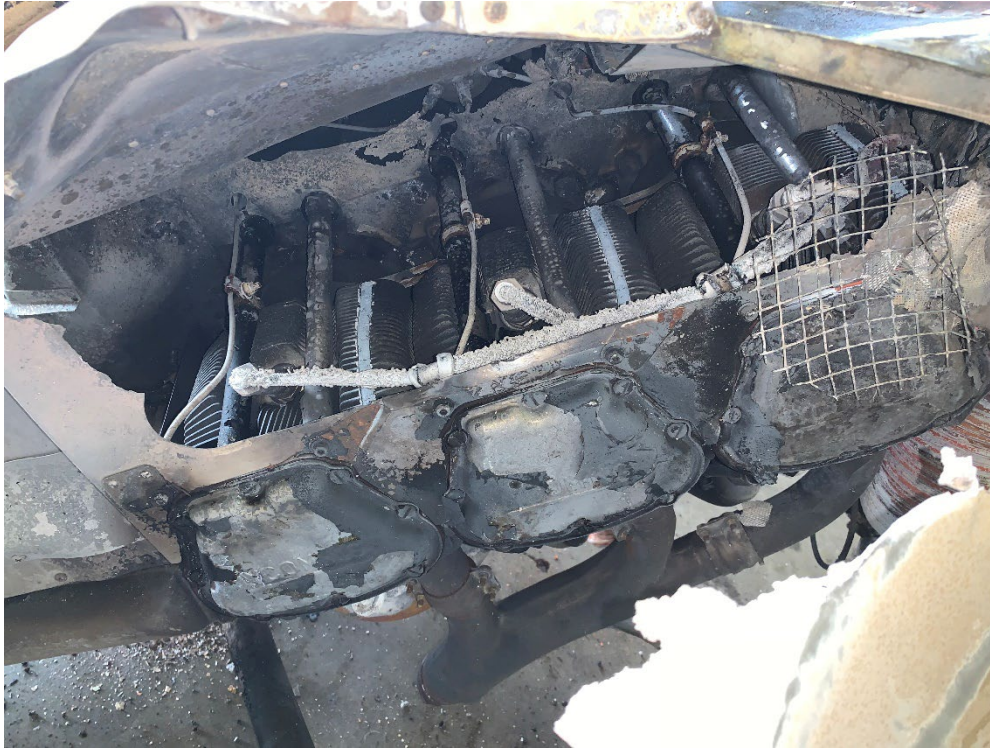
The engine was still located in the steel tube cage of the fuselage and exhibited extensive impact and fire damage. After removal of the fan mounted to the crankshaft, the engine was able to be

rotated. Valve train continuity, and compression and suction on all cylinders was verified. The engine fuel controls had extensive fire damage and could not be tested. The engine magnetos were removed and could not be rotated, Partial disassembly of the magnetos showed that the internal plastic components of both magnetos had melted, precluding functional testing of the magnetos. No preimpact anomalies could be determined.

*Figure 4: View of the helicopter engine during examination.*
