## **NATIONAL TRANSPORTATION SAFETY BOARD**

# **ENGINE EXAMINATION**

**CEN20LA140**

Location: Sequin, TX  
Date: April 1, 2020  
Aircraft: Beech M35, Registration N9883R, Serial #D-6454  
NTSB IIC: Michael Hodges

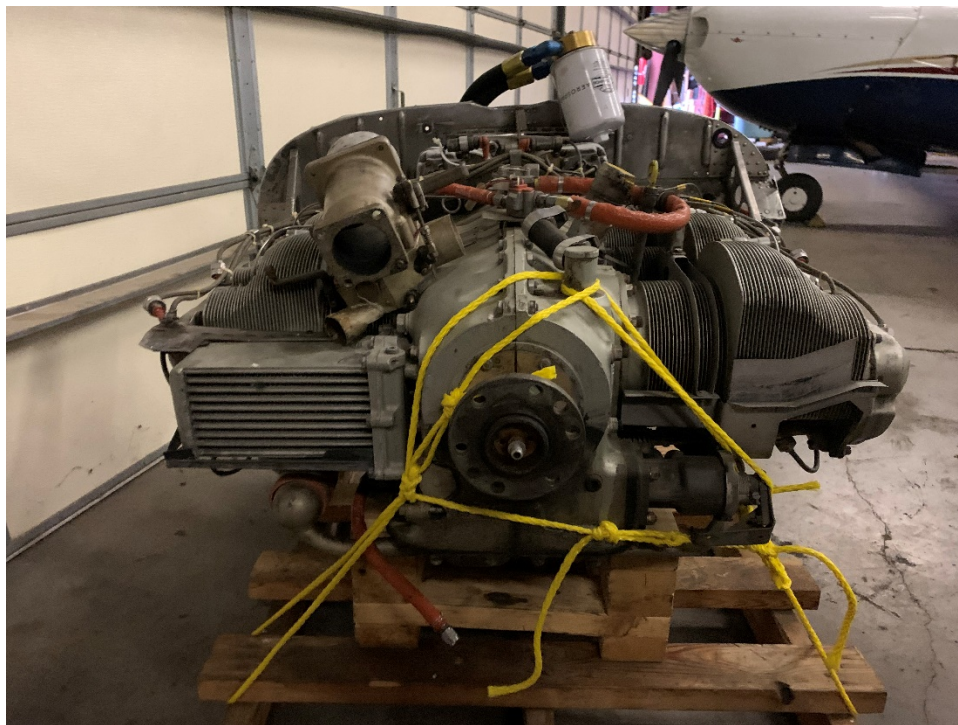
Figure 1: Front of Engine

- The engine remained mostly intact and undamaged. There were no obvious visual indications of catastrophic failure.
- The engine had been separated from the airframe prior to the examination.

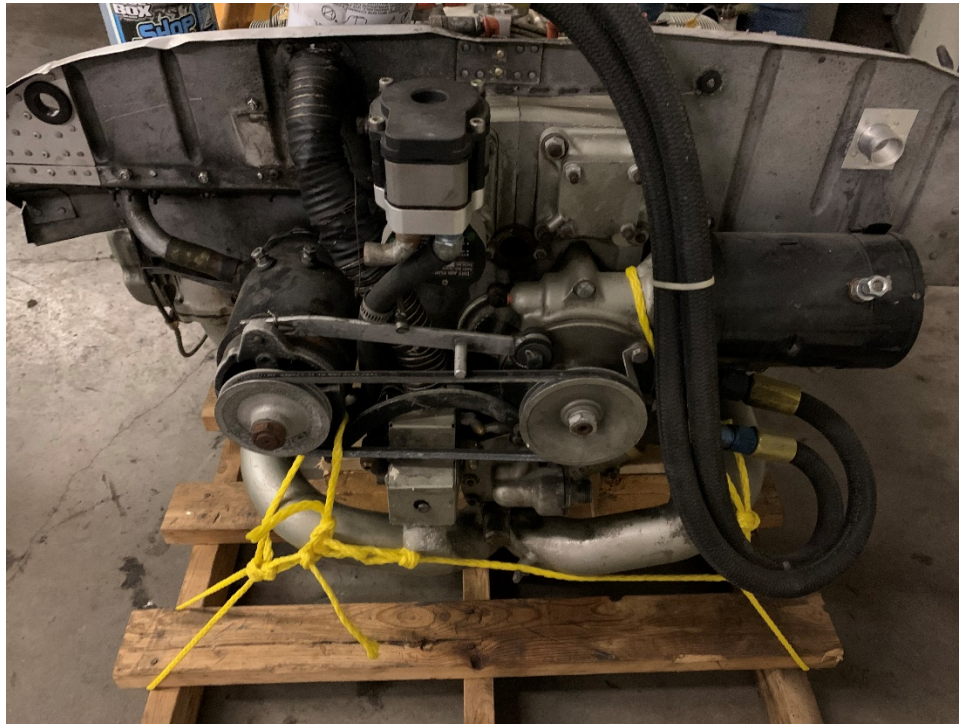
Figure 2: Accessory Section of Engine

- The propeller hub and blades had been previously removed from the engine and were not present for the examination.
- The engine governor and drive belt remained attached to the accessory section.

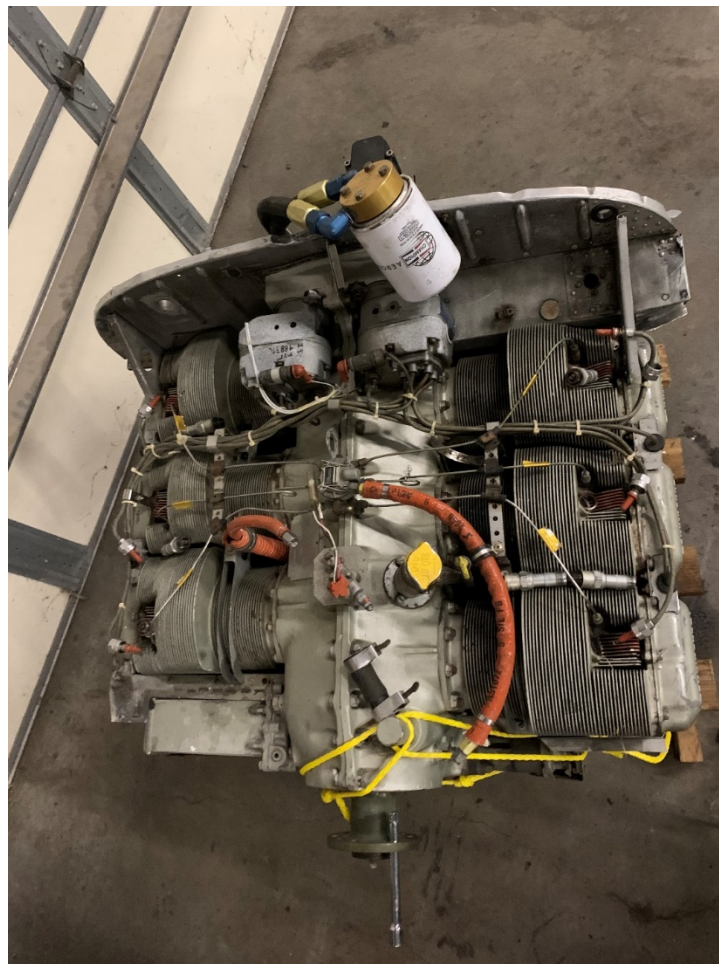
Figure 3: Top of Engine

- Center electrodes were circular, and gaps were present.
- The rocker box covers were removed, and the rocker arms were oily
  - A thin layer of crusty oil was noted on all cylinder heads.

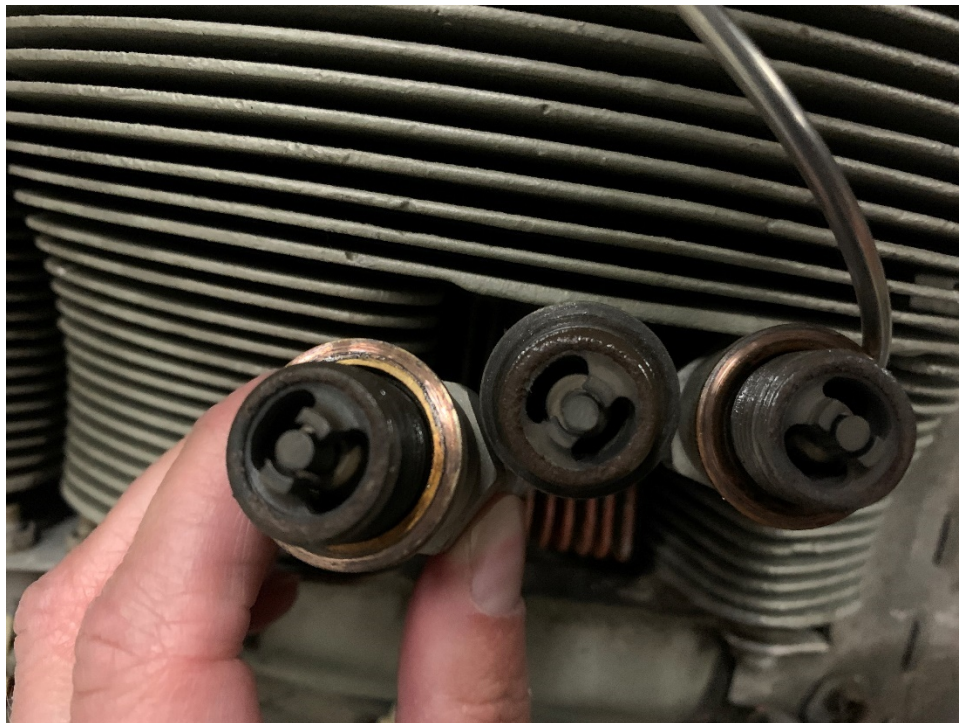
Figure 4: Upper Spark Plugs from 1, 3, 5 cylinders (In order)

- The ignition harness remained attached at the magnetos and their respective spark plugs. The harness condition was overall unremarkable.
- The upper leads and spark plugs were removed and consistent with normal operations

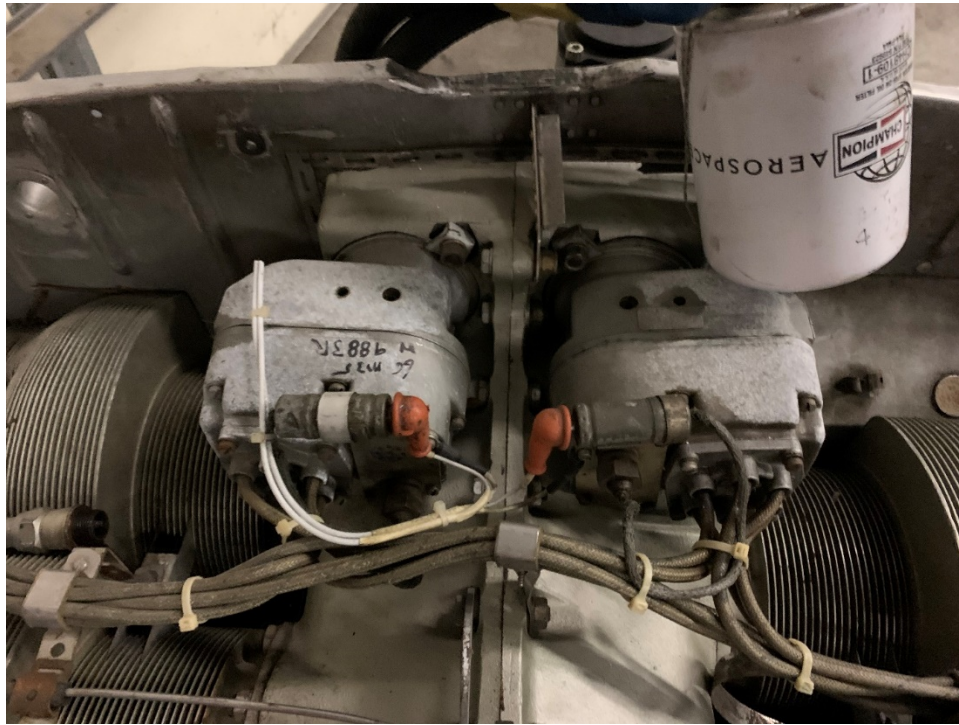
Figure 6: Magnetos

- The airframe was not present for this examination.
  - The oil had been drained post recovery.
- The magnetos remained attached to their mounting pad. Their outside housing exhibited wear.

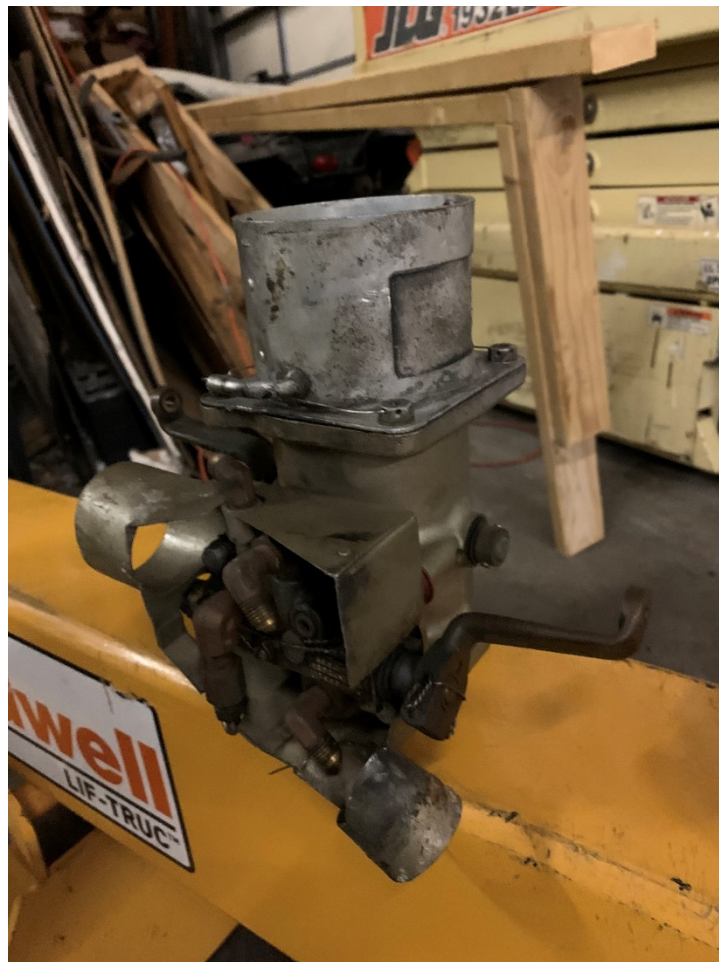
Figure 7: Fuel Servo

- No fuel was present.
- The fuel servo was found separated from the engine.
  - The throttle arm was secured and moved freely from stop to stop. Corresponding motion was observed on the butterfly valve.

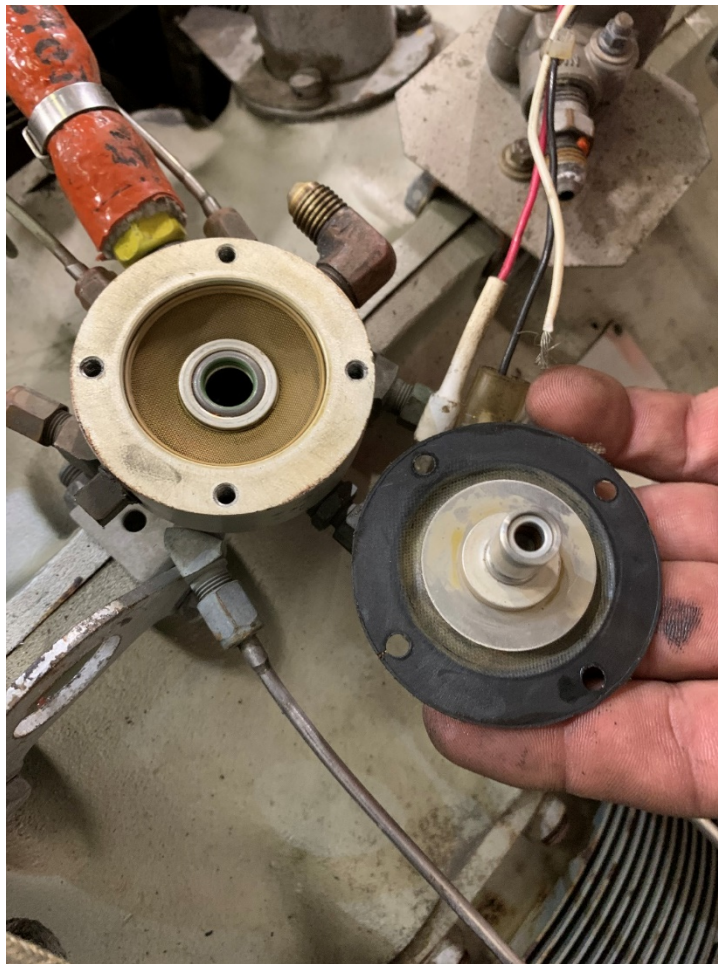
Figure 8: Internal Components of Fuel Manifold Valve

- The fuel manifold valve was disassembled, and the internal components displayed normal operating signatures.
  - Some minor debris was noted underneath the screen.
