**NATIONAL TRANSPORTATION SAFETY BOARD**  
**Office of Aviation Safety**  
**Washington, D.C. 20594**

**Powerplants Group Chairman's Factual Report**  
**NTSB No.: CEN20LA159**

Location: Mesquite, Texas

Aircraft: Boutique Air, Pilatus PC-12, N477SS

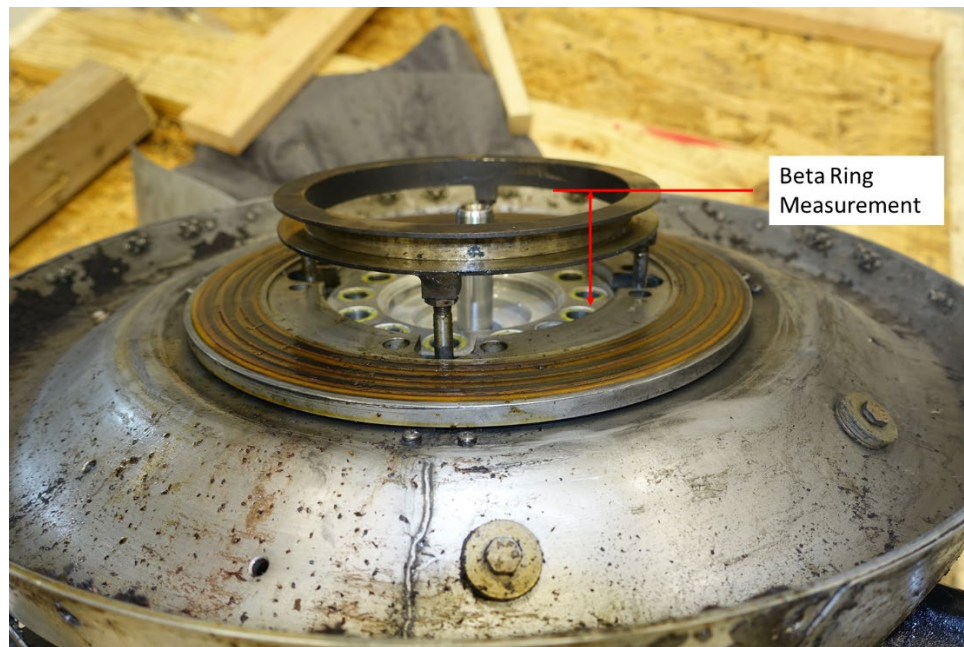
**Photo 6- Beta Ring Measurement**

The twelve propeller mount bolts were torqued, and safety wired. Following propeller removal, the aft pitch rod bushing was loose, deformed, and missing material. The distance between the top of the beta ring and the hub mount flange measured approximately 2.4 inches<sup>2</sup> using a metal ruler (**Photo 6**). Propeller blades 2 and 3 had tip bending opposite the direction of rotation while propeller blades 1 and 4 exhibited S-shaped bending (**Photo 7**). Shop air was ported into the pitch change rod and the hydraulic unit, and blade 4 actuated normally<sup>3</sup>. There was no oil leakage visible during hydraulic actuation. The fracture surface on all four blades was rough and granular (**Photo 8**).

<sup>2</sup> According to the Hartzell Propeller maintenance manual, the beta ring should be rigged to 2.37 inches  $\pm 0.005/-0.020$ .

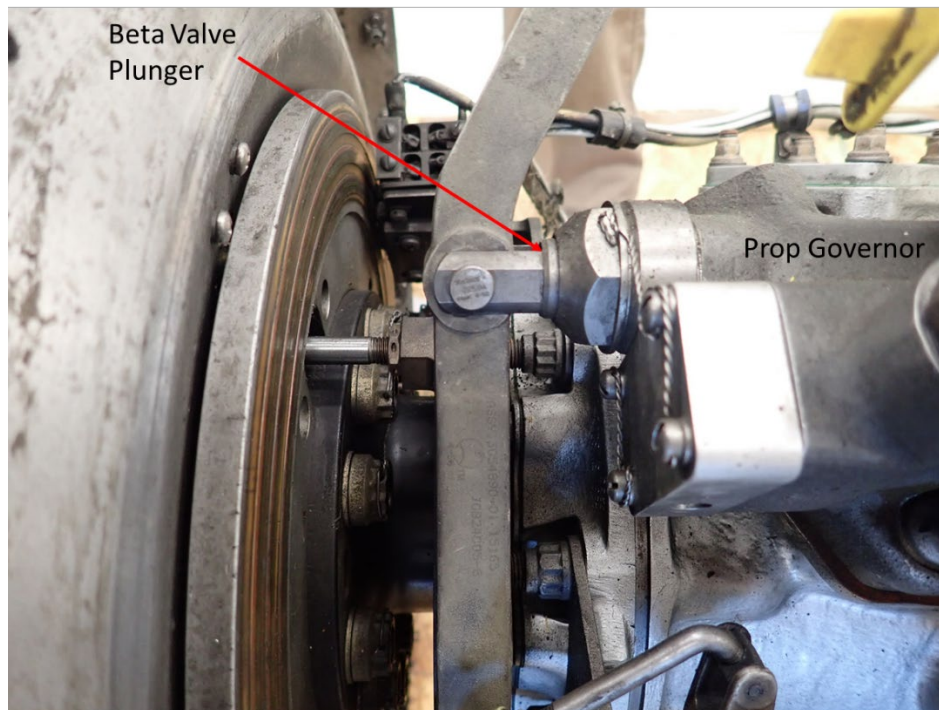
**Photo 12- Beta Valve Position**

<sup>4</sup> The Pilatus AMM includes a step in both the test and rigging procedures to “make sure the beta valve aligns with the face of the propeller governor.”

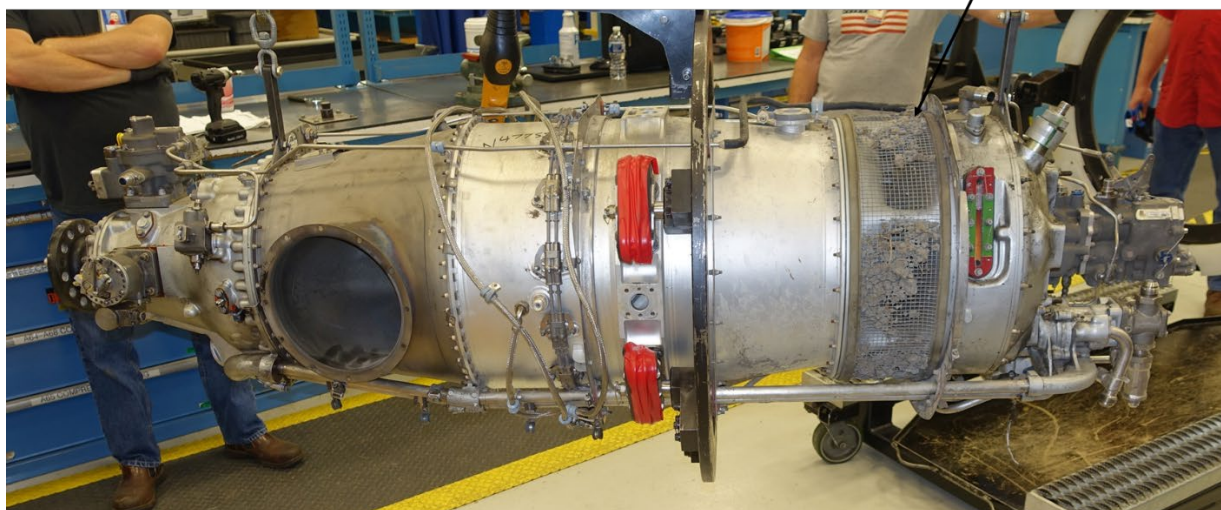
**Photo 16- Left Side of Engine**

Inlet Screen Debris

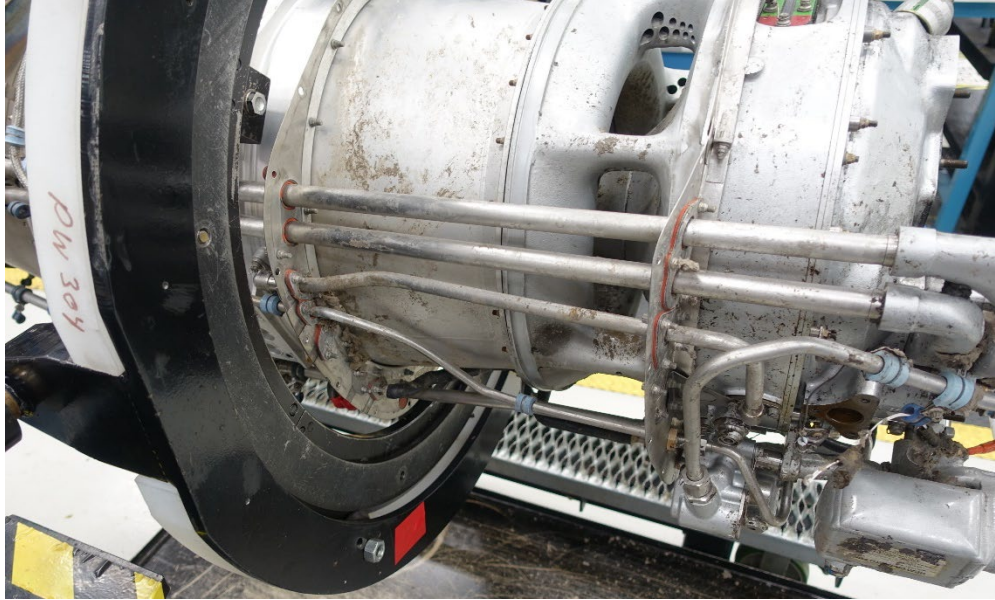
**Photo 18- Engine Line Deformation, 6 o'clock Position**

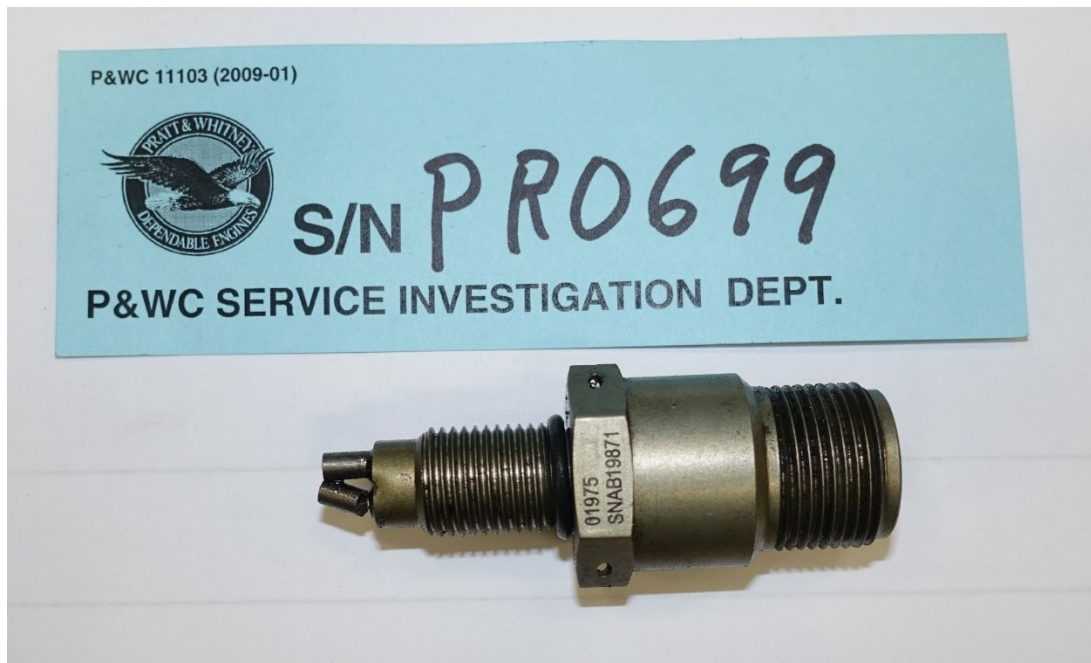
**Photo 19- Magnetic Chip Detector (\*Damaged During Removal)**

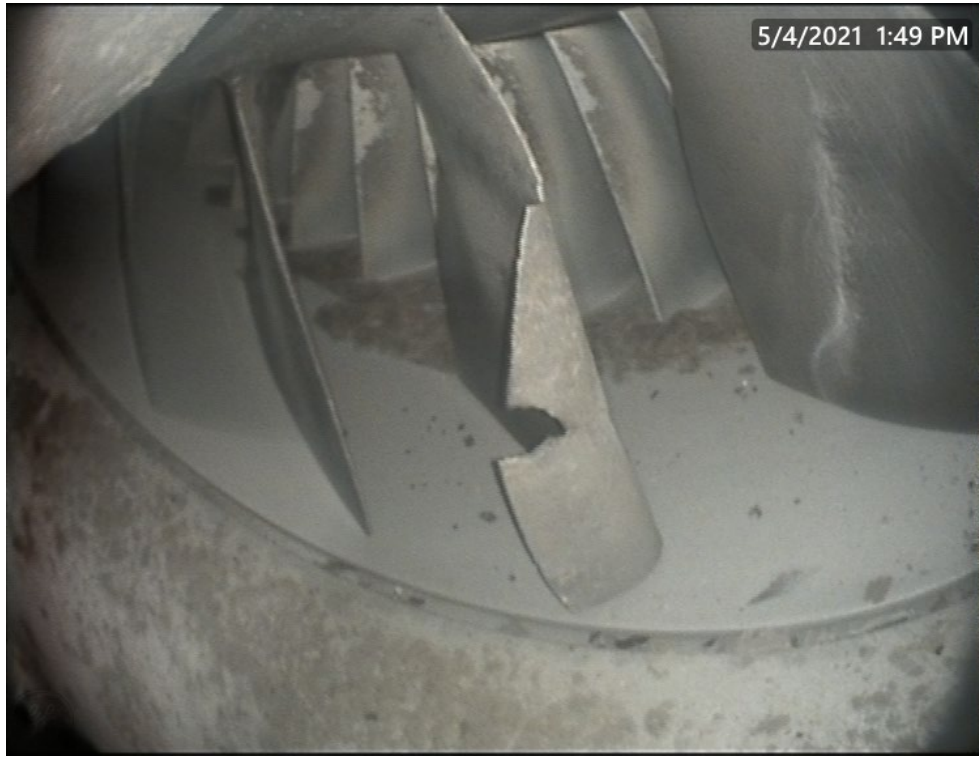
Impact damage/tearing was observed on the leading edge of one 1<sup>st</sup> stage compressor blade and minor leading edge damage was present on four blades (**Photo 20**)<sup>8</sup>. A

<sup>8</sup> The compressor blade damage precluded safely running the engine on the test cell.

**Photo 20- 1st Stage Compressor Blade Damage**

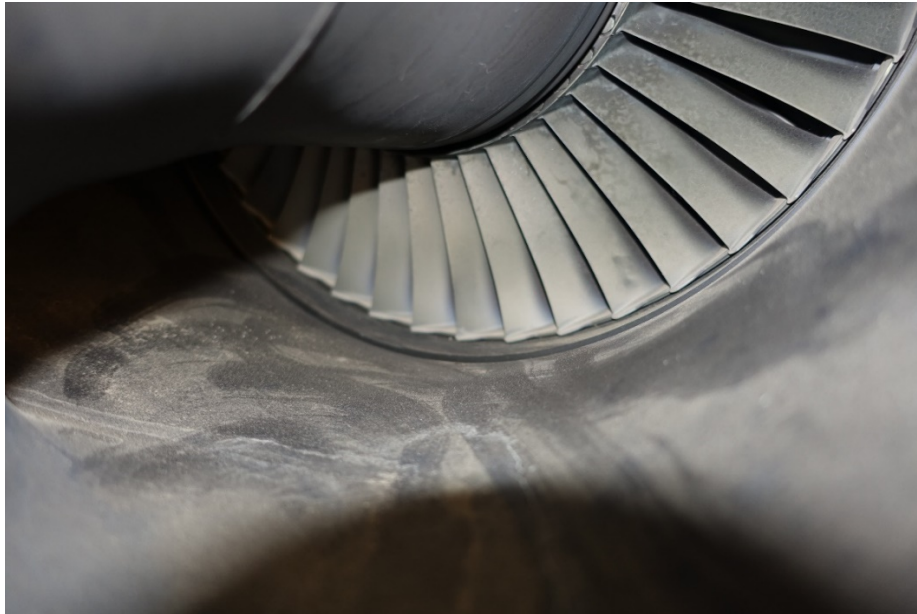
The PT module was separated from the engine. The trailing edge of all CT blades were in good condition. The combustion liner was intact and there was no evidence of burn through and fuel nozzle streaking (**Photo 22**). The leading edge of the 1<sup>st</sup> stage PT blades and trailing edge of the 2<sup>nd</sup> stage PT blades visible through the exhaust were unremarkable (**Photo 23**). The team decided not to further disassemble the engine modules due to a lack of evidence of internal damage.

**Photo 22- Trailing Edge, 2nd Stage Power Turbine Blades**
