# National Transportation Safety Board

## Performance Study

### Specialist Report

Location: Houston, Texas  
Date: May 2, 2020  
Time: 02:03 central daylight time (CDT)  
Airplane: 369E MD Helicopter, N8375F  
NTSB Number: CEN20LA167

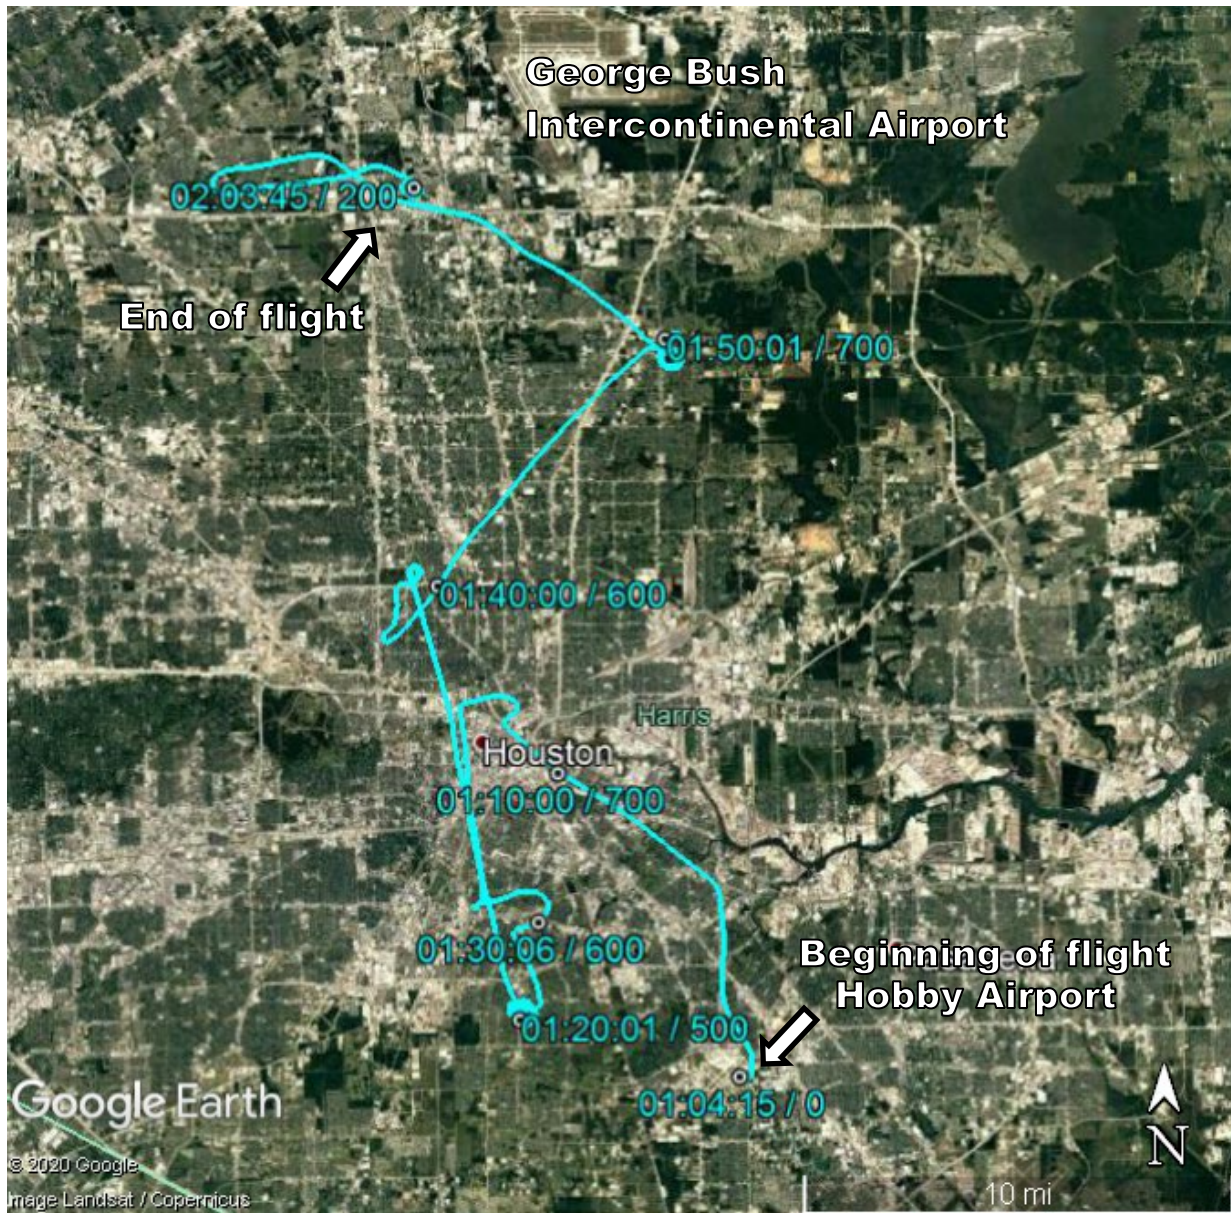
Figure 1 shows the helicopter leaving William P. Hobby Airport (HOU) at 01:04. The flight lasted just under an hour during which time the altitude varied between 400 and 700 ft<sup>1</sup> mean sea level (msl) and the groundspeed between 20 and 130 kts (Figure 2).

**Figure 1.** Accident flight in blue with select times and altitudes (msl) annotated in blue.

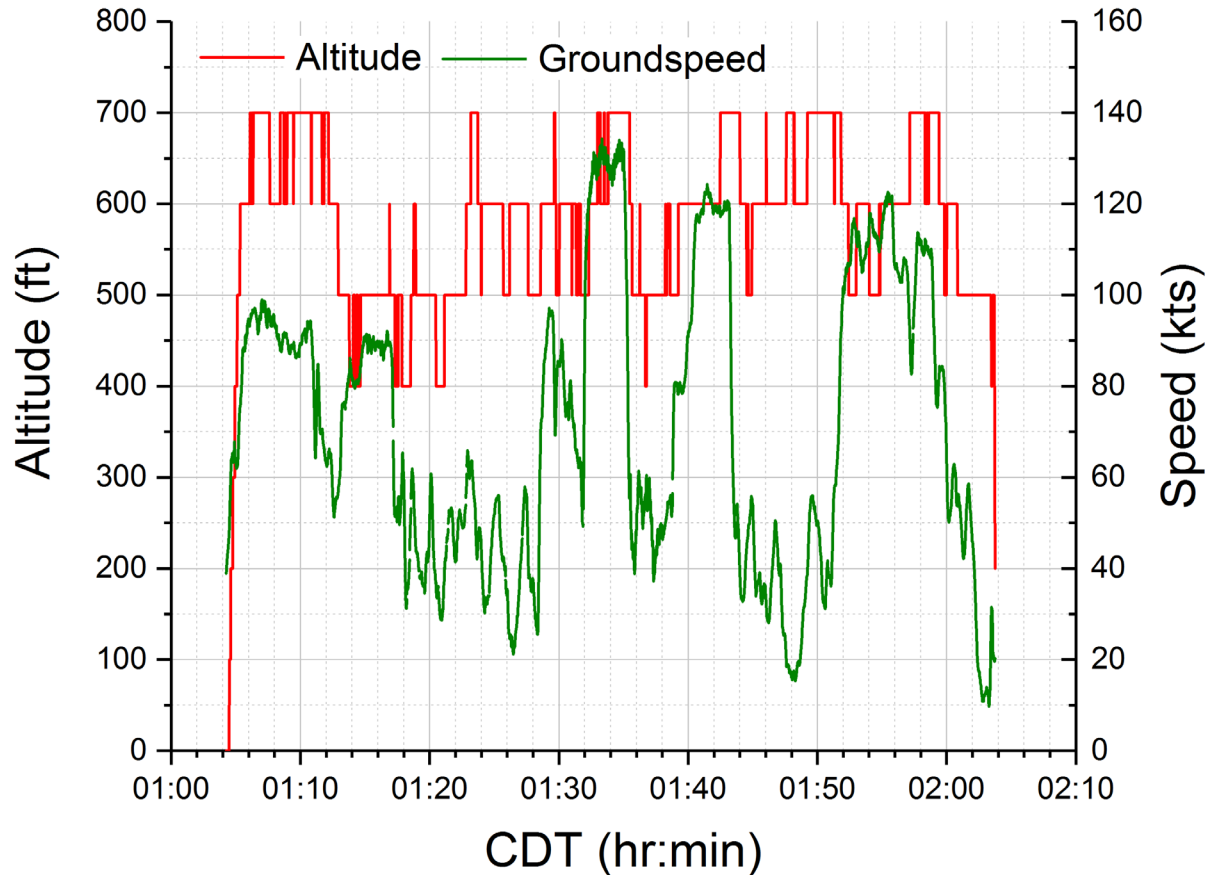
**Figure 2.** Recorded altitude (msl) and calculated groundspeed.

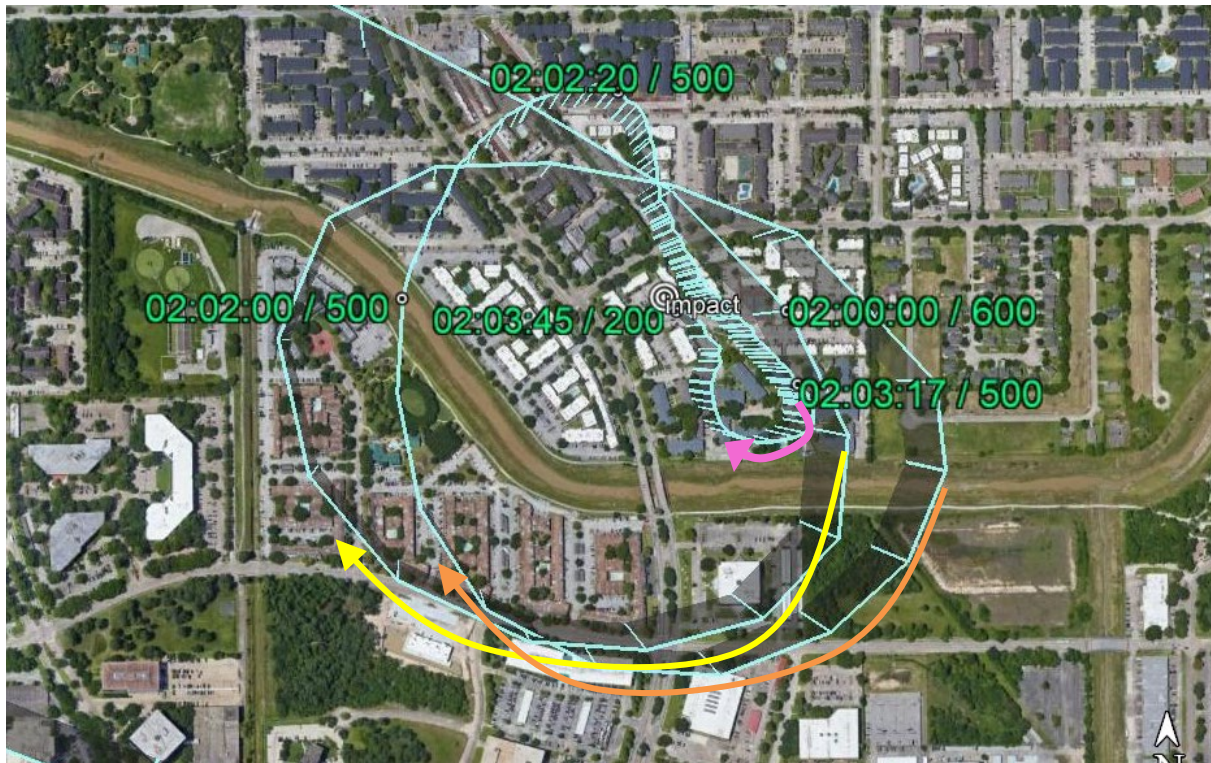
The helicopter approached the accident location just before 02:00 (Figure 3 and Figure 4). It slowed to a groundspeed between 40 and 60 kts and descended to complete a right-hand circling turn over the area at an altitude of 600 ft. A minute later it began a second right-hand turn, this time at a recorded altitude of 500 ft. At 02:02:20, the helicopter turned onto a south-easterly heading and slowed to near 10 kts.

**Figure 3.** End of flight path. First right-hand turn at 600 ft msl indicated by yellow arrow, second right-hand turn at 500 ft msl indicated by orange arrow. The final right-hand turn is shown in pink.

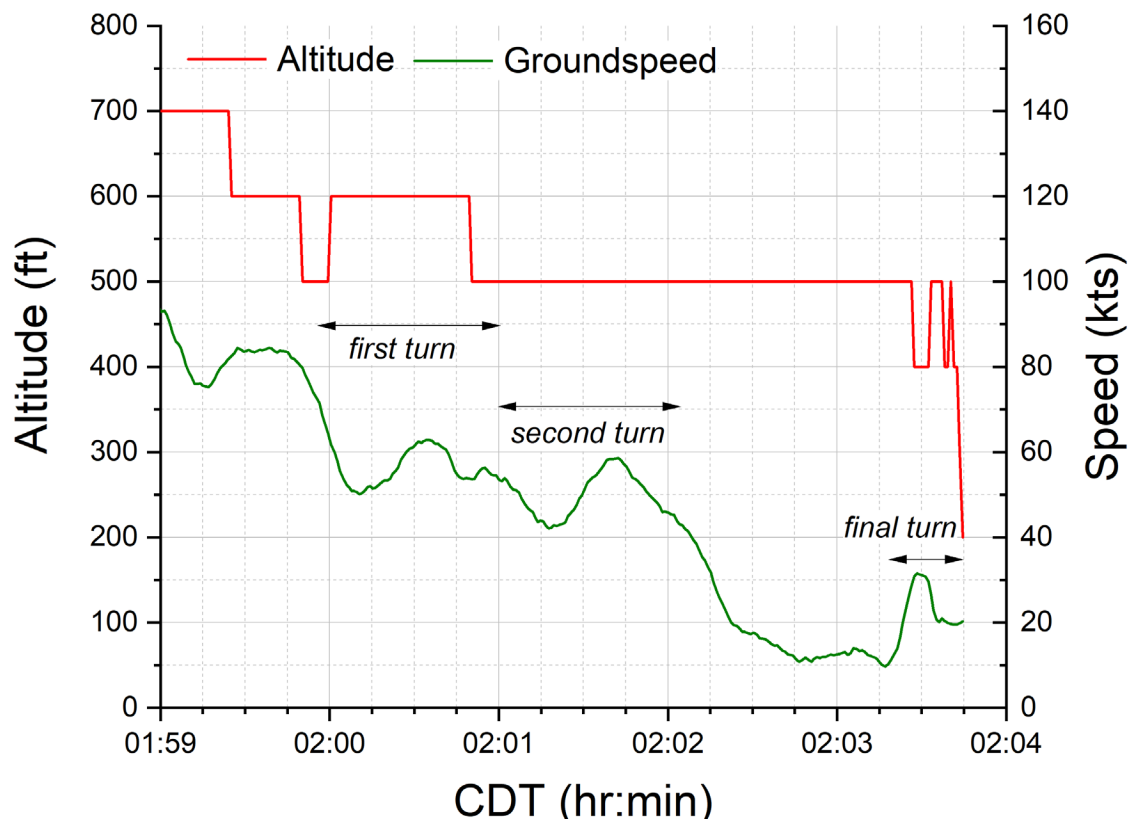
**Figure 4.** Altitude (msl) and groundspeed for last five minutes of flight.

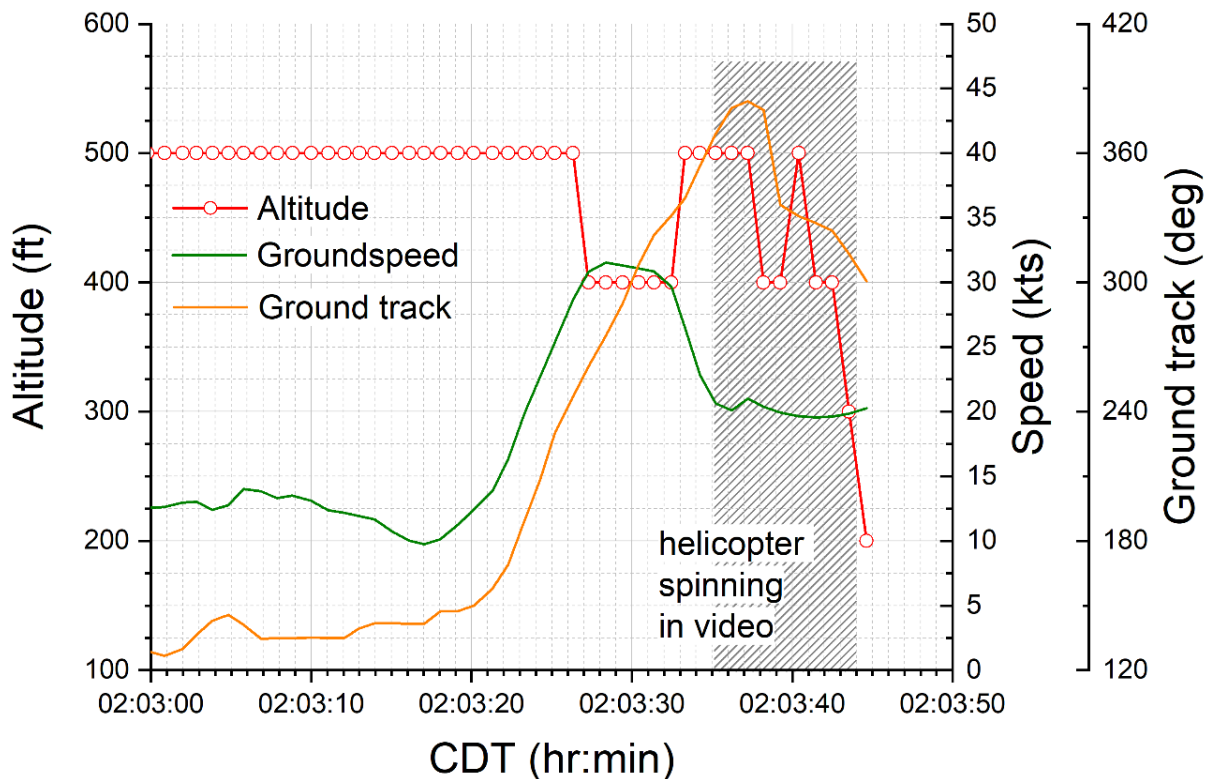
At about 2:03:20, the helicopter began a tight right turn and accelerated from 10 kts to 30 kts (Figure 5). The helicopter stayed at 30 kts for about five seconds before slowing to 20 kts. The right turn continued and tightened until about 2:03:39 when it straightened for the final five seconds of flight.

A witness video of the accident helicopter is evaluated in the NTSB Video Study [1]. The helicopter could be seen spinning from 2:03:35 to 2:03:44 (Figure 5), but the beginning of the spin was not recorded in the video. The video study determined the yaw rate was increasing from 146 to 178 deg/s while the helicopter was visible. The helicopter's yaw was to the right, opposite the rotation of the main rotor blades.

In an interview, the pilot stated that he accelerated in an attempt to gain control of the helicopter yaw. If the pilot's statement corresponds with the increase in speed at 2:03:20, the yaw began before 2:03:20 and preceded the final tightening right turn.

**Figure 5.** Altitude (msl), groundspeed, and ground track for end of flight.

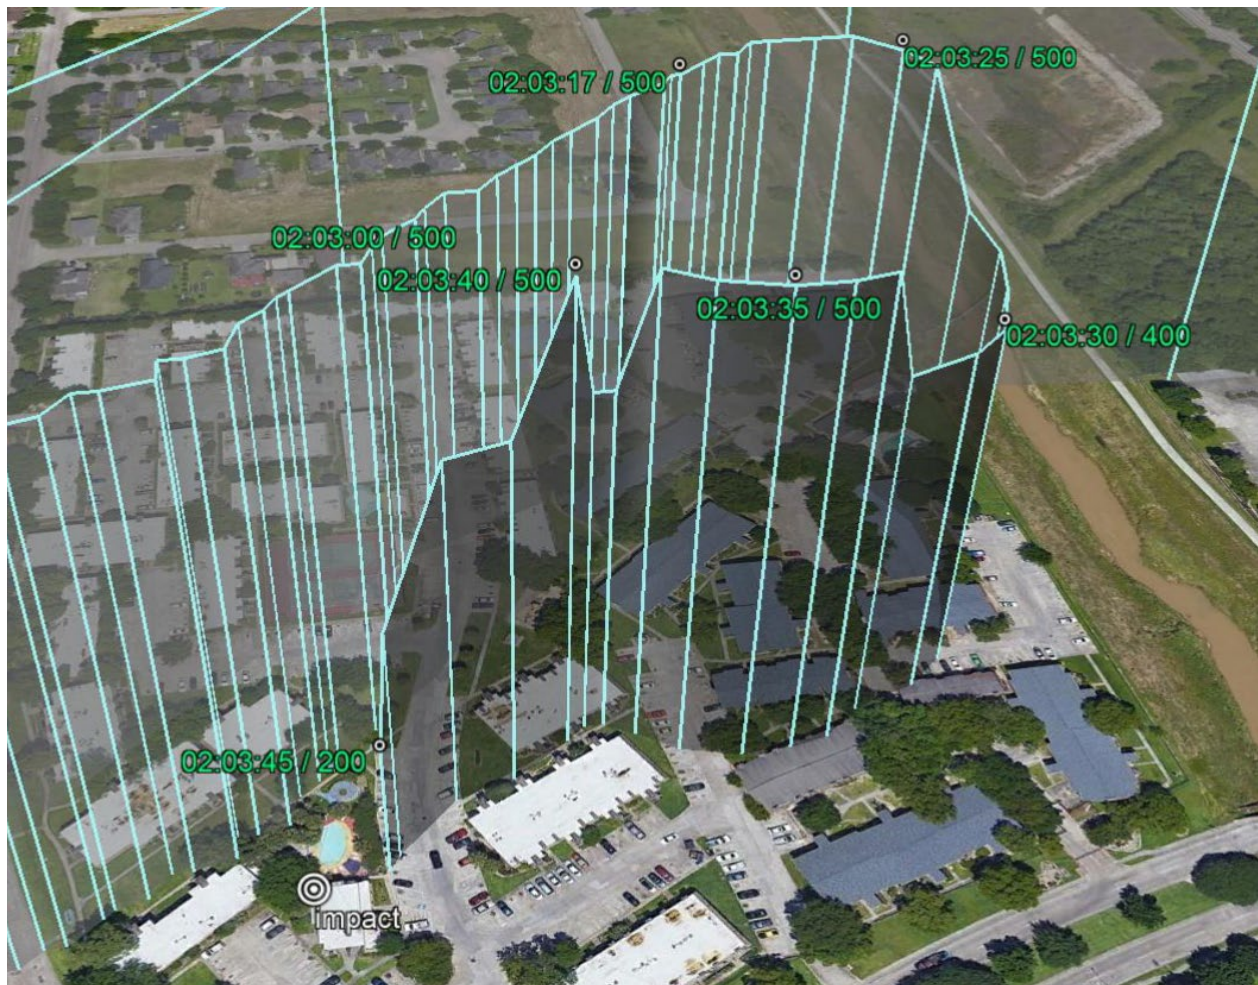
**Figure 6.** Final turn and descent.

Of interest was the possibility of loss of tail rotor effectiveness (LTE). LTE occurs when airflow through the tail rotor is altered such that there is no longer enough anti-torque thrust to keep the helicopter fuselage from yawing opposite the rotation of the main rotor blades. Helicopters with counterclockwise rotating main rotor blades are at risk of LTE in low-speed flight when winds are from the left or a tailwind. Winds recorded at the time of the accident were 4 kts from 170°. From 2:02:50 until 2:03:20, the helicopter was on a track of about 137°. The resulting wind would have been a right quartering headwind of low magnitude. The recorded winds were not conducive to LTE for this helicopter.

Within the resolution of the recorded altitude, the helicopter's flight path appeared to be level at the suspected onset of spin, making it unlikely that the spin and descent were a result of vortex ring state (also known as settling with power). Additionally, vortex ring state does not usually result in an uncontrolled spin.
