**NATIONAL TRANSPORTATION SAFETY BOARD**  
**Office of Aviation Safety**  
**Washington, D.C. 20594**

**AIRWORTHINESS GROUP CHAIRMAN'S FACTUAL REPORT**

**NTSB No: CEN20LA167**

Operator: Houston Police Department  
Aircraft: MD Helicopters 369E, registration N8375F  
Location: Houston, Texas  
Date: May 2, 2020  
Time: 0203 central daylight time

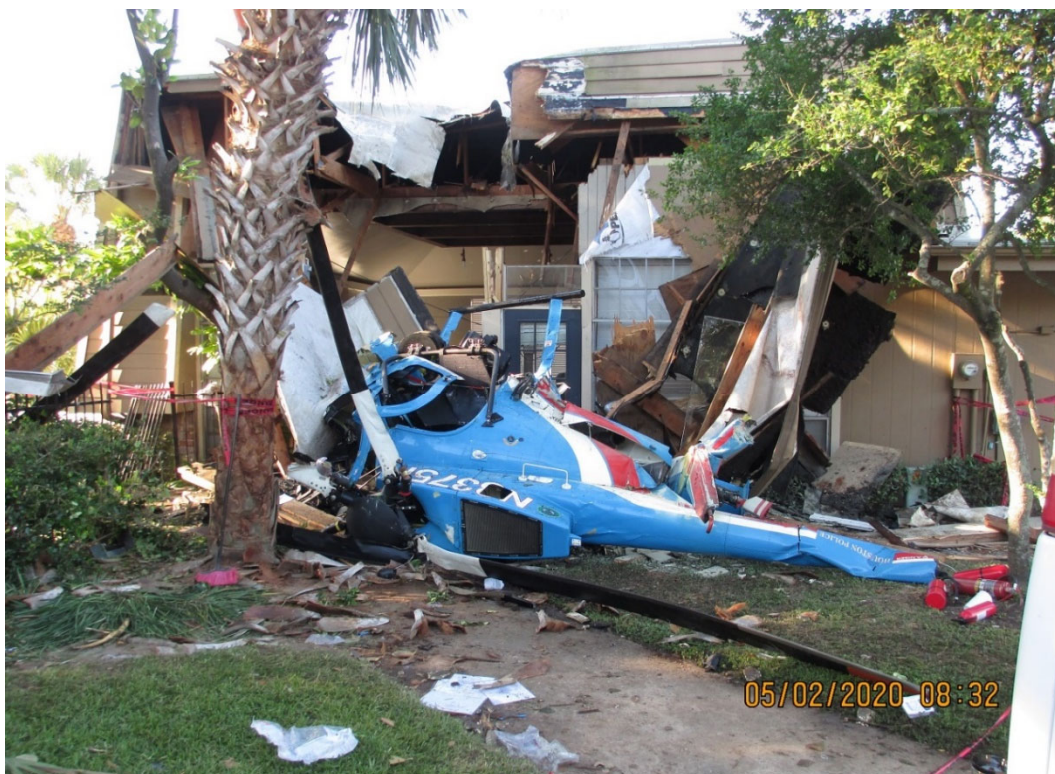
The helicopter came to rest on its left side at the base of a building (**Figure 1**). The helicopter initially impacted the roof of a building and subsequently fell to the ground. The wreckage area was compact with no significant debris trail. There was no postcrash fire. All five main rotor blades were present at the accident site. The left skid tube was separated from the main fuselage but the right skid remained attached. A longitudinal tear was observed along the skin and structure of the fuselage underside. The tail boom remained attached to the main fuselage but the empennage, composed of the vertical fin, horizontal stabilizer, tail rotor gearbox, and tail rotor, was separated from the tail boom; the empennage came to rest on top of the right side of the helicopter near the engine bay. The tail rotor gearbox remained installed on the empennage and both tail rotor blades remained attached to the tail rotor hub.

**Figure 1. The helicopter at the accident site. (Image courtesy of the FAA)**

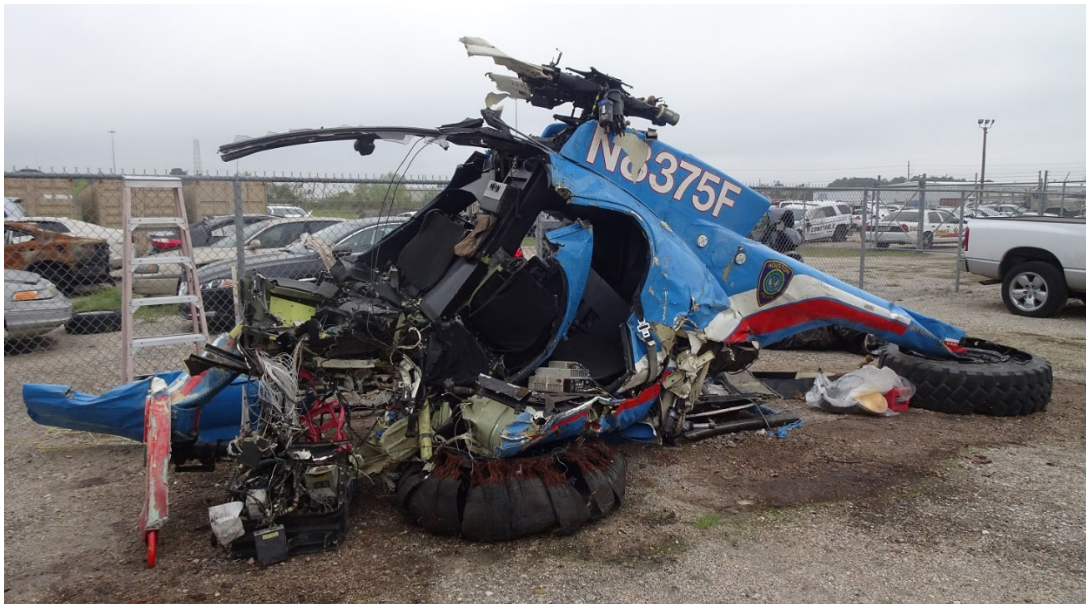
The main fuselage exhibited multiple fractures and deformation from the impact. The majority of the cockpit canopy was separated from the airframe (**Figure 2**). The upper fairings, including the engine inlet and filter, were present and whole. The right engine bay door remained attached to the main fuselage but the left engine bay door was separated. The left side of the cockpit and the left (pilot) seat were partially attached to the structure. A piece of lumber had penetrated, and remained lodged within, the cabin structure from underneath the helicopter. The right skid tube and its struts remained attached to the main fuselage. The left skid tube was fractured and separated but its struts remained attached to the main fuselage. The fuel bladder was torn but was present within the main fuselage.

**Figure 2. The helicopter main fuselage.**

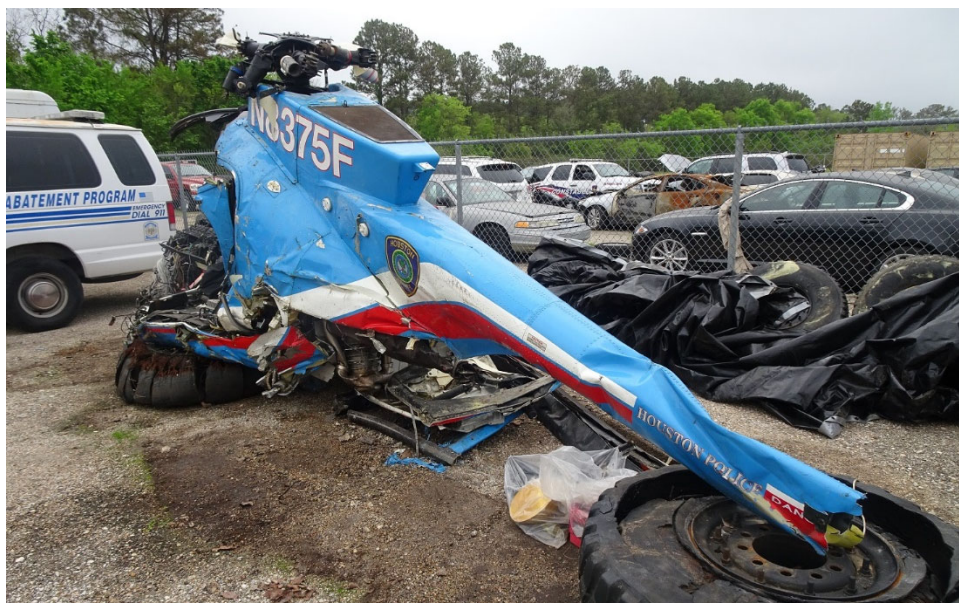
The tail boom remained attached to the main fuselage (**Figure 3**) but its empennage was fractured and separated (**Figure 4**). There was impact deformation on the left side of the aft end of the tail boom, likely due to contact with main rotor blades. Blue paint transfer of the same color as the tail boom was observed on the leading edges of the 'yellow' and 'green' main rotor blades.

Figure 3. An aft view of the main wreckage showing deformation to the tail boom.

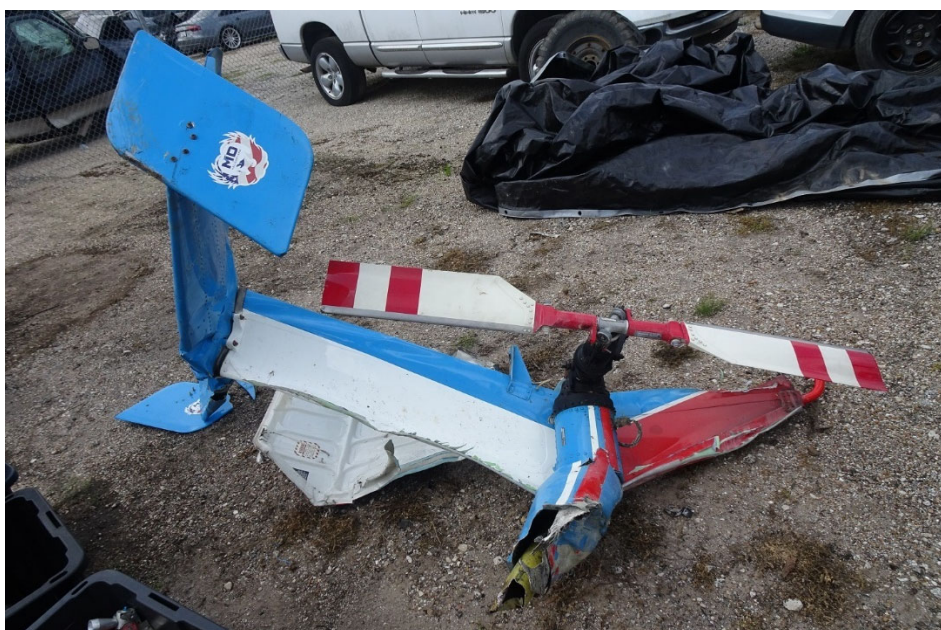
The empennage was displaced to the left. The leading edges of the upper and lower vertical fins were also displaced to the left. The left and right horizontal stabilizers exhibited impact deformation, with the right horizontal stabilizer leading edge exhibiting impact deformation in the aft direction. The left horizontal stabilizer tip plate remained attached and the right horizontal stabilizer tip plate was fractured and separated, but recovered.

Figure 4. The separated empennage.

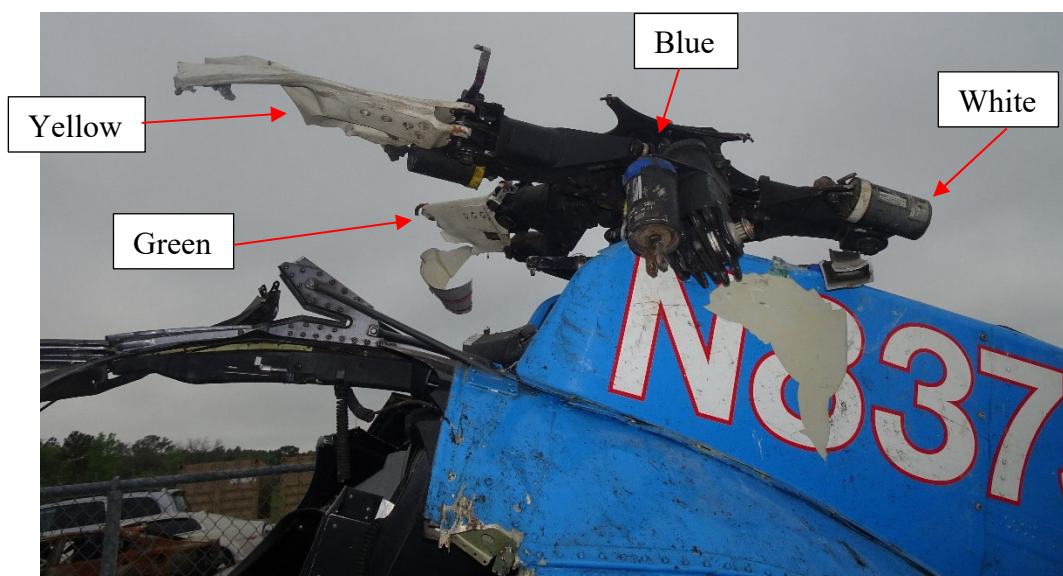
The main rotor hub, main rotor drive shaft and static mast, and main transmission remained installed on the airframe (**Figure 5**). All five pitch housing assemblies remained attached to the main rotor hub. The main rotor blade airfoils were separated from the main rotor head during recovery and storage (**Figure 6**).

**Figure 5. The main rotor head installed on the helicopter.**

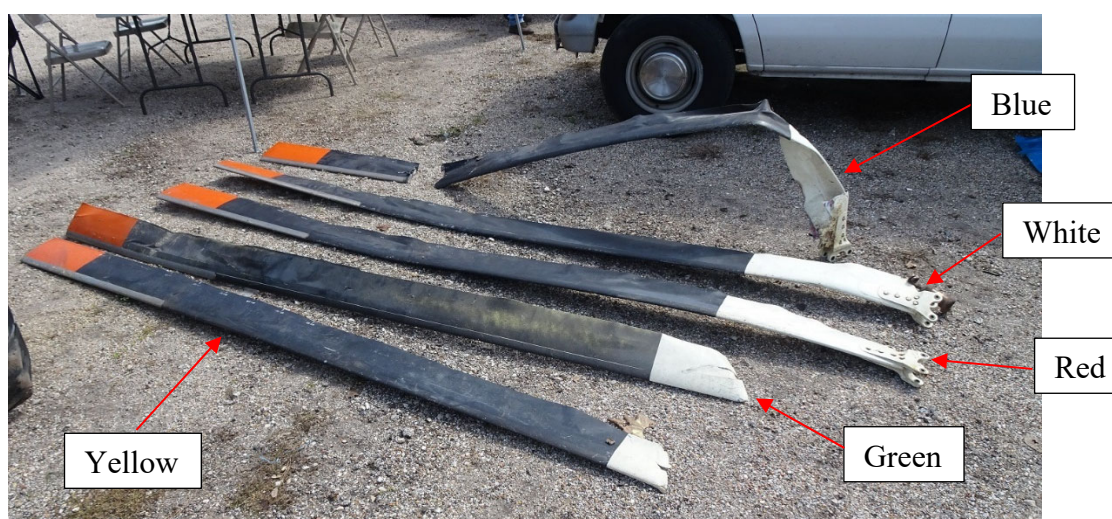
**Figure 6. The five main rotor blades.**

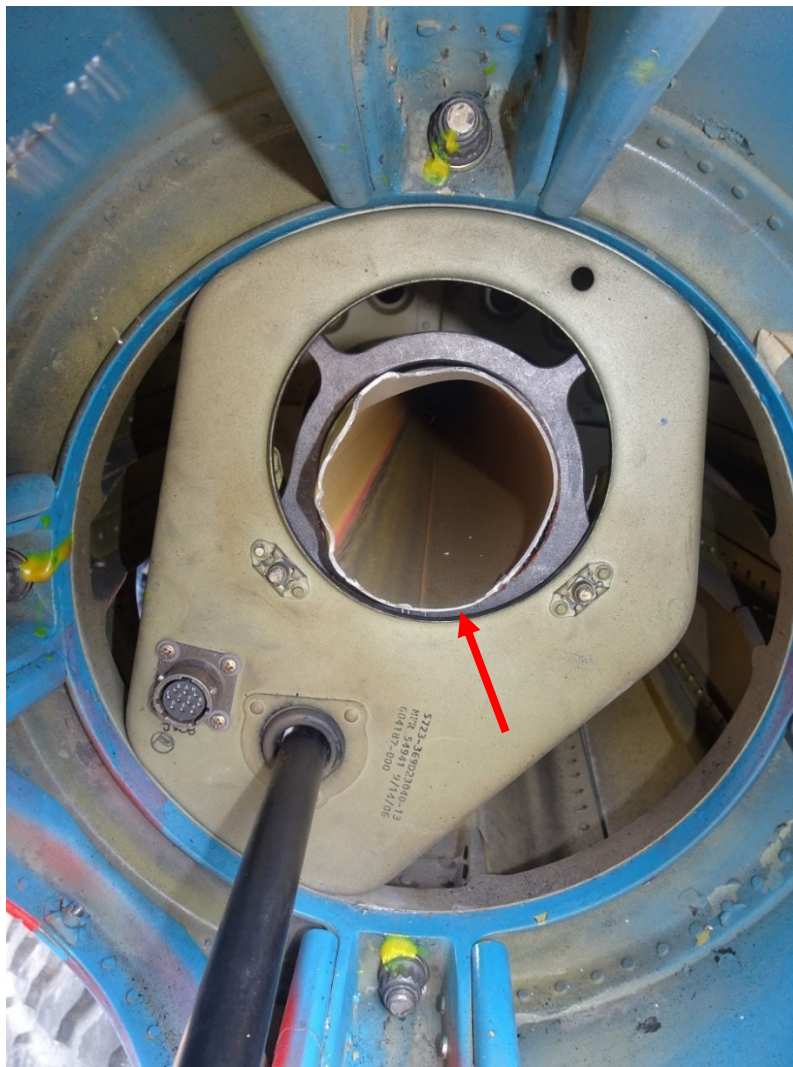
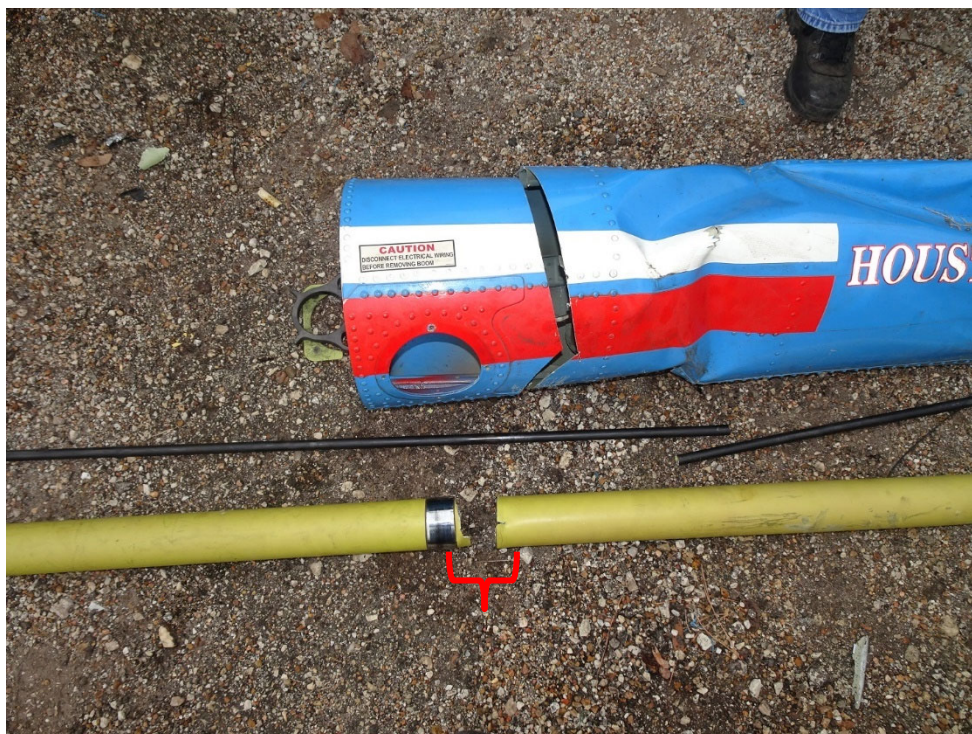
The tail rotor drive shaft (TRDS) remained connected to the main transmission tail takeoff flange. The TRDS was fractured in two locations between the tail takeoff flange and the tail rotor gearbox Kaflex coupling. The forward segment of the TRDS was continuous until a fracture immediately adjacent to the aft side of the steel sleeve (on the TRDS) that contacted the

TRDS dampener (**Figures 7 and 8**). The fracture was circumferential and generally on the same [transverse] plane, i.e. not a spiral fracture. On the aft side of the fracture, a small, longitudinal gouge (perpendicular to the fracture plane) was present but the source of the gouge in areas adjacent to the TRDS could not be determined. A dent was observed at the aft edge of the TRDS steel sleeve; the dent was offset from the gouge by about 0.5 to 1.0 inches (**Figure 9**). The dampener was whole and its mounting holes showed deformation from impact with its attaching hardware. The middle segment of the TRDS, aft of the fracture near the dampener, was continuous until a second fracture that was co-located with the fractured and separated aft section of the tail boom (**Figure 10**). The aft segment of the TRDS remained within the separated empennage. The aft segment of the TRDS was a singular piece up to its attachment to the tail rotor gearbox input flange, but the TRDS contained a fracture partially around its circumference (**Figure 11**). **Figure 12** shows a view of the reconstructed TRDS after its removal from the tail boom. Portions of the TRDS were cut by the investigation group to retain smaller segments of the TRDS for metallurgical examination of the fracture adjacent to the steel sleeve by the NTSB Materials Laboratory in Washington, D.C.

**Figure 7. The TRDS fracture (red arrow) near the dampener within the tail boom.**

**Figure 8. The TRDS fracture near the dampener (red bracket) after removal of the TRDS from the tail boom. The tail rotor control tube is seen above the TRDS.**

The forward TRDS fracture was examined by the NTB Materials Laboratory in Washington, D.C. Examination of the fracture surfaces showed signatures consistent with overstress. Compressive buckling was observed in multiple locations. Overall, the observed fracture features were consistent with torsional overstress with some bending.

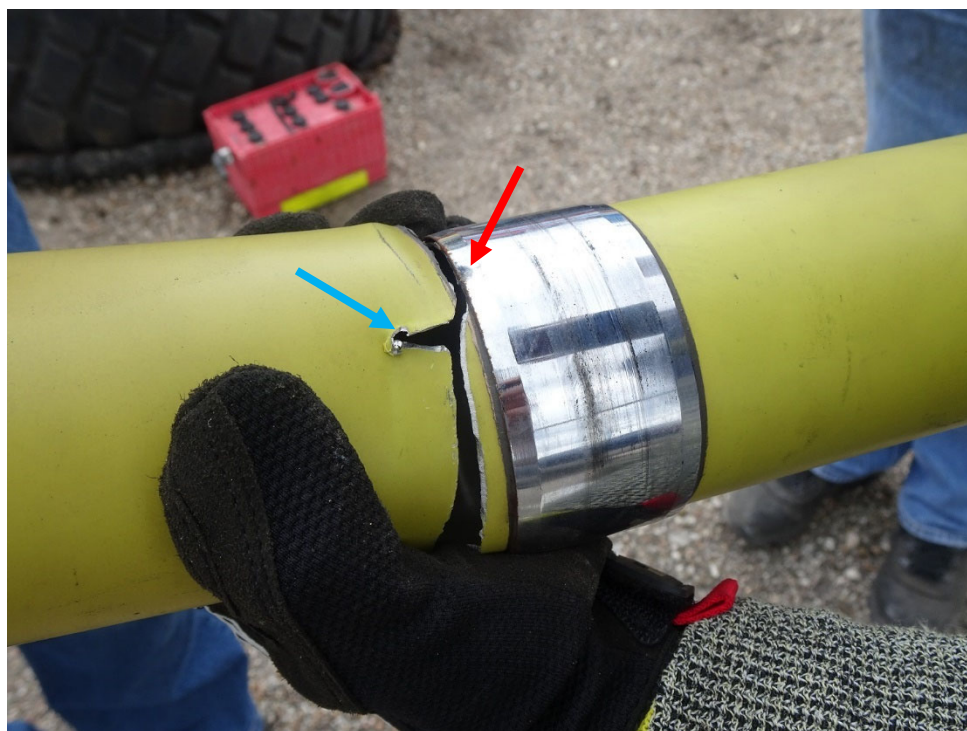
**Figure 9. The two fracture halves of the fracture near the TRDS dampener. The red arrow points to the dent on the steel sleeve and the blue arrow points to the gouge.**

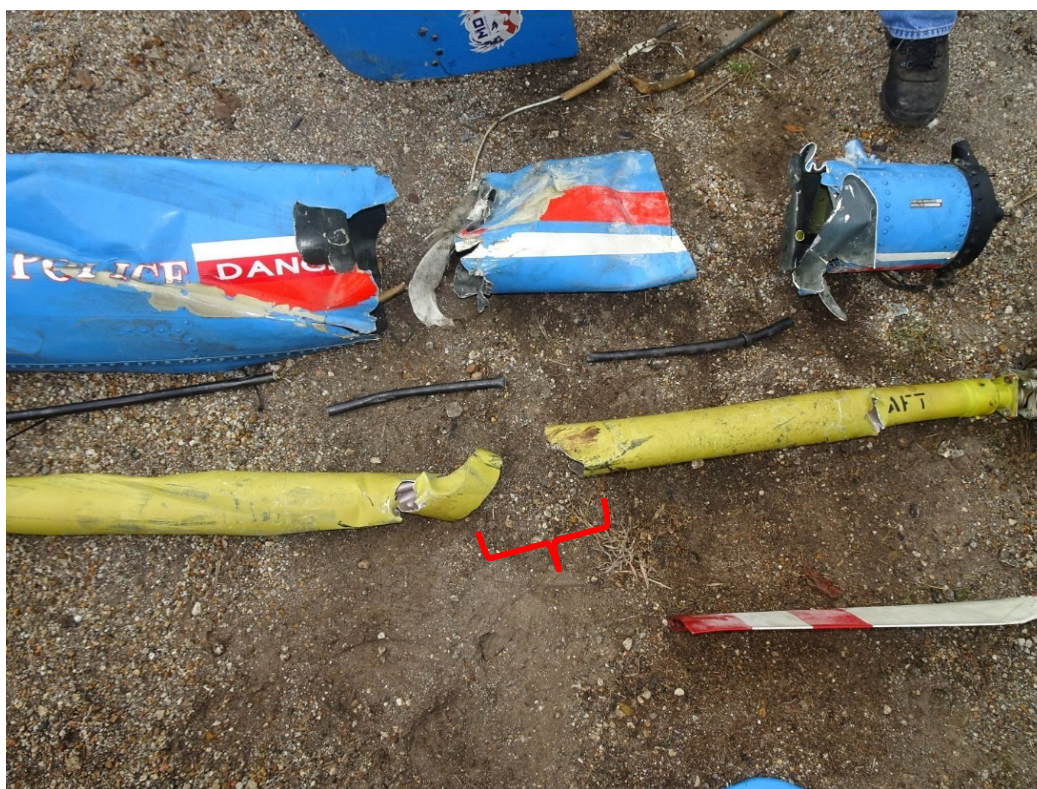
**Figure 10. The TRDS fracture (red bracket) co-located with the aft tail boom separation.**

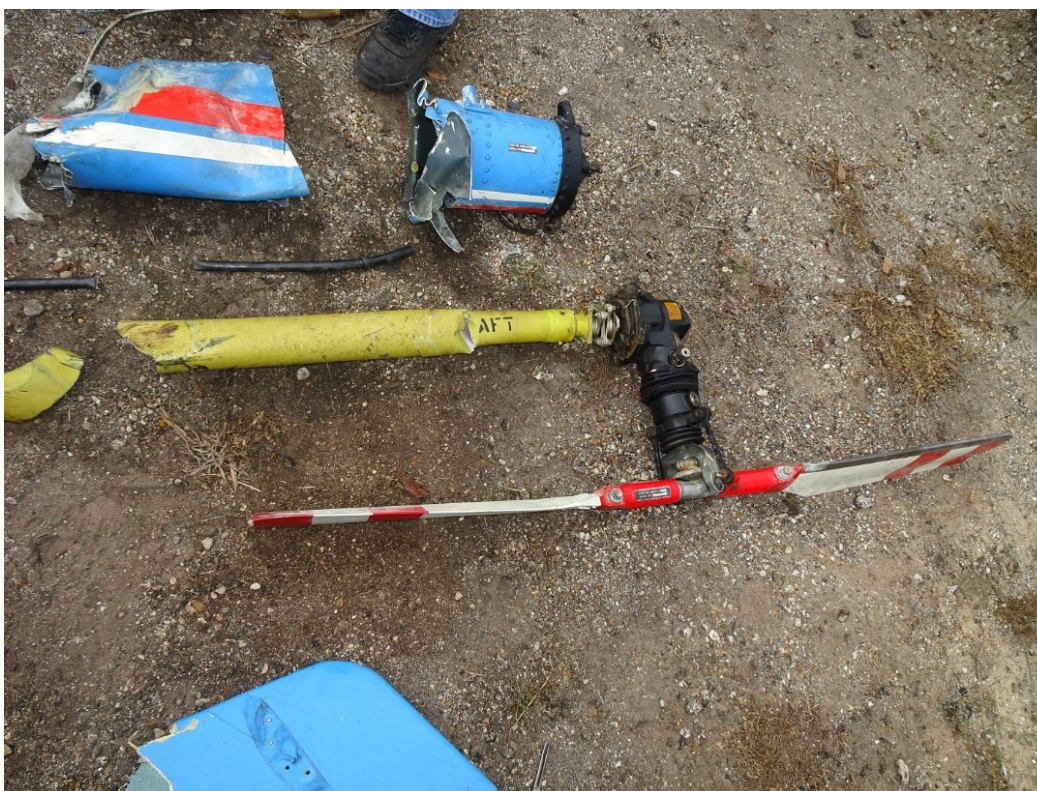
**Figure 11. The aft TRDS segment leading to the tail rotor gearbox.**

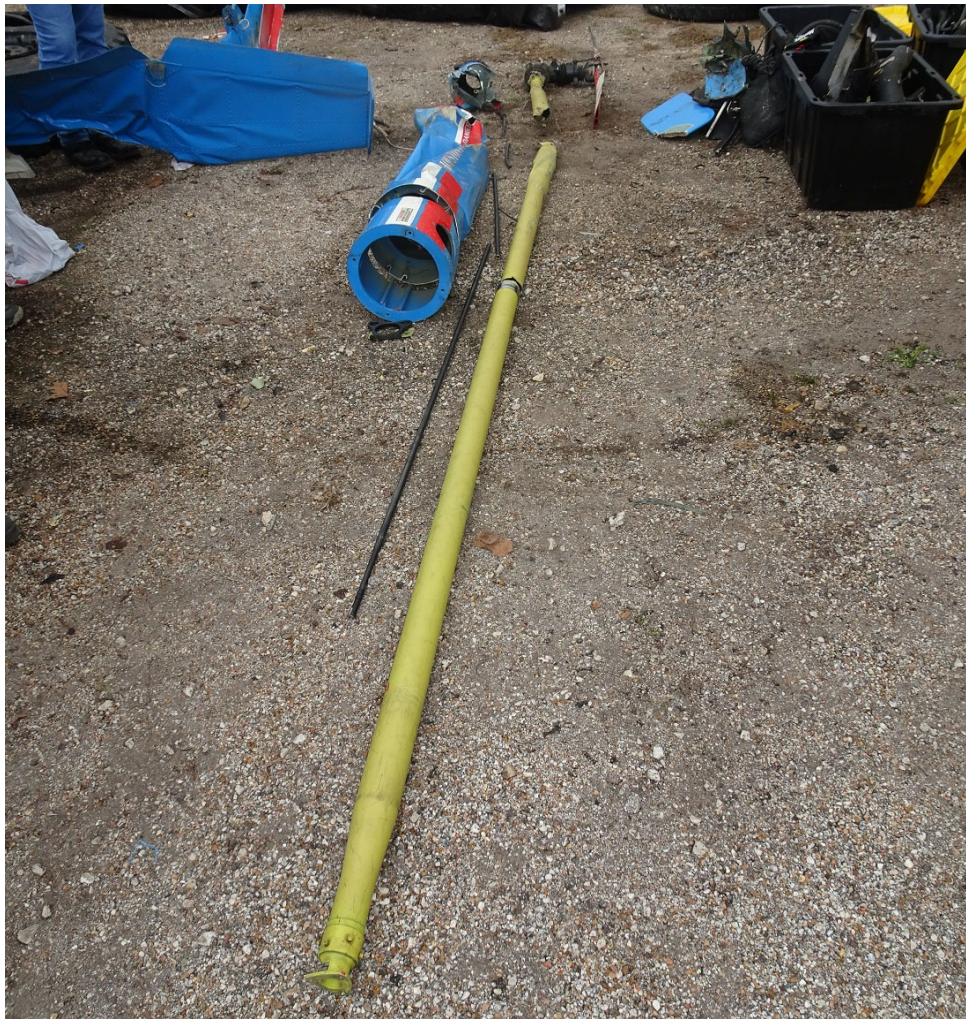
**Figure 12. A view of the reconstructed TRDS after removal from the tail boom.**

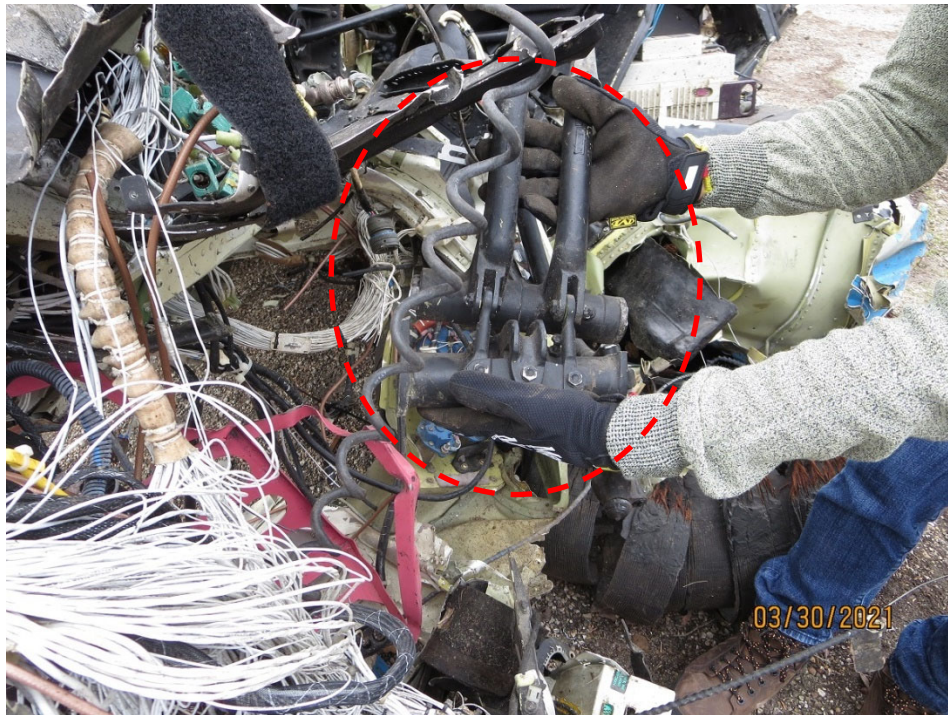
The left seat pedal mounts and its linkages were recovered as a single assembly but was separated from the main fuselage (**Figure 13**). The foot pedals were also separated from the assembly but were recovered. The torque tube extending to the left seat pedal assembly was fractured with signatures consistent with overload. The torque tube remained installed in the main wreckage but the tube was collapsed about mid-length and its outboard end was deformed upward (**Figure 14**). The torque tube remained connected to the [center] sleeve assembly and its attaching hardware remained installed. The sleeve assembly remained installed within the main fuselage.

**Figure 13. The recovered left seat pedal mounts and linkages. (Image courtesy of MD Helicopters Inc.)**

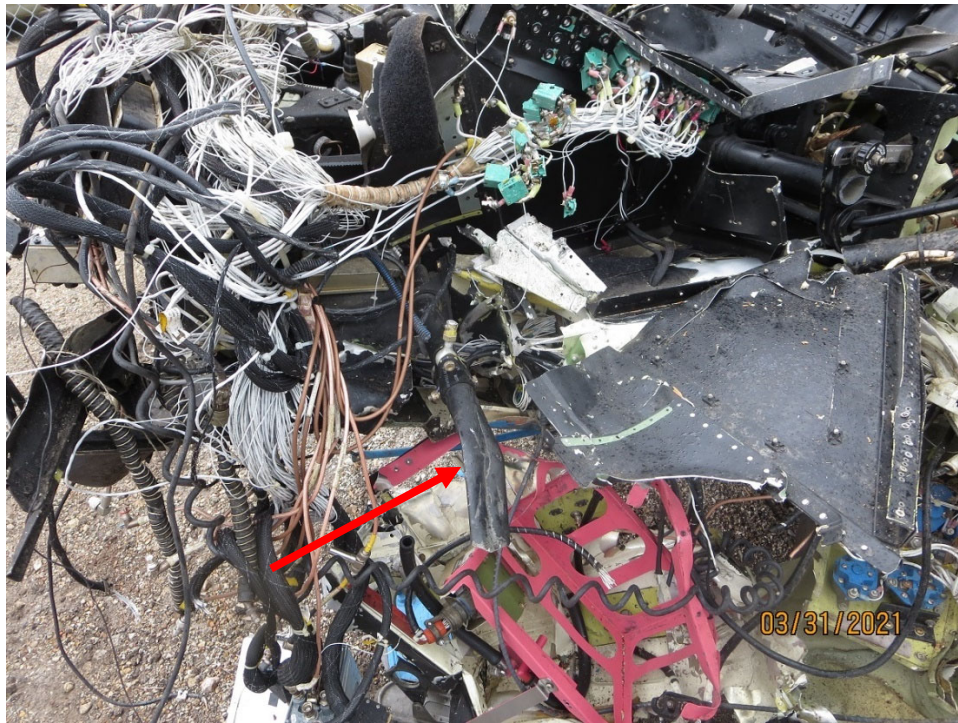
**Figure 14. The red arrow points to the pedal torque tube as seen in the main wreckage. (Image courtesy of MD Helicopters Inc.)**

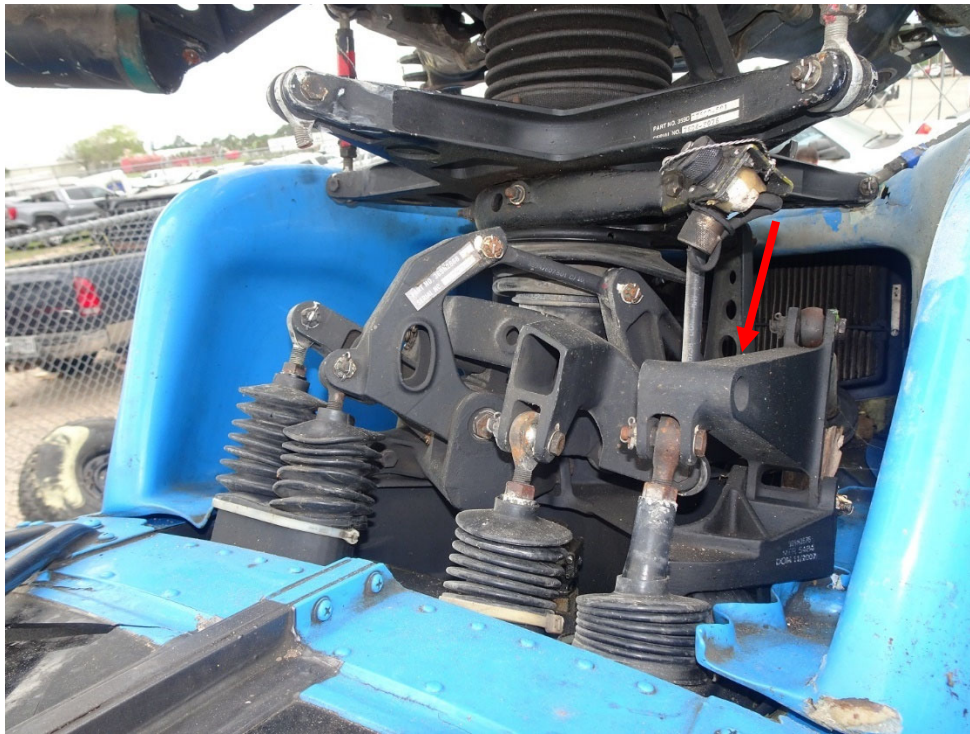
**Figure 15. Transmission deck flight control bellcranks. The red arrow points to the directional control system bellcrank at STA 96.**

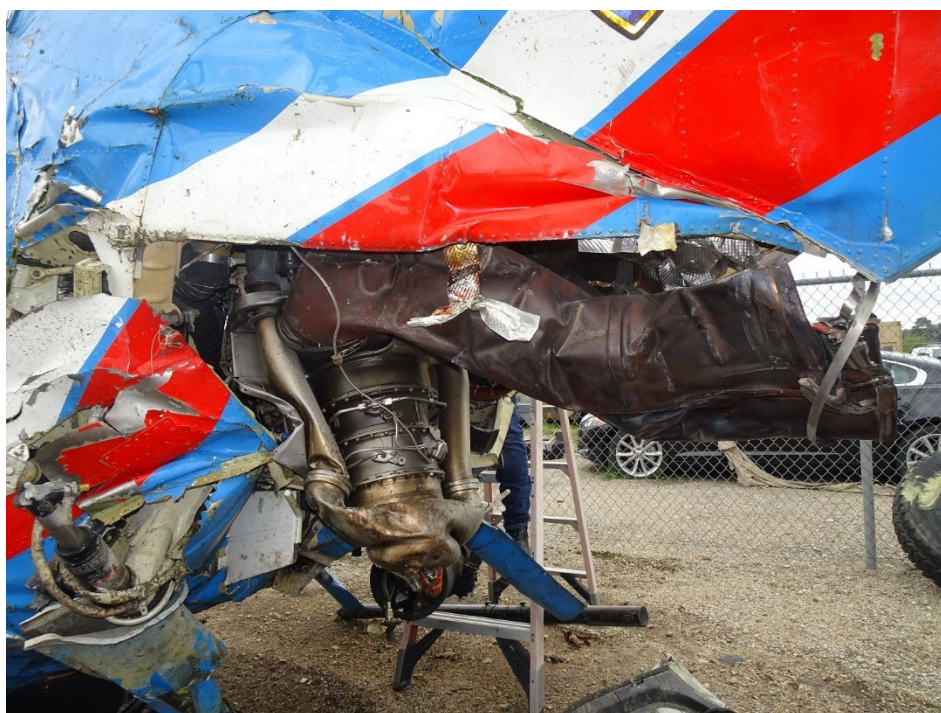
The engine remained partially attached to the airframe but had rotated upward due to impact deformation of the engine bay (**Figure 16**). The left engine mount remained installed but exhibited a fracture near its engine attachment. The center engine mount remained installed but its left arm exhibited a fracture near its airframe attachment. The right engine mount remained installed and intact. All engine accessories remained installed onto the engine accessory gearbox. The left compressor discharge tube was deformed inward due to impact and the outer combustion case was crushed inward. The left and right exhaust tubes were also deformed. The upper and lower chip detectors were removed and were free of magnetic debris.

**Figure 16. A view of the engine installation within the airframe prior to its removal.**
