# NATIONAL TRANSPORTATION SAFETY BOARD

## MATERIALS LABORATORY FACTUAL REPORT

Report No. 21-041

Place : Houston, Texas  
Date : May 2, 2020  
Vehicle : MD Helicopters 369E, N8375F  
NTSB No. : CEN20LA167  
Investigator : Chihoon Shin, AS-40

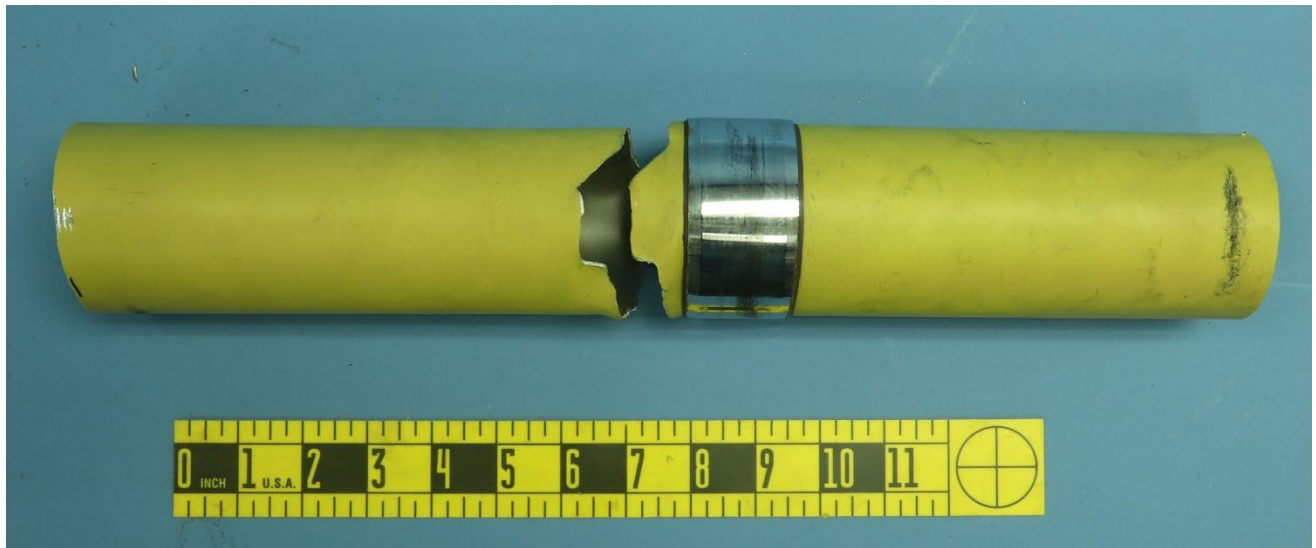
Sections from the fractured tail rotor drive shaft of the helicopter were received by the NTSB Materials Laboratory, as illustrated in Figure 1 and Figure 2. The shaft remnants were generally straight, and still displayed the green primer on the exterior surfaces. The shaft had fractured adjacent to a cylindrical support sheath, located to the right of the fracture in the figures. This sheath had a reflective metallic trait, consistent with having been polished.

Figure 1 – The fractured tail rotor drive shaft sections, as received.

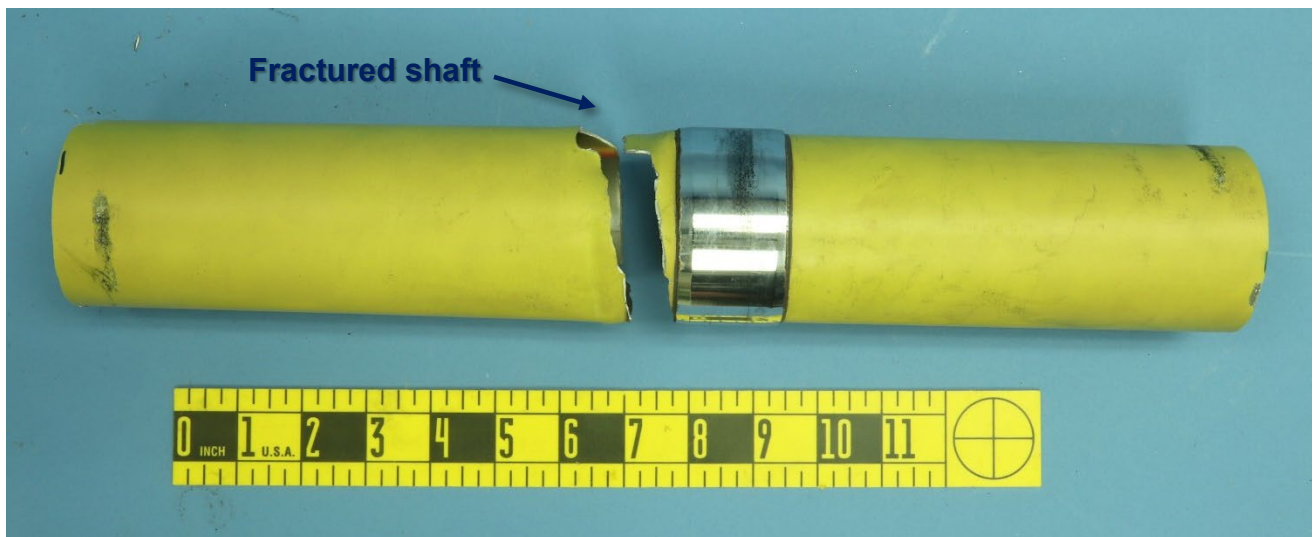
Figure 2 – The fractured tail rotor drive shaft sections from Figure 1, rotated 90° to show a side view.

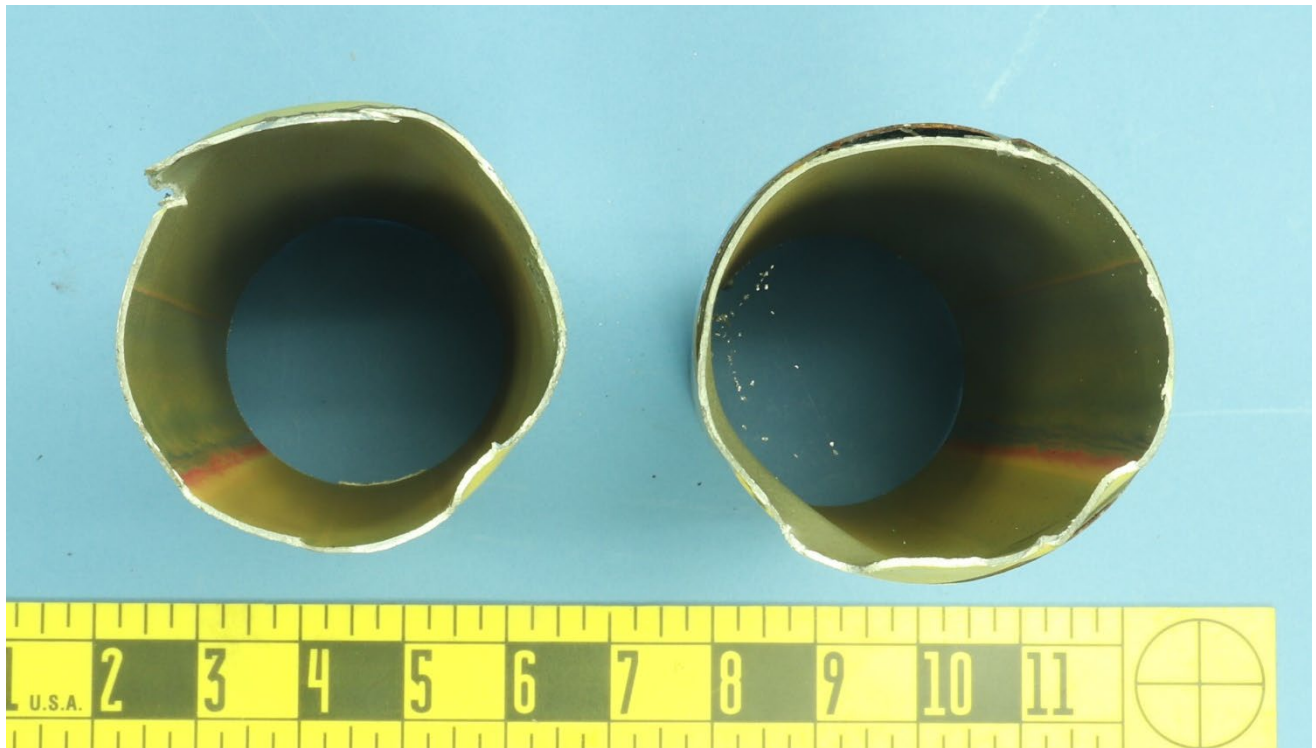
Figure 3 shows mating fracture surfaces of the tail rotor drive shaft. The fracture surface was oriented transverse (perpendicular) to the longitudinal direction of the shaft. The fracture surface was generally rough in texture, with no indications of reflective areas. As demonstrated in Figures 3 and 4, the shaft material adjacent to the fracture surface exhibited localized areas with deformation both inward and outward. This deformation was located on one half of the fracture shaft remnants. These deformation features were consistent with compressive buckling.

Figure 3 – View of the mating fracture surfaces of the tail rotor drive shaft sections.

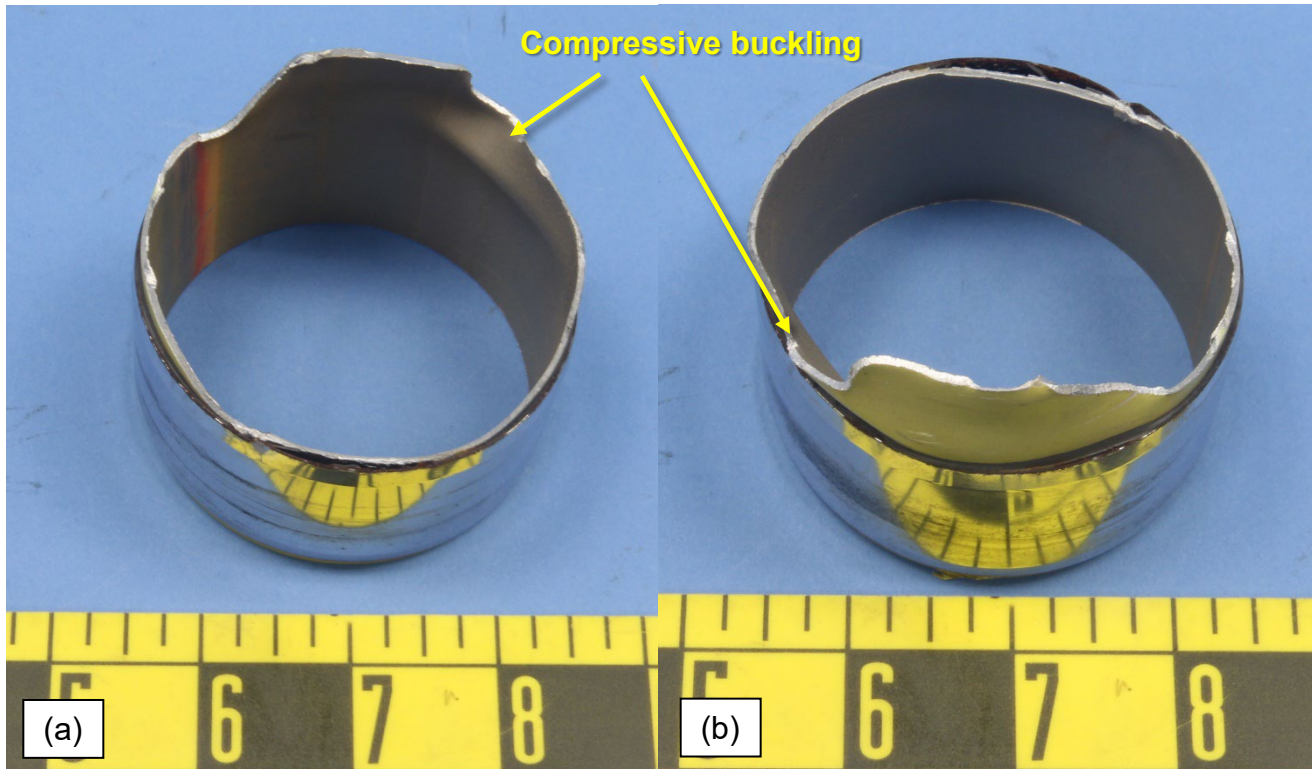
Figure 4 – View of the sectioned end of the fractured shaft from the side with the support ring. The areas of compressive buckling are annotated (arrows).

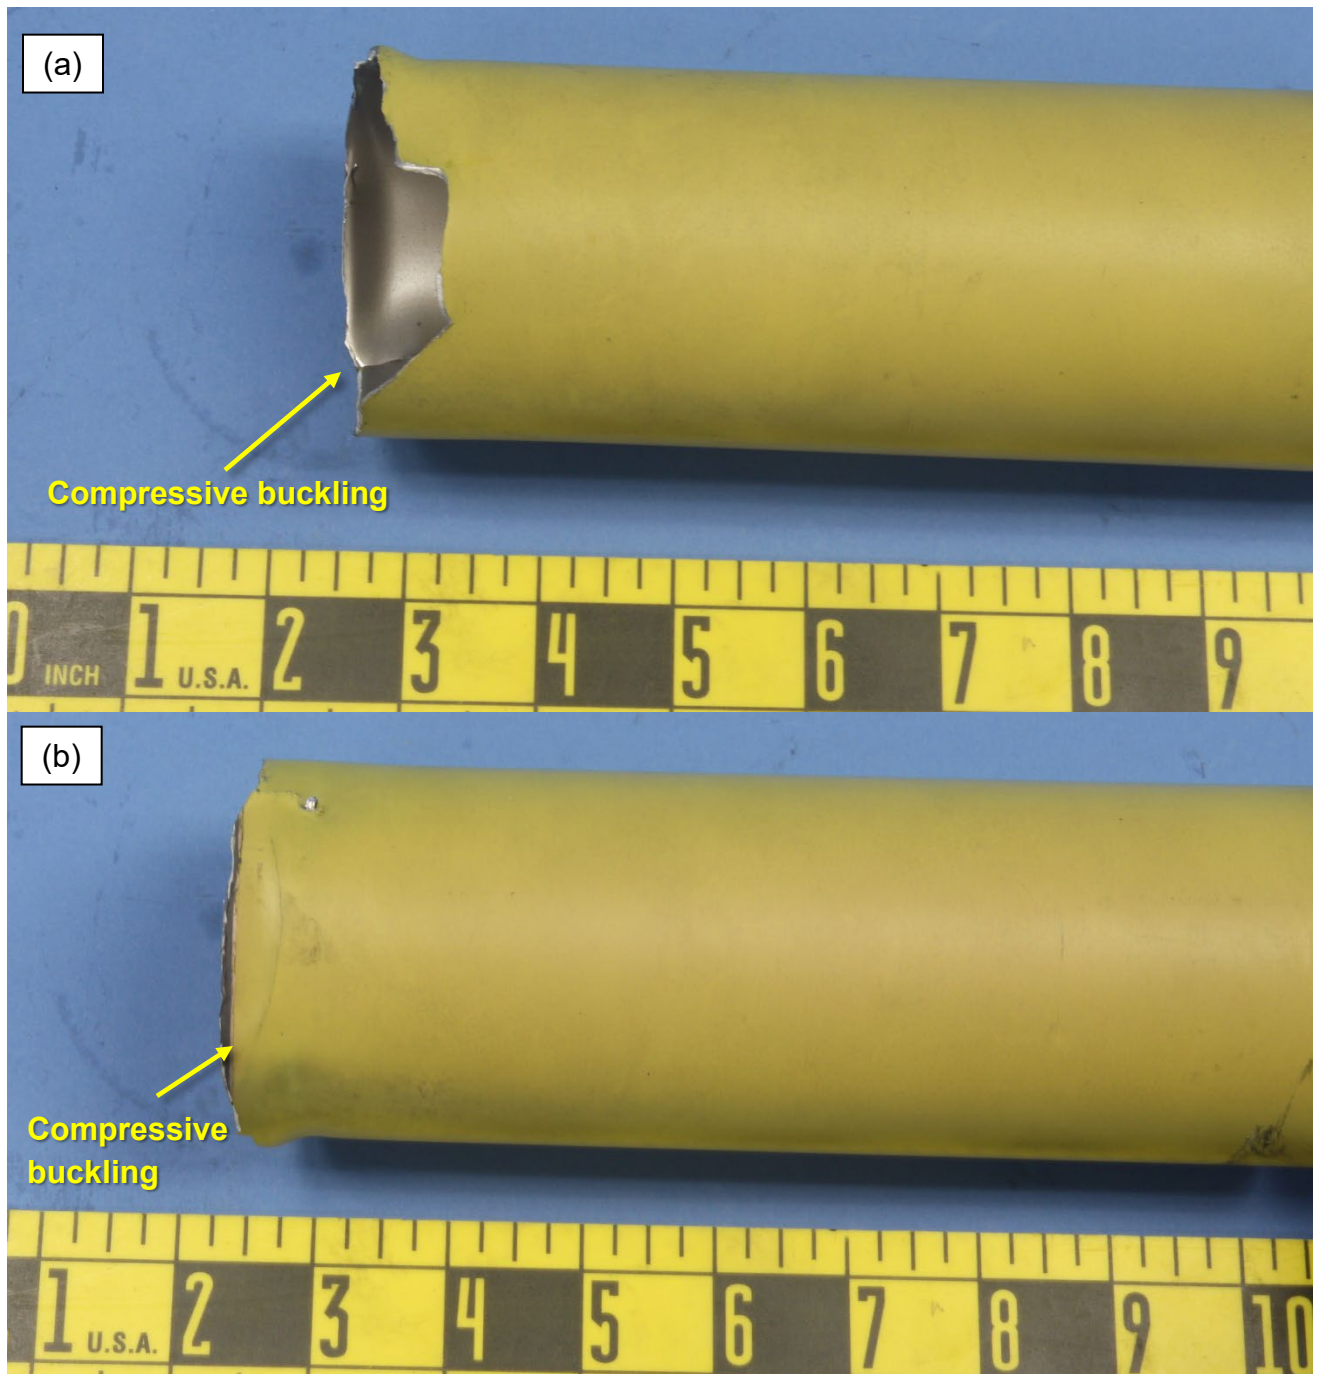
Figure 5 – View of the mating fracture surface to Figure 4. The areas of compressive buckling are annotated (arrows).

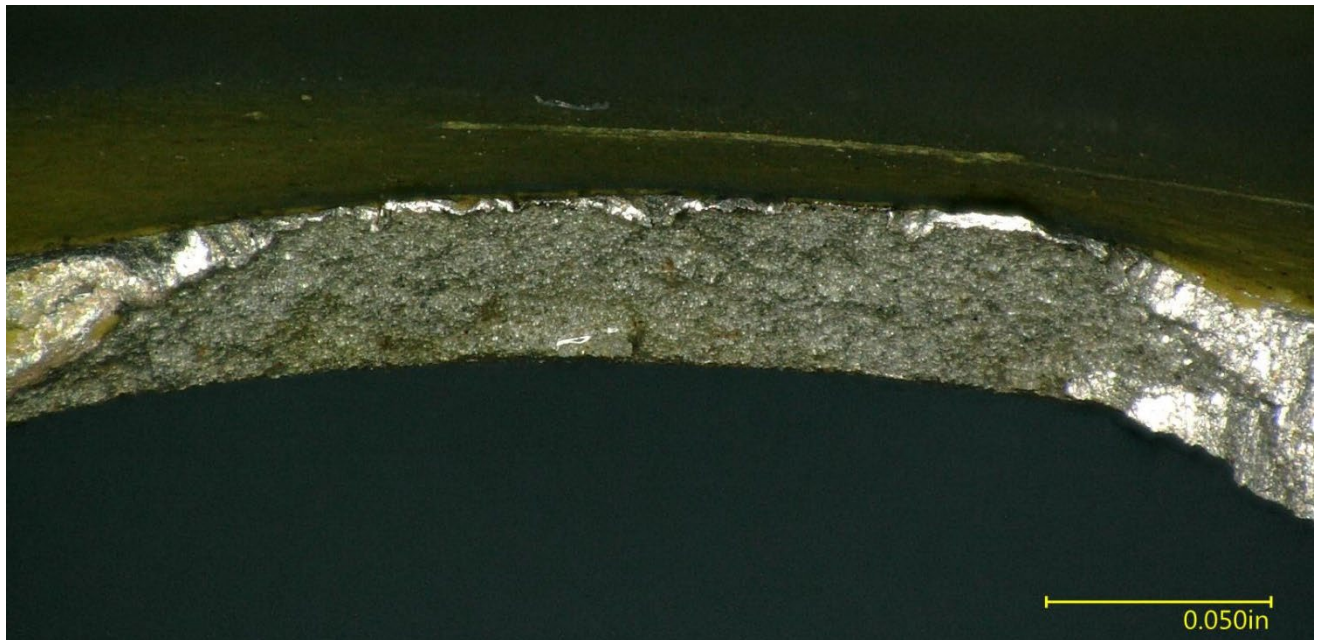
The opposite side did not exhibit this buckling, but rather localized thinning or necking of material adjacent to the fracture. Figure 6 shows a closer view of this side of the fracture. Some of the outer edges of this fracture area exhibited angled protrusions, consistent with shear lips. These features were consistent with fracture in tension on this side of the shaft.

Figure 6 – View of the fracture surface from the tension side.

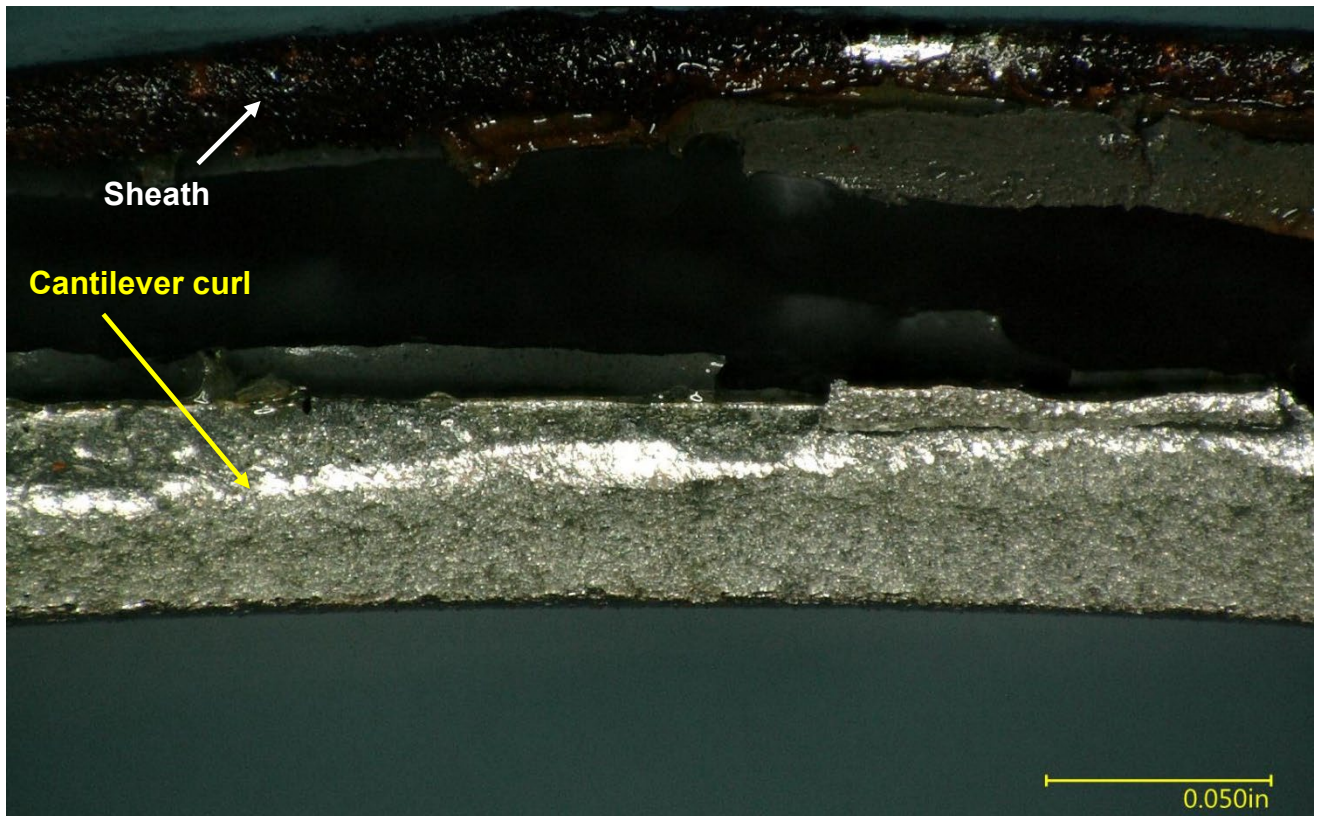
The opposite side of the fracture, which exhibited compressive buckling, is highlighted in Figure 7. This side of the fracture contained areas with reflective and flattened features—these characteristics were consistent with post-fracture damage such as smearing. This smearing had occurred on the cantilever curl region of the fracture, with shear lips on the outer edge. The outer sheath had also separated from the outer surface of the shaft, which had deformed inward relative to the sheath. In the undamaged region, the fracture surface exhibited a rough, fibrous texture, with a dull gray luster. These features were also present on the opposite side shown in Figure 6.

Figure 7 – View of the fracture surface from the compression side, showing the sheath separated from the outer surface.

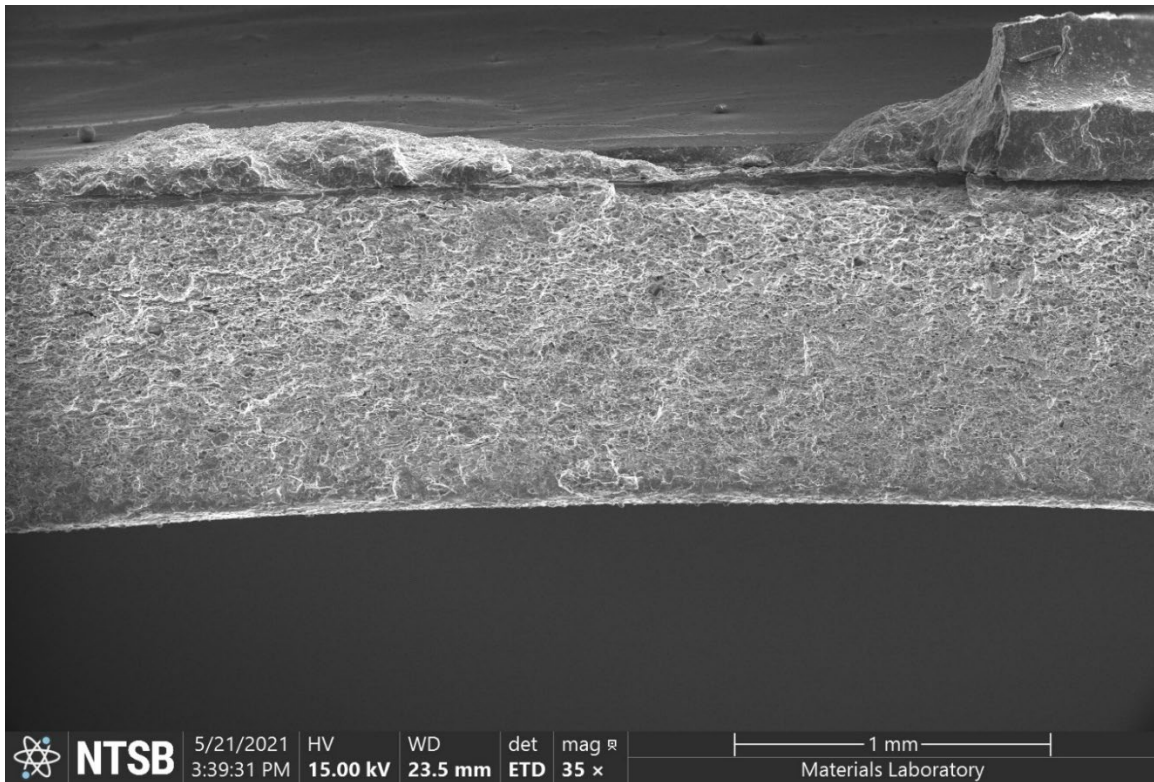
The section of the fractured shaft with the sheath (shown in Figure 4) was examined using a scanning electron microscope (SEM). Figure 8 shows a typical view of the tension side of the fracture surface. A closer view of this area is shown in Figures 9 and 10. These areas revealed dimpled rupture, consistent with tensile overstress fracture. No other features consistent with other fracture modes were observed in this area.

Figure 8 – Secondary electron (SE) micrograph of the tension side region of the fracture surface.

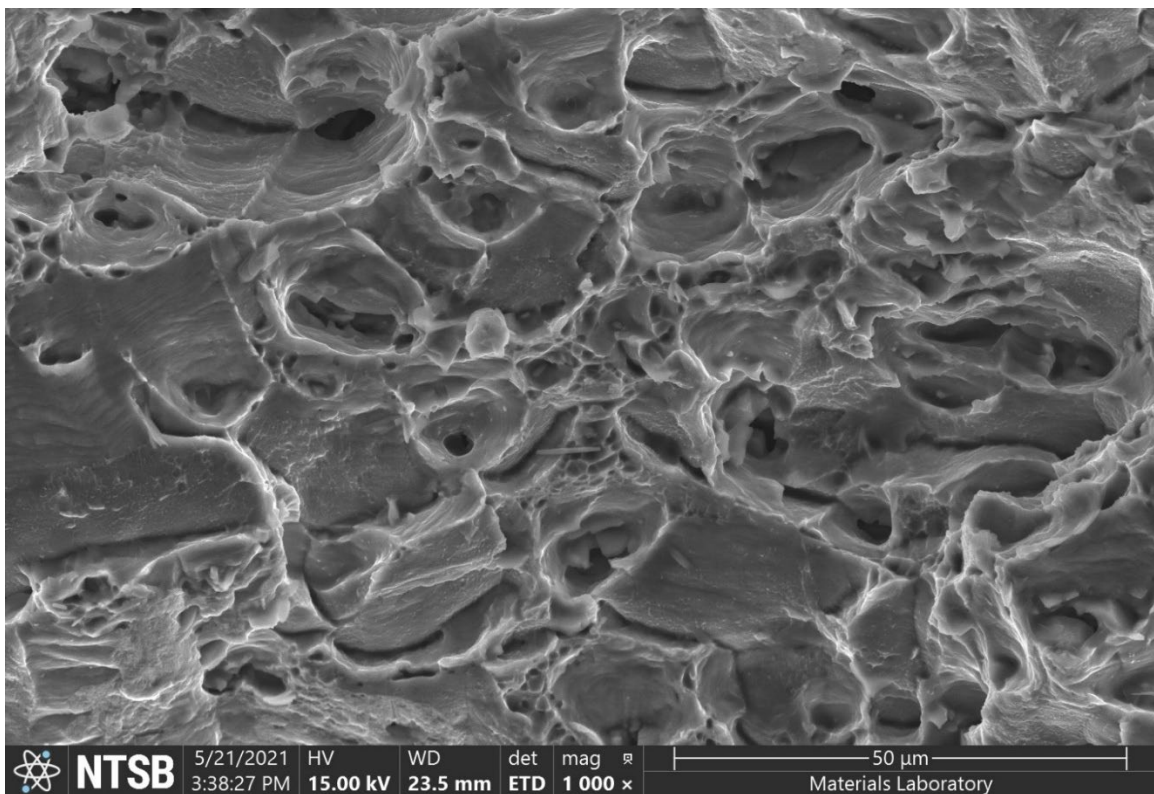
Figure 9 – SE micrograph of the dimple rupture on the tension side fracture.

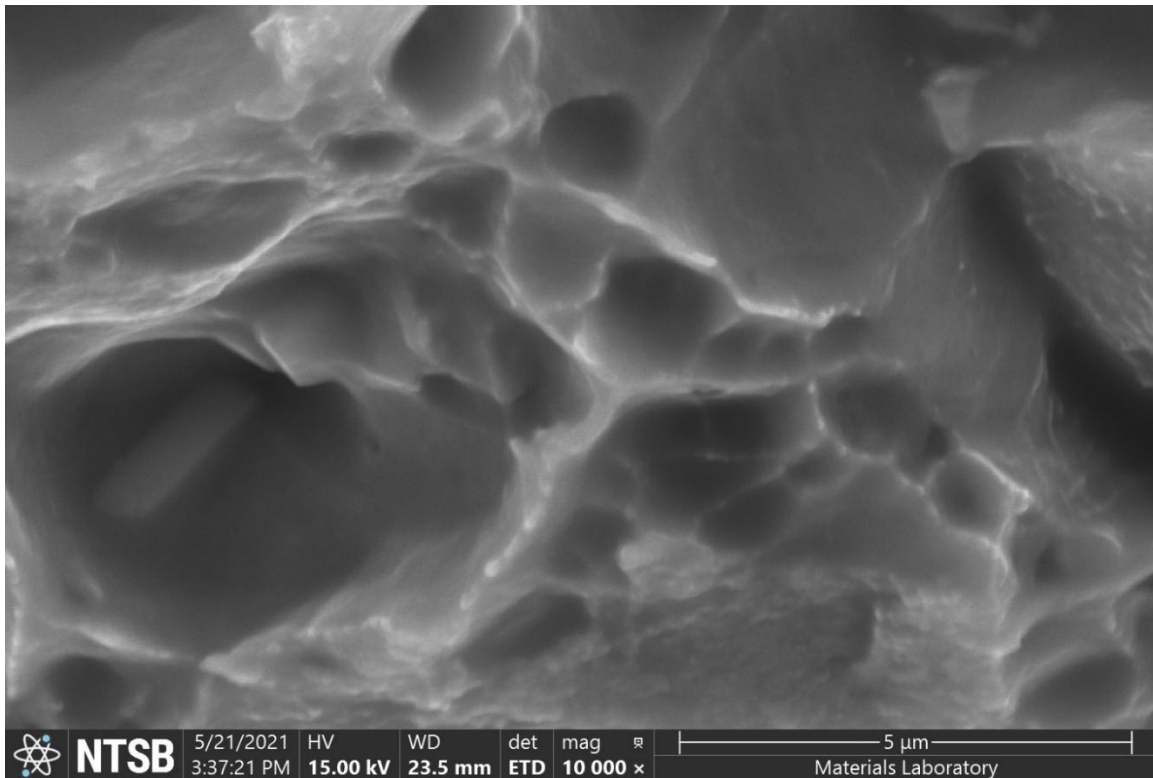
Figure 10 – SE micrograph of a closer view of the dimpled rupture in Figure 9.

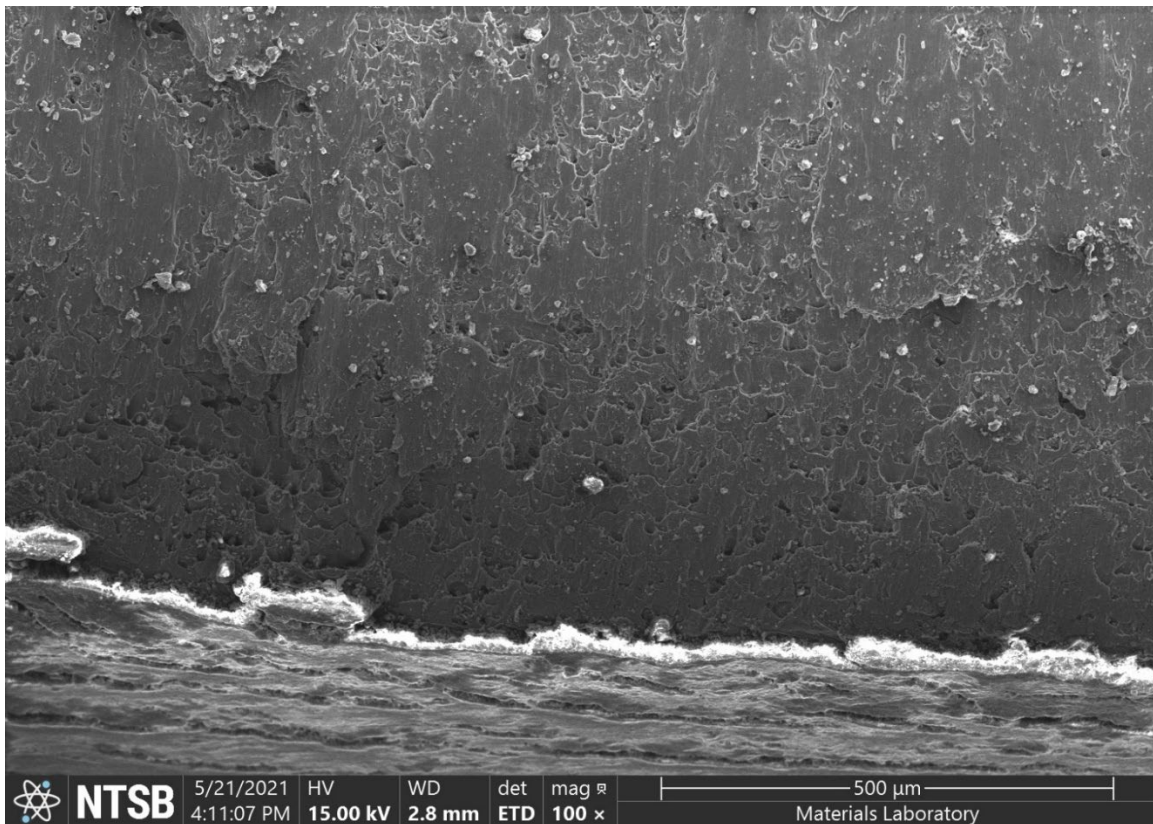
The compressive side of the fracture surface is illustrated at the edge in Figure 11. This portion of the fracture surface was generally flatter than the tensile side. Figures 12 and 13 show a closer view of the fracture features in this area. As demonstrated in these figures, this area exhibited slanted dimpled rupture, consistent with overstress with a shear component.

Figure 11 – SE micrograph of the edge of the compression side of the fracture.

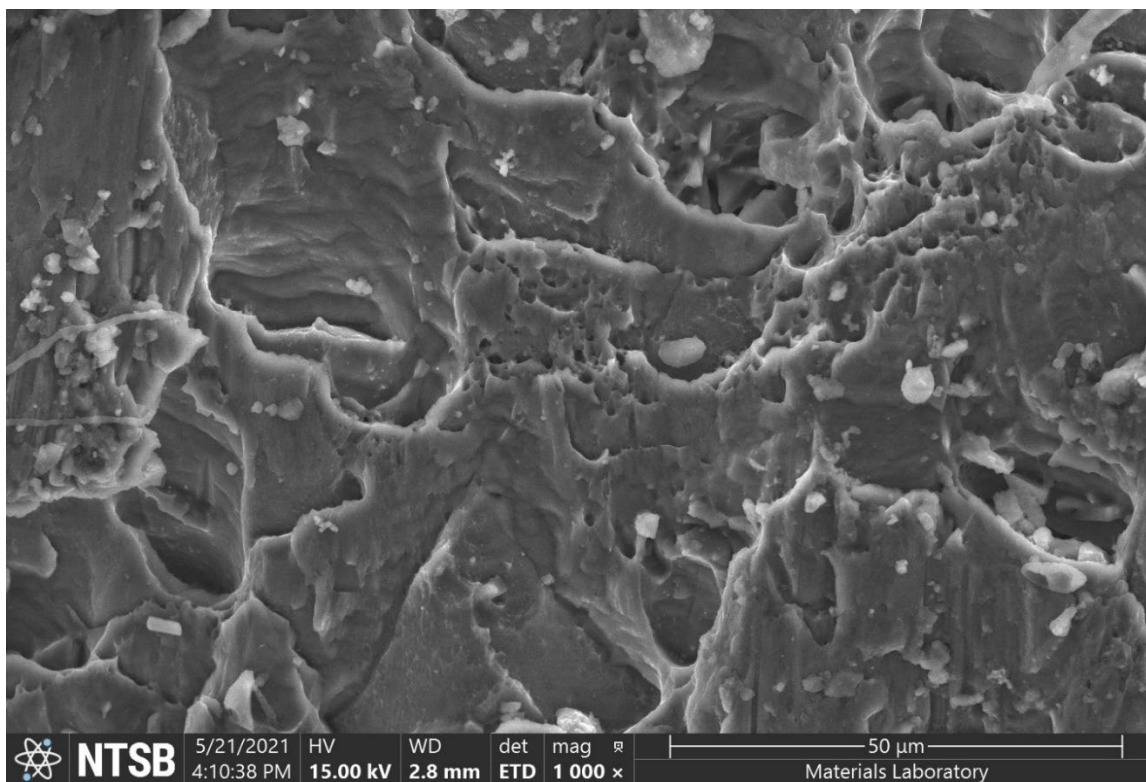
Figure 12 – SE micrograph of dimpled rupture from the compressive fracture area.

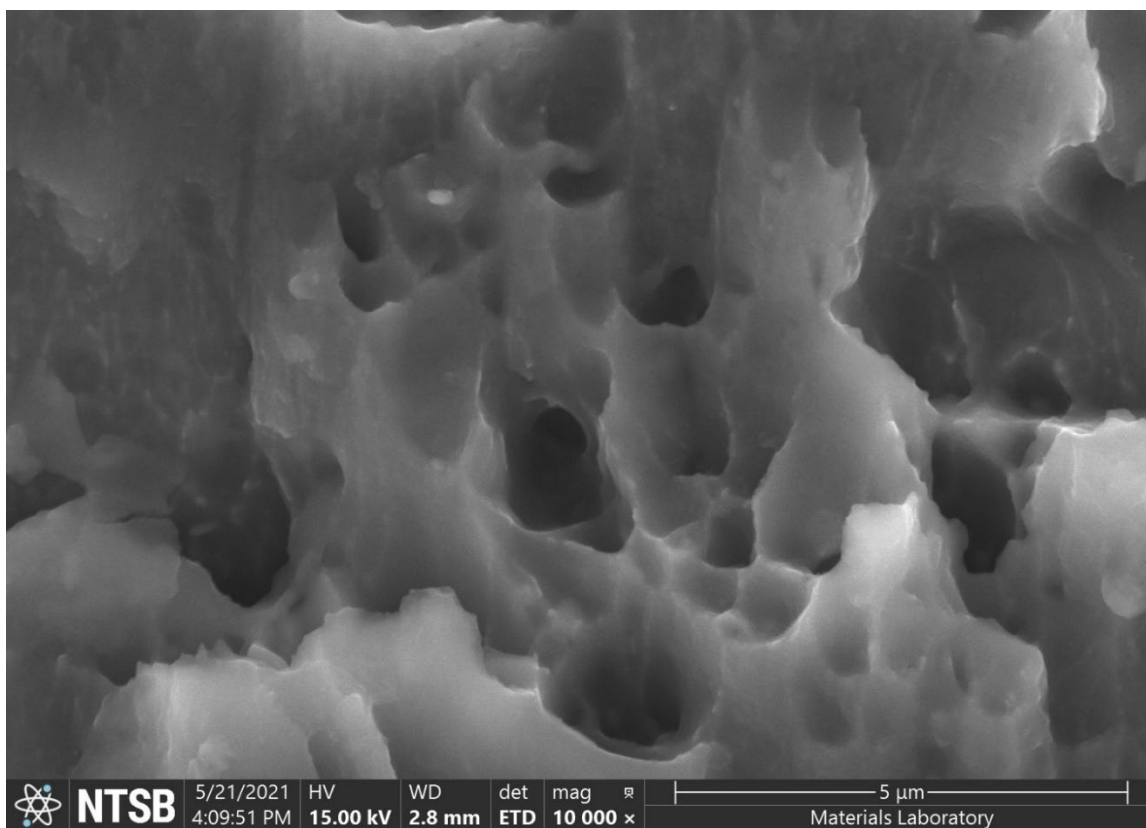
Figure 13 – SE micrograph of shear dimpled rupture from Figure 12.

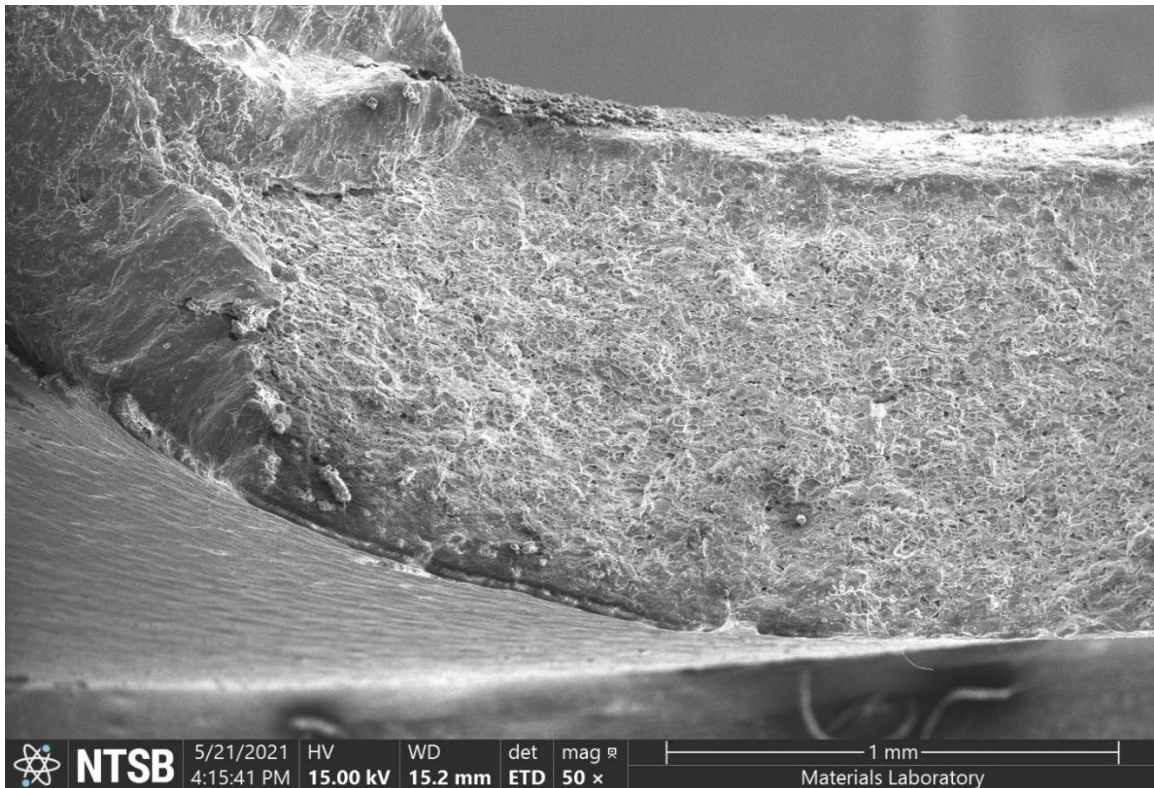
The areas of the fracture surface adjacent to the compressive buckling were also examined. One such area is typified in Figure 14. As shown in Figure 15, this portion of the fracture surface exhibited dimpled rupture, consistent with overstress.

Figure 14 – SE micrograph of the fracture surface on the compressive side adjacent the buckled area.

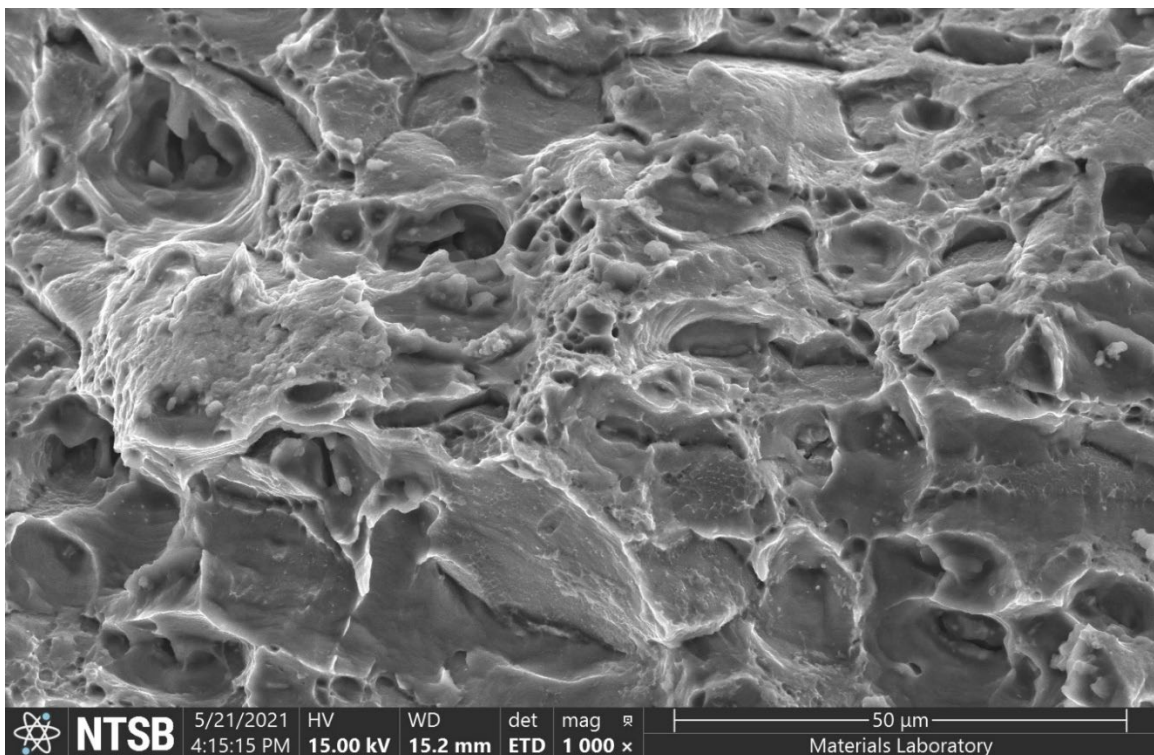
Figure 15 – SE micrograph of dimpled rupture in the area in Figure 14.

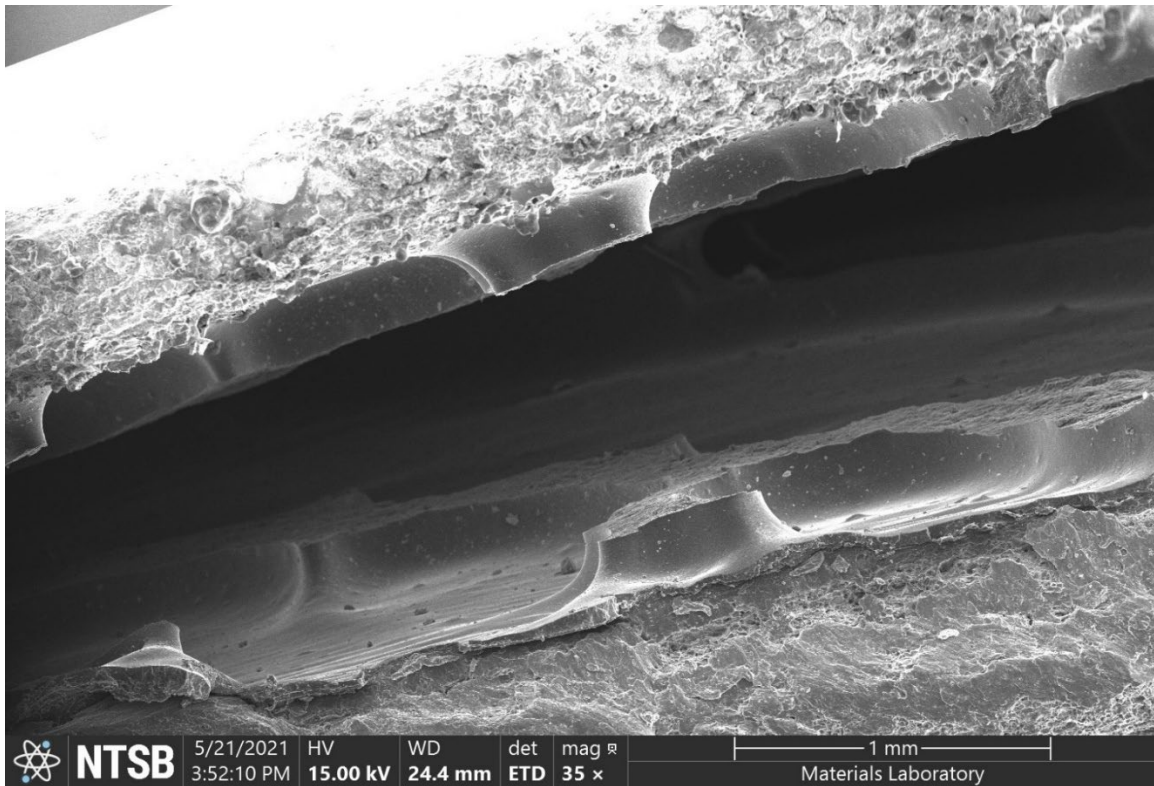
The fracture surface areas nearest to the cylindrical support sheath were examined, as illustrated in Figures 16 and 17. Figure 16 shows an area where some compressive buckling had occurred in the shaft. This figure shows fracture of the adhesive between the sheath and outer surface of the shaft. Figure 17 shows an area in the tensile side of the fracture surface. In this figure, the intermediate adhesive had fractured parallel to the shaft fracture surface but was still affixed to both the shaft and the cylindrical sheath.

Figure 16 – SE micrograph of the fractured adhesive between the cylindrical outer sheath and the fractured shaft on the compressive side.

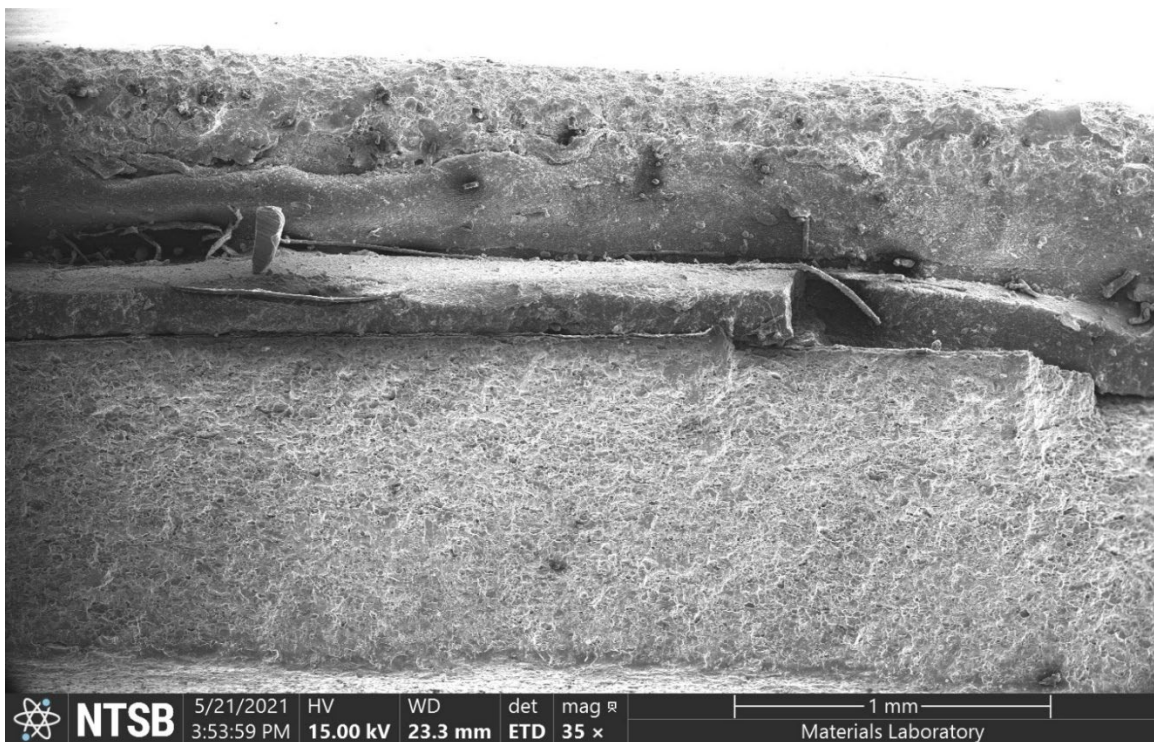
Figure 17 – SE micrograph of the fractured adhesive between the cylindrical outer sheath and the fractured shaft on the compressive side.

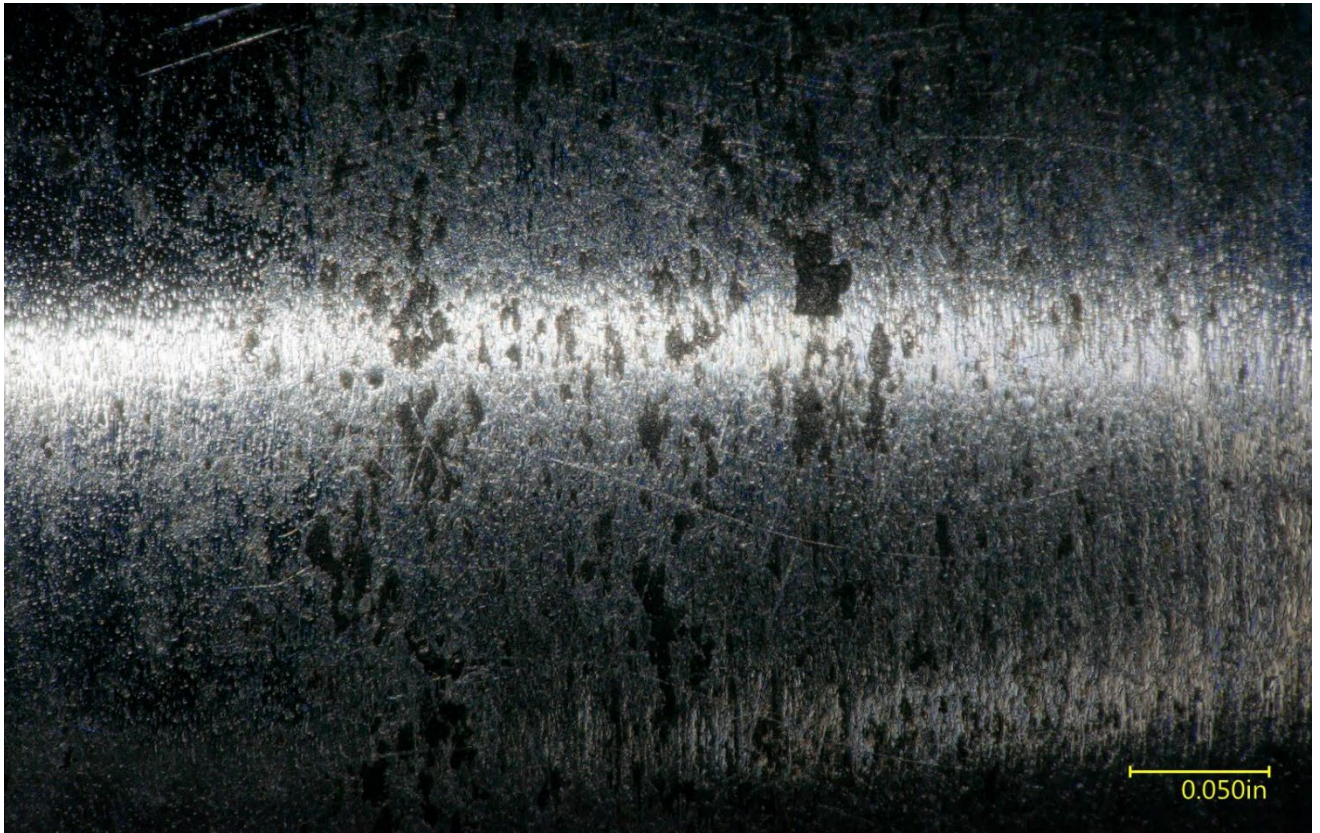
Figure 18 shows a closer view of the surface of the cylindrical sheath. This surface, while generally reflective and typical of having been polished, exhibited darker parallel wear marks oriented in the circumferential direction of the shaft. These wear marks were consistent with the direction of rotation of the shaft and sheath. There were no indications of gouging or material spalling on this part.

Figure 18 – Wear marks on the outer shaft sheath.
