# National Transportation Safety Board

## Performance Study Addendum

Location: Houston, Texas  
Date: May 2, 2020  
Time: 02:03 central daylight time (CDT)  
Airplane: 369E MD Helicopter, N8375F  
NTSB Number: CEN20LA167

**Performance Study**  
**CEN20LA167, 369E MD Helicopter, N8375F**

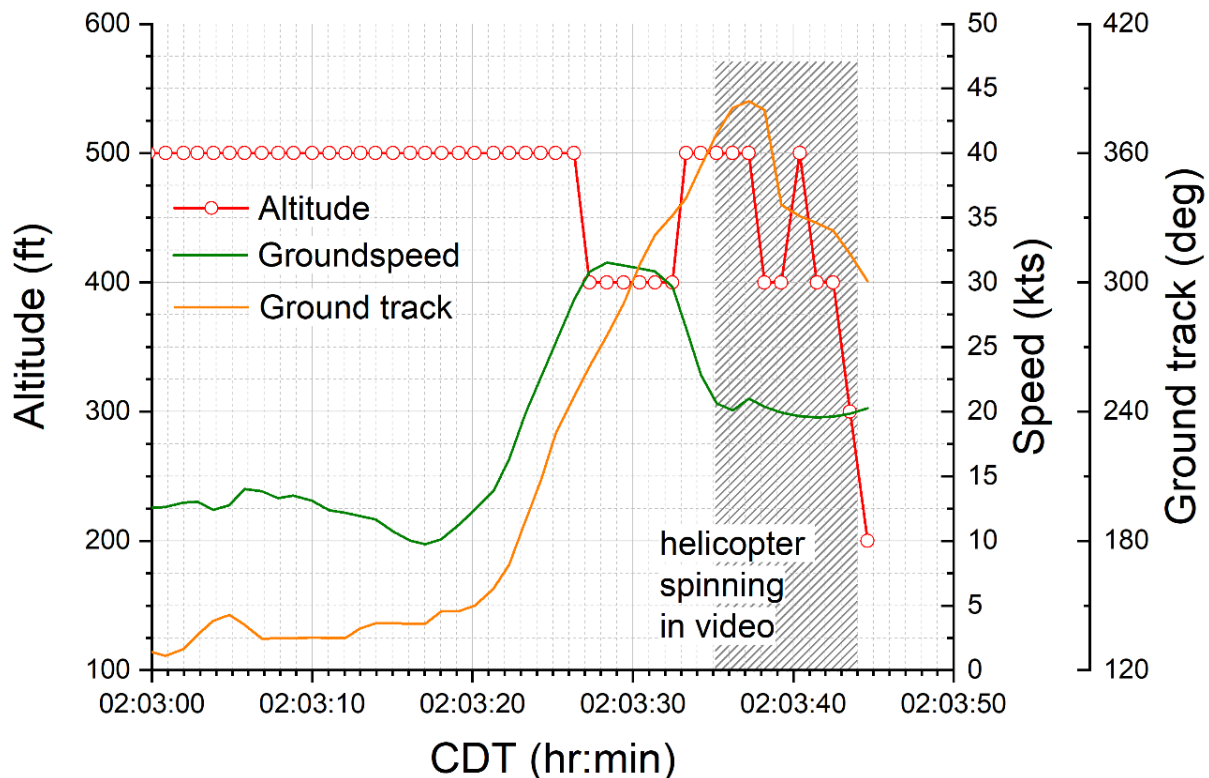
Figure 1 (Figure 5 in the Performance Study) shows the helicopter's groundspeed at the end of flight. As stated above, from 02:02:50 until 02:03:20 the helicopter was on a track of 137° into a 4 kts right quartering headwind. The helicopter's 10 to 15 kts groundspeed plus the headwind would have made it susceptible changing lift and power conditions along with changes in the required anti-torque. If sufficient anti-torque was not added, it could result in an uncommanded right yaw.

Additionally, as the helicopter accelerates, and translational lift increases, it induces a right rolling motion and the helicopter pitches up [2] necessitating increased anti-torque and forward cyclic. The result is that if the helicopter experiences an uncommanded right yaw below the transition to translational lift, increasing power to increase speed can further contribute to the right yawing motion and need for anti-torque.

**Figure 1.** Altitude (msl), groundspeed, and ground track for end of flight.

The increased anti-torque requirement when below the onset of translational lift and right rolling moment induced by the introduction of translational lift when accelerating from low speed may have been factors contributing to the uncommanded right yaw event reported by the pilot. Without additional data about when the yaw event began, the helicopter's attitude and power, or pilot inputs, it is not possible to evaluate the cause of the accident.
