**From:** Sheehan, Greg P (FAA) [REDACTED]  
**Sent:** Monday, November 2, 2020 4:04 PM  
**To:** Scott Arnold [REDACTED]  
**Subject:** N2074S Teardown Inspection

On 10/29/2020, Henry Soderlund and I performed an airframe and engine teardown inspection of N2074S. The results of our inspection:

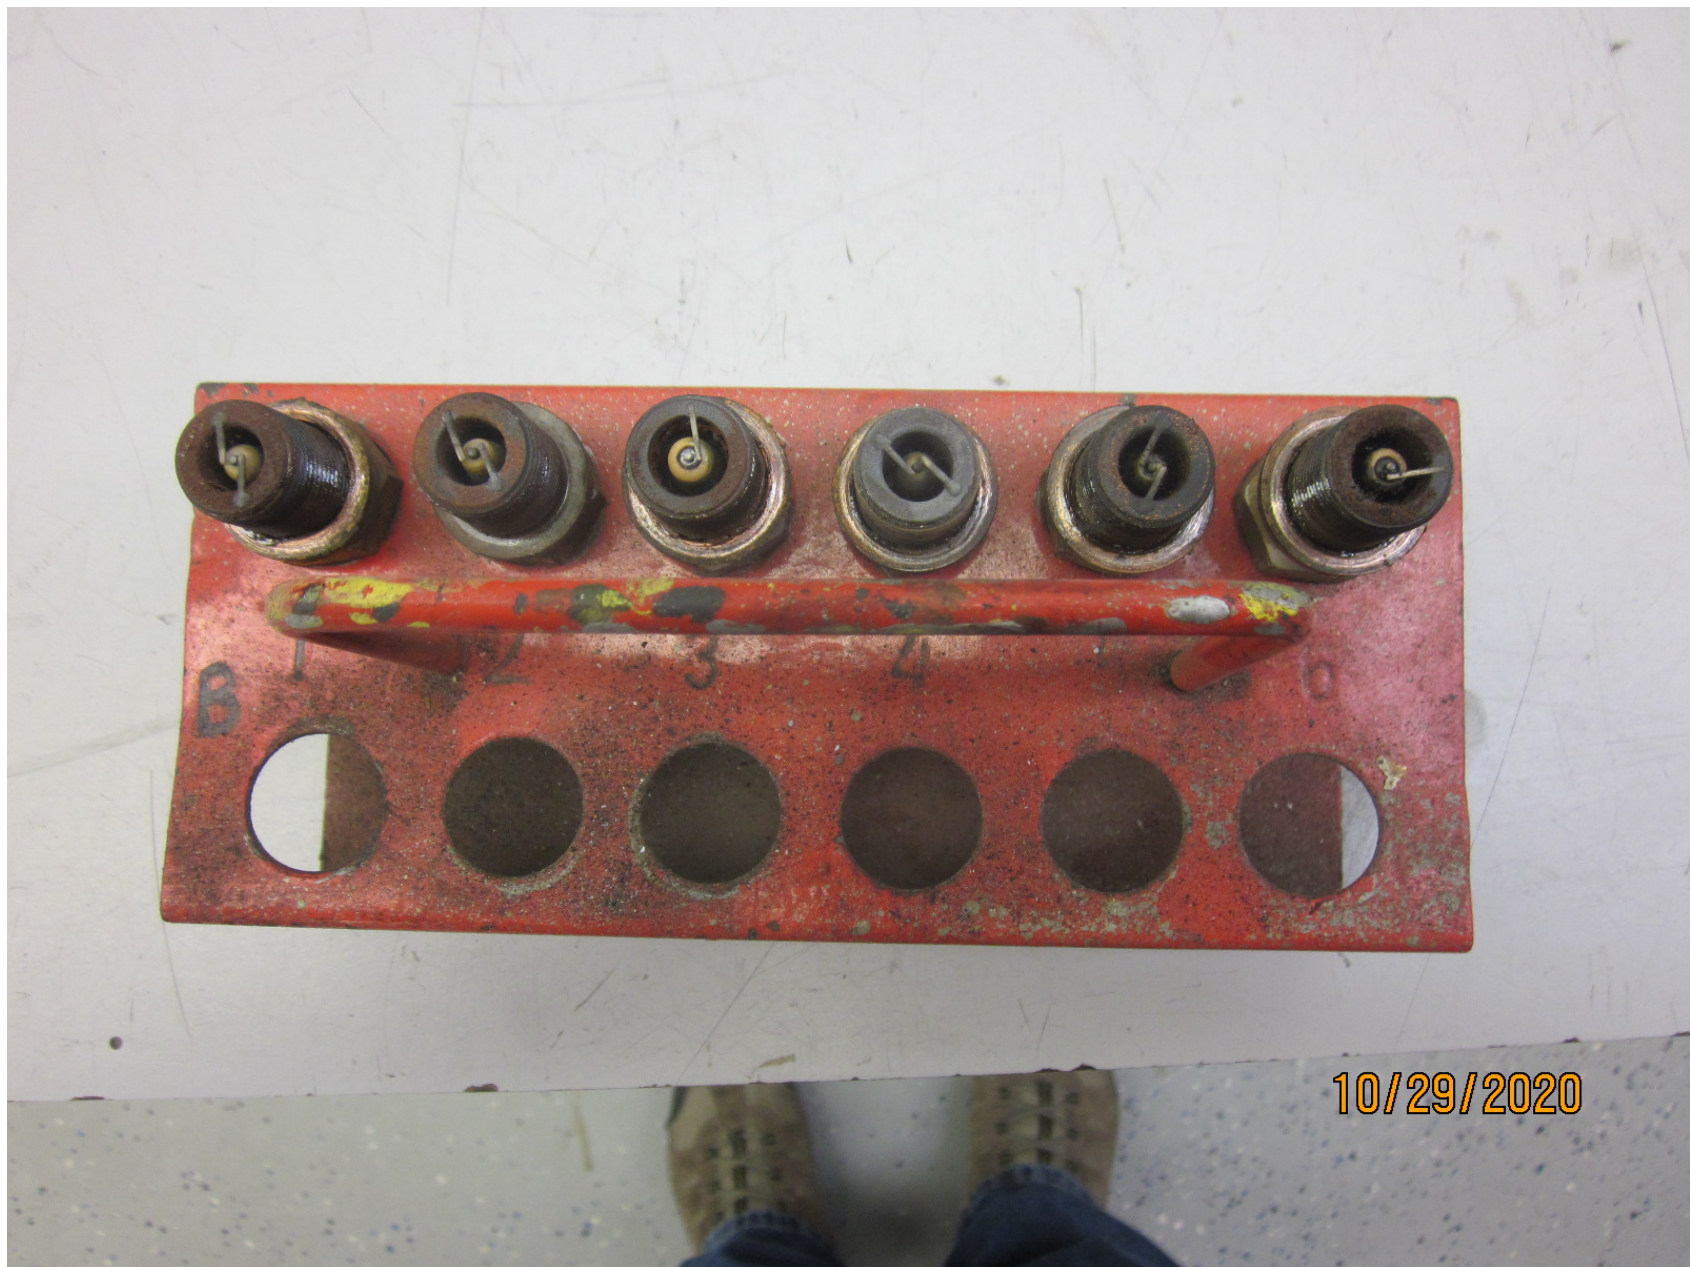
**Photo 1 – Top spark plugs after removal from cylinder heads (FAA photo)**

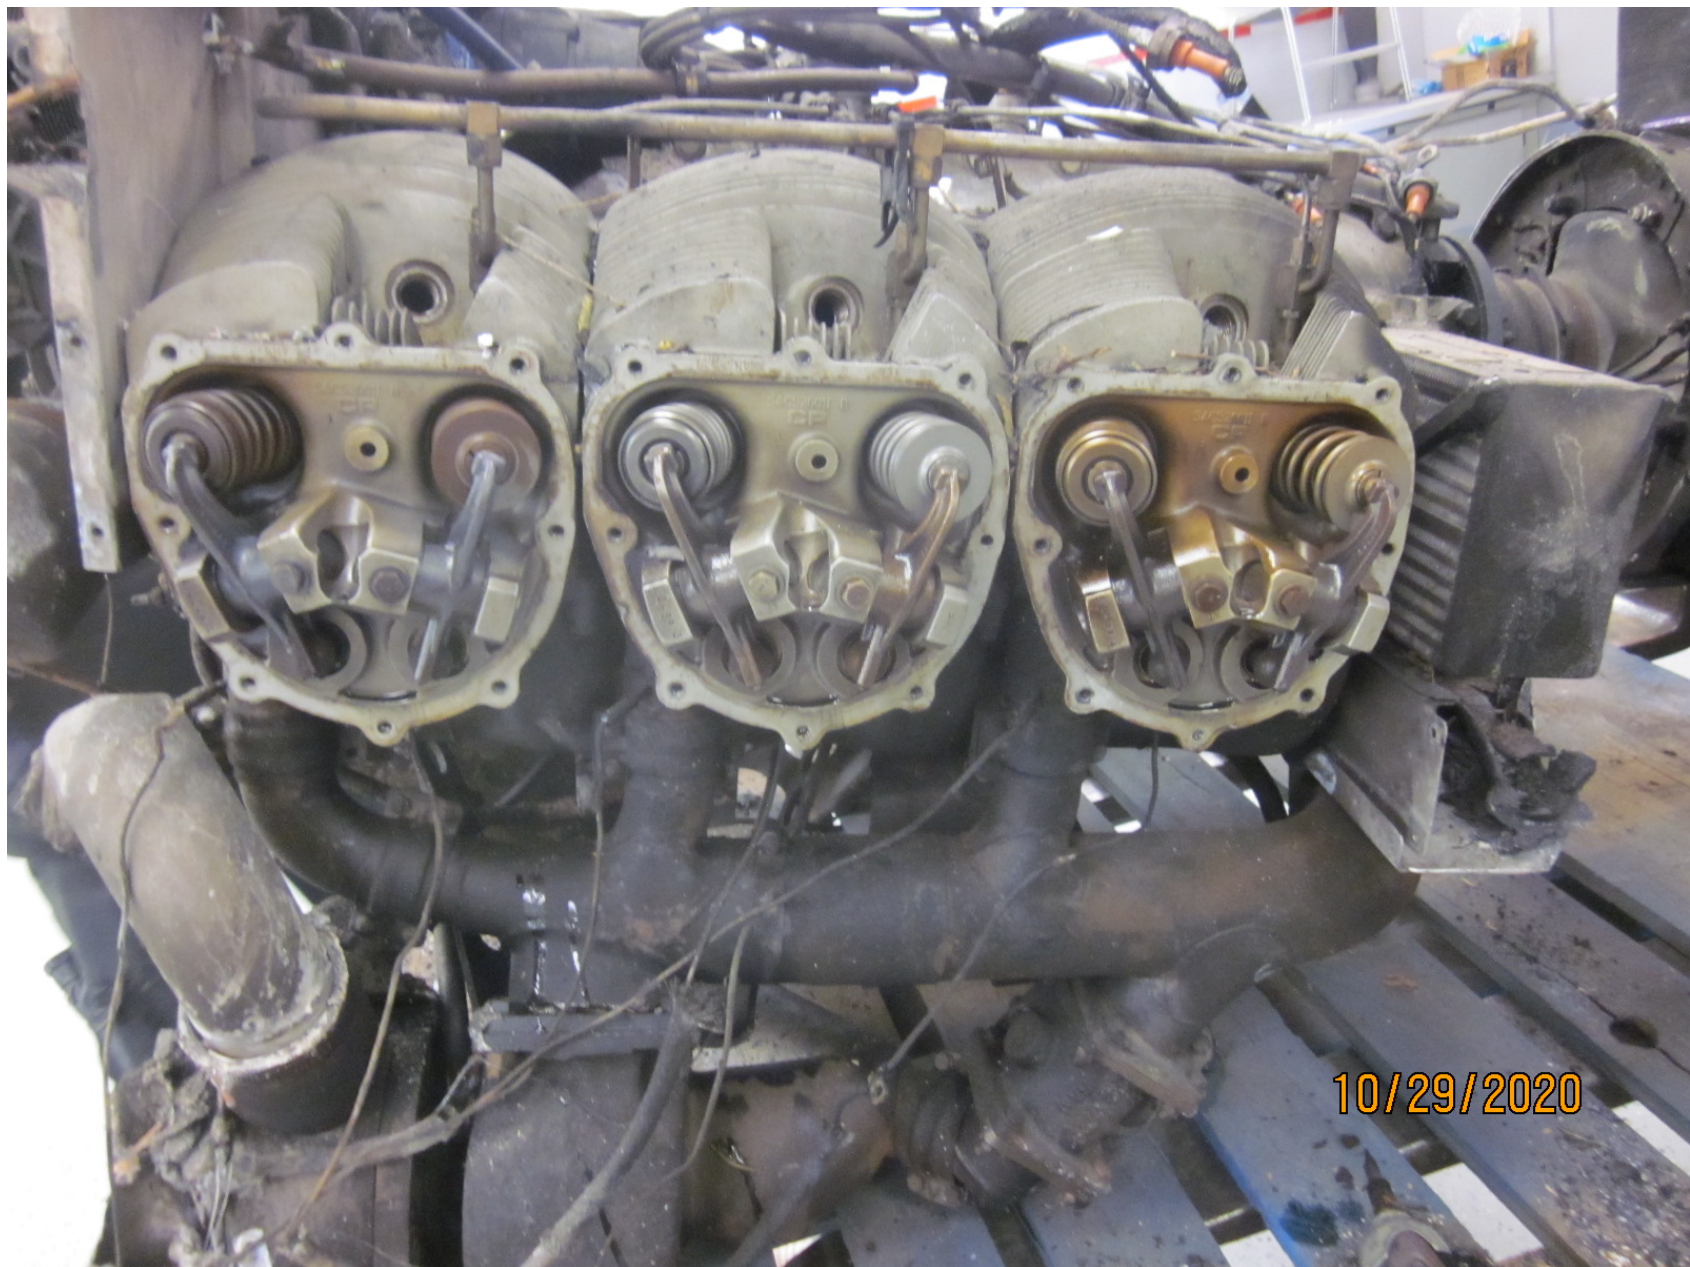
**Photo 2 – Engine cylinder head after spark plug removal (FAA photo)**

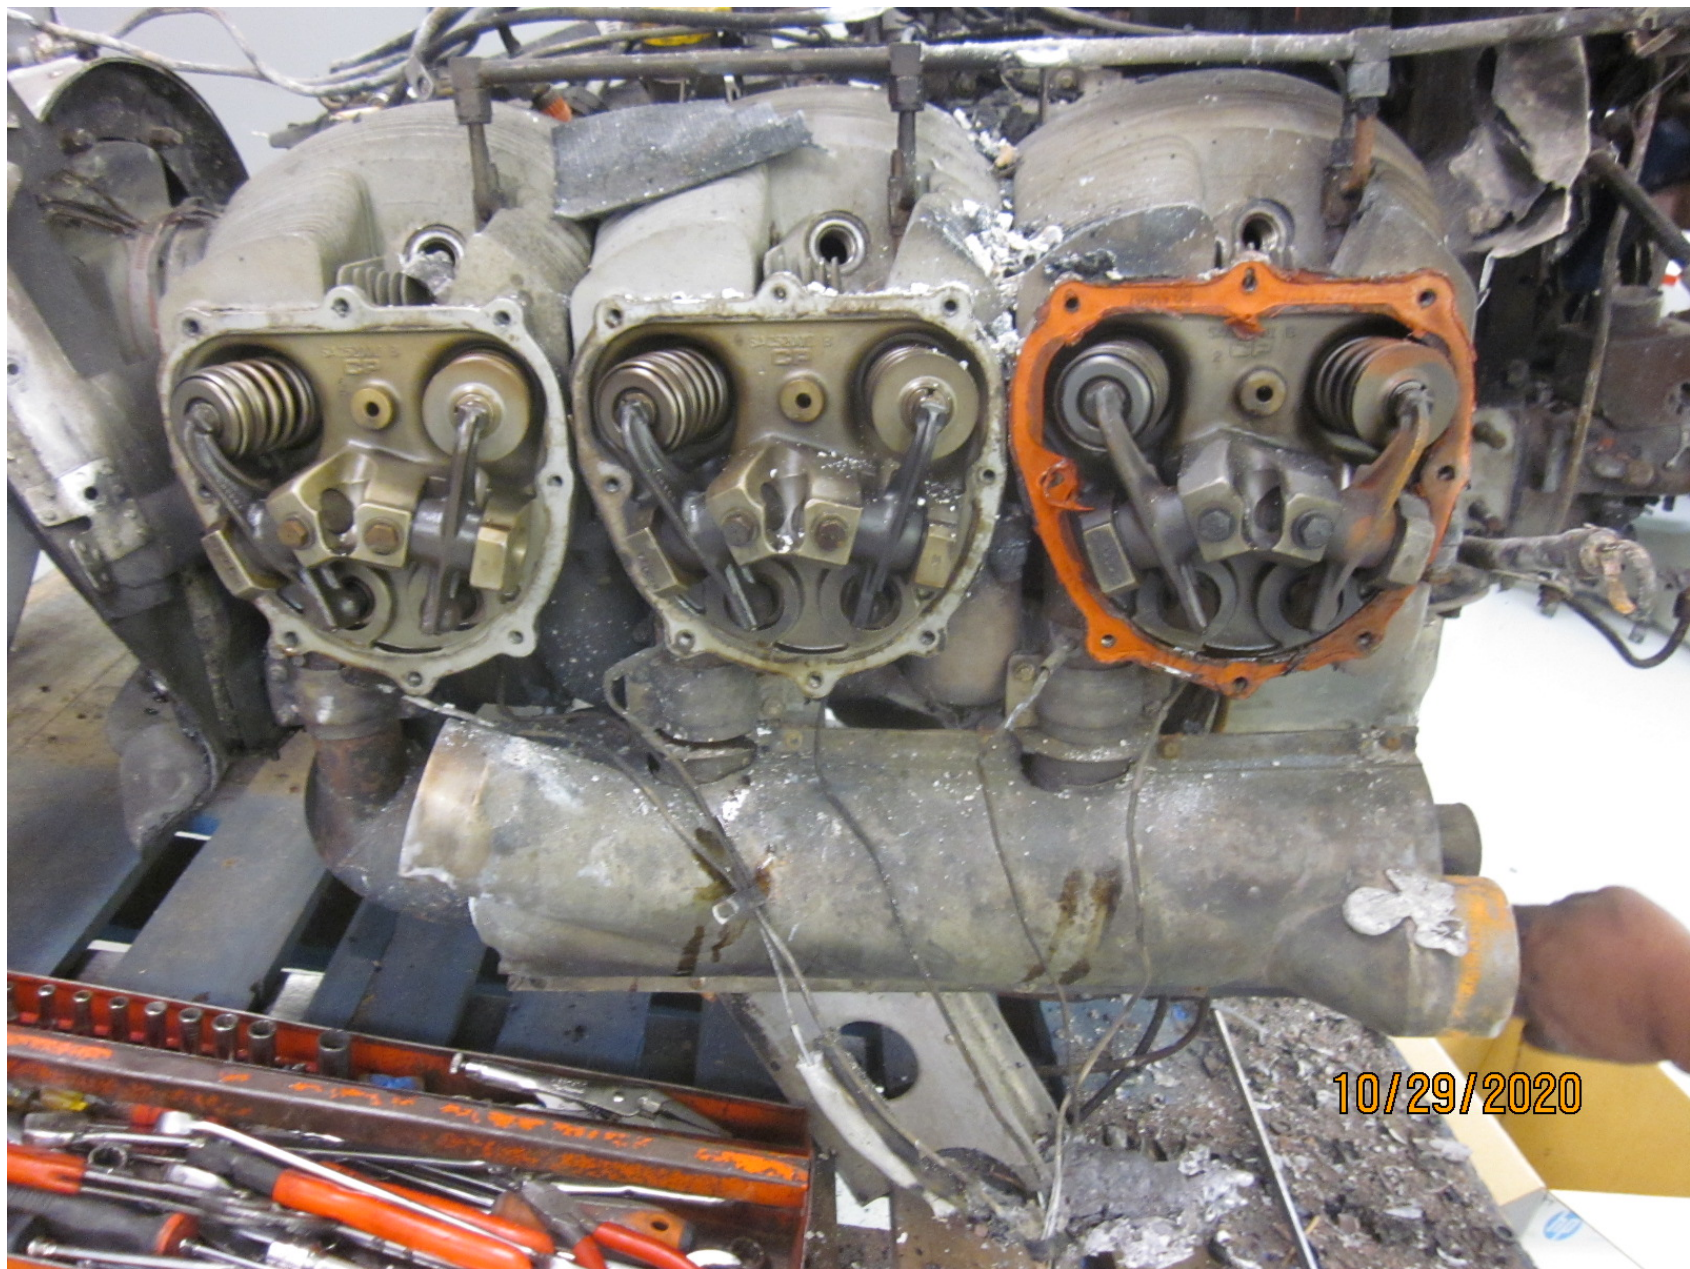
**Photo 3 - Engine cylinder head after spark plug removal (FAA photo)**

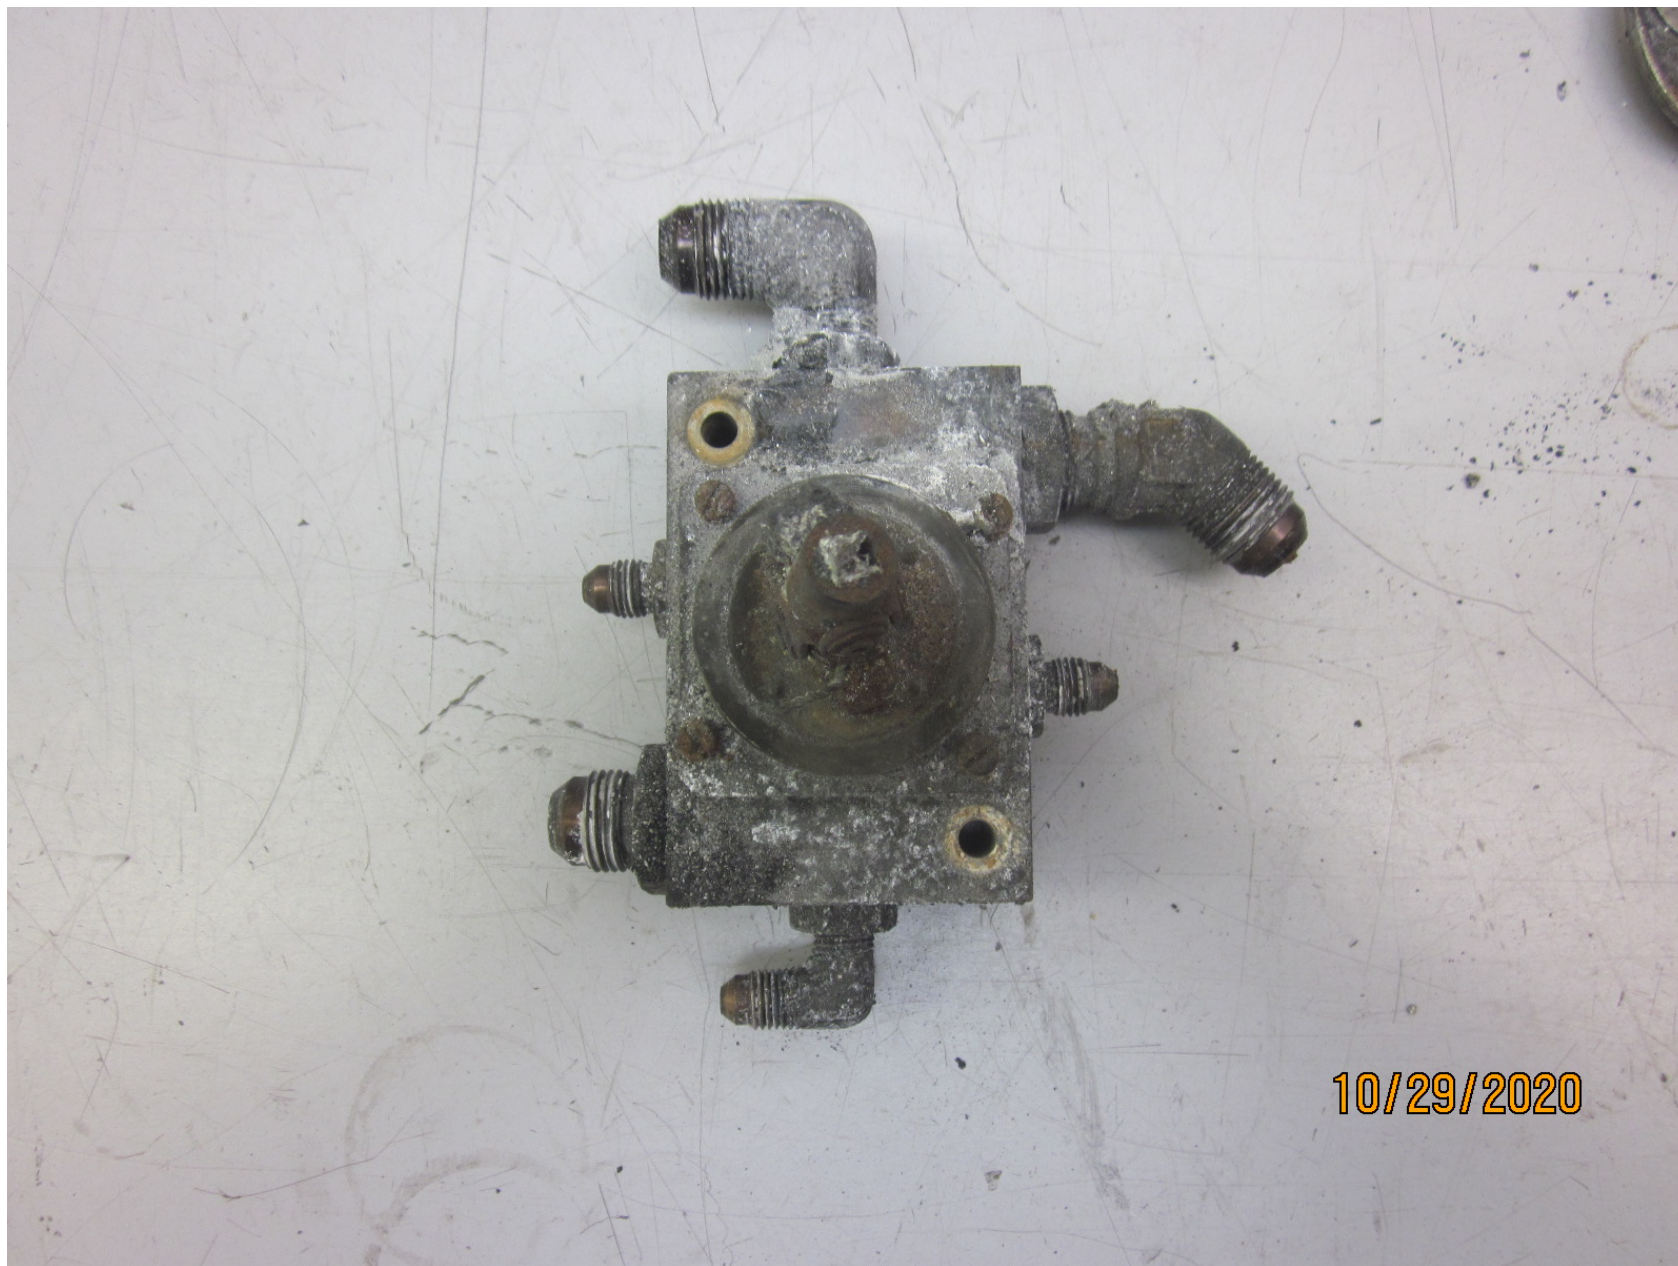
**Photo 4 – Fuel selector valve (FAA photo)**

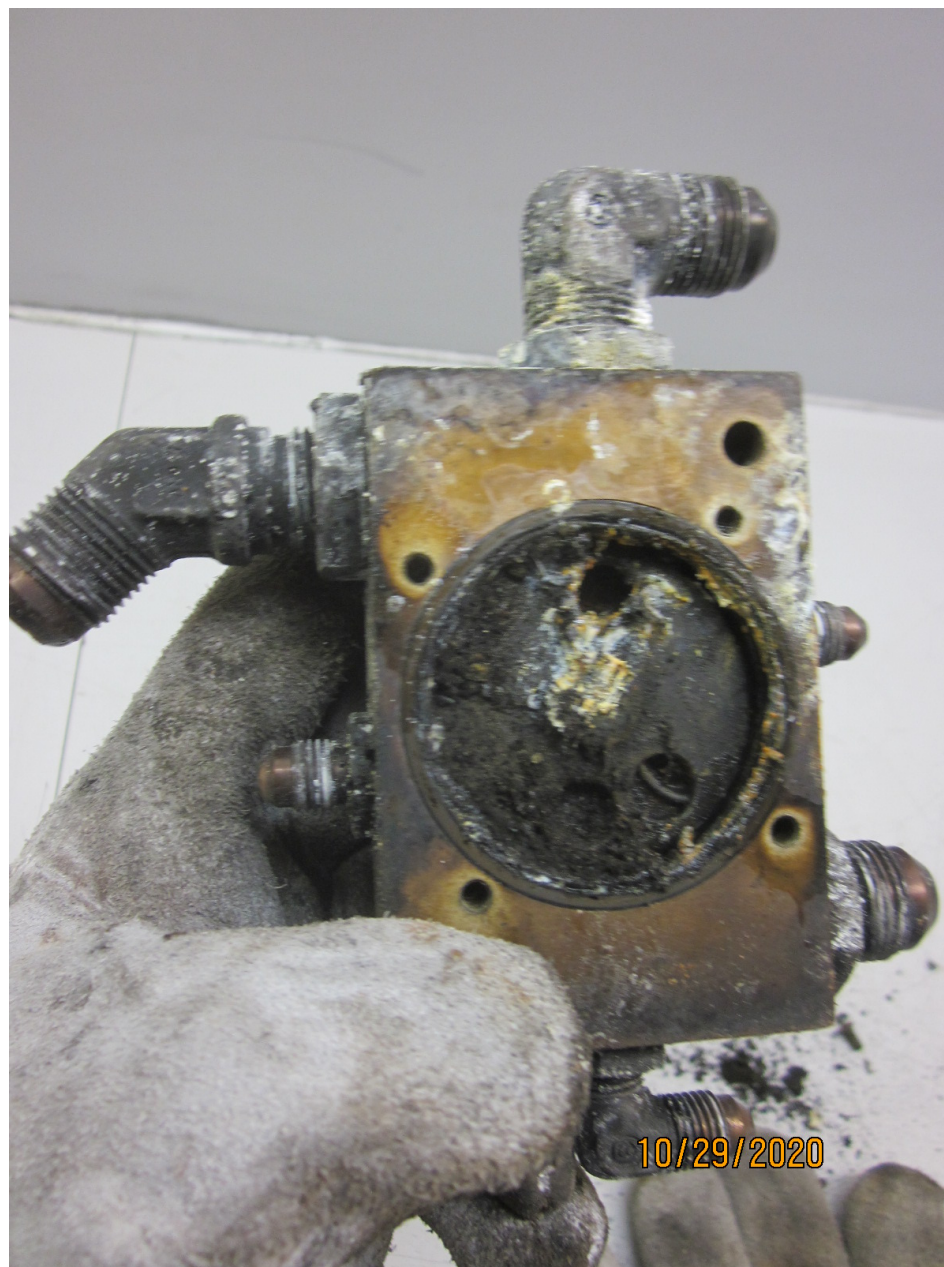
**Photo 5 – Fuel selector valve (FAA photo)**

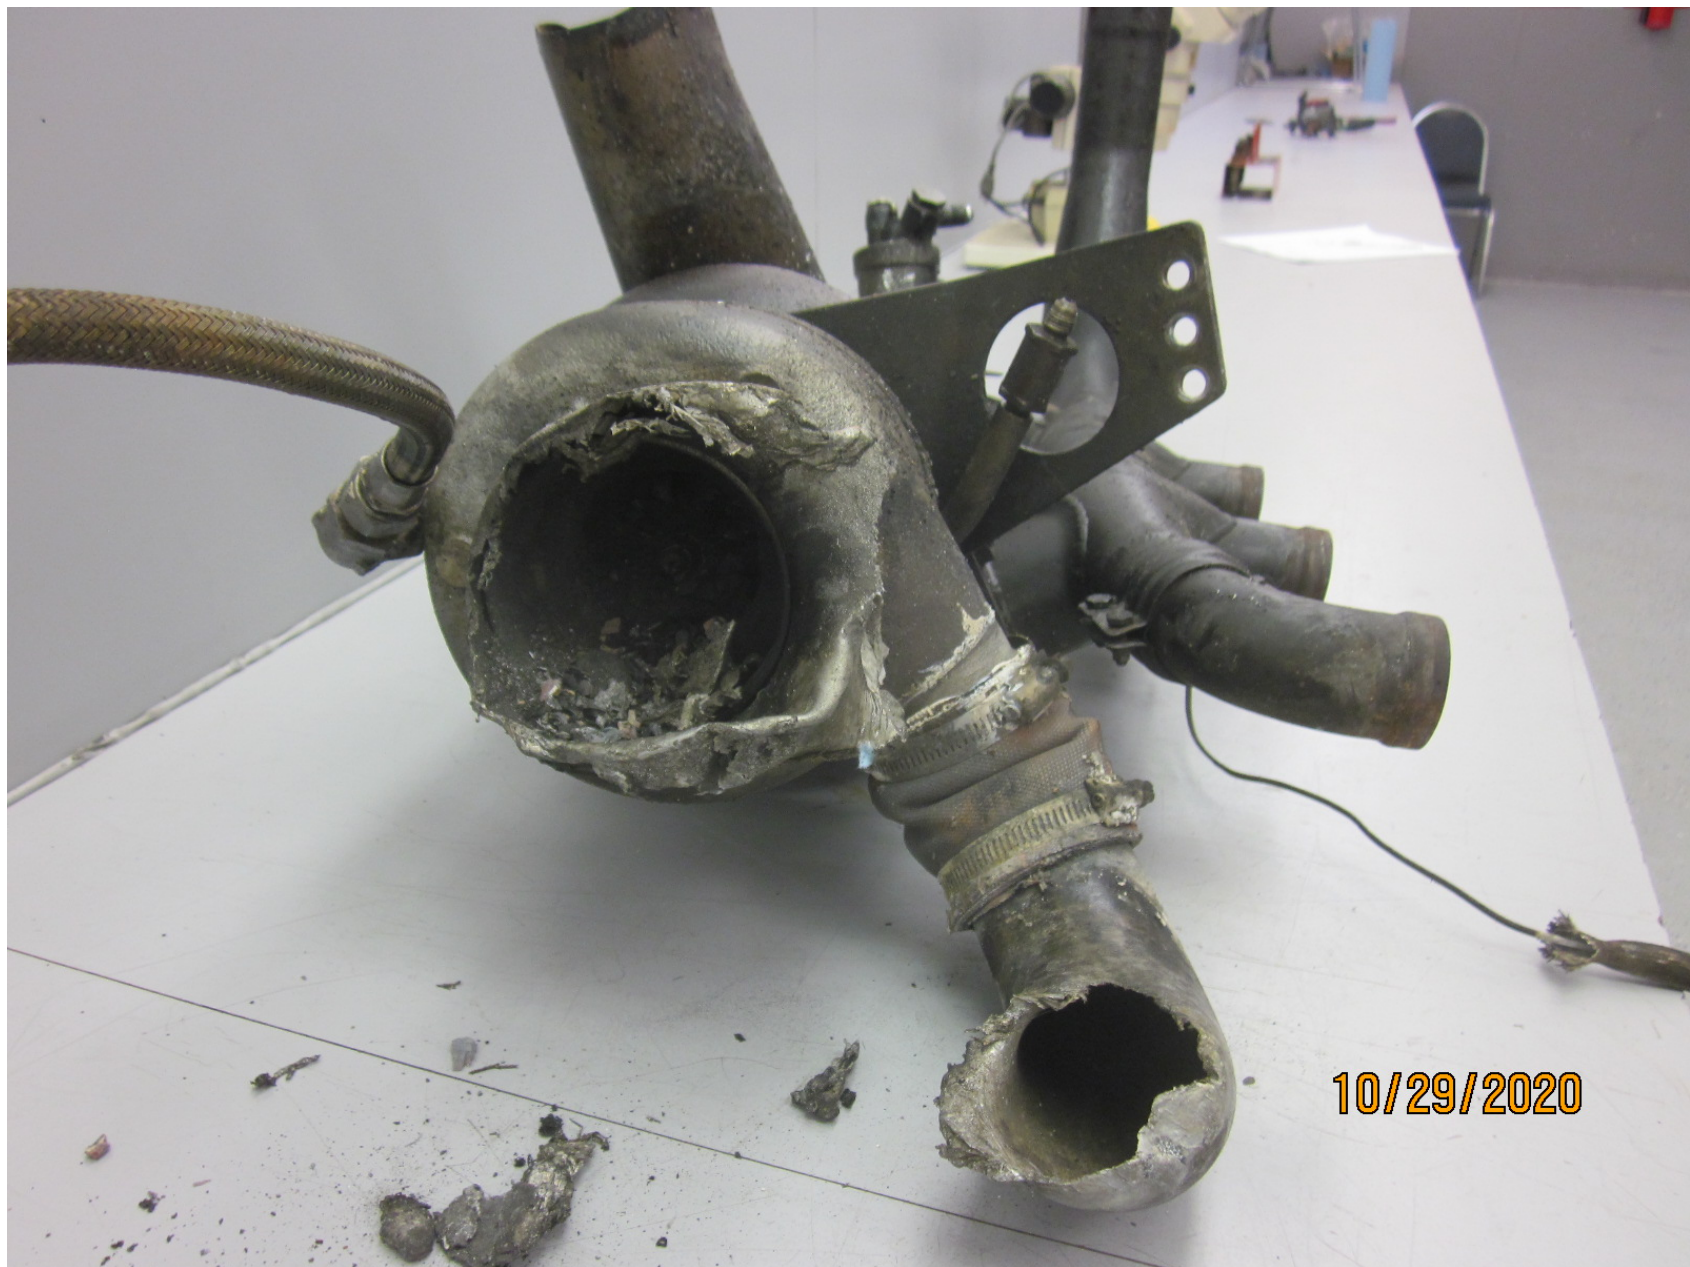
**Photo 6 – Turbocharger (FAA photo)**

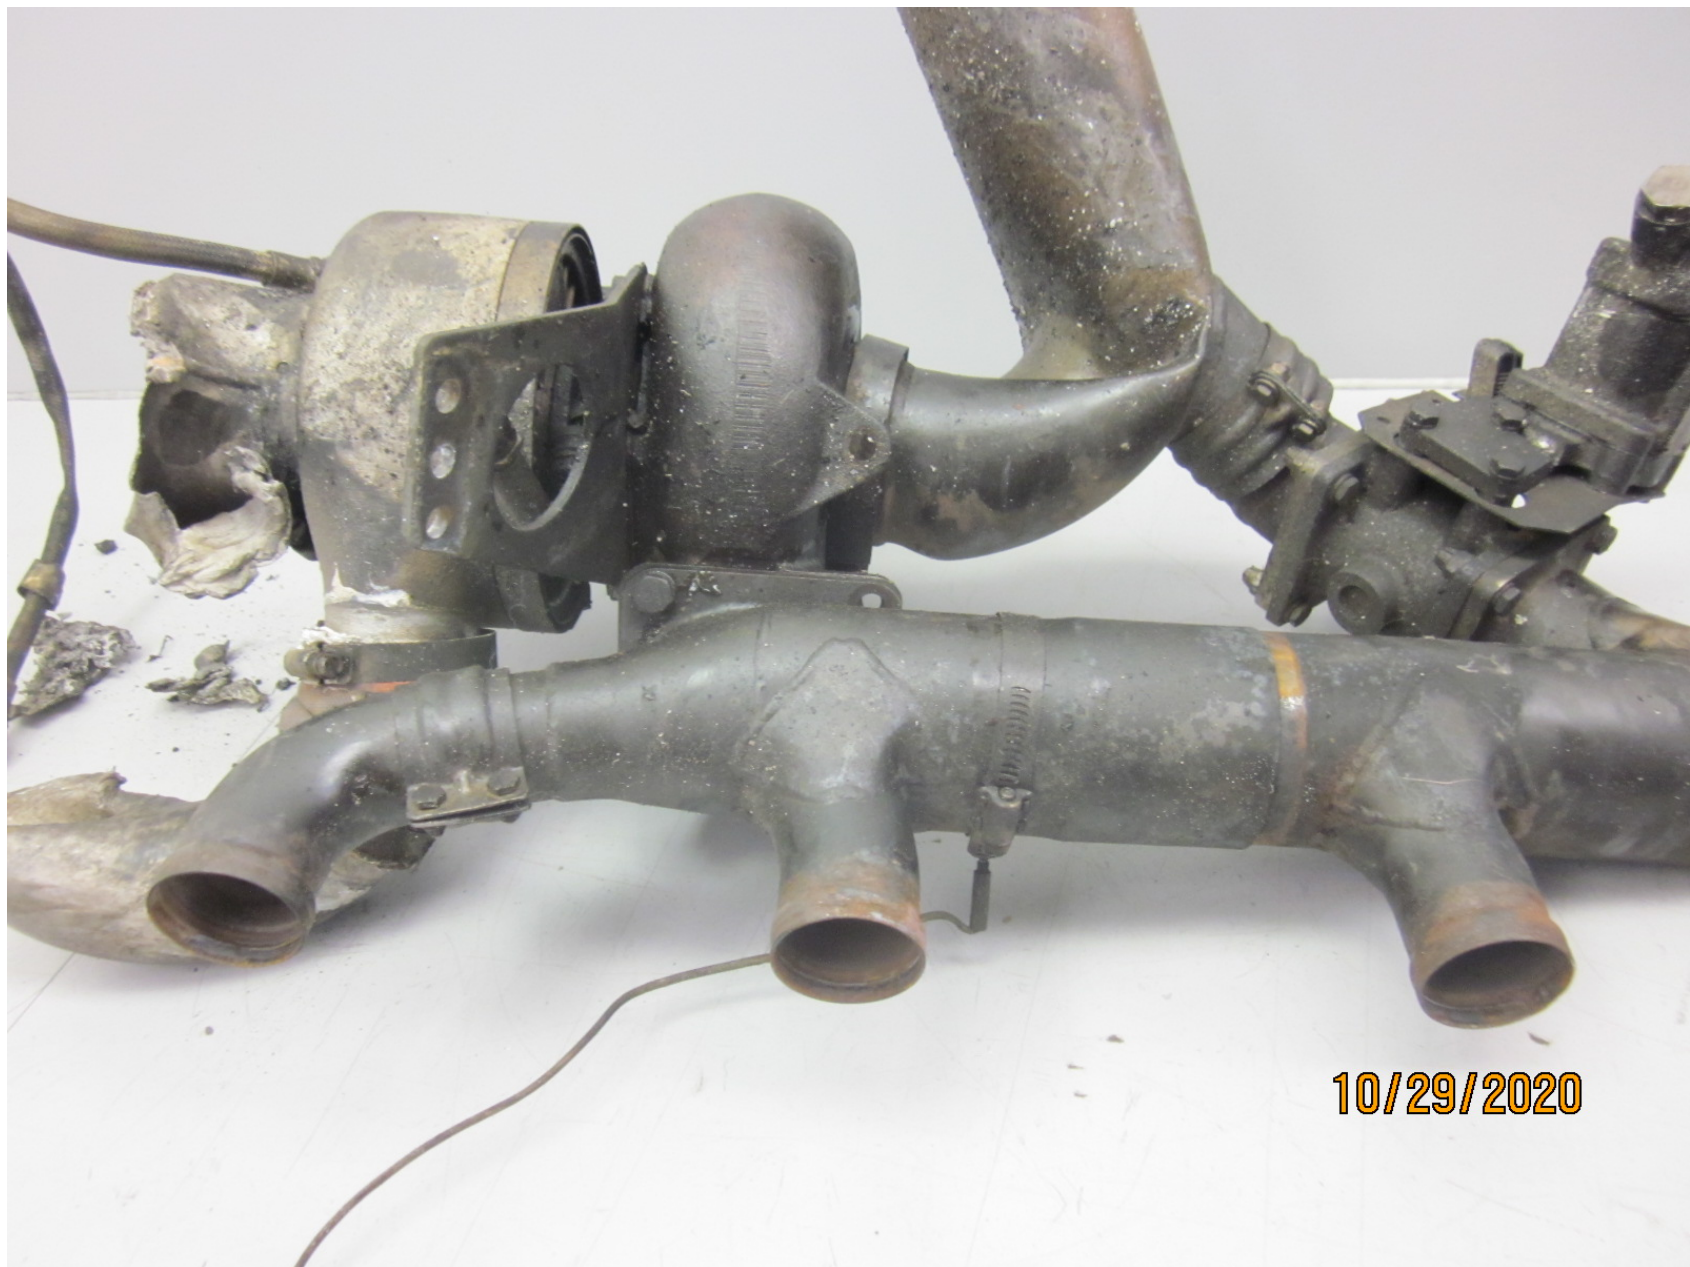
**Photo 7 – Turbocharger, wastegate, and exhaust manifold (FAA photo)**

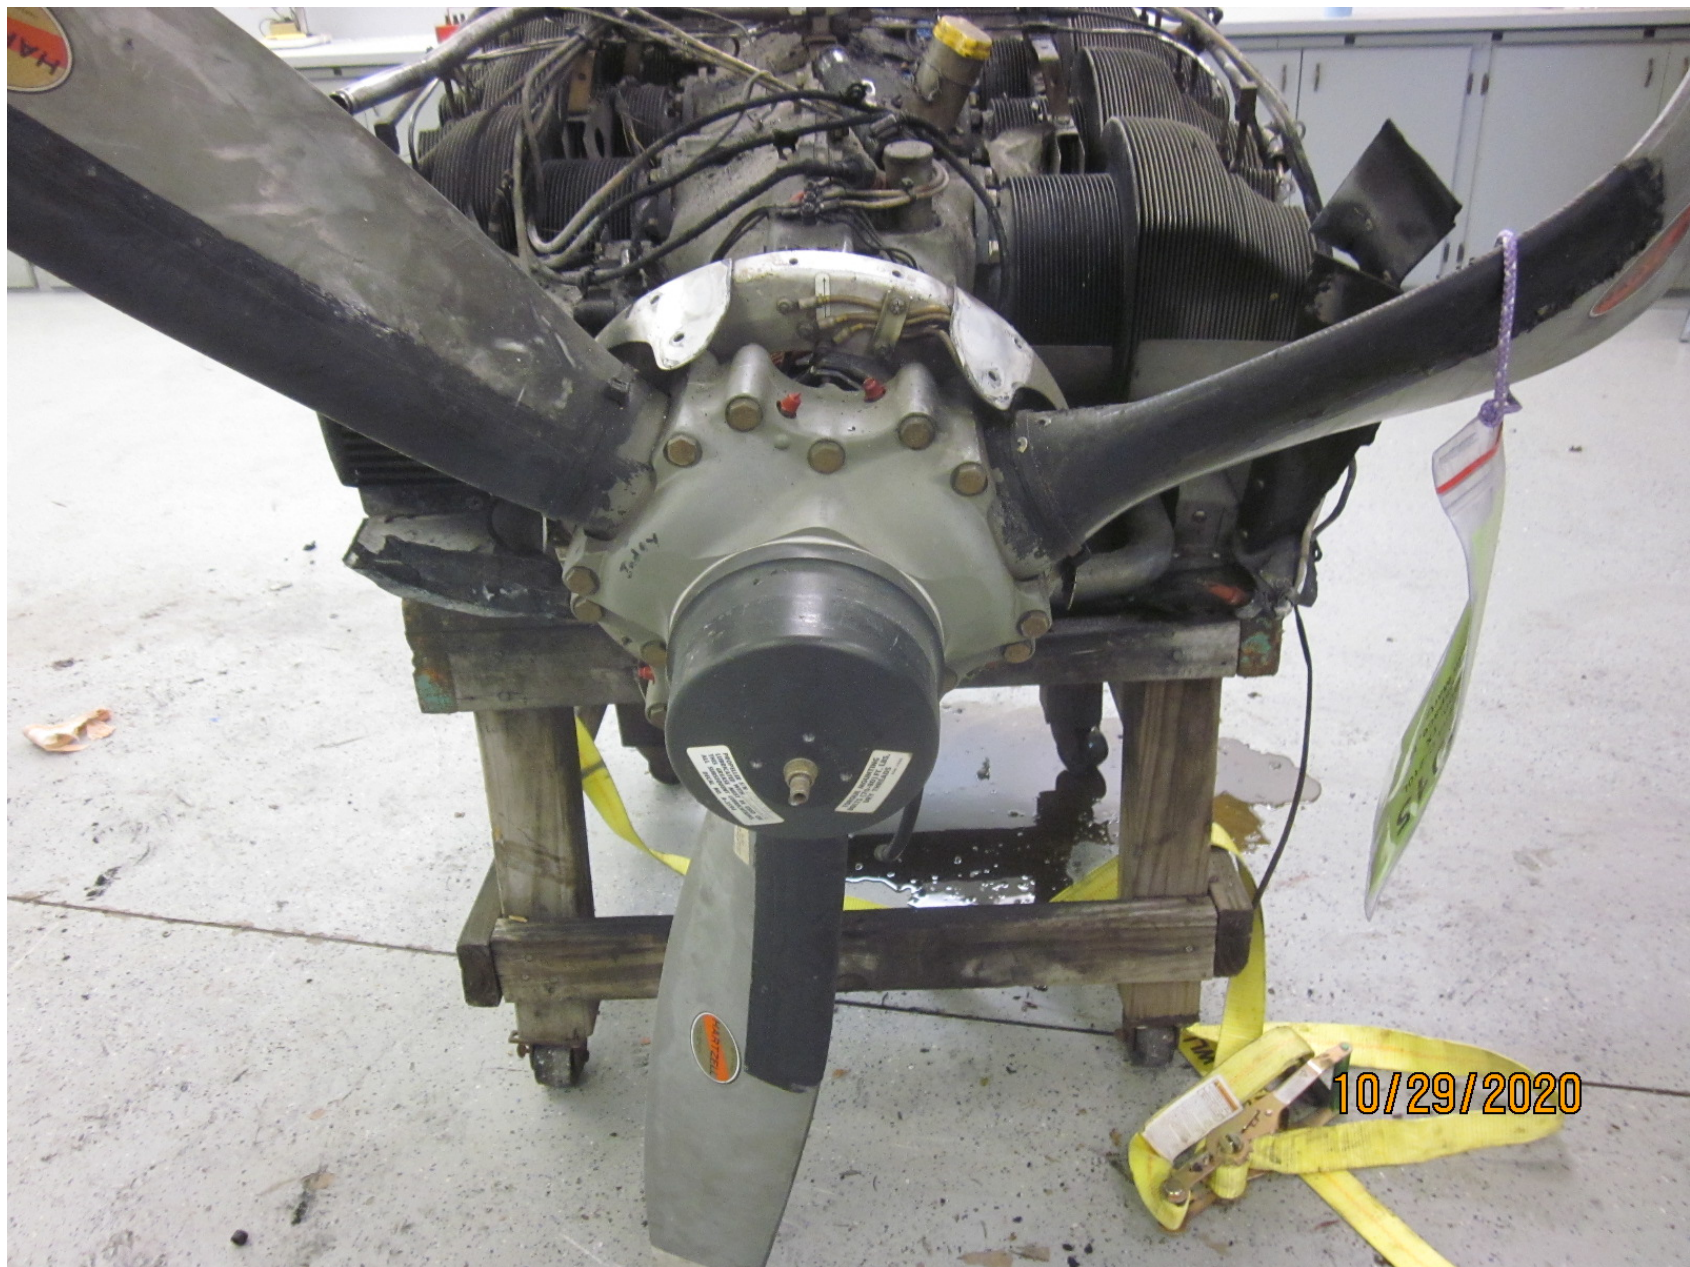
1. Based on this inspection it appears there isn't any reason the engine shouldn't have been running.
2. The condition of the propeller blades indicates the engine was not running. (Post-accident observation)

**Photo 8 – The engine and propeller (FAA photo)**
