**NATIONAL TRANSPORTATION SAFETY BOARD**  
Office of Aviation Safety

**STRUCTURES GROUP CHAIRMAN'S FACTUAL REPORT**

**CEN20LA175**

Operator: Ameriflight, LLC  
Location: San Antonio, Texas  
Date: May 8, 2020  
Time: 2050 Central Daylight Time (CDT)  
Aircraft: Beechcraft 1900C, SN UB-12  
Registration: N31704

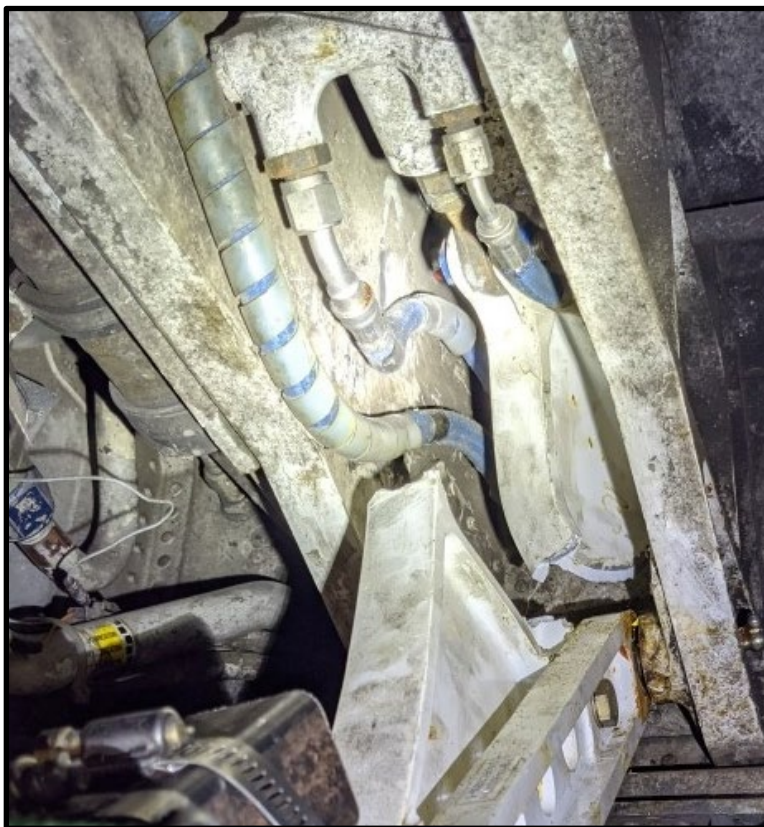
The airplane sustained abrasion damage to the lower surface of the left wing, left aileron, left flap, and LMLG doors. In places, the abrasion penetrated the skin causing damage to the underlying structure. The outboard portion of the 4 blades on the left propeller were separated. The left wing leading edge had two impact impressions. There was damage to the outboard portions of the wing spars. The airplane was lifted to allow the LMLG to be manually extended and pinned in place. The upper drag leg arm was fractured, and the actuator forward rod end was bent (Figure 3).

*Figure 3-Fractured left Upper Drag Leg Arm on accident airplane.*

The accident airplane LMLG actuator and fractured drag brace assembly were sent to the Textron Aviation Material and Process group for examination under the direction of the NTSB. The FAA attended the examination in person and the NTSB and Ameriflight participated virtually. Ameriflight records indicated that the drag leg assembly had accrued 7.1 hours and 8 landing cycles since overhaul. The actuator was unbolted from the upper drag leg arm. See Appendix B for the Textron Aviation report of the examination. The Textron report shows that the upper drag leg arm fractured in bending and twisting overload. There was no evidence of pre-existing cracking or corrosion. The dimensions of the part were consistent with the drawing and the chemical composition and microstructure were consistent with 7075 aluminum alloy as required. The mechanical properties were lower and the electrical conductivity was higher than the requirements for 7075-T6 aluminum alloy. The measured mechanical properties and electrical conductivity did not conform to any standard temper for 7075 aluminum alloy.
