## **NATIONAL TRANSPORTATION SAFETY BOARD**

# **STRUCTURES**

**CEN20LA175**

**Report Title:** Examination of a damaged MLG Drag Leg Assembly p/n 114-810023-1 on Beechcraft 1900C, S/N UB-12, N31704

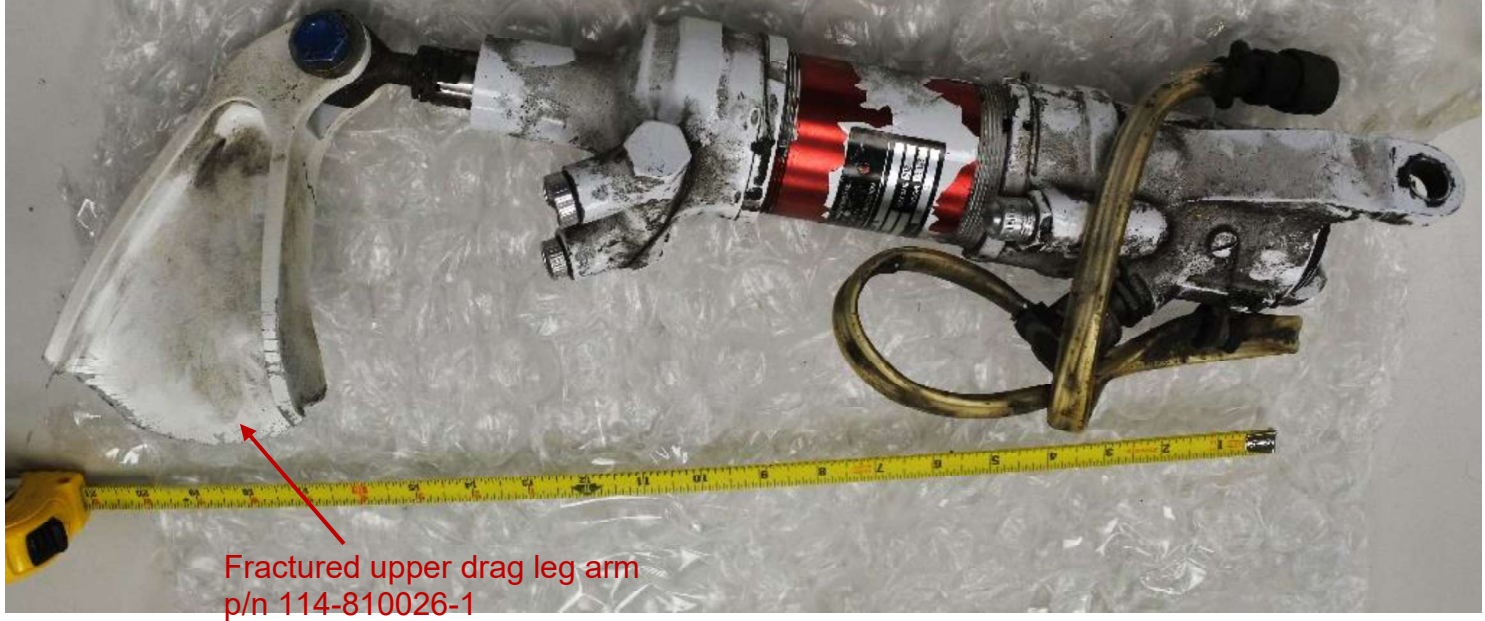
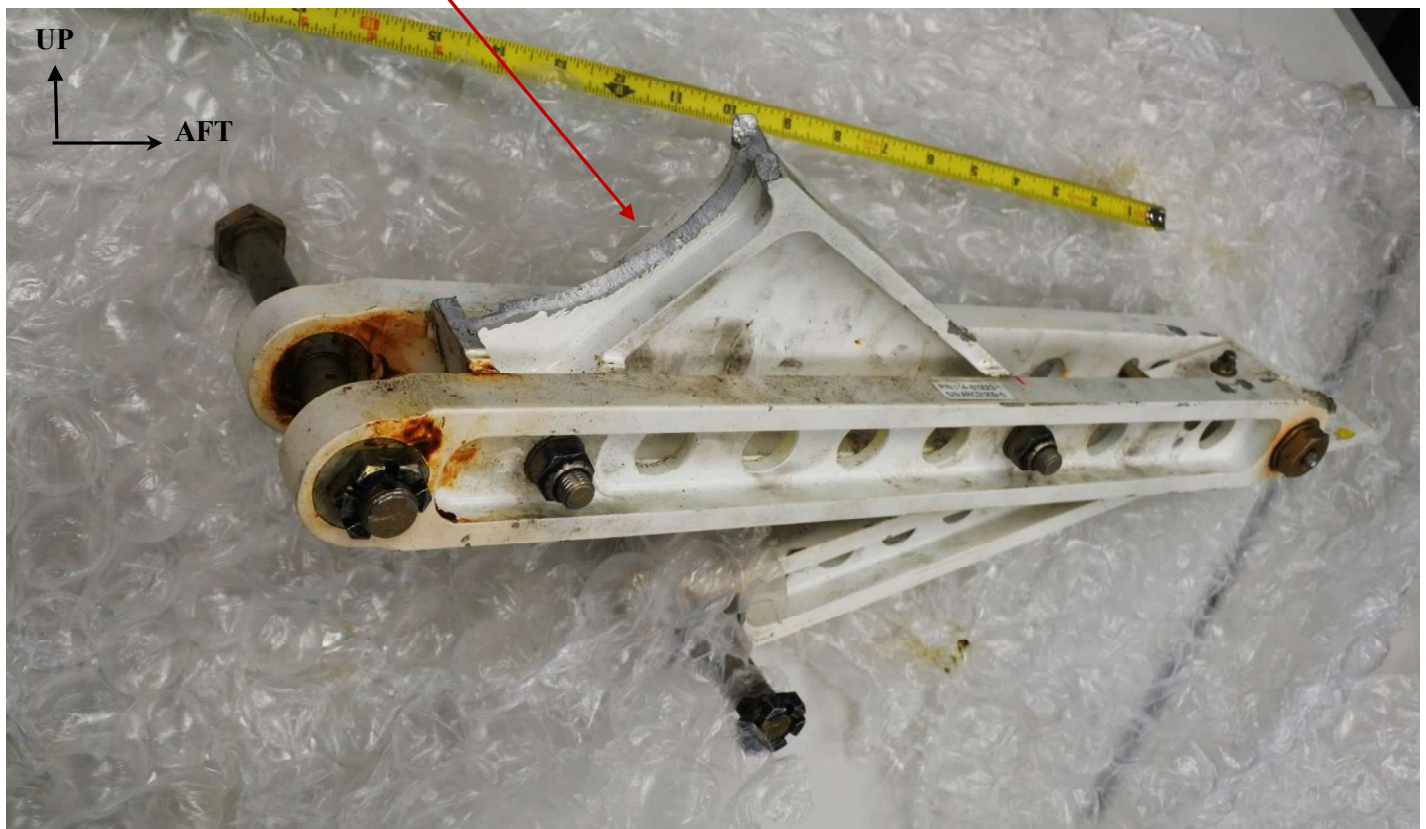
The as-received sections of the left MLG is shown in Figure 3; the upper drag leg arm p/n 114-810026-1 was broken into two pieces fwd of a stiffening web as shown by red arrows. Figures [4-5] show inbd and outbd bending/twisting of the flange and the web near the fracture area of the broken upper drag leg arm. The actuator attach holes on both INBD and OUTBD views displayed deformation of the bushings and the corresponding holes. The paint and primer were cracked and peeled off from the part surfaces near the fracture area; reference Figure 6.

Figure 3 View showing contents of the box in Figure 2. The upper drag leg arm p/n 114-810026-1 was broken into two pieces fwd of a stiffening web as shown by red arrows. Magnification: x0.3.

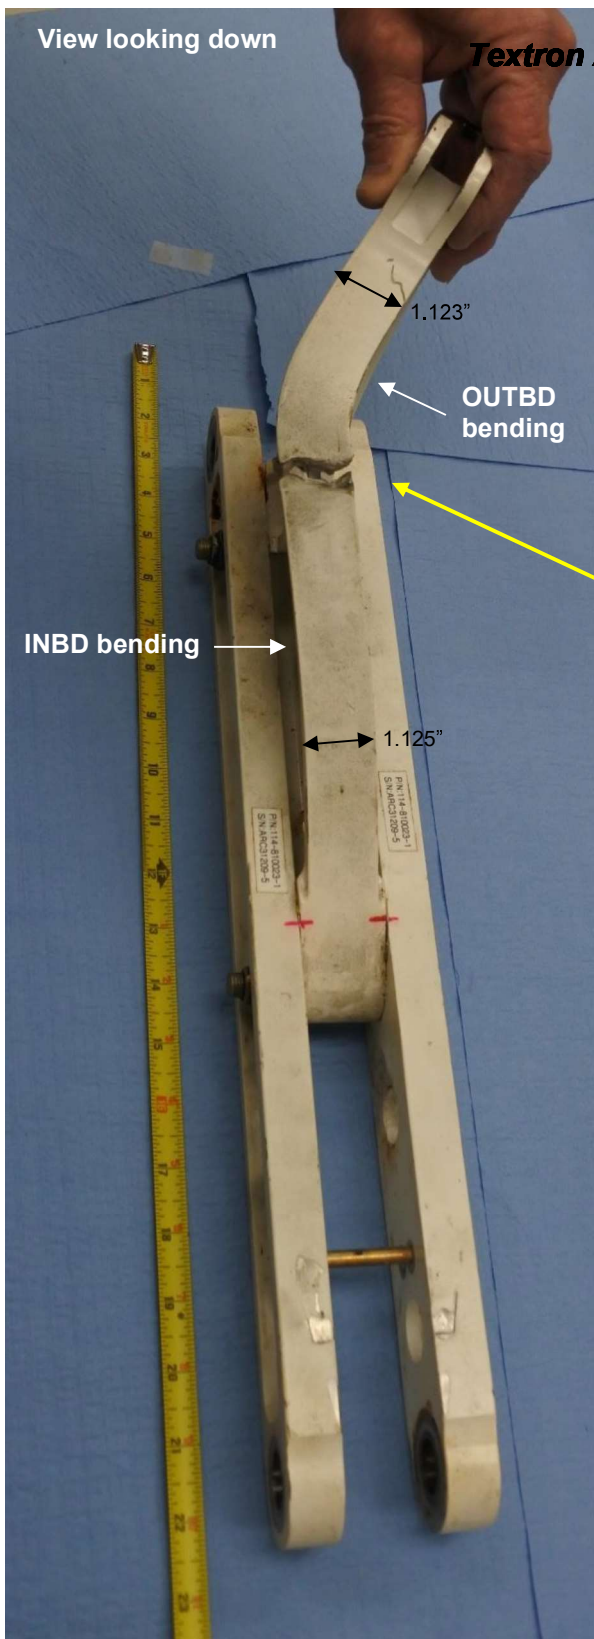
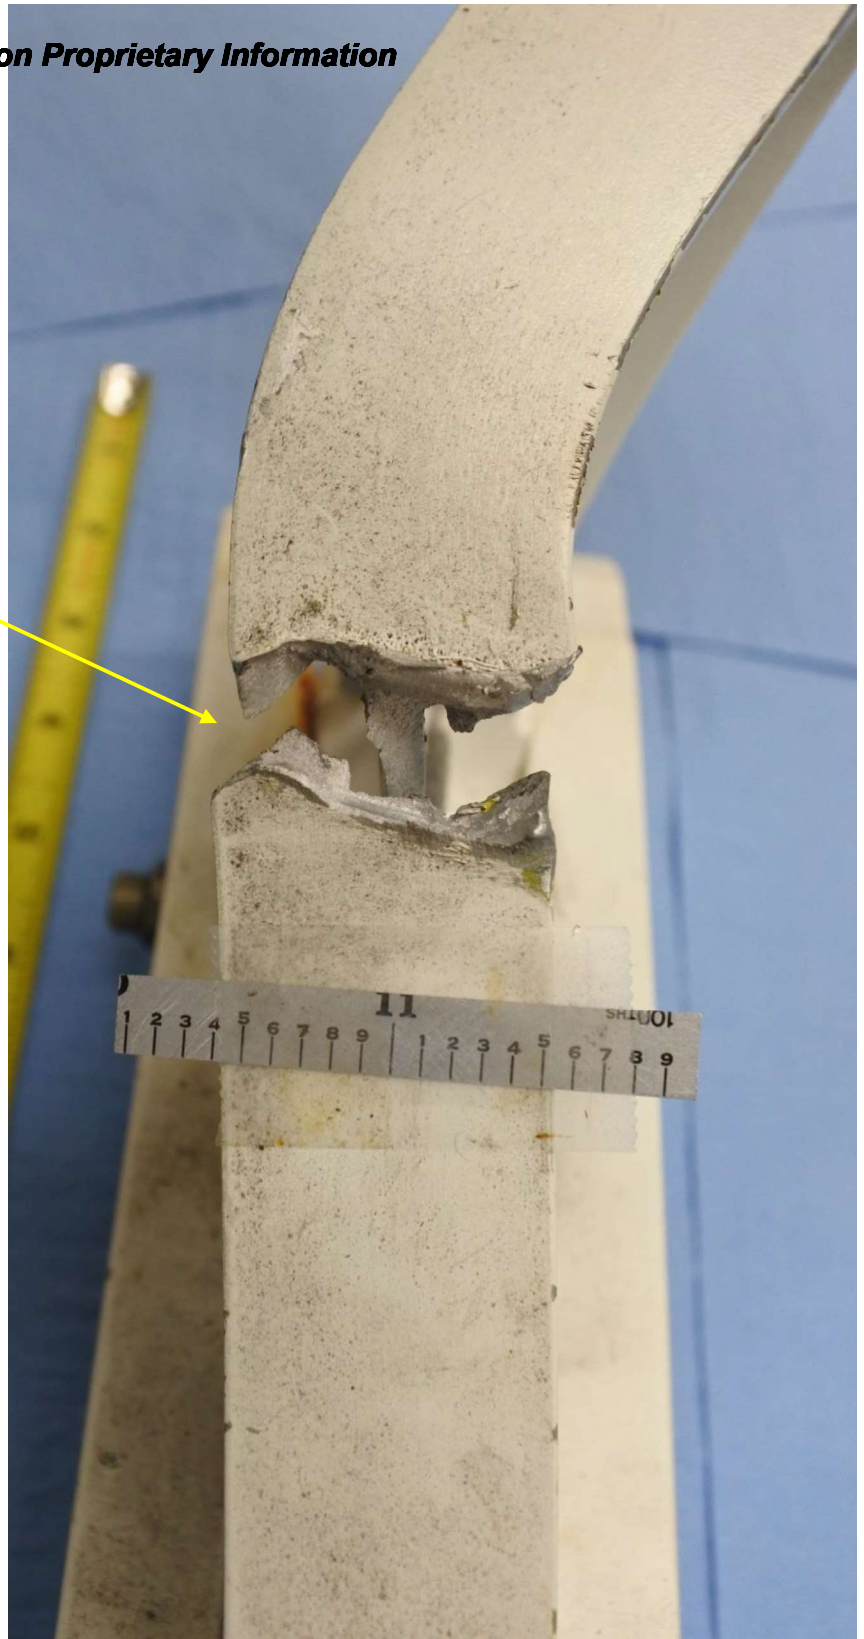
Figure 4 View showing inbd and outbd bending of the fractured upper drag leg arm. The flange width measured approximately 1.123" to 1.125" vs 1.120 +/- 0.010" required by the engineering drawing. Magnification: x0.2 and x1.7.

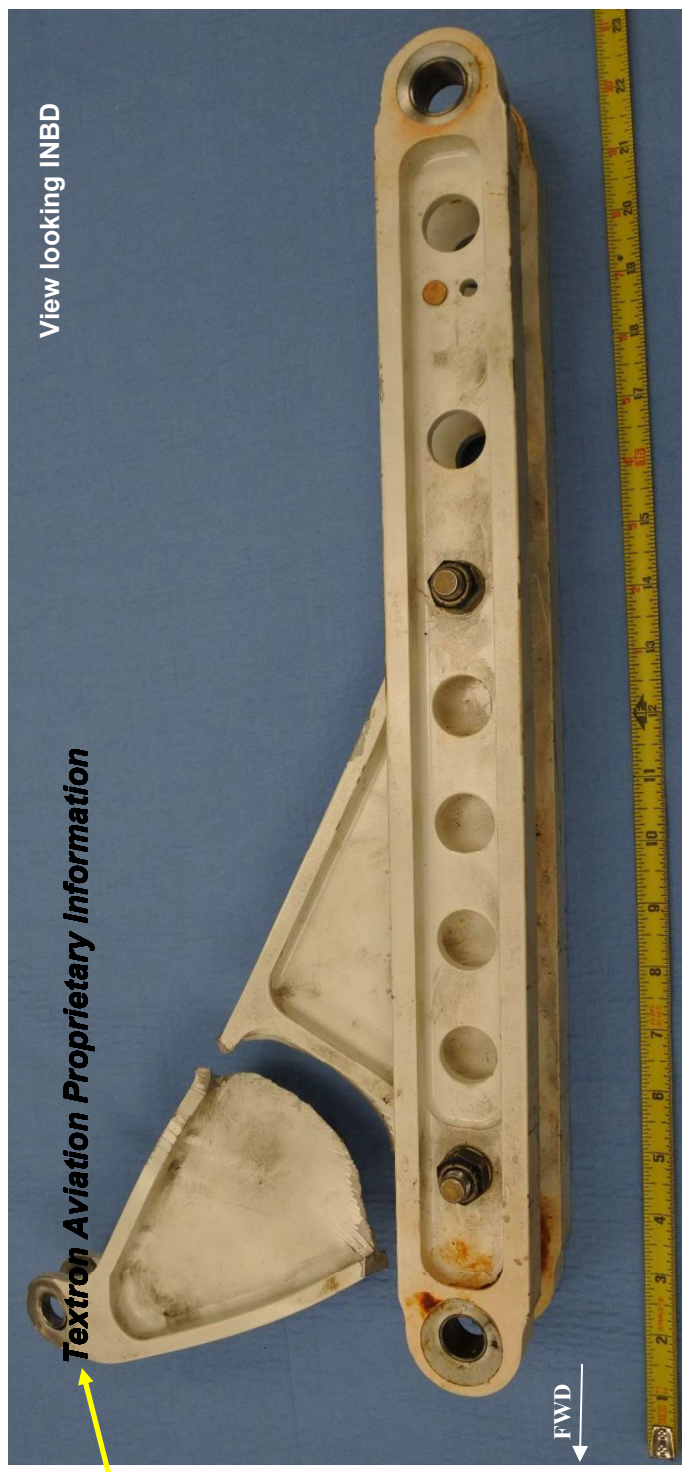
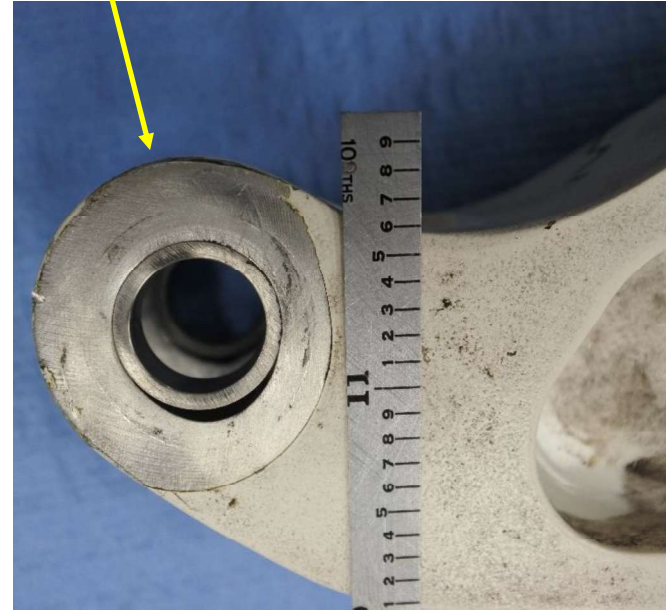
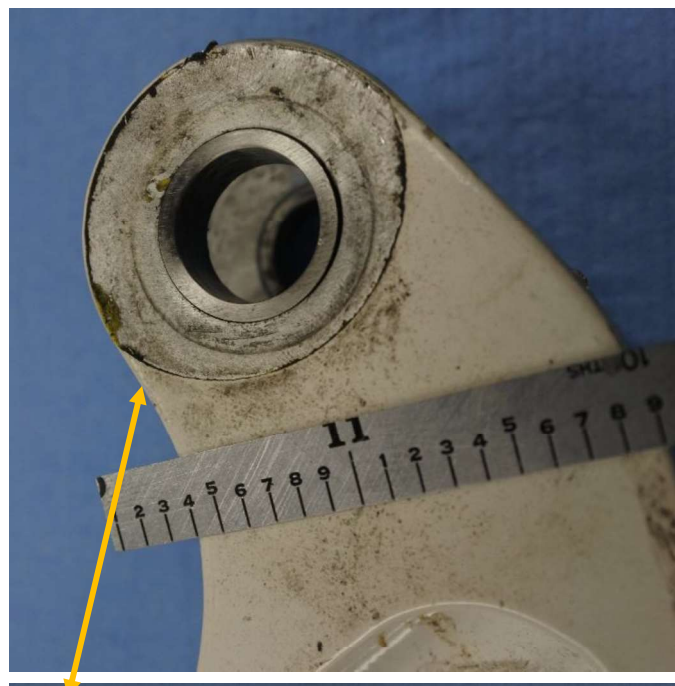
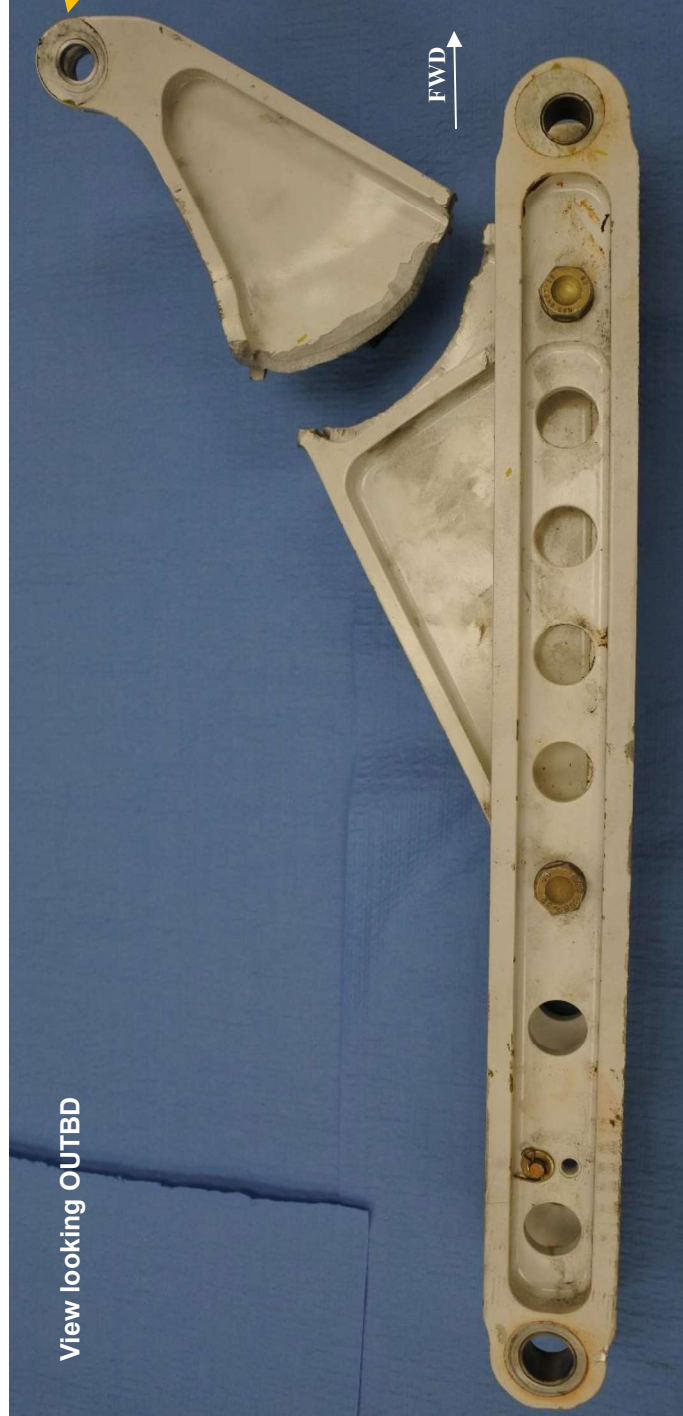
Figure 5 INBD and OUTBD views of the broken upper drag leg arm from Figure 4. As shown both holes were enlarged, and the corresponding bushings were deformed. Flange thicknesses were approximately 0.287" to 0.290" vs. 0.28 +/- 0.03" required. Web thickness measured 0.180" approximately vs. 0.18 +/- 0.03" required. Magnification: x0.4 and x1.5.

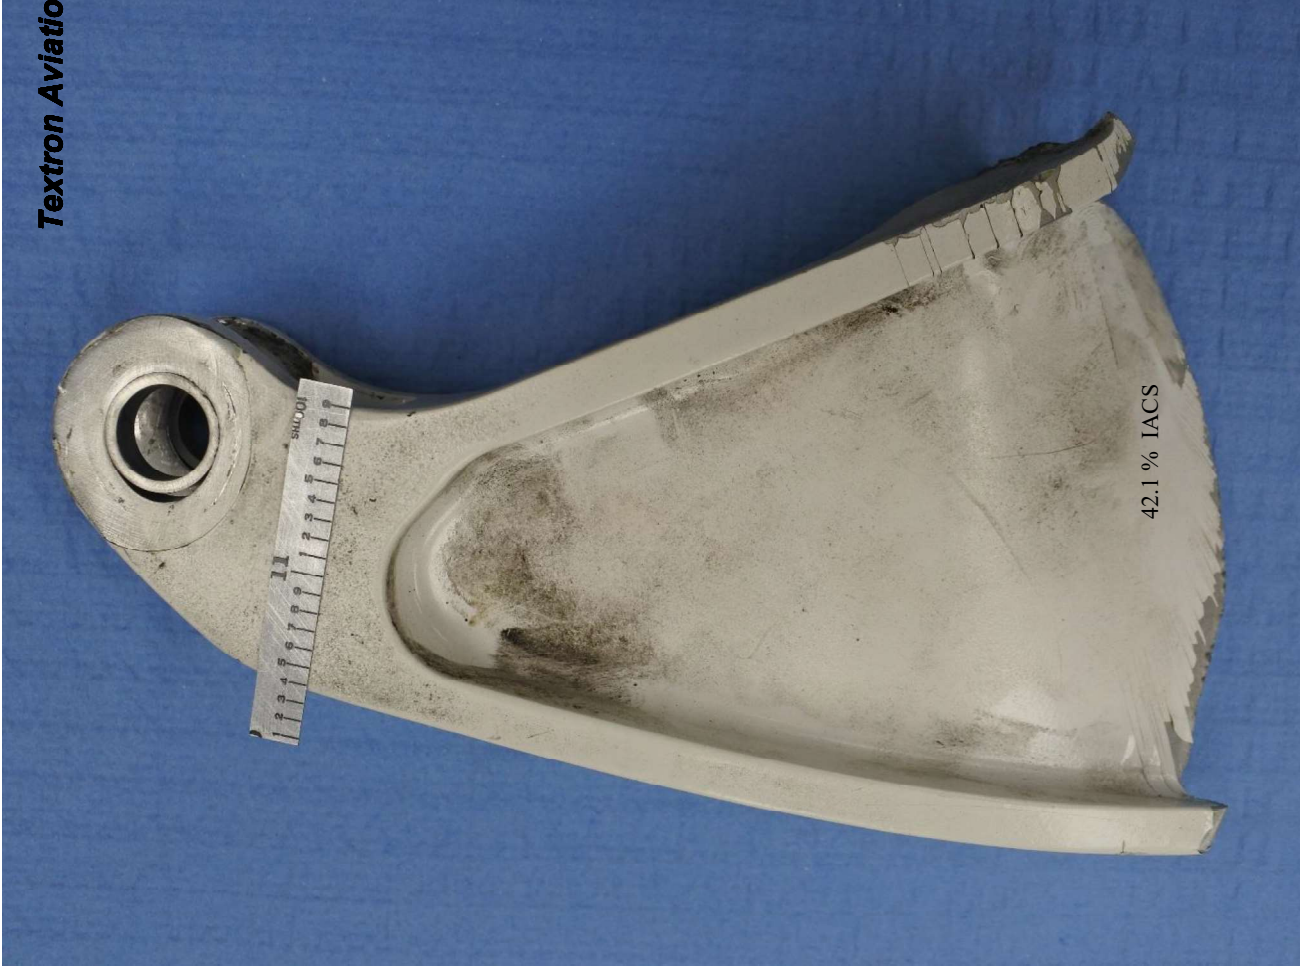
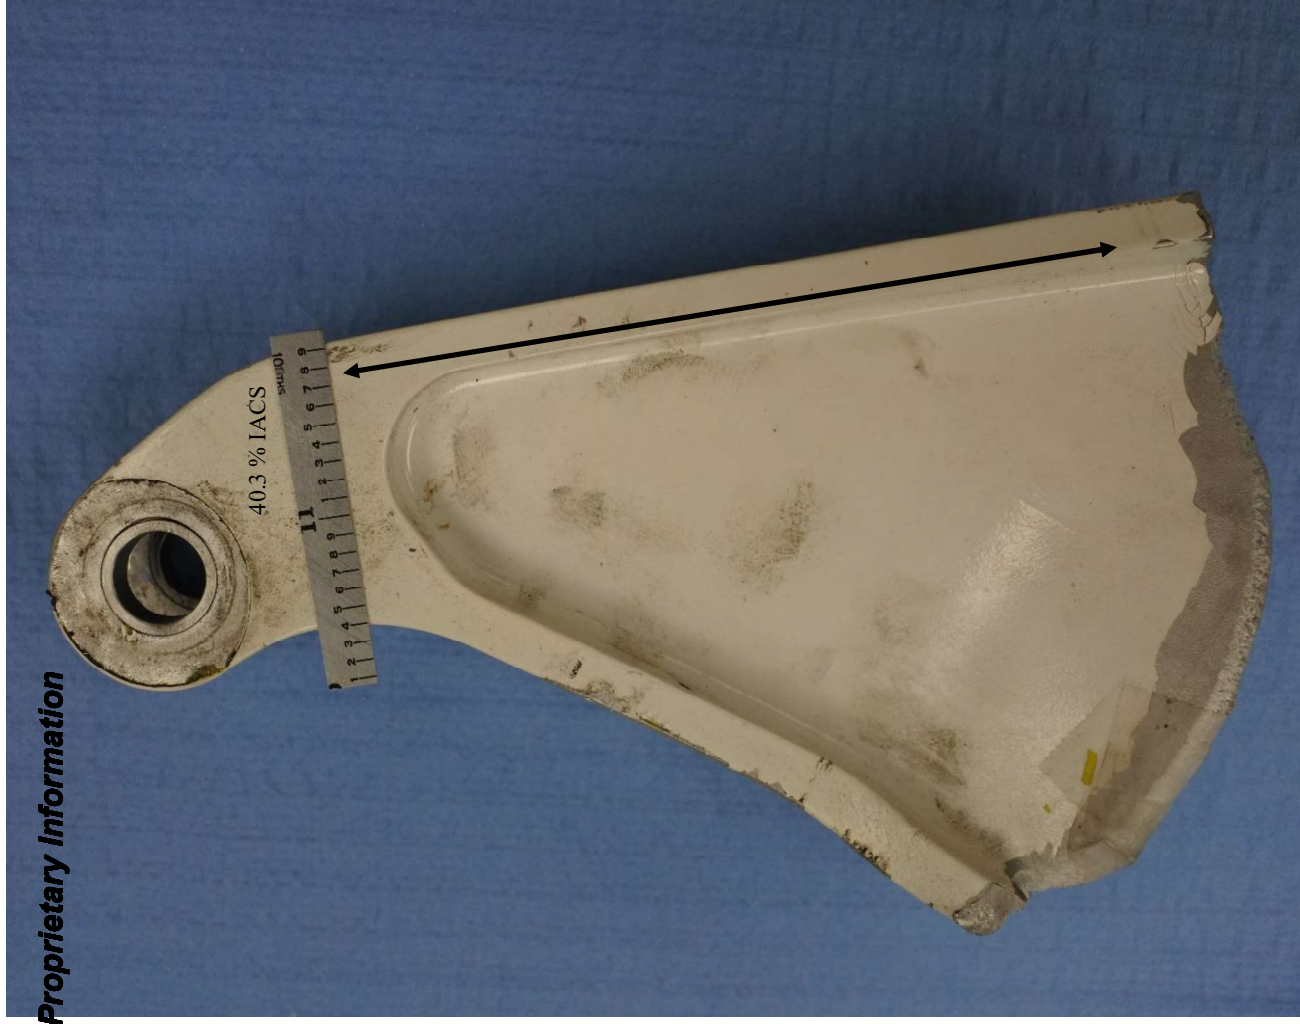
Electrical conductivity measurement on the upper drag leg arm p/n 114-810026-1 indicated higher values near the fracture area and lower readings farther away; reference Figures [6 and 11]. The conductivity measured (38.5 - 42.1) % IACS vs. (30.5 – 36.0) % IACS typical for 7075-T6 aluminum alloy plate per AMS2658.

Figure 6 The paint and primer were cracked and peeled off from the part surfaces near the fracture area. Electrical conductivity measured higher near the fracture area, 42.1 % IACS. The typical electrical conductivity for 7075-T6 plate is 30.5 – 36.0 % IACS. Black arrow depicts tensile specimen location on the flange. Magnification: x1.1.

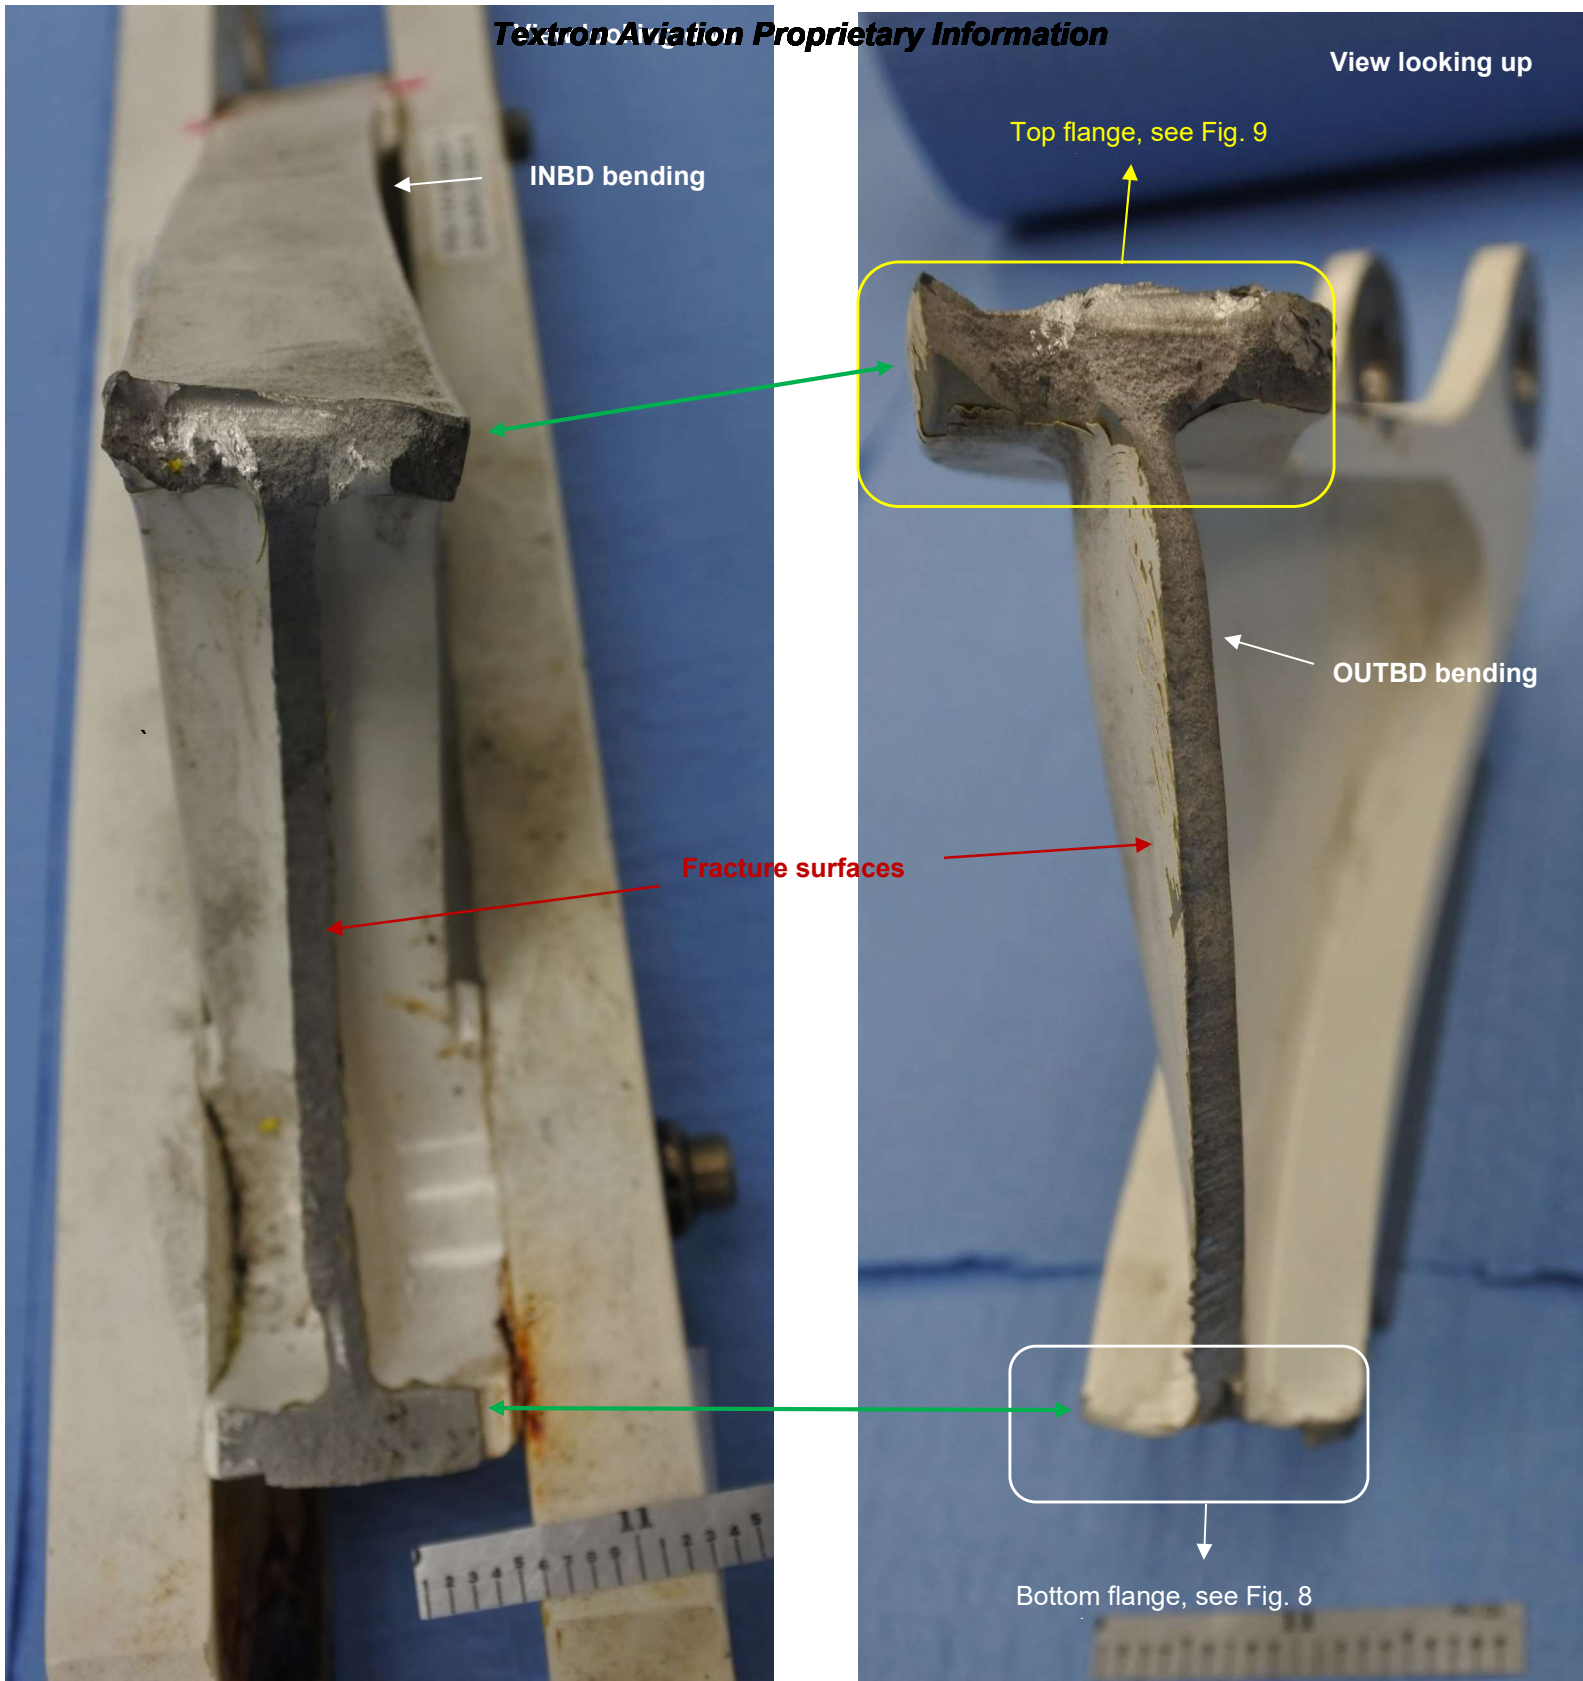
Figure 7 shows visual appearance of the fracture area on both the top and the bottom fragments. As seen in both views, the top flange displayed larger bending and twisting than the lower flange. The web fracture appeared as shear overload with some areas showing rubbing. Fracture areas near the bottom and the top flanges were sectioned for further examination; reference Figures [8 and 9].

Figure 7 View showing the fracture area on both the top and the bottom fragment. Unlike the bottom flange, the top flange displayed large bending and twisting. The web fracture appeared as 45° shear overload with some areas showing rubbing. Magnification: x1.4 and x1.3.

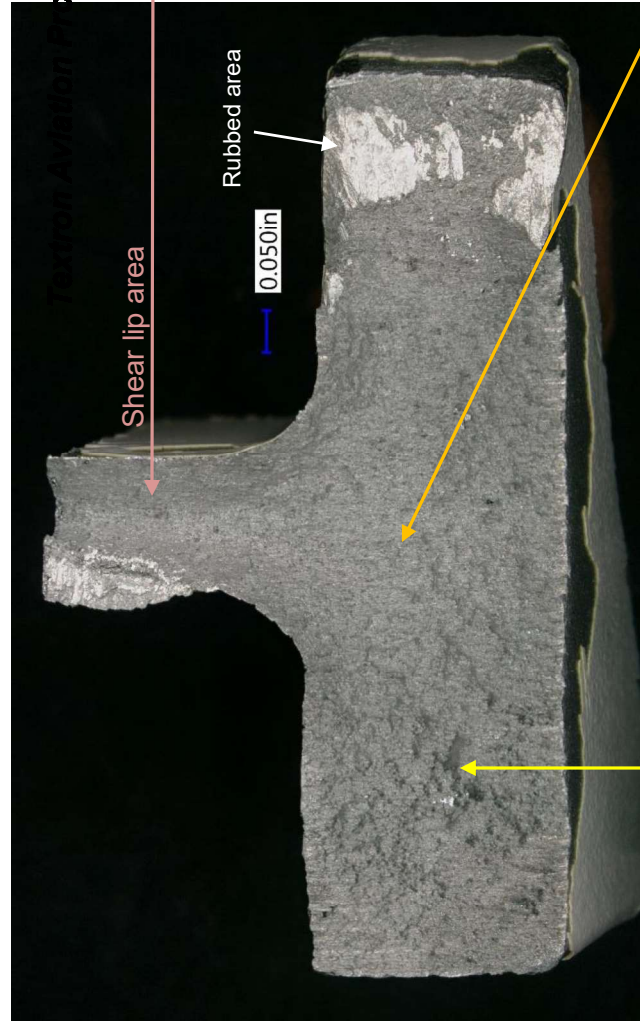
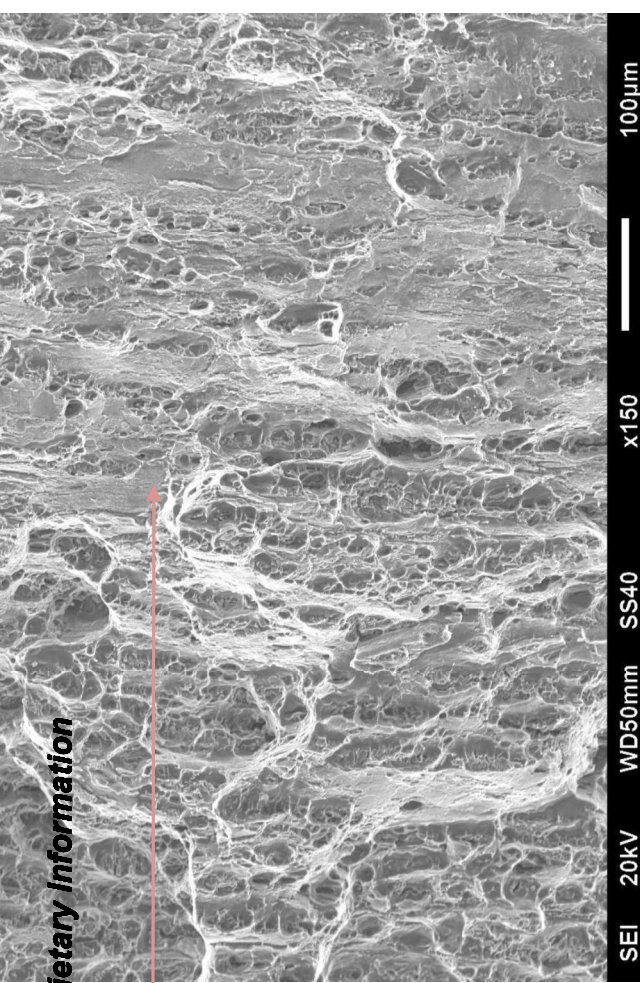
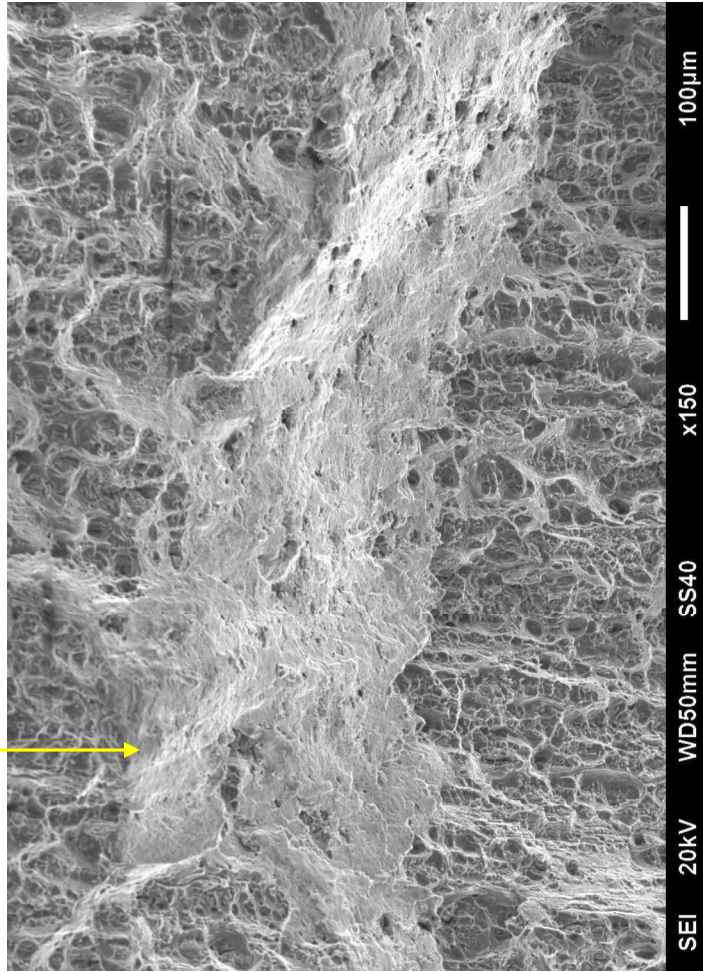
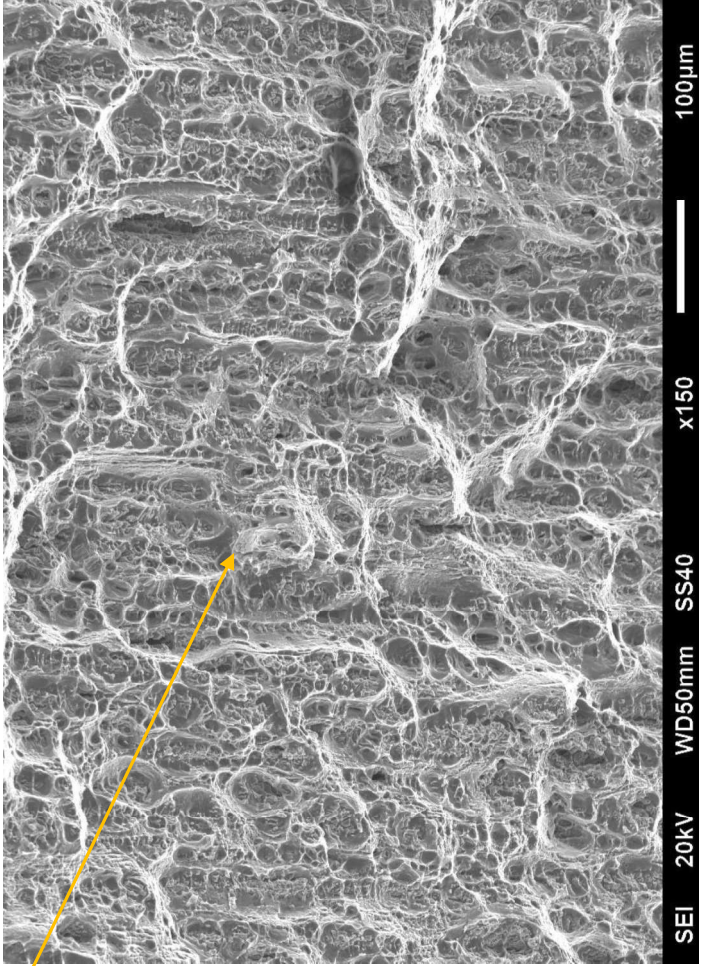
Figure 8 shows SEM examination results of the fracture surface near the bottom flange. The fracture surface showed no evidence of corrosion/oxidation damage; an area of rub marks was present on the outer edge of the inbd flange. Away from the rubbed area the fracture surface displayed overload features.

Figure 8 View of the fracture surface on the bottom flange in Figure 7. Fracture surface features represents an overload fracture. Magnification: x6 and x150.

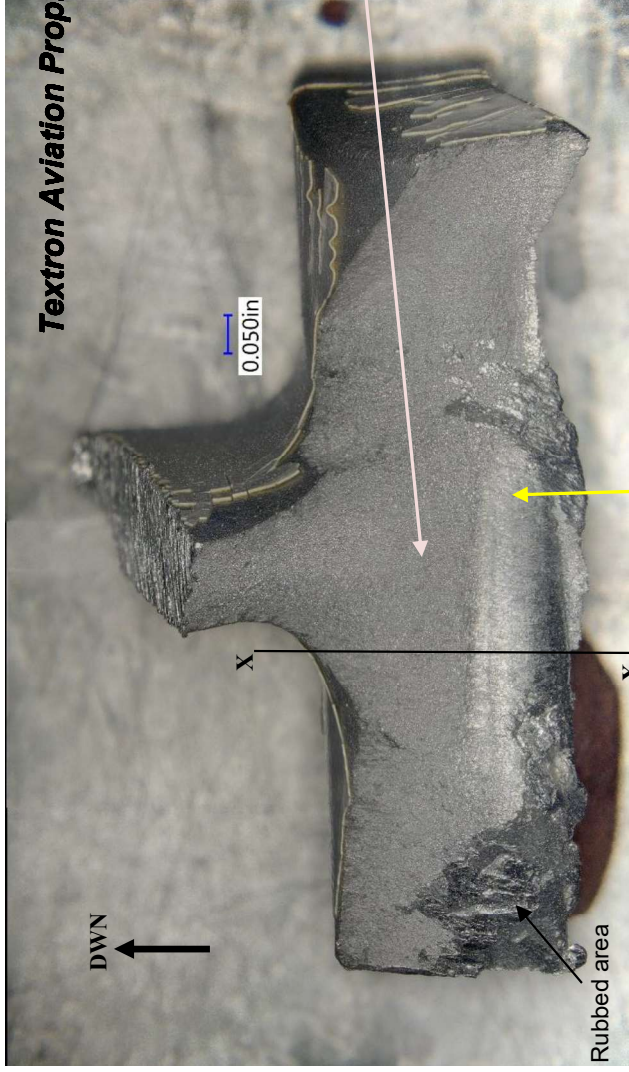
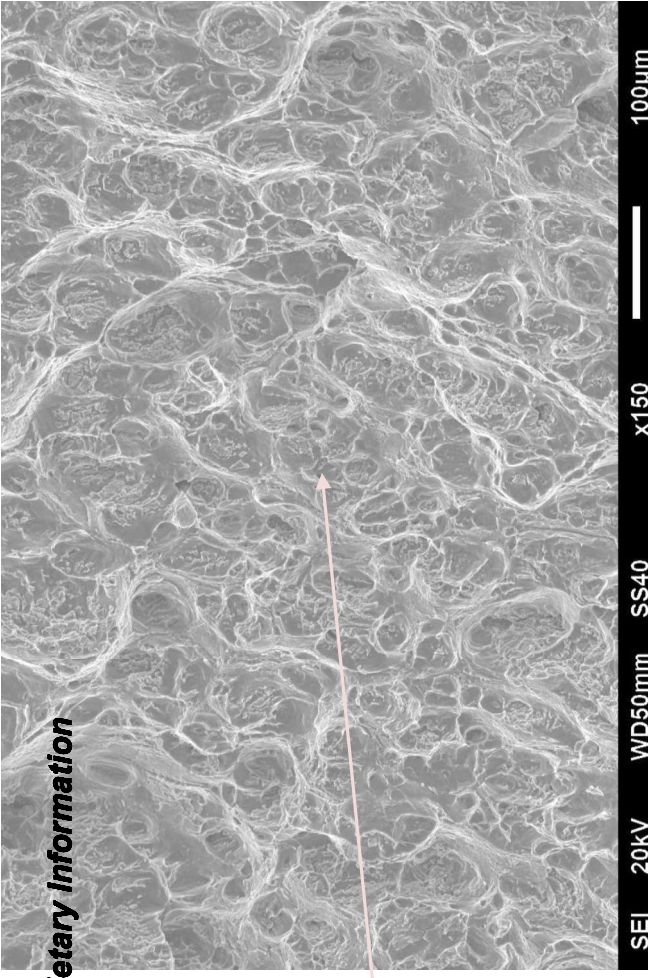
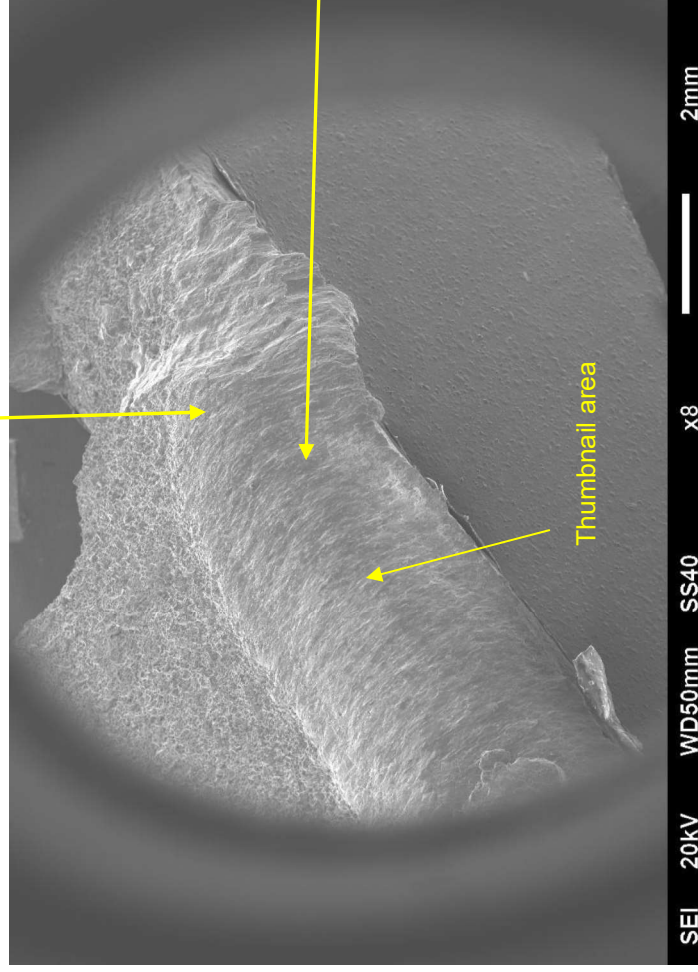
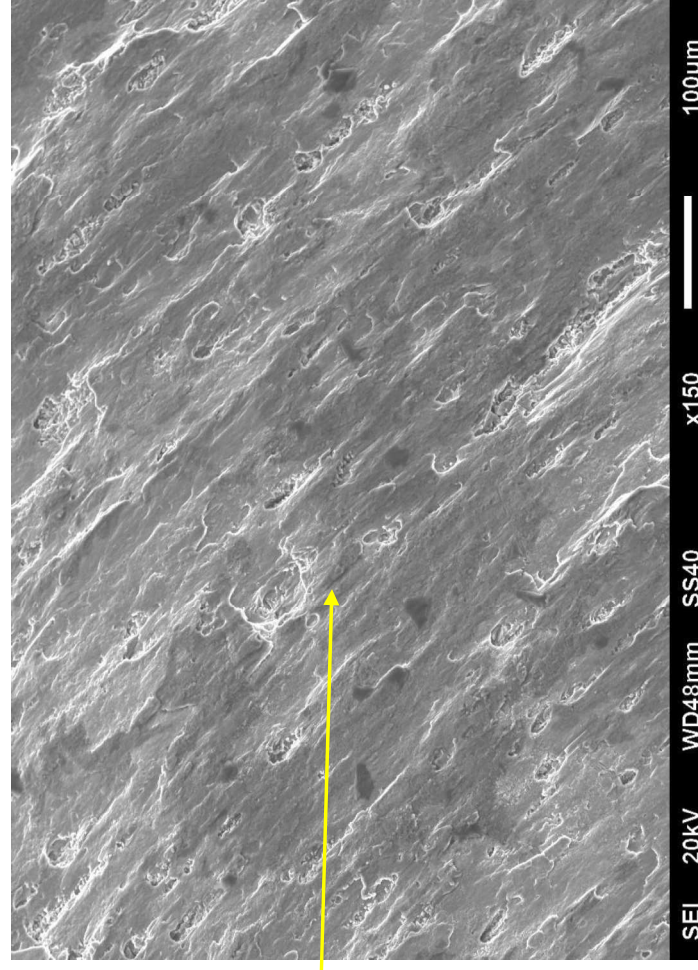
Figure 9 shows SEM examination results of the fracture surface near the top flange. The fracture surface appeared in good condition with no evidence of corrosion/oxidation damage. Likewise, an area of rub marks was present near the outer edge of inbd flange. The fracture surface displayed overload features elsewhere. SEM examination of a suspect thumbnail area indicated no fatigue and displayed features similar to a fracture under a compressive load with some deformed metals extending over the flange top edge.

Figure 9 View of the fracture surface on the top flange in Figure 7. An area resembling a thumbnail shape near the top surface was visually suspected as a fatigue fracture; further examination revealed a rubbed surface. The fracture surface displayed overload features elsewhere. XX represents a cross section cut. Magnification: x5; x8 and x150.

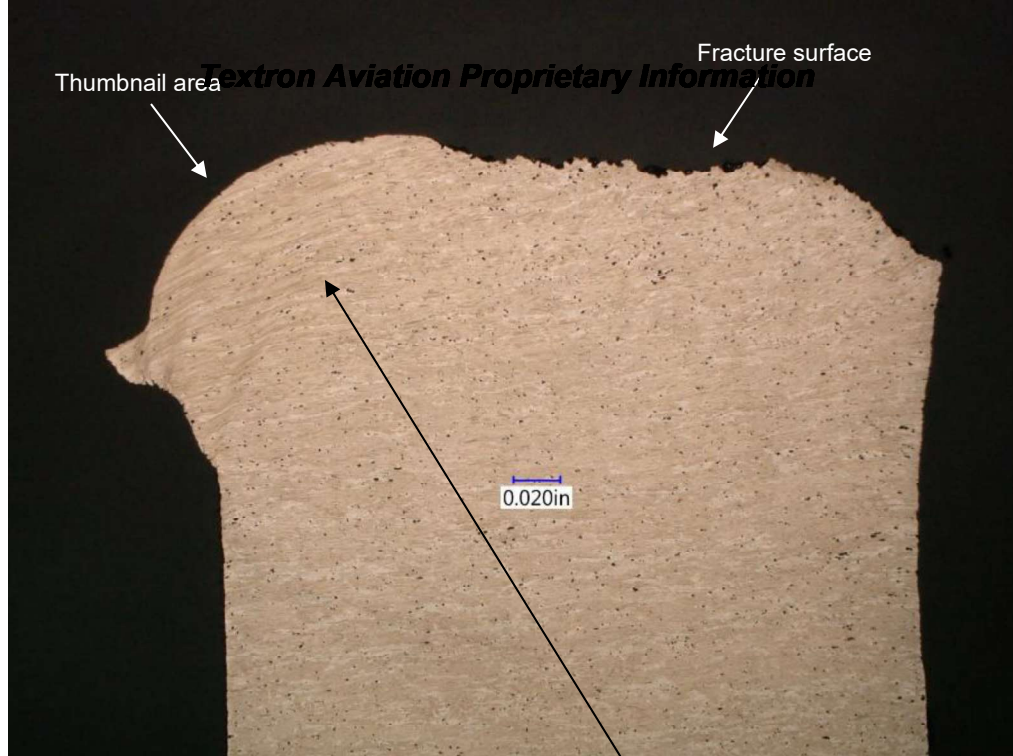
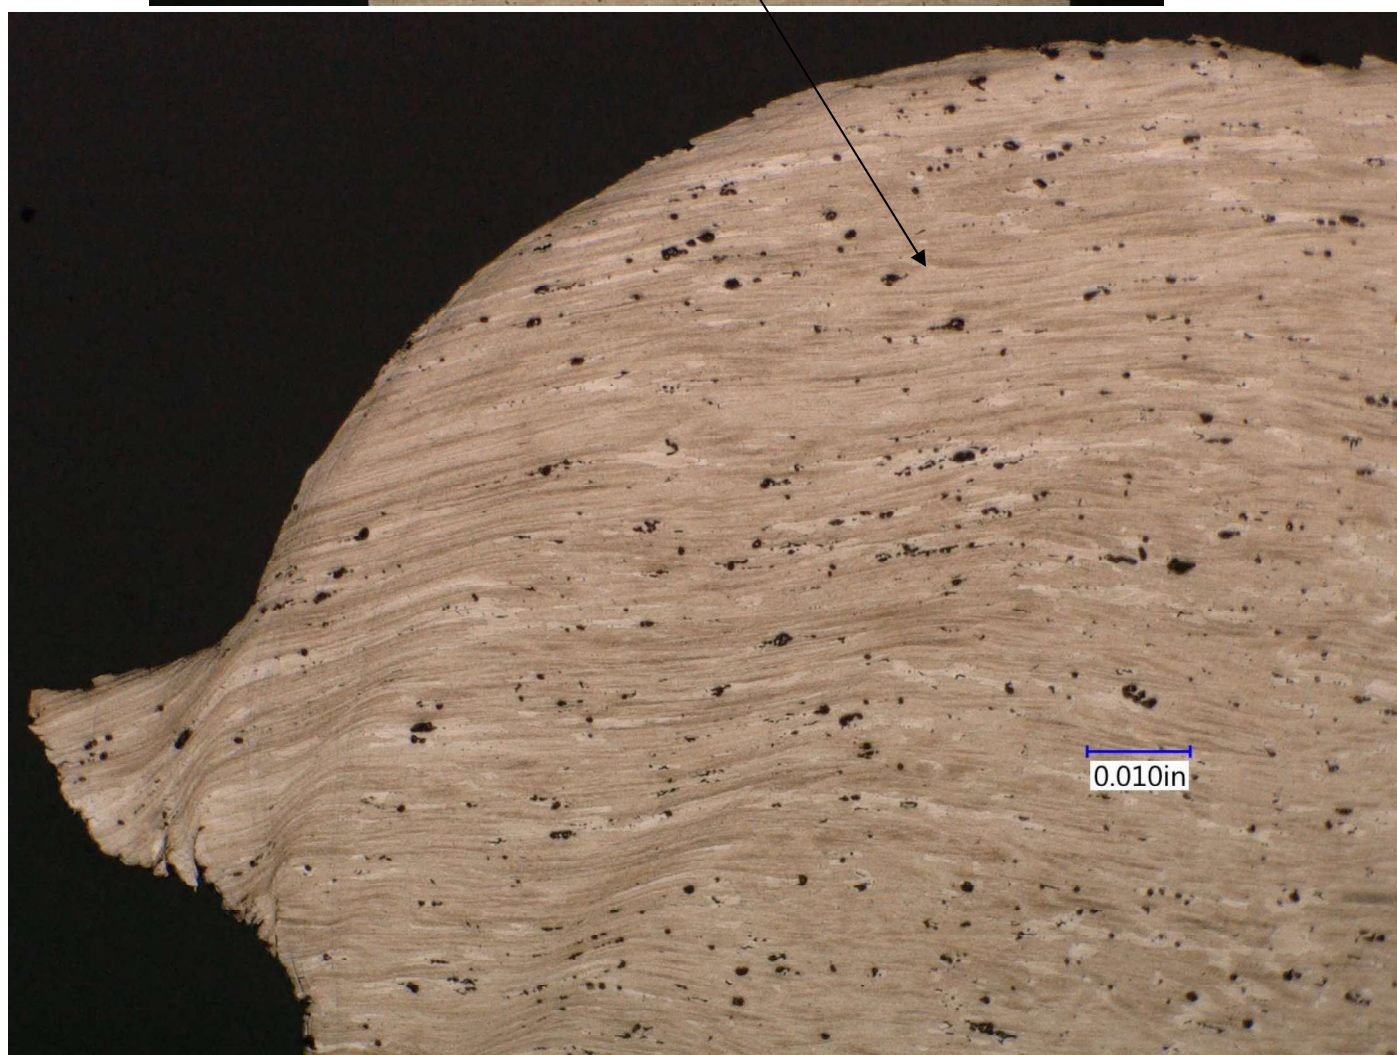
A cross sections was prepared from location XX in Figure 9 to examine microstructure. The microstructure was typical for 7075 series aluminum alloy in the heat treated condition. The thumbnail feature appeared as compressed metal; reference Figure 10.

Figure 10 Cross section through location XX in Figure 9. Microstructure was typical for 7075 aluminum alloy plate in the heat treated condition. The thumbnail area indicated an area of compressed metal. Etchant Keller's. Mount index No. 4424. Magnification: x14 and x60.
