## **NATIONAL TRANSPORTATION SAFETY BOARD**

# **STRUCTURES**

**CEN20LA175**

**Report Title:** Examination of a damaged MLG Drag Leg Assembly p/n 114-810023-1 on Beechcraft 1900C, S/N UB-12, N31704

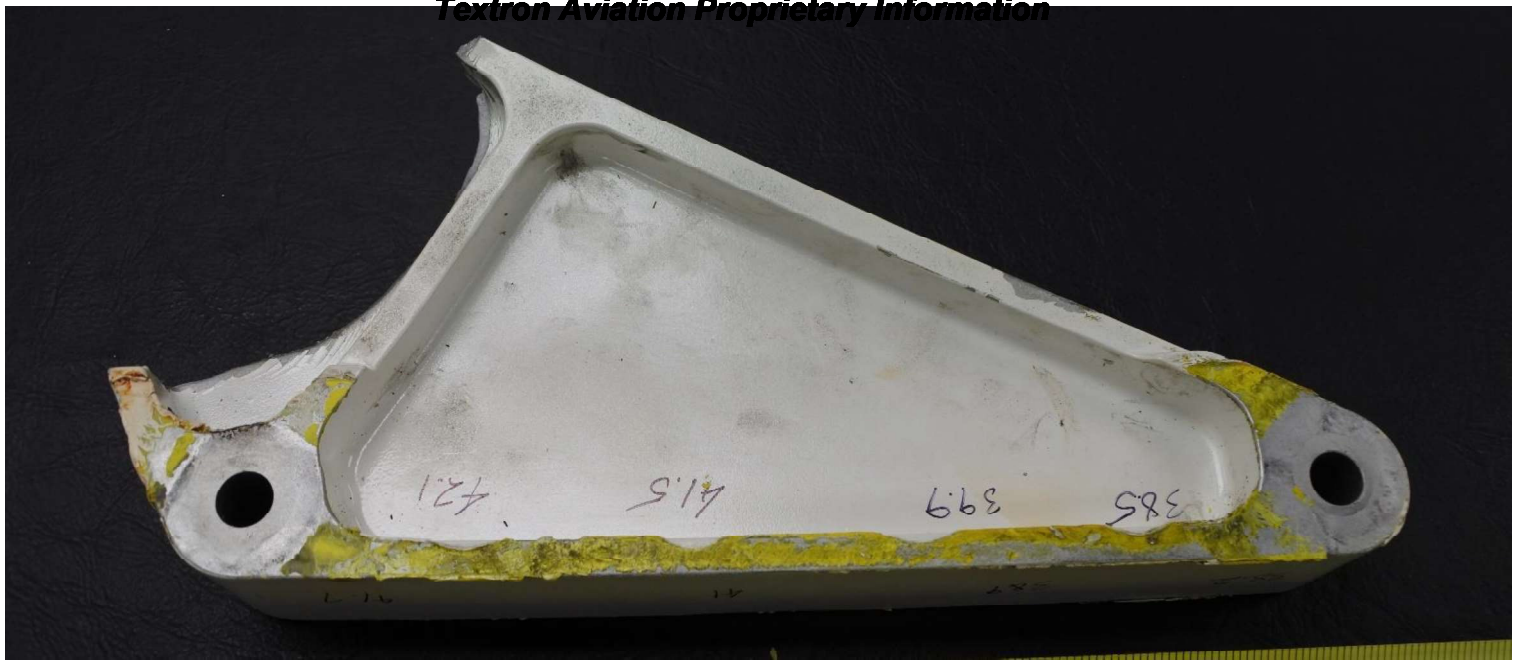
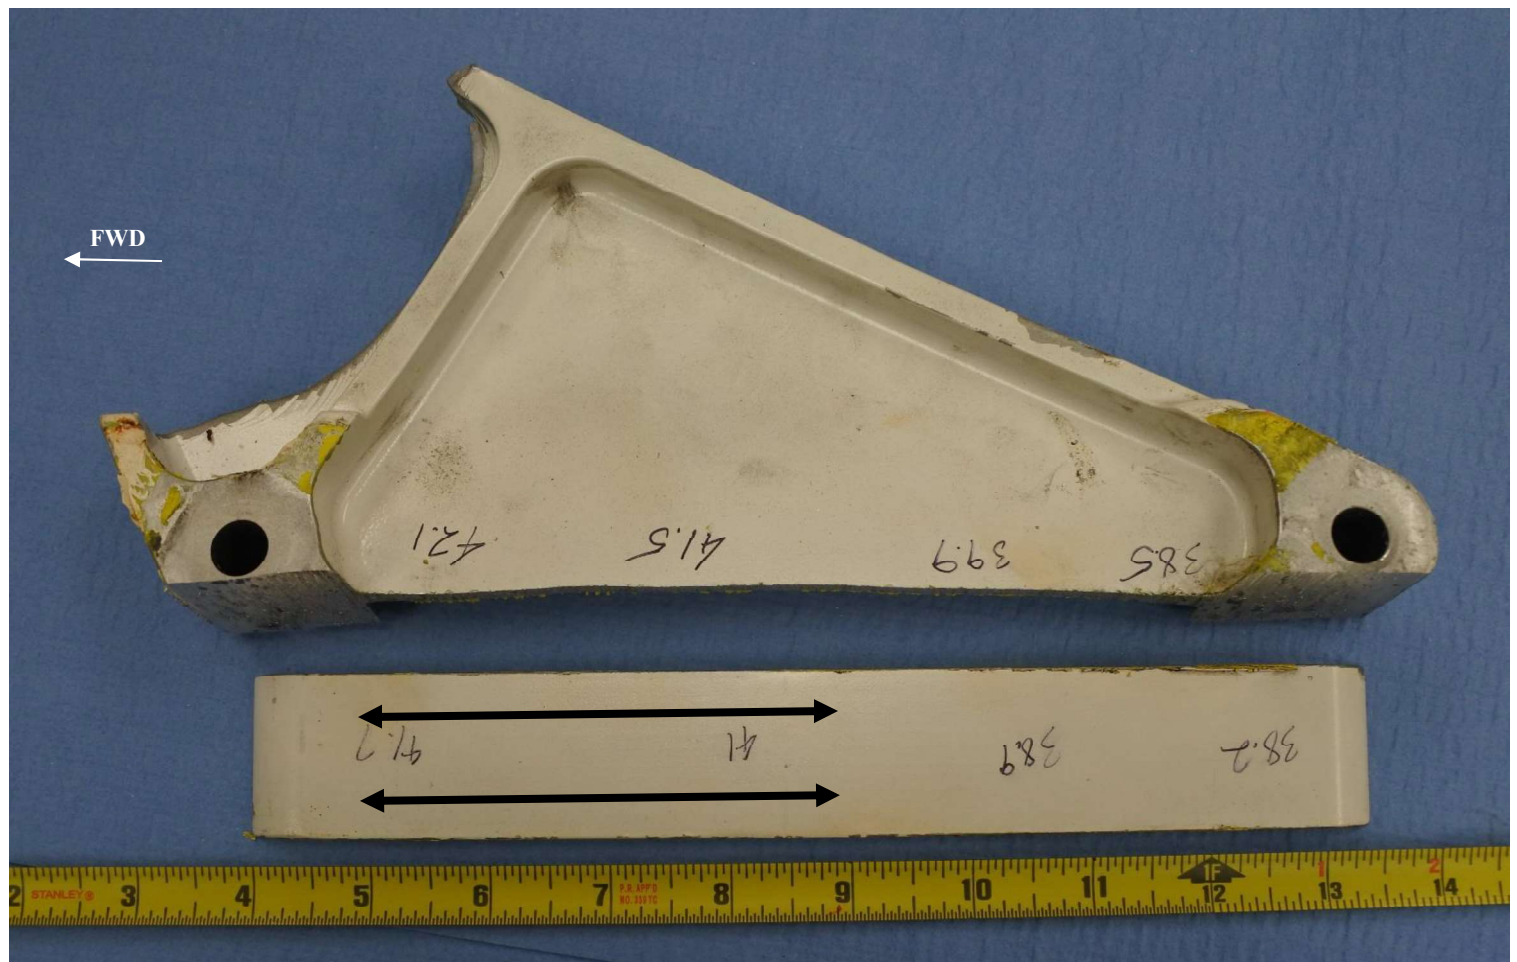
A sub-size tensile specimen was prepared from the least bent area of the fwd flange with test results shown in Table 1; both tensile and yield strength appeared lower than the specification requirements for 7075-T6. To validate the tensile strength of the broken upper drag leg arm p/n 114-810026-1, two more tensile specimens were fabricated from the least damaged area on the opposing fracture piece as shown in Figure 11. Consistent with previous results, the tensile strength and yield strength were lower than the specification requirements. Tensile properties of the upper drag leg arm were not consistent with any of the standard tempers for 7075 plate.

Figure 11 View of the opposing fractured piece showing location of the two new compact tensile specimens on the bottom flange. Consistent with previous conductivity measurements in Figure 6 the conductivity was higher near the fracture area and lower away from it; measurements indicated (38.2 to 42.1) % IACS in the area between the two holes. Black arrows depict location of the two new tensile specimens.
