# NATIONAL TRANSPORTATION SAFETY BOARD

## MATERIALS LABORATORY FACTUAL REPORT

Report No. 21-014

Place : Steele, Missouri  
Date : May 22, 2020  
Vehicle : Piper PA-28-180  
NTSB No. : CEN20LA189  
Investigator : John Brannen, AS-CEN

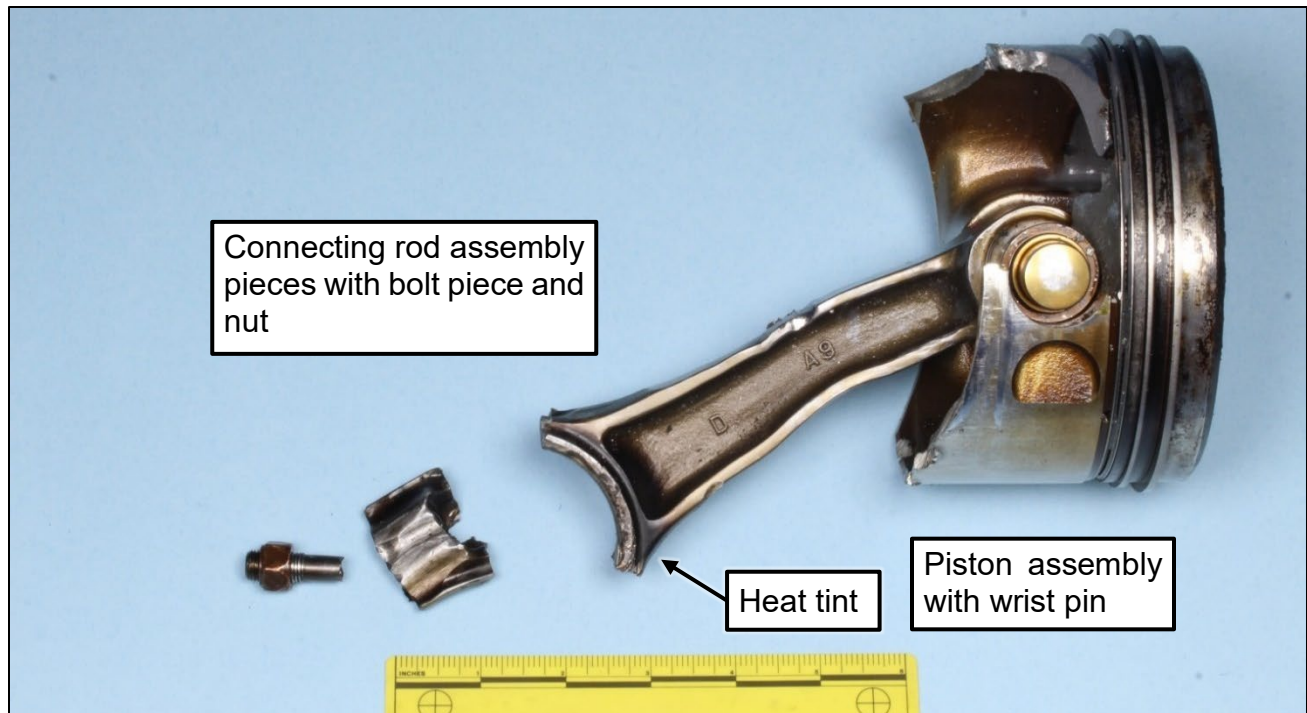
An overall view of the submitted piston assembly with piston pin and connecting rod assembly pieces with a connecting rod bolt piece and nut is shown in figure 1. The piston was fractured around a portion of the skirt and showed impact damage corresponding to contact with the connecting rod. The connecting rod was fractured at the big end on both sides of the strap, and a strap piece with mating fracture features was included as shown in figure 1. The connecting rod bolt was fractured, and the attached nut was intact.

Figure 1. Photograph of the submitted components.

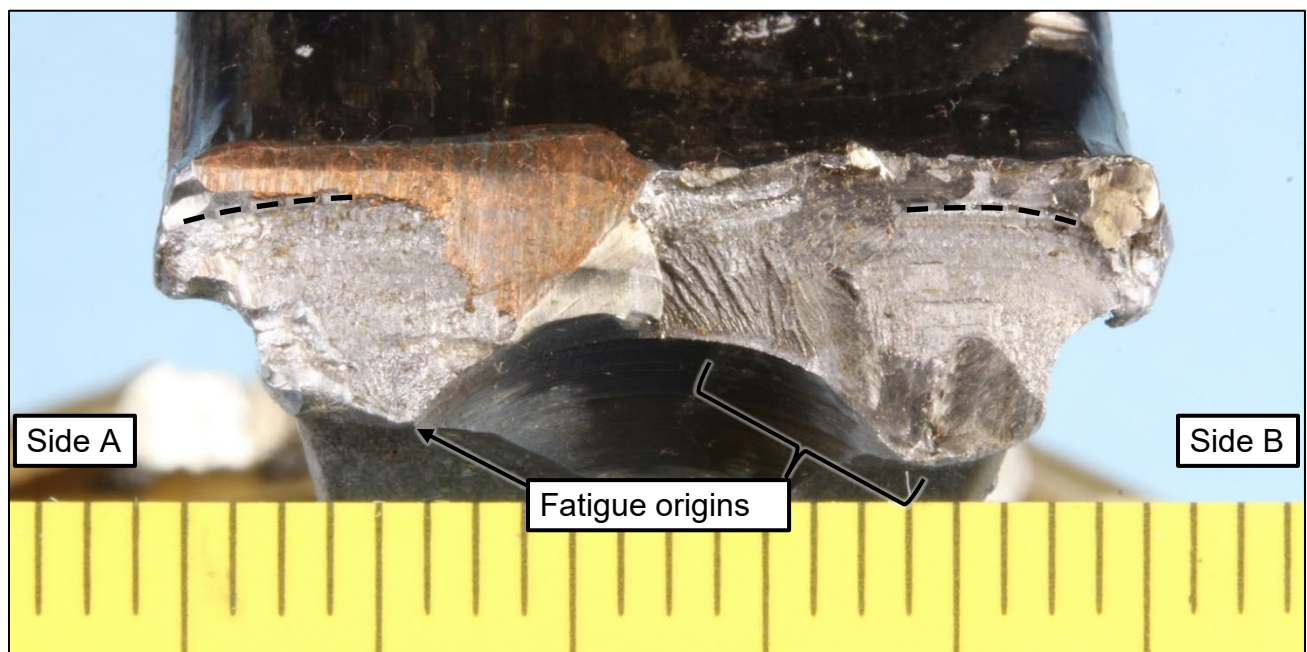
Close views of fracture surfaces through the connecting rod strap are shown in figures 2 and 3. For reference, the sides of the connecting rod were arbitrarily labeled A and B, where the A side is shown facing the camera in figure 1. Portions of the fracture surfaces on each arm of the strap were in planes perpendicular to the hoop direction and had curving crack arrest lines, features consistent with fatigue. Fatigue origins were located at the outer sides of the strap around the recess for the connecting rod bolt nut as indicated with arrows and brackets in figures 2 and 3. On the A side, the fatigue origins on each arm appeared to be located at the intersection between the recess and the outer surface. On the B side, ratchet marks were observed consistent with multiple origins located along the recess as indicated with brackets in figures 2 and 3. Origin areas on both arms were damaged by post-fracture contact.

Dashed lines in figures 2 and 3 indicate the approximate location of fatigue boundaries consistent with fatigue cracks propagating through most of the thickness on each arm. Portions of the fatigue boundaries were damaged by post-fracture contact, particularly on the arm shown in figure 2.

Figure 2. Close view of fracture features on the connecting rod strap. Dashed lines indicate portions of the fatigue boundary that remained identifiable.

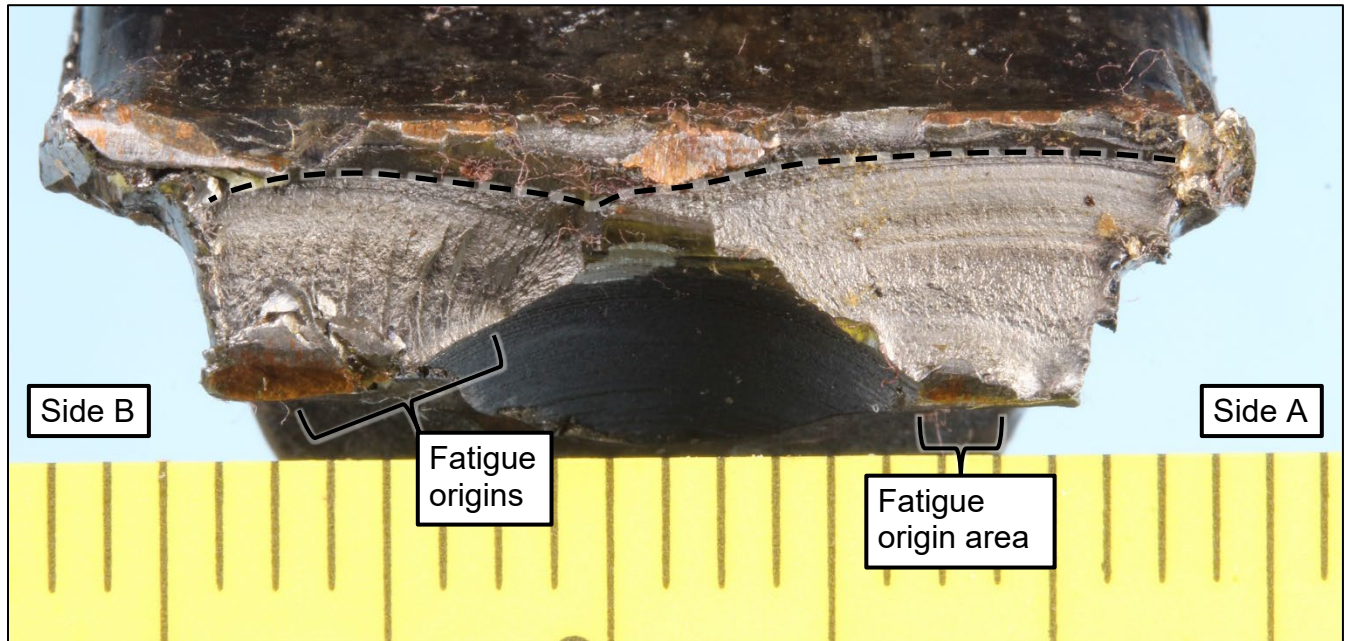
Figure 3. Fracture features on the opposite side of the connecting rod strap. A dashed line indicates the fatigue boundary.

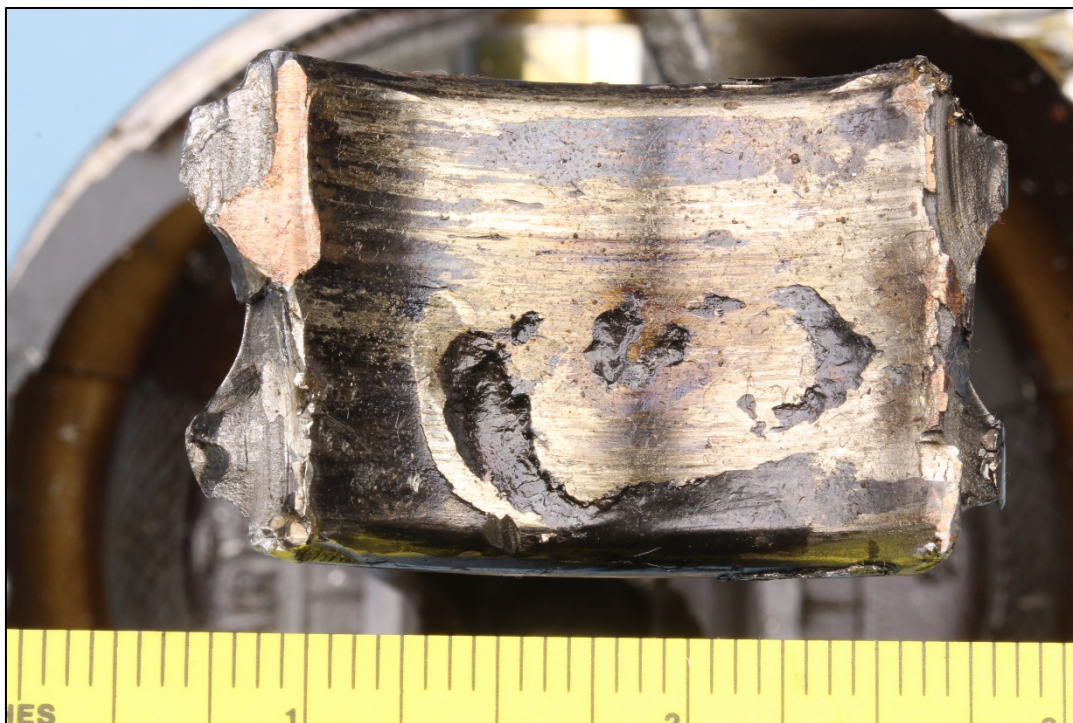
The big end of the connecting rod was tinted dark consistent with high heat exposure at the bearing journal contact area (see figure 1). The bearing contact face shown in figure 4 was tinted dark and had orange deposits on the surface consistent with bearing material that had fused to the connecting rod. Much of the bearing face on the strap piece shown in figure 5 was obliterated by heavy contact damage, but an area outlined in figure 5 showed heat tinting and circumferential sliding contact marks.

Figure 4. Bearing contact face on the connecting rod strap showing heat damage, circumferential sliding marks, and galled bearing material on the surface.

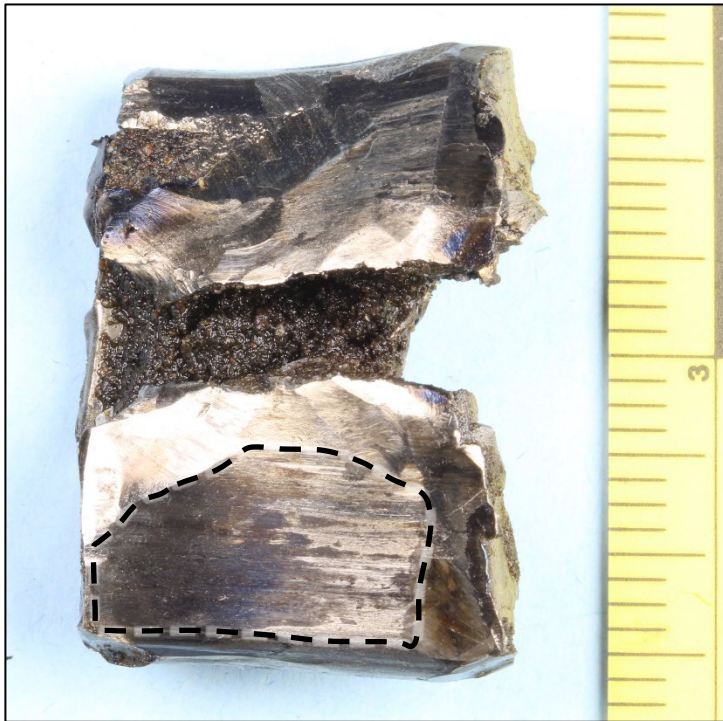
Figure 5. Bearing contact face on the connecting rod strap piece showing heat tinting and circumferential sliding contact marks in the area outlined with a dashed line.

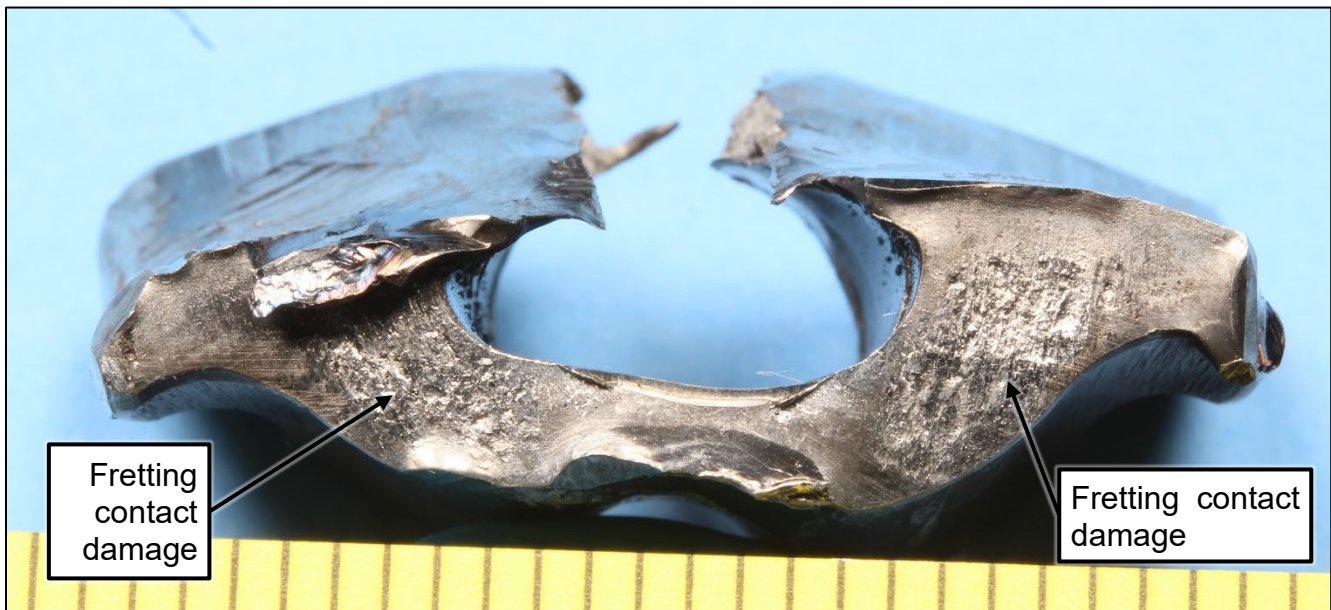
The connecting rod strap piece was cleaned using a soft-bristle brush and a solution of Alconox and water followed by ultrasonic cleaning in a bath of the Alconox solution. The split line for the strap piece where it mated to the cap is shown in figure 6 after cleaning. Pit-like features consistent with fretting contact damage were noted on the split-line face as indicated in figure 6. The connecting rod nut seat on the opposite end of the connecting rod strap piece is shown in figure 7. Overall, the connecting rod bolt hole was deformed to an oblong shape. Contact marks consistent with contact with two threads from the connecting rod bolt were observed in the connecting rod bolt hole. The thread impressions were located on the bearing side and the outer side of the hole where the hole was deformed to the smaller diameter, and gaps between the impressions were present on the A and B sides of the hole (see figure 7).

Figure 6. Cleaned connecting rod strap showing fretting contact damage on the split-line face.

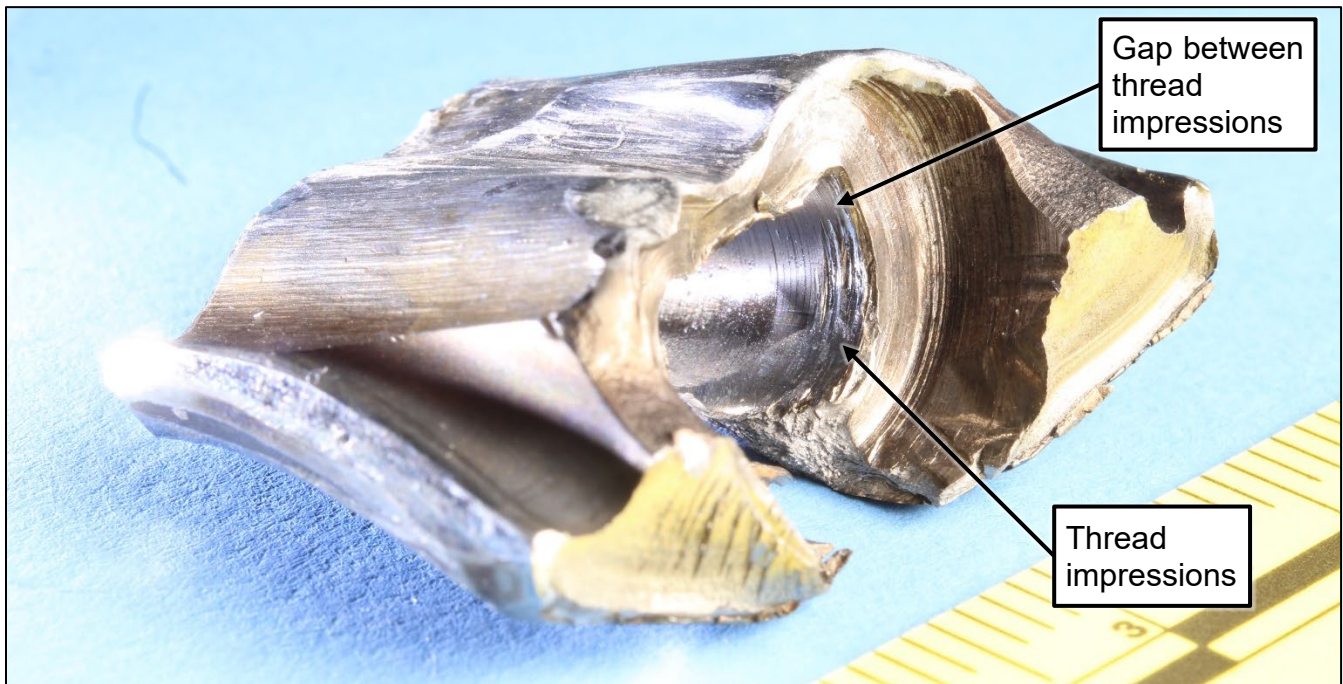
Figure 7. Connecting rod strap piece showing thread impressions on the bore of the connecting rod bolt hole.

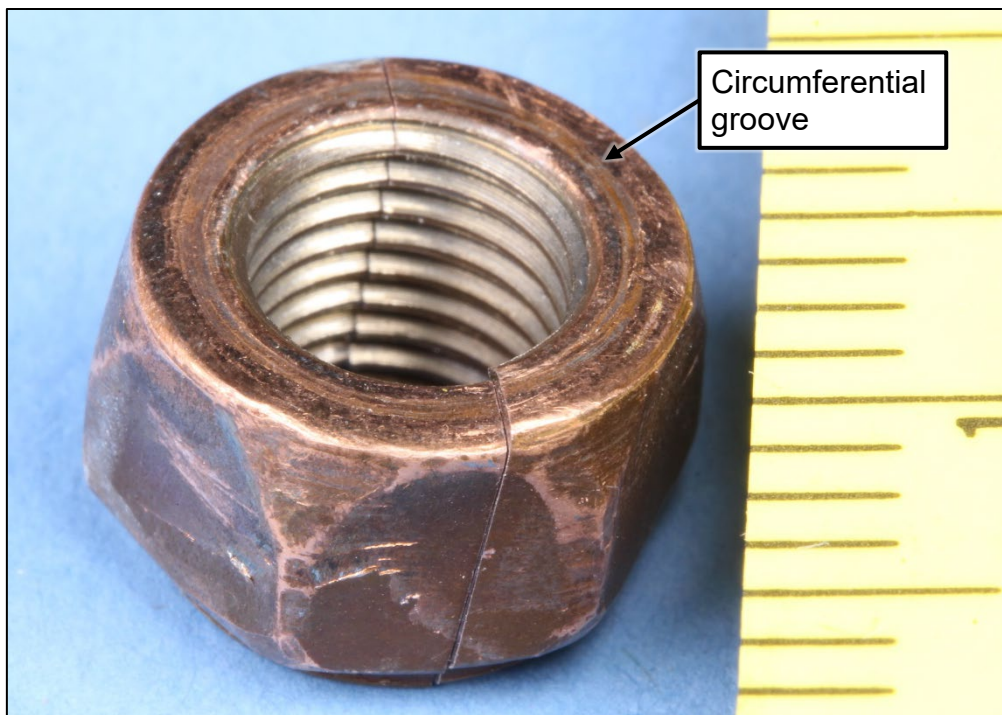
The nut was trapped on the threaded end by deformed threads on either side of the nut. To facilitate an examination of the threads on the nut and bolt, a water-cooled abrasive saw was used to cut the nut on two sides to remove it from the bolt. The sectioned bolt and nut were submerged in a bath of acetone and cleaned using an ultrasonic cleaner. A view of the seating face of the nut after cleaning is shown in figure 8. A shallow circumferential groove in the copper coating was observed on the seating face as indicated. The contact flanks of the nut threads, shown in figure 9, were examined for contact with the mating connecting rod bolt threads. Circumferential contact marks were observed on most of the thread flanks. However, rough surfaces with limited circumferential contact marks were observed on some of the threads, particularly on the three threads closest to the seating face.

Figure 8. Connecting rod nut shown after sectioning from the bolt and cleaning with acetone in an ultrasonic cleaner. A shallow circumferential groove on the seating face is indicated.

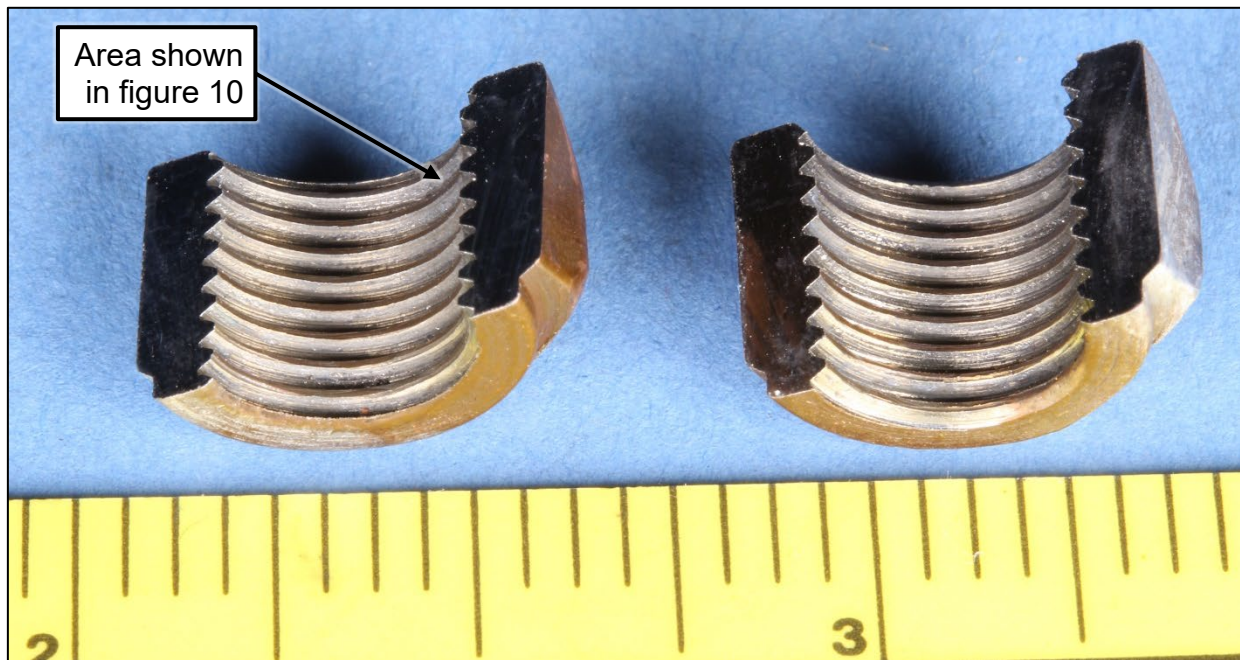
Figure 9. Overall view of the contact flanks of the sectioned and cleaned connecting rod nut. Irregular surface roughness was observed, particularly on the three thread flanks closest to the nut seating face.

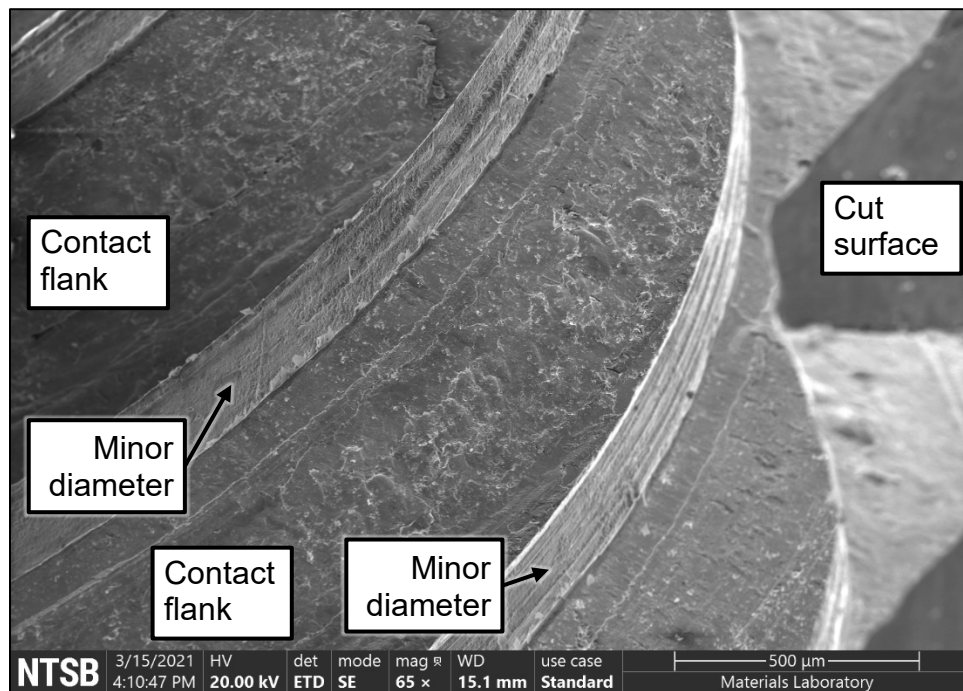
The nut half shown at the left in figure 9 was examined using a scanning electron microscope (SEM), and an SEM image of the contact flanks for several threads near the nut seating face is shown in figure 10. The contact flanks appeared to have smeared metal features that were deformed in the radial direction across the flanks.

Figure 10. SEM image of smeared metal features on the contact flanks of threads near the nut seating face.
