# NATIONAL TRANSPORTATION SAFETY BOARD

## MATERIALS LABORATORY FACTUAL REPORT

Report No. 22-031

Place : Cambridge, Ohio  
Date : May 27, 2020  
Vehicle : Beech 35-A33, N123JB  
NTSB No. : CEN20LA197  
Investigator : Andrew Todd Fox, ASI – CEN

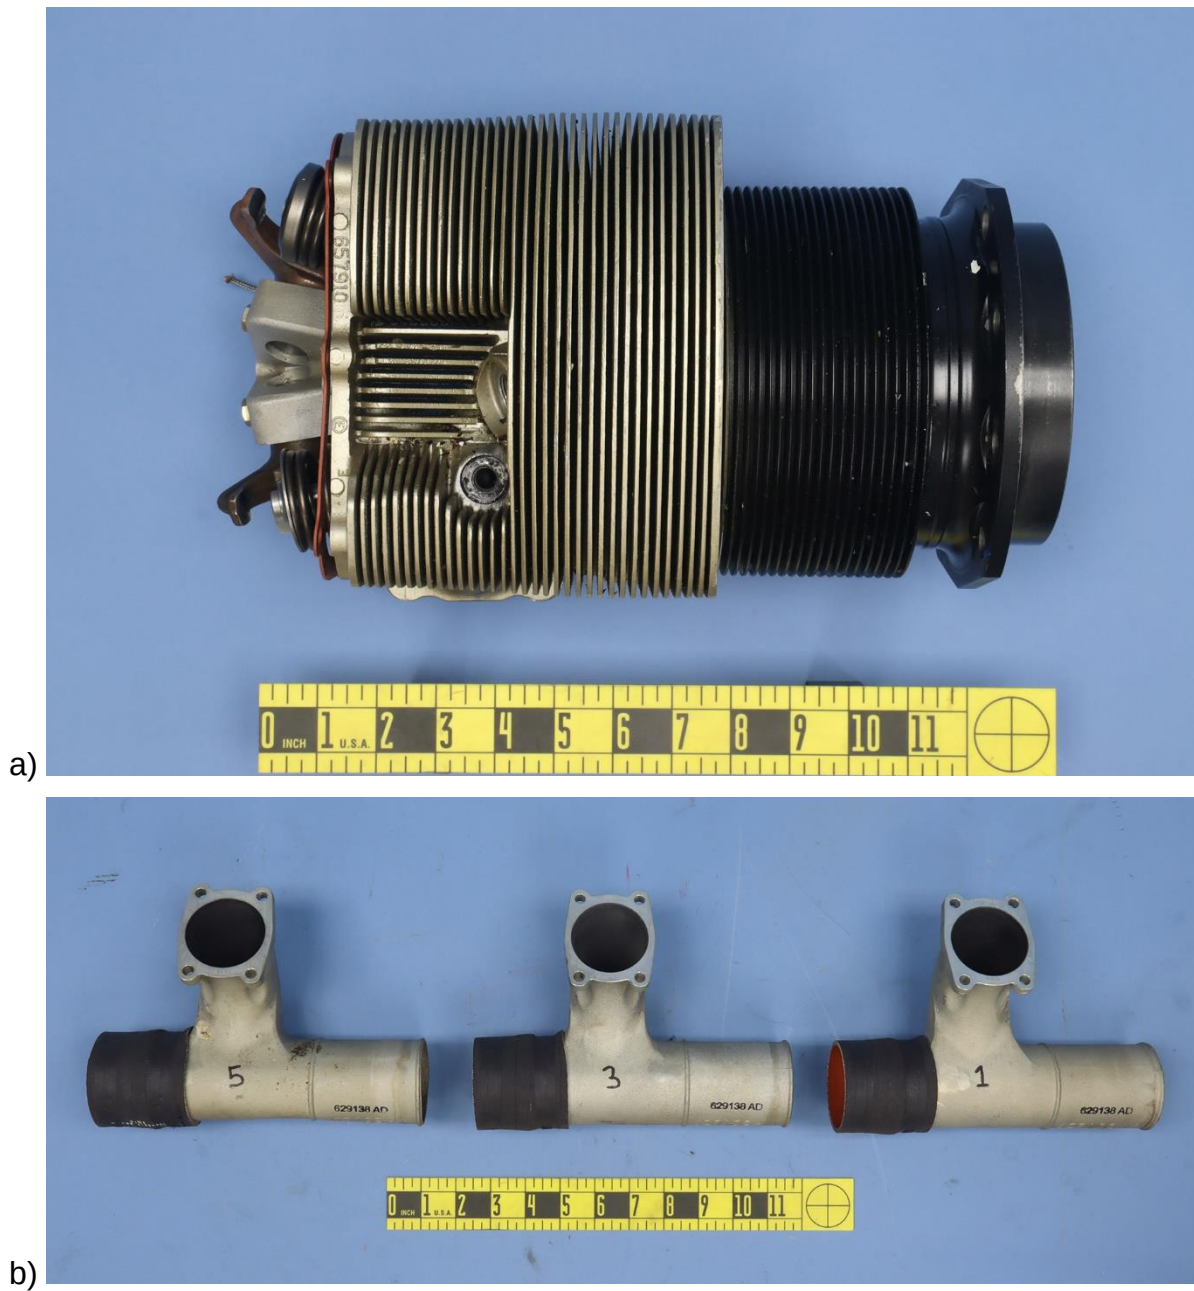
Components from a Continental Motors IO-470-N13B engine, as listed above and shown in figures 1a – 1i, were submitted to the NTSB Materials Laboratory for examination. The number 3 cylinder head exhibited staining from a blue dye (consistent with 100LL aviation gasoline) on several cooling fins located on the forward-facing side of the intake port, as shown in figure 2a. Blue staining was also observed on a number 3 – 5 inter-cylinder baffle, as shown in figure 1g. The number 3 intake elbow (see figure 2b) and cylinder intake port flange face (see figure 2c) were examined for any apparent indication of staining, but none were found. The intake flange gasket compression faces (see one side shown in figure 1d) were flattened around the inner diameter hole and there were no apparent kinks or tears.

**Figure 1:** Images of accident parts as received: a) number 3 cylinder assembly; b) numbers 1, 3, and 5 intake elbow tubes;

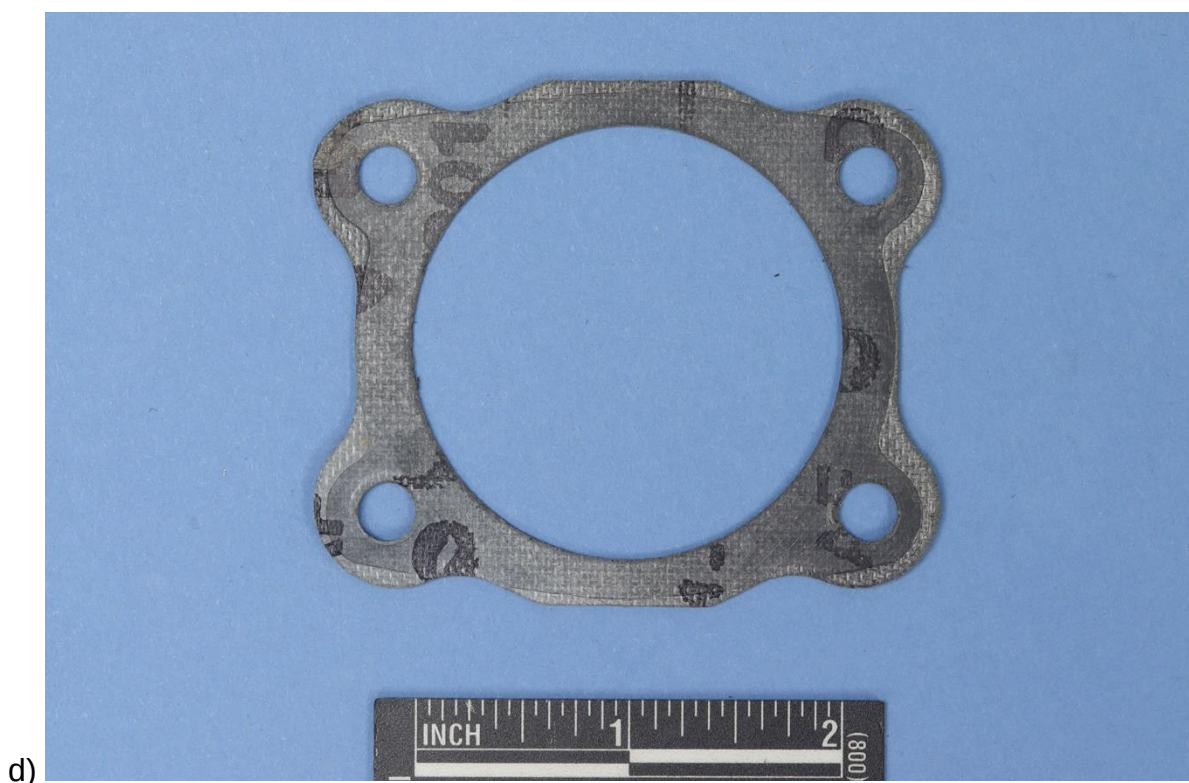
**Figure 1 (cont.):** c) number 3 piston; d) number 3 cylinder intake flange gasket;

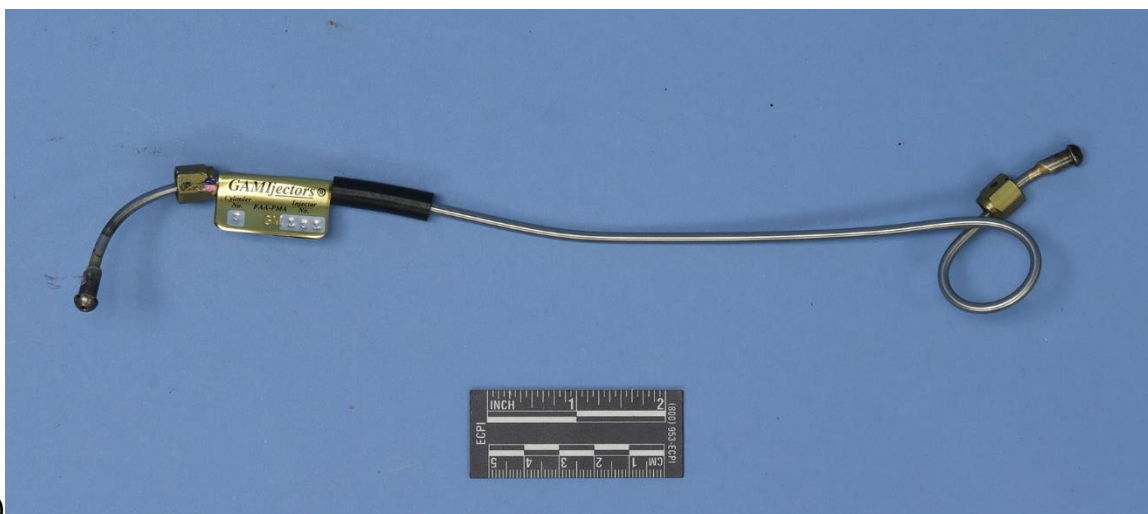
The insulated fuel lines and number 3 fuel injector line were plugged at one end, connected to regulated shop air, and pressurized to between 15 psi and 25 psi. All fuel lines held pressure. Soapy water was applied to end fittings and gaps in insulation to check for formation of foam or bubbles, but no such indications were observed. The fuel injector line was also examined visually with the aid of a stereo microscope for cracks or other notable indications but none were found. The fractured fittings on all submitted components were examined visually with the stereo microscope and all were consistent with overstress separations.

**Figure 1 (cont.):** e) number 3 cylinder injector fuel line; f) numbers 3 and 4 fuel injectors;

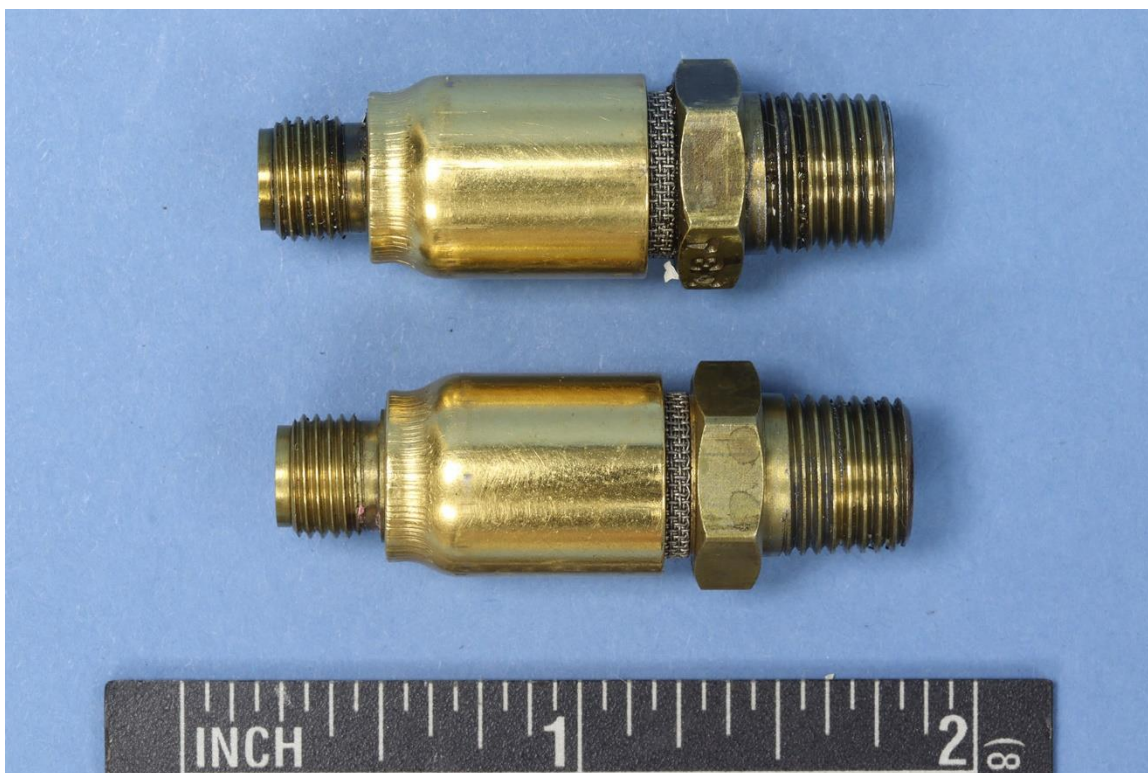
f)

The fuel injectors (figure 1f) had no apparent cracks or obstructions. As received, an oily substance had wicked into the aerator filter screen on one of the injectors but there were no apparent particulate blockages. The injector port (figure 3a) and intake port on the number 3 cylinder were examined for cracks in the surrounding material but none were found. The inside of the cylinder (figure 3b) was comparatively clean, and the exhaust valve exhibited a red tint from high-temperature exposure.

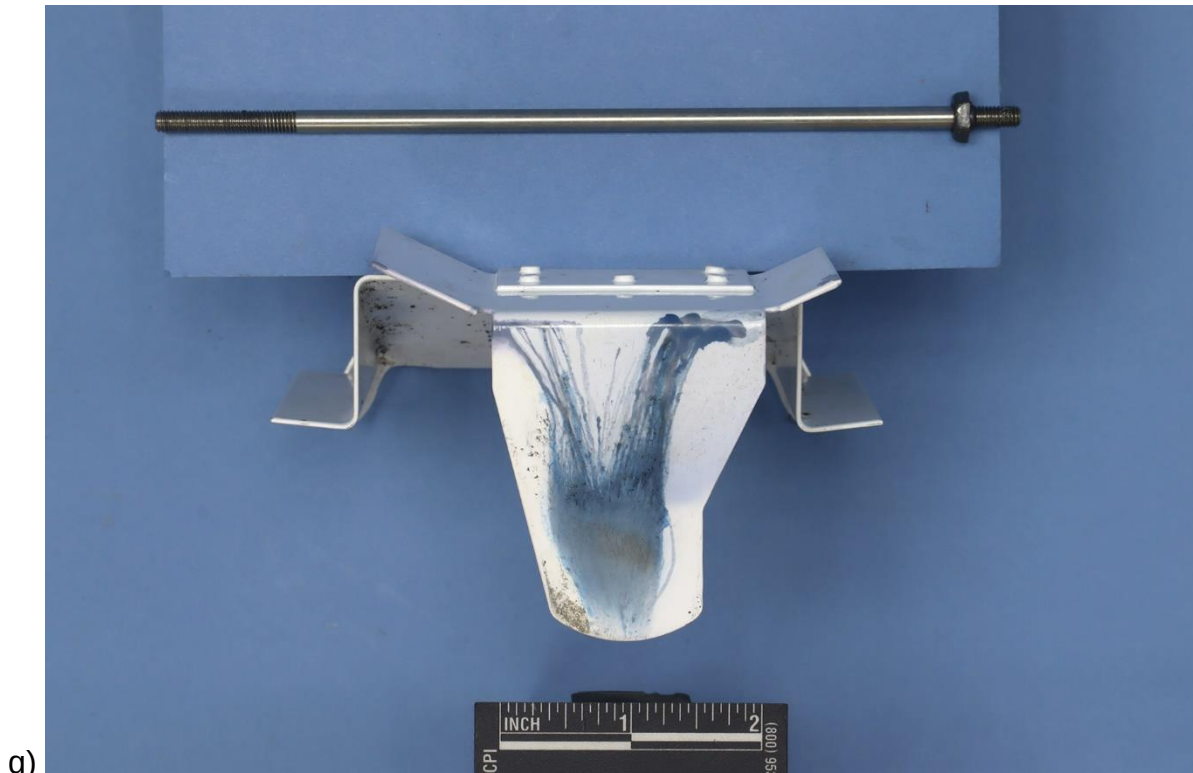
**Figure 1 (cont.):** g) numbers 3 – 5 intercylinder baffle exhibiting a fuel stain; h) six fuel lines and fuel pump; and

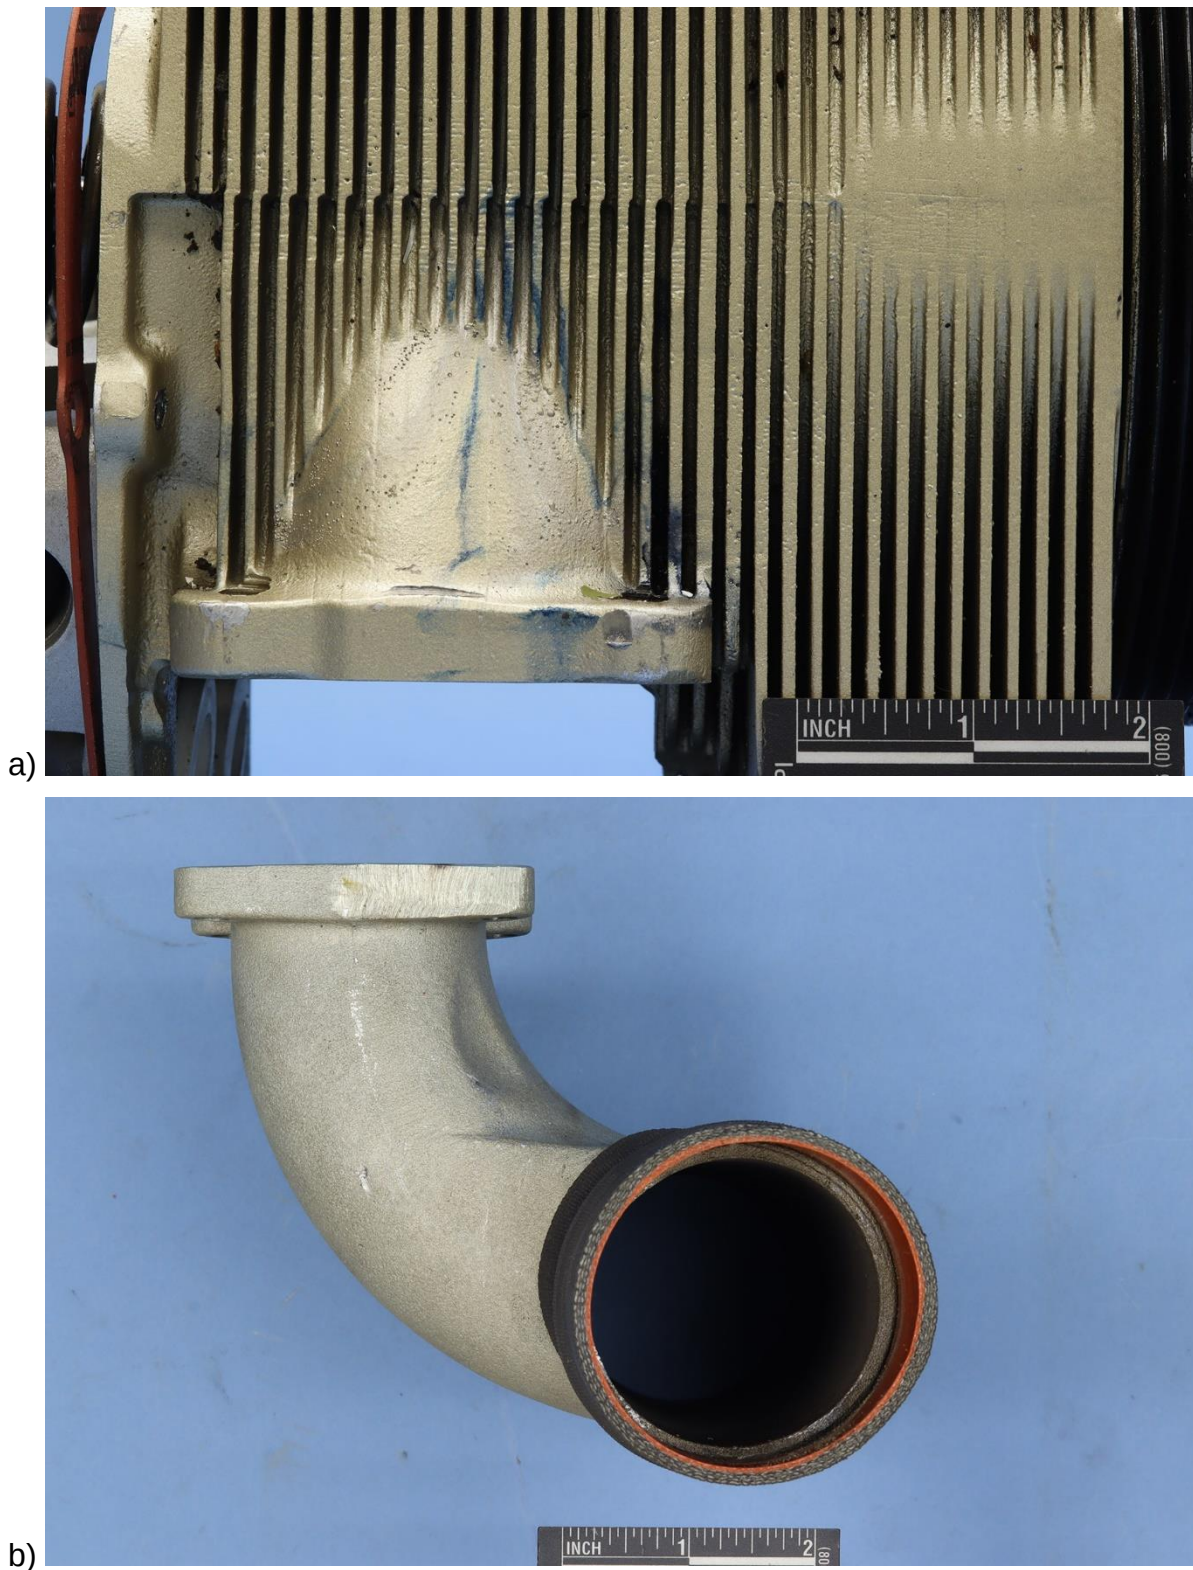
**Figure 2:** a) Image of the number 3 cylinder head at the air intake showing fuel dye staining and b) corresponding intake elbow.

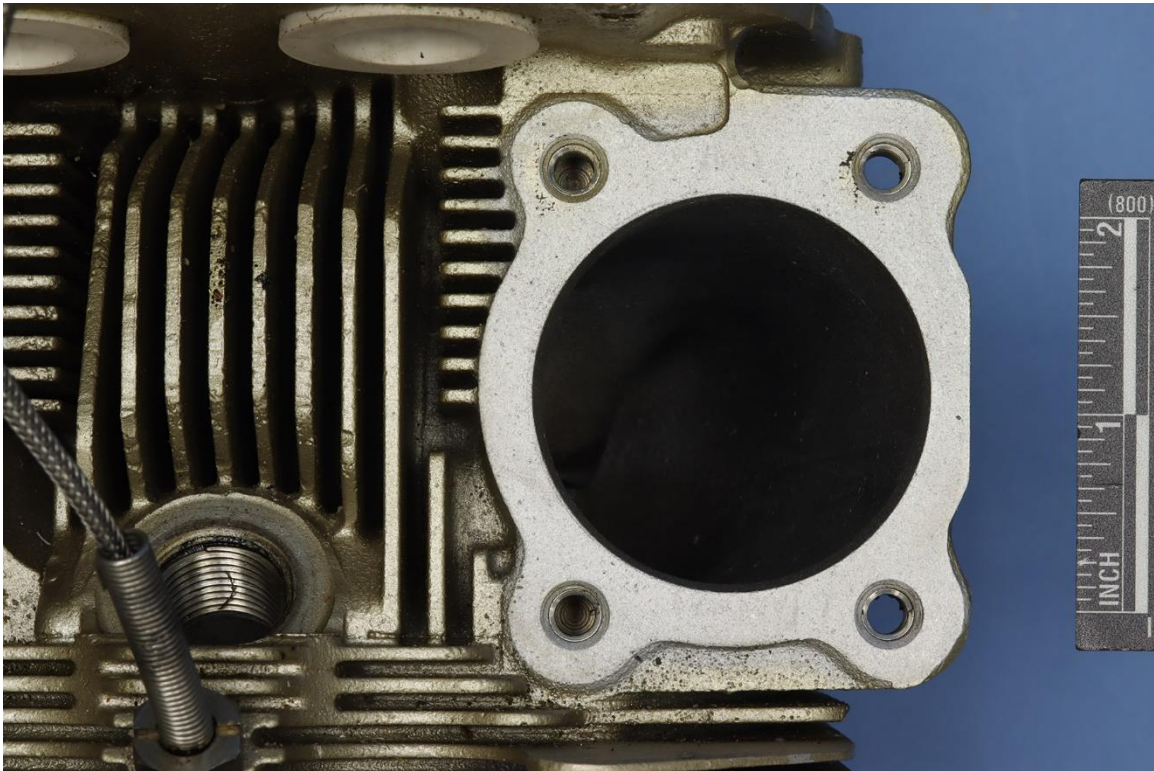
**Figure 2 (cont.):** c) Image of number 3 cylinder head intake port flange end face.

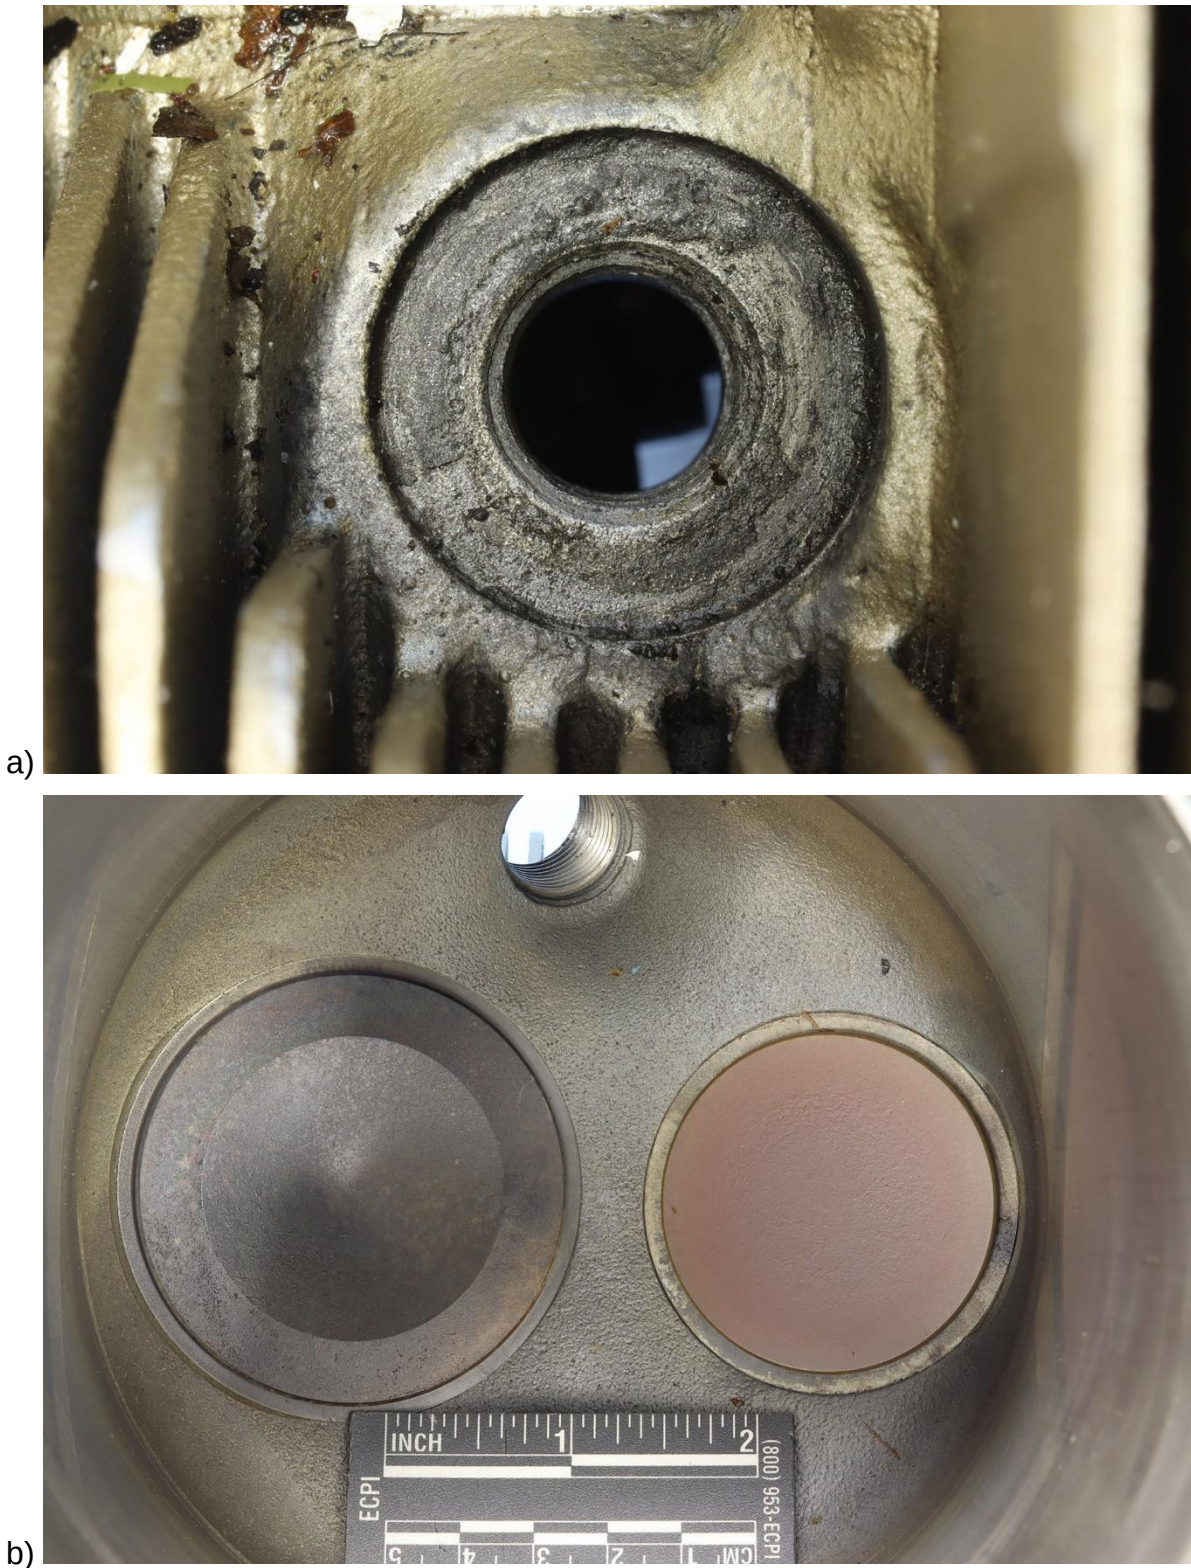
**Figure 3:** a) Image of number 3 cylinder fuel injector port. There were no apparent cracks or stains around the port; and b) inside view of the number 3 cylinder head. The exhaust valve exhibited a red tint.
