### Memorandum

Date: September 10, 2020

Subject: National Transportation Safety Board (NTSB) Information Request 20-195x

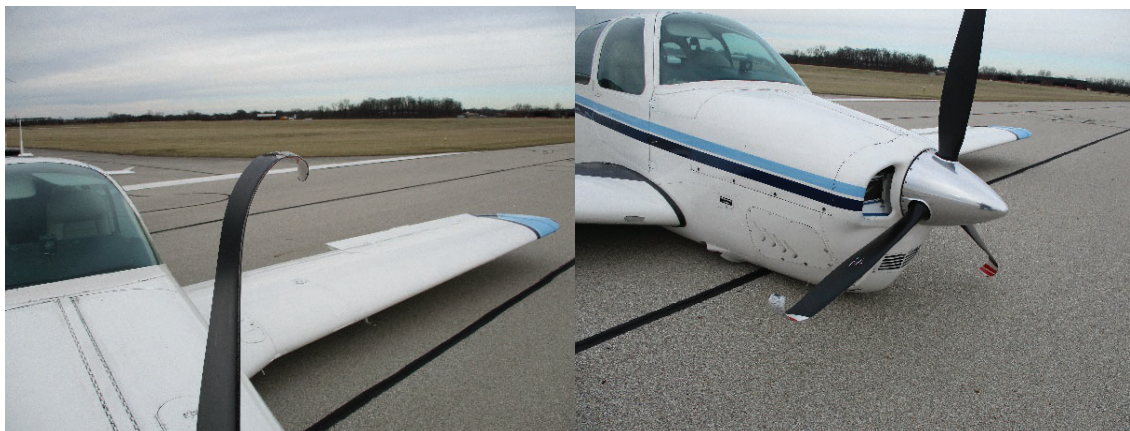
This is the condition of the props on N123JB after the 02/04/2020 incident.

The propeller installed on N123JB met both conditions as described in the Continental manual to require the specified unscheduled propeller inspection after the 02/04/2020 incident.

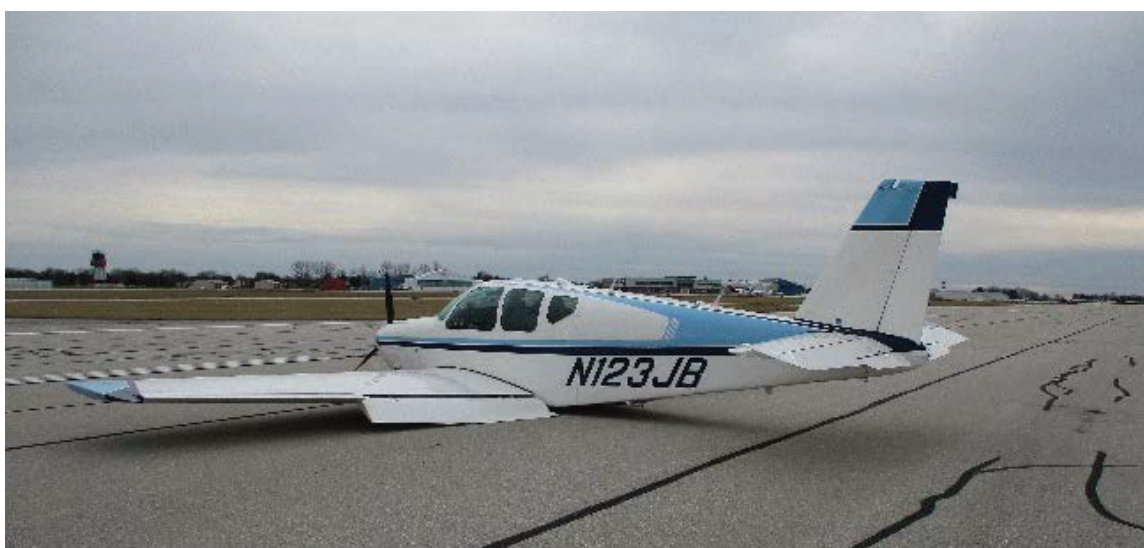
A couple of days prior to the issuance of the ferry permit it was noted that the flaps had not been changed from the event on 02/04/2020. The left flap had sustained more damage than the right causing it to have a different shape than the right. It appeared as though the flap could not be retracted without causing damage to the fuselage.

Please see the left flap near the fuselage.

The lift differential posed by the bent flap on the left side if not changed prior to the ferry flight, was concerning. The FSDO asked the mechanic to change this flap shortly before the ferry permit was issued. He did install a flap from another aircraft that was damaged

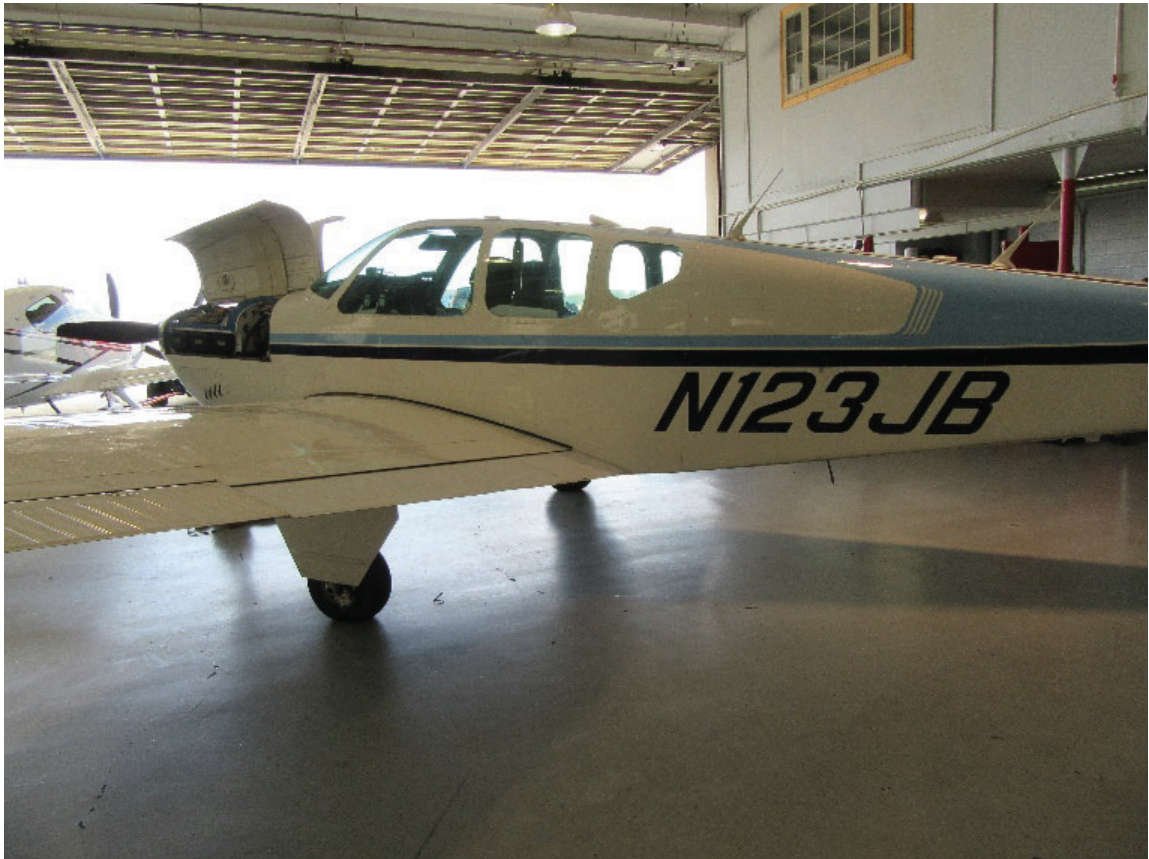
in another accident. This flap had been repaired just enough to have the same form fit and function as a normal flap. It was still a damaged flap, as described in the mechanic's logbook sign off above. This flap would be able to provide symmetrical lift reducing the work load for Mr. Eamus during the ferry flight.

**This is a picture of the flap replaced with a damaged flap.**
