# National Transportation Safety Board

CEN20LA197

## **WRECKAGE EXAMINATION SUMMARY**

Location: Cambridge, Ohio  
Date: May 27, 2020  
Time: 1458 eastern daylight time  
Airplane: Beech 35-A33, Registration No. N123JB

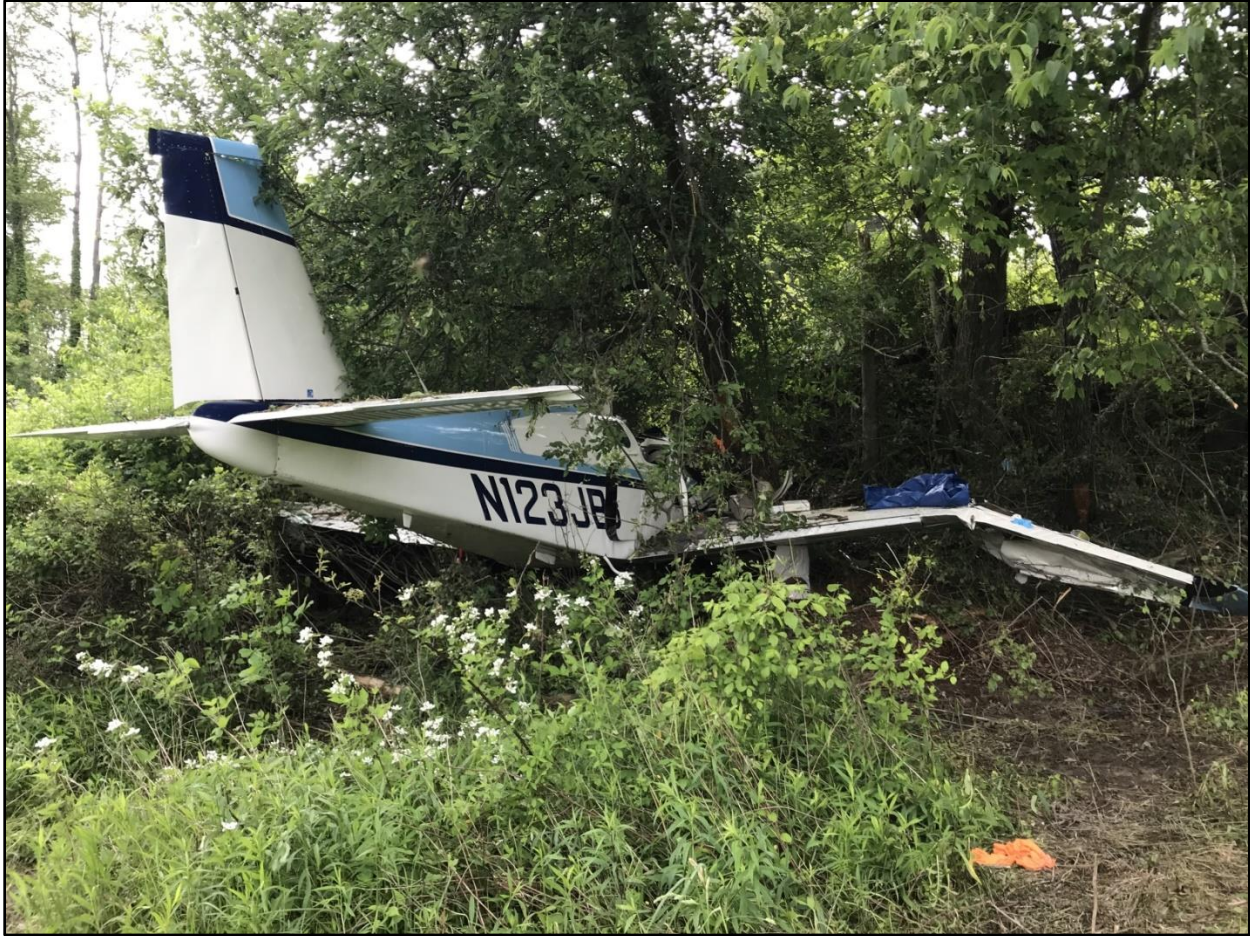
According to the FAA inspectors who responded to the accident site, the airplane wreckage was at the edge of a field located about 3 nautical mile northeast of Cambridge Municipal Airport (CDI), Cambridge, Ohio, as shown in figures 1 and 2. There was no evidence that the airplane's wheels contacted the ground before the airplane flew into the trees at the eastern edge of the field on an east heading. Based on the damage to the trees and the airplane, the airplane impacted the trees a few feet above ground level in a level pitch attitude, as shown in figure 3.

**Figure 3** - Main Wreckage at Accident Site (AMF Aviation Photo)

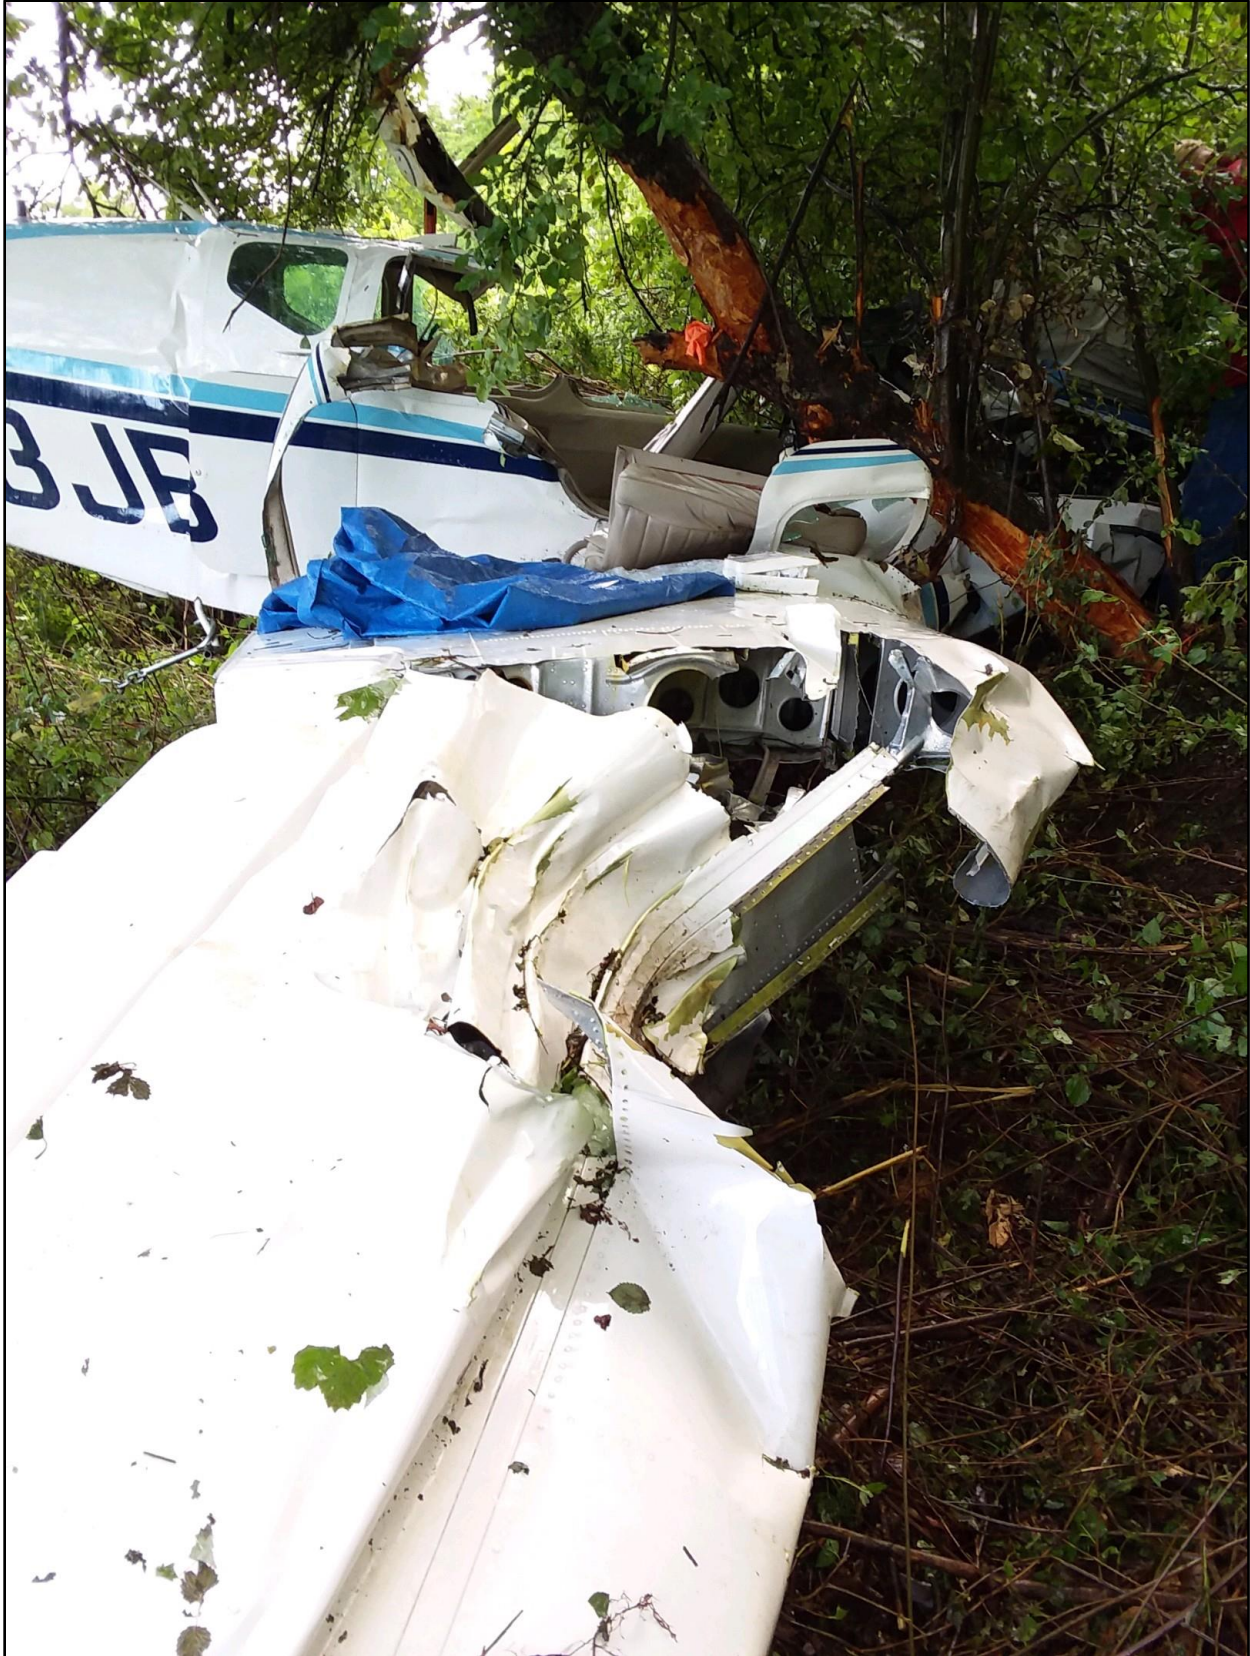
The right wing impacted a tree outboard of the fuel tank crushing the leading edge aft into the main wing spar, as shown in figure 4. The left wing tip also exhibited a semicircular crush zone near the wingtip consistent with a tree impact. The empennage appeared to be undamaged.

**Figure 4** - Right Wing and Fuselage at Accident Site (FAA Photo)

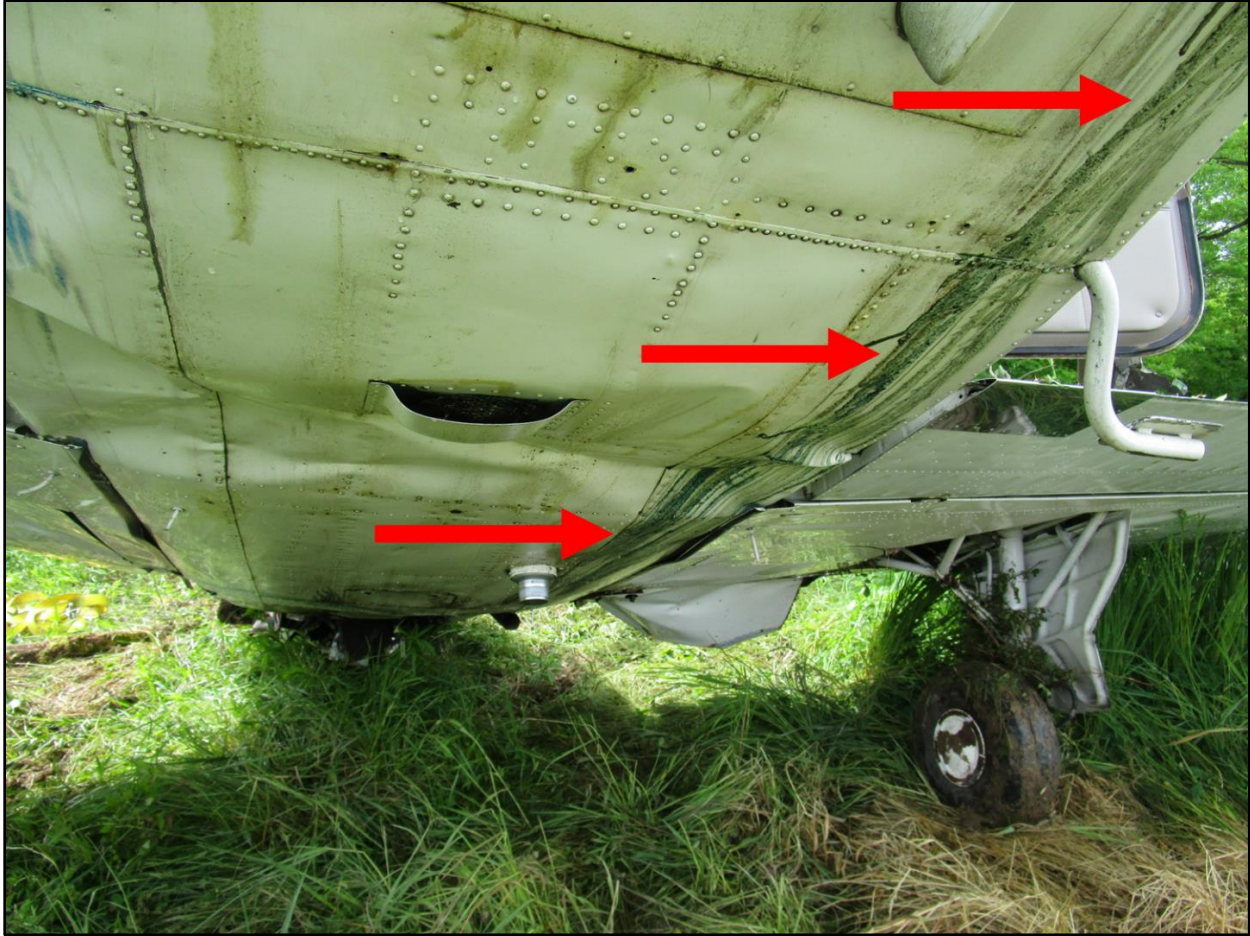
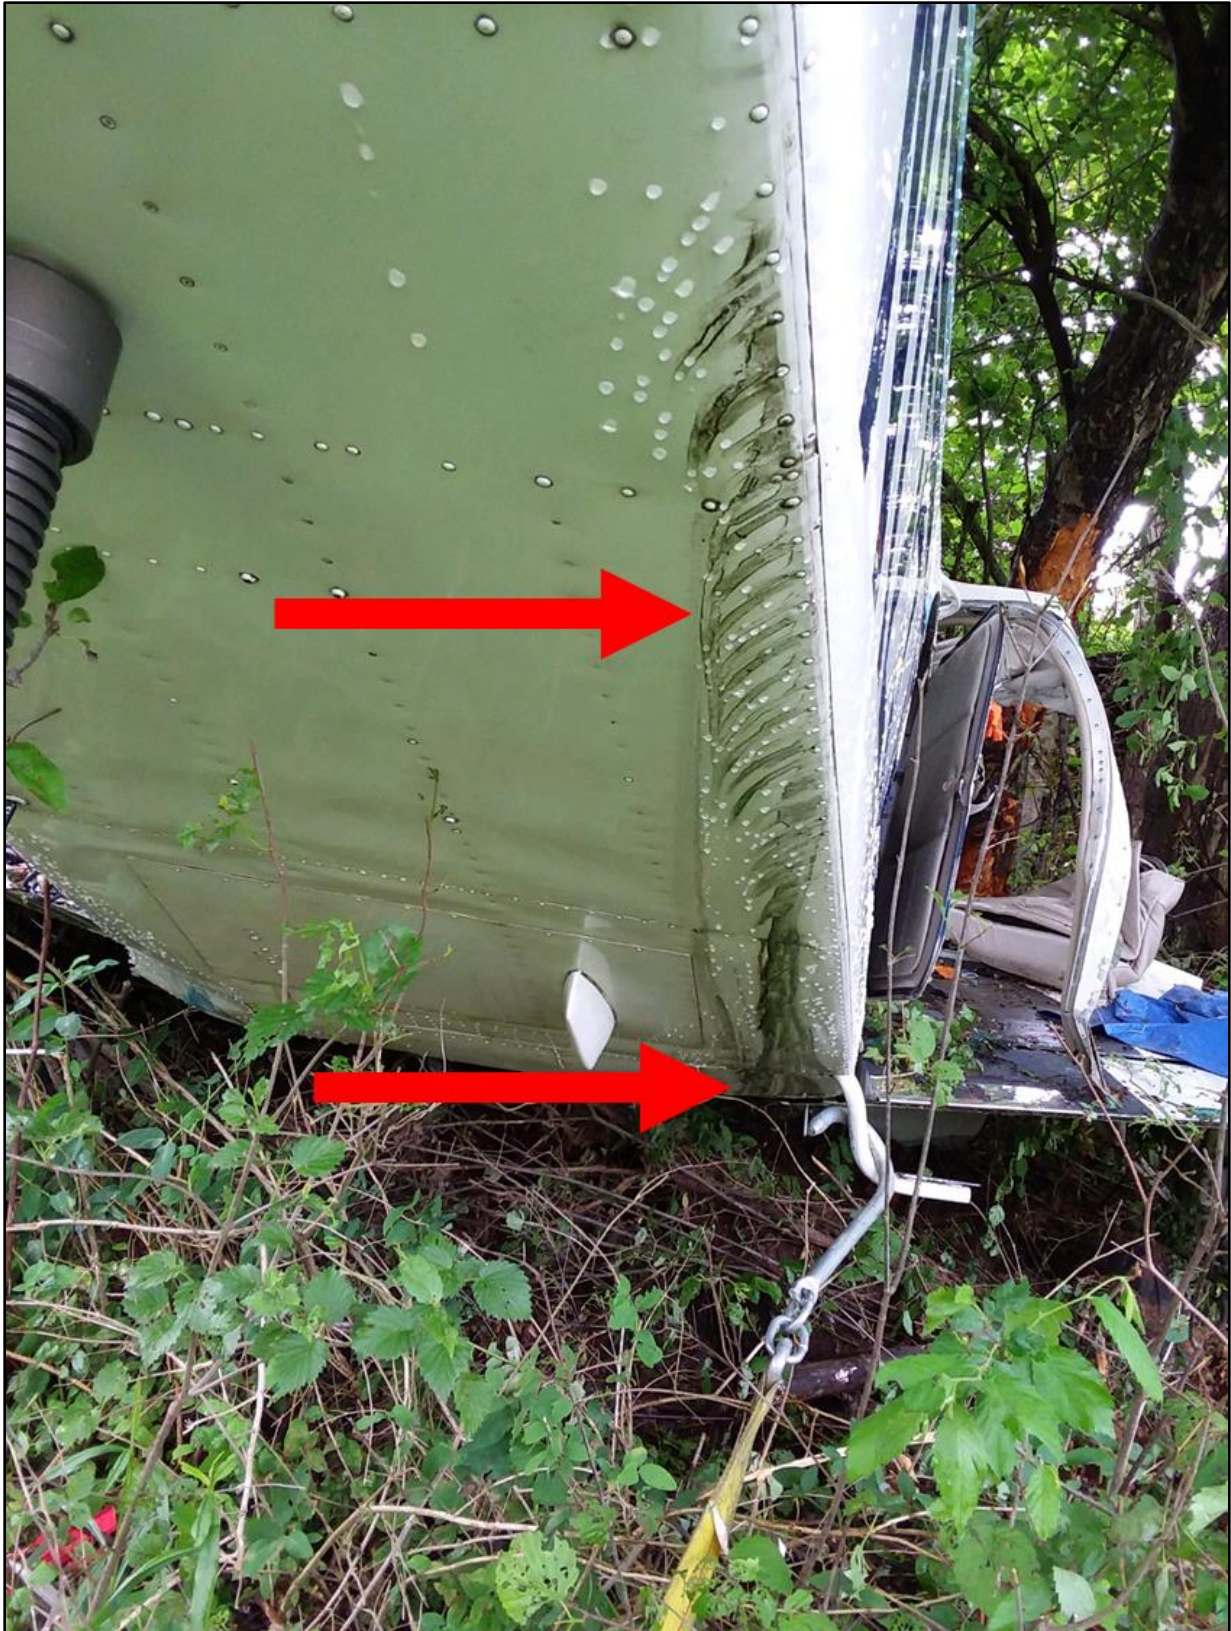
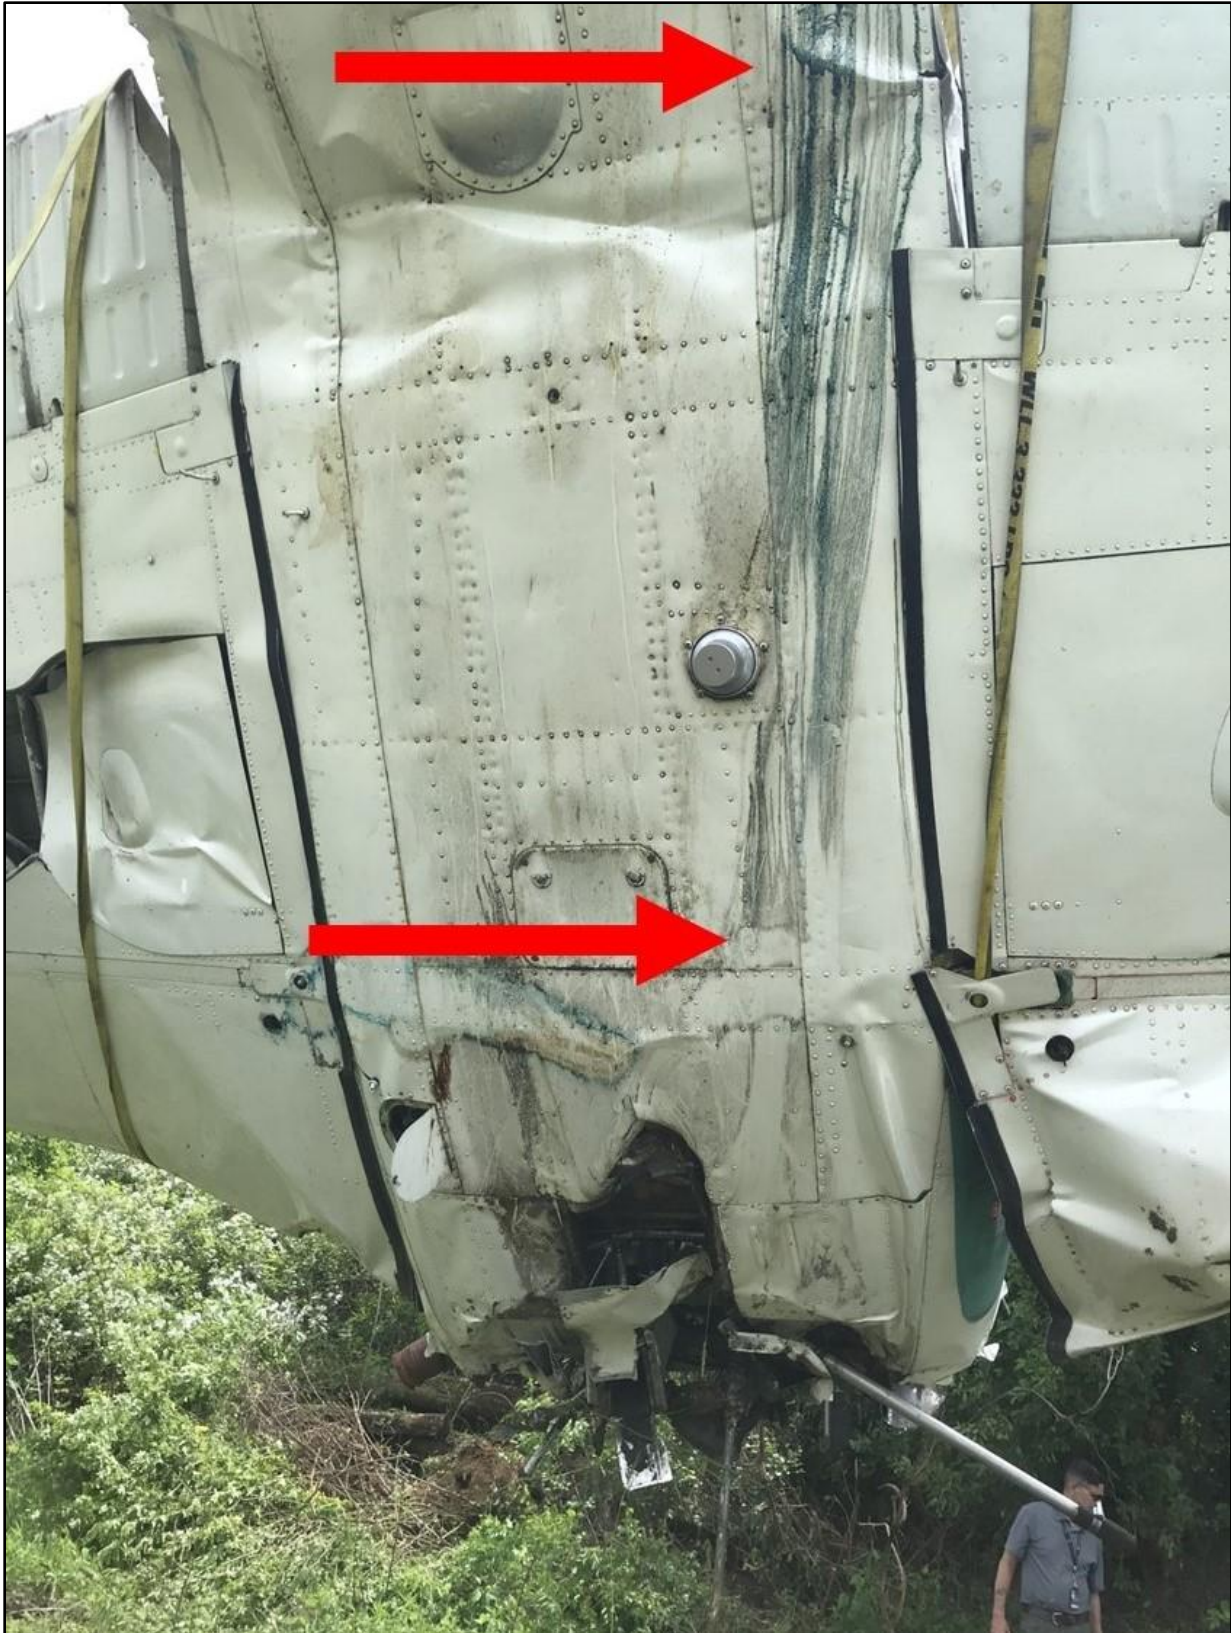
Visual examination of the fuselage's exterior revealed fuel streaks emerging from a louvered vent and access panel at the lower right side of the engine compartment, continuing aft along the lower right fuselage, as shown in figures 5-7. The source of the fuel leak was not identified during the onsite examination.

**Figure 5** - Fuel Streaks on Lower Right Side of Fuselage (FAA Photo)

**Figure 6** - Fuel Streaks on Lower Right Side of Fuselage (FAA Photo)

**Figure 7** - Fuel Streaks on Lower Right Side of Fuselage (AMF Aviation Photo)

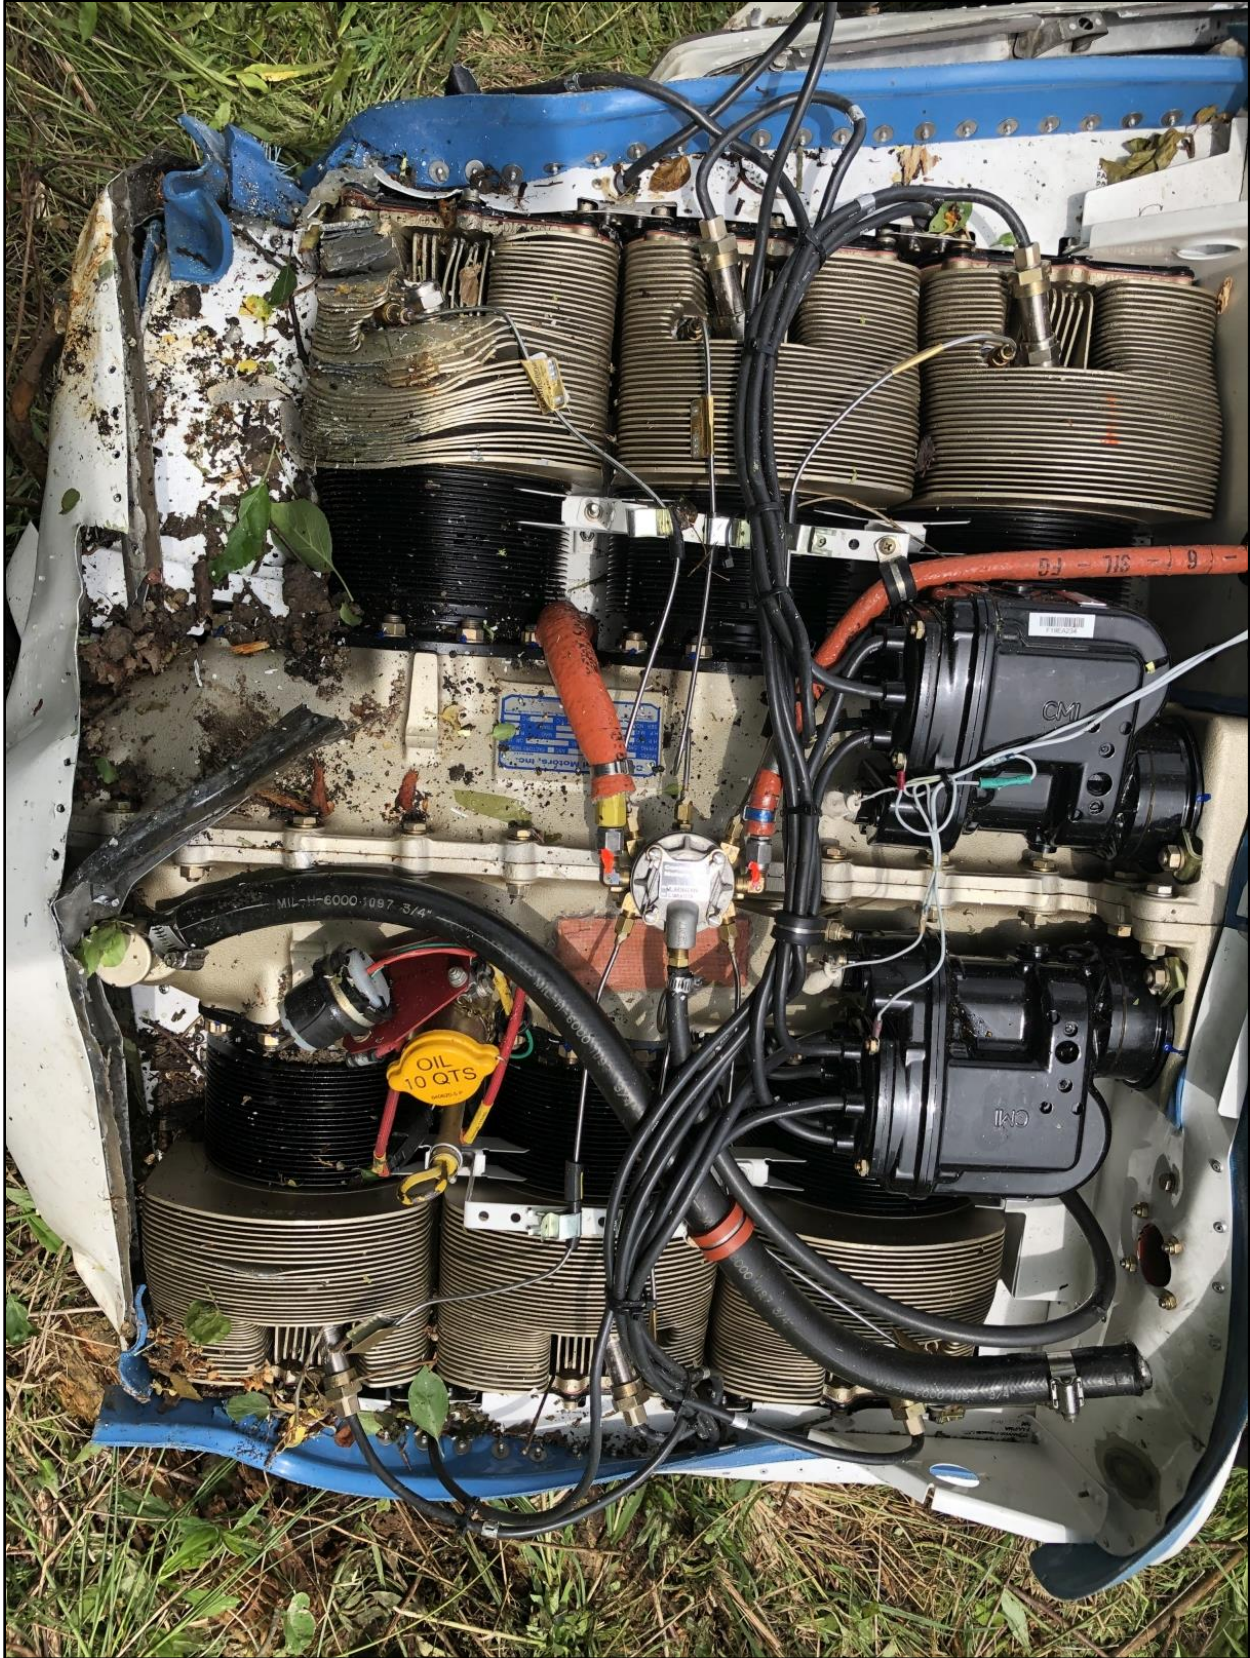
The throttle and mixture controls were in the full aft position, and the propeller control was full forward. A visual examination of the engine crankcase did not reveal any holes or cracks, as shown in figure 8. The crankshaft was not seized, but a damaged propeller blade prevented a full rotation of the crankshaft at the accident site. All six fuel injector lines were observed attached to their respective fuel injector nozzles. There was no visible sign of fuel leakage at any of the fuel injector nozzles.

**Figure 8 - Engine at Accident Site (FAA Photo)**

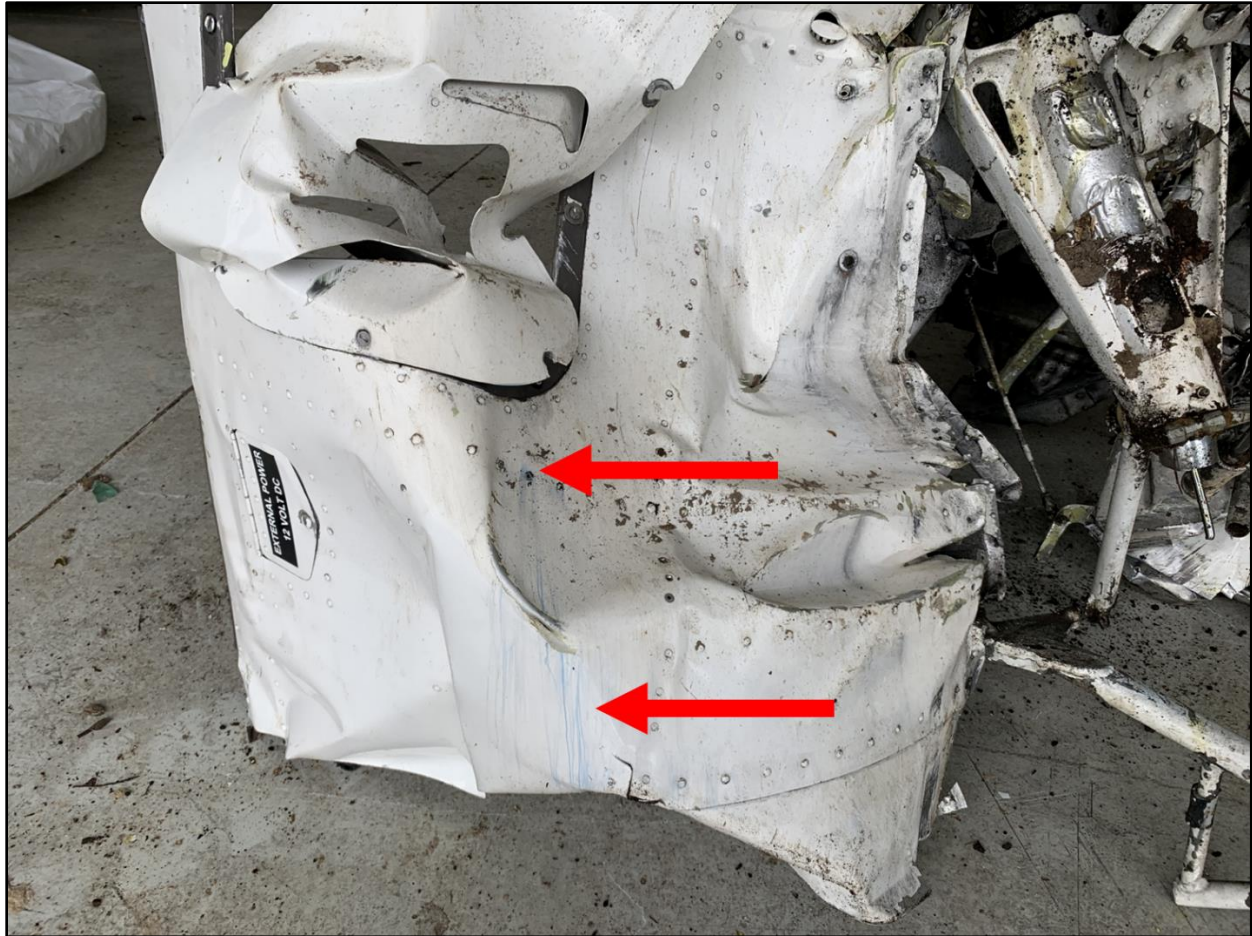
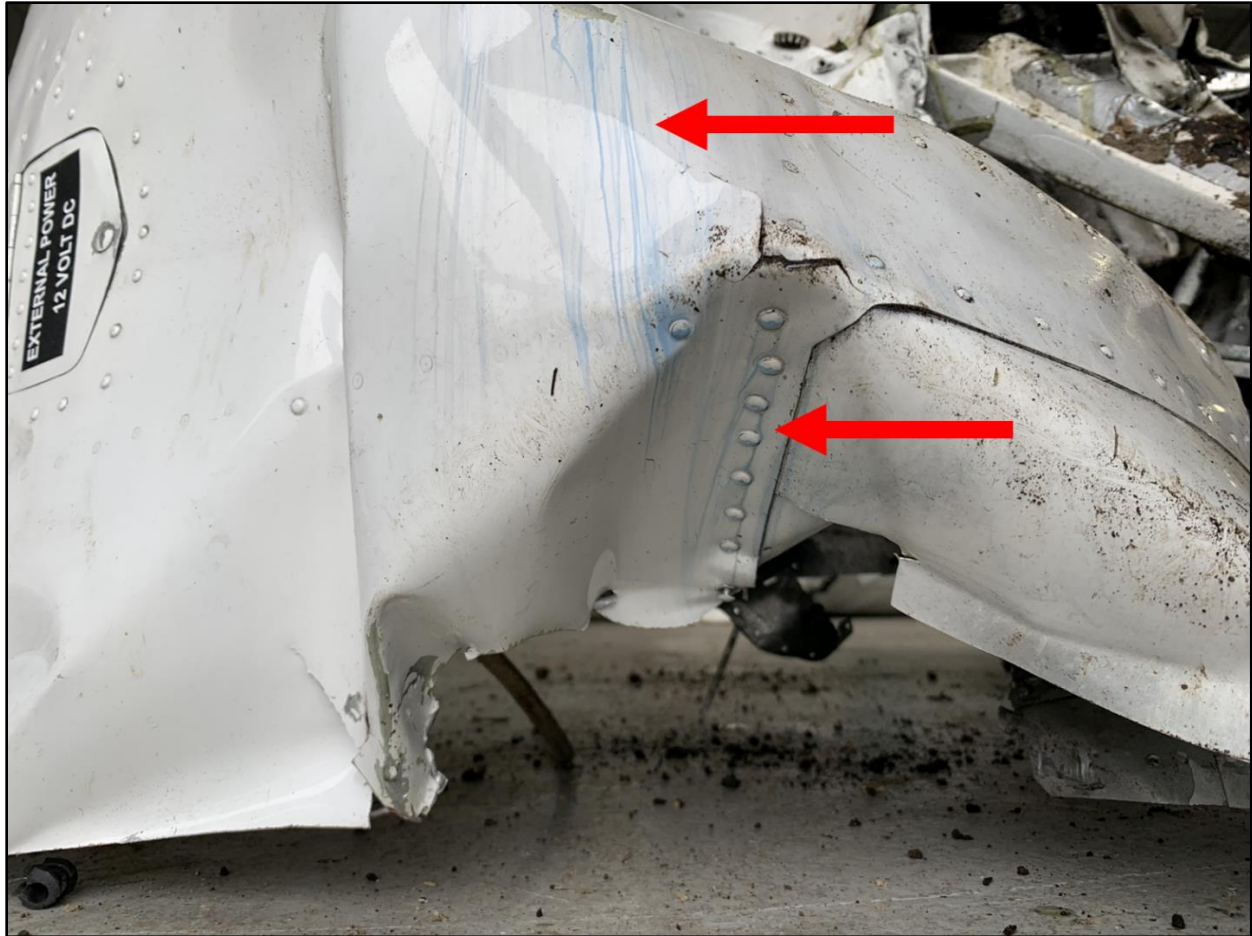
There was no evidence of pooling or streaking of fuel on the internal surfaces of the engine cowling; however, there were a few rivet bucktails that exhibited fuel staining. The fuel streaks previously observed on the exterior of the airplane traced back to the louvered vent and access panel at the lower right side of the engine compartment, as shown in figures 9 and 10.

**Figure 9** - Fuel Streaks on Lower Right Engine Cowl

**Figure 10** - Fuel Streaks on Lower Right Engine Cowl

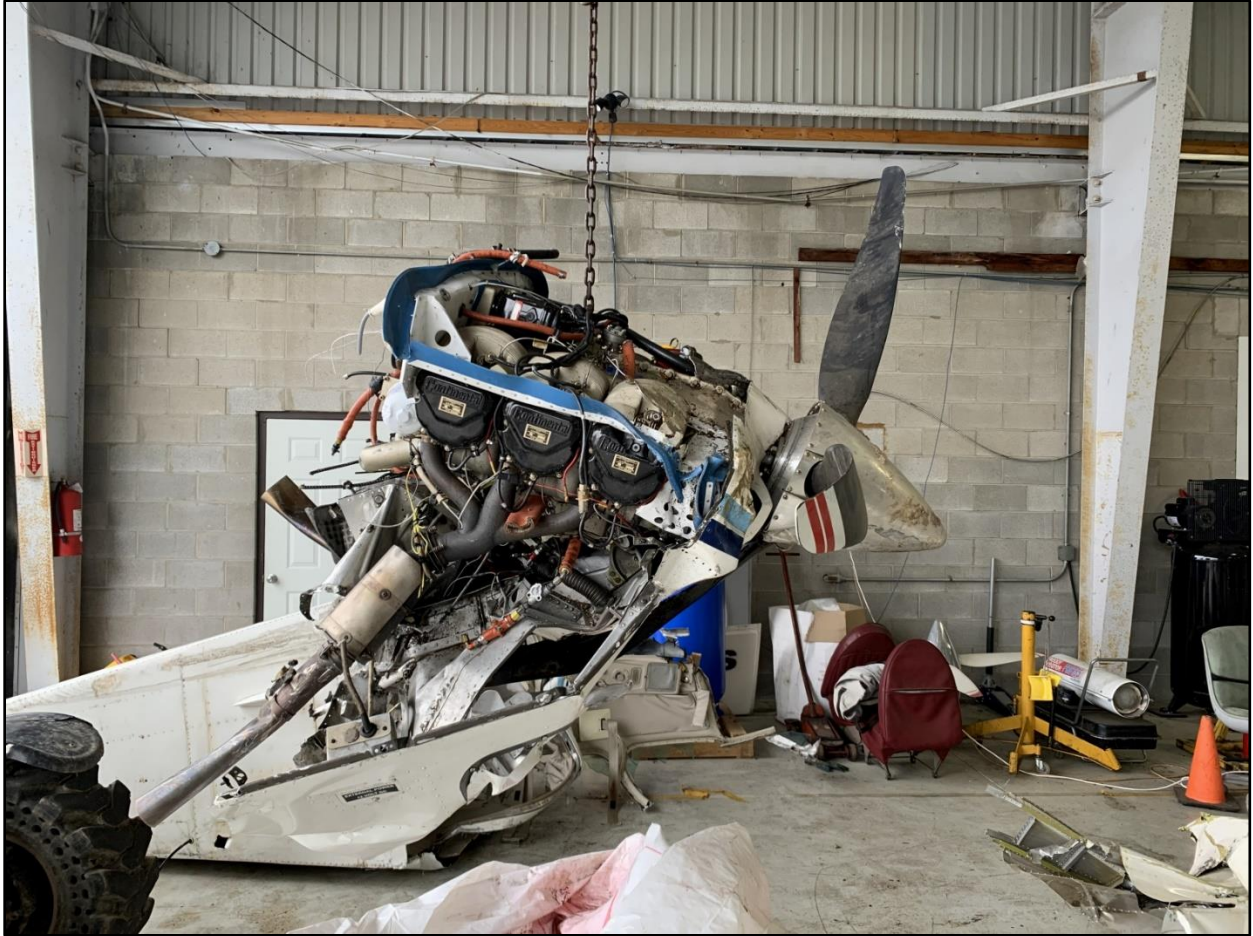
The engine was separated from the firewall before the examination, as shown in figure 11. The engine mounts exhibited impact related damage. A borescope examination of each cylinder confirmed no anomalies with the cylinders, pistons, valves, or valve seats.

**Figure 11** - Engine and Propeller

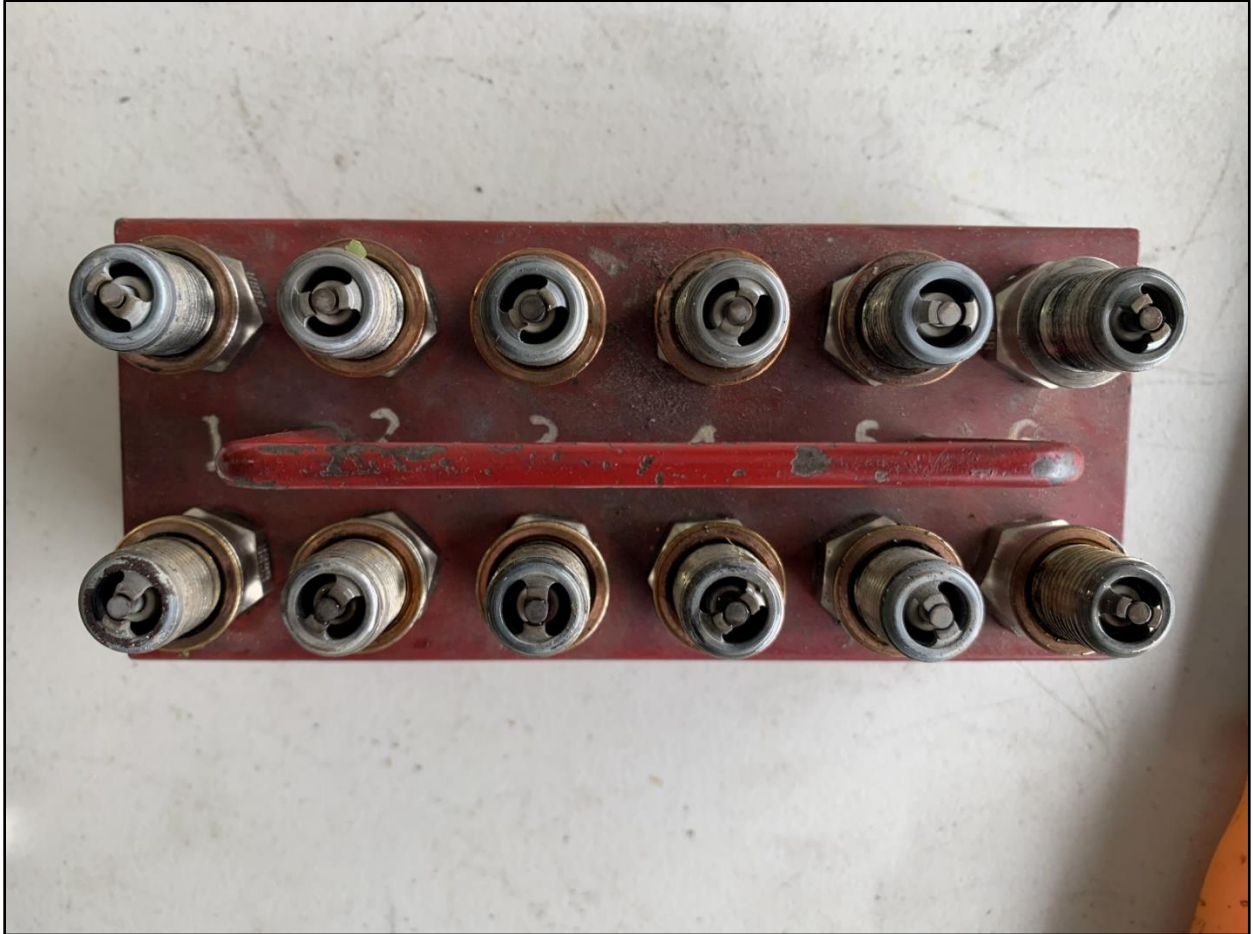
The right and left magnetos produced spark in the proper firing order while the engine crankshaft was rotated. The upper and lower spark plugs exhibited features consistent with normal engine operation, as shown in figure 12.

**Figure 12** - Upper and Lower Spark Plugs

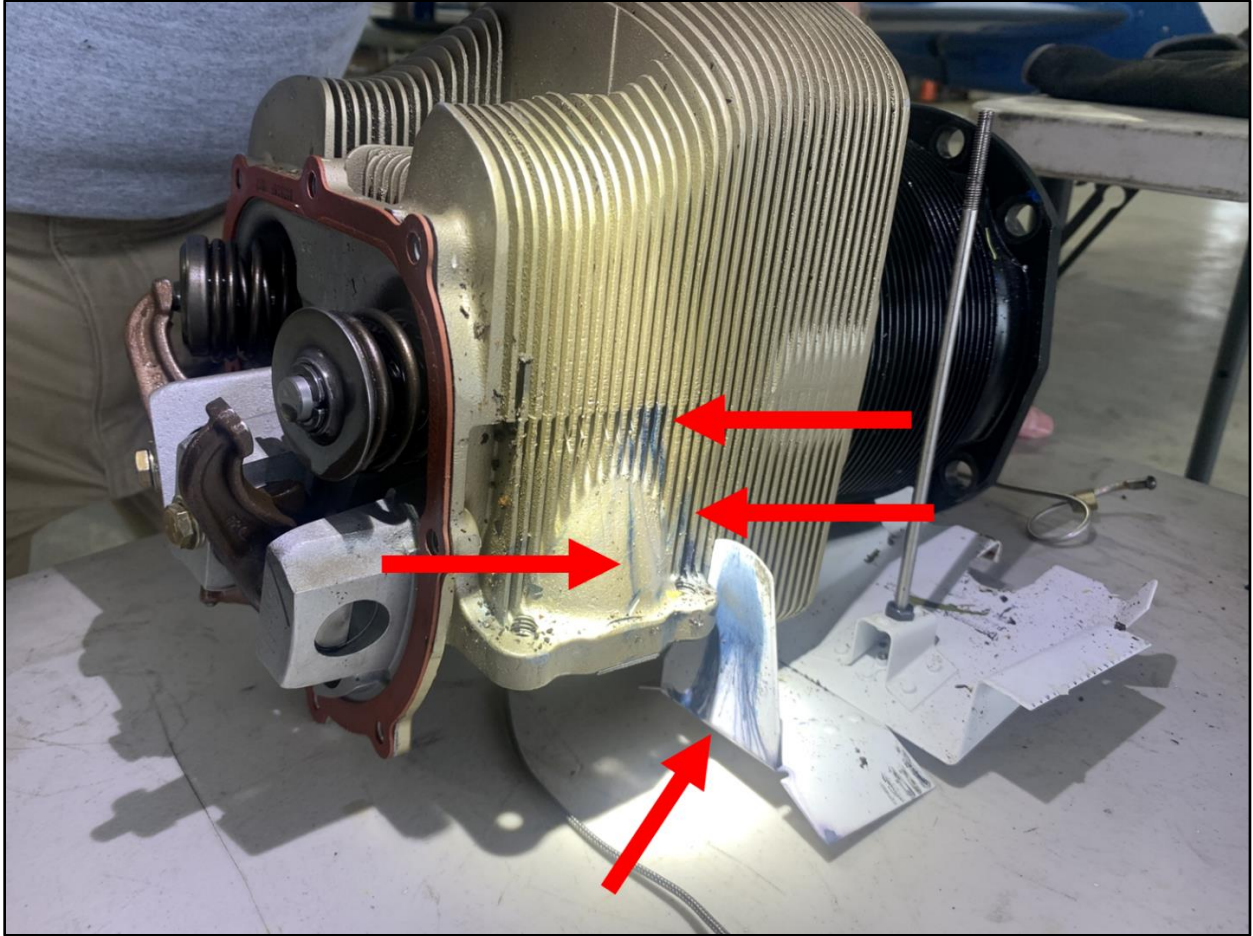
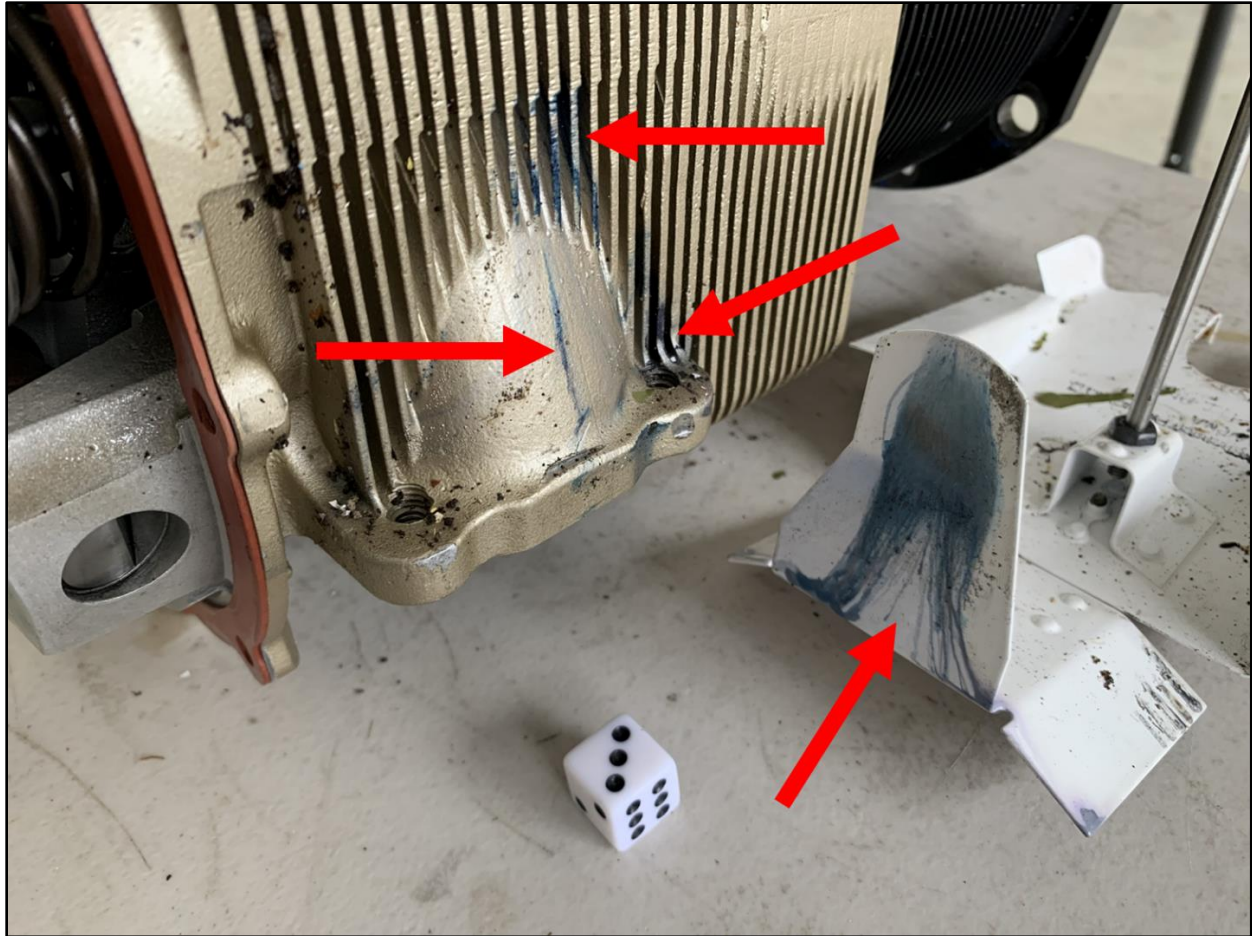
The No. 3 cylinder head exhibited blue fuel stains on several cooling fins located on the forward-facing side of the intake port, as shown in figures 13 and 14. There were no apparent cracks or fuel stains around the fuel injector nozzle or spark plug ports. The inter-cylinder baffle between cylinders Nos. 3 and 5 exhibited blue fuel staining, as shown in figure 15. The intake flange gasket compression faces were flattened around the inner diameter hole and there were no apparent kinks or tears. The No. 3 cylinder intake elbow and cylinder intake port flange face did not exhibit any fuel stains. The remaining cylinders and engine components did not exhibit any visible fuel stains.

**Figure 13** - Fuel Stains on Cylinder No. 3 and Inter-Cylinder Baffle

**Figure 14** - Fuel Stains Near No. 3 Cylinder Intake and on Inter-Cylinder Baffle

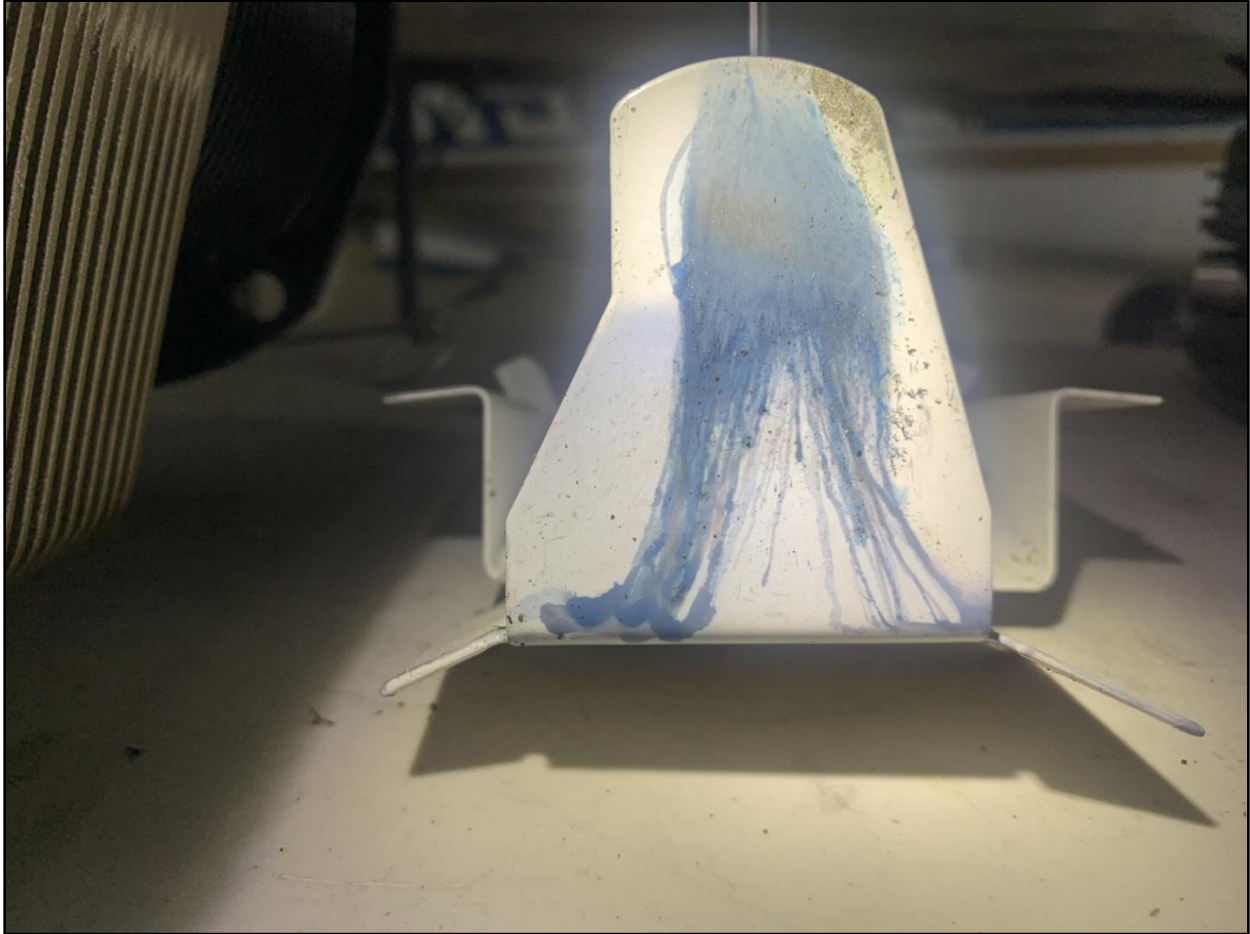
**Figure 15** - Fuel Streaking on Inter-Cylinder Baffle Between Cylinders Nos. 3 and 5

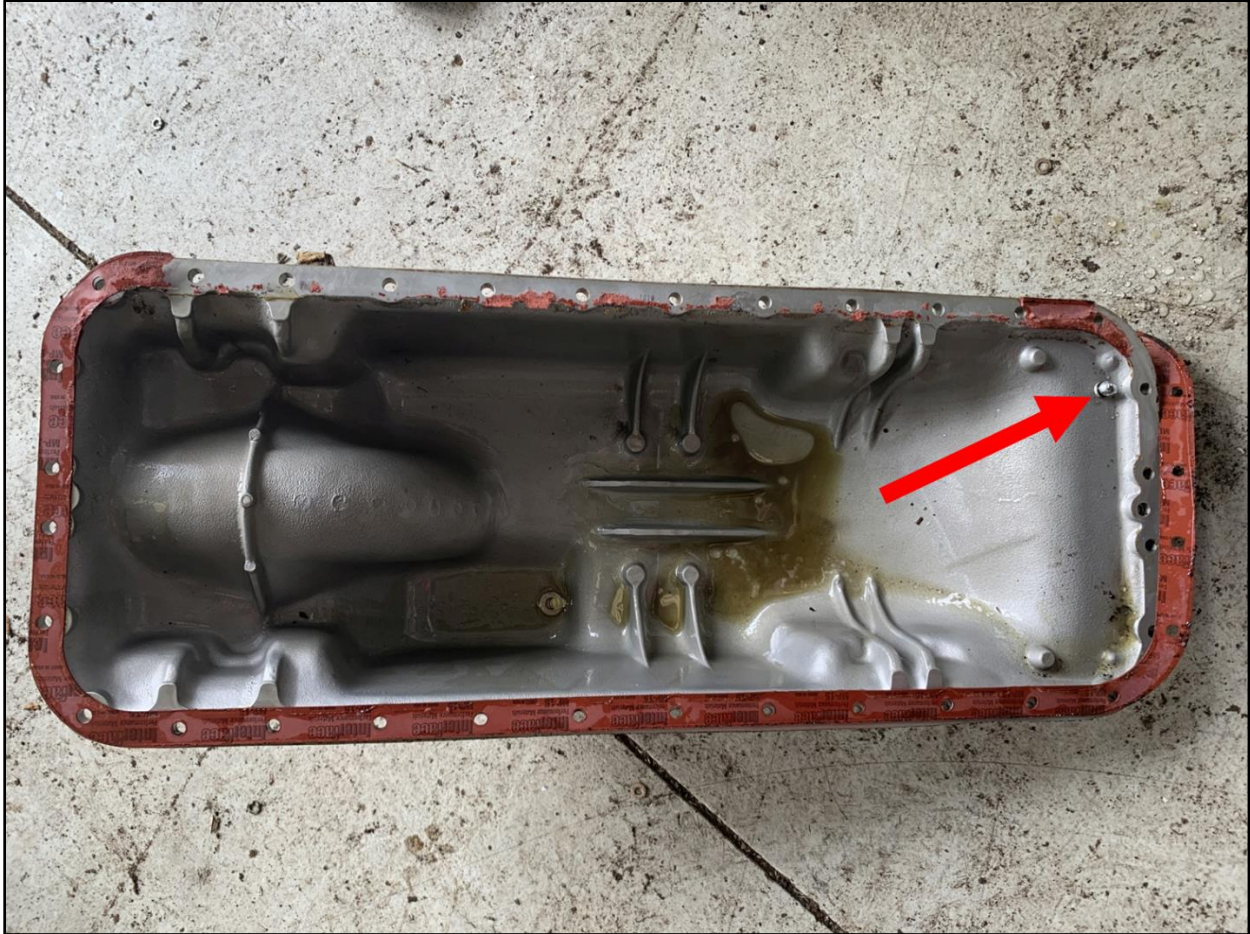
The oil sump pan remained intact, as shown in figure 16. The oil quick-drain installed at the bottom of the oil sump pan was damaged during impact, leaving a fractured portion of an aluminum plug with O-ring loose in the oil sump pan, as shown in figure 17. There was no evidence that the fractured aluminum plug had been damaged by engine operation. No additional metal debris was observed in the sump pan. Disassembly of the oil pump revealed no mechanical issues. The oil filter remained installed on the engine with no evidence of an oil leak. The oil filter was cut open and the paper filter element contained a few small metallic flakes.

**Figure 16** - Engine Oil Sump Pan Containing Portion of Quick-Drain Plug

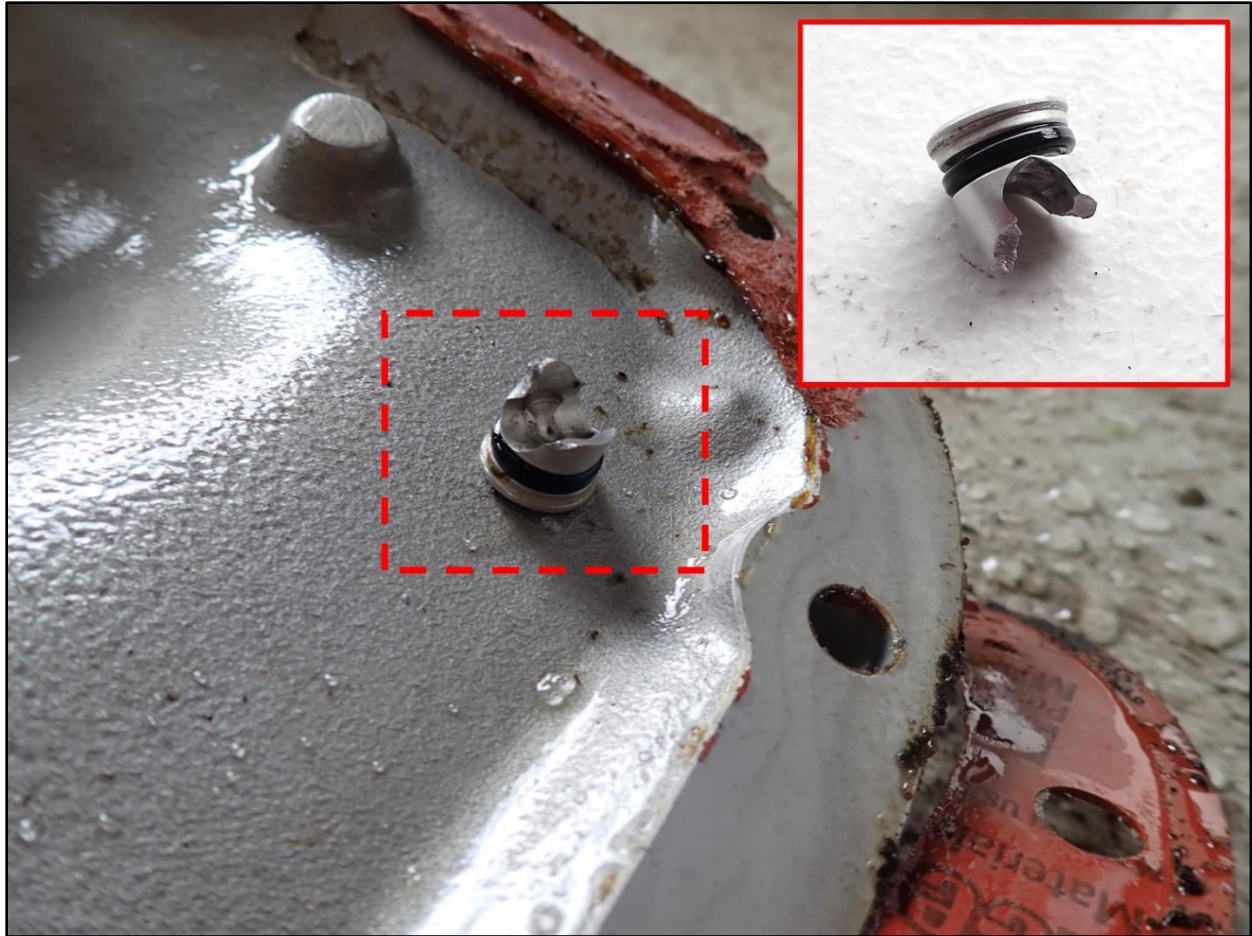
**Figure 17** - Quick-Drain Plug Found in Oil Sump Pan (Textron Aviation Photos)
