# National Transportation Safety Board

CEN20LA197

## **WRECKAGE EXAMINATION SUMMARY**

Location: Cambridge, Ohio  
Date: May 27, 2020  
Time: 1458 eastern daylight time  
Airplane: Beech 35-A33, Registration No. N123JB

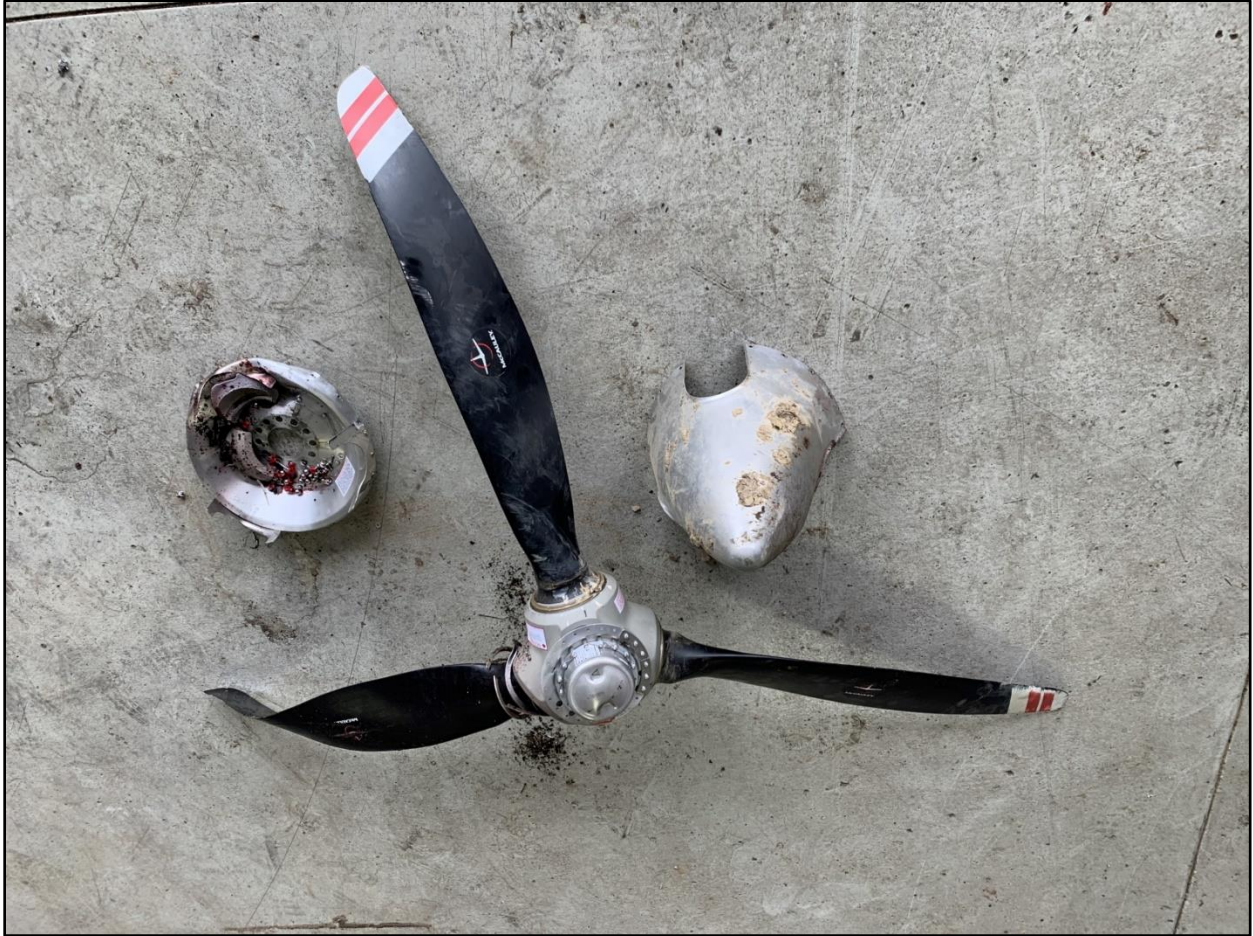
The propeller remained attached to the crankshaft flange. The spinner displayed minimal rotational impact signatures and no fore-aft crush damage. The propeller blades exhibited various impact related damage, as shown in figure 18. The outboard 1/3 of the No. 1 blade was bent slightly aft. The No. 2 blade was relatively straight, exhibited leading edge scuff marks near the blade tip, and a small leading-edge gouge about 2" from the blade tip. The No. 3 blade was fractured in hub, bent slightly aft and under the engine cowlings, and exhibited light spanwise scratches.

**Figure 18** - Propeller and Spinner
