# The National Transportation Safety Board

Office of Aviation Safety  
Central Region  
Memorandum for the Record  
Airframe and Accident Site  
Examination Findings  
CEN20LA199  
Pineville, Louisiana  
May 31, 2020

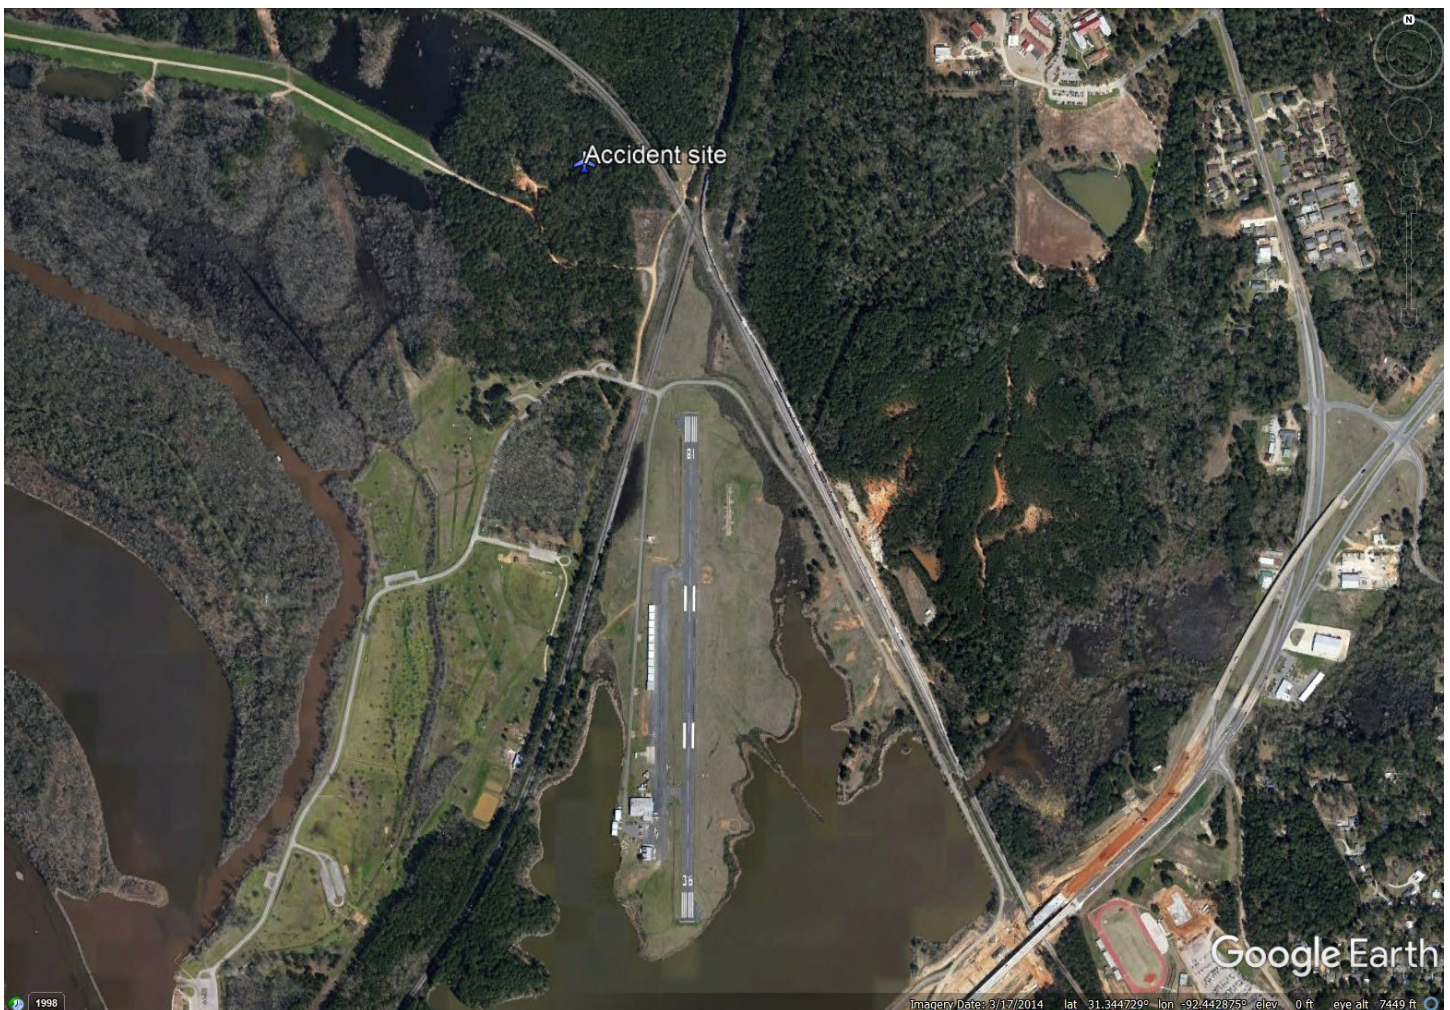
Overhead Image of Runway 36 and Accident Site

The accident site was in a heavily wooded area, about 1.5 miles from the departure end of runway 36 at Pineville Municipal Airport (2L0). After initial on-site examinations, the airplane wreckage was transported to a secure facility for further examinations. Several small trees showed cuts consistent with propeller blade contact.
