**NATIONAL TRANSPORTATION SAFETY BOARD**  
Vehicle Recorder Division  
Washington, D.C. 20594

## **Onboard Image Recorder**

### **Specialist's Factual Report by Gerald Kawamoto**

Location: Carlinville, Illinois  
Date: May 31, 2020  
Aircraft: Piper PA-28-235  
Registration: N8991W  
Operator: Private  
NTSB Number: CEN20LA201

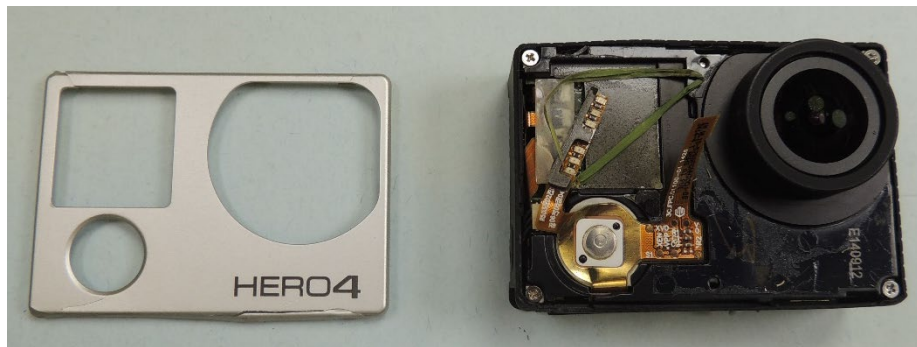
Upon arrival at the Vehicle Recorder Laboratory, an external examination revealed the device had sustained impact damage, as shown in Figure 1. The internally mounted 256 GB microSD card was undamaged and data was extracted normally.

**Figure 1. GoPro Hero 4 as received.**
