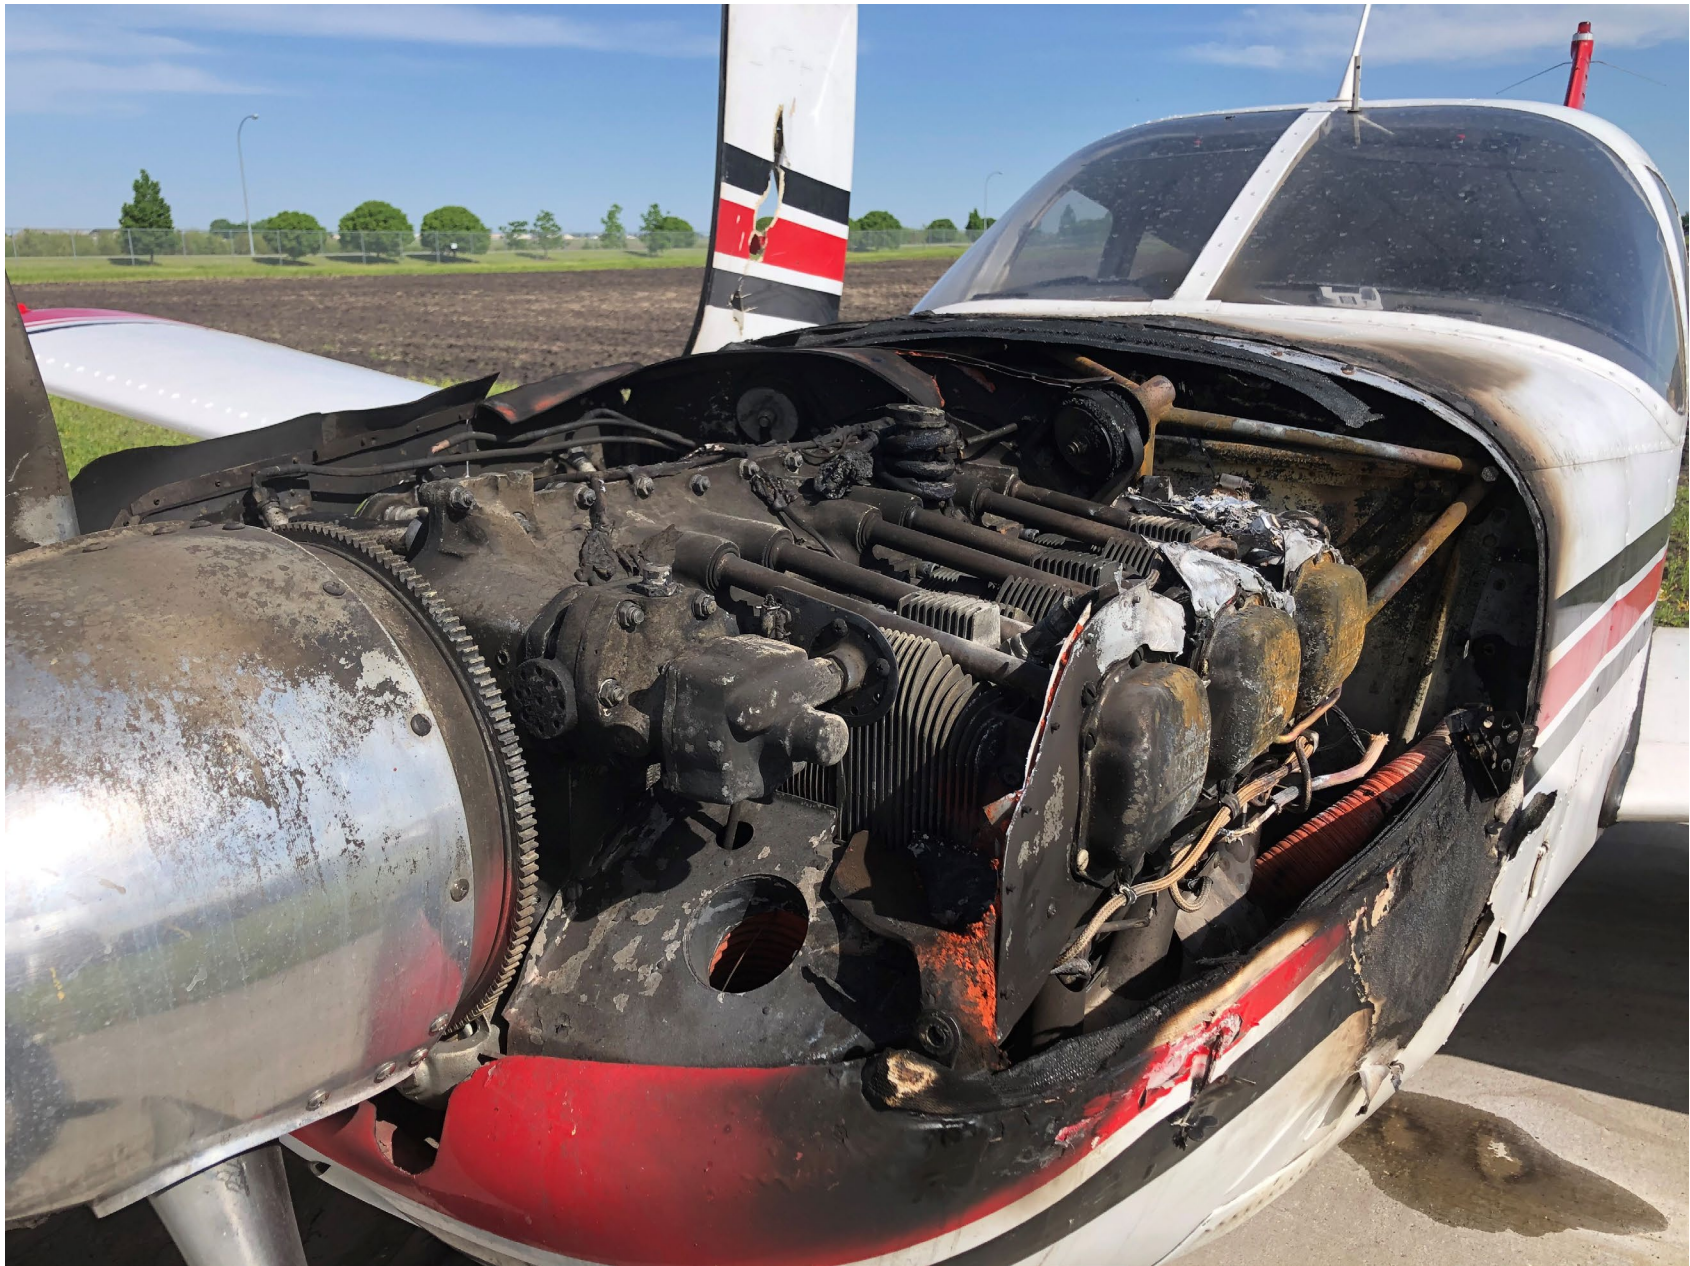
**Photo 1 – Fire Damage to Left Side of Engine (Courtesy of FAA)**

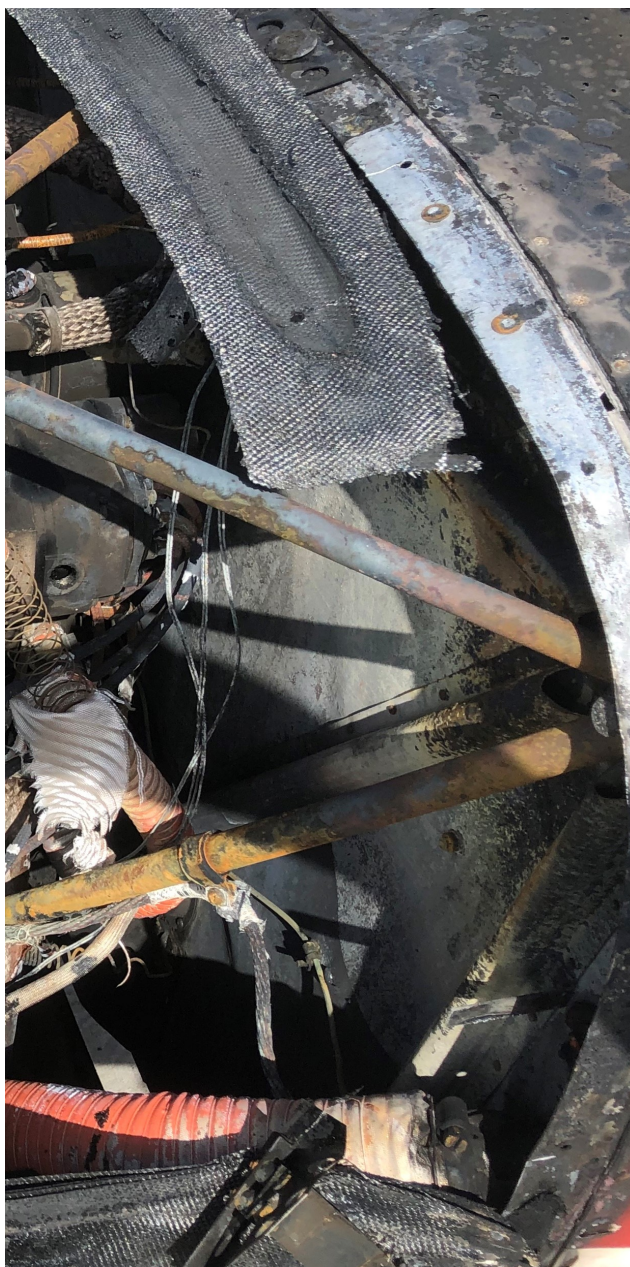
**Photo 2 –Severe Heat Damage to Engine in Area of Left Side Firewall (Courtesy of FAA)**
