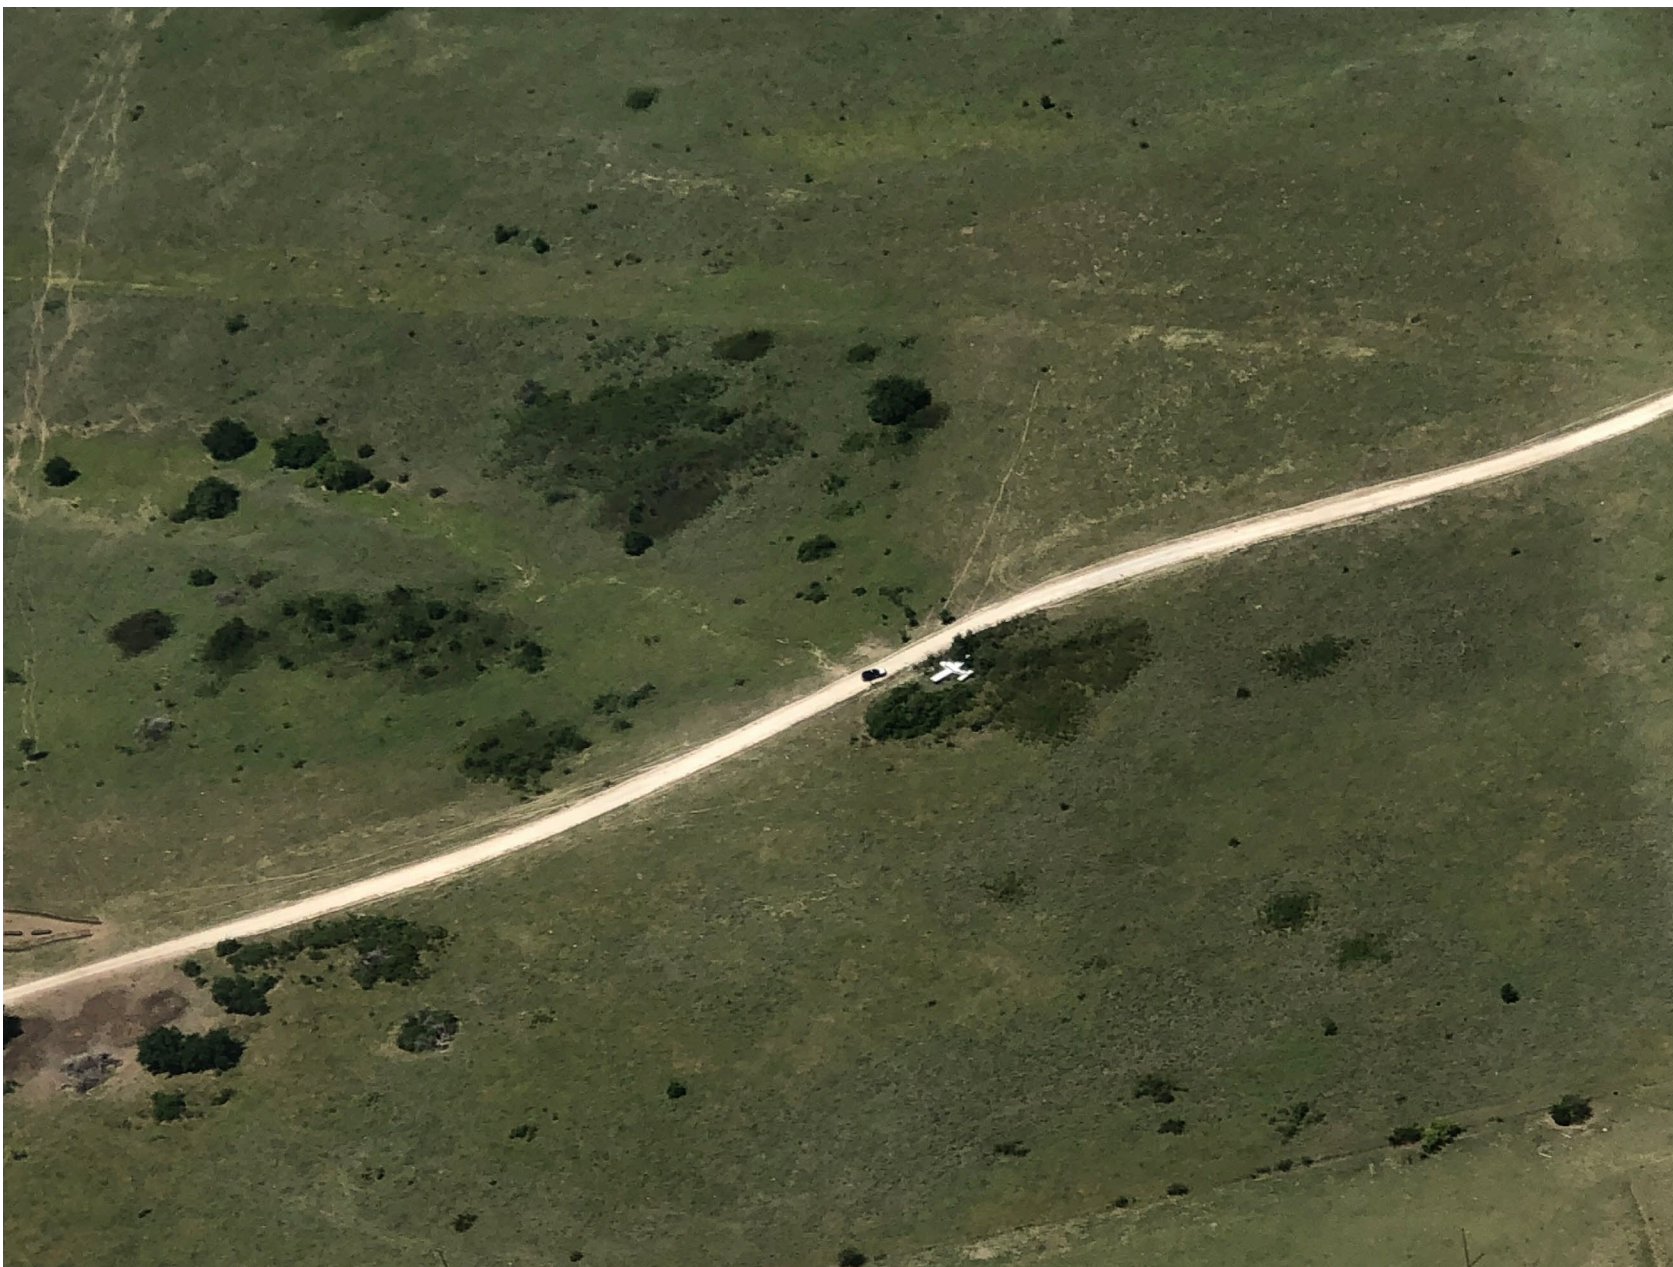
**Photo 1 – FAA supplied aerial view of the accident site.**

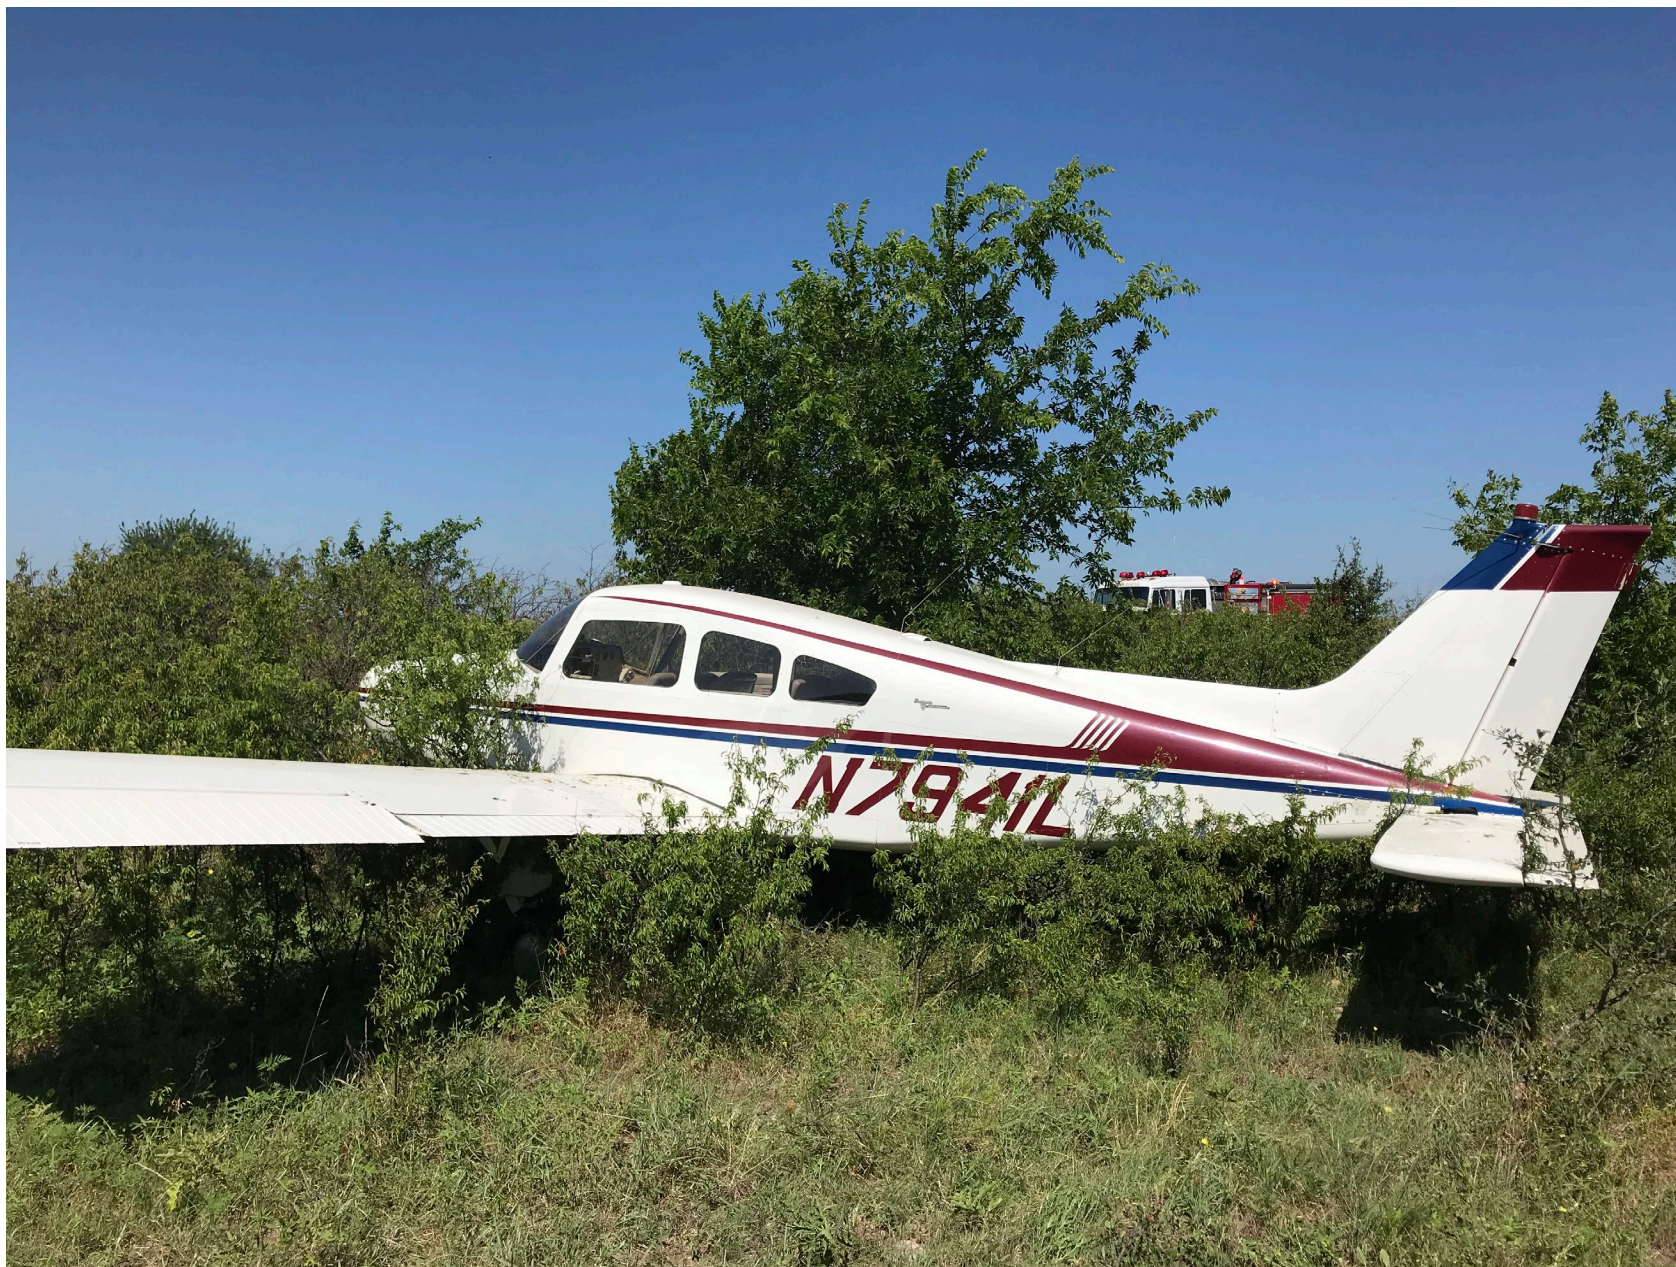
**Photo 2 - FAA supplied quartering view of the left rear side of the airplane.**

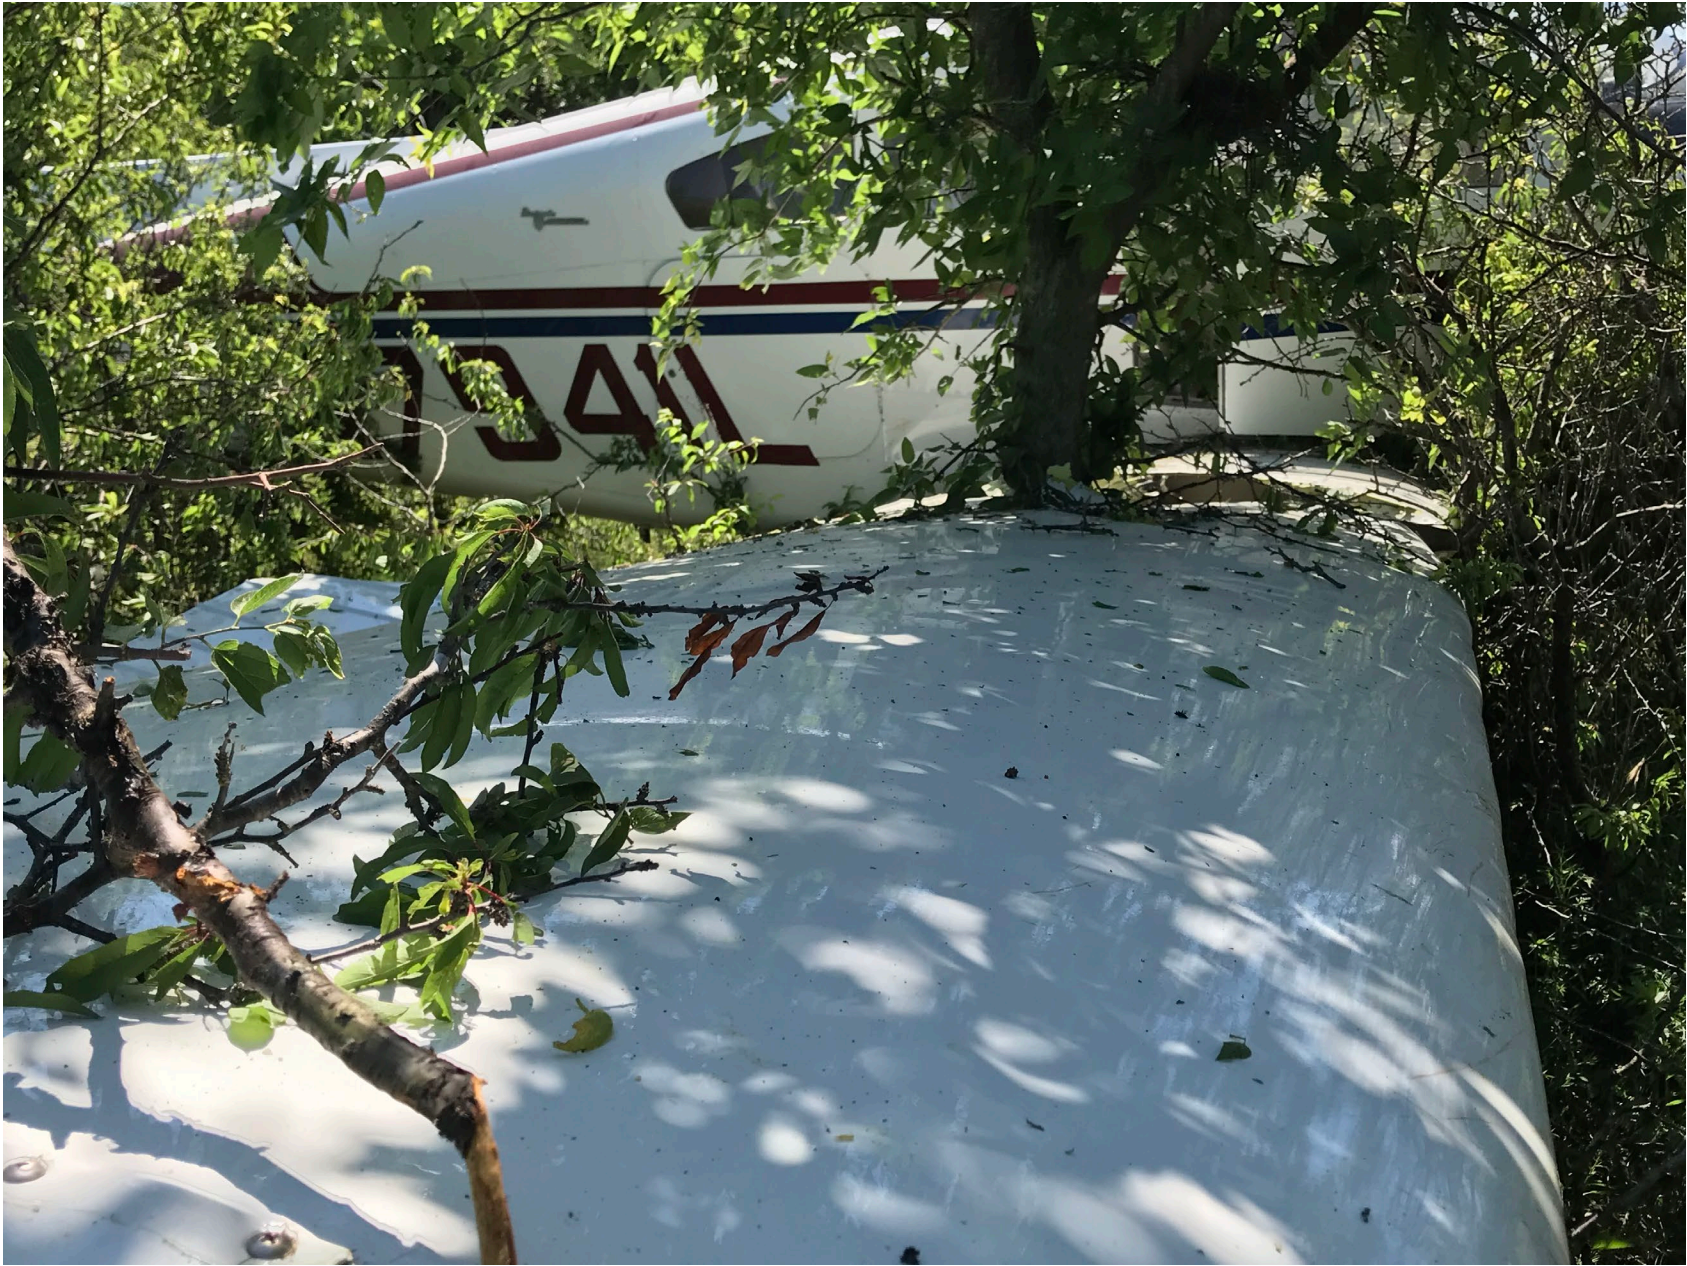
**Photo 3 - FAA supplied view of the right wing. The leading edge of the wing about midspan is deformed around a tree trunk.**

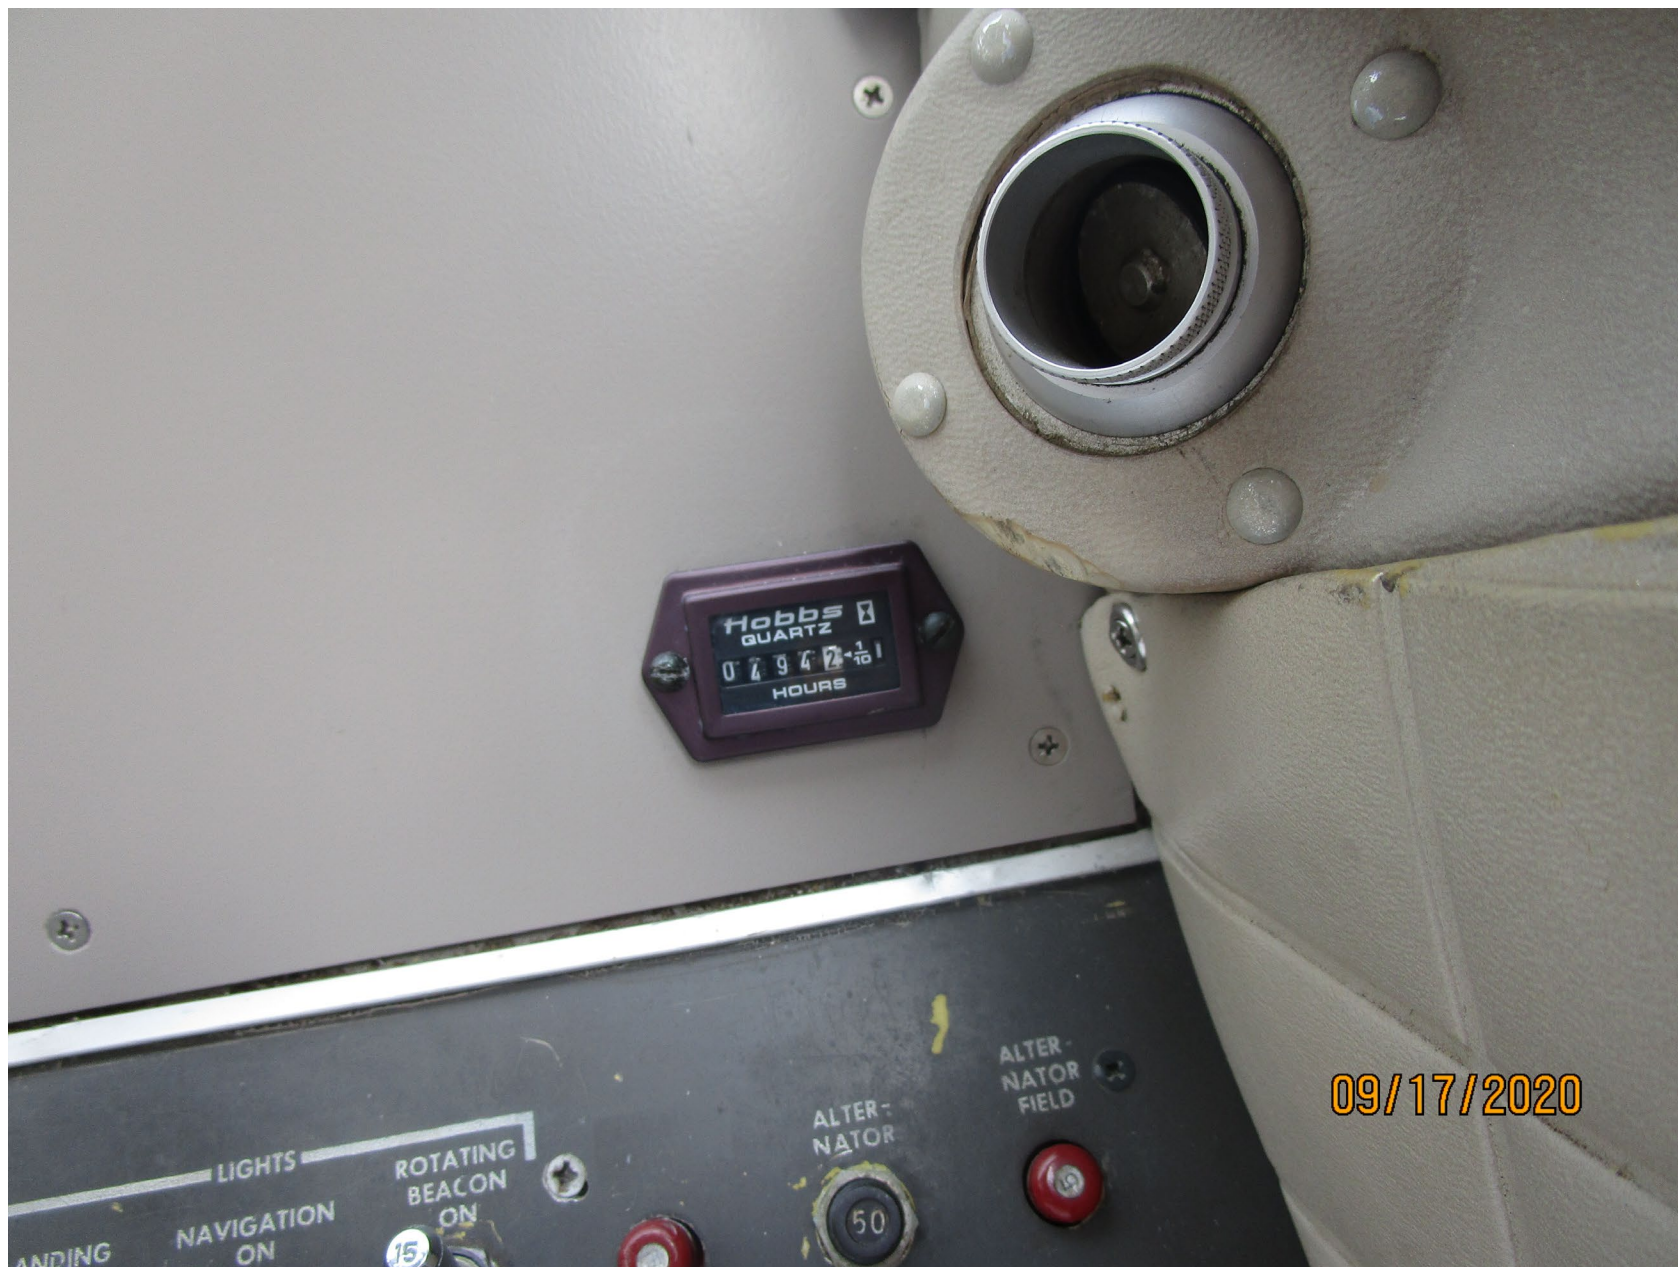
**Photo 4 - View of the Hobbs meter. The meter indicates 494.2 hours.**

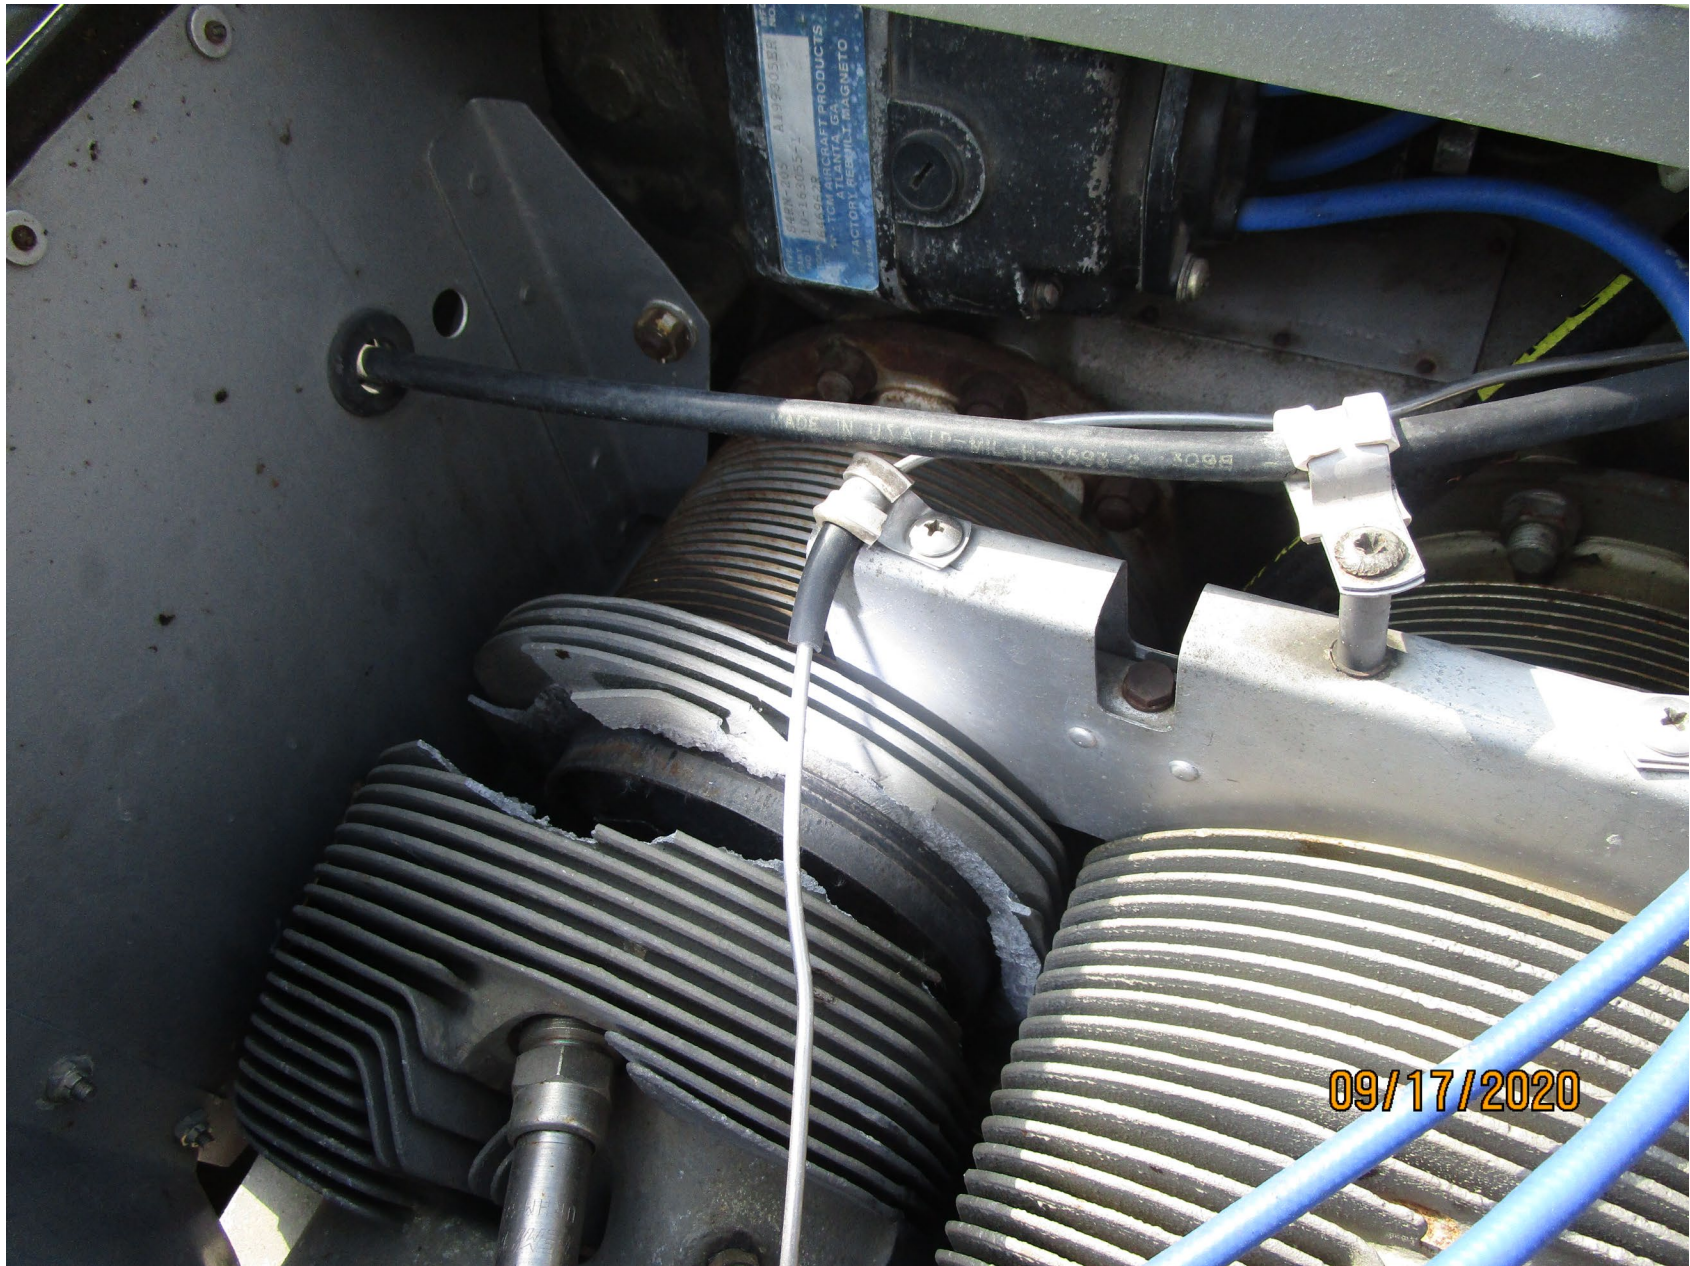
**Photo 5 - View of the separated cylinder.**

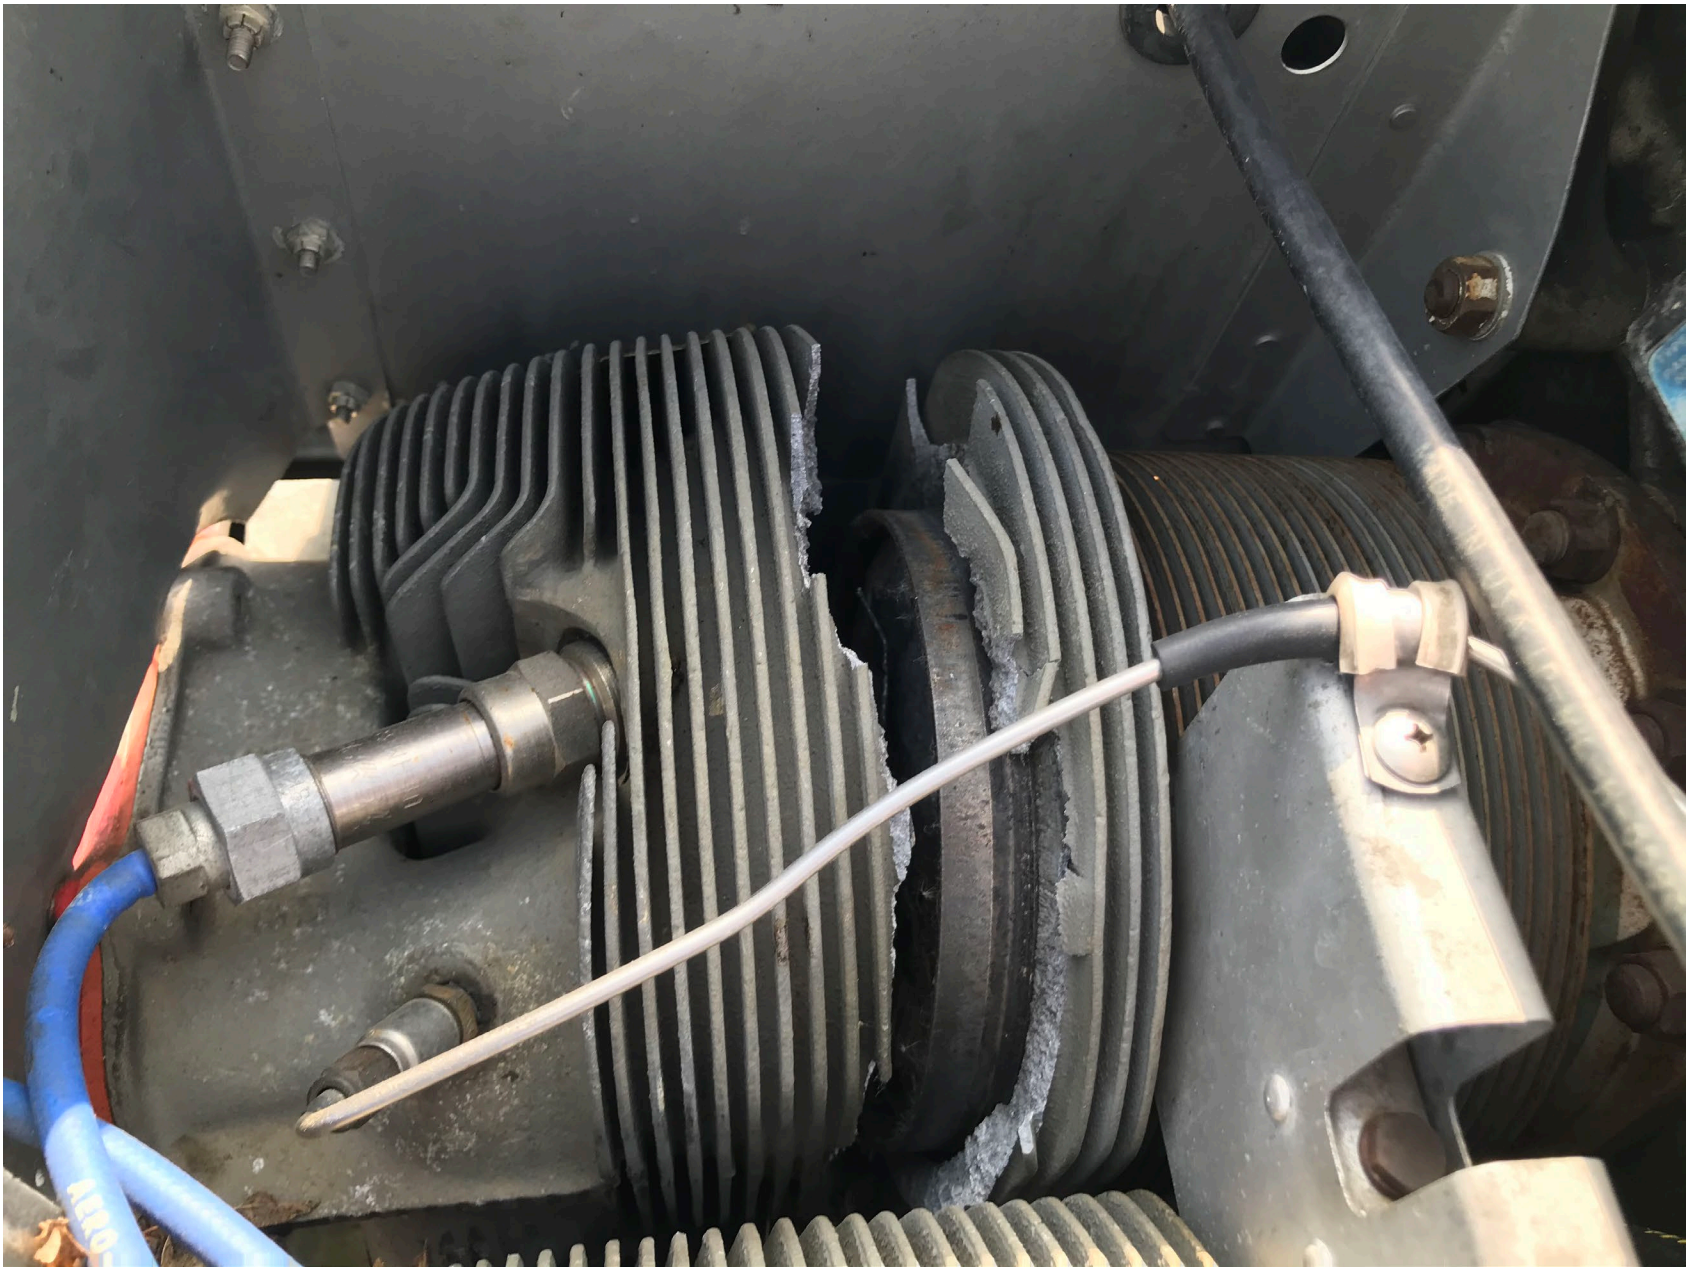
**Photo 6 - Close-up view of the separated cylinder.**

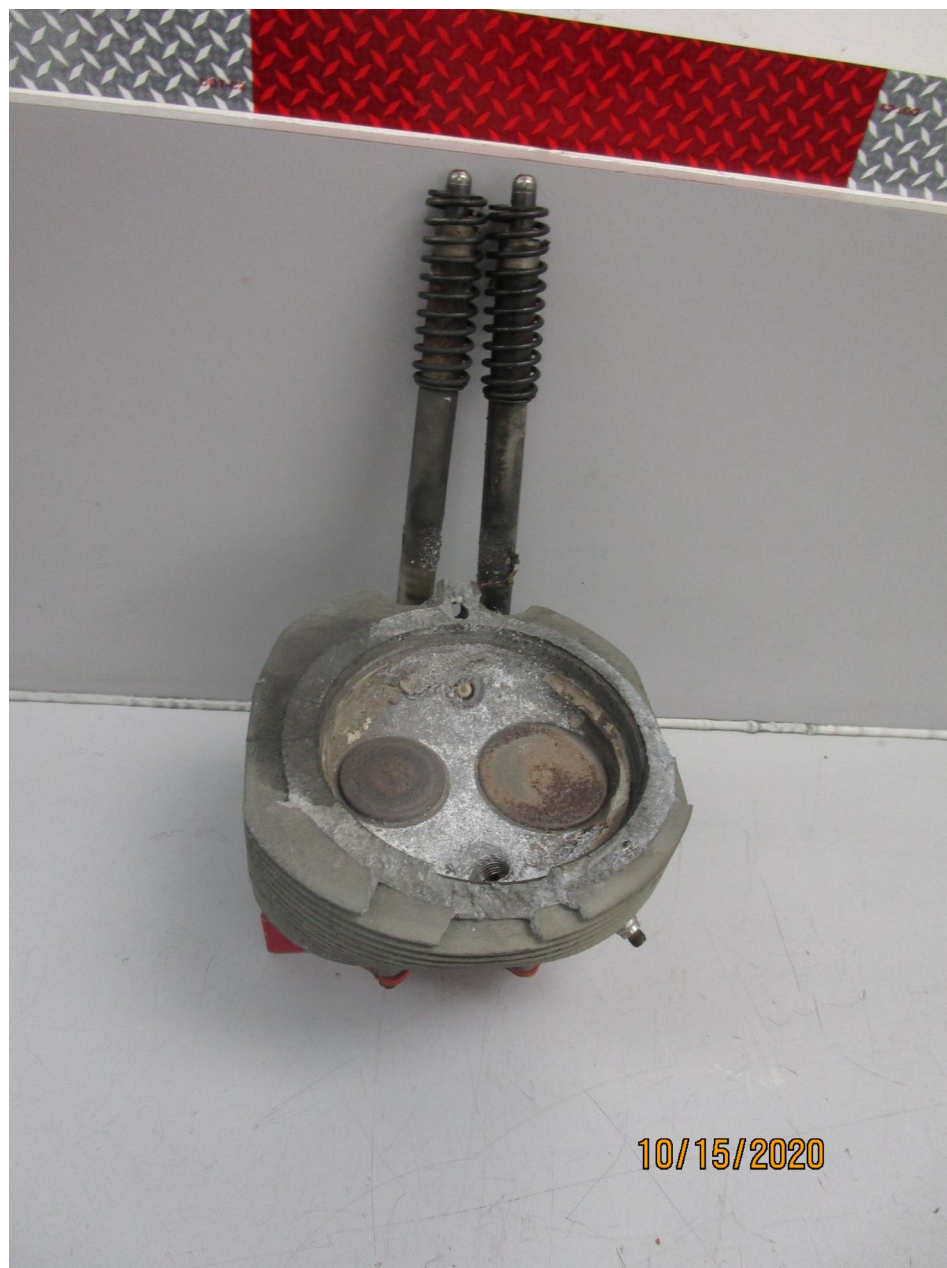
**Photo 8 - Close-up view of the piston crown.**

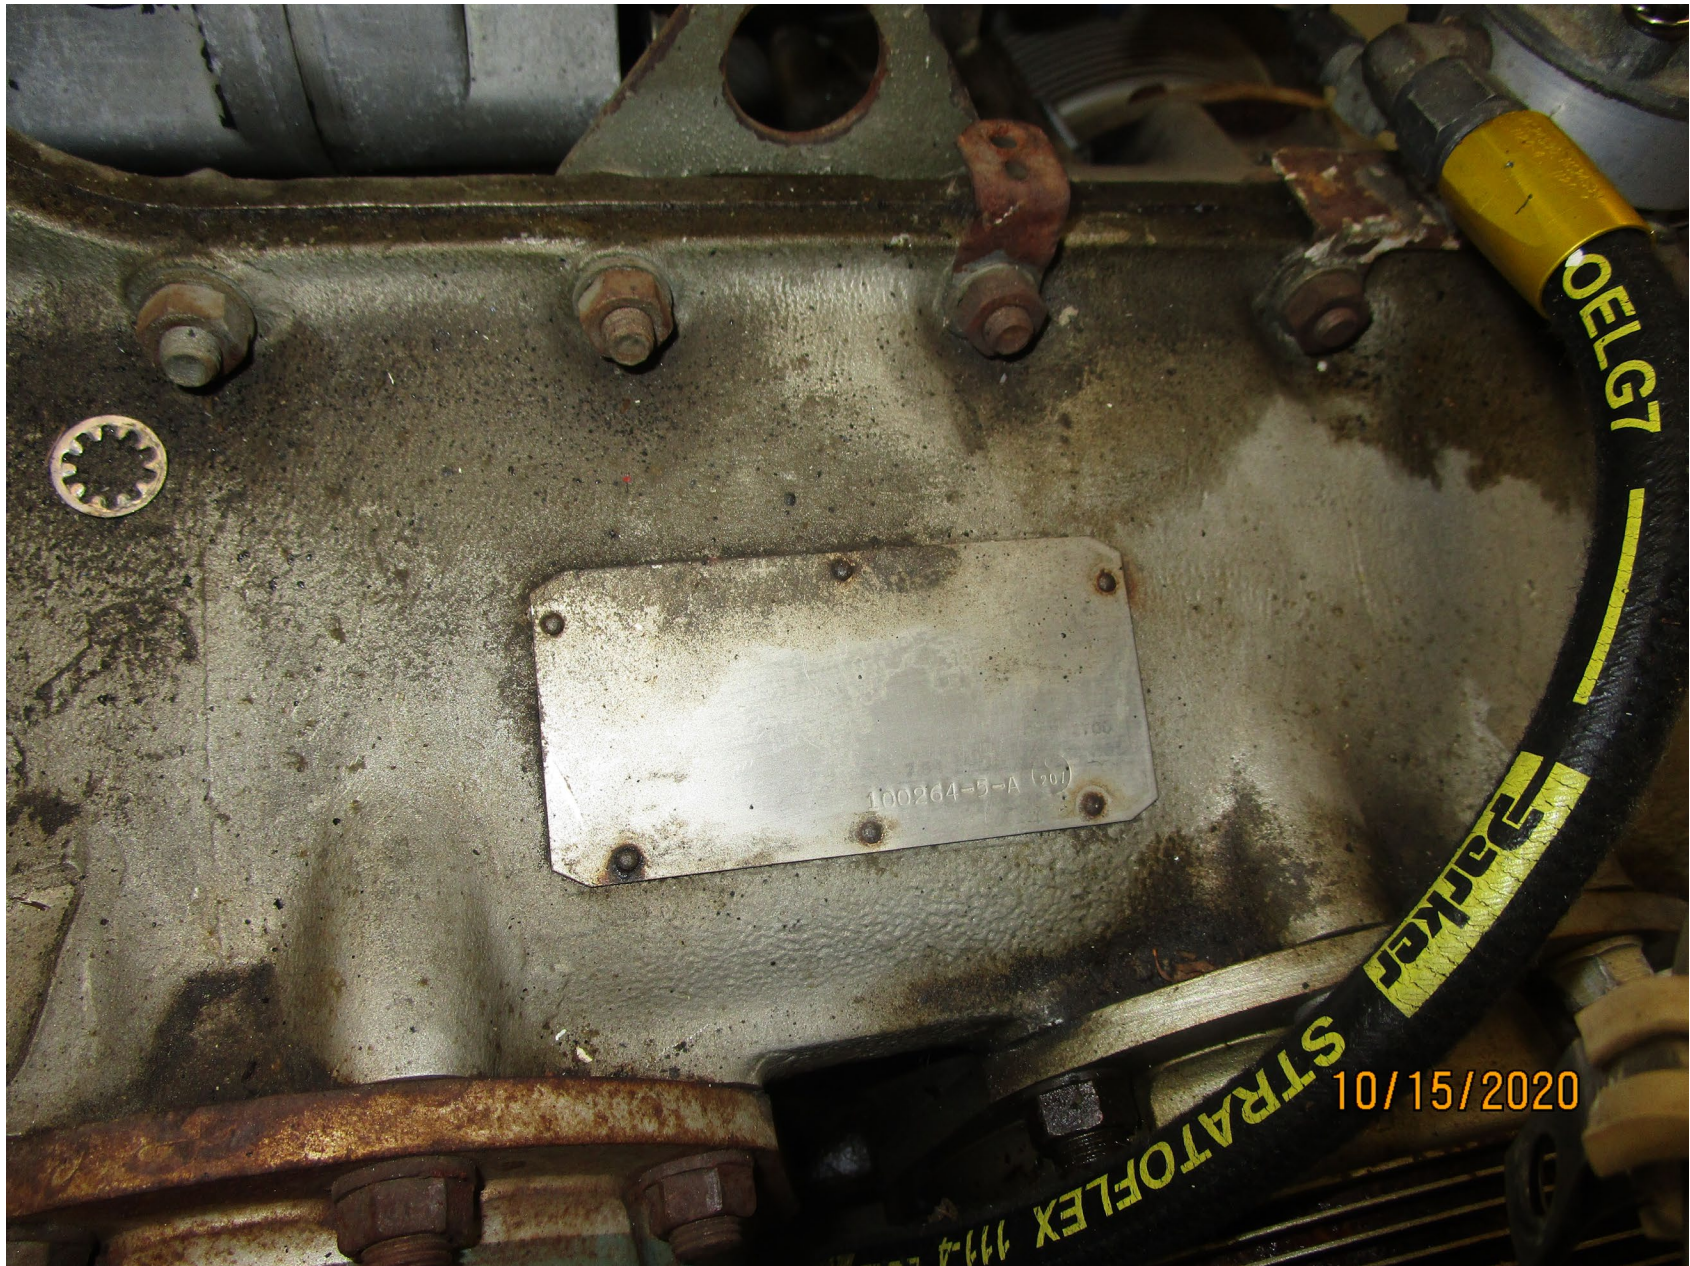
Photo 9 - View of the data plate.

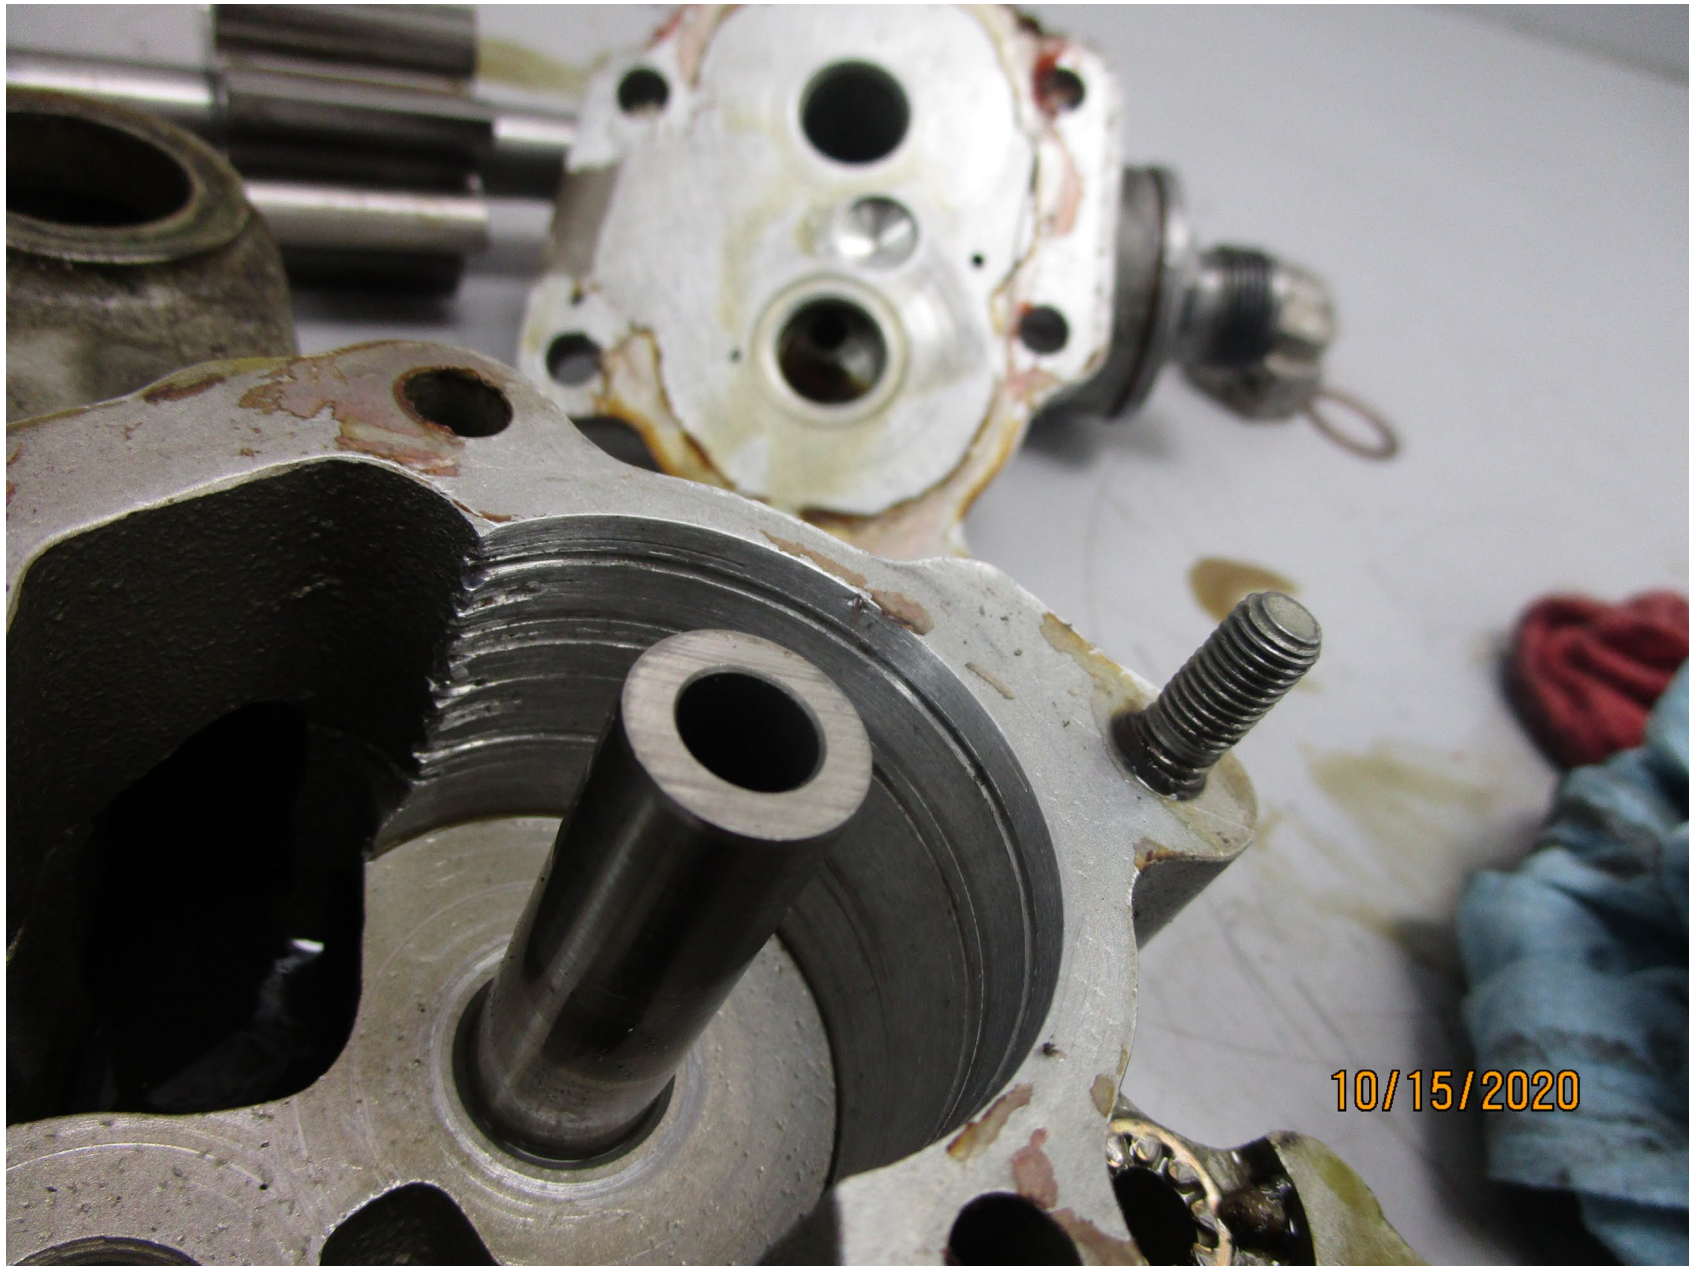
**Photo 10 - Close-up view of inside surfaces of the oil pump. The surfaces exhibit witness marks consistent with hard particle passage.**

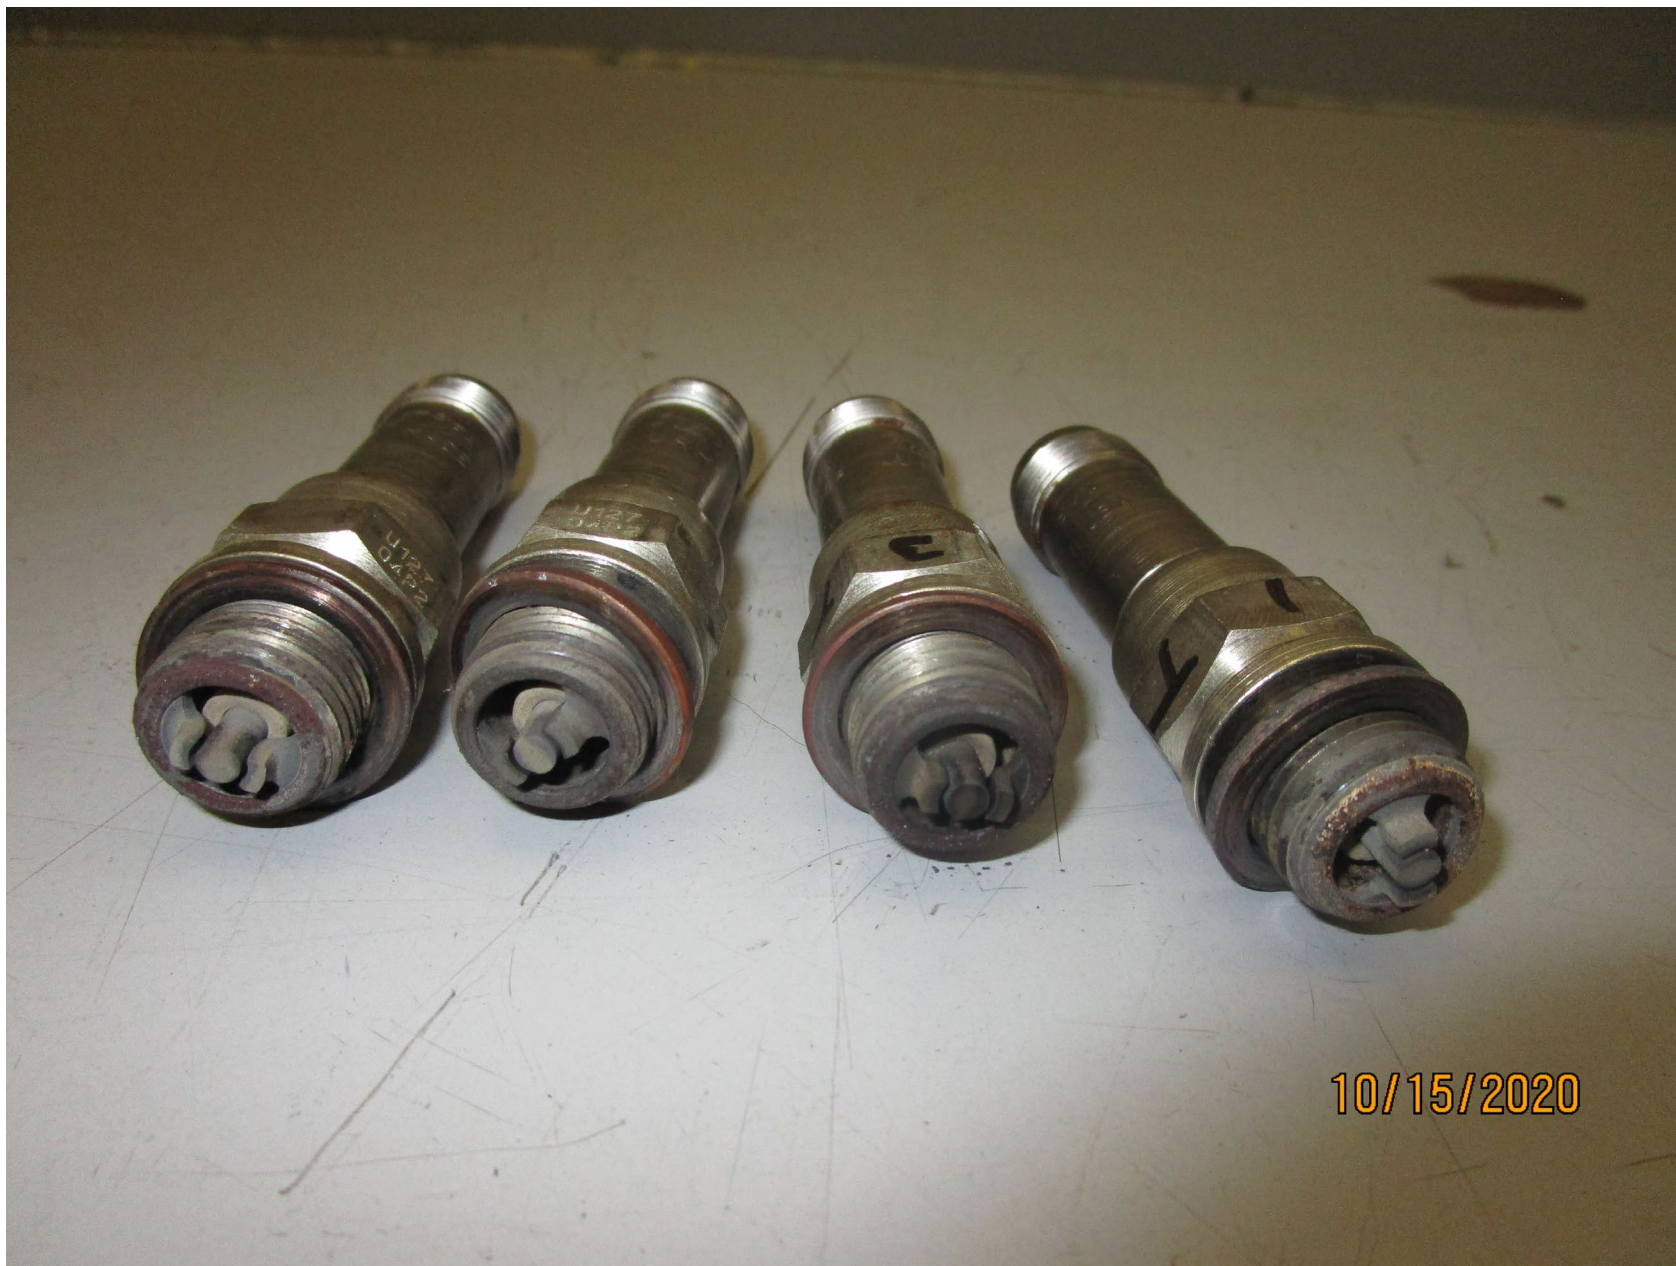
**Photo 11 - Close-up view of removed spark plugs.**

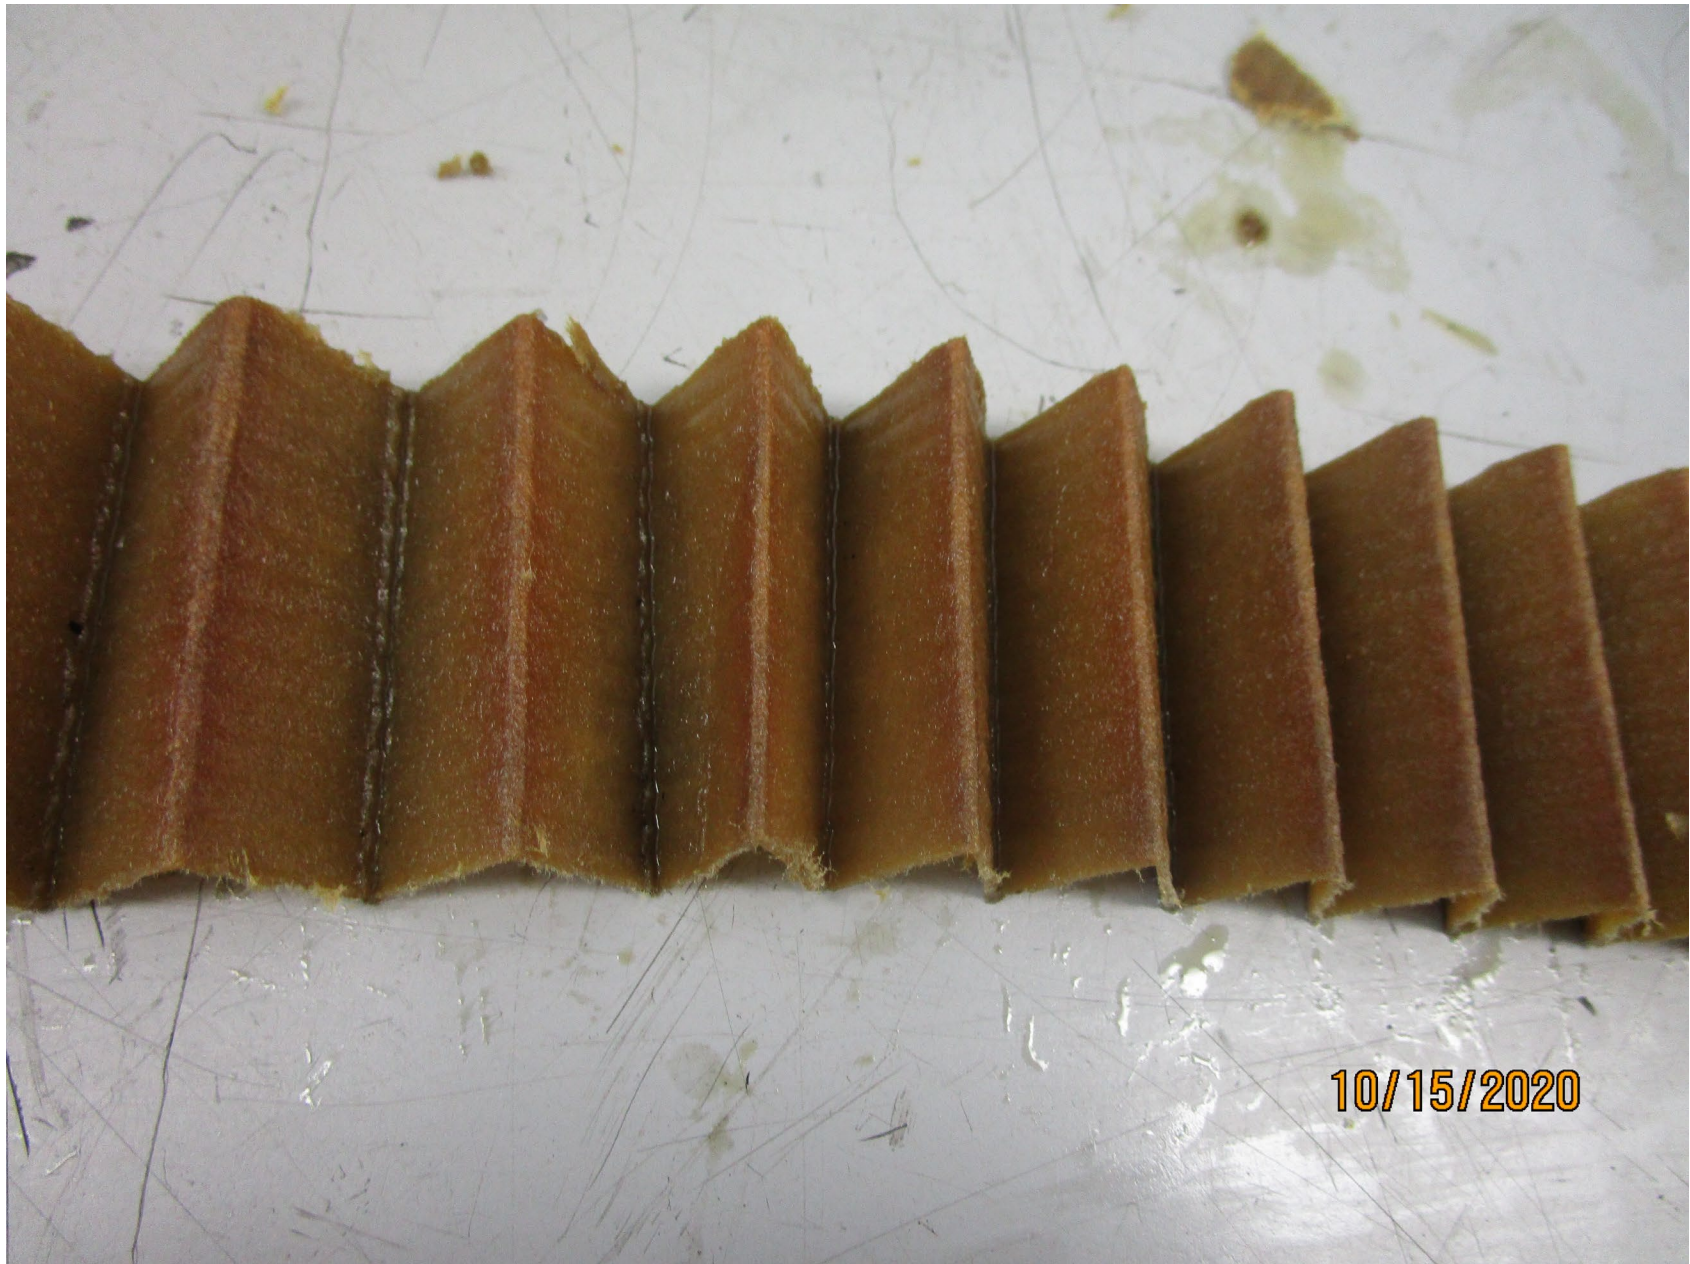
**Photo 12 - Close-up view of the filter in the oil filter.**
