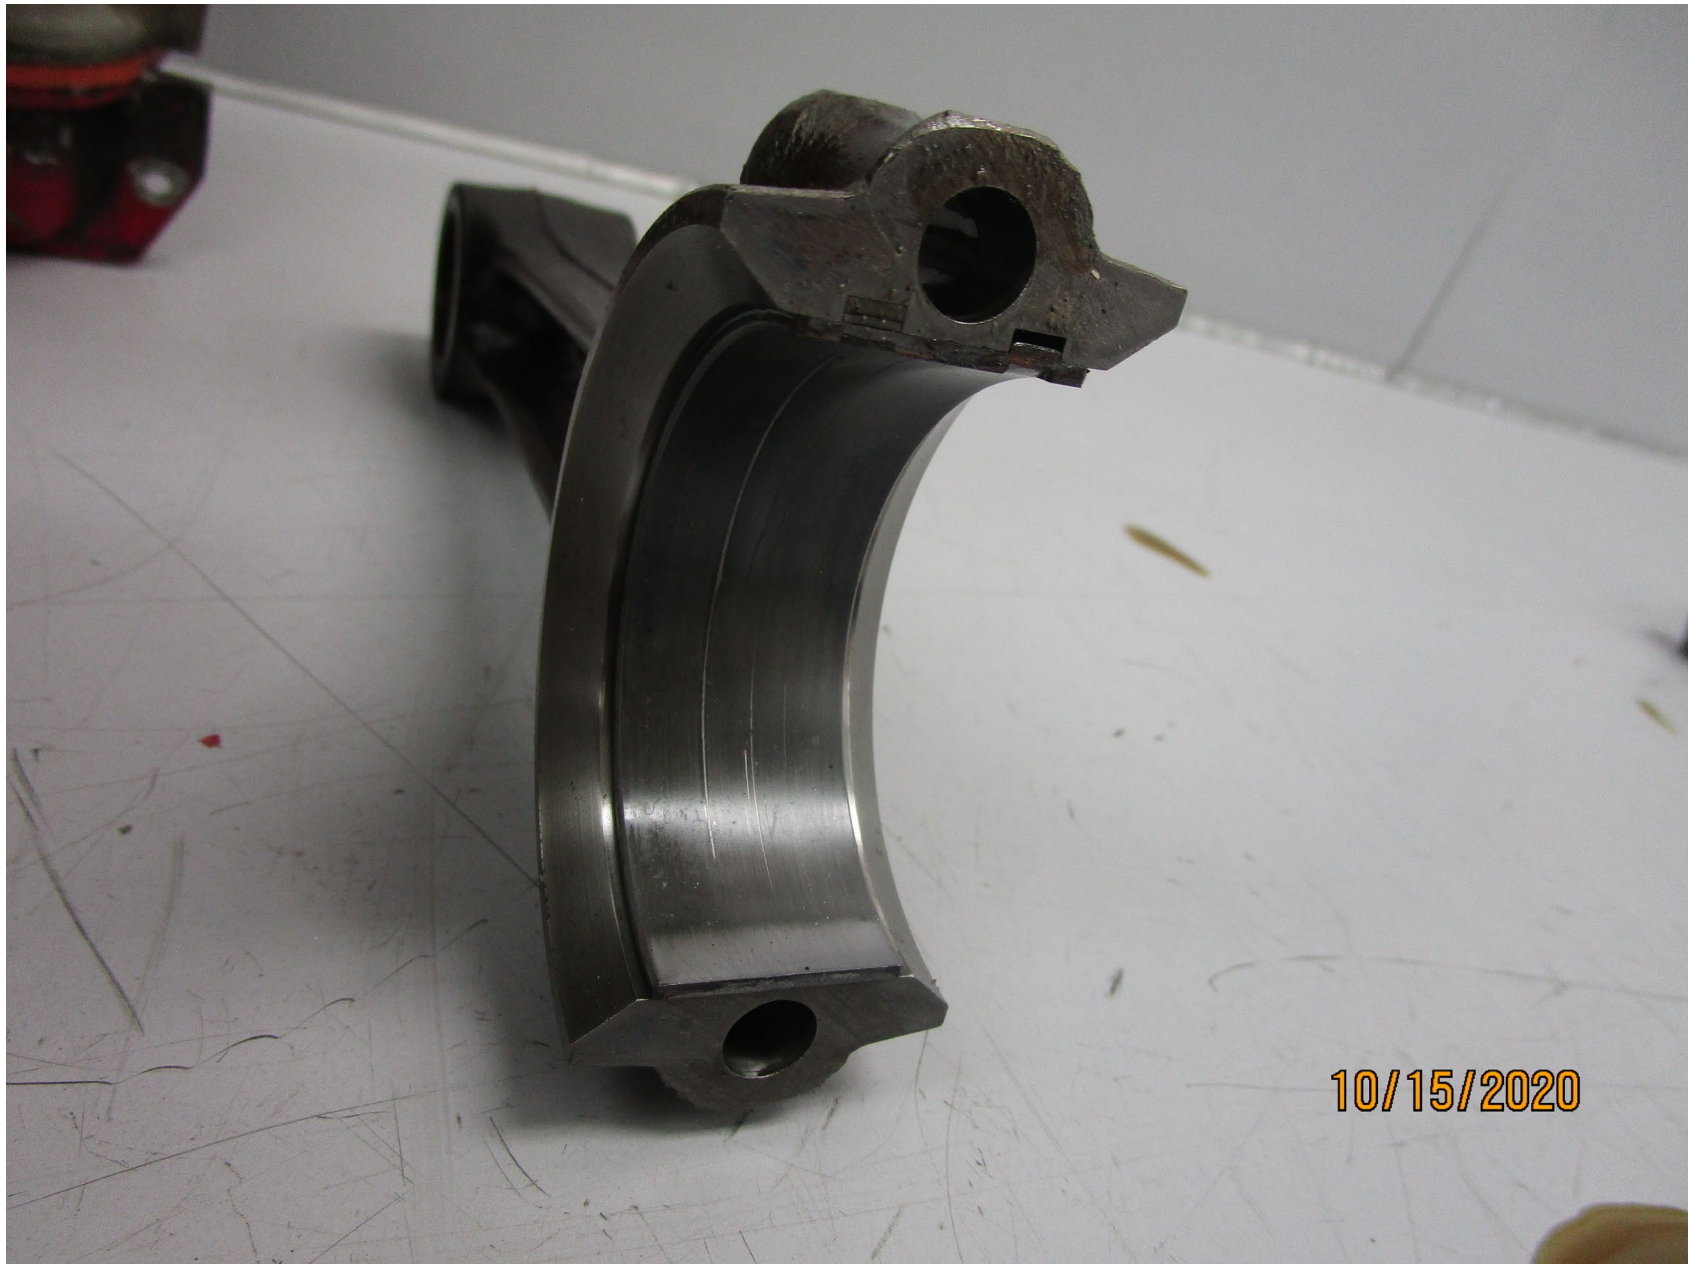
**Photo 13 - Close-up view of the connecting rod bearing. The bearing surface exhibits witness marks consistent with hard particle passage.**

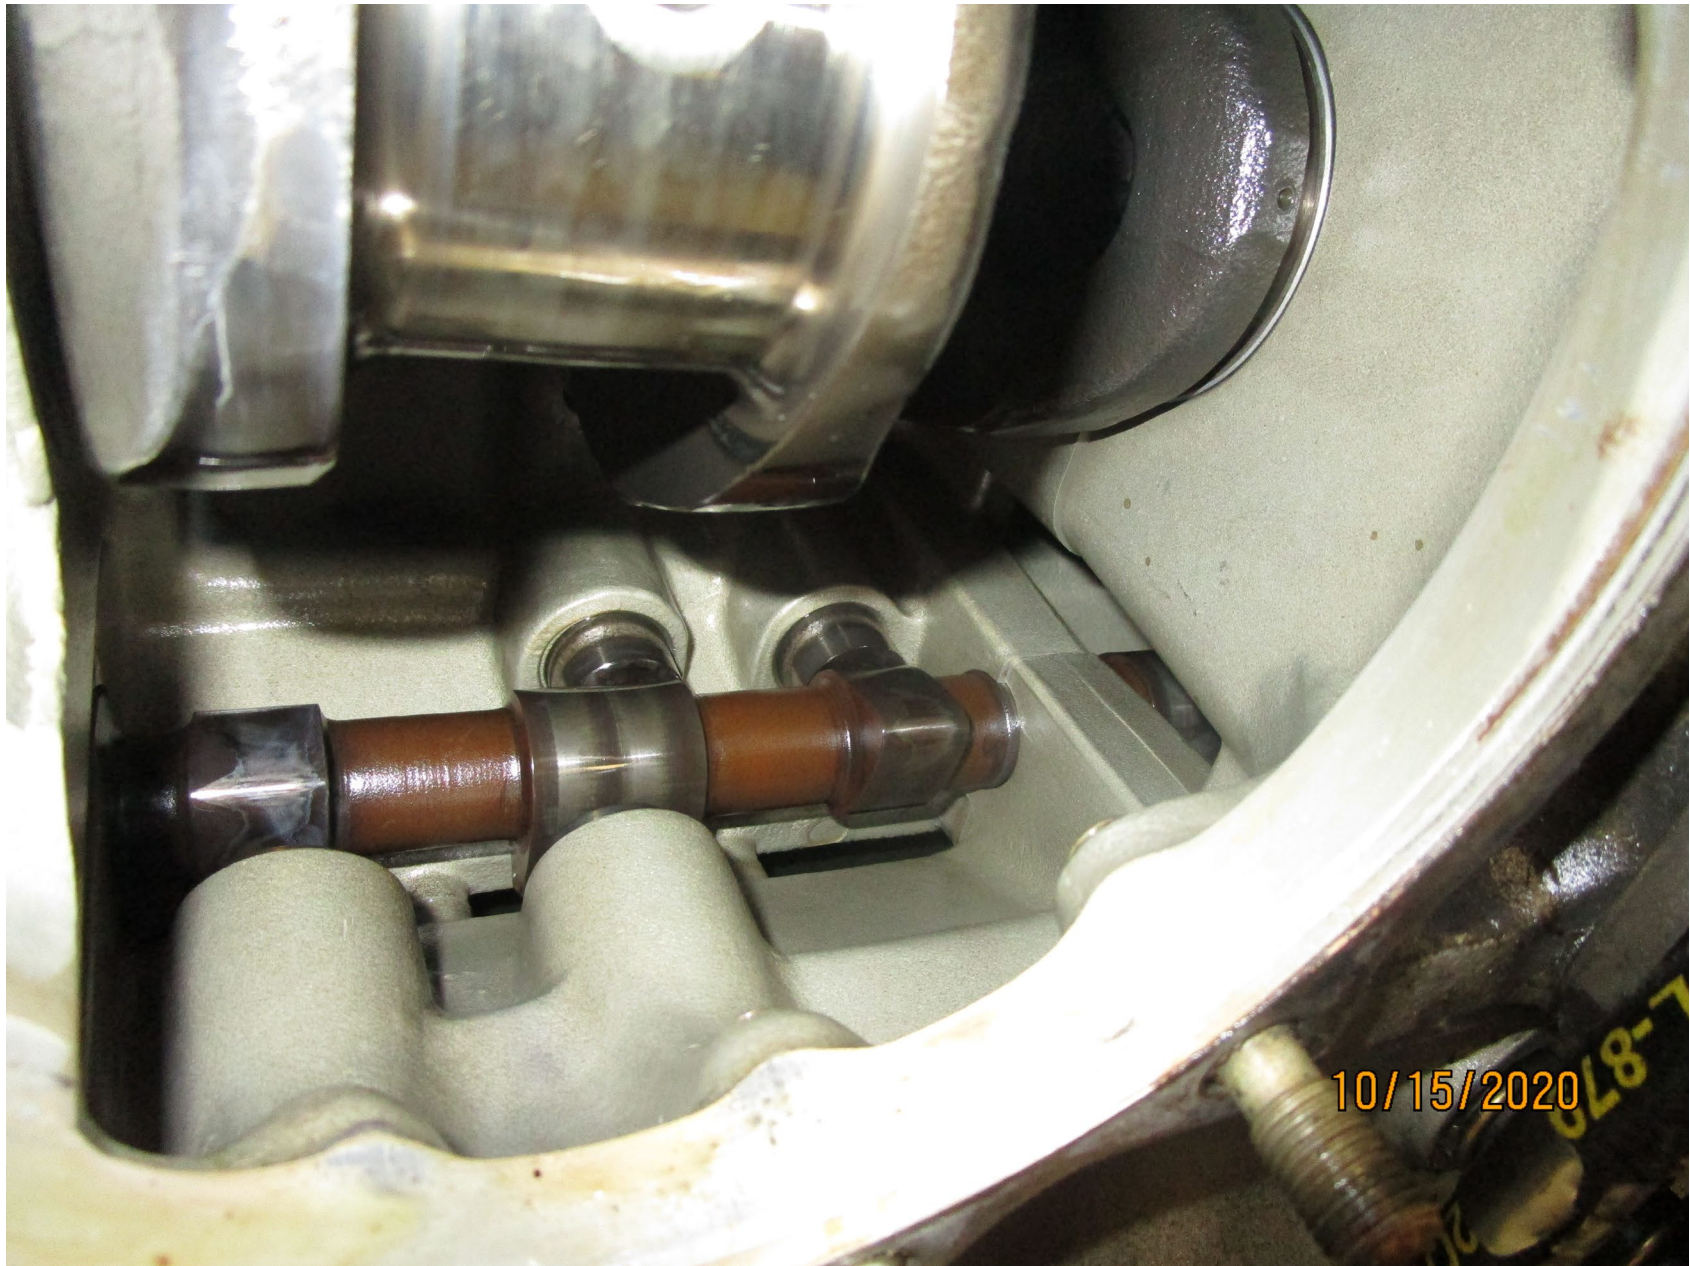
**Photo 14 - Close-up view through the removed cylinder of the crankshaft and camshaft inside the crankcase.**
