# NATIONAL TRANSPORTATION SAFETY BOARD

## MATERIALS LABORATORY FACTUAL REPORT

Report No. 21-018

Place : Celburne, TX  
Date : June 4, 2020  
Vehicle : Beech 23, N7941L  
NTSB No. : CEN20LA211  
Investigator : David Bowling (AS-CEN)

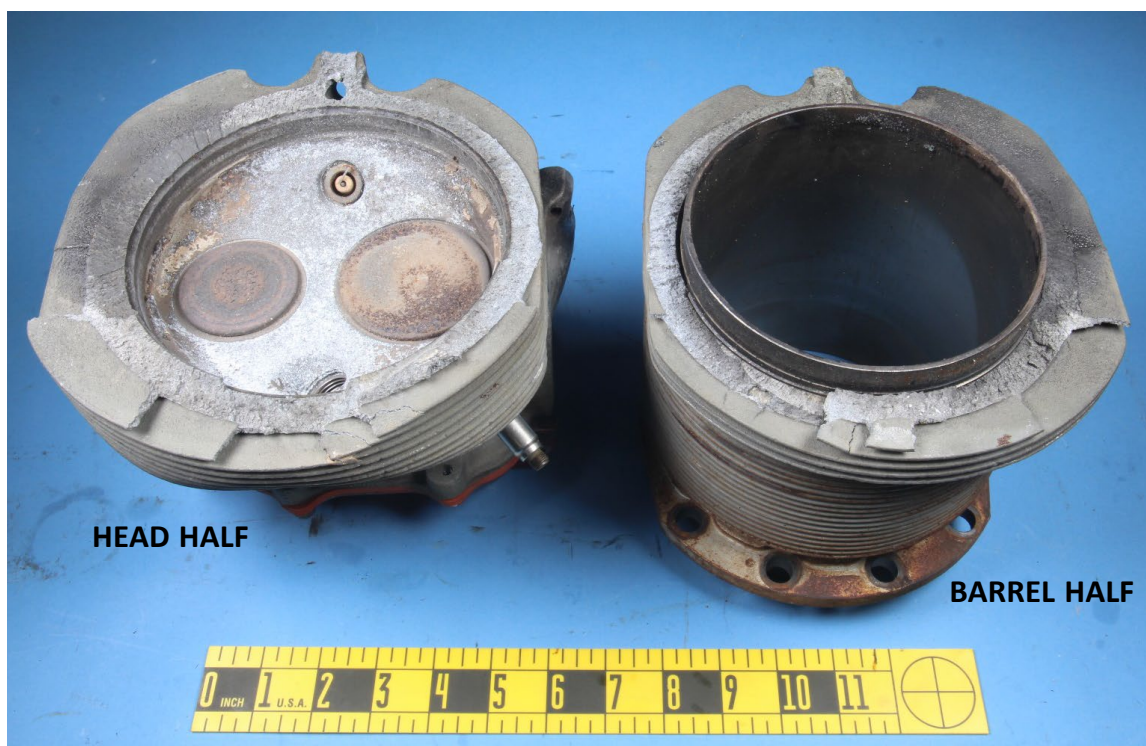
The no. 1 cylinder was submitted separated into 2 pieces, as shown in Figure 1. The separation occurred between the 4<sup>th</sup> and 5<sup>th</sup> cooling fins, near the barrel to head junction. The part marking '536727 MPG' was observed cast into the external surface of the cylinder.

Figure 1: Macro photo of the two halves of the separated no. 1 cylinder.

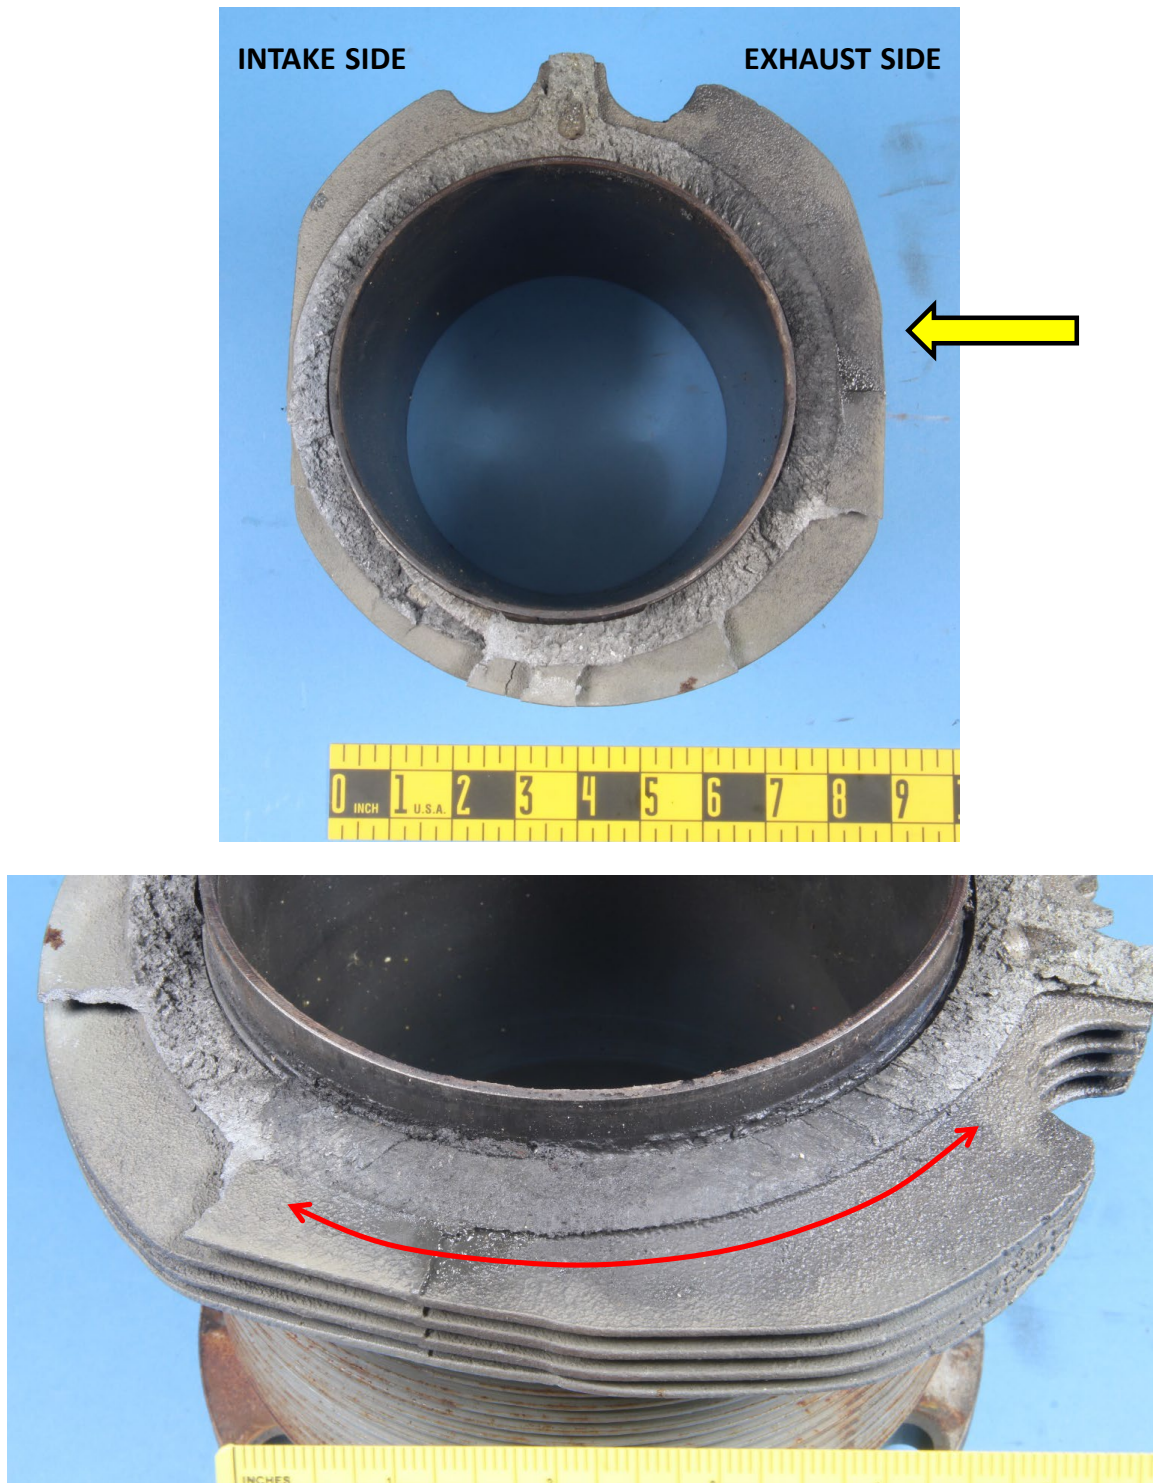
Figures 2 and 3 show the fracture surface on the barrel half of the cylinder, while Figures 4 and 5 show the mating fracture surface on the head portion of the cylinder. The fracture surface was flat and had features consistent with fatigue cracking around roughly 60 degrees on the exhaust side of the cylinder (red double-sided arrows, Figures 2 and 4). The fatigue cracking emanated from the inner diameter (ID) of the cylinder. Dark colored deposits coated the fracture surface in this area, likely resulting from combustion products exiting the cylinder during operation once the fatigue cracking had progressed through-wall.

Figure 2: (Top) Macro photo of the fracture surface on the barrel half of the separated cylinder. (Bottom) Close-up photo of the fracture surface on the exhaust side in the location indicated by the yellow arrow in the top photo. The red double-sided arrow indicates a through-wall crack on the fracture surface.

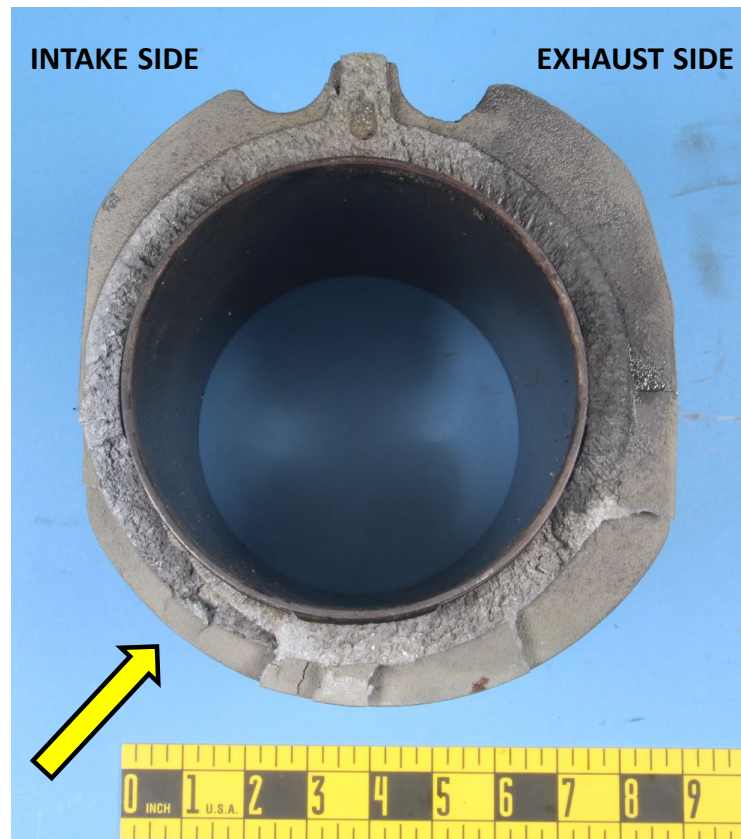
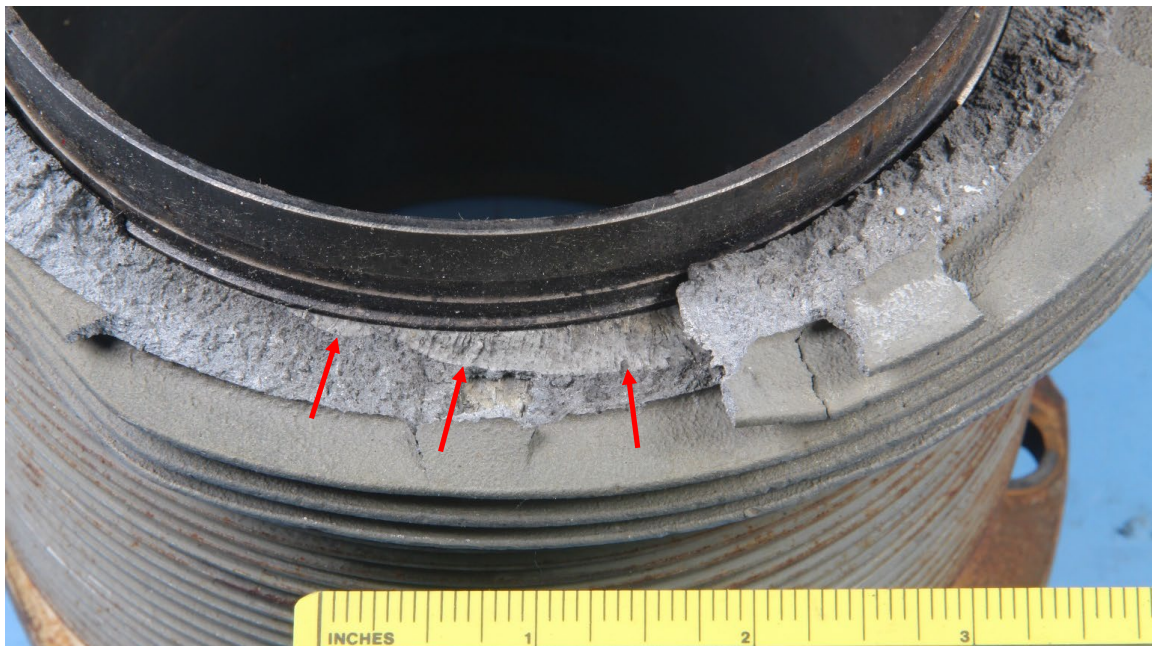
Thumbnail-shaped patterns consistent with fatigue cracking were observed on the fracture surface at the intake side of the cylinder (red arrows, Figures 3 and 5). The patterns were located diametrically opposite the cracking on the exhaust side of cylinder. The cracking was not through-wall like on the exhaust side, but the patterns did emanate from the ID of the cylinder. The fatigue cracking on the intake side was likely secondary to the through-wall fatigue cracking on the exhaust side.

Figure 3: (Top) Macro photo of the fracture surface on the barrel half of the separated cylinder. (Bottom) Close-up photo of the fracture surface on the intake side in the location indicated by the yellow arrow in the top photo. The red arrows point to thumb-nail-shaped fatigue cracking emanating from the cylinder ID.

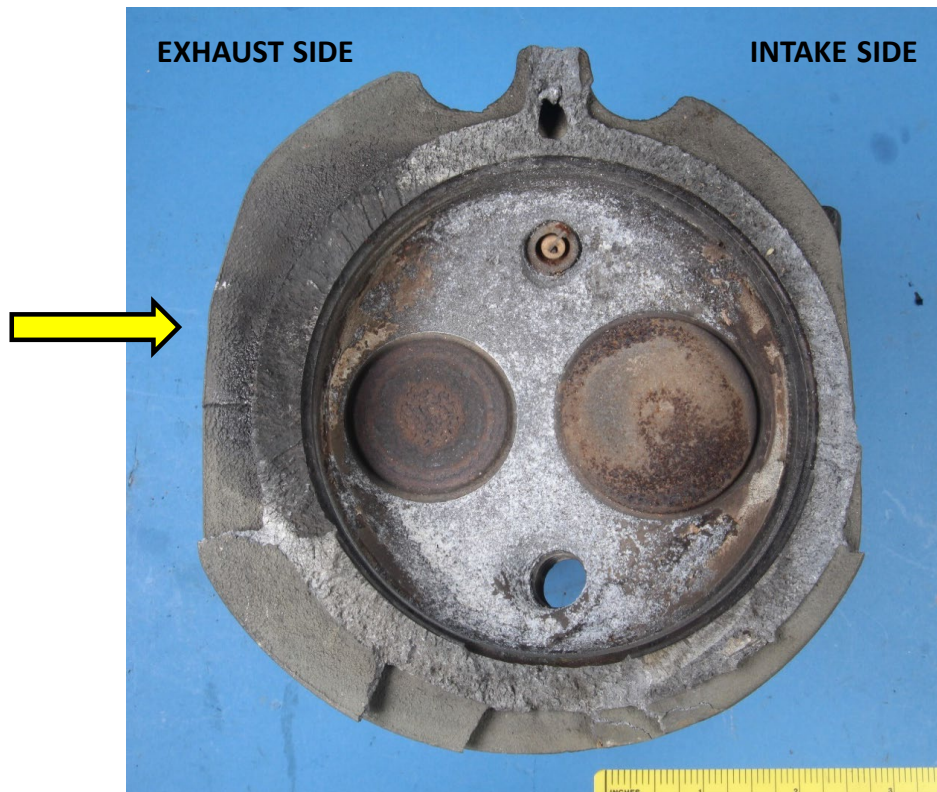
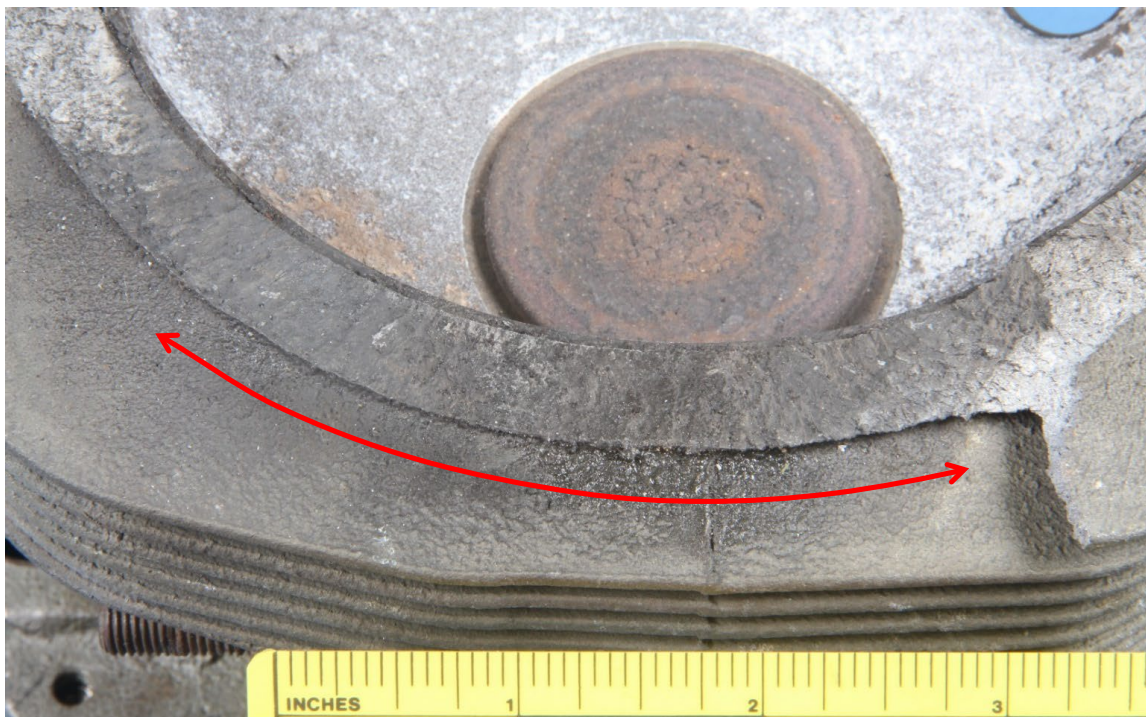
Figure 4: (Top) Macro photo of the fracture surface on the head half of the separated cylinder. (Bottom) Close-up photo of the fracture surface on the exhaust side in the location indicated by the yellow arrow in the top photo. The red double-sided arrow indicates a through-wall crack on the fracture surface.

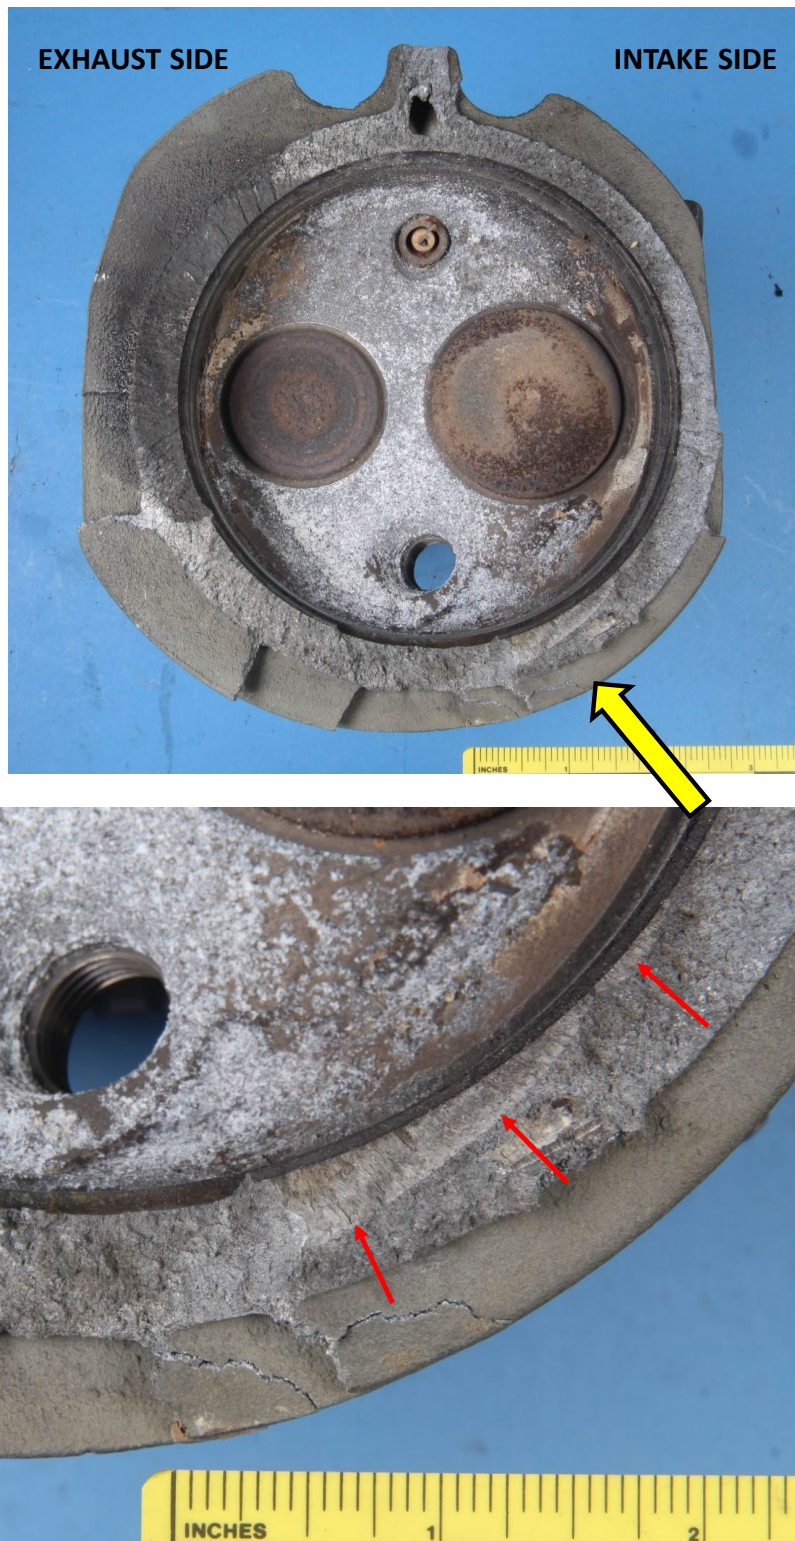
Figure 5: (Top) Macro photo of the fracture surface on the head half of the separated cylinder. (Bottom) Close-up photo of the fracture surface on the intake side in the location indicated by the yellow arrow in the top photo. The red arrows point to thumb-nail-shaped fatigue cracking emanating from the cylinder ID.

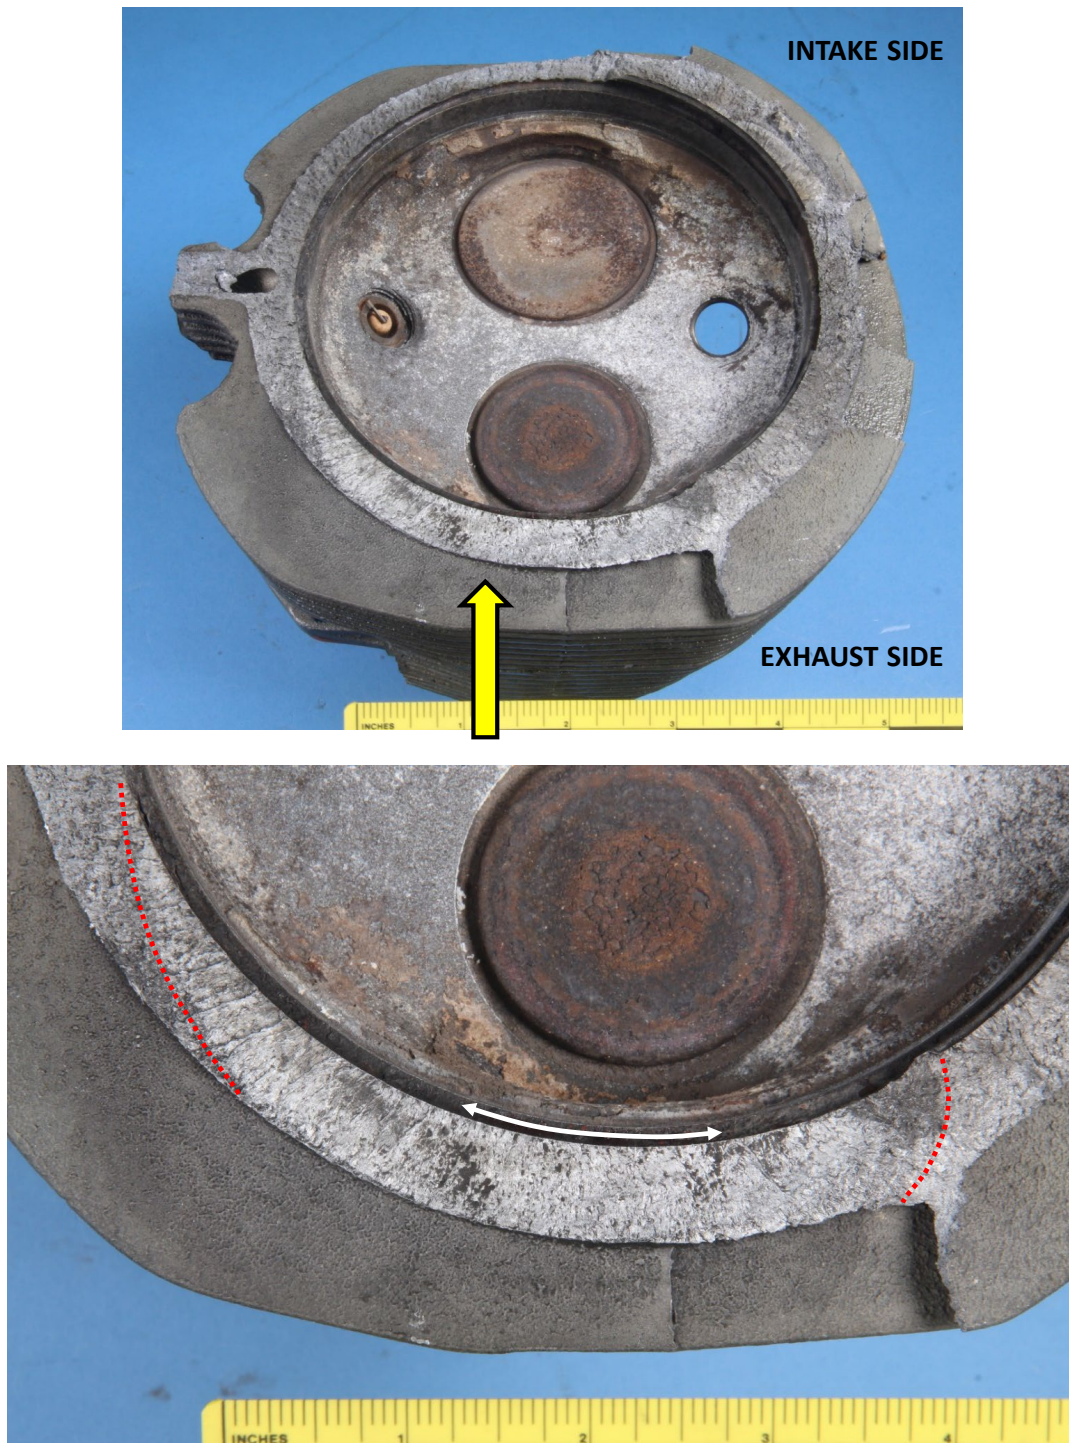
The fracture surface on the barrel half of the cylinder was cleaned using a solution of water and Alconox detergent (manufactured by Alconox, Inc., White Plains, NY), and rinsed with isopropanol. The red dots in Figure 6 outline the edges of the through-wall

fatigue crack. The white double-sided arrow indicates the fatigue initiation region. Multiple fatigue initiation sites were visible along the ID of the cylinder within the initiation region.

Figure 6: (Top) Macro photo of the fracture surface after cleaning on the barrel half of the separated cylinder. (Bottom) Close-up photo of the fracture surface on the exhaust side in the location indicated by the yellow arrow in the top photo. The red dots outline the edges of the through-wall fatigue crack. The white double-sided arrow indicates the fatigue initiation region along the ID of the cylinder.

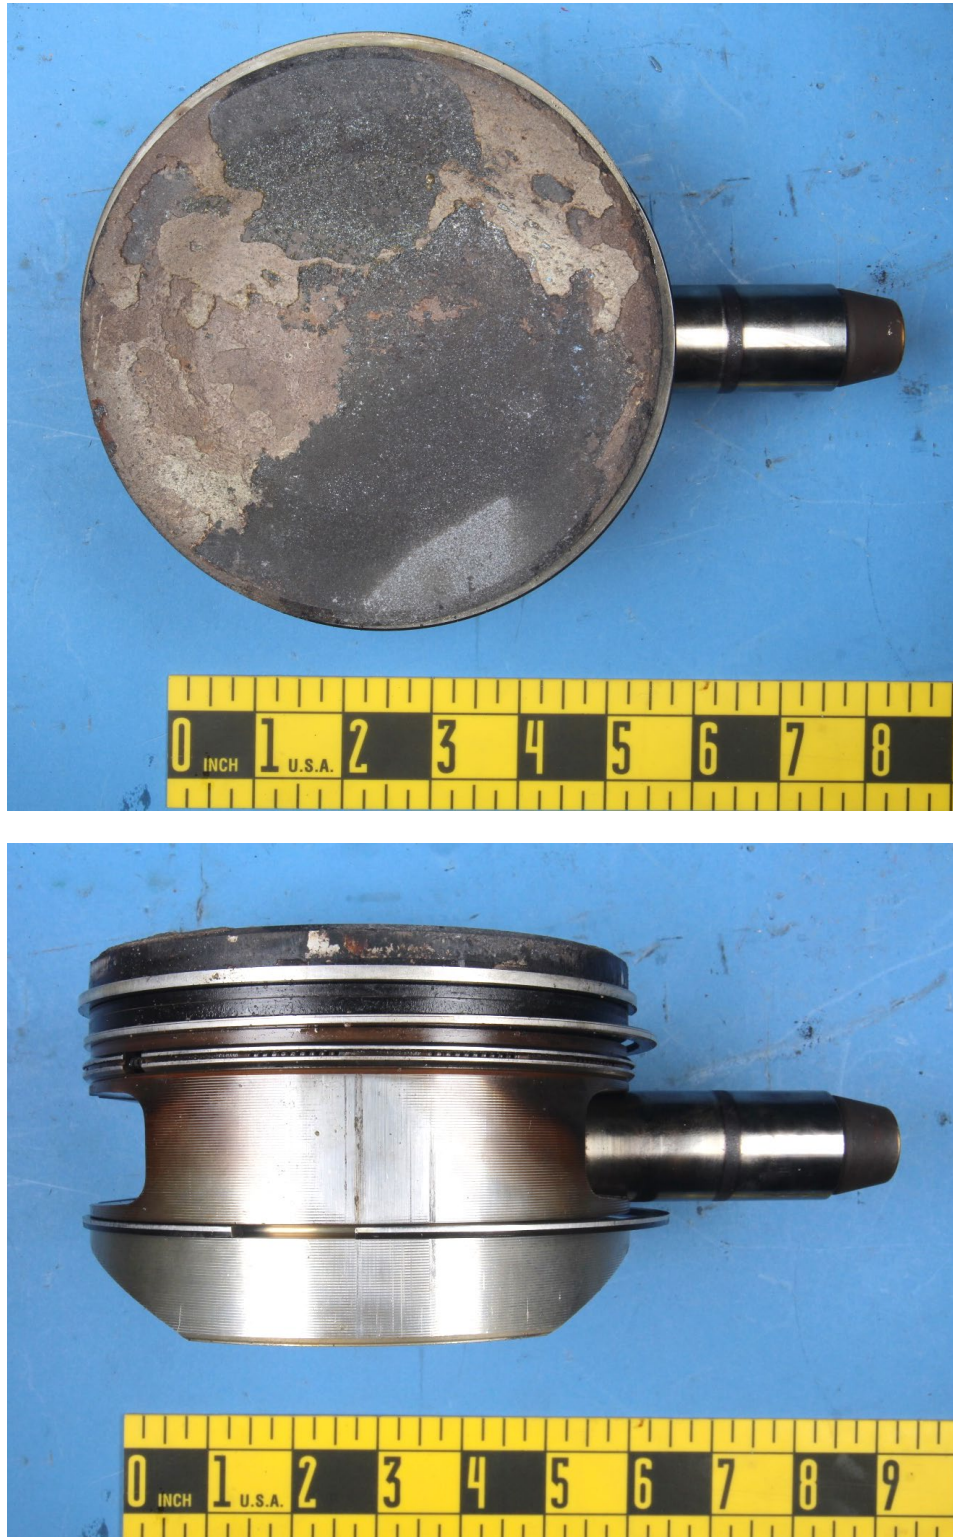
The piston head from the no. 1 cylinder was submitted with the piston pin still assembled, as shown in Figure 7. Dark colored carbon deposits consistent with combustion byproduct were observed on the flat top of the piston head. Slight detonation damage was observed around the outer edge of the piston head. The piston skirting appeared in relatively good condition, but some dark colored staining consistent with blow-by was present near the piston pin bore hole.

Figure 7: Macro photos of the no. 1 piston head and mating piston pin as viewed from the top and side (top and bottom images, respectively).
