## **NATIONAL TRANSPORTATION SAFETY BOARD**

# **WRECKAGE EXAMINATION SUMMARY**

**CEN20LA214**

| Aircraft: | N13520; Cessna 172M |

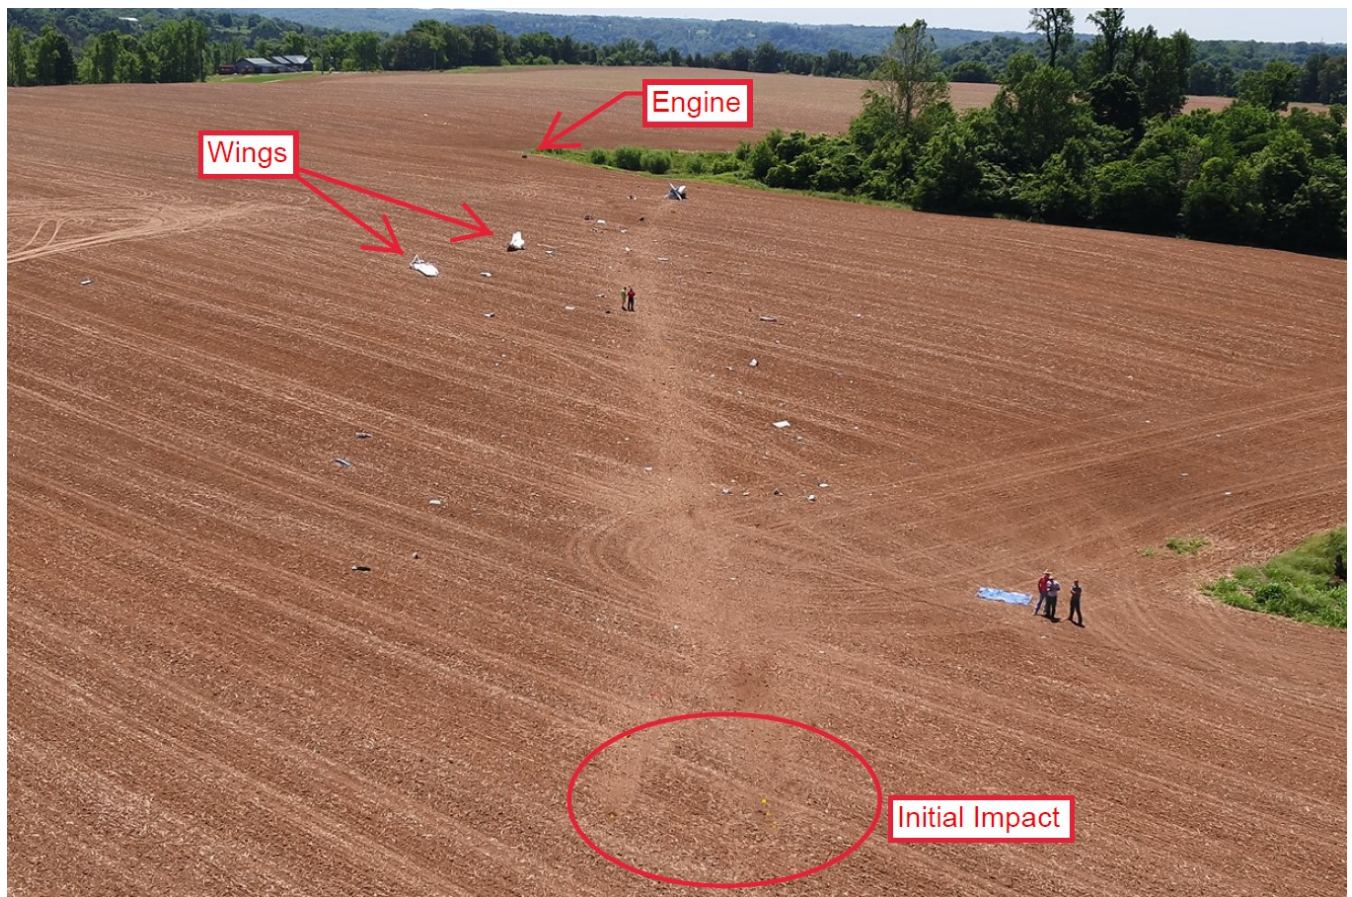
On 6/7/20, Inspector House and Inspector Stombaugh traveled to the scene, in a field about 3 miles east/southeast of New Washington, IN. ISP trooper was on scene, soon to be joined by ISP detective and crime scene technician. Inspector House took pictures while Inspector Stombaugh reviewed the pilot's personal belongs, including his flight log and certificates. The airplane impacted the soybean field at an apparent high speed, resulting it in tumbling along the flight path. The debris field started shortly after impact, with ground scarring indicating that the left wing tip and left main gear hit first. The airplane appeared to tumble along the flight path, shedding the propeller, then both wings, with the fuselage and tail coming to rest approximately 600 ft from initial impact. The engine continued another 200 ft, with the left fuel tank coming to rest about 1,000 ft from initial impact. The pilot was ejected from the airplane and was found in the vicinity and left of the fuselage. An examination of the wreckage showed all control surfaces intact and the flaps were retracted, with continuity of all control cables. There was damage to the throttle cable, but it appeared the engine controls were in appropriate adjustment for flight. The propeller showed signs of rotation at impact, with no apparent anomalies. There was a smell of fuel near the resting point of the fuel tank. After documenting the scene, the Inspectors traveled to the FBO that owned the aircraft, meeting with the student's CFI. The CFI stated that he and the student had flown the day prior, doing a 'mock checkride', in anticipation of the student's private pilot checkride six days later. The CFI stated the student was well prepared to pass the checkride, and that student had asked permission for another solo flight, for more practice. The CFI stated that the student was one of his best and that he was always well prepared. The CFI was questioned if he was aware why the student had a restricted medical and he explained that the student had previously taken anti-depression medicines and that he had been evaluated, drug

The inspectors received drone video and photos from the ISP troopers which is seen below.
