**NATIONAL TRANSPORTATION SAFETY BOARD**

**Attachment 2 –Honeywell No. 1 Engine (P36058C) Materials Laboratory  
Analysis Report**

**POWERPLANTS**

**CEN20LA215**

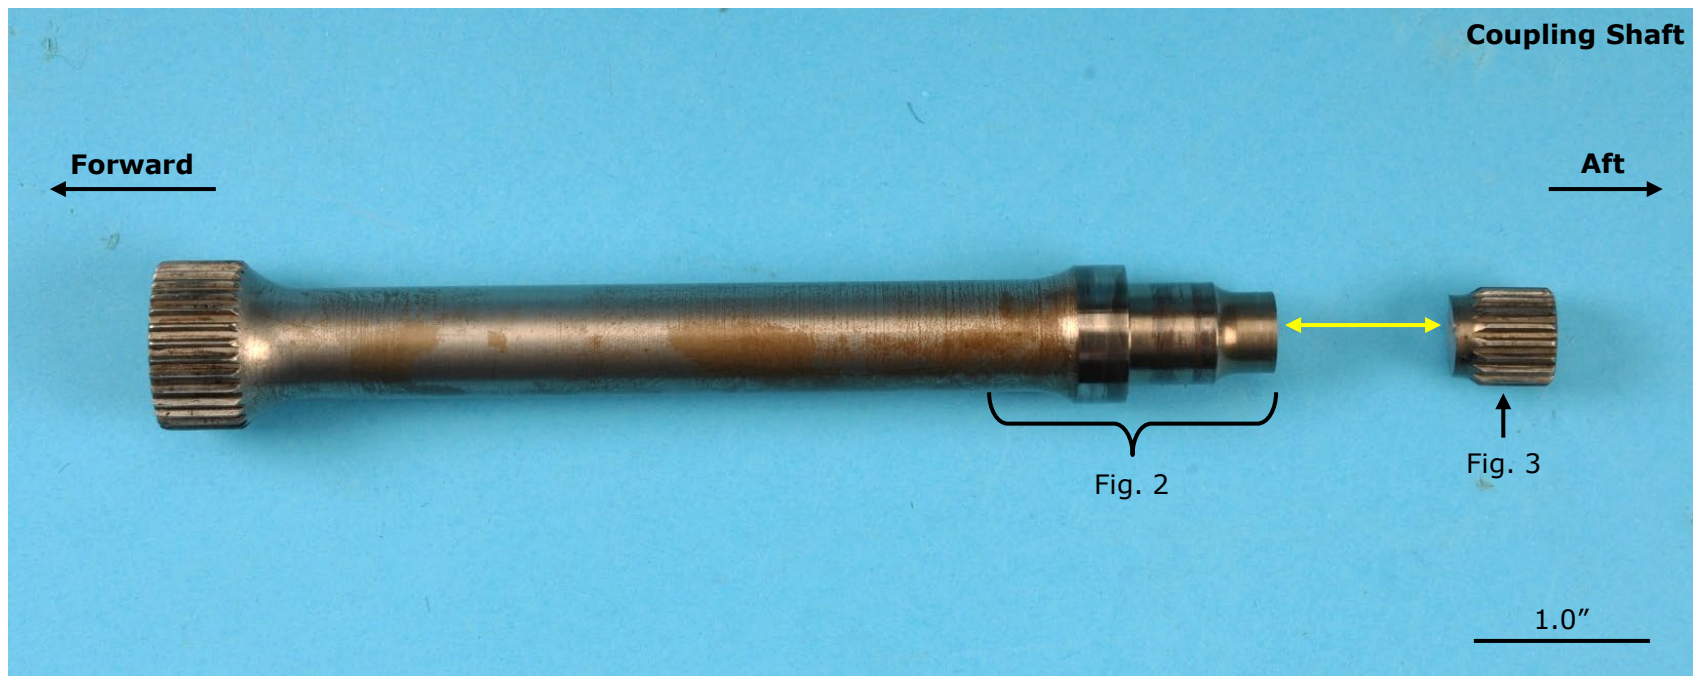
**Figure 1.**

The coupling shaft (Lot Number 9828) from the left engine S/N P36058C had separated approximately 0.582" from the aft end (Figure 1). The fracture surface of the separation was oriented normal to the shaft axis and was flat in appearance. Wear was observed adjacent to the shoulder of the shaft (Figure 2). Contact/wear patterns were observed on the loaded side of the gear teeth from the aft end of the coupling shaft (Figure 3).

Overall image showing the as-received condition of the separated coupling shaft (Lot Number 9828) from TPE331 engine S/N P36058C (left engine). The coupling shaft had separated near the aft end (yellow double-sided arrow). Close up images of the shaft are shown in Figures 2-3, as indicated.

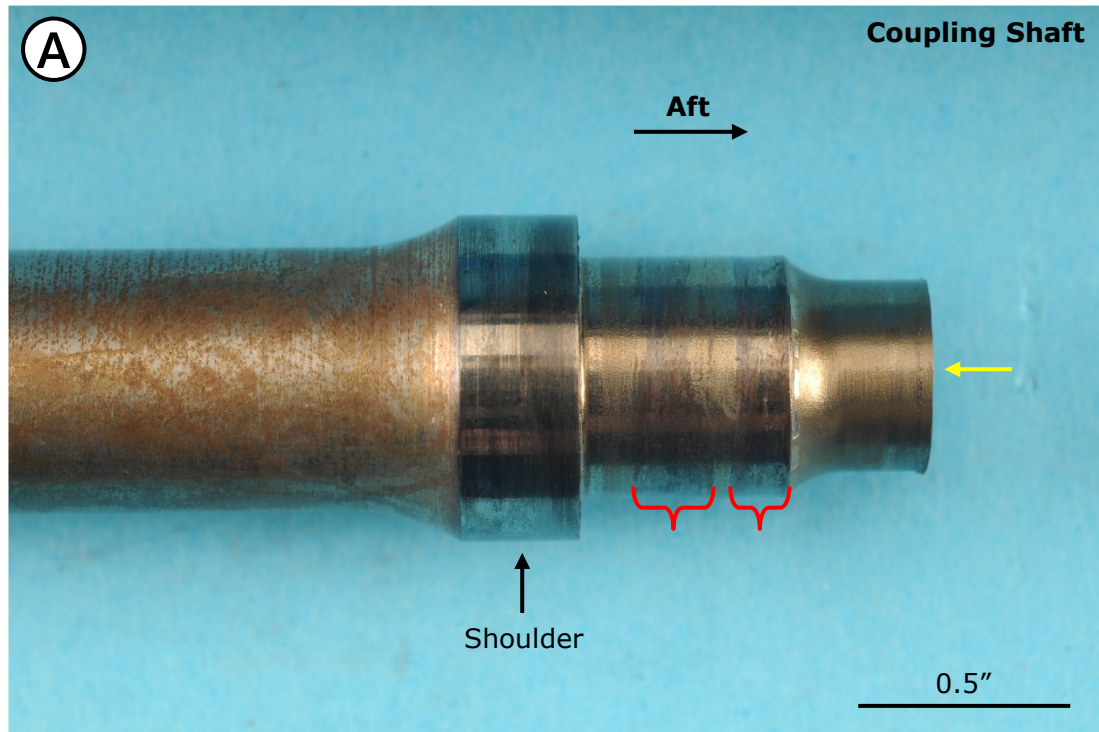
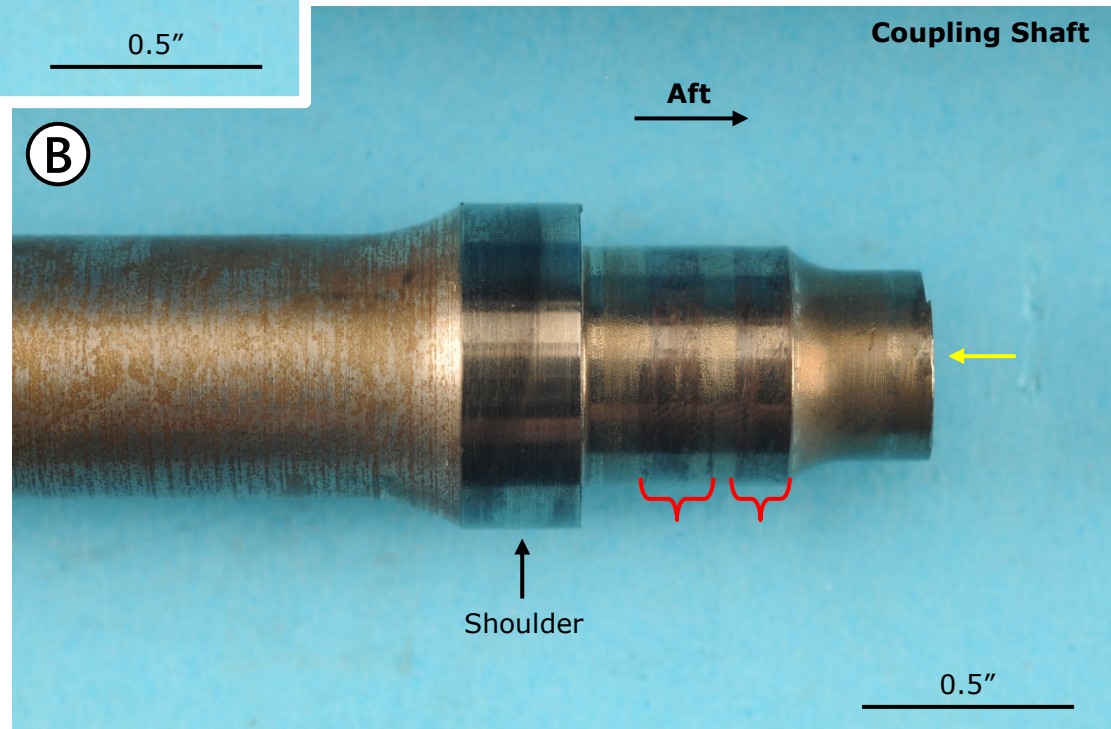
**Figure 2.**

(A-B) 180° views of the aft end of the coupling shaft (reference Figure 1). Non-uniform wear was observed aft of the shoulder (red brackets). The yellow arrows identify the fracture surface.

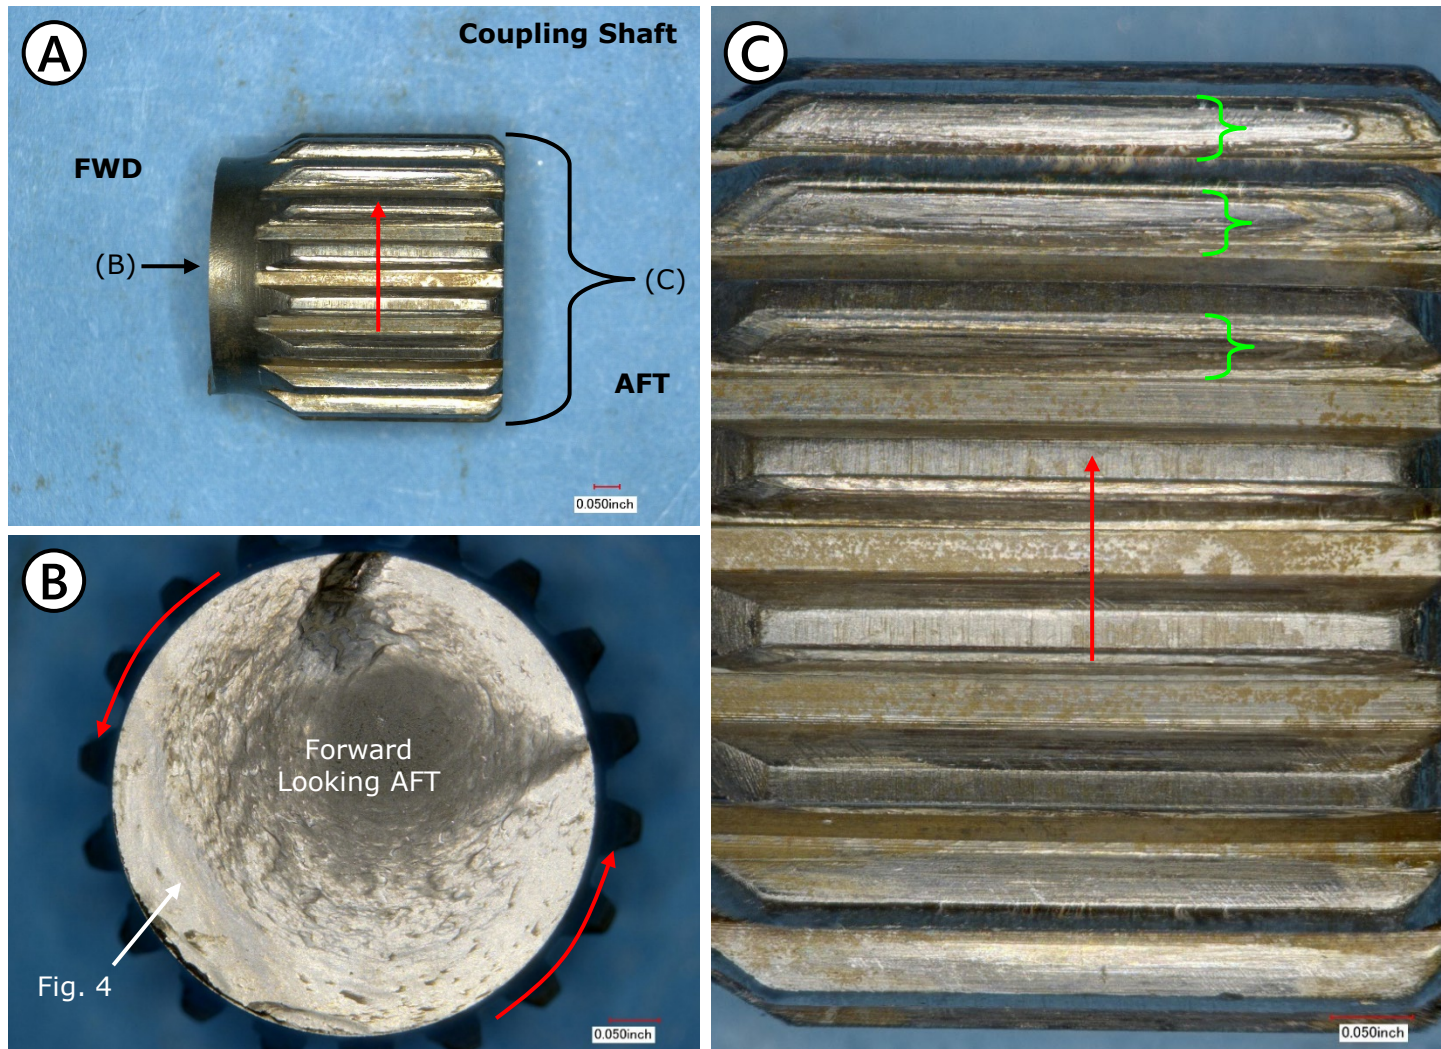
**Figure 3.**

(A-C) Digital microscope images of the separated coupling shaft (reference Figure 1). The red arrows indicate the specified direction of the shaft rotation within the engine (counterclockwise forward looking aft (FLA)). Wear was observed on the loaded side of the gear teeth (green brackets in (C)). Scanning electron microscope (SEM) images of the coupling shaft fracture surface are shown in Figure 4.

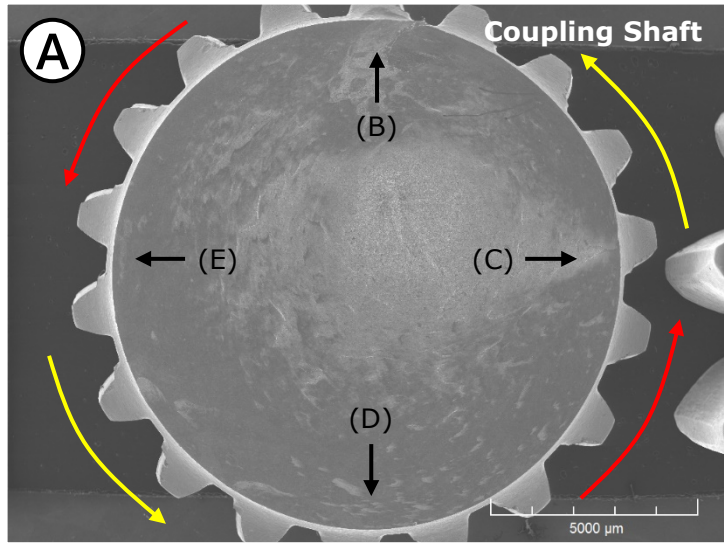
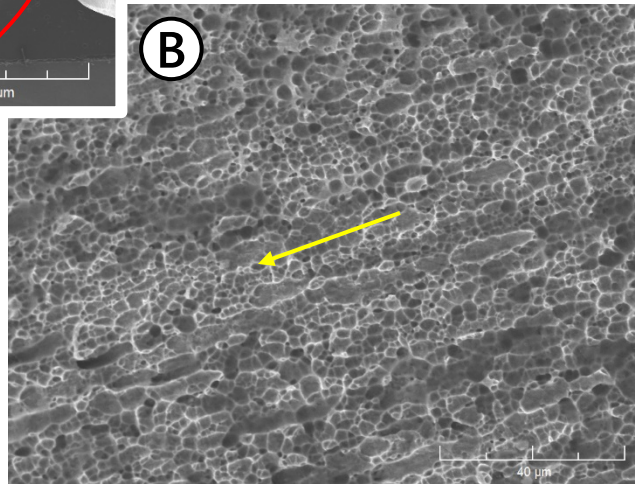
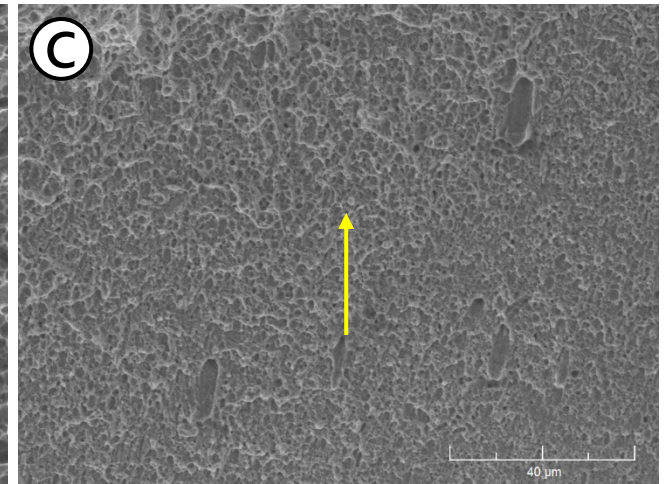
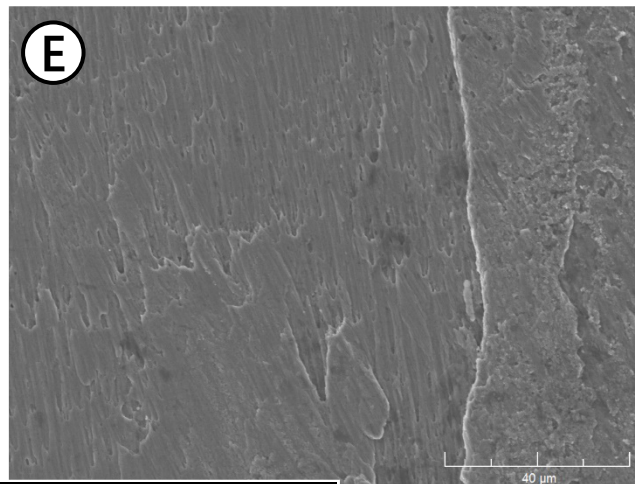
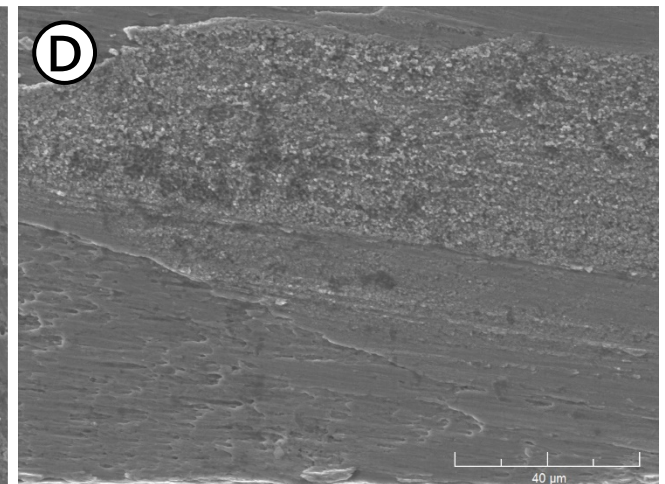
**Figure 4.**

- The separation of the coupling shaft was the result of torsional overload. Overload dimples were observed to be elongated in the counterclockwise direction (forward looking aft (FLA)) which indicated that the aft section separated as a result of torsional loading in the clockwise direction, relative to the forward section.
- The separation of the starter shaft could not be determined due to secondary smearing and damage of the fracture features.
- Debris collected from the magnetic plug was suggestive of steel similar to 9310 or 4340, stainless steel similar to 17-4PH or 15-5PH, debris suggestive of an aluminum alloy, and debris rich in copper.
- See Findings.

The fracture surface of the coupling shaft was examined in the scanning electron microscope (SEM) and is shown in Figure 4. Examination revealed that most of the fracture features were obscured by smearing and secondary damage. In some areas, overload dimples elongated in the counterclockwise direction (forward looking aft (FLA)) were observed, which indicated that the aft section of the coupling shaft had separated as a result of torsional loading in the clockwise direction relative to the forward section (aft looking forward (ALF)). The specified direction of rotation of the shaft was counterclockwise FLA.

(A-E) Secondary electron (SE) SEM images showing the fracture surface on the aft section of the separated coupling shaft (reference Figure 3B). Fracture features indicative of torsional overload were observed in some locations, as indicated by the elongated dimples in the counterclockwise direction as shown in views (B-C); however, most of the fracture features were obscured by smearing and secondary damage (reference views (D-E)). The yellow arrows in (A-C) indicate the direction of rotation with respect to the mating fracture surface. The red arrows in (A) indicate the specified direction of the shaft rotation within the engine (counterclockwise FLA).

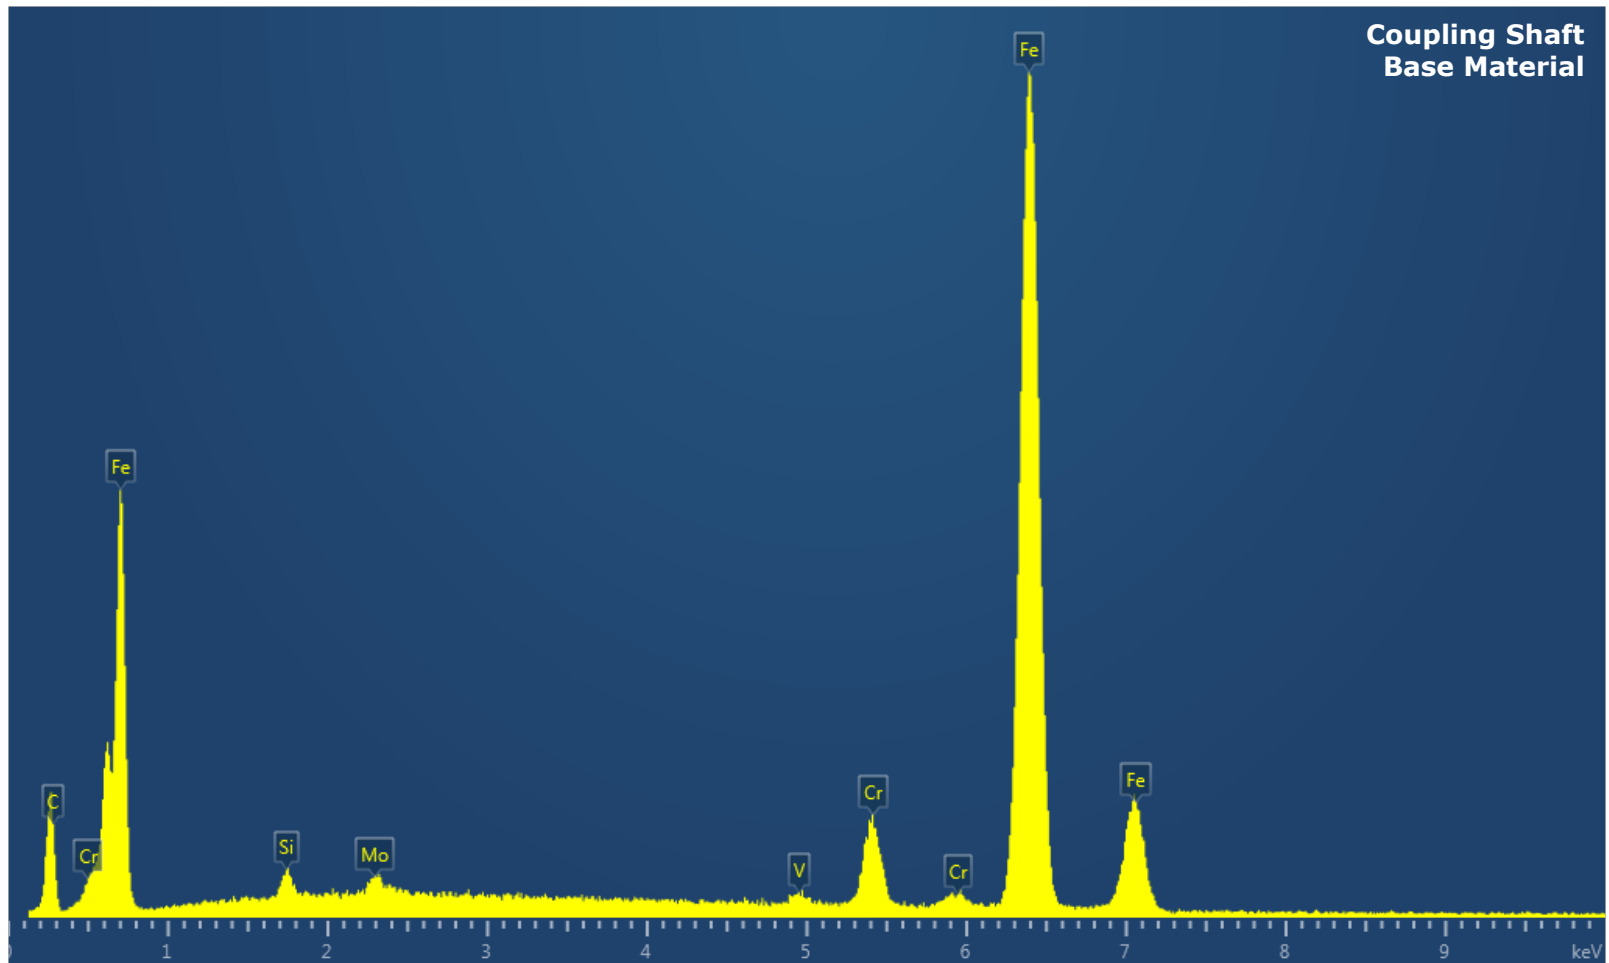
**Figure 5.**

Energy dispersive X-ray (EDX) analysis of the coupling shaft produced a spectrum indicative of the specified H11 tool steel material (Figure 5).

Representative energy dispersive X-ray (EDX) spectrum generated from analysis of the coupling shaft base material. The spectrum was indicative of the specified H11 material.

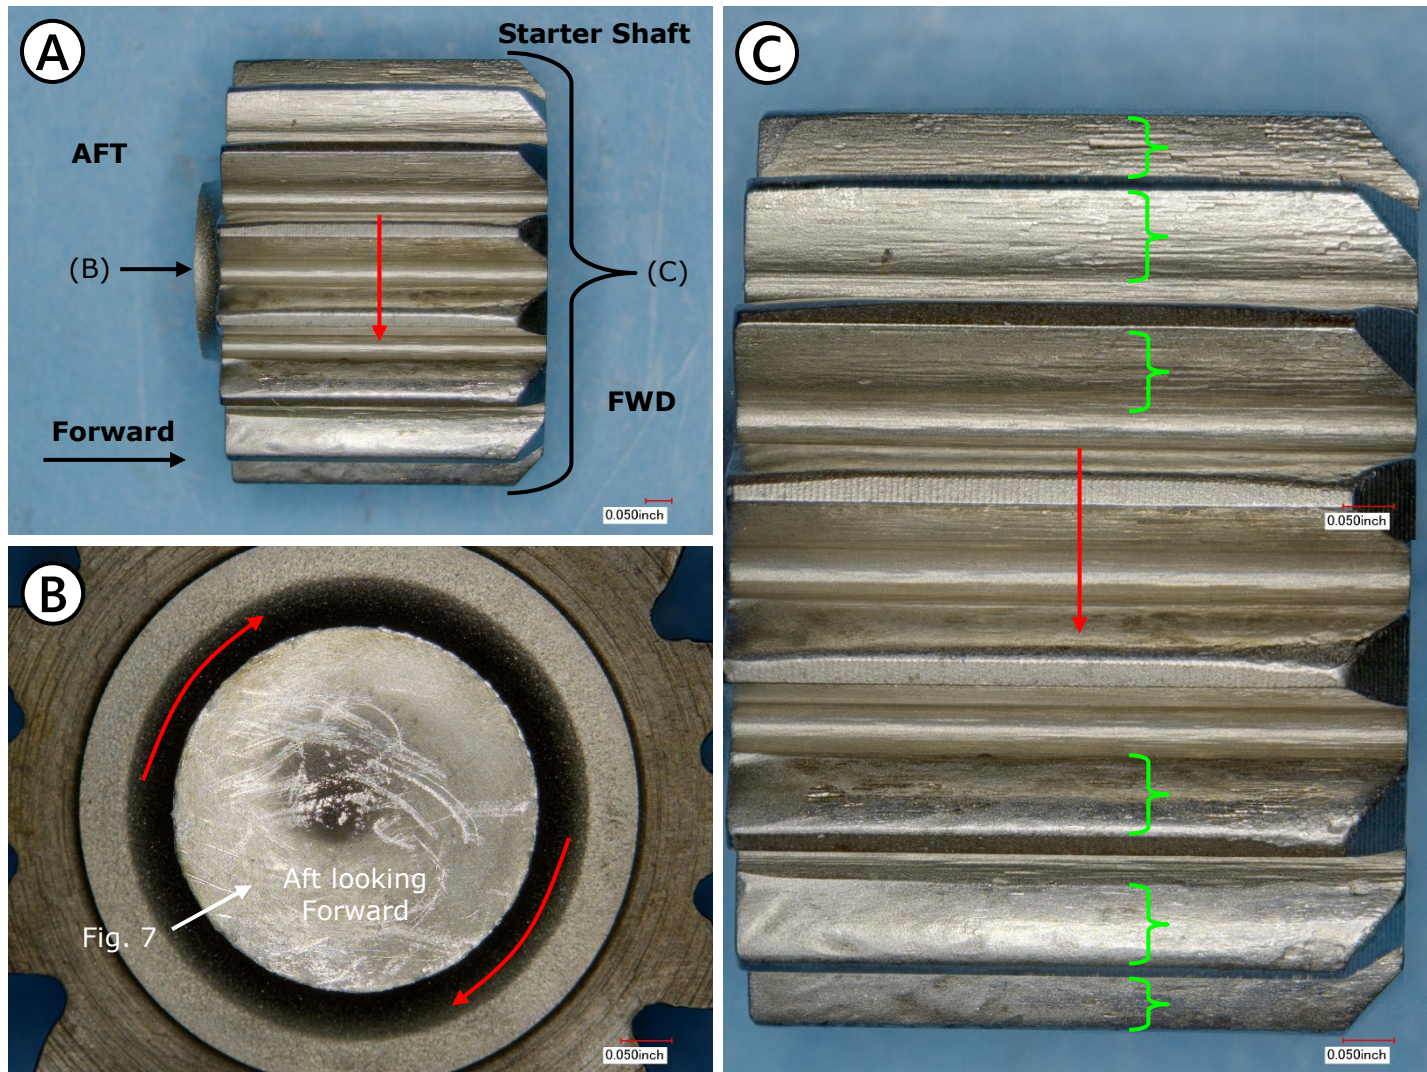
**Figure 6.**

The starter shaft had separated approximately 0.689" from the forward end (Figure 6). Wear was observed on both sides of the gear teeth.

(A-C) Digital microscope images of the separated starter shaft (P/N not provided). The red arrows indicate the specified direction of the shaft rotation within the engine (clockwise aft looking forward (ALF)). Wear was observed on both sides of the gear teeth (green brackets in (C)). SEM images of the starter shaft fracture surface are shown in Figure 7.

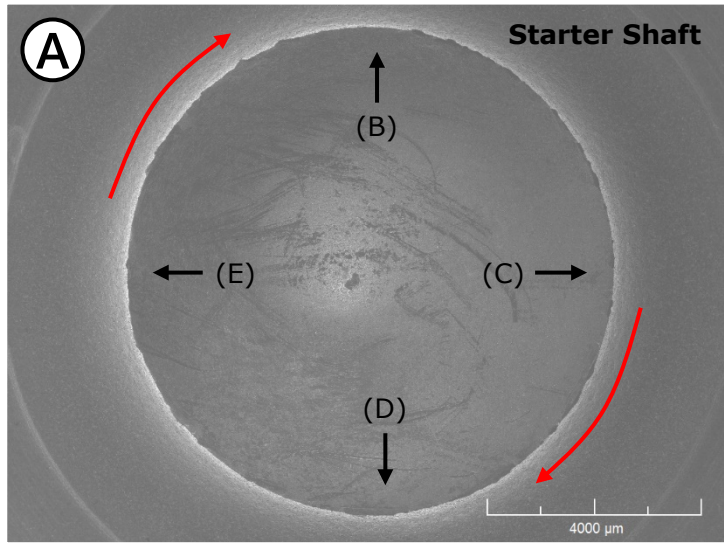
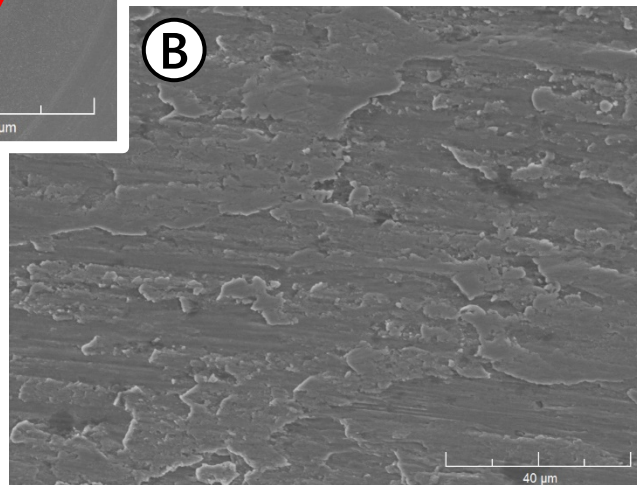
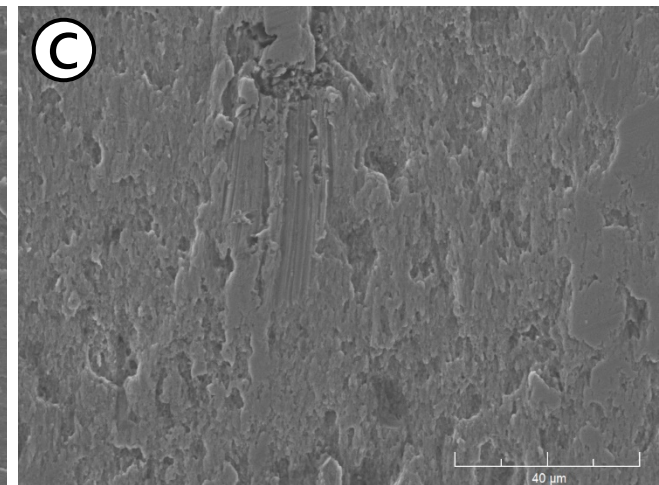
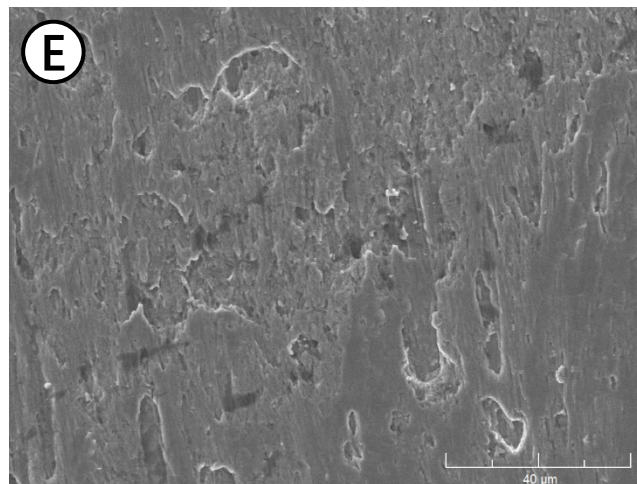
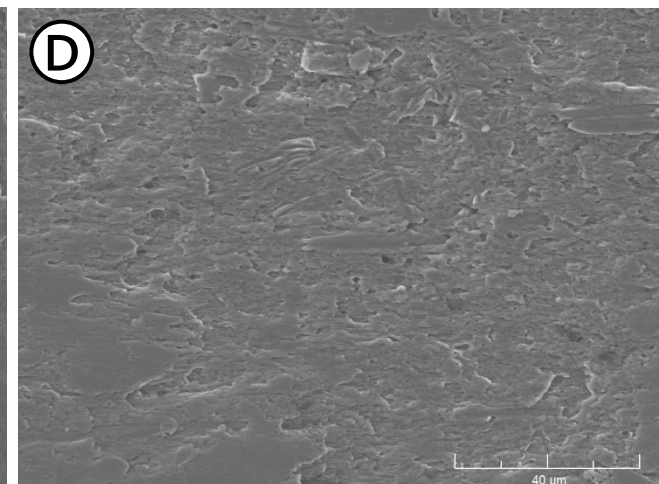
**Figure 7.**

The fracture surface of the starter shaft was examined in the SEM and is shown in Figure 7. The finer fracture features of the starter shaft could not be determined due to smearing and secondary damage of the fracture surface. The specified direction of rotation of the shaft was clockwise ALF.

(A-E) SE SEM images of the starter shaft fracture surface (reference Figure 6B). The finer fracture features could not be determined due to smearing and secondary damage of the fracture surface. The red arrows in (A) indicate the specified direction of the shaft rotation within the engine (clockwise ALF).

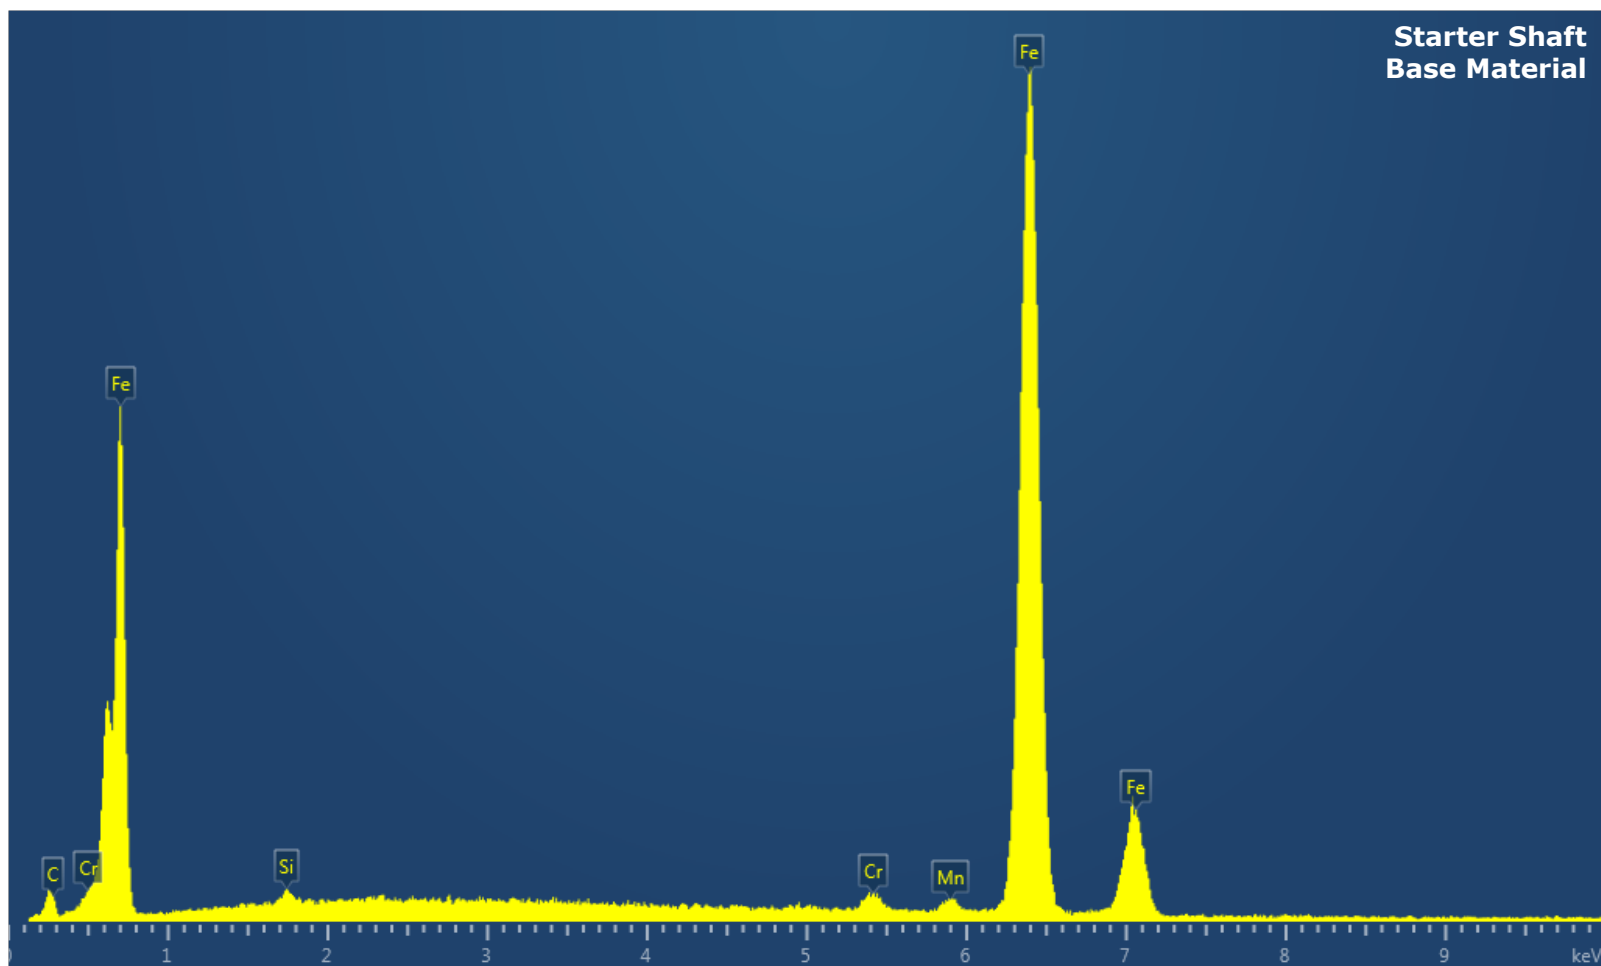
**Figure 8.**

EDX analysis of the starter shaft produced a spectrum suggestive of a steel similar to 4140 (Figure 8). Note that the specified base material of the starter shaft was not reported.

Representative EDX spectrum generated from analysis of the starter shaft base material. The spectrum was suggestive of a steel similar to 4140. Note that the specified base material of the starter shaft was not reported.

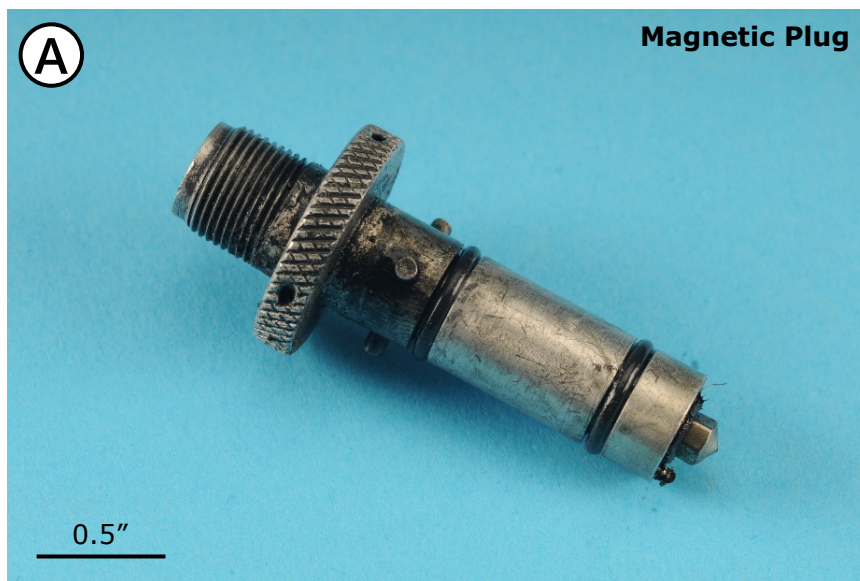
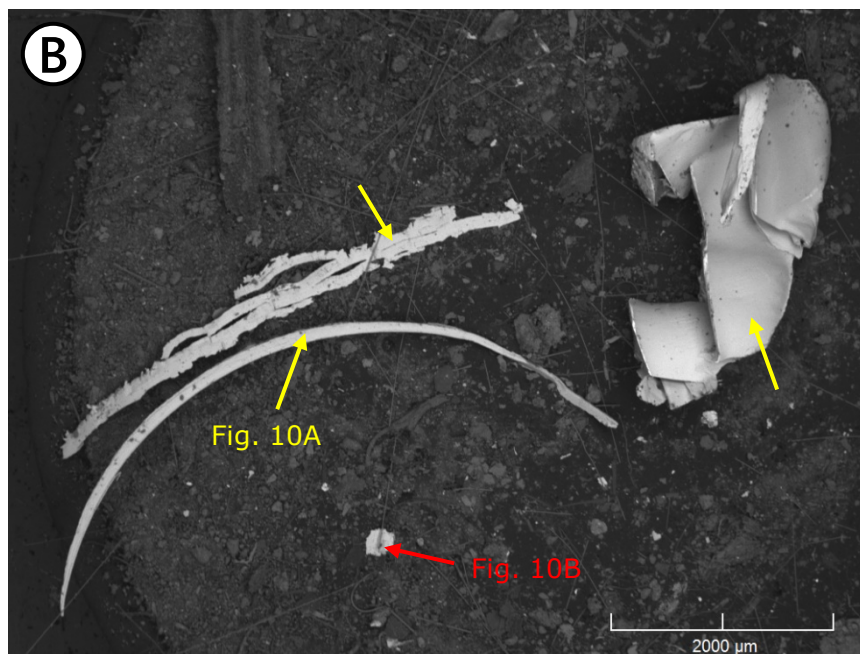
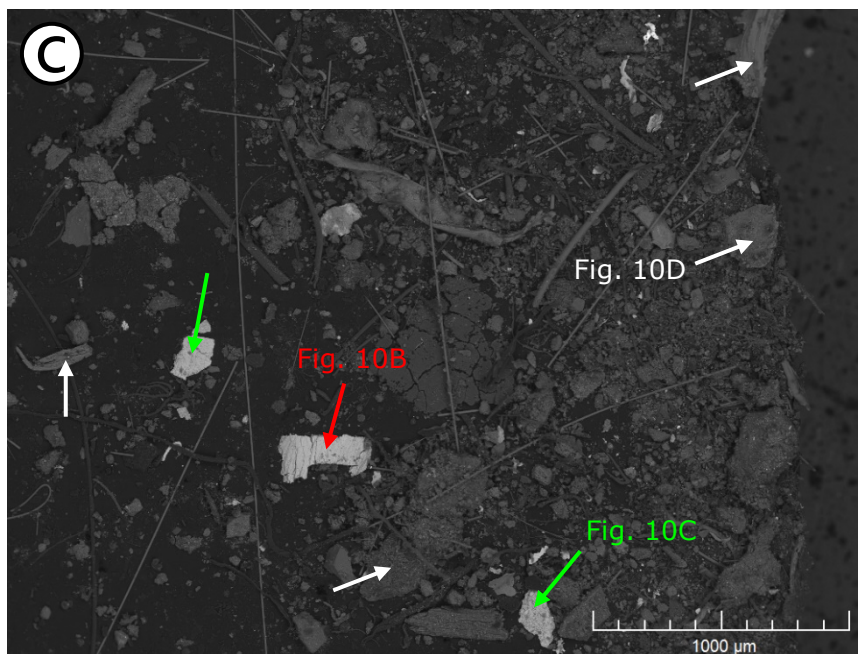
**Figure 9.**

The as-received condition of the submitted magnetic plug from left engine S/N P36058C is shown in Figure 9A. The magnetic plug was flushed using Flash 142 mineral spirits and captured onto an 8 micron filter patch. The collected debris was cleaned with toluene and dried. The weight of the debris was measured to be 28 mg.

(A) Macro image showing the magnetic plug in the as-received condition. (B-C) Backscattered electron (BSE) SEM images showing representative debris collected from the magnetic plug. EDX analysis of the debris identified by the yellow, red, green, and white arrows are shown in Figure 10, as indicated.

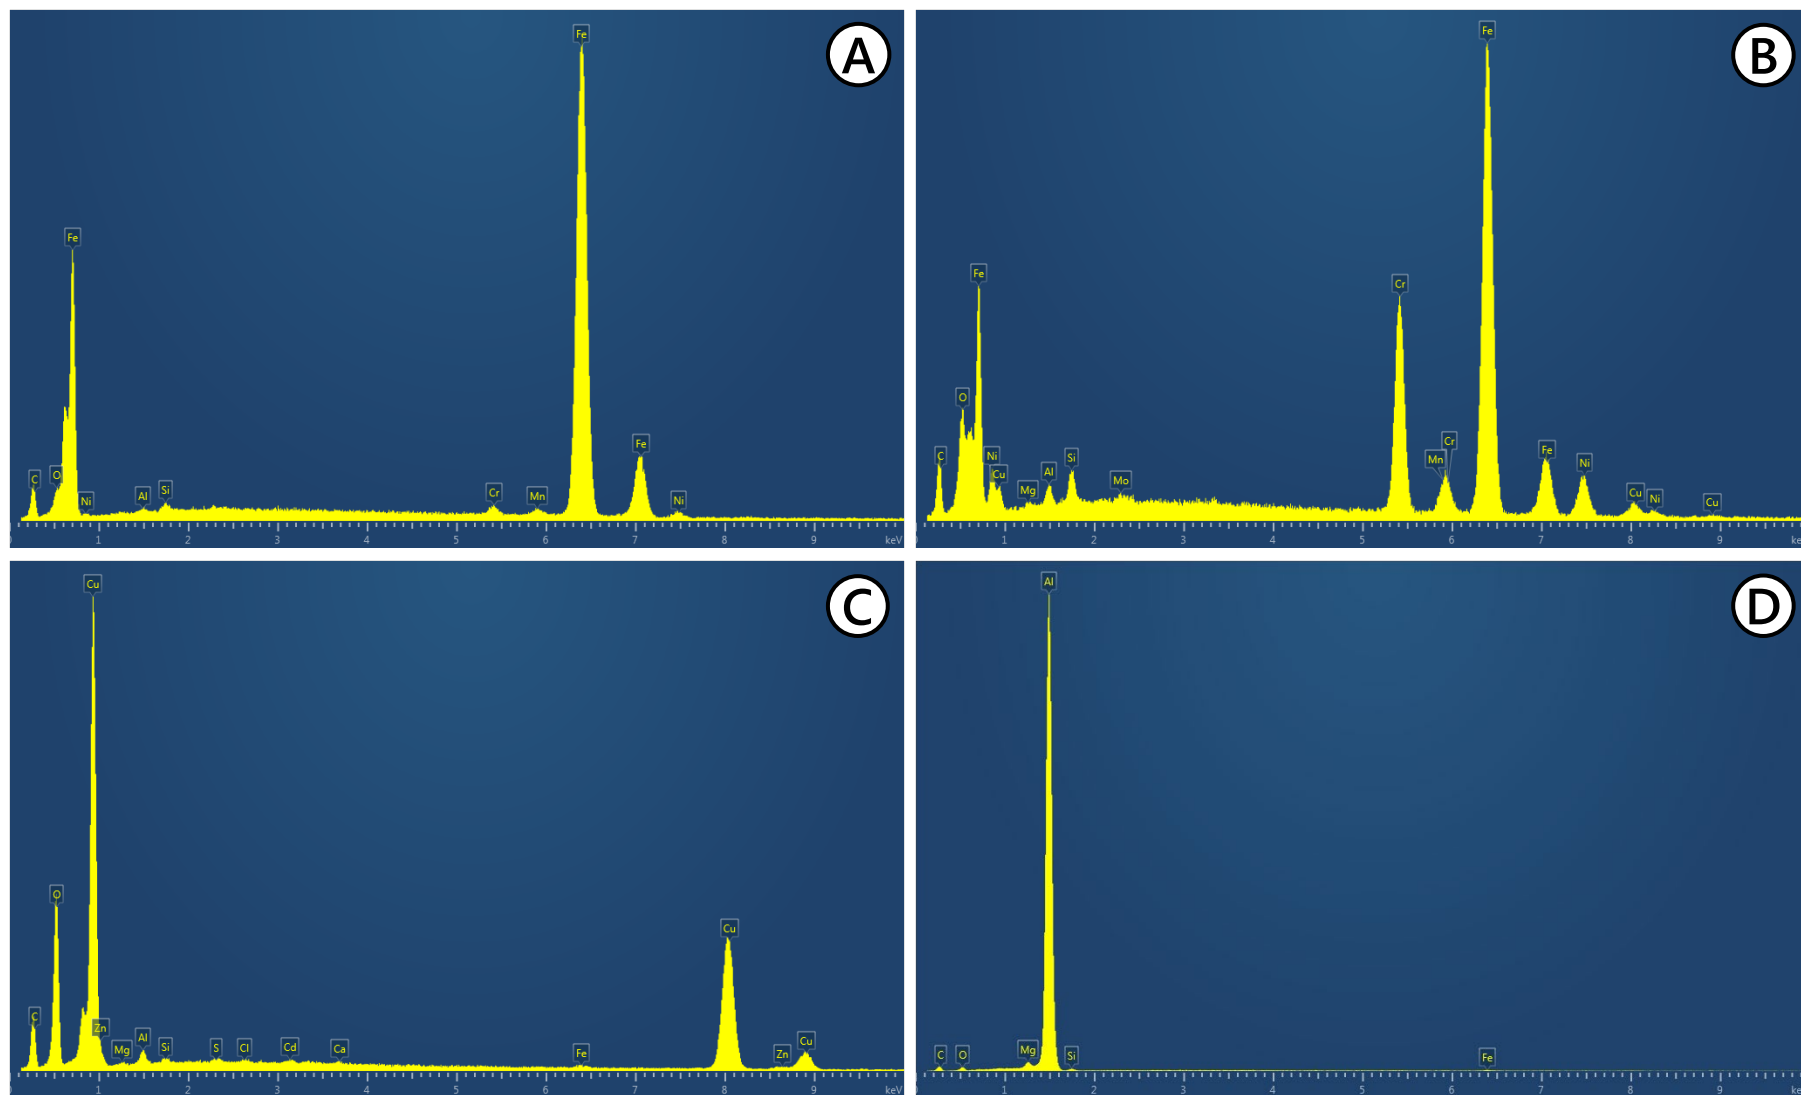
**Figure 10.**

SEM analysis of the collected debris is shown in Figures 9B-C. EDX analysis of the larger metallic particles were suggestive of a steel similar to 4340 or 9310 (Figure 10A). The smaller metallic particles were suggestive of a stainless steel similar to 17-4PH or 15-5PH, as determined by EDX analysis (Figure 10B). Debris rich in copper (Figure 10C) and debris suggestive of an aluminum alloy (Figure 10D) were also detected amongst the debris, as determined by EDX analysis.

(A-D) Representative EDX spectra generated from analysis of the debris collected from the magnetic plug identified by the yellow, red, green, and white arrows in Figures 9B-C. The spectrum in (A) was suggestive of a steel similar to 9310 or 4340. The spectrum in (B) was suggestive of a stainless steel similar to 17-4PH or 15-5PH. The spectrum in (C) was rich in copper with lower concentrations in other elements. The spectrum in (D) was suggestive of an aluminum alloy.
