**NATIONAL TRANSPORTATION SAFETY BOARD**

**Attachment 7 –Honeywell No. 2 Engine (P36235C) Materials Laboratory  
Analysis Report**

**POWERPLANTS**

**CEN20LA215**

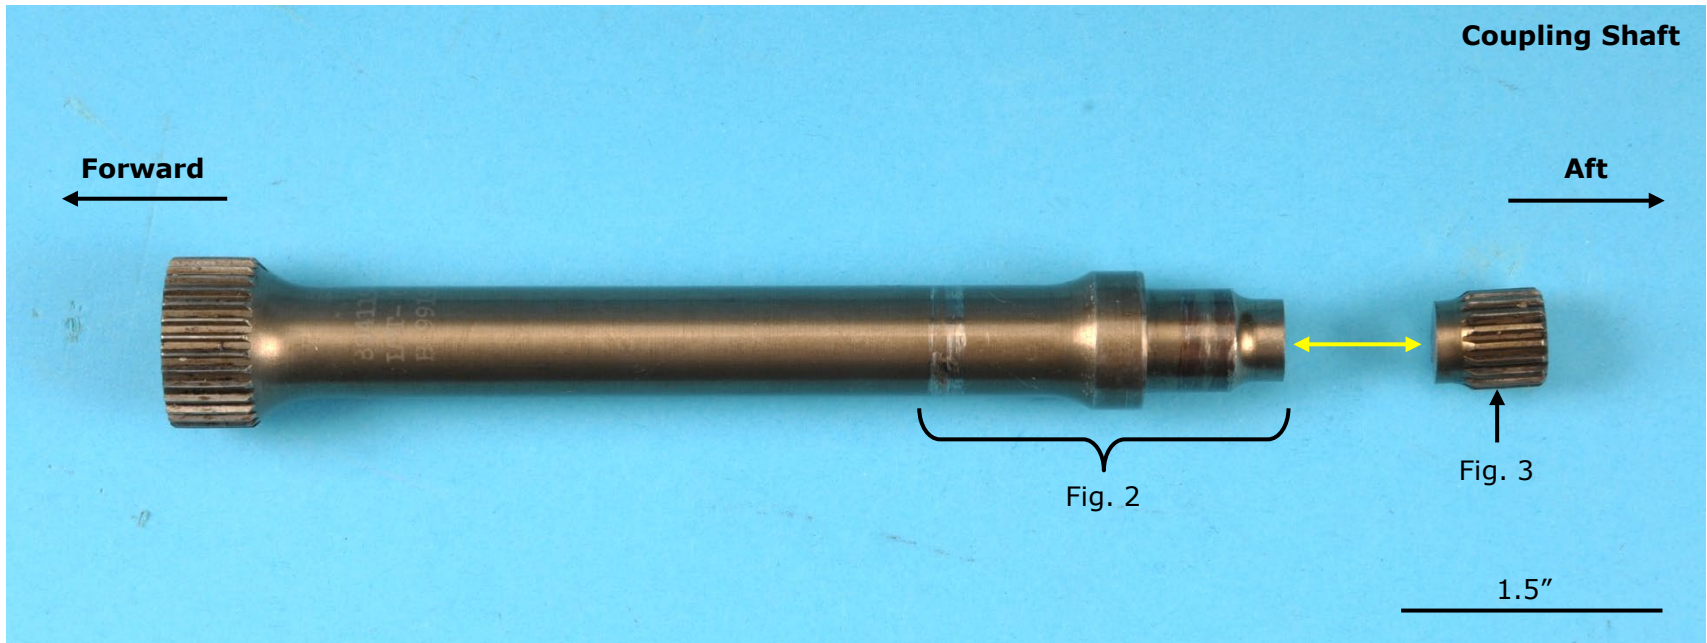
**Figure 1.**

The coupling shaft (Lot Number 1050) from the left engine S/N P36235C had separated approximately 0.632" from the aft end (Figure 1). The fracture surface of the separation was oriented normal to the shaft axis and was flat in appearance. Wear was observed on and adjacent to the shoulder of the shaft (Figure 2). Contact/wear patterns were observed on the loaded side of the gear teeth from the aft end of the coupling shaft (Figure 3).

Overall image showing the as-received condition of the separated coupling shaft (Lot Number 1050) from TPE331 engine S/N P36235C (right engine). The coupling shaft had separated near the aft end (yellow double-sided arrow). Close up images of the shaft are shown in Figures 2-3, as indicated.

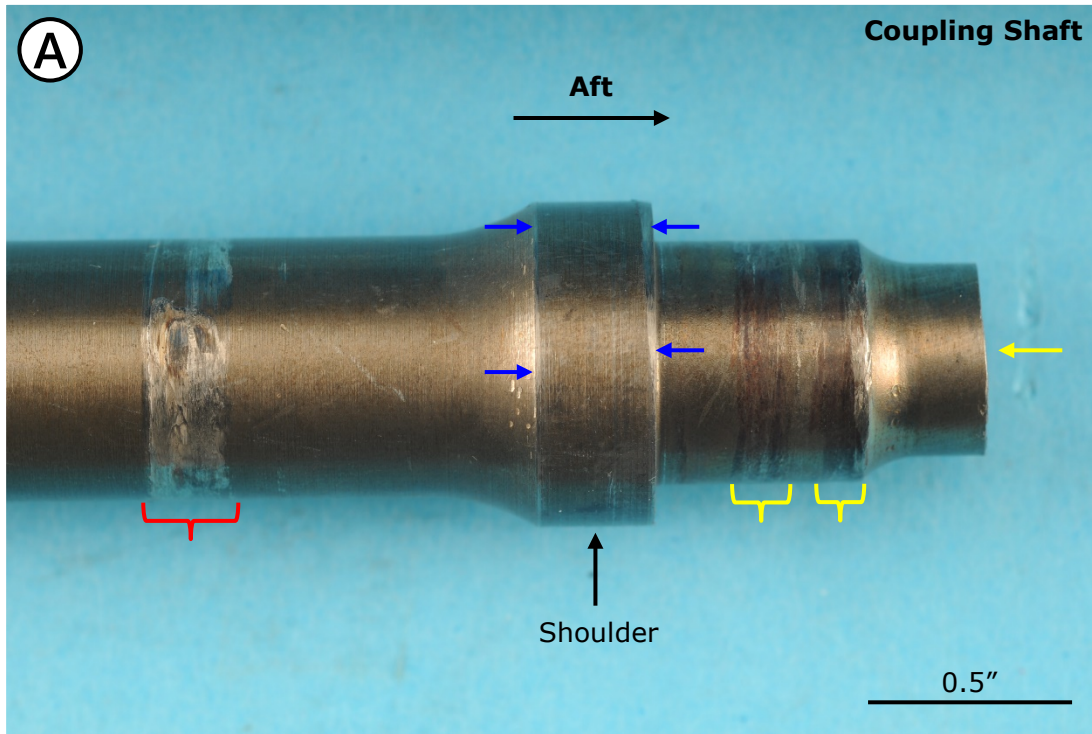
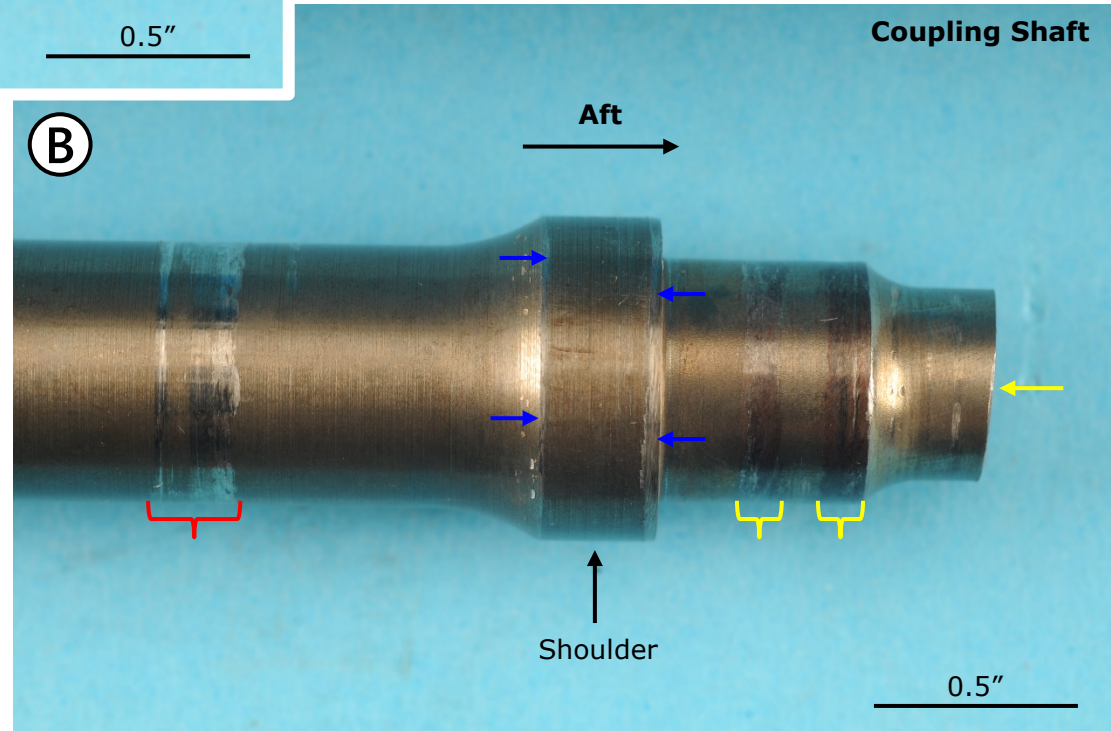
**Figure 2.**

(A-B) 180° views of the aft end of the coupling shaft (reference Figure 1). Non-uniform wear was observed on the shoulder (blue arrows), aft of the shoulder (yellow brackets), and forward of the shoulder (red brackets). The yellow arrows point to the fracture surface.

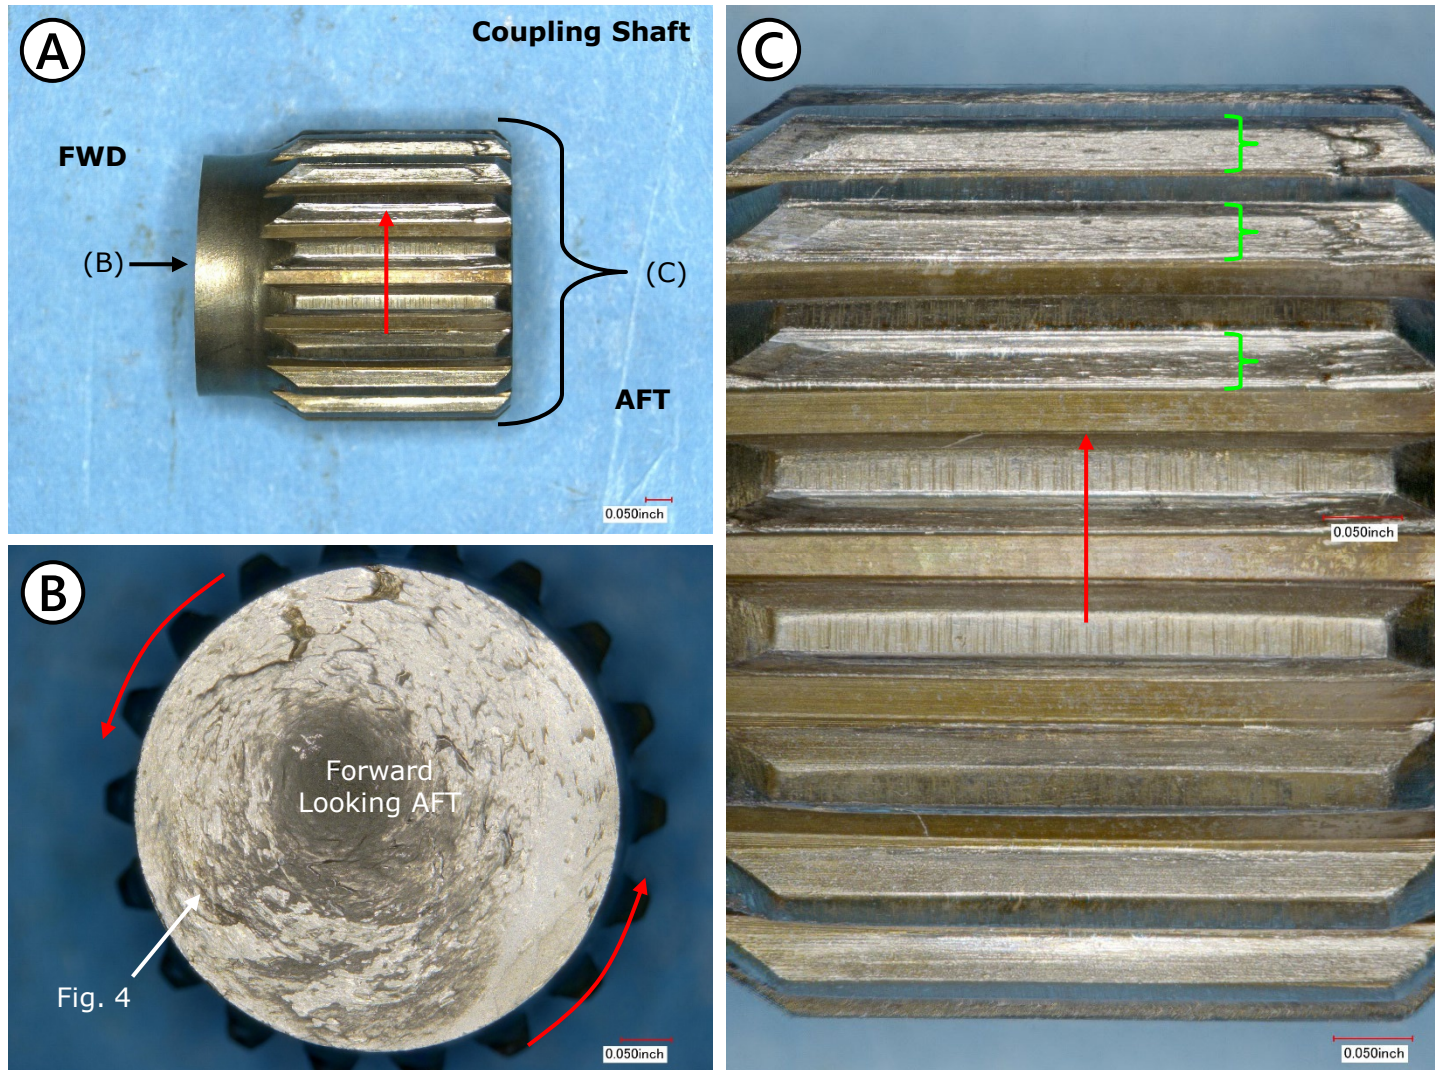
**Figure 3.**

(A-C) Digital microscope images of the separated coupling shaft (reference Figure 1). The red arrows indicate the specified direction of shaft rotation within the engine (counterclockwise forward looking aft (FLA)). Wear was observed on the loaded side of the gear teeth (green brackets in (C)). Scanning electron microscope (SEM) images of the coupling shaft fracture surface are shown in Figure 4.

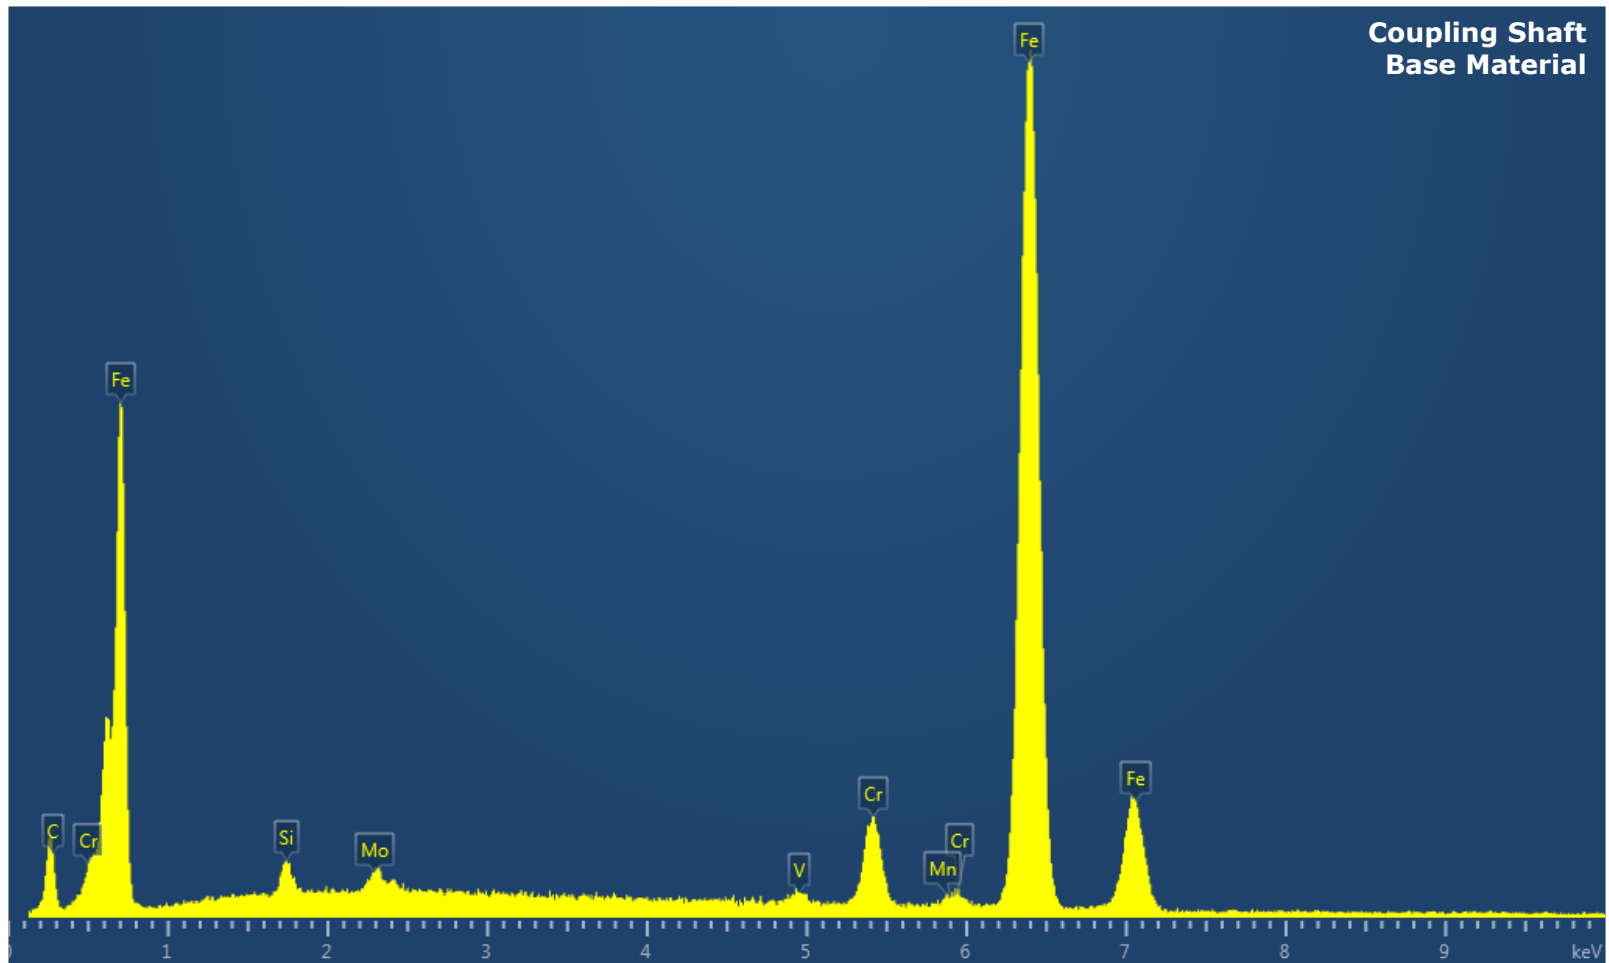
**Figure 5.**

Energy dispersive X-ray (EDX) analysis of the coupling shaft produced a spectrum indicative of the specified H11 tool steel material (Figure 5).

Representative energy dispersive X-ray (EDX) spectrum generated from analysis of the coupling shaft base material. The spectrum was indicative of the specified H11 material.

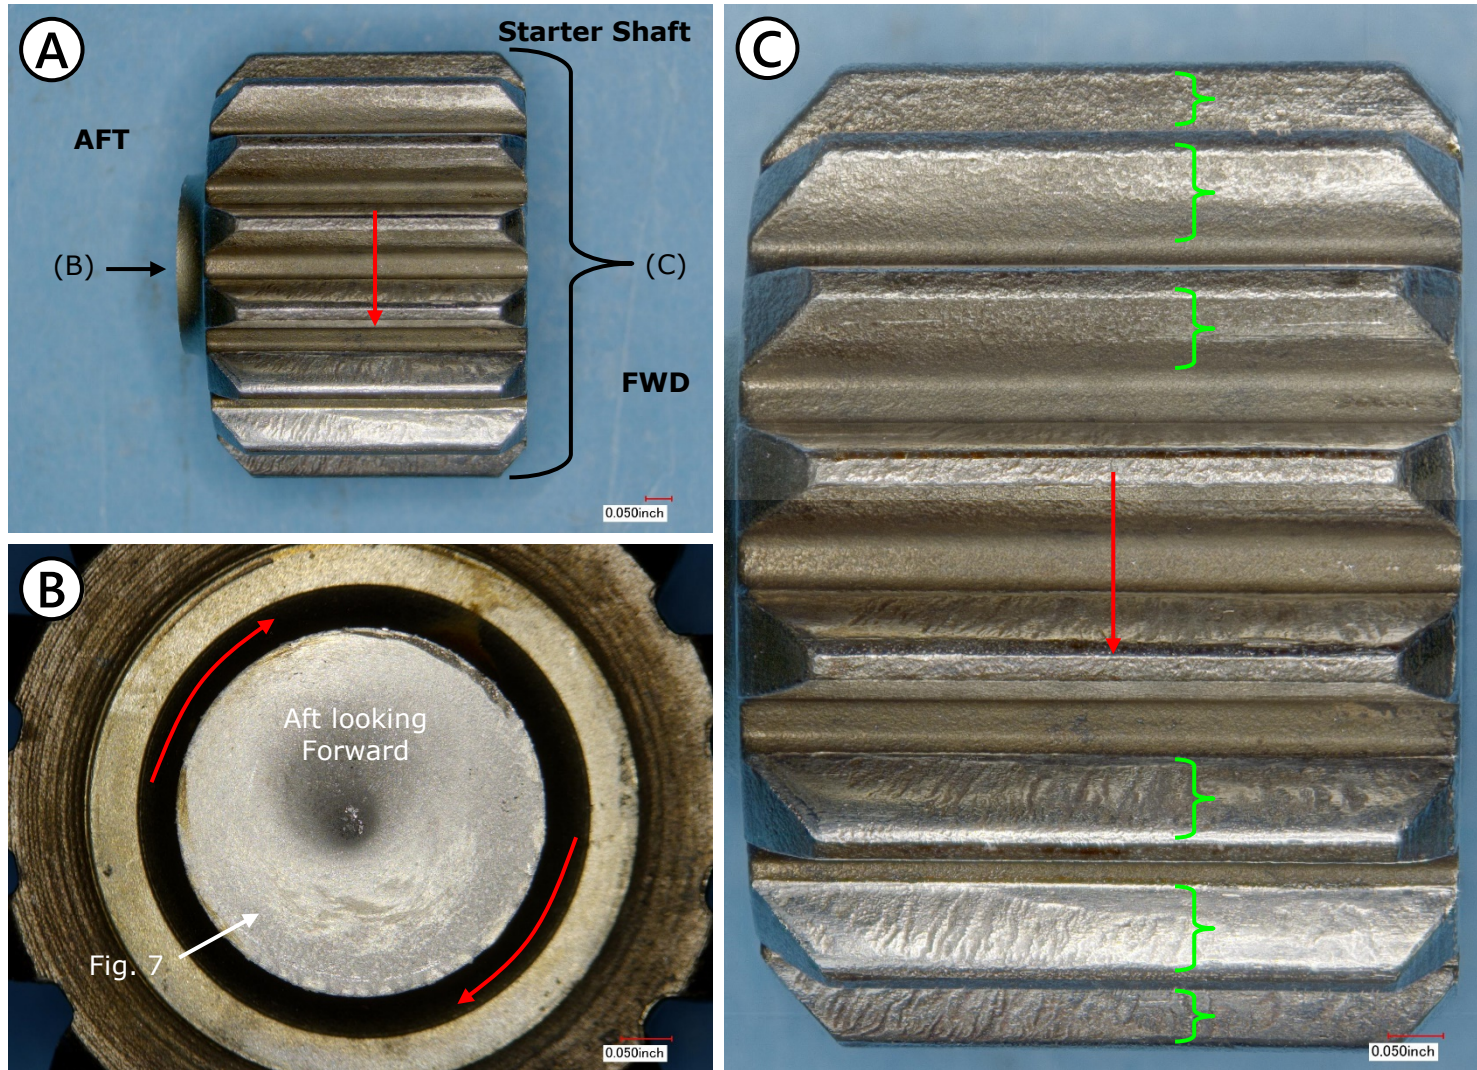
**Figure 6.**

The starter shaft has separated approximately 0.690" from the forward end (Figure 6). Wear was observed on both sides of the gear teeth.

(A-C) Digital microscope images of the separated starter shaft (P/N not provided). The red arrows indicate the specified direction of the shaft rotation within the engine (clockwise aft looking forward (ALF)). Wear was observed on both sides of the gear teeth (green brackets in (C)). SEM images of the starter shaft fracture surface are shown in Figure 7.

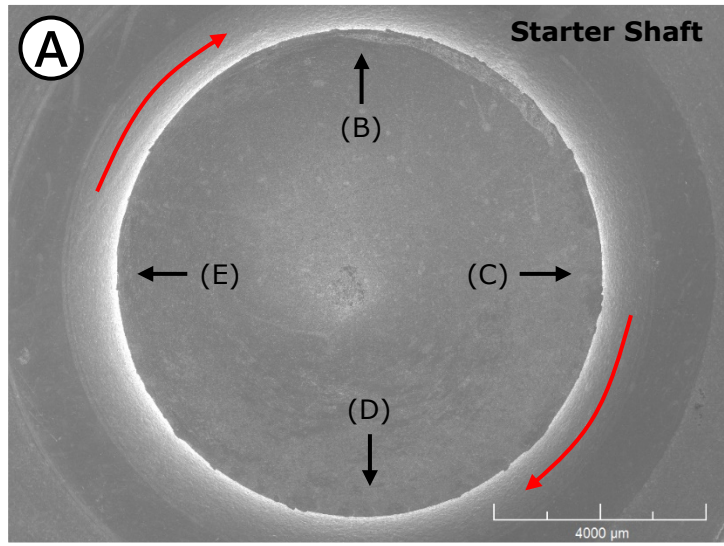
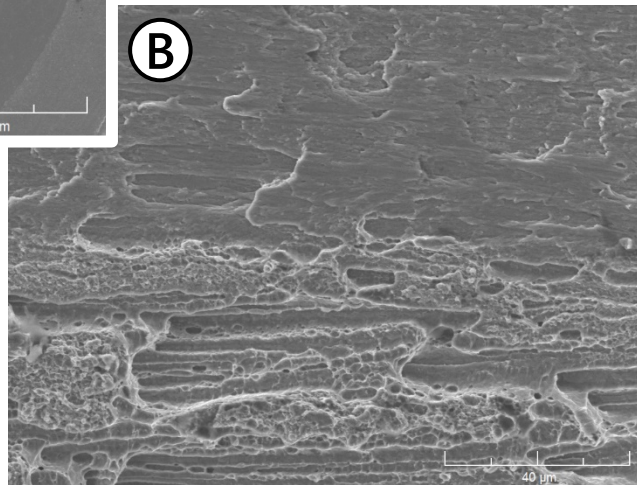
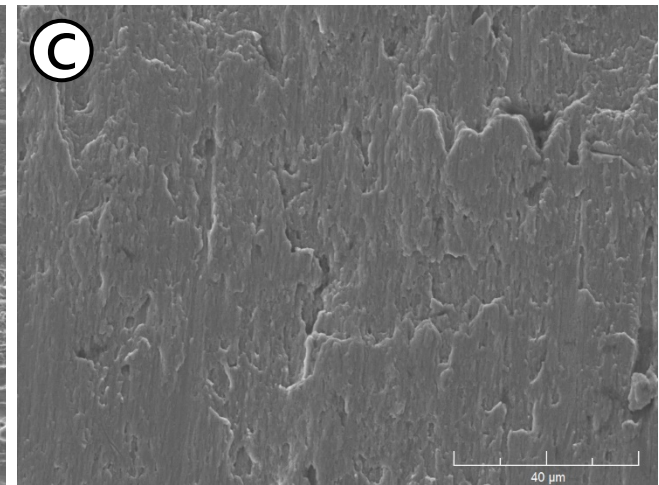
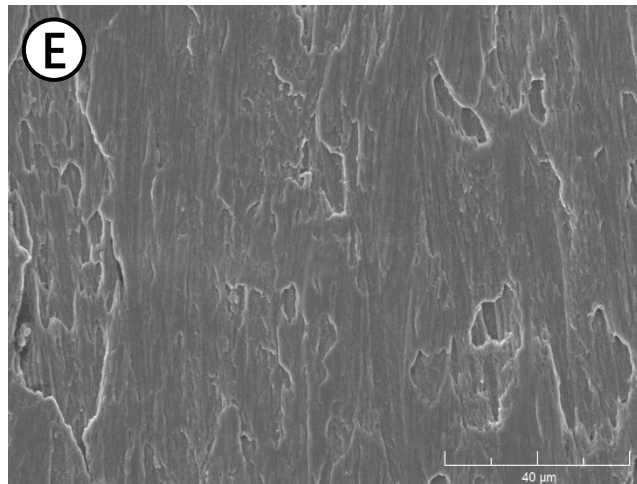
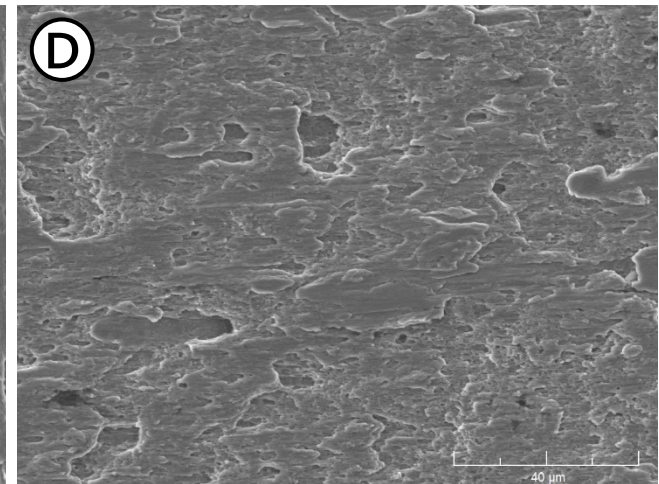
**Figure 7.**

The fracture surface of the starter shaft was examined in the SEM and is shown in Figure 7. Fracture features indicative of overload were observed in some locations; however, most of the finer fracture features could not be determined due to smearing and secondary damage of the fracture surface. The specified direction of rotation of the shaft was clockwise ALF.

(A-E) SE SEM images of the starter shaft fracture surface (reference Figure 6B). Fracture features indicative of overload were observed in some locations (reference view (B)); however, most of the finer fracture features were obscured by smearing and secondary damage (reference views (C-E)). The red arrows in (A) indicate the specified direction of the shaft rotation within the engine (clockwise ALF).

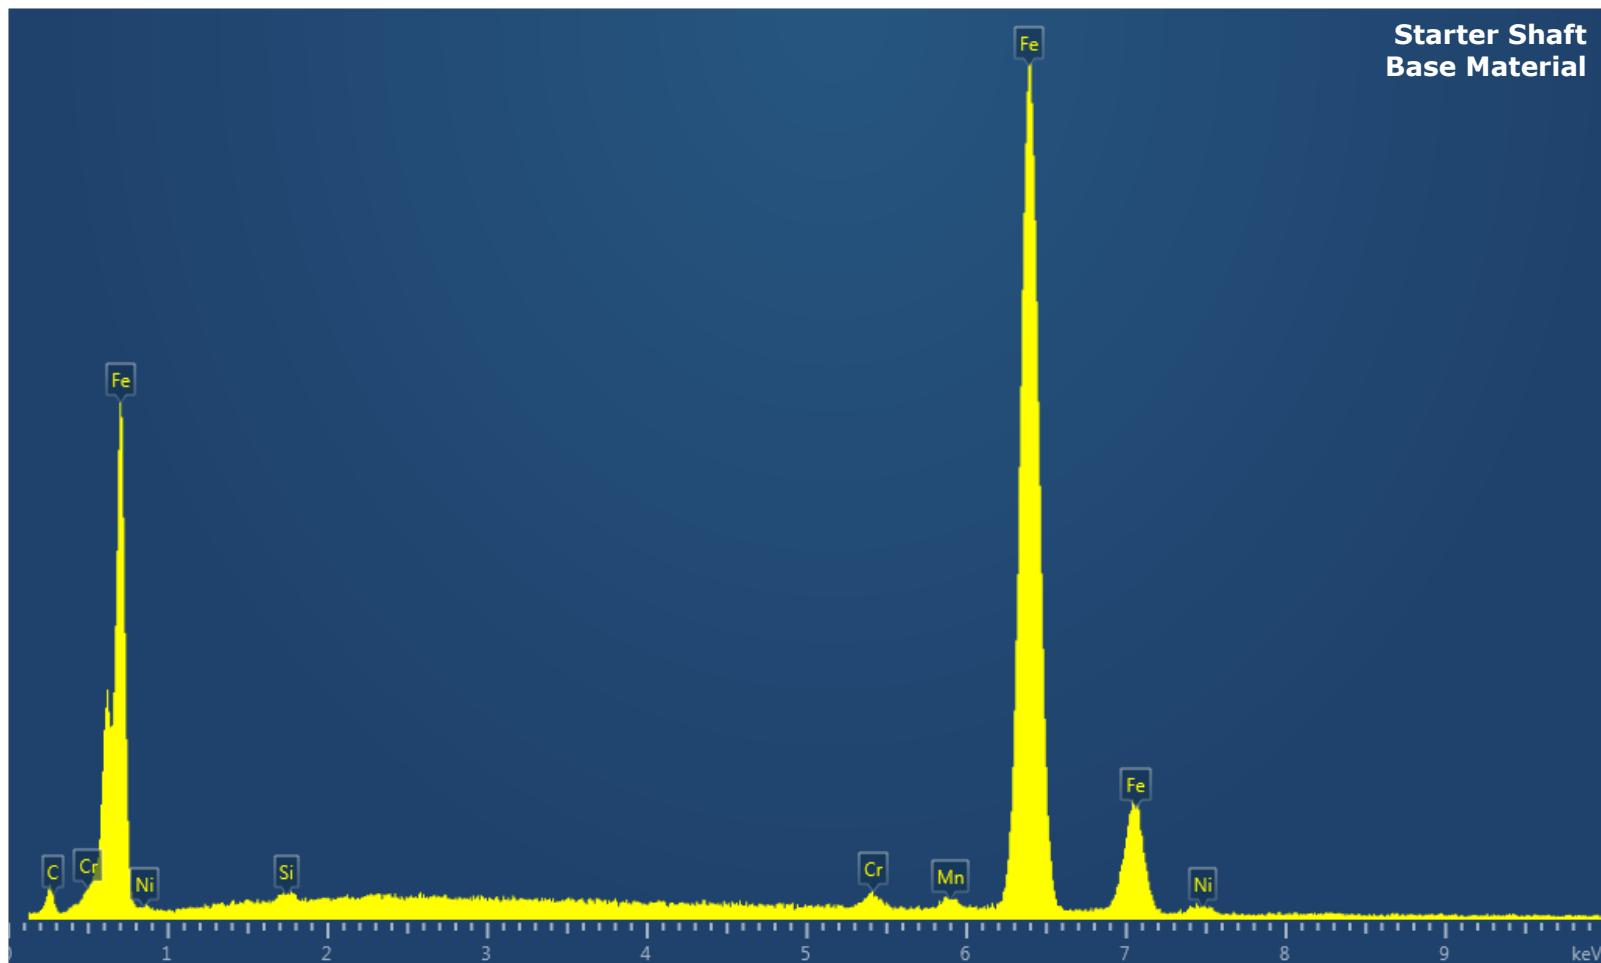
**Figure 8.**

EDX analysis of the starter shaft produced a spectrum suggestive of a steel similar to 4340 (Figure 8). Note that the specified base material of the starter shaft was not reported.

Representative EDX spectrum generated from analysis of the starter shaft base material. The spectrum was suggestive of a steel similar to 4340. Note that the specified base material of the start shaft was not reported.

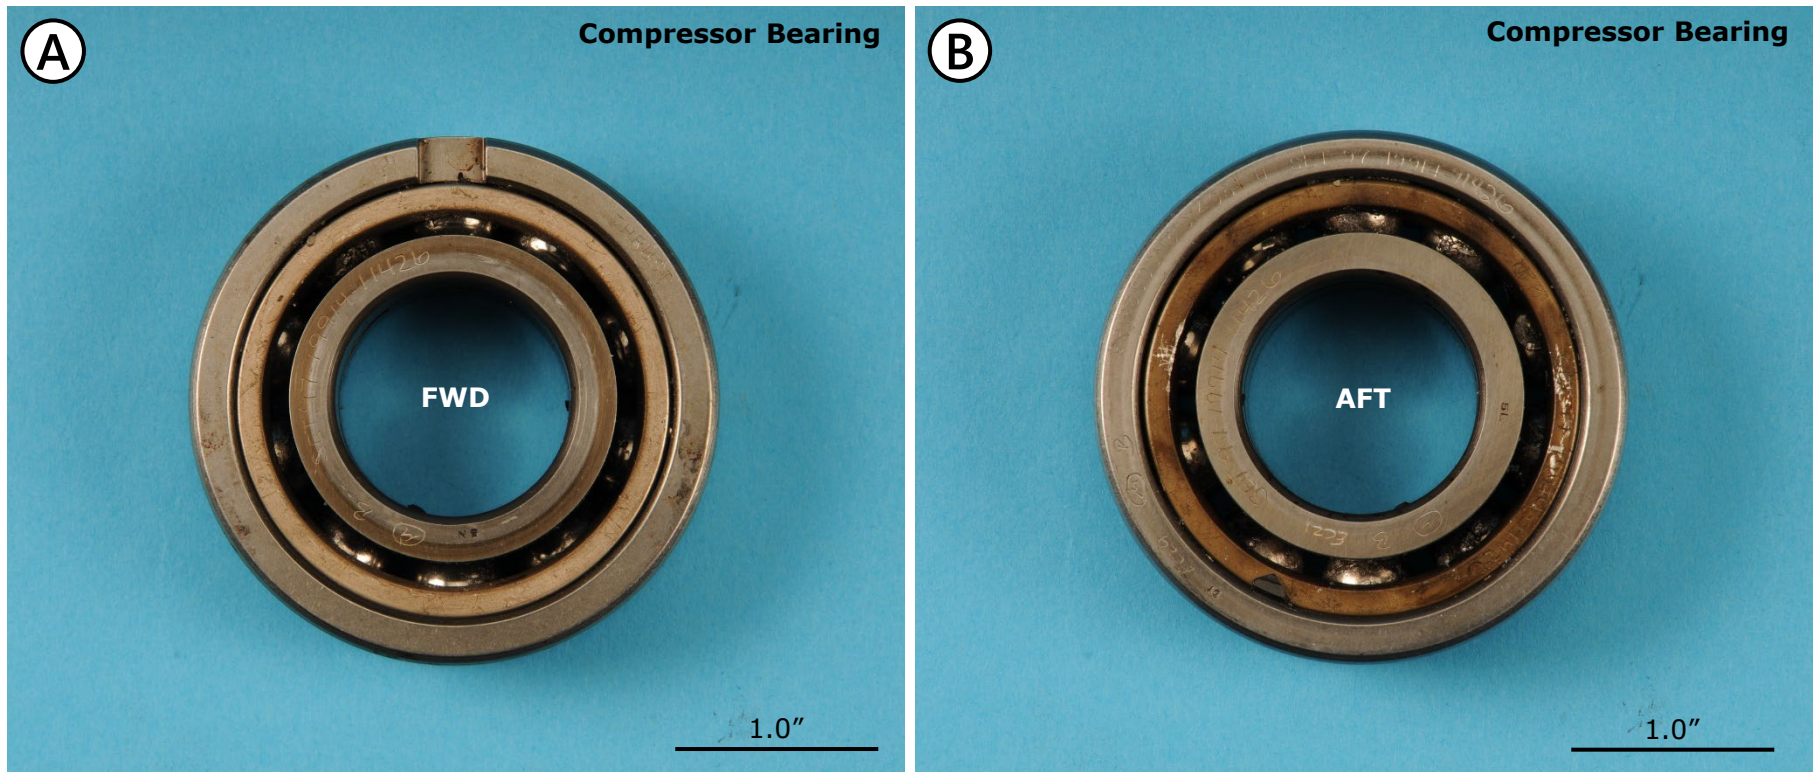
**Figure 9.**

Overall images showing the as-received condition of the (A) forward and (B) aft sides of the compressor bearing (S/N 97-19914-11426). An image of the bearing after disassembly is shown in Figure 10.

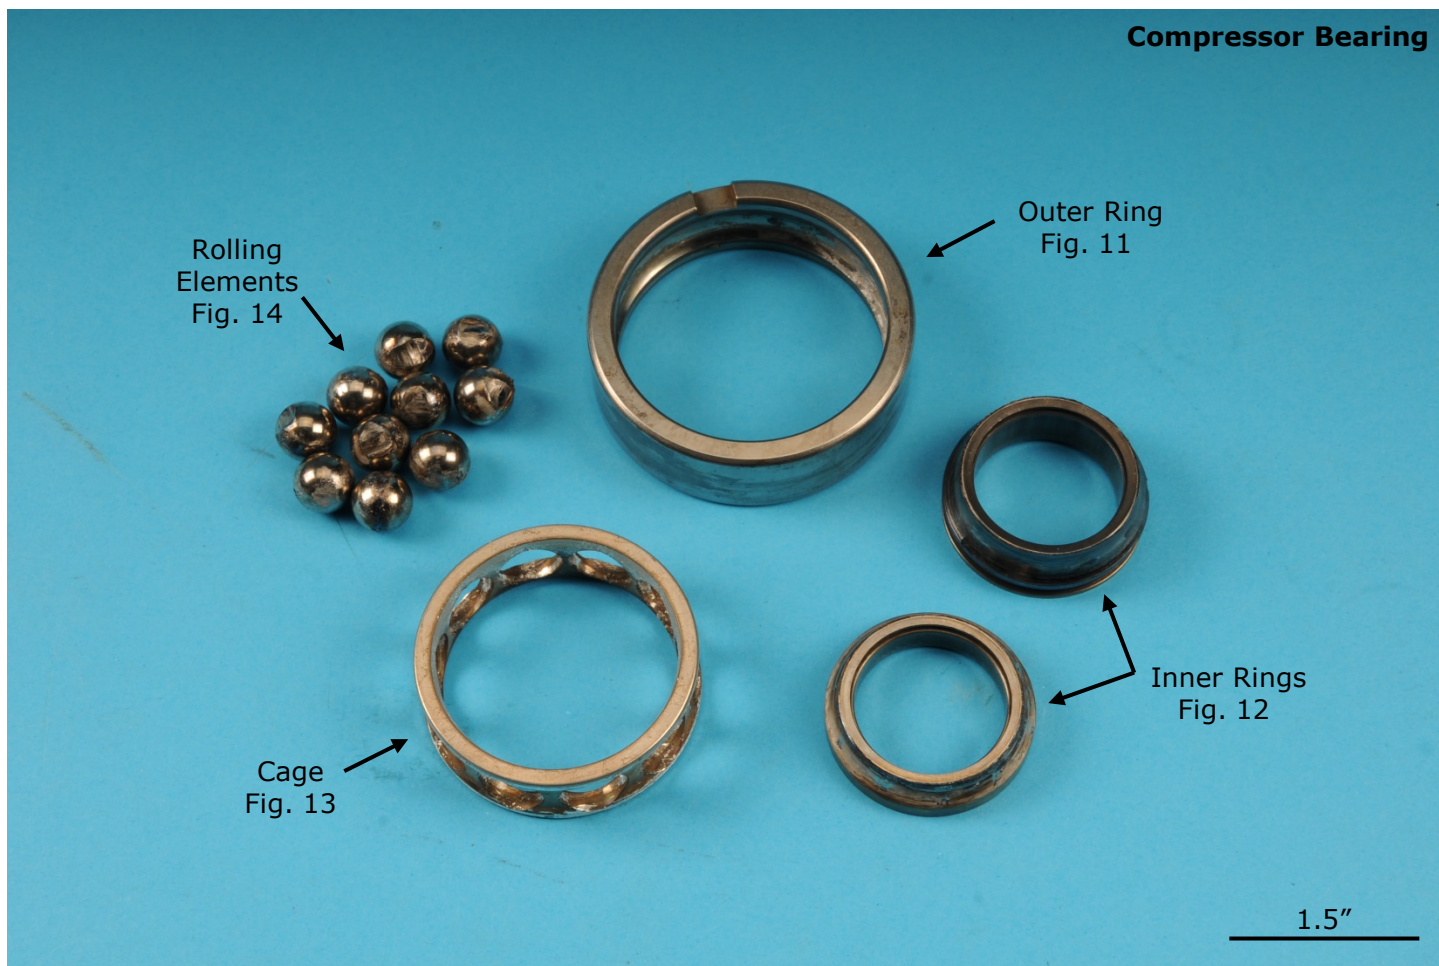
**Figure 10.**

Overall image showing the compressor bearing after disassembly. Close up images of the bearing components are shown in Figures 11-14, as indicated.

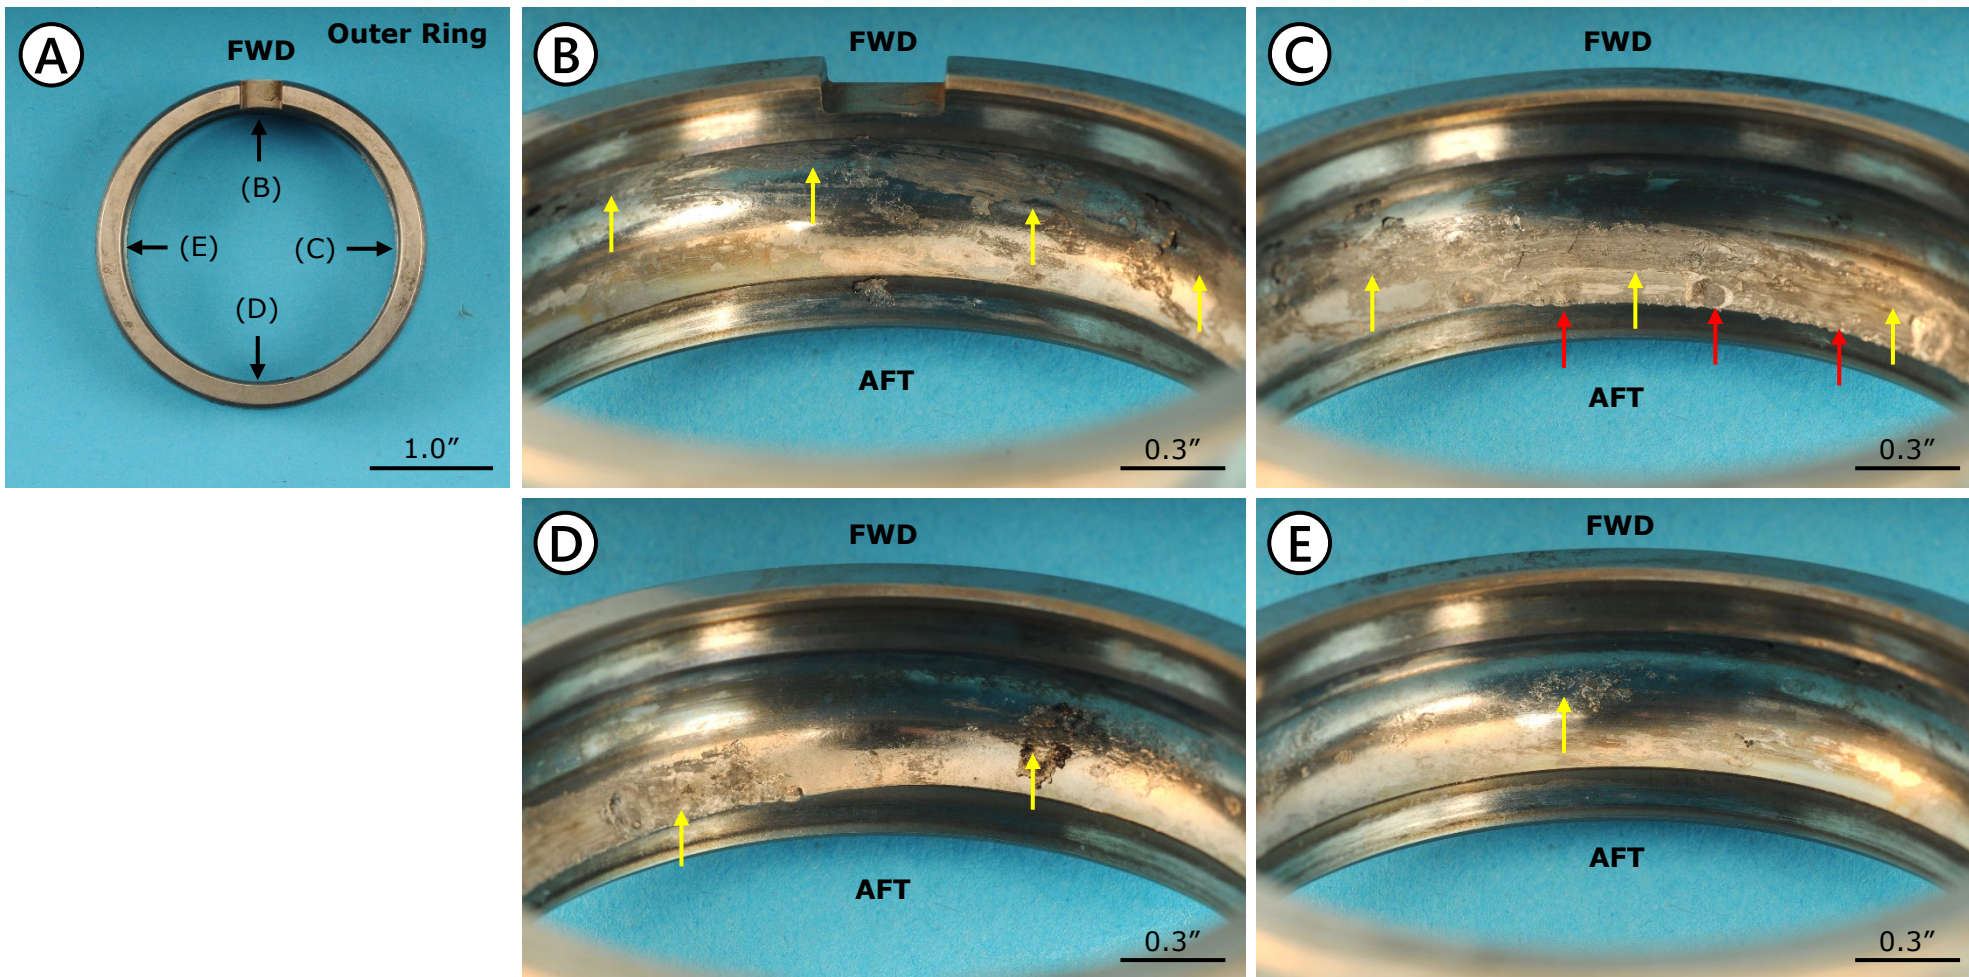
**Figure 11.**

The as-received condition of the compressor bearing is shown in Figure 9. The bearing was disassembled for evaluation purposes and is shown in Figure 10. Damage and non-uniform wear were observed on the outer ring raceway (Figure 11). Deformed material

from the outer ring raceway onto the aft shoulder was observed in some locations.

(A) Overall and (B-E) close up images showing the compressor bearing outer ring (reference Figures 9-10). Damage and non-uniform wear were observed on the outer ring raceway (yellow arrows). Deformed material from the outer ring raceway onto the aft shoulder was observed in some locations (red arrows in (C)).

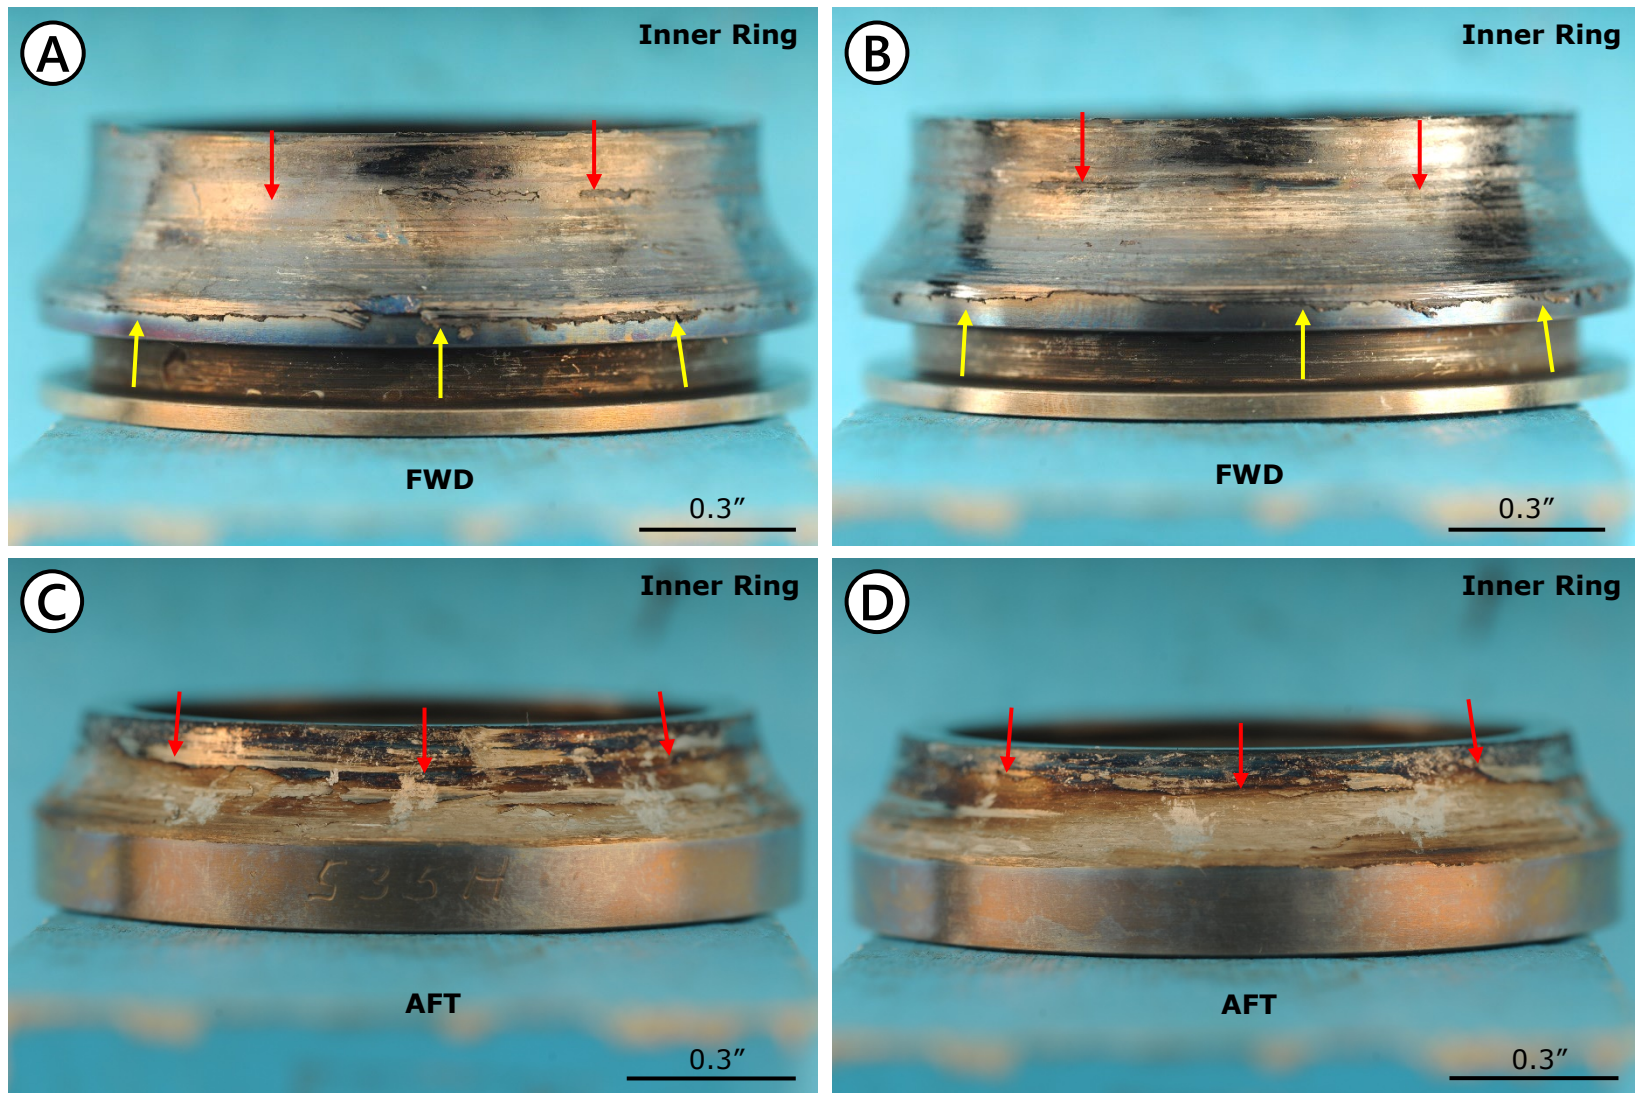
**Figure 12.**

Views showing the (A-B) forward and (C-D) aft sides of the split inner rings (reference Figures 9-10). Rolled over material was observed at the OD shoulder of the forward side of the split inner ring (yellow arrows in (A-B)). Damage was observed on the split inner ring raceways (red arrows).

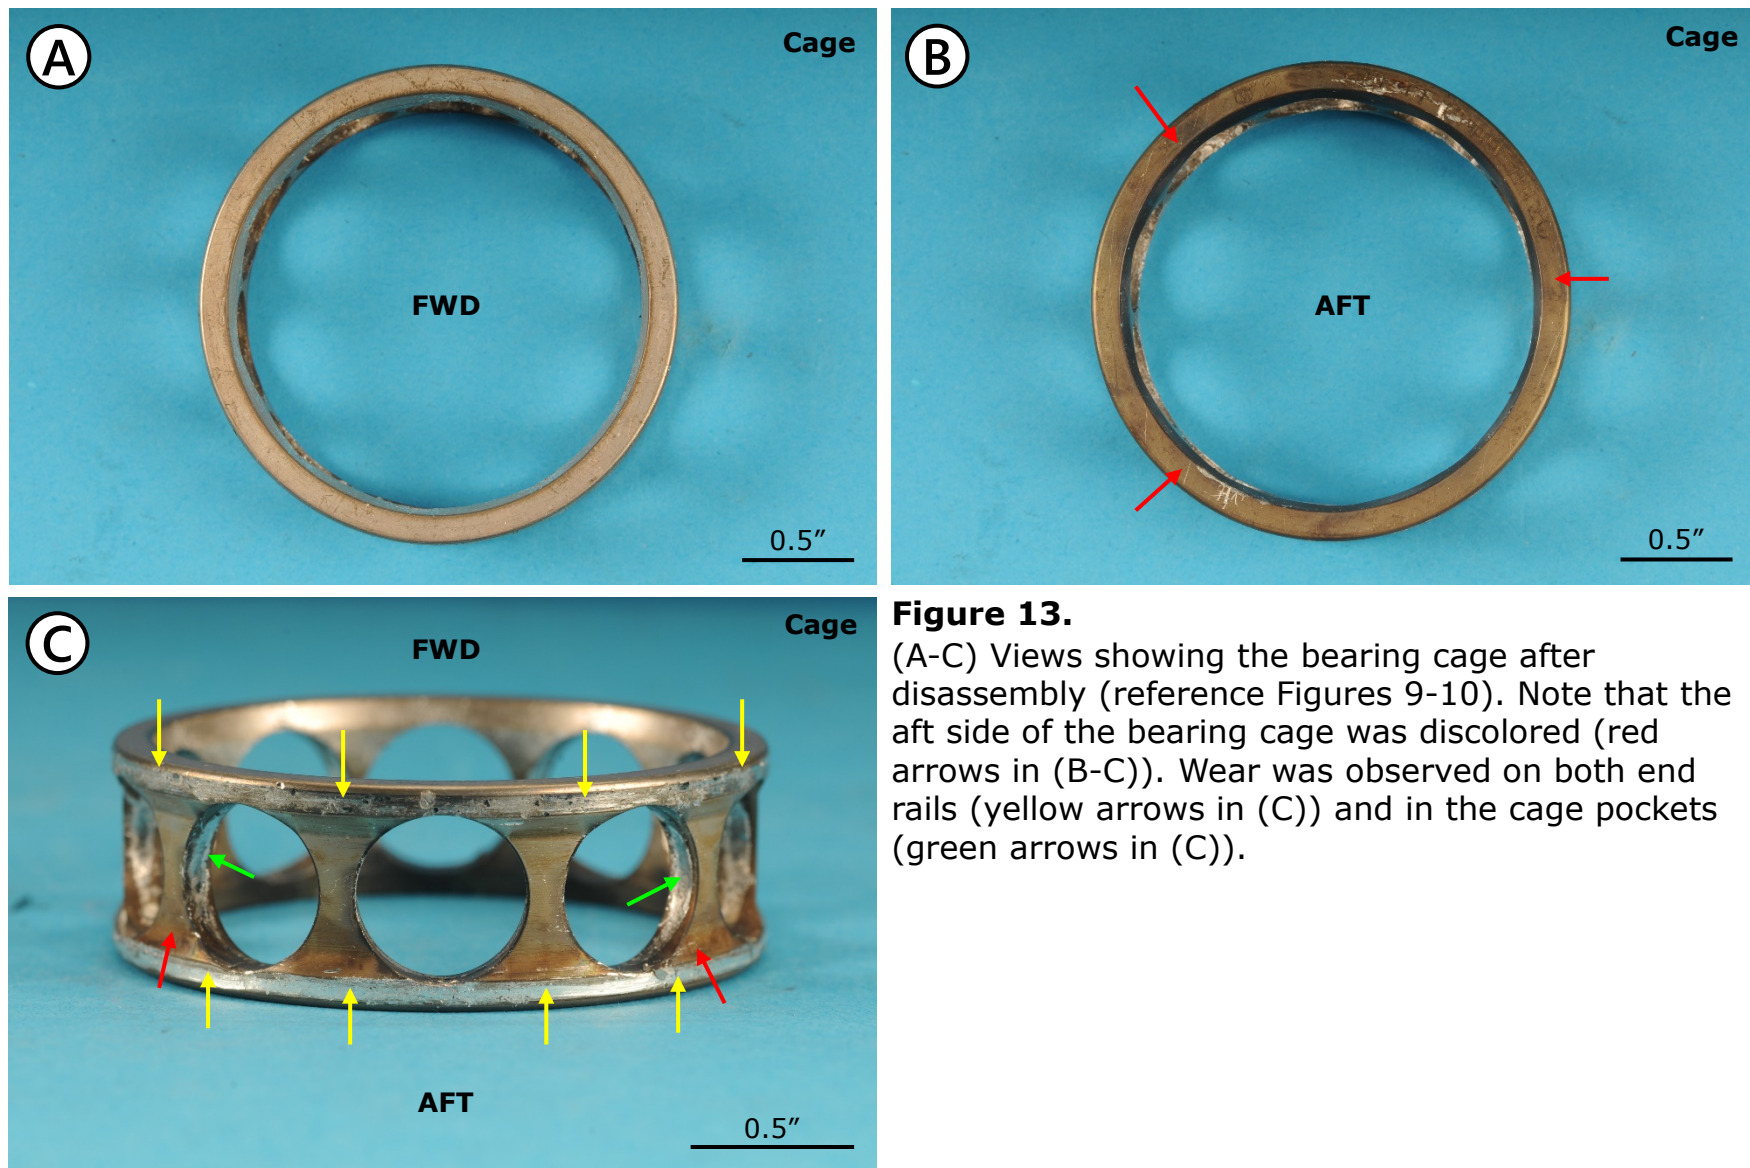
**Figure 13.**

(A-C) Views showing the bearing cage after disassembly (reference Figures 9-10). Note that the aft side of the bearing cage was discolored (red arrows in (B-C)). Wear was observed on both end rails (yellow arrows in (C)) and in the cage pockets (green arrows in (C)).

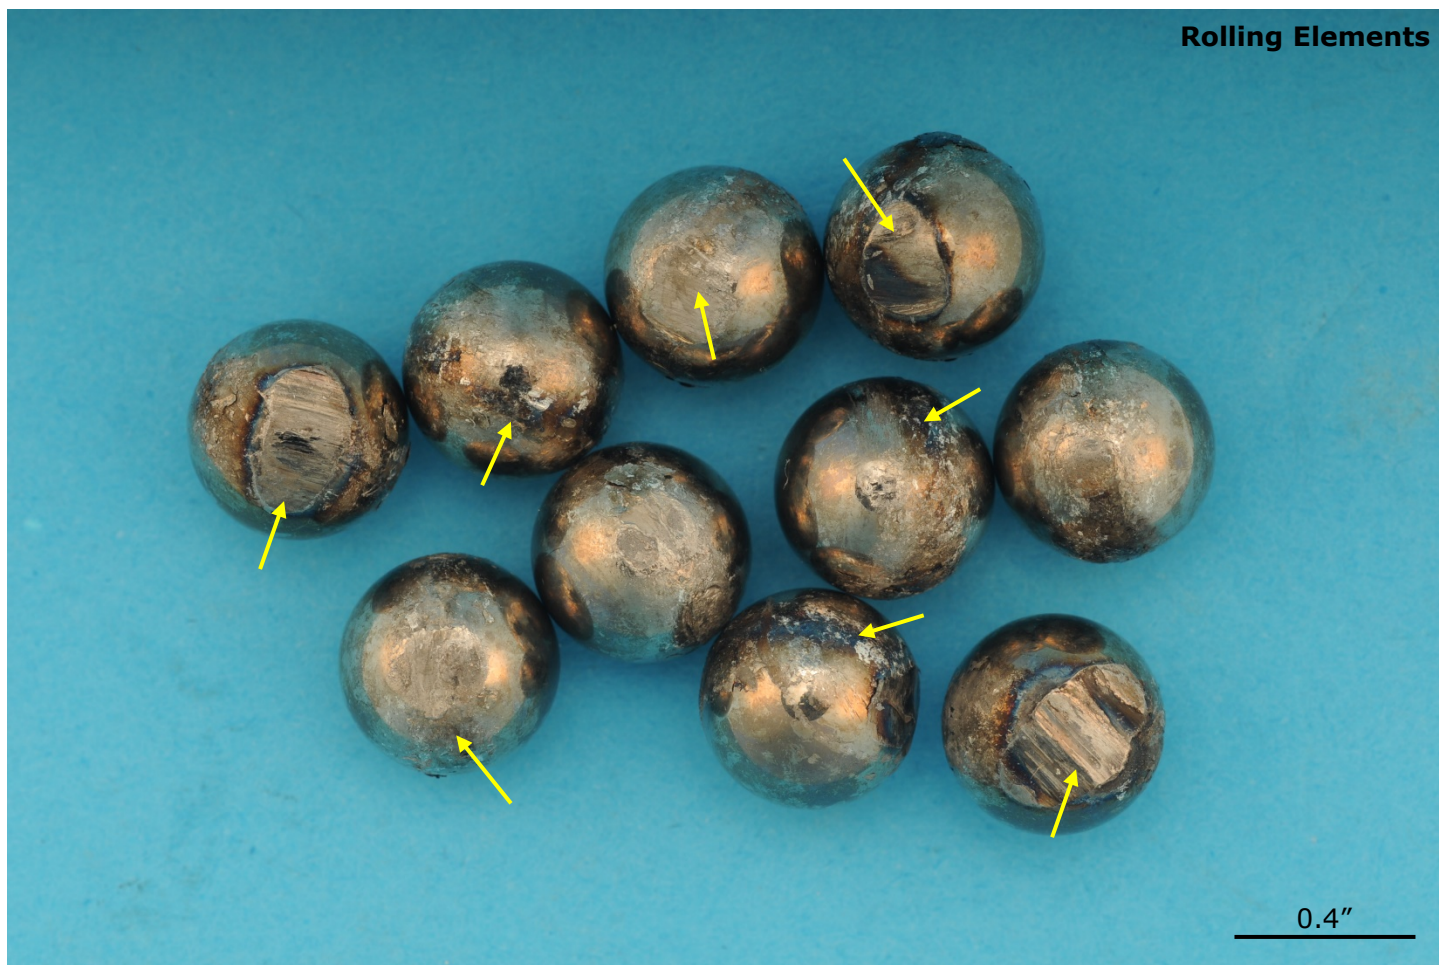
**Figure 14.**

View showing the rolling elements (reference Figures 9-10). All the rolling elements exhibited damage and discoloration (yellow arrows).
