**NATIONAL TRANSPORTATION SAFETY BOARD**

**Attachment 7 –Honeywell No. 2 Engine (P36235C) Materials Laboratory  
Analysis Report**

**POWERPLANTS**

**CEN20LA215**

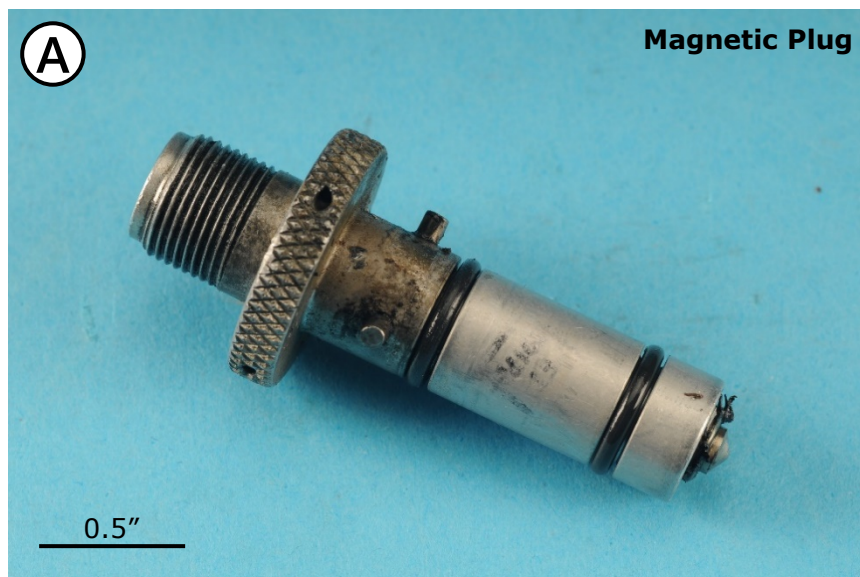
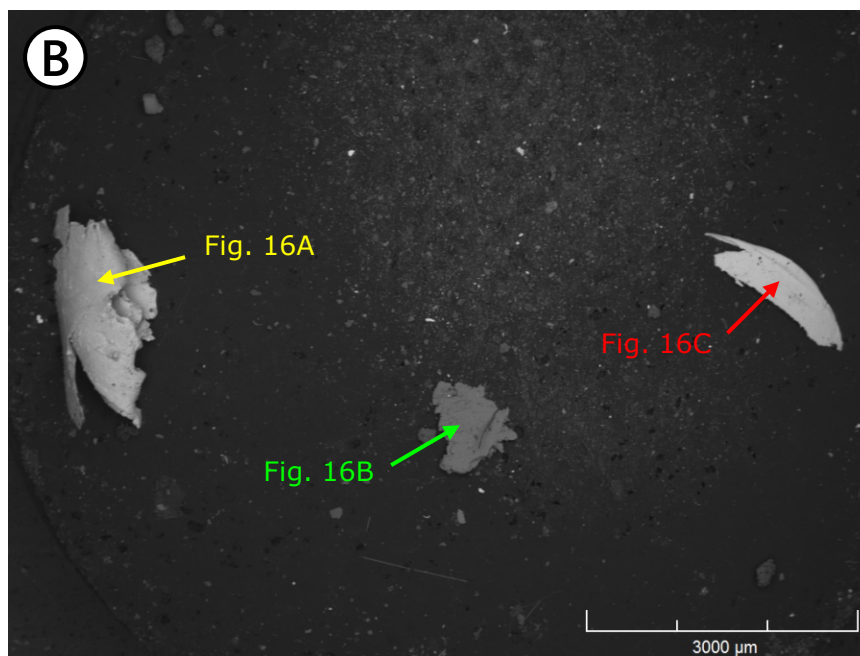
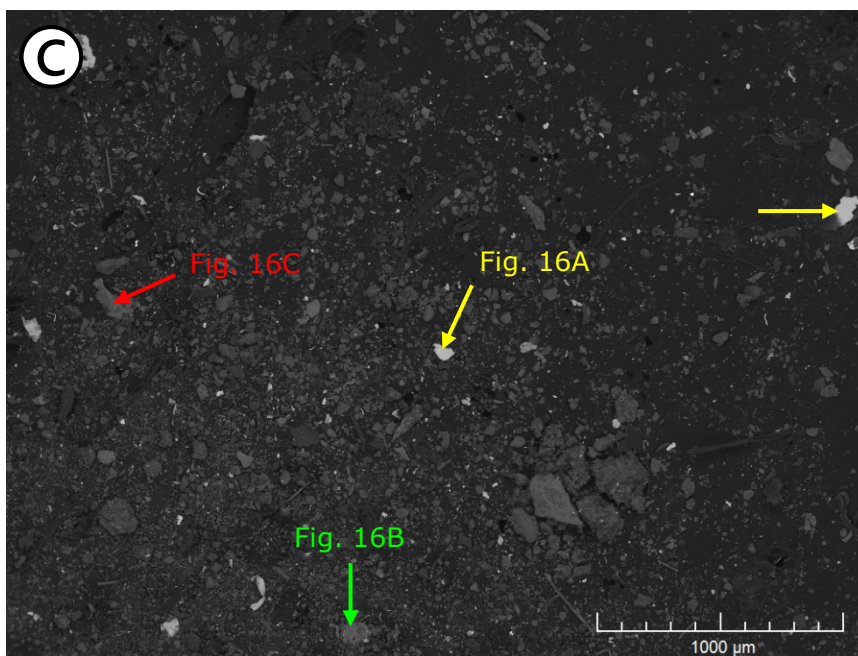
**Figure 15.**

The as-received condition of the submitted magnetic plug from right engine S/N P36235C is shown in Figure 15A. The magnetic plug was flushed using Flash 142 mineral spirits and captured onto an 8 micron filter patch. The collected debris was cleaned with toluene and dried. The weight of the debris was measured to be 7 mg.

(A) Macro image showing the magnetic plug in the as-received condition. (B-C) Backscattered electron (BSE) SEM images showing representative debris collected from the magnetic plug. EDX analysis of the debris identified by yellow, green, and red arrows are shown in Figure 16.

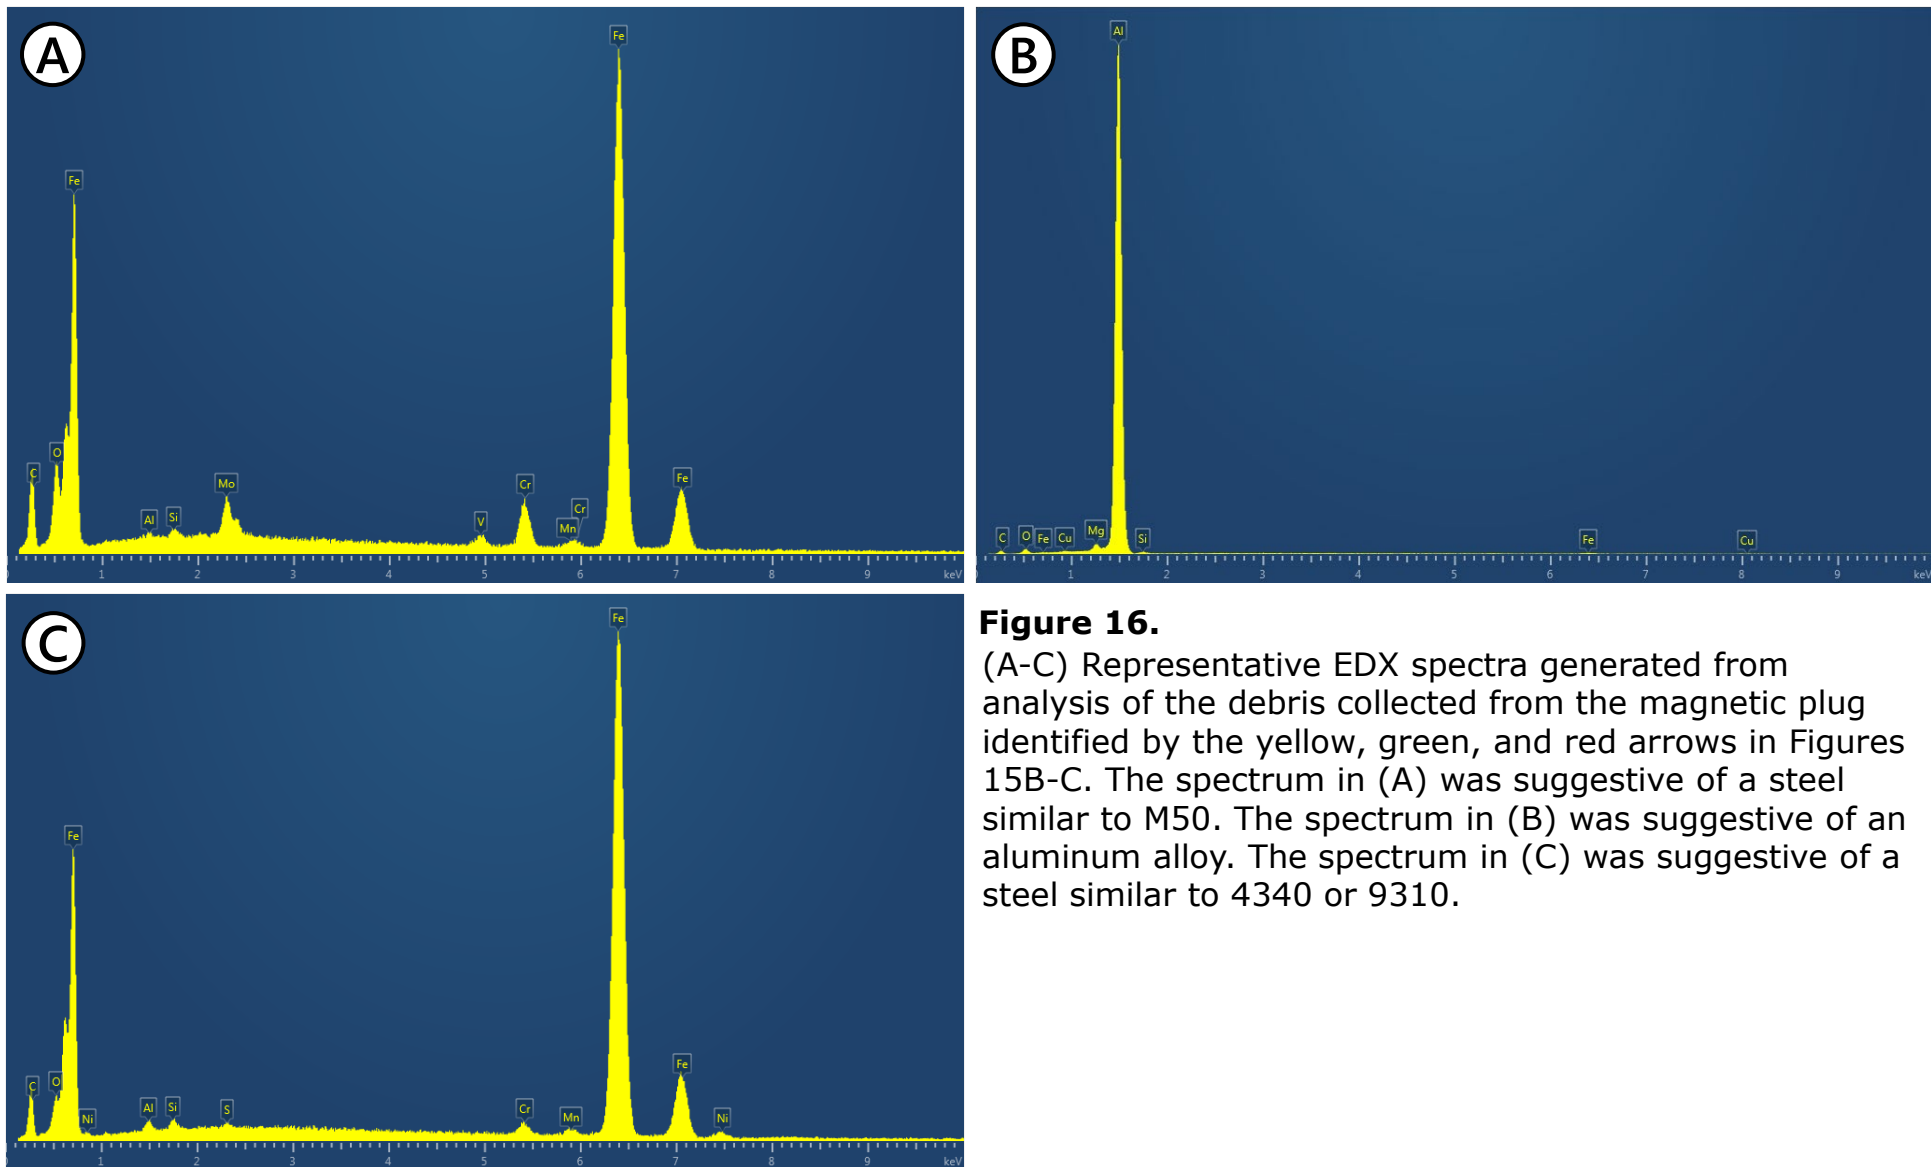
**Figure 16.**

SEM analysis of the collected debris is shown in Figures 15B-C. EDX analysis generated from some of the metallic particles was suggestive of a steel similar to M50, the specified compressor bearing inner rings, outer ring, and rolling elements base material (Figure 16A). Other metallic particles were suggestive of an aluminum alloy (Figure 16B) and a steel similar to 4340 or 9310, as determined by EDX analysis (Figure 16C).

(A-C) Representative EDX spectra generated from analysis of the debris collected from the magnetic plug identified by the yellow, green, and red arrows in Figures 15B-C. The spectrum in (A) was suggestive of a steel similar to M50. The spectrum in (B) was suggestive of an aluminum alloy. The spectrum in (C) was suggestive of a steel similar to 4340 or 9310.

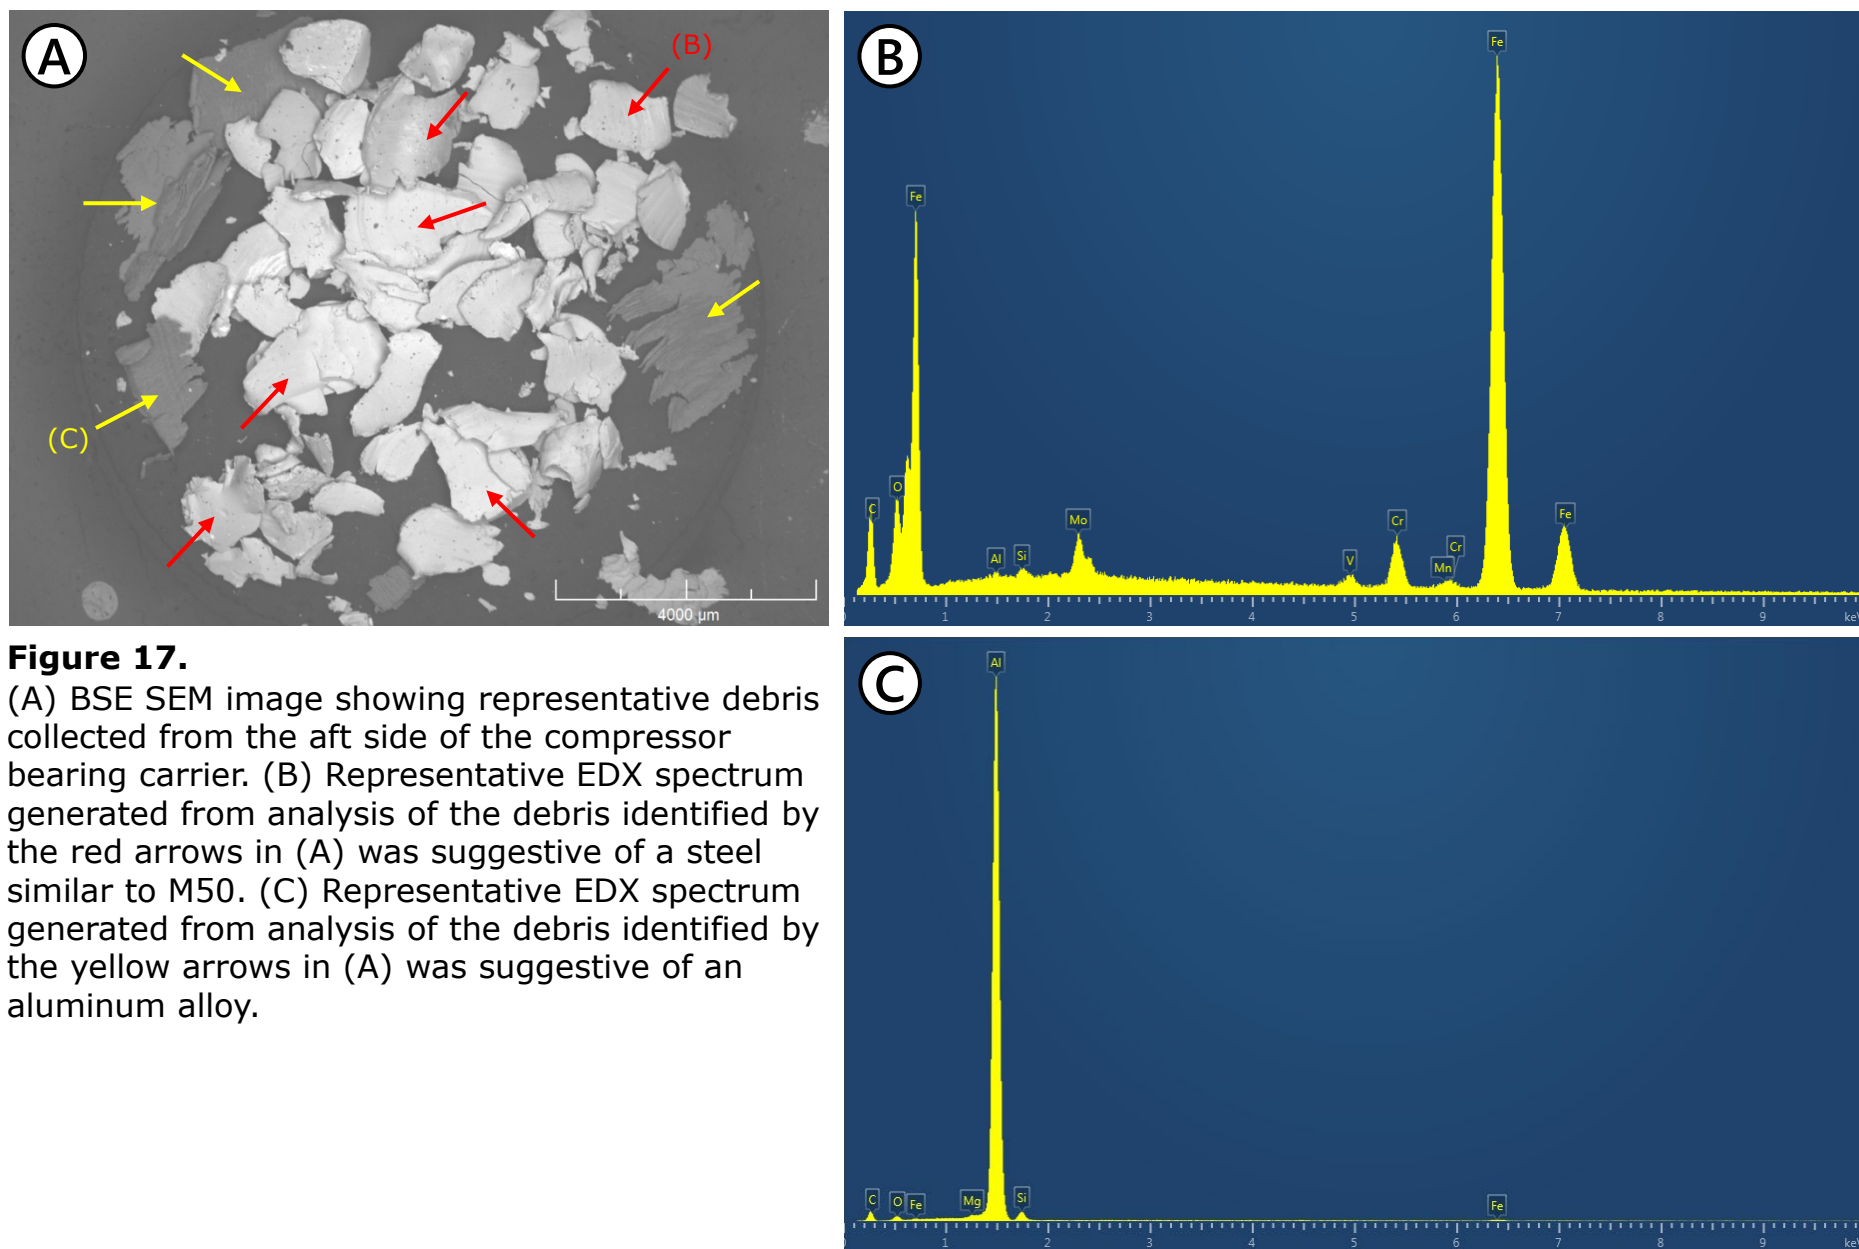
**Figure 17.**

Debris was collected from the aft side of the compressor bearing carrier is shown in Figure 17A. The debris was suggestive of a steel similar to M50 (Figure 17B) and an aluminum alloy (Figure 17C), as determined by EDX analysis.

(A) BSE SEM image showing representative debris collected from the aft side of the compressor bearing carrier. (B) Representative EDX spectrum generated from analysis of the debris identified by the red arrows in (A) was suggestive of a steel similar to M50. (C) Representative EDX spectrum generated from analysis of the debris identified by the yellow arrows in (A) was suggestive of an aluminum alloy.

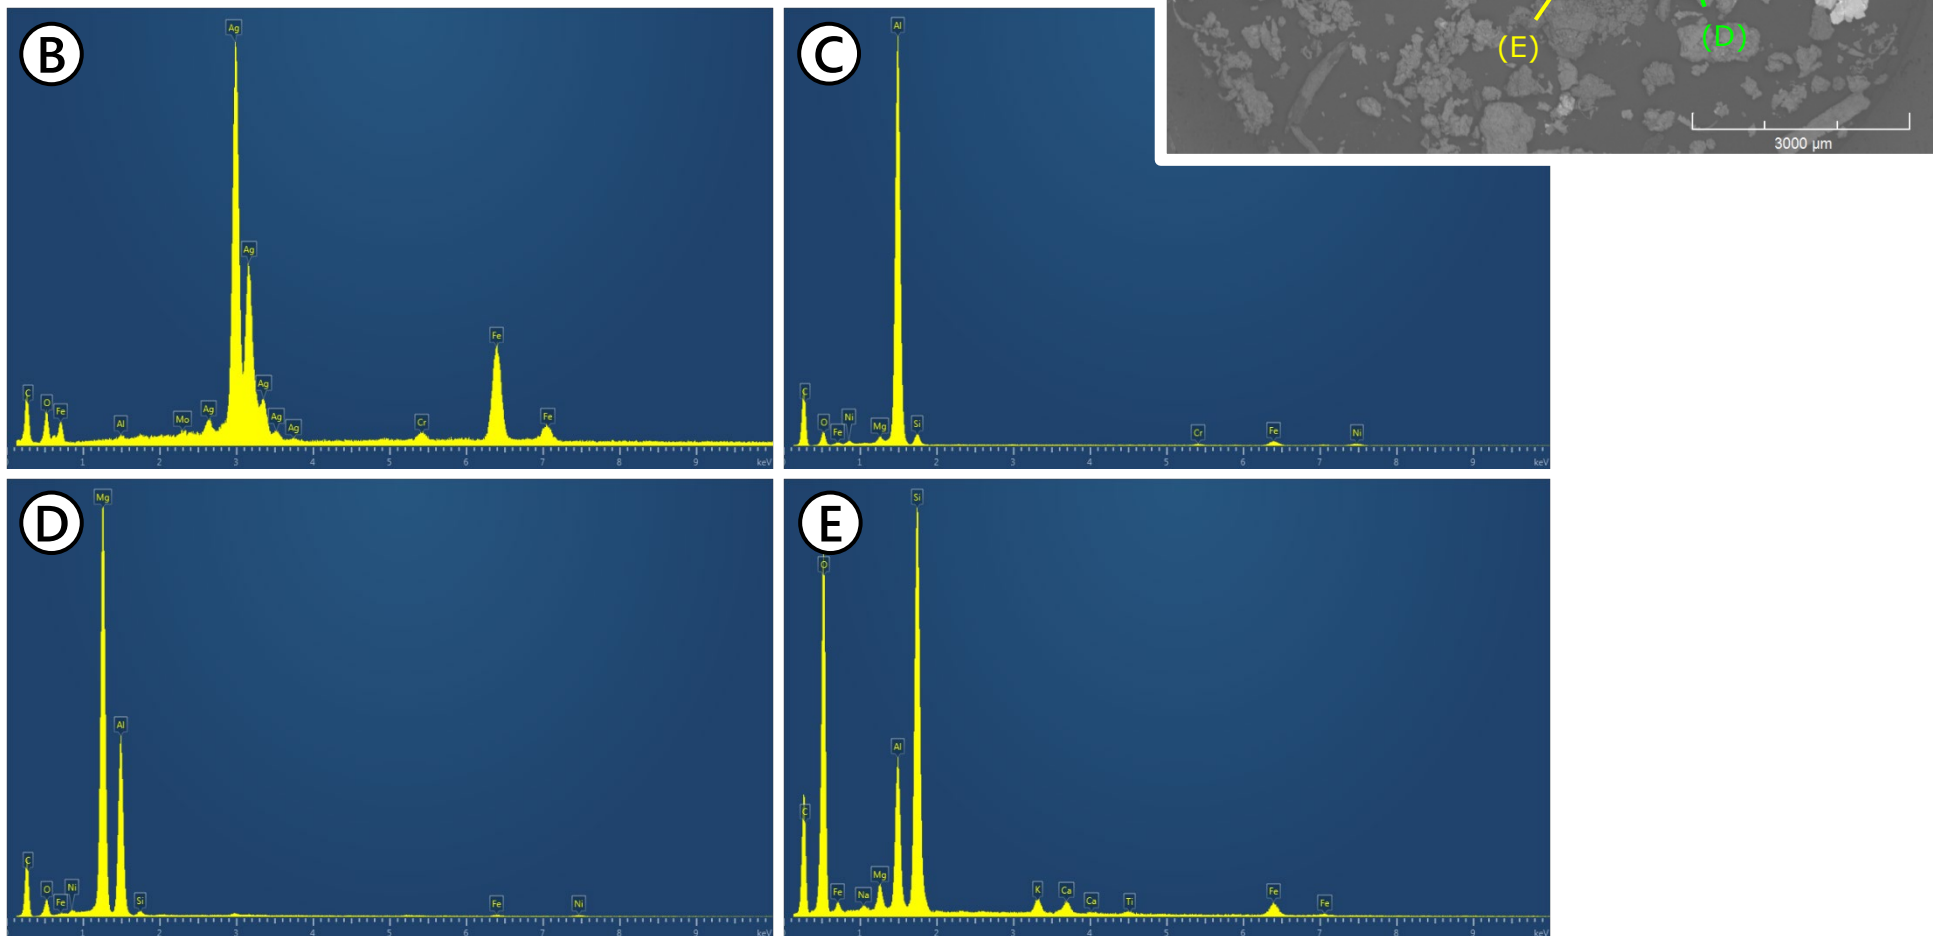
**Figure 18.**

Debris was collected from the forward side of the compressor bearing carrier and is shown in Figure 18A. EDX analysis of some of the debris was rich in silver with concentrations in other elements (Figure 18B), and suggestive of an aluminum alloy (Figure 18C). Other debris was rich in magnesium and aluminum (Figure 18D) and rich in silicon, oxygen, aluminum, carbon, and traces of other elements (Figure 18E), as determined by EDX analysis.

(A) BSE SEM image showing representative debris collected from the forward side of the compressor bearing carrier. (B-E) Representative EDX spectra generated from analysis of the debris identified by the red, blue, green, and yellow arrows in (A). The spectrum in (B) was indicative of silver with concentrations in other elements. The spectrum in (C) was suggestive of an aluminum alloy. The spectrum in (D) was rich in magnesium and aluminum. The spectrum in (E) was rich in silicon, oxygen, aluminum, carbon, with traces of other elements.

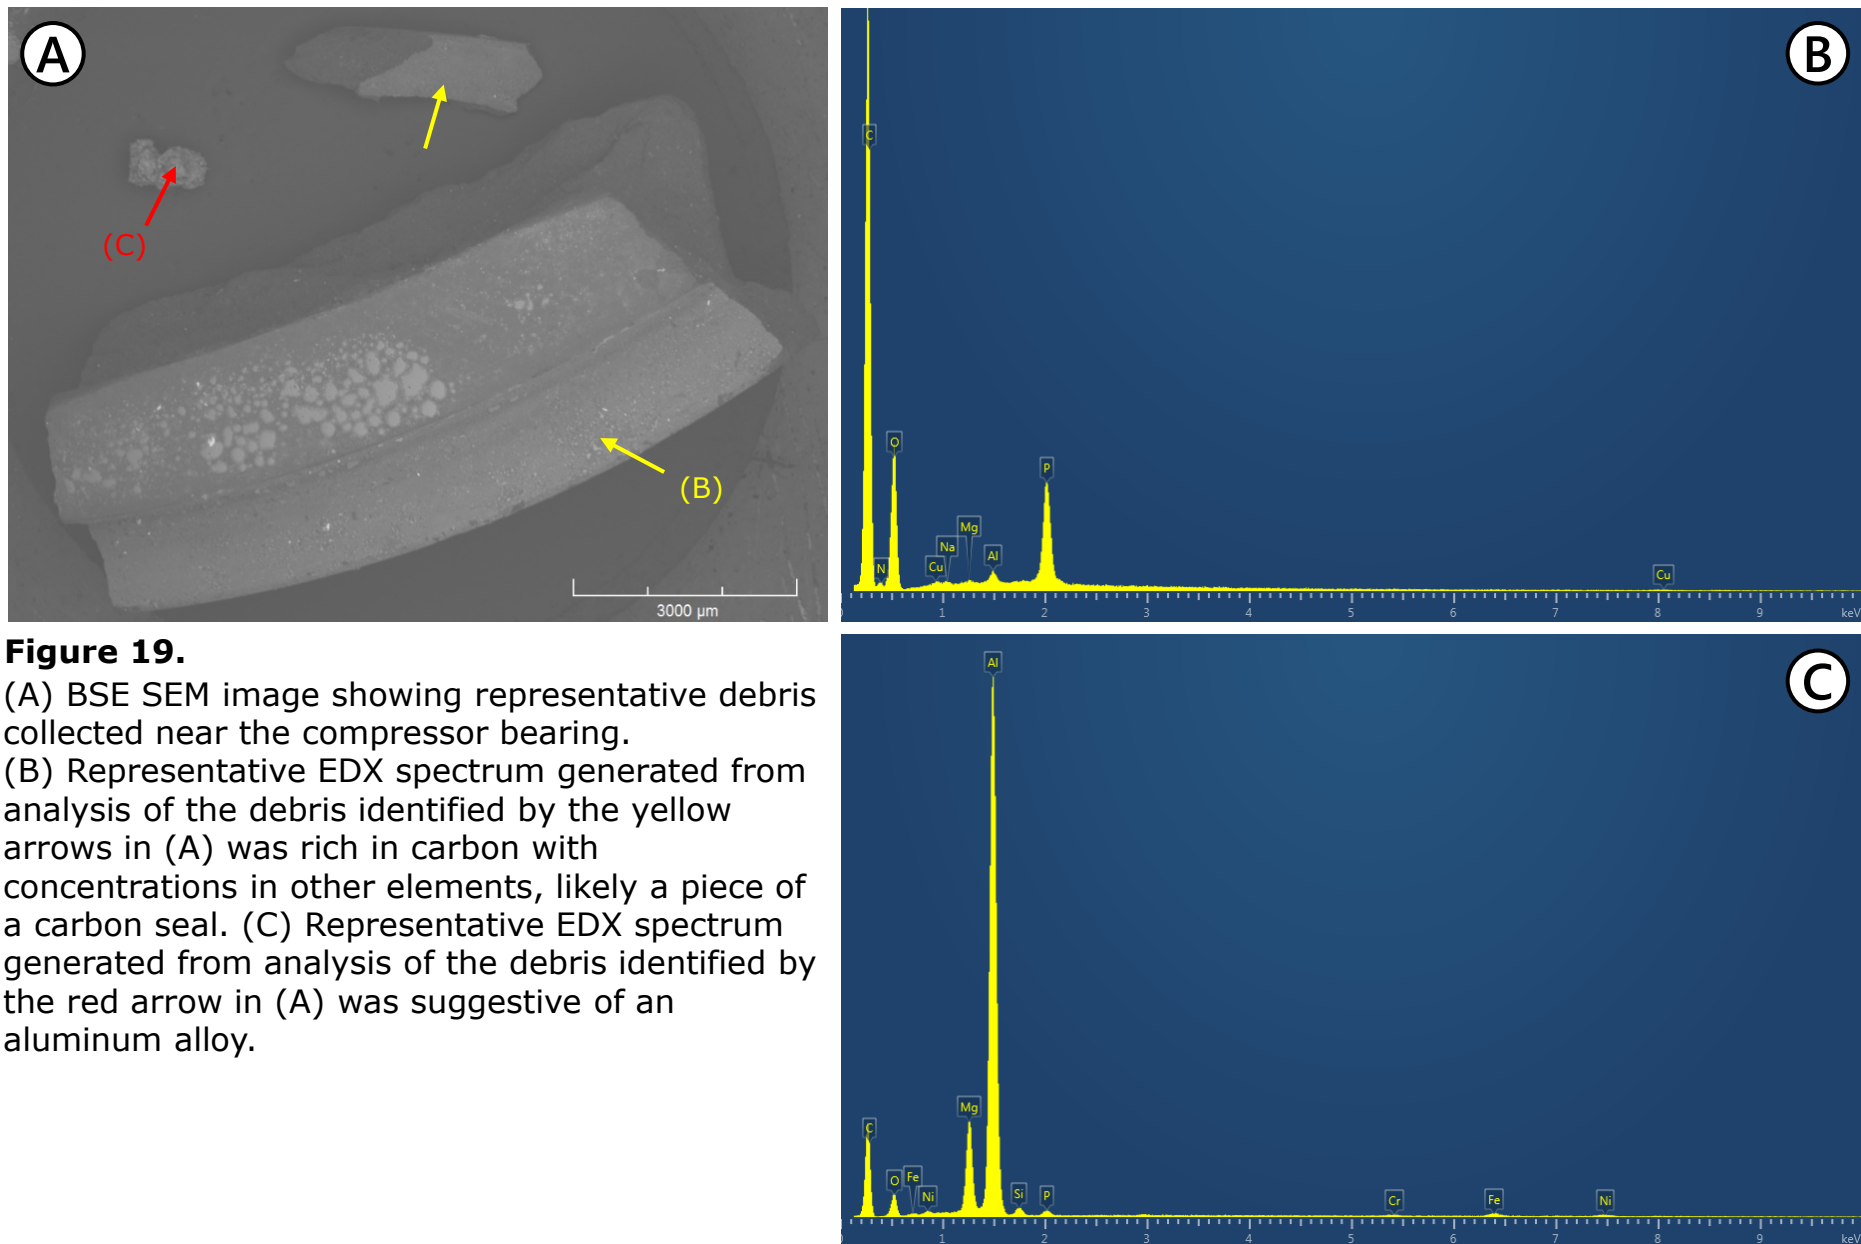
**Figure 19.**

Debris was collected near the compressor bearing is shown in Figure 19A. EDX analysis of the large non-metallic particles were rich in carbon with concentrations in other elements, likely a piece of a carbon seal (Figure 19B). The smaller metallic particle was suggestive of an aluminum alloy, as determined by EDX analysis (Figure 19C).

(A) BSE SEM image showing representative debris collected near the compressor bearing.

(B) Representative EDX spectrum generated from analysis of the debris identified by the yellow arrows in (A) was rich in carbon with concentrations in other elements, likely a piece of a carbon seal. (C) Representative EDX spectrum generated from analysis of the debris identified by the red arrow in (A) was suggestive of an aluminum alloy.
