**NATIONAL TRANSPORTATION SAFETY BOARD**  
**Office of Aviation Safety**  
**Washington, D.C. 20594**

**POWERPLANTS GROUP CHAIRMAN'S FACTUAL REPORT**

**NTSB No: CEN20LA215**

Aircraft: Mitsubishi MU2B, N44MX, McNeely Charter Service, Inc.

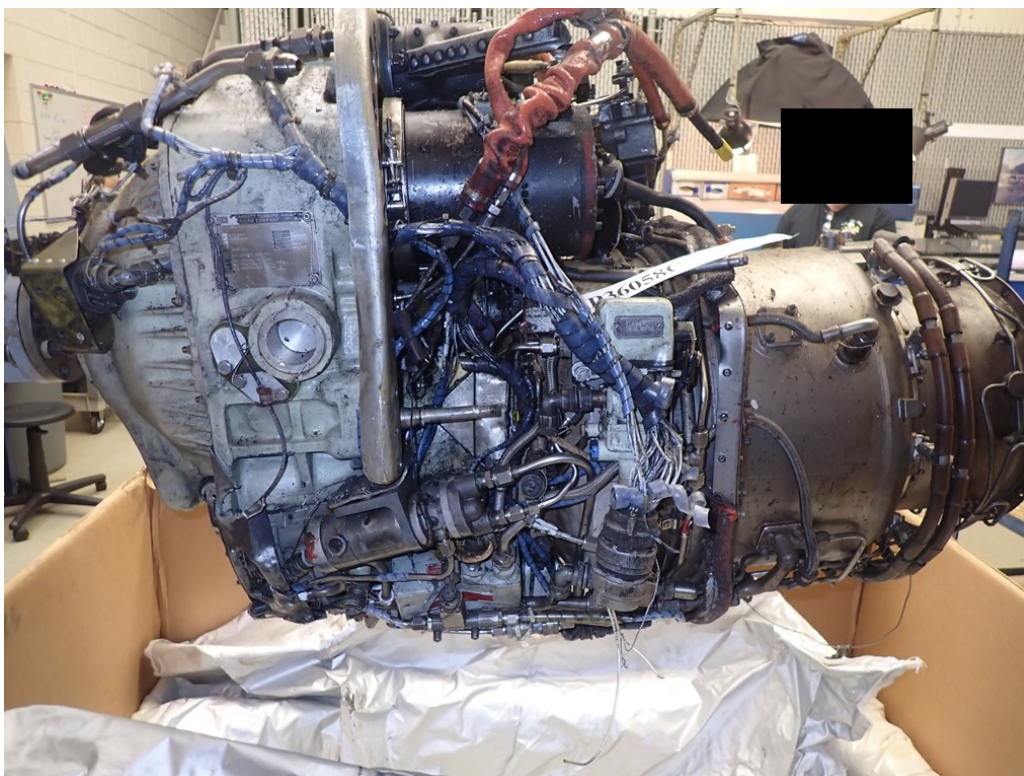
installed including: the engine mount horseshoe, starter generator, fire detection loops, wiring harnesses, and part of the aft firewall (**Photos 2, 3, and 4**). The beta tube and oil samples collected at Wentworth Aircraft, Inc. in Crystal, Minnesota during the wreckage layout were included in the shipping box.

**Photo 2- ESN P36058C, Left Side, As Received**

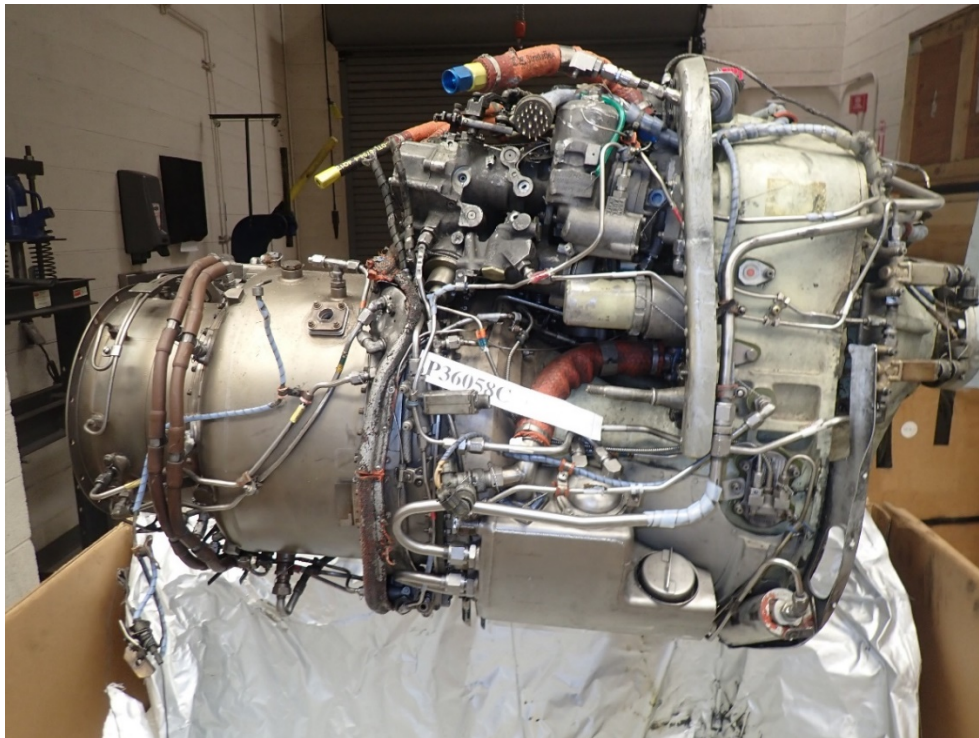
**Photo 3- ESN P36058C, Right Side, As Received**

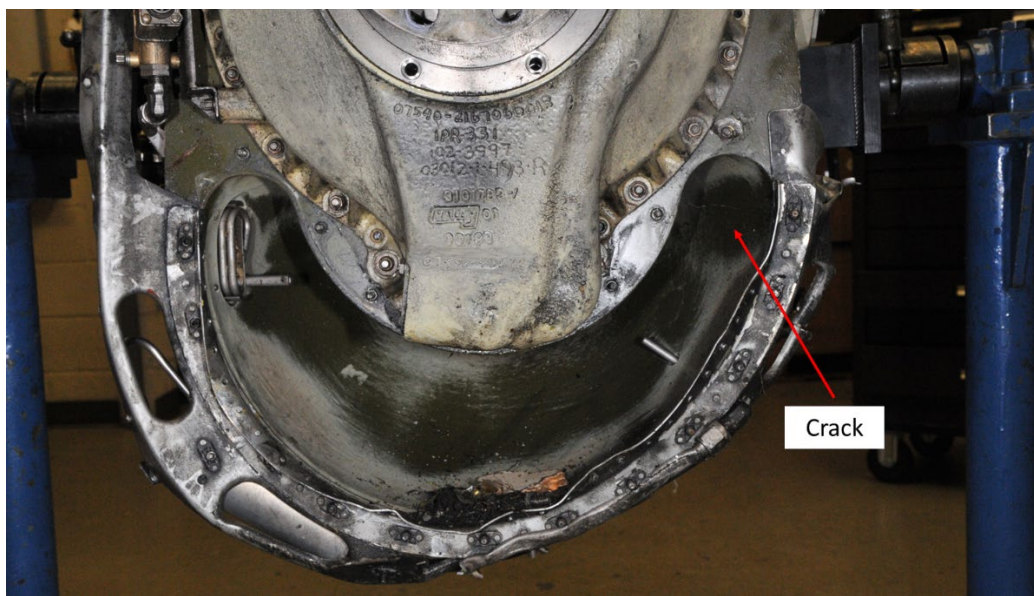
The airframe components were stripped from the engine and a visual inspection was performed to document the external condition. The engine did not exhibit indications of uncontainment or undercowl fire. The accessory gearbox (AGB) inlet forward lip had impact deformation along the bottom of the engine from the 5 to 7 o'clock positions and an approximately 6 inch long axial crack at the 7 o'clock position that originated 1 inch aft of the forward lip and extended aft (**Photo 5**). Five of the seven forward propeller bearing mount bolts were not present in the bolt holes. The two remaining bolts

**Photo 5- Accessory Gearbox Inlet Impact Damage**

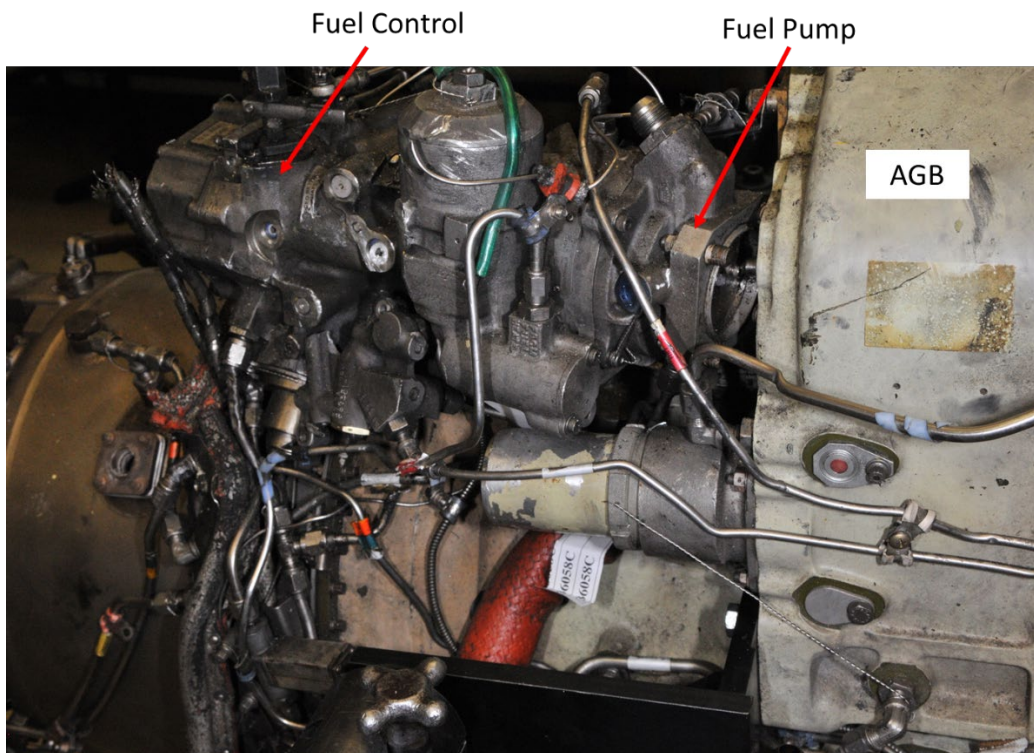
were loose and could be removed by hand. The propeller pitch control was partially separated from the AGB mount at two of the three attachment studs (**Photo 6**). The fuel pump mounting studs were pulled out of the AGB, and the fuel pump drive spline was broken off in the AGB housing. The fuel control unit (FCU) link tree and FCU-to-fuel pump mount flange were both fractured. The propeller feather valve was disconnected/broken at the linkage connection (**Photo 7**). The propeller governor was intact and when removed, the check valve orifice was verified to be free of obstruction. The starter spline was separated, and the broken spline was recovered from the AGB case. The oil tank exhibited impact damage that was most concentrated along the forward left side (**Photo 8**). The fuel shutoff valve (FSOV) shaft indicator was at the 9 o'clock position<sup>2</sup> (**Photo 9**).

**Photo 6- Fuel Pump and Fuel Control Unit Partially Separated from the AGB**

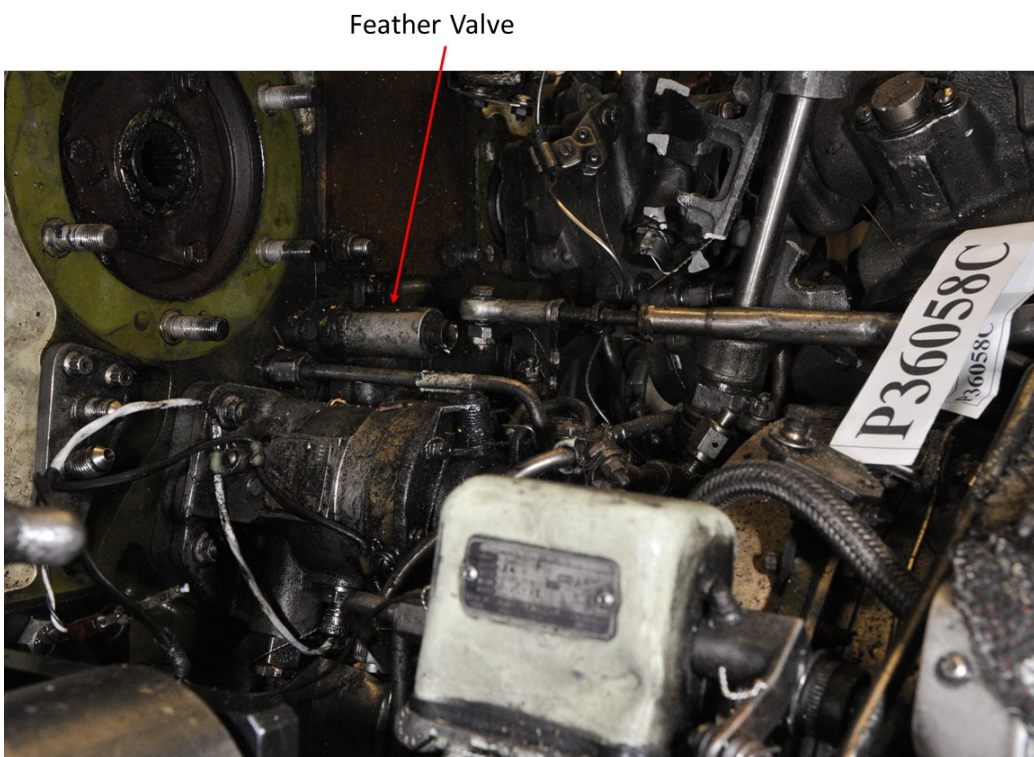
**Photo 7- Feather Valve Linkage Fractured**

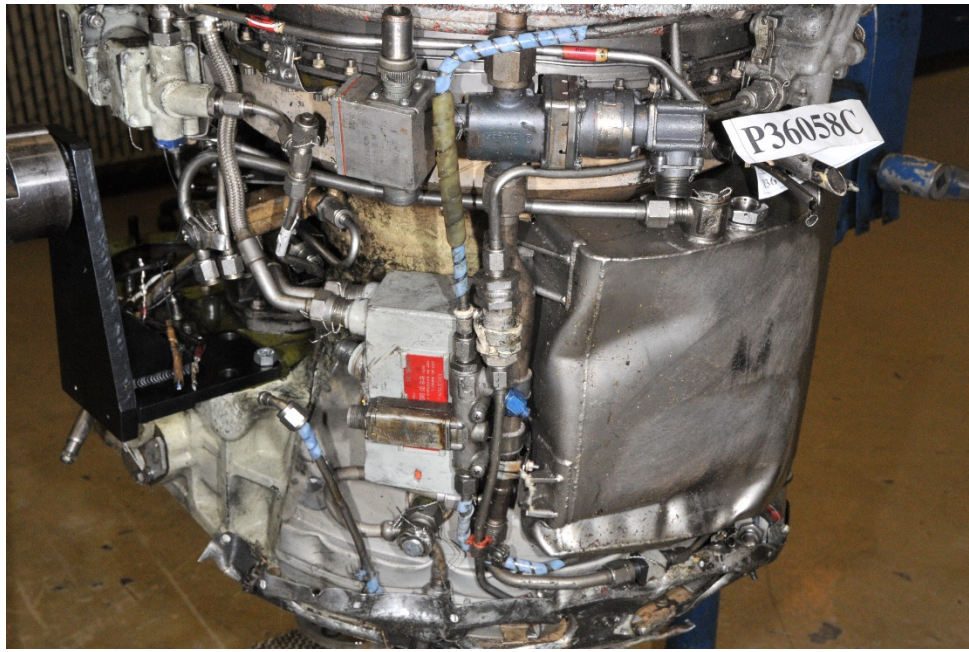
**Photo 8- Oil Tank Impact Damage**

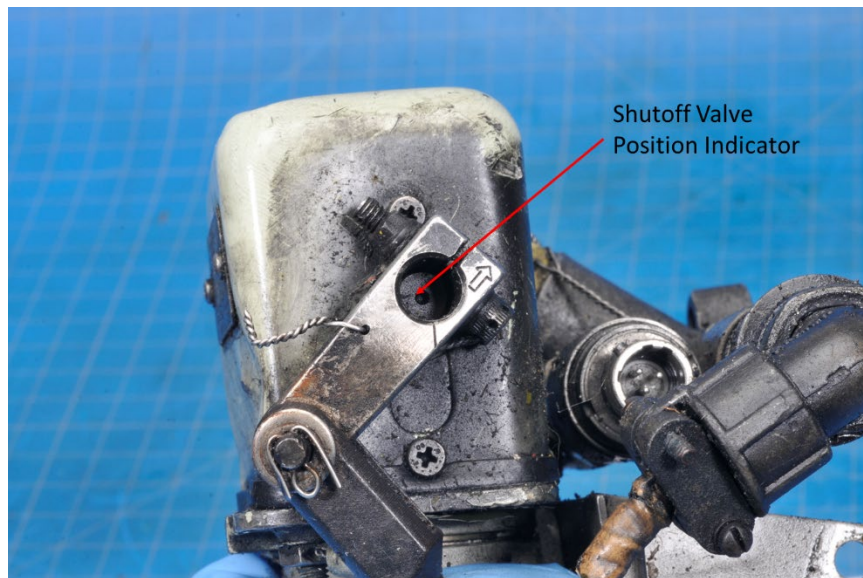
<sup>2</sup> The FSOV indicator is aligned with the 12 o'clock position in auto mode and rotates to the 3 o'clock position when the condition lever is retarded to the emergency shutoff position in the cockpit. According to Honeywell, the FSOV is closed when the indicator is at the 3 or 9 o'clock position, but rotation to the 9 o'clock position is consistent with FSOV/linkage damage.

**Photo 9- Fuel Shutoff Valve**

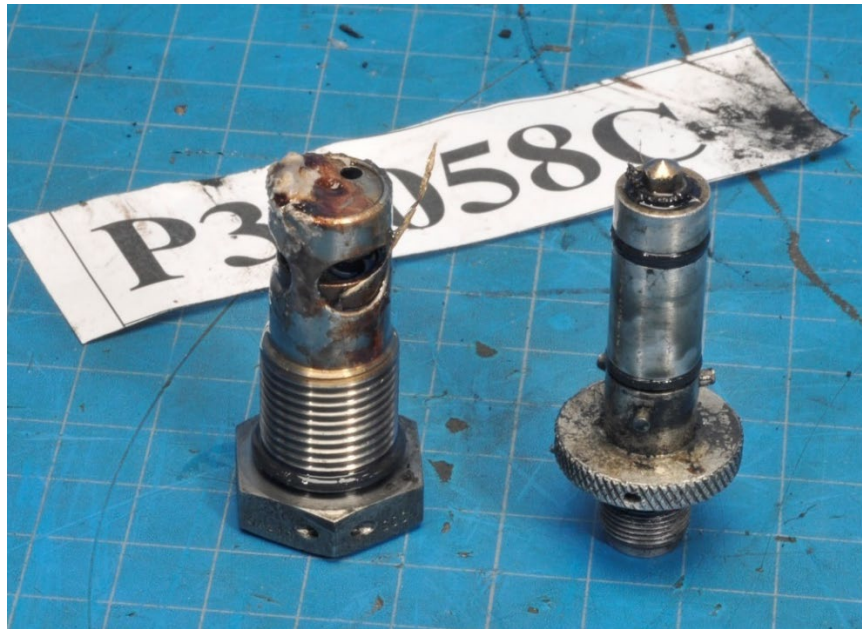
The magnetic chip detector (MCD) had some debris accumulation including fine metal shavings and fuzz. The MCD housing was coated in slimy white and brown buildup and metal shavings were protruding from the housing cutouts (**Photo 10**). The oil filter bowl was difficult to unthread and required a strap wrench for removal. The oil filter pleats, and bowl were both free of debris accumulation. The fuel filter had no debris accumulation. The propeller shaft was manually spun to check for continuity and there was no concurrent rotation of the 3<sup>rd</sup> stage turbine rotor.

**Photo 10- (L) Magnetic Chip Detector Housing, (R) Magnetic Chip Detector Plug**

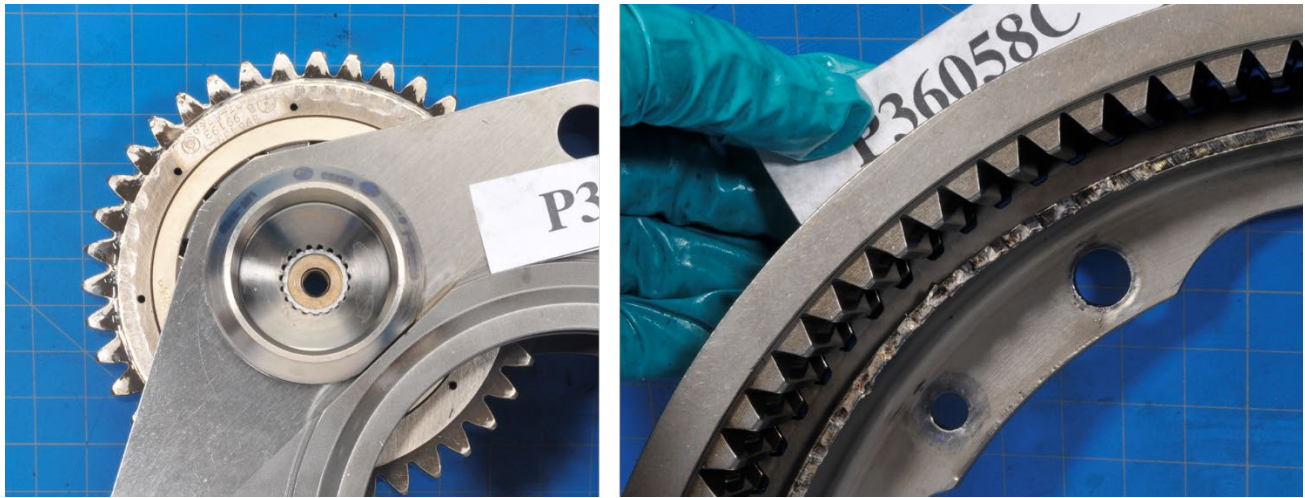
**Photo 13- (L) Damage on Planetary Gear Teeth Aft Face, (R) Rub/Impact Damage on the Ring Gear Support**

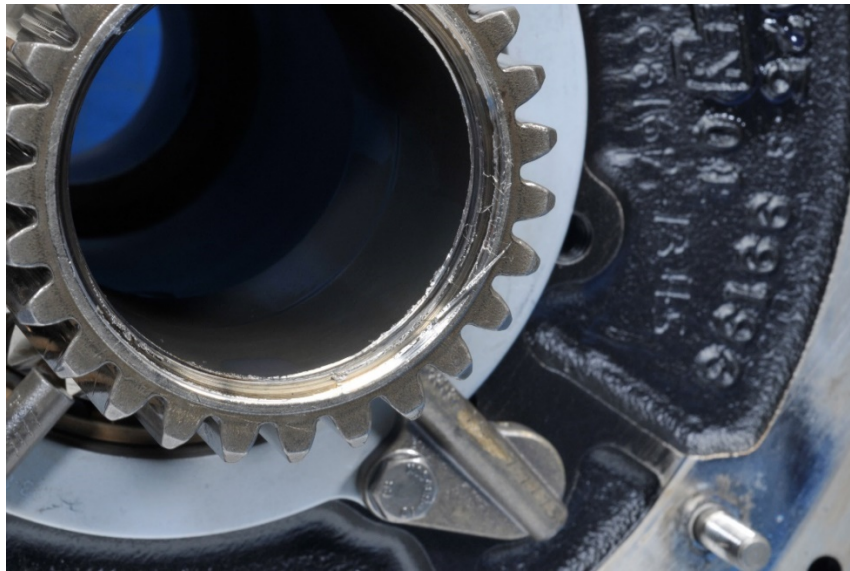
The mechanic notified the group that AGB nose cone attaching bolts were not torqued as expected. Breakaway torque was checked on a random sample of bolts and each had less than 5 inch-pounds (in-lbs.) of torque.<sup>3</sup> When the nose cone was removed, the propeller thrust bearing, propeller shaft, and propeller coupling were complete. The propeller thrust bearings were oil wetted and rotated smoothly. The nose cone had white slimy residue in the lower recess and five nuts, and three fractured bolts were recovered from 6 o'clock position. The propeller shaft had a 360 degree circumferential rub at the forward radius, light localized rubs 1 inch and 1.5 inches aft of the shaft base, and non-uniform circumferential rub and gouging 5.75 inches from the shaft base that resulted in raised metal (**Photo 11**). The ring gear, sun gear and planetary gears were intact (**Photo 12**). Impact marks and rub were noted on the aft gear tooth surface of all four planet gears and there was concurrent impact and rub marks on the forward face of the ring gear support (**Photo 13**). One planetary gear bearing outer race was cracked at two locations and rotated with some resistance. The other three planetary gears rotated smoothly. Metal shavings were observed on the planetary gear carrier. The forward side of the sun gear inner diameter had 360 degree circumferential rub and raised metal slivers (**Photo 14**).

**Photo 14- Sun Gear Inner Diameter Rub Damage**

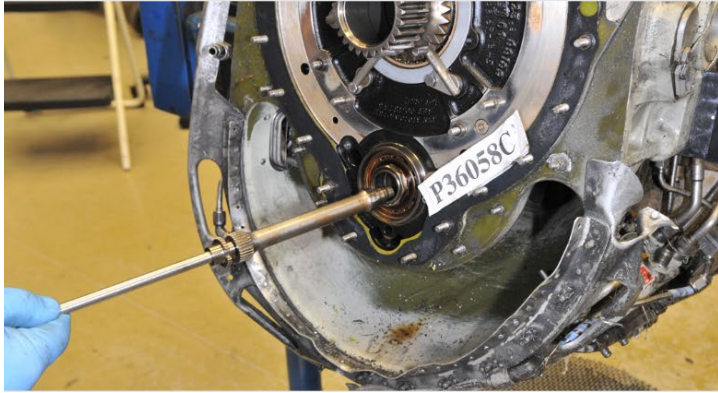
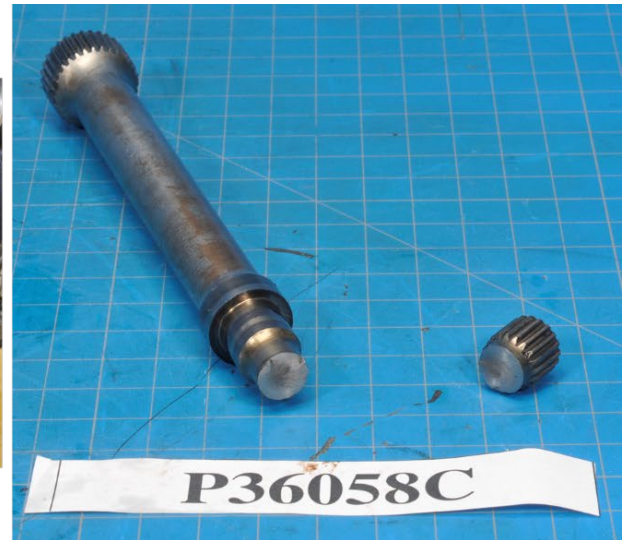
The AGB diaphragm was intact and in good condition. The torque coupling shaft was removed, and the aft spline was separated. The broken spline was later recovered from the torsion shaft (**Photos 15**). The aft diaphragm gearset and mating accessory gears were intact (**Photo 16**). The torque sensor was intact, and the gear teeth were in good condition. The high speed pinion was manually rotated and the geartrain rotated smoothly. After removal of the torque sensor housing, the main shaft gear was manually rotated and there was concurrent rotation of the turbine as viewed through the exhaust. Impact marks were observed on the AGB case feather valve bore and the torque sensor housing (**Photo 17**). According to Honeywell Product Integrity, impacts in these locations are common during propeller strike events on airplanes equipped with TPE331 engines.

**Photo 15- Separated Torque Coupling Shaft**

The separated No. 1 engine torque coupling shaft (**Photos 15 and 36**), separated starter shaft<sup>5</sup>, and the debris removed from the MCD were submitted to the Honeywell Materials Laboratory for analysis. The torque coupling shaft was separated approximately 0.582 inches from the aft end. The fracture surfaces were examined in the scanning electron microscope (SEM) which revealed that most of the fracture surfaces were obscured by smearing and secondary impact damage. Areas of overload dimples elongated in the shaft direction of rotation were identified, consistent with torsional overload. The torque coupling shaft material was analyzed using energy dispersive x-ray (EDX) and the spectrum was consistent with H11 tool steel material as called out in the part drawing.

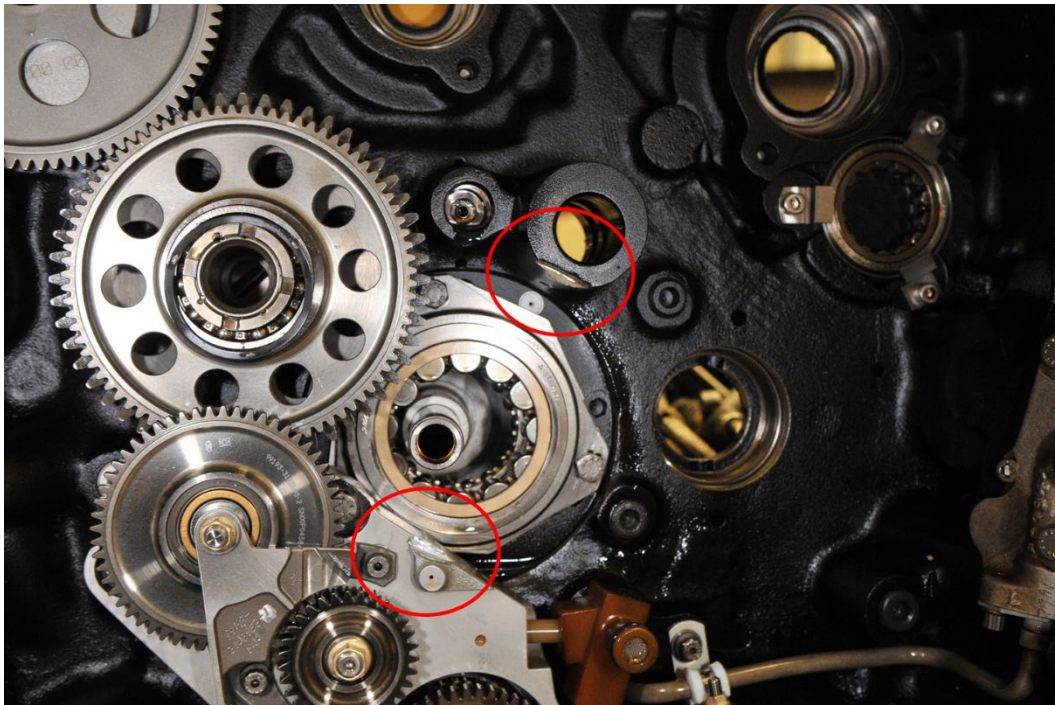
**Photo 17- Impact Marks on Feather Valve Bore and Torque Sensor Housing**

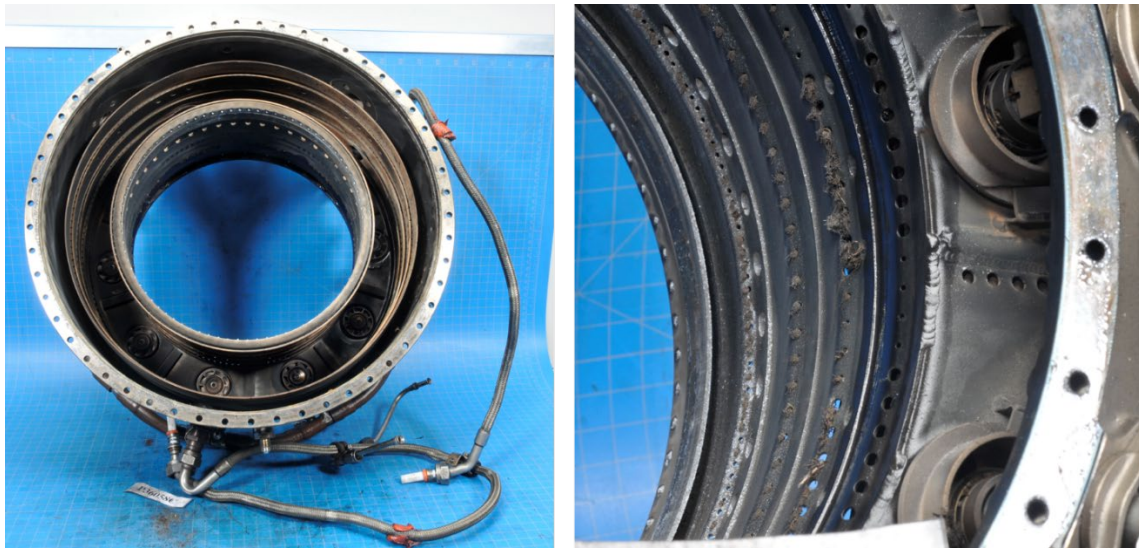
The combustion liner was intact and had no indications of fuel nozzle streaking or uneven thermal wear. There was minor combustion liner outer wall deformation coincident with deformation that was observed around the compressor discharge (P3) bleed bore on the plenum case. Earthen debris was accumulated in the liner cooling air holes around the liner circumference (**Photo 24**). There was light metal spray on the liner walls. All the fuel nozzles were properly seated and there was no evidence of coking. The fuel manifold plumbing was intact and in good condition.

**Photo 24- Combustion Liner**

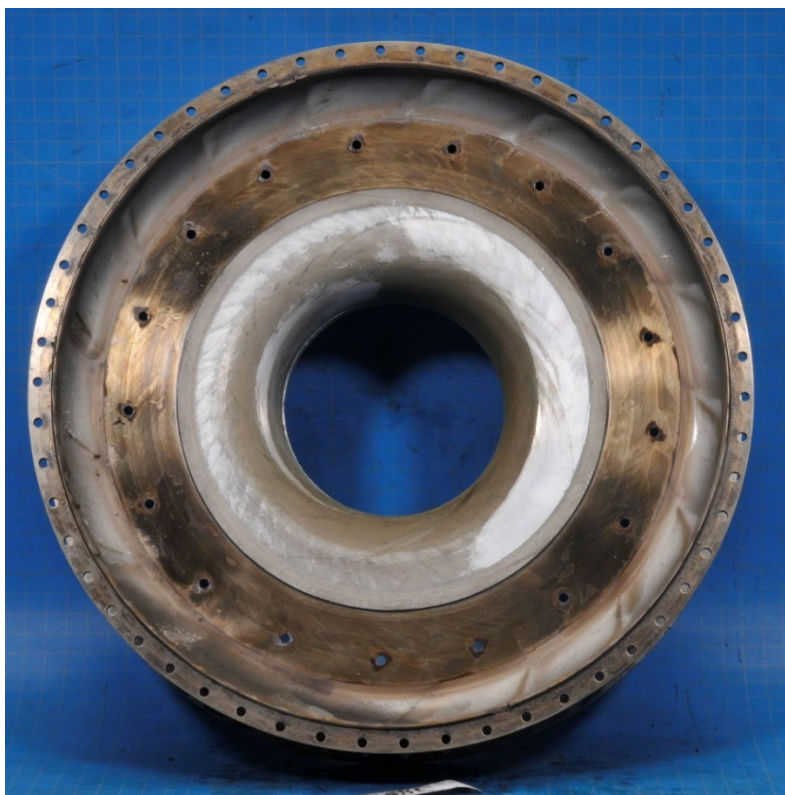
The 2<sup>nd</sup> stage compressor impeller was intact. The impeller vanes had light tip rub along the length of all blades and localized impact damage was observed on the leading edge of one blade. There was 360 degree rotational scoring aft of the forward 2<sup>nd</sup> stage impeller curvic coupling (**Photo 25**). The 2<sup>nd</sup> stage impeller shroud<sup>4</sup> inducer had 360 degree rotational scoring, more severe from the 6 to 12 o'clock positions. The impeller shroud knee had rotational scoring from 6 to 12 o'clock positions. The impeller shroud exducer had rotational scoring from the 7 to 5 o'clock positions, more severe from the 12 to 5 o'clock positions (**Photo 26**). The 2<sup>nd</sup> stage compressor diffuser had debris between the vanes (**Photo 27**).

**Photo 26- 2<sup>nd</sup> Stage Compressor Impeller Shroud Circumferential Scoring**

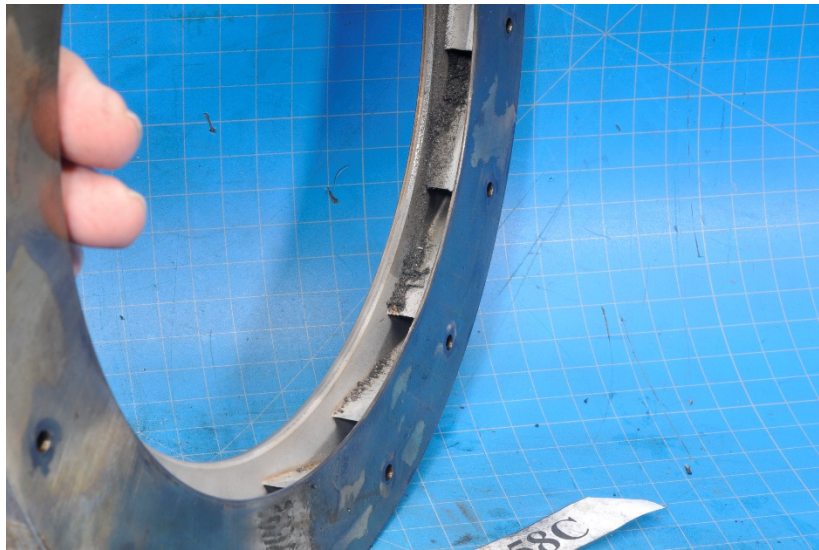
**Photo 27- 2<sup>nd</sup> Stage Compressor Diffuser with Debris Accumulation Between Vanes**

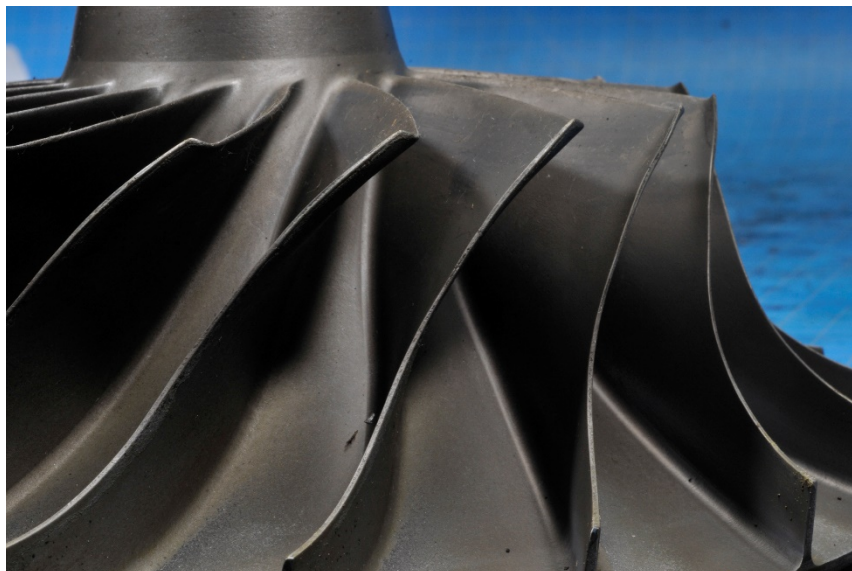
The 1<sup>st</sup> stage compressor impeller had blade tip rub along the length of all blades. All blade tips exhibited leading edge bending opposite the direction of rotation (**Photo 28**). The main shaft was intact and did not appear to be deformed/bent. Debris was accumulated in the forward shaft knife edge seals and the 1<sup>st</sup> stage impeller had 360 degree scoring on the outer diameter of the aft hub, forward of the curvic coupling (**Photo 29**). The 1<sup>st</sup> stage impeller shroud had rotational rub and scoring from the 1 to 11 o'clock positions of the inducer that was more severe between the 6 and 11 o'clock positions (**Photo 30**). The impeller shroud knee had rub damage from the 7 to 2 o'clock positions and the exducer had 360 degree rub damage that was more severe from the 9 to 5 o'clock positions. The crossover duct had inner diameter rub damage from the 7 to 10 o'clock position and there was impact damage and a hole in the outer surface at about the 12 o'clock position (**Photo 31**). The metal around the hole was pushed in toward the engine centerline and the damage was coincident with impact damage on the AGB housing. There was debris between the 1<sup>st</sup> stage compressor diffuser vanes.

**Photo 28- 1<sup>st</sup> Stage Compressor Impeller Blades**

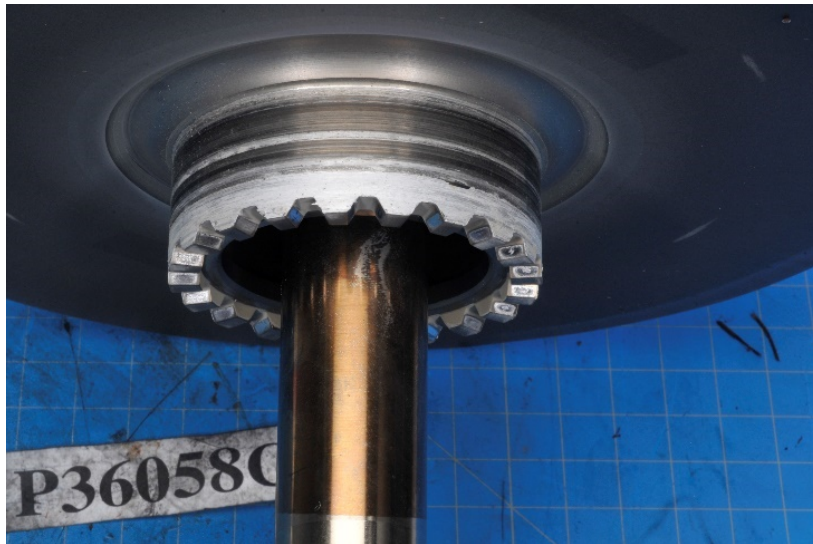
**Photo 29- 1<sup>st</sup> Stage Compressor Impeller Curvic Coupling Outer Diameter Scoring**

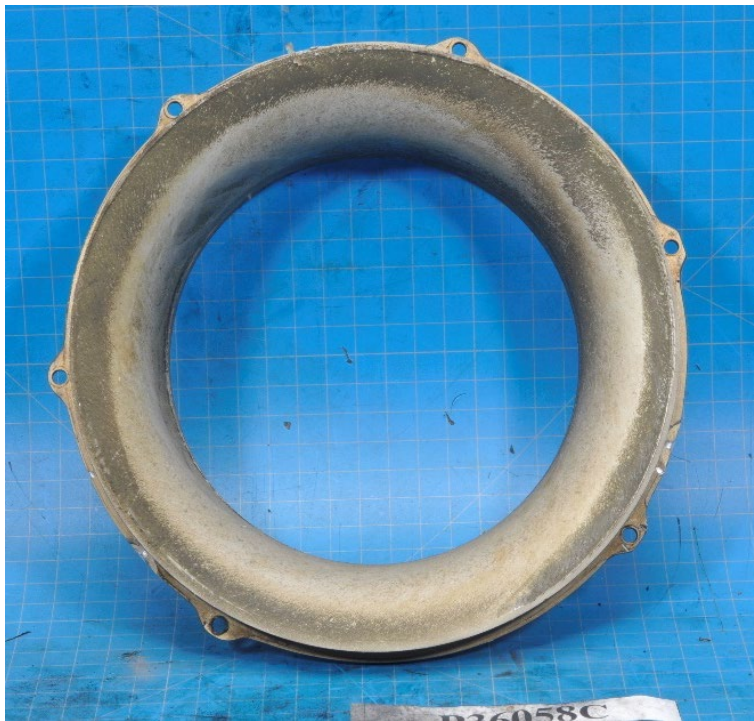
**Photo 30- 1<sup>st</sup> Stage Impeller Shroud Circumferential Scoring**

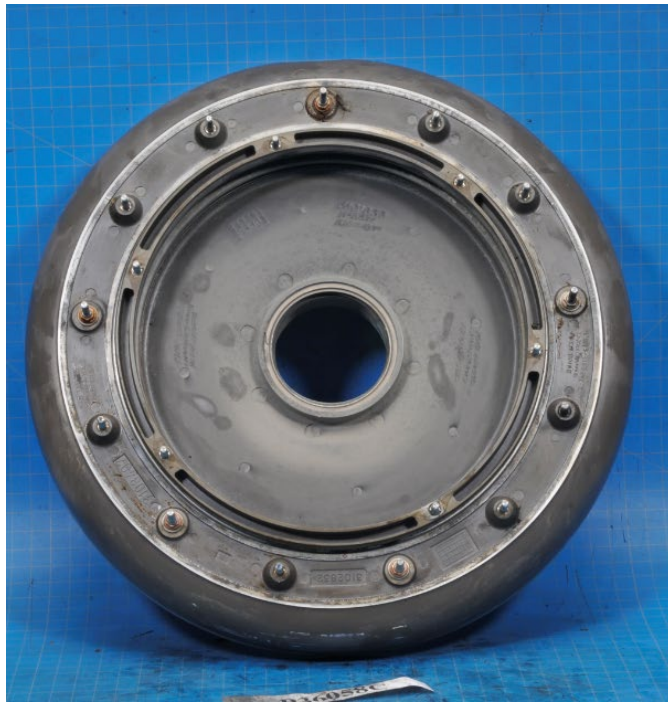
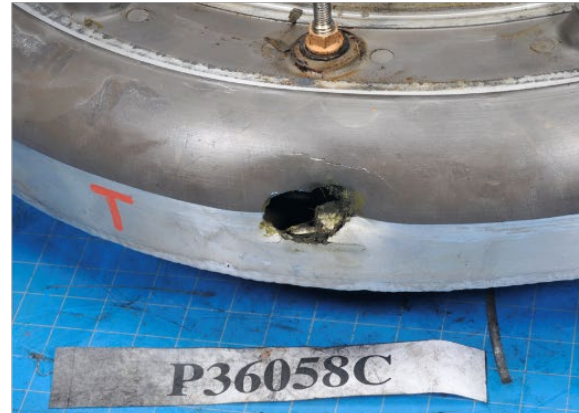
**Photo 31- Compressor Crossover Duct Impact Damage/Hole**

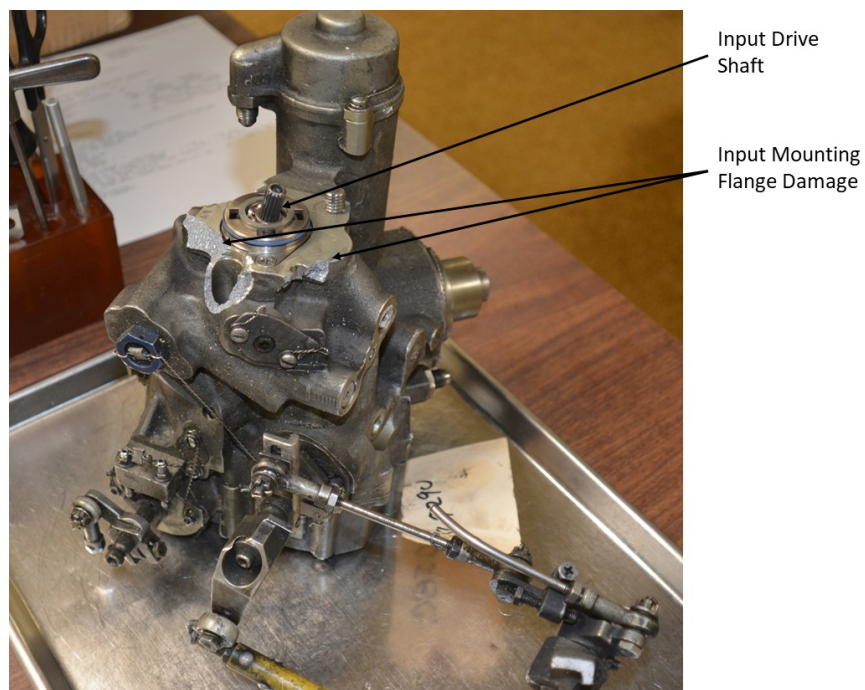
A visual examination of the FCU, part number (P/N) 807426, serial number (S/N) 1569290, removed from the No. 1 engine revealed that the input drive shaft was bent, and the input mounting flange exhibited impact damage and was missing material (**Photo 32**). The FCU could not be safely installed on a test bench due to the damage, so the FCU was fully disassembled (**Photo 33**). There was no evidence of preimpact part failure or other internal anomalies.

**Photo 32- No. 1 Engine FCU, as Received at Woodward**

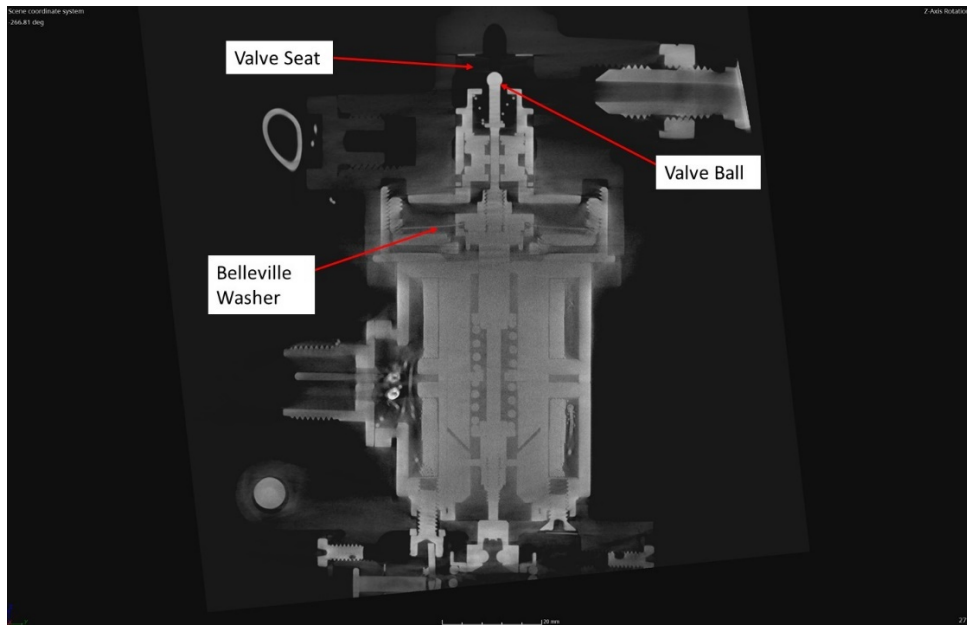
The No. 1 engine FSOV was computerized tomography (CT) scanned at the Honeywell Materials Laboratory in Phoenix, Arizona and no internal anomalies were observed. Video files of the CT scans were provided to the NTSB for review. The CT scan showed the FSOV was in the closed position, consistent with the shaft indicator. The internal Belleville washer was deflected toward the valve seat, and the valve ball was against the seat, which would have stopped fuel flow through the valve (**Photo 35**).

**Photo 35- No. 1 Engine FSOV Computed Tomography Scan (Photo Courtesy of Honeywell)**

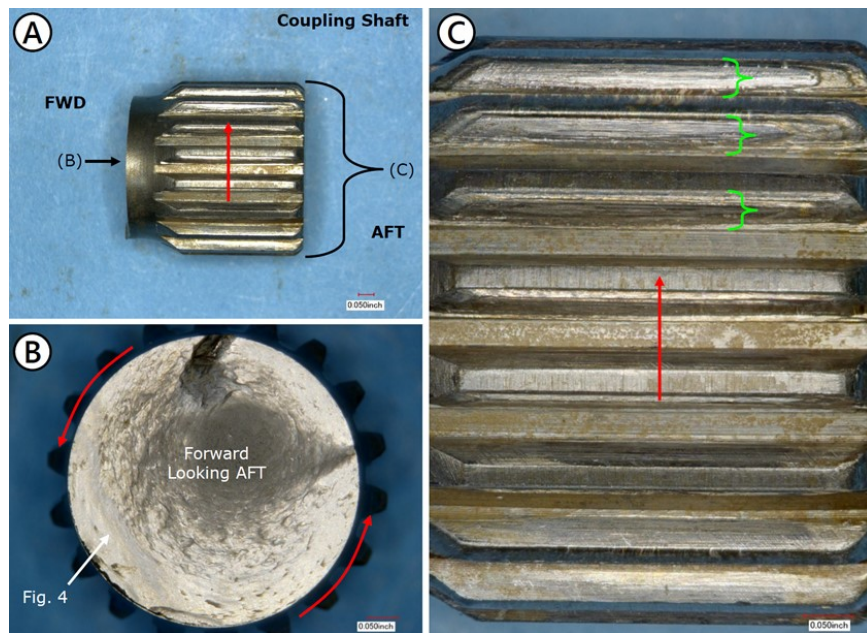
**Photo 36- No. 1 Engine Torque Coupling Shaft Spline (Photos Courtesy of Honeywell)**

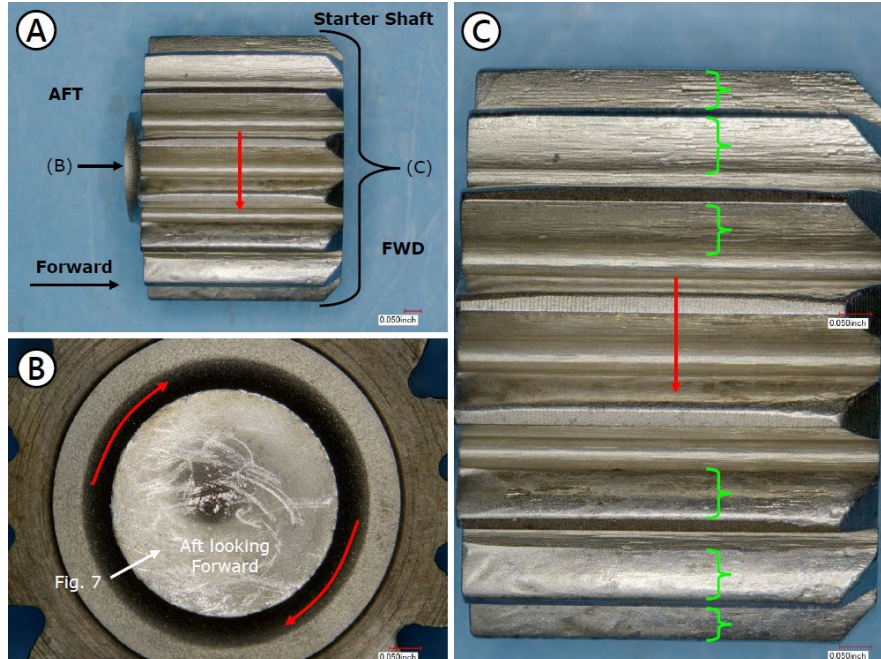
The No. 1 engine starter shaft was separated approximately 0.689 inches from the forward end (**Photo 37**). The fracture surface was examined with a SEM and the features were too obscured by smearing and secondary damage to identify the failure mode. EDX analysis of the starter shaft produced a spectrum similar to 4140 steel.

**Photo 37- No. 1 Engine Starter Spline (Photos Courtesy of Honeywell)**

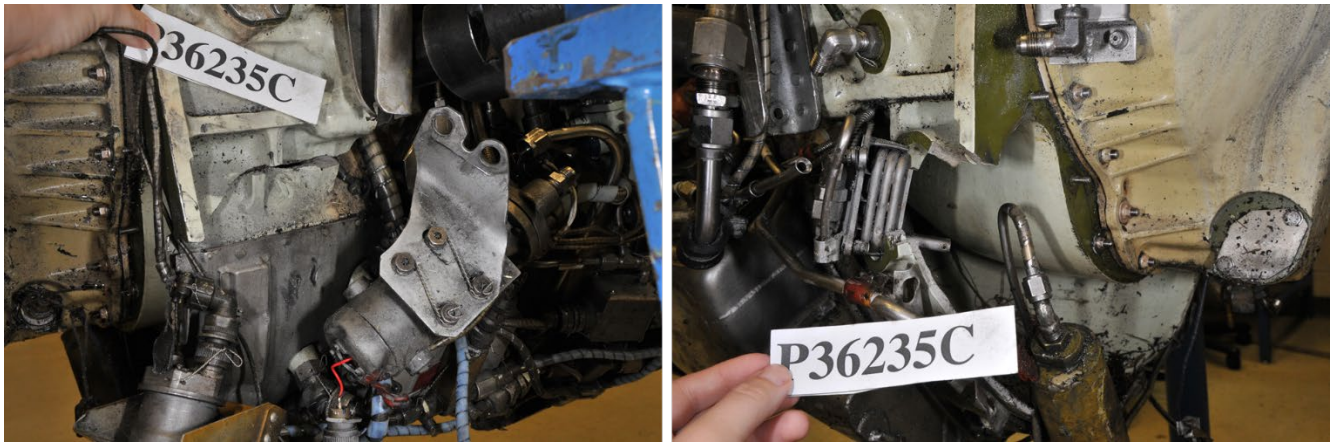
The airframe components were stripped from the engine and a visual inspection was performed to document the external condition. The engine did not exhibit indications of uncontainment or undercowl fire. The AGB inlet had impact damage along the bottom of the engine that separated the cowling attachment flange. The AGB case had a continuous crack from the 3 to 9 o'clock positions that extended around the boat tail over the top of the case (**Photo 42**). Five of the seven forward propeller bearing mount bolts were not present in the bolt holes. The propeller pitch control was partially separated

**Photo 42- AGB Case Fracture, (L) Left Side, (R) Right Side**

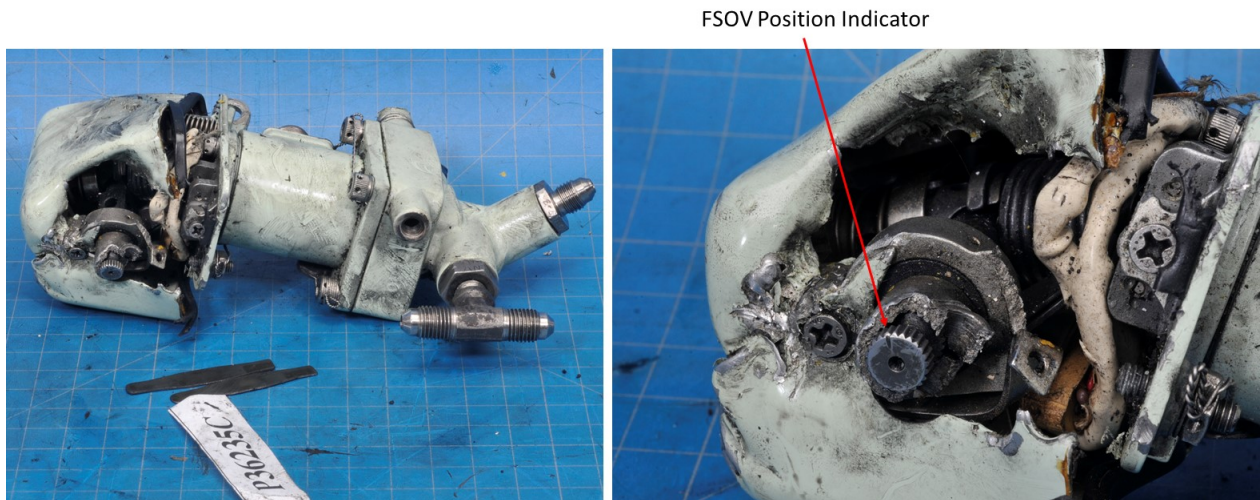
from the AGB mount. The FCU was pulled apart from the fuel pump at the interface flange (**Photo 43**). The FCU housing was fractured at the three fuel pump attachment studs and the attaching bolt was broken. The FCU drive spline appeared to have rust surface discoloration. The propeller feather valve plunger was separated and attached to the linkage arm (**Photo 44**). The propeller governor was intact and when removed it was verified that the check valve orifice was free of obstructions. The starter spline was separated, and the broken spline was recovered from the AGB case. The oil tank exhibited crushing damage and after removal, a small impact penetration and an indent were observed on the aft bottom side of the tank. The FSOV cover was torn open around the input shaft exposing the internal mechanism. The shaft indicator was aligned with the 3 o'clock position, consistent with the manual off position (**Photo 45**).

**Photo 45- (L) FSOV, (R) FSOV Indicator**

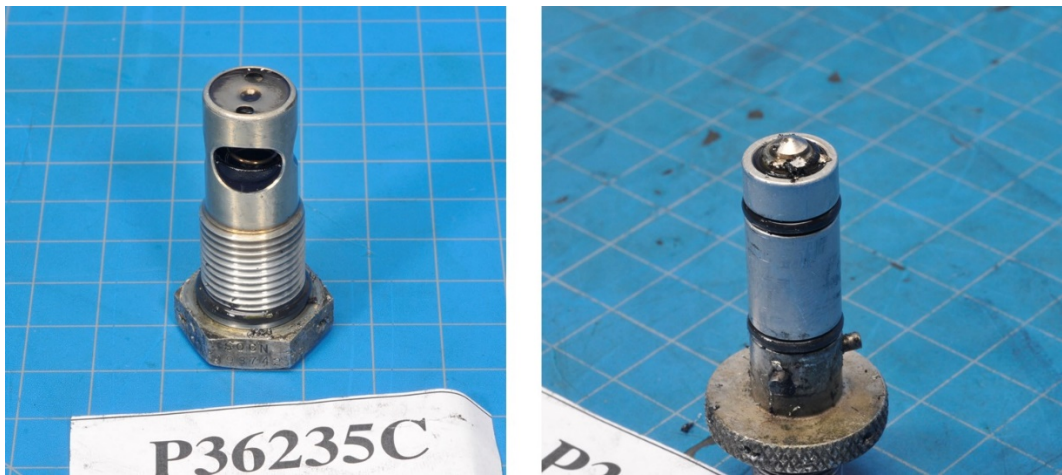
The MCD had some debris accumulation including fine metal shavings and fuzz. The MCD housing was in good condition (**Photo 46**). There was no debris accumulation in the fuel or oil filters. The propeller shaft was seized and could not be manually rotated. The turbine rotor was also seized and could not be rotated.

**Photo 46- (L) MCD Housing, (R) MCD**

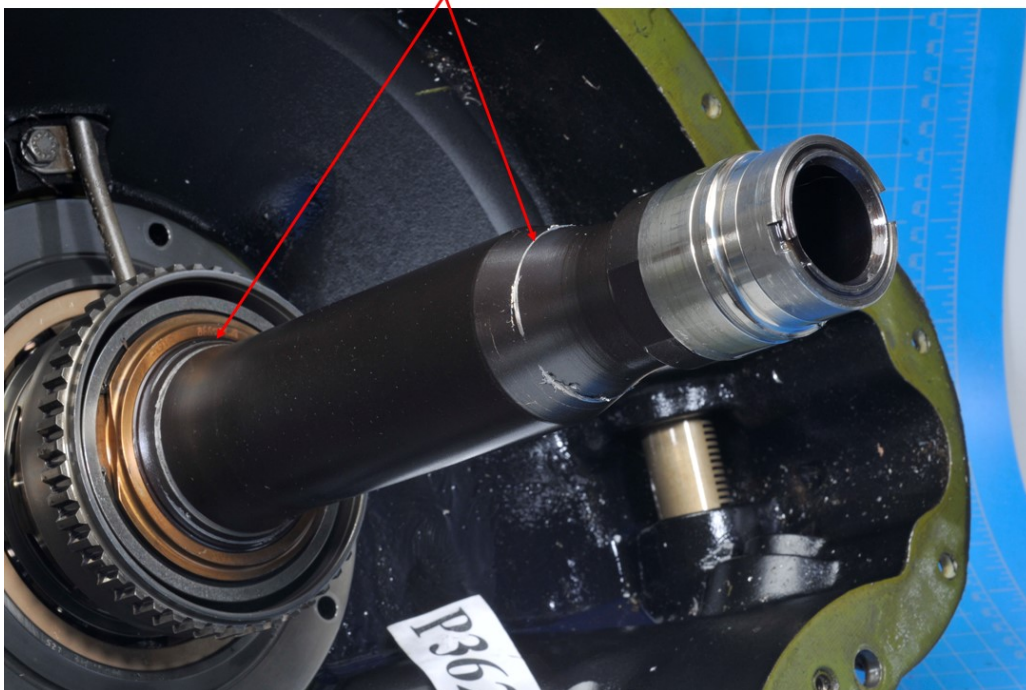
**Photo 48- Propeller Shaft Rubs**

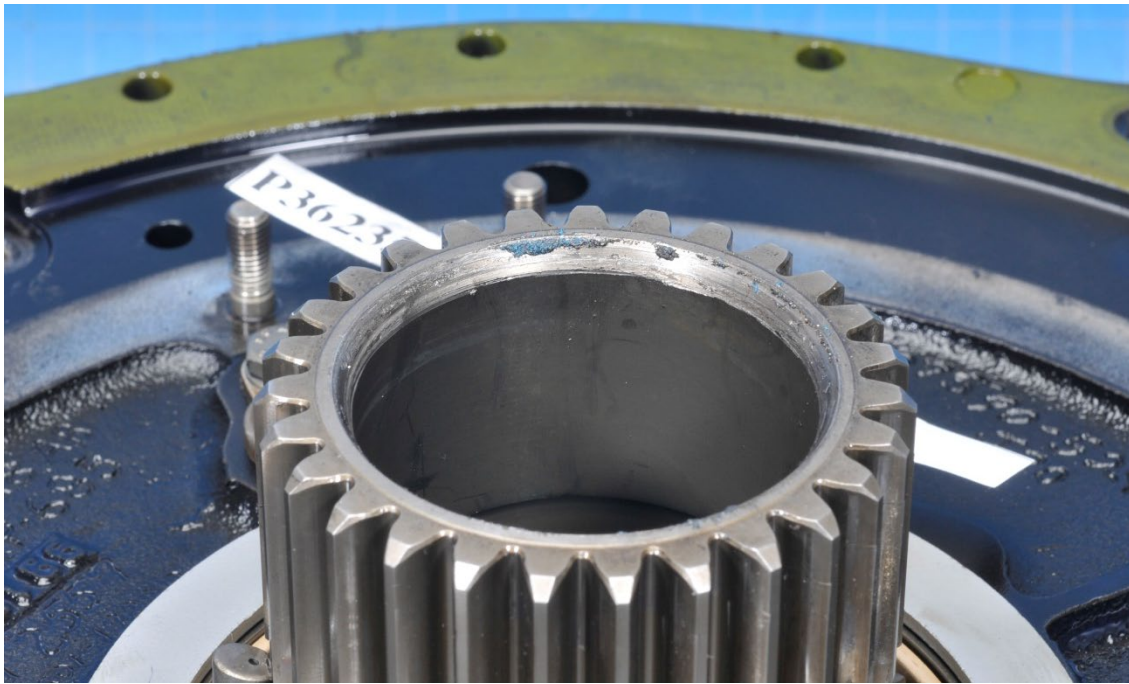
**Photo 51- Sun Gear Forward Face Circumferential Scoring**

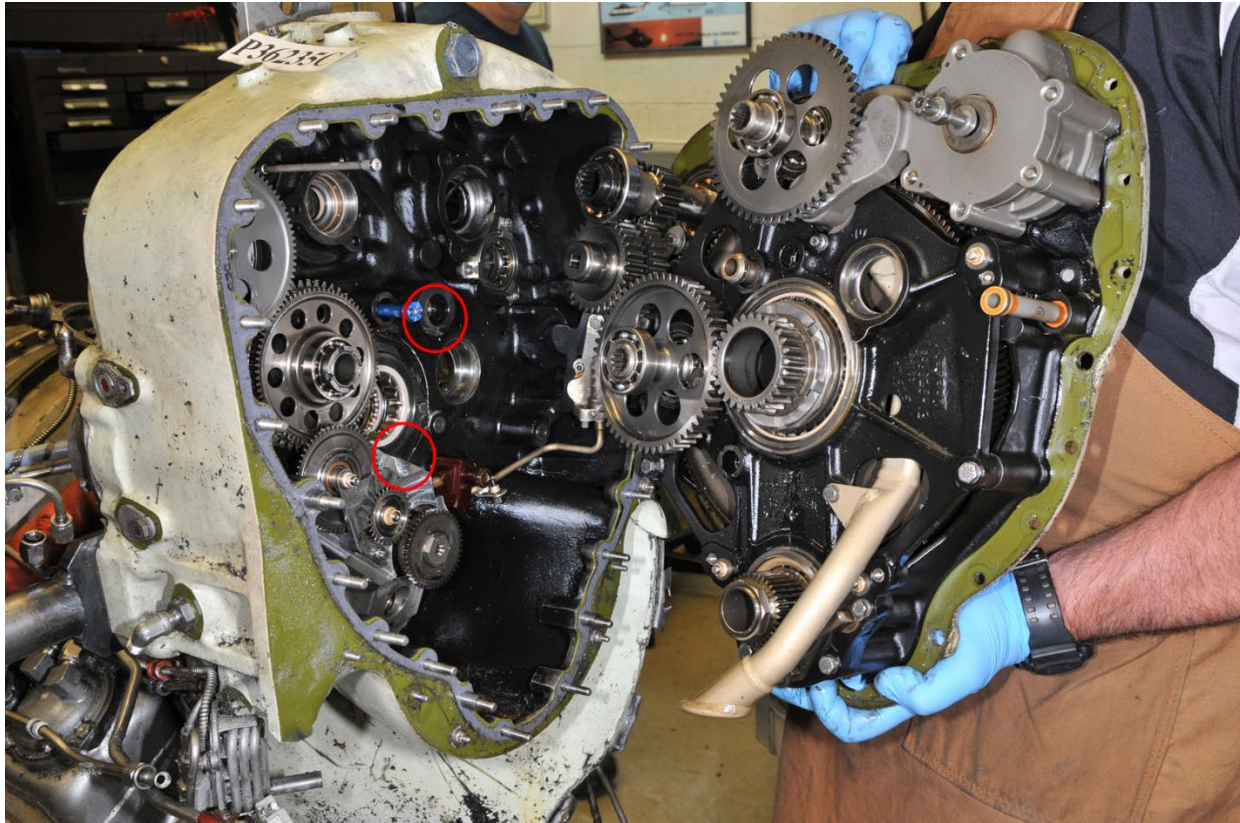
The AGB diaphragm was removed, and all components were complete (**Photo 53**). The torque coupling shaft aft spline was broken and later recovered from the torsion shaft (**Photos 54**). The aft diaphragm gearset and mating gears in the AGB were intact. The high speed pinion manually rotated smoothly, and all gears meshed properly. The torque sensor was intact. The torque sensor gears could not

be rotated by hand. The torque sensor primary gear (direct drive fuel control gear 1) had light contact marks on the loaded face of each gear tooth. The forward main shaft coupling spline had 360 scoring/deformation of the gear tooth near the forward face. Metallic debris was accumulated under the main shaft spline/compressor carrier and at the 6 o'clock position of the AGB case (**Photo 55**). Impact marks were observed on the AGB case feather valve bore and the torque sensor housing (**Photo 53**).

**Photo 53- Diaphragm Assembly**
