**NATIONAL TRANSPORTATION SAFETY BOARD**  
**Office of Aviation Safety**  
**Washington, D.C. 20594**

**POWERPLANTS GROUP CHAIRMAN'S FACTUAL REPORT**

**NTSB No: CEN20LA215**

Aircraft: Mitsubishi MU2B, N44MX, McNeely Charter Service, Inc.

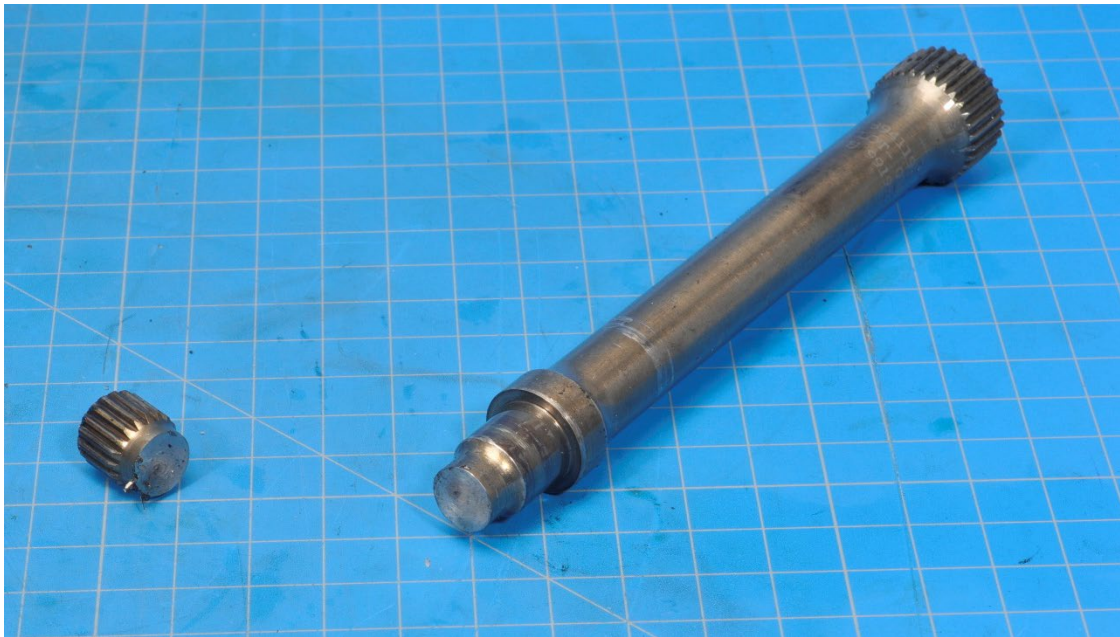
The AGB diaphragm was removed, and all components were complete (**Photo 53**). The torque coupling shaft aft spline was broken and later recovered from the torsion shaft (**Photos 54**). The aft diaphragm gearset and mating gears in the AGB were intact. The high speed pinion manually rotated smoothly, and all gears meshed properly. The torque sensor was intact. The torque sensor gears could not

**Photo 54- Separated Torque Coupling Shaft**

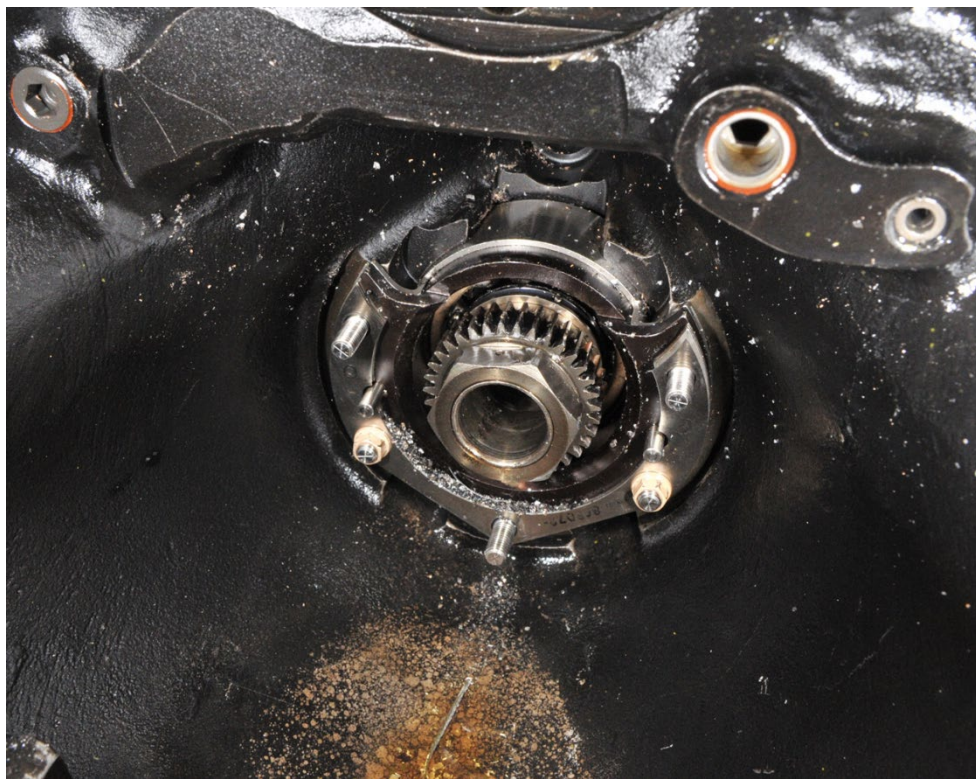
**Photo 55- Main Shaft and AGB Debris Accumulation**

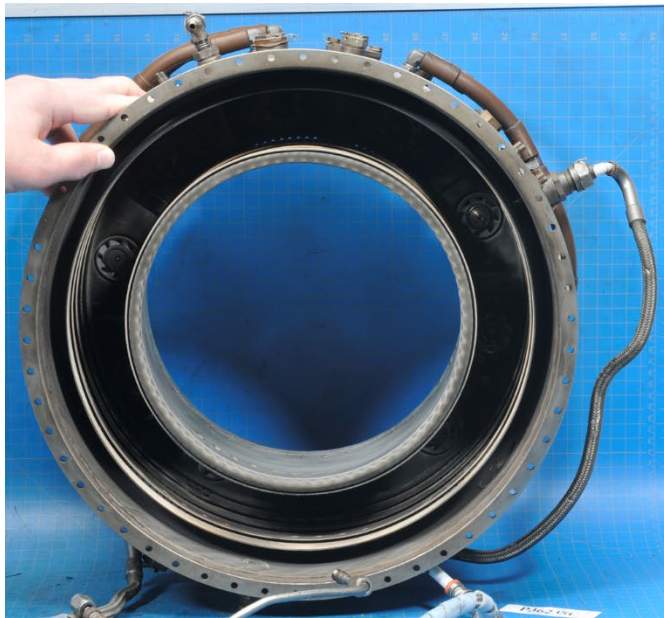
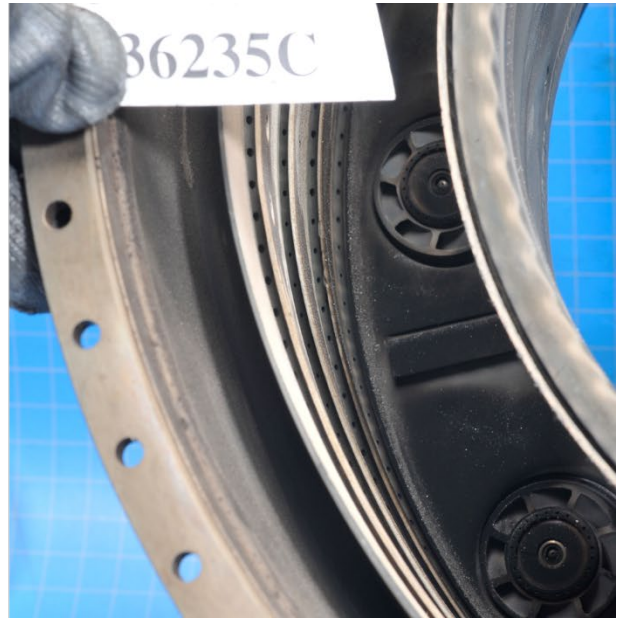
The combustion liner was intact and had no indications of fuel nozzle streaking or thermal damage (**Photo 62**). Earthen debris was accumulated between the liner and the plenum wall. There was light metal spray on the liner walls. All the fuel nozzles were properly seated and there was no evidence of coking. The fuel manifold plumbing was intact and in good condition. The igniter leads at the 5:30 and 10 o'clock positions were partially pulled from plenum case connections and the leads were deformed. The plenum case had wrinkling deformation from the 11 to 12 o'clock positions.

**Photo 62- (L) Combustion Liner, (R) Fuel Nozzles**

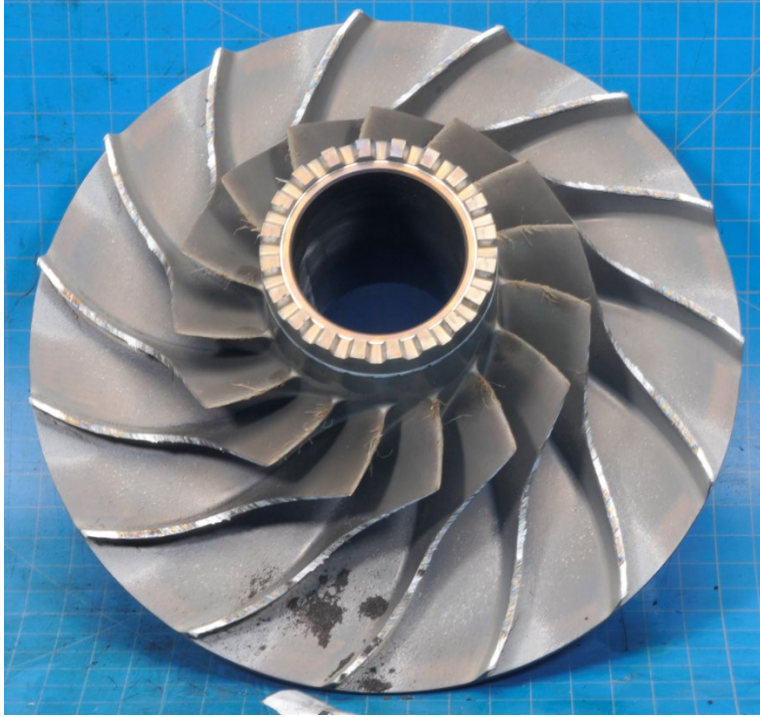
The 2<sup>nd</sup> stage compressor impeller was intact (**Photo 63**). The impeller blades all exhibited tip rub along the blade span and there was earthen debris on the leading edges. There was 360 degree rotational scoring on the forward impeller hub. The 2<sup>nd</sup> stage impeller shroud had heavy 360 degree scoring from the forward (inducer) to aft (exducer) end (**Photo 64**). There was debris between the 2<sup>nd</sup> stage compressor diffuser vanes.

**Photo 63- 2<sup>nd</sup> Stage Compressor Impeller Tip Rub**

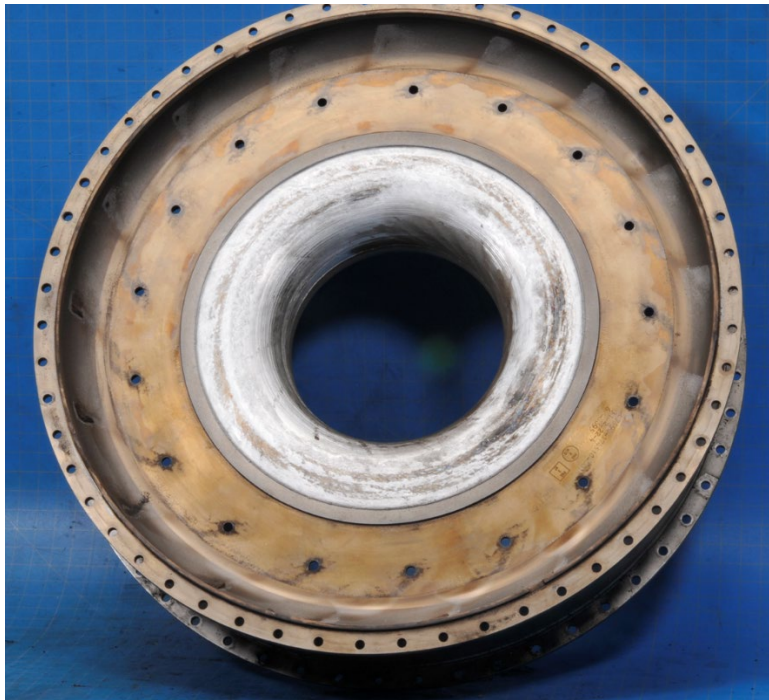
**Photo 64- 2<sup>nd</sup> Stage Impeller Shroud Circumferential Scoring**

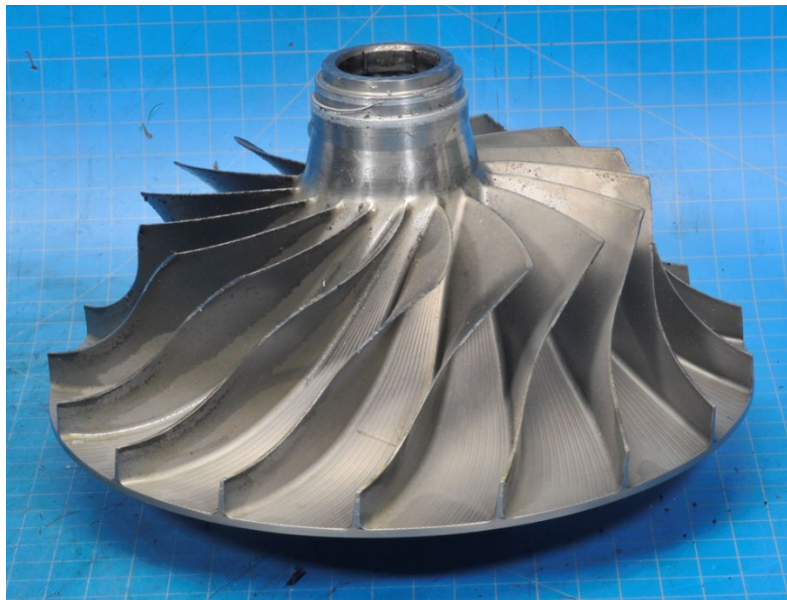
The 1<sup>st</sup> stage compressor impeller had blade tip rub along the span of all blades (**Photo 65**). The impeller forward hub had 360 degree rotational scoring and the aft hub had light 360 rotational scoring. The 1<sup>st</sup> stage shroud had a crack from the 3 to 12 o'clock positions at the o-ring groove\*. The six impeller shroud mount flange holes were torn, and the flange was separated\*. The 1<sup>st</sup> stage impeller shroud had light 360 rotational scoring at the inducer, 360 degree rotational scoring at the knee, more severe from the 7 to 11 o'clock positions, and 360 degree scoring at the exducer, more severe from the 12 to 5 o'clock positions (**Photo 66**). The crossover duct was in a good condition. There was earthen debris between the 1<sup>st</sup> stage diffuser vanes (**Photo 67**).

**Photo 65- 1<sup>st</sup> Stage Compressor Impeller Blade Tip Rub**

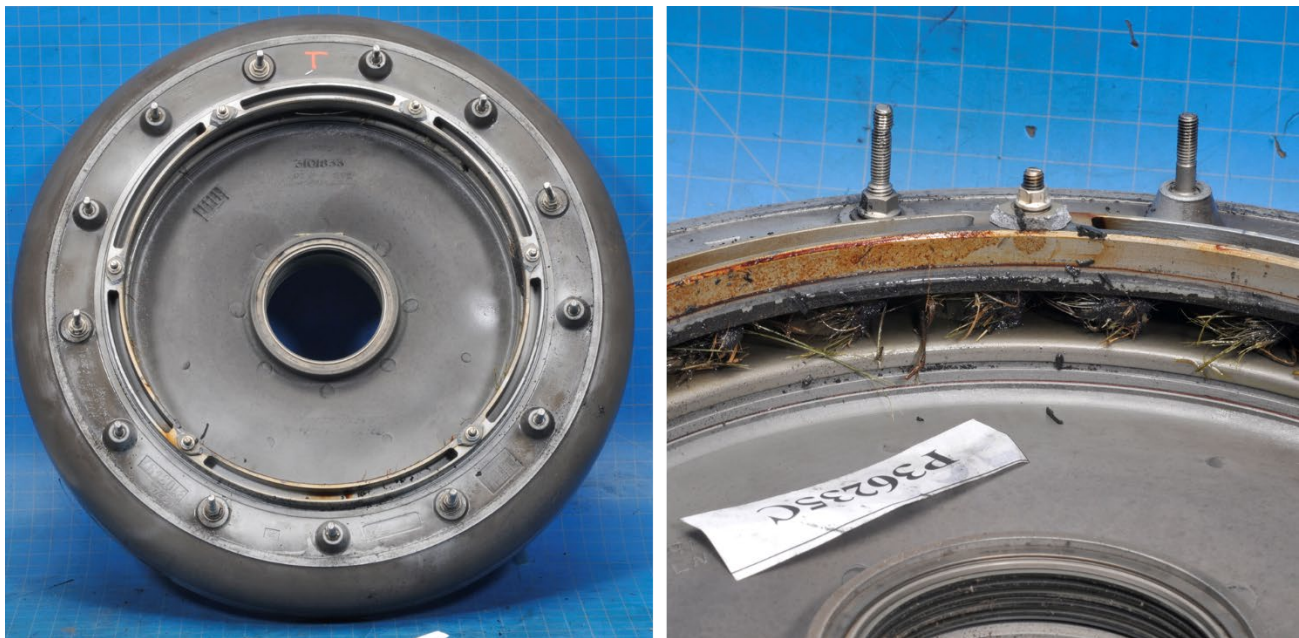
**Photo 67- (L) Compressor Crossover Duct, (R) 1<sup>st</sup> Stage Diffuser with Debris Accumulation**

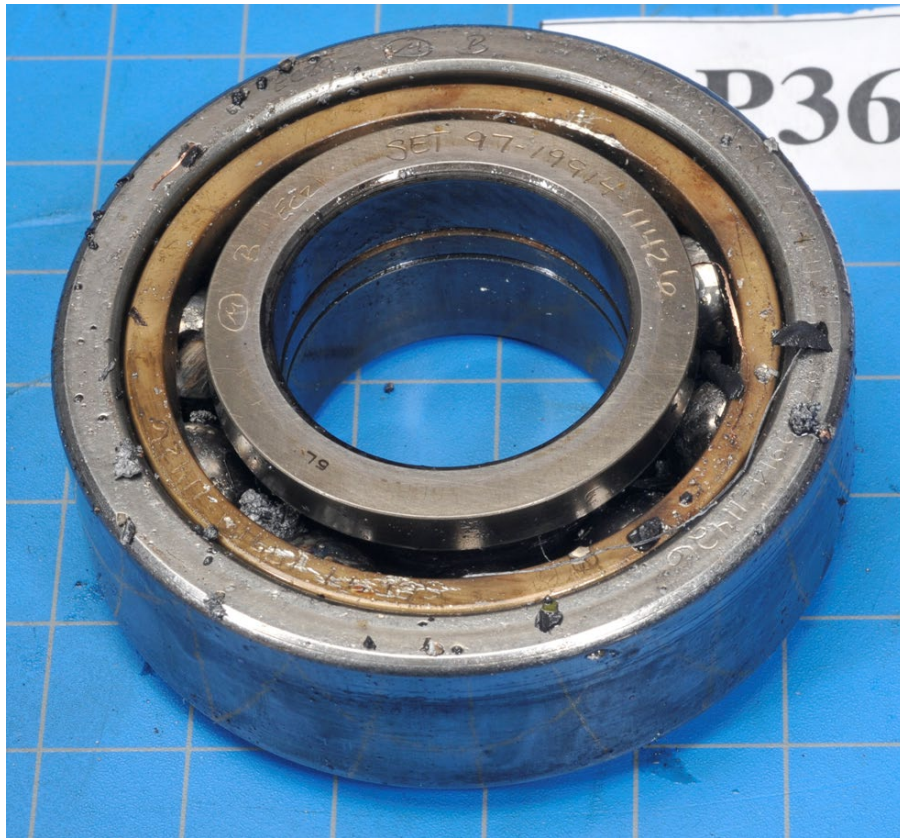
Due to the alternate disassembly method, the carrier, compressor bearing, carbon seal, carbon seal rotor, main shaft coupling gear, and main shaft nut remained on the front of the shaft when the main shaft was removed. The shaft was placed in a padded vice and an air impact gun was used to remove the nut. The bearing was removed by carefully tapping the bearing outer race. The compressor bearing was dirty and rotated roughly (**Photo 68**). Ball bearing damage was visible between the bearing races. The main shaft was not bent. The knife edge seals exhibited rub damage, had debris accumulation between the knives, and a section of one knife was separated (**Photo 69**).

**Photo 68- No. 1 (Compressor) Bearing**

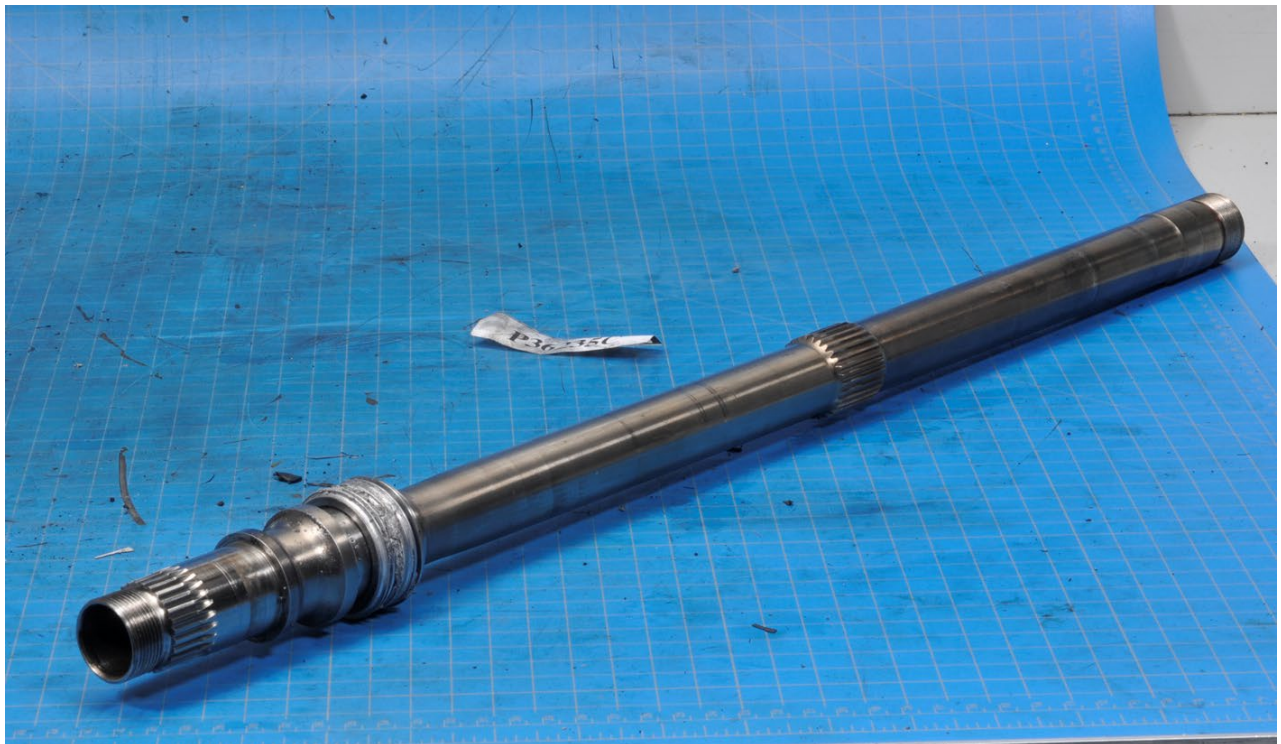
**Photo 69- Main Shaft Knife Edge Seal Damage**

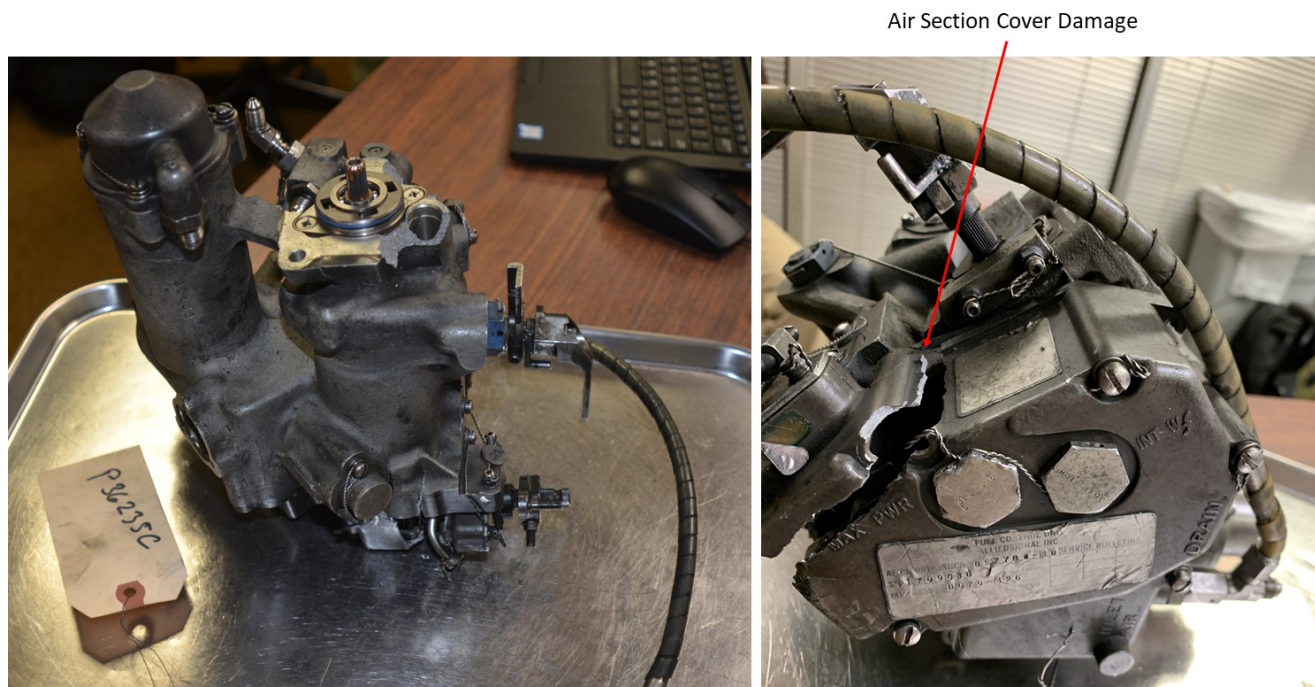
The No. 2 engine FCU, P/N 807426, S/N 1706938, and propeller governor, P/N 8210-262, S/N 1806734, were shipped to Woodward in Loves Park, Illinois for examination. A visual examination of the FCU was performed to determine if it was safe to install on a test bench. The FCU air section cover<sup>7</sup> was fractured and missing material. The input mounting flange exhibited impact damage and was missing three of the four flange attaching lugs (ears) (**Photo 70**). The air section cover was replaced with a spare and the FCU was secured/clamped to the test bench with angled metal bar stock and all thread rod (**Photo 71**). The input drive speed on the test bench was slowly increased and there were no audible indications of internal damage. A steady drip leak was observed that appeared to originate from the mounting flange interface. According to Woodward engineering, the leak would not impact the test schedules. The FCU was tested in accordance with Woodward TSP-8963 Revision D. There were no anomalies noted during testing that would have precluded normal FCU operation. Multiple test points were outside of ATP limits but according to Woodward engineering were within the expected range of customer adjustments for a service run unit. The FCU test run sheet is available in the docket as Powerplants- Attachment 4- No. 2 Engine (P36235C) Fuel Control Test Report.

**Photo 70- (L) No. 2 Engine FCU, as Received at Woodward, (R) Air Section Cover Damage**

<sup>7</sup> The FCU air section cover must be airtight to perform at altitude. The altitude fuel schedules could not be tested during the component exam, but other fuel schedules were not affected.

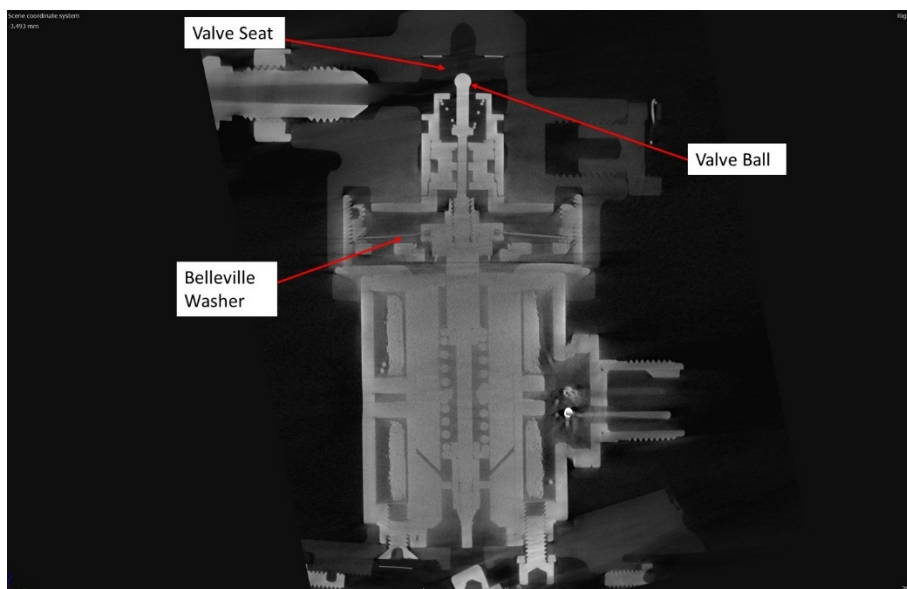
The No. 2 engine FSOV was CT scanned at the Honeywell Materials Laboratory in Phoenix, AZ and no internal anomalies were observed. Video files of the CT scans were provided to the NTSB for review. The CT scan showed the FSOV was in the closed position, consistent with the shaft indicator. The internal Belleville washer was deflected toward the valve seat, and the valve ball was against the seat, which would have stopped fuel flow through the valve (**Photo 73**).

**Photo 73- No. 2 Engine FSOV Computed Tomography Scan (Photo Courtesy of Honeywell)**

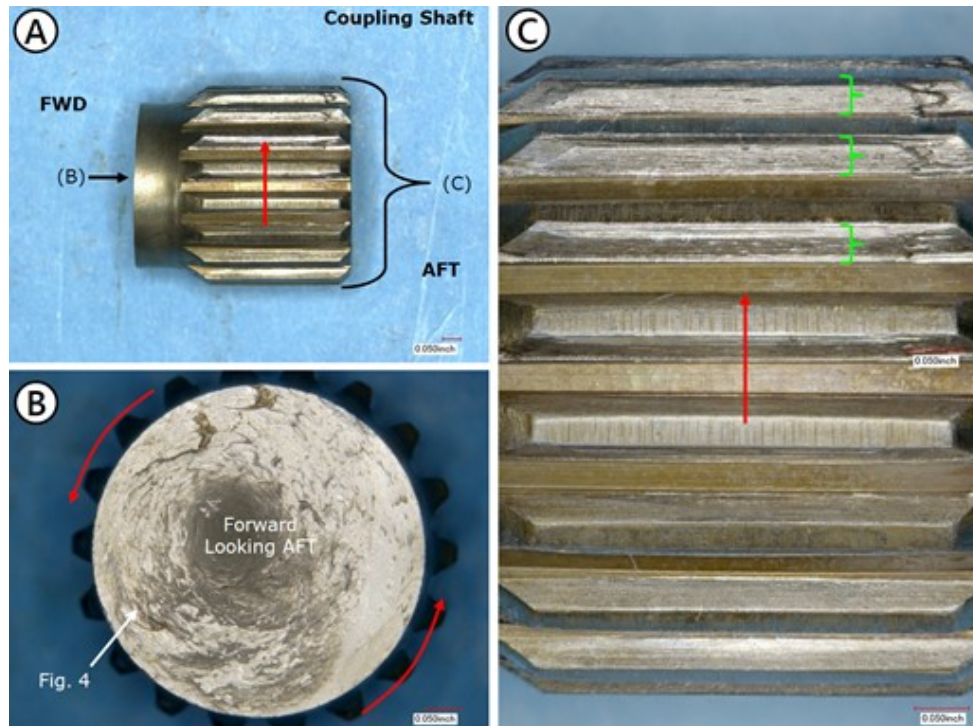
The No. 2 engine torque coupling shaft separated starter shaft, No. 1 bearing, and the debris removed from the MCD and near the No. 1 bearing were submitted to the Honeywell Materials Laboratory for analysis. The torque coupling shaft was separated approximately 0.632 inches from the aft end (**Photos 54 and 74**). The torque coupling shaft fracture surfaces were examined with a SEM which revealed that most of the fracture surfaces were obscured by smearing and secondary impact damage. Areas of overload dimples elongated in the shaft direction of rotation were identified, consistent with torsional overload. The torque coupling shaft material was analyzed using EDX and the spectrum was consistent with H11 tool steel material in accordance with the part drawing.

**Photo 74- No. 2 Engine Torque Coupling Shaft, Separated Spline (Photos Courtesy of Honeywell)**

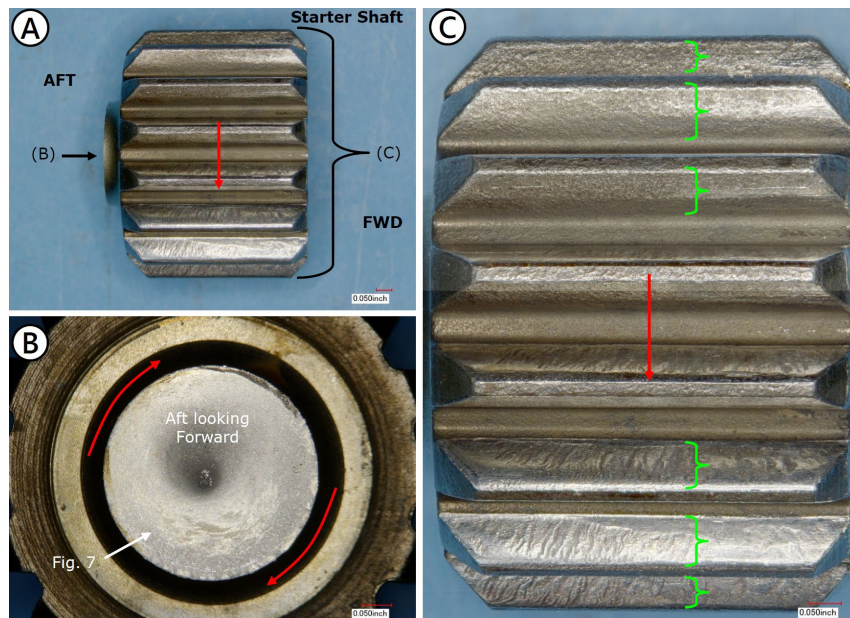
The No. 2 engine starter shaft was separated approximately 0.690 inches from the forward end (**Photo 75**). The fracture surface was examined with a SEM and the features were too obscured by smearing and secondary damage to identify the failure mode. EDX analysis of the starter shaft produced a spectrum similar to 4340 steel.

**Photo 75- No. 2 Engine Starter Shaft, Separated Spline (Photos Courtesy of Honeywell)**

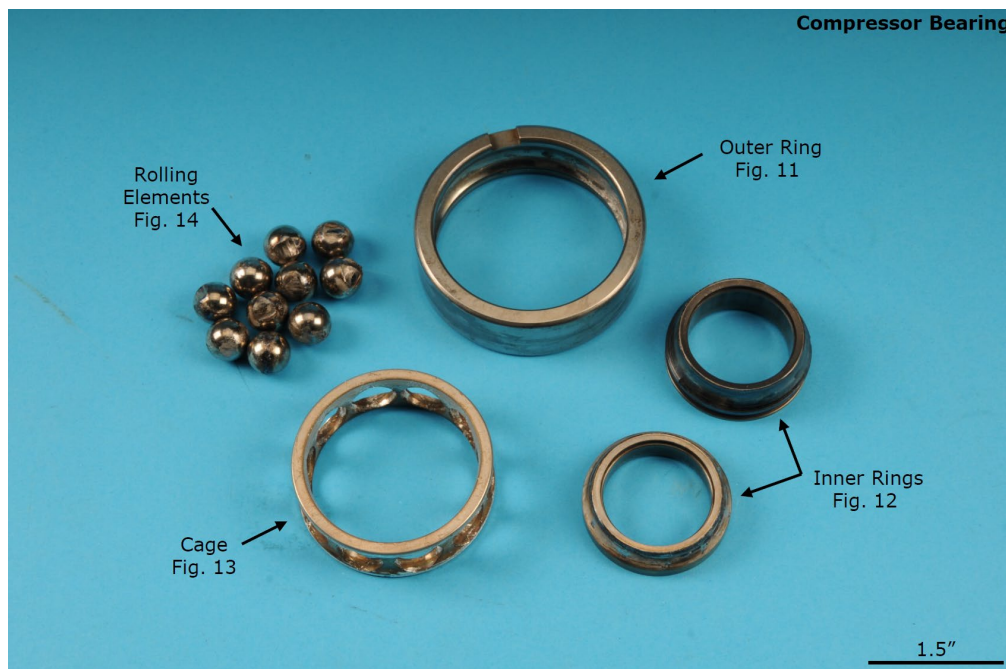
The No. 1 bearing was disassembled for evaluation (**Photo 76**). Damage and non-uniform wear were observed on the outer race and there was deformed material from the outer race onto the aft shoulder in some locations. The split inner ring race exhibited impact damage and the forward inner ring race half had rolled over material on the outer diameter shoulder. The bearing cage had wear damage on both end rails and in the cage pockets. The aft side of the bearing cage was discolored compared to the forward side. All bearing rolling elements were damaged and discolored.

**Photo 76- Disassembled No. 1 Bearing**
