# NATIONAL TRANSPORTATION SAFETY BOARD

## MATERIALS LABORATORY FACTUAL REPORT

Report No. 21-045

Place : Sioux Falls, South Dakota  
Date : June 7, 2020  
Vehicle : MU-28-60  
NTSB No. : CEN20LA215  
Investigator : Shaun Williams  
AS-CEN

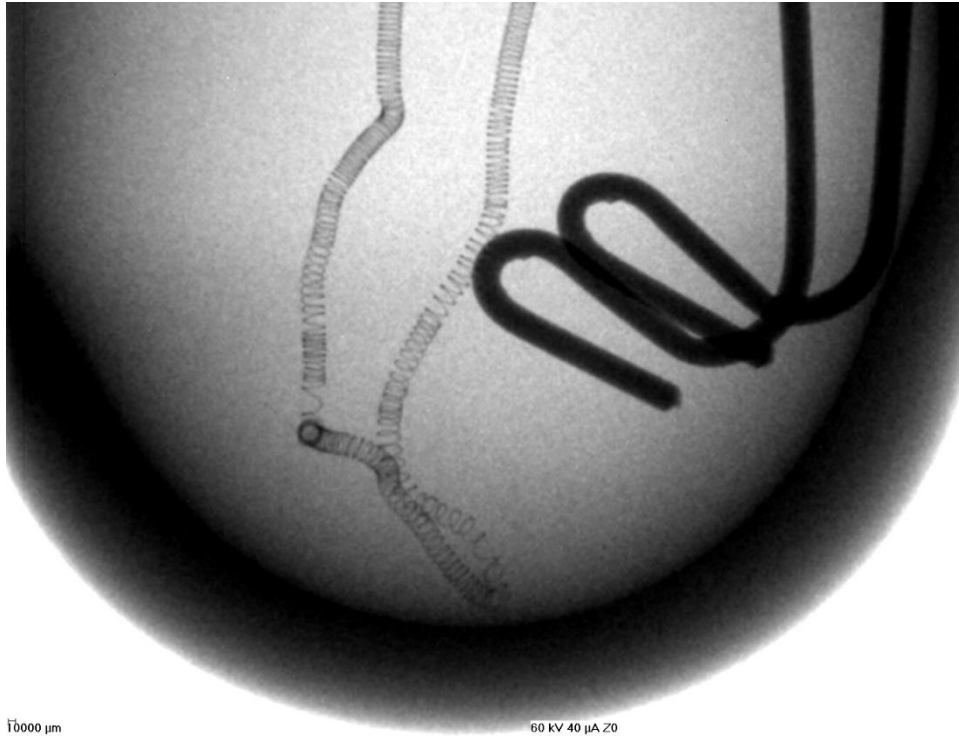
| Left Bulb | Middle Bulb | Right Bulb |
|---|---|---|
| Intact, stretched | Intact, stretched | Intact, stretched |

**Figure 1. Radiograph of left bulb in Master Warning Annunciator.**

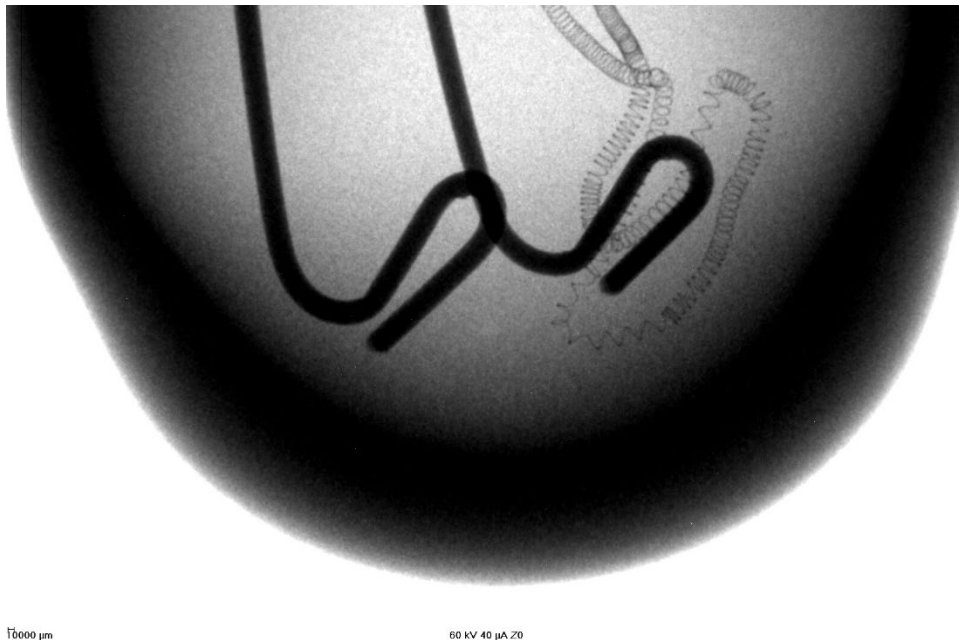
**Figure 2. Radiograph of center bulb of Master Warning annunciator.**

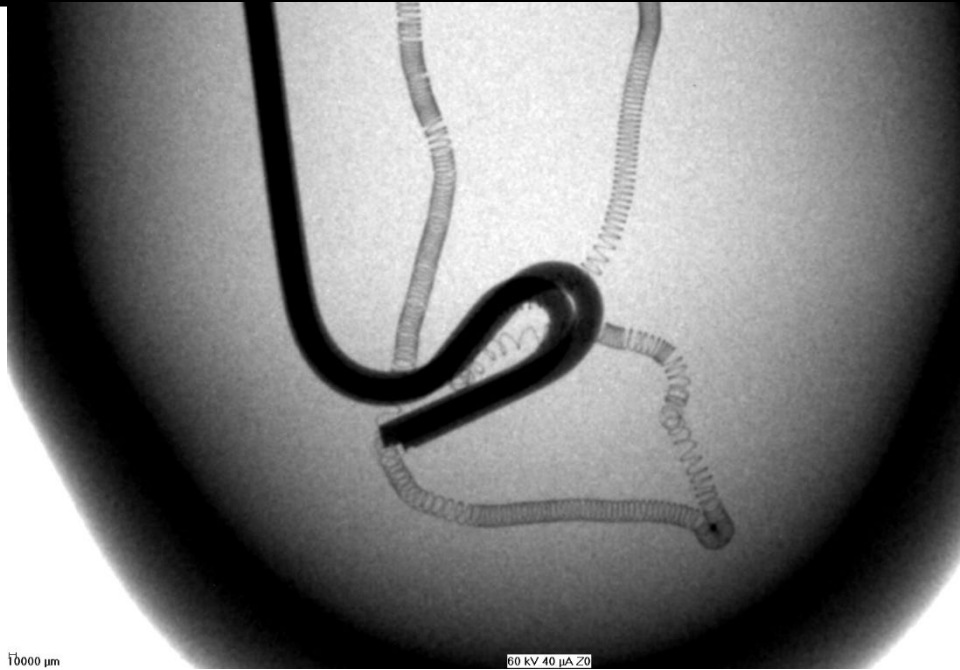
**Figure 3. Radiograph of right bulb of Master Warning annunciator.**

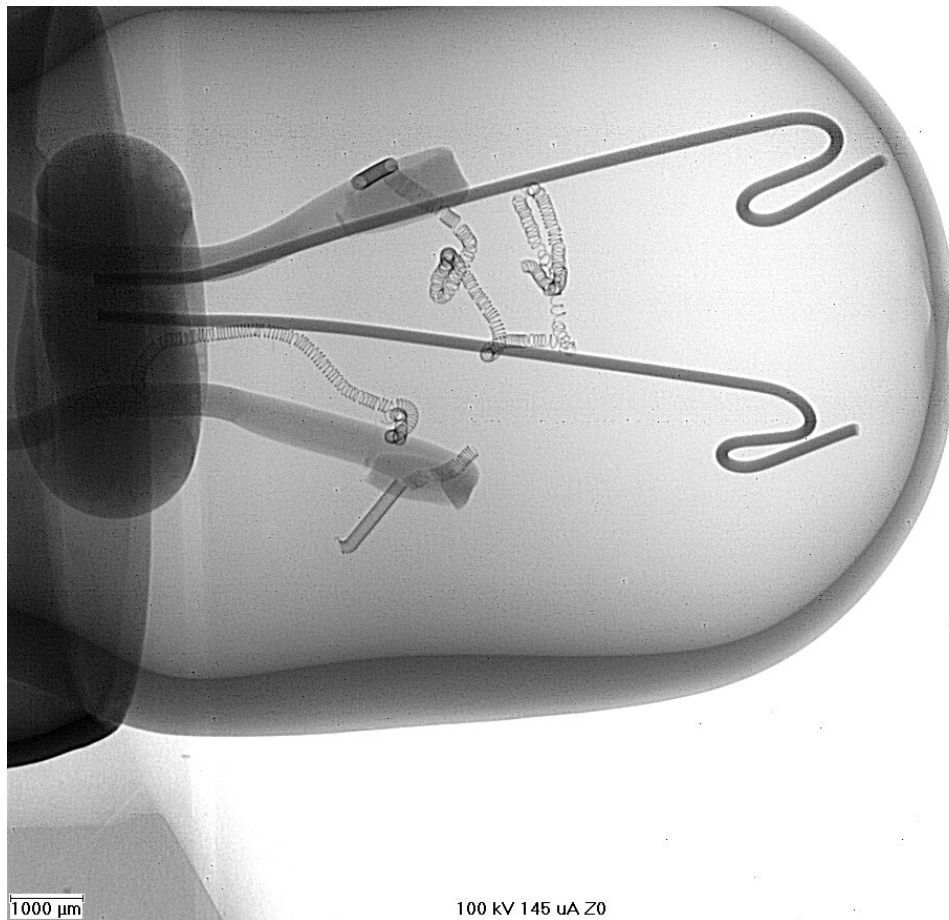
| <b>Annunciator</b> | <b>Bulb #1</b> | <b>Bulb #2</b> |
|---|---|---|
| R BOOST PUMP FAIL | Broken, stretched | Intact, stretched |

**Figure 4. Radiograph of bulb 1 from Right Fuel Boost Pump Fail.**

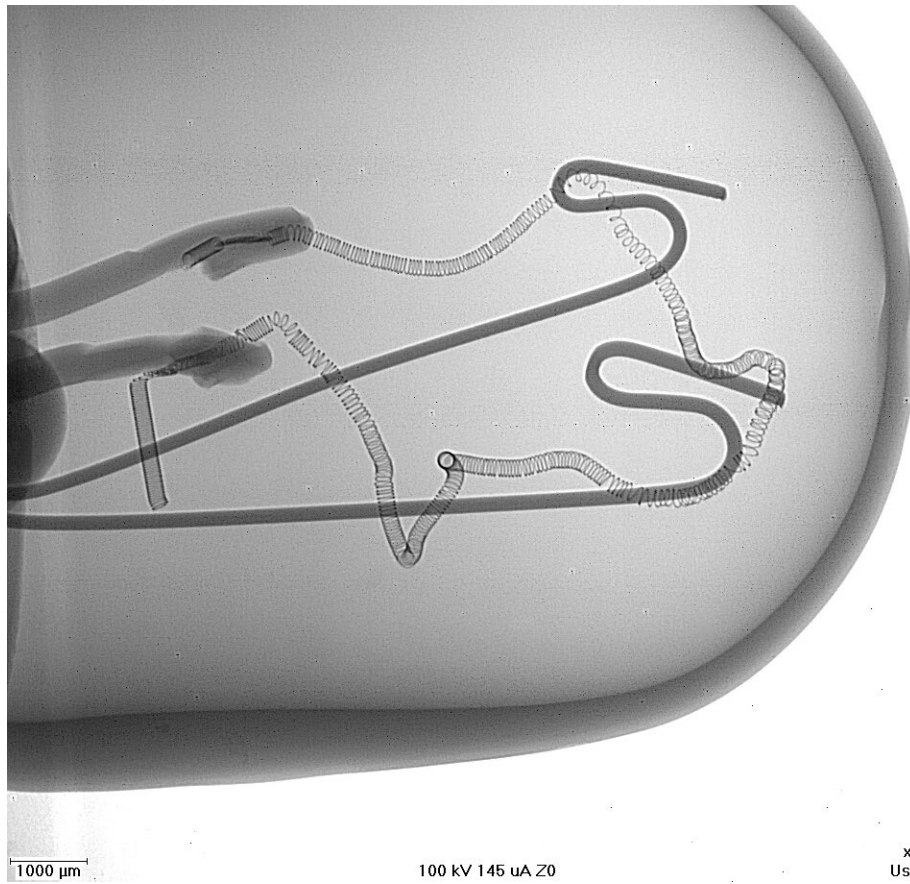
**Figure 5. Radiograph of bulb 2 from Right Fuel Boost Pump Fail.**
