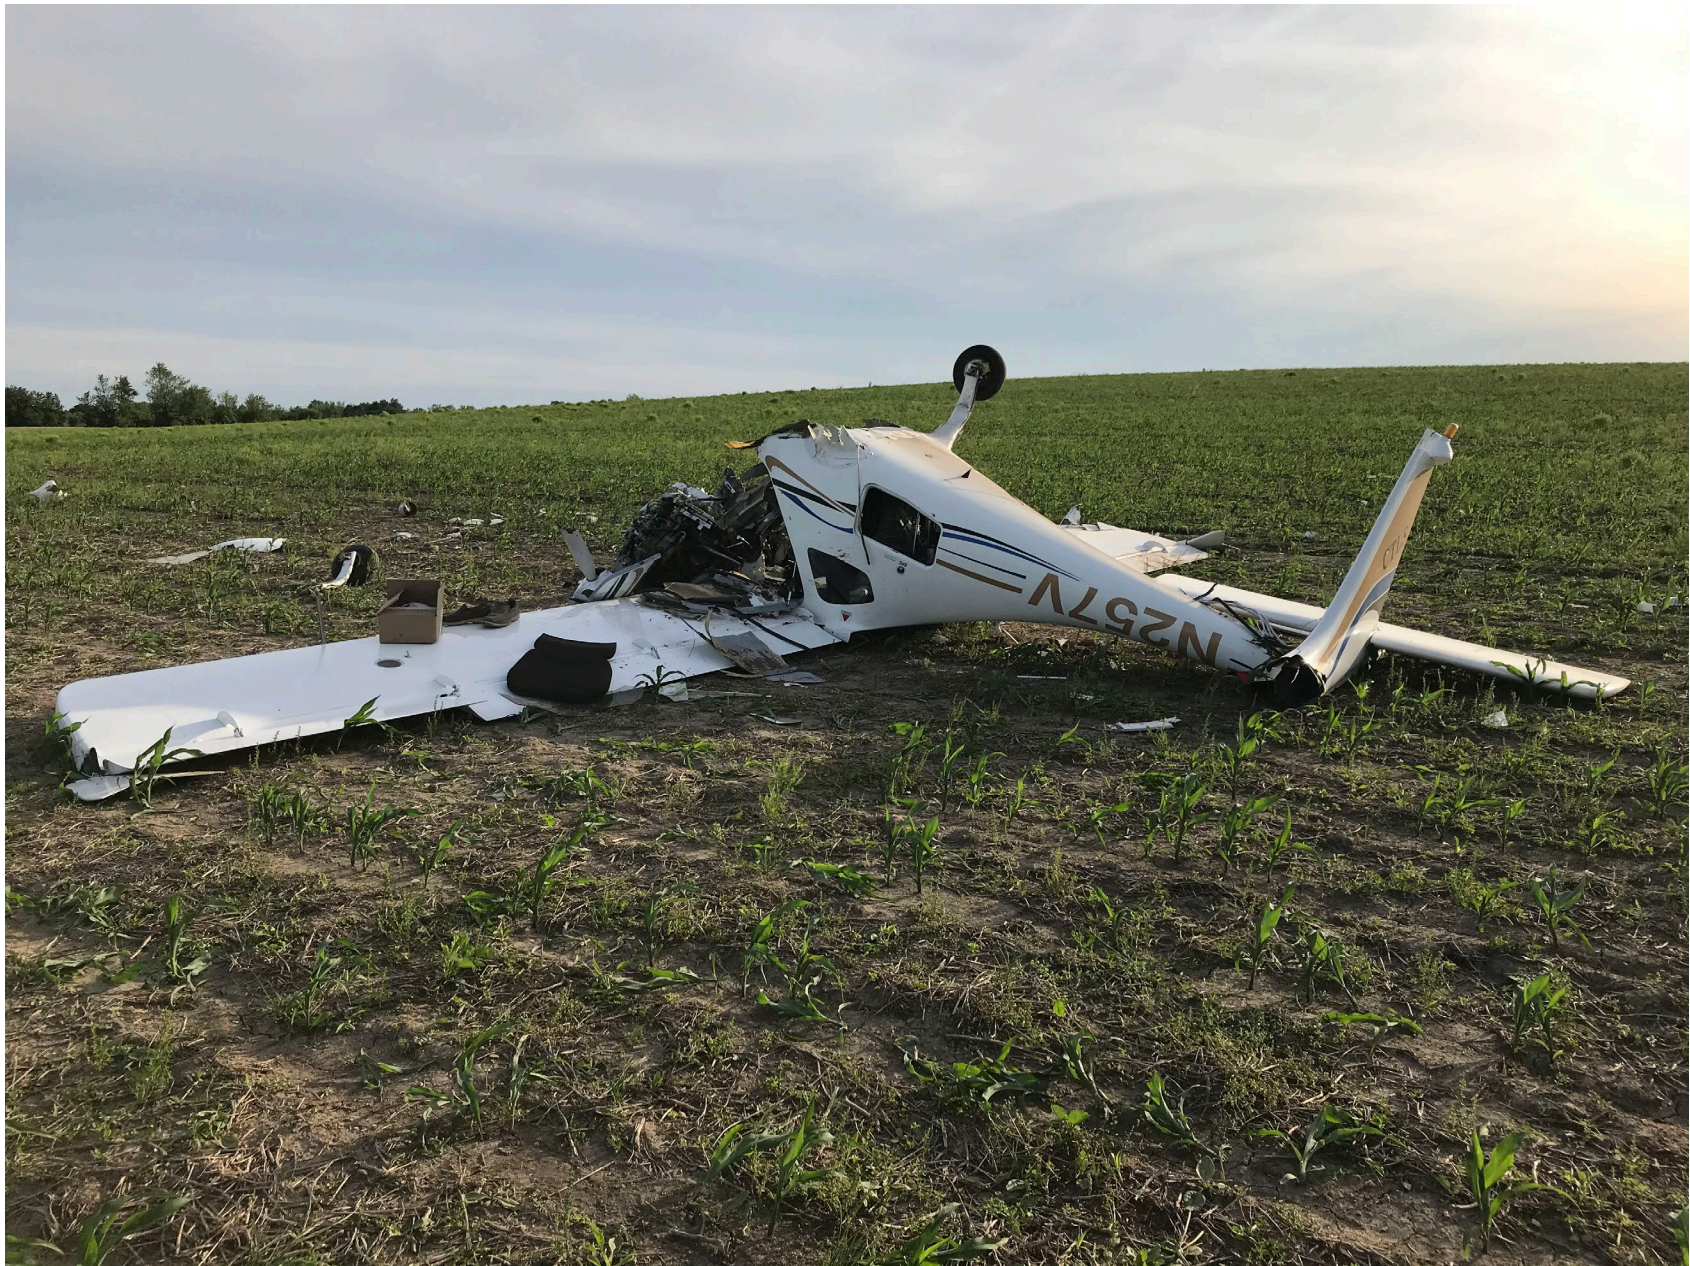
**Photo 1 – N257V at site viewed from its right rear (NTSB Photo)**

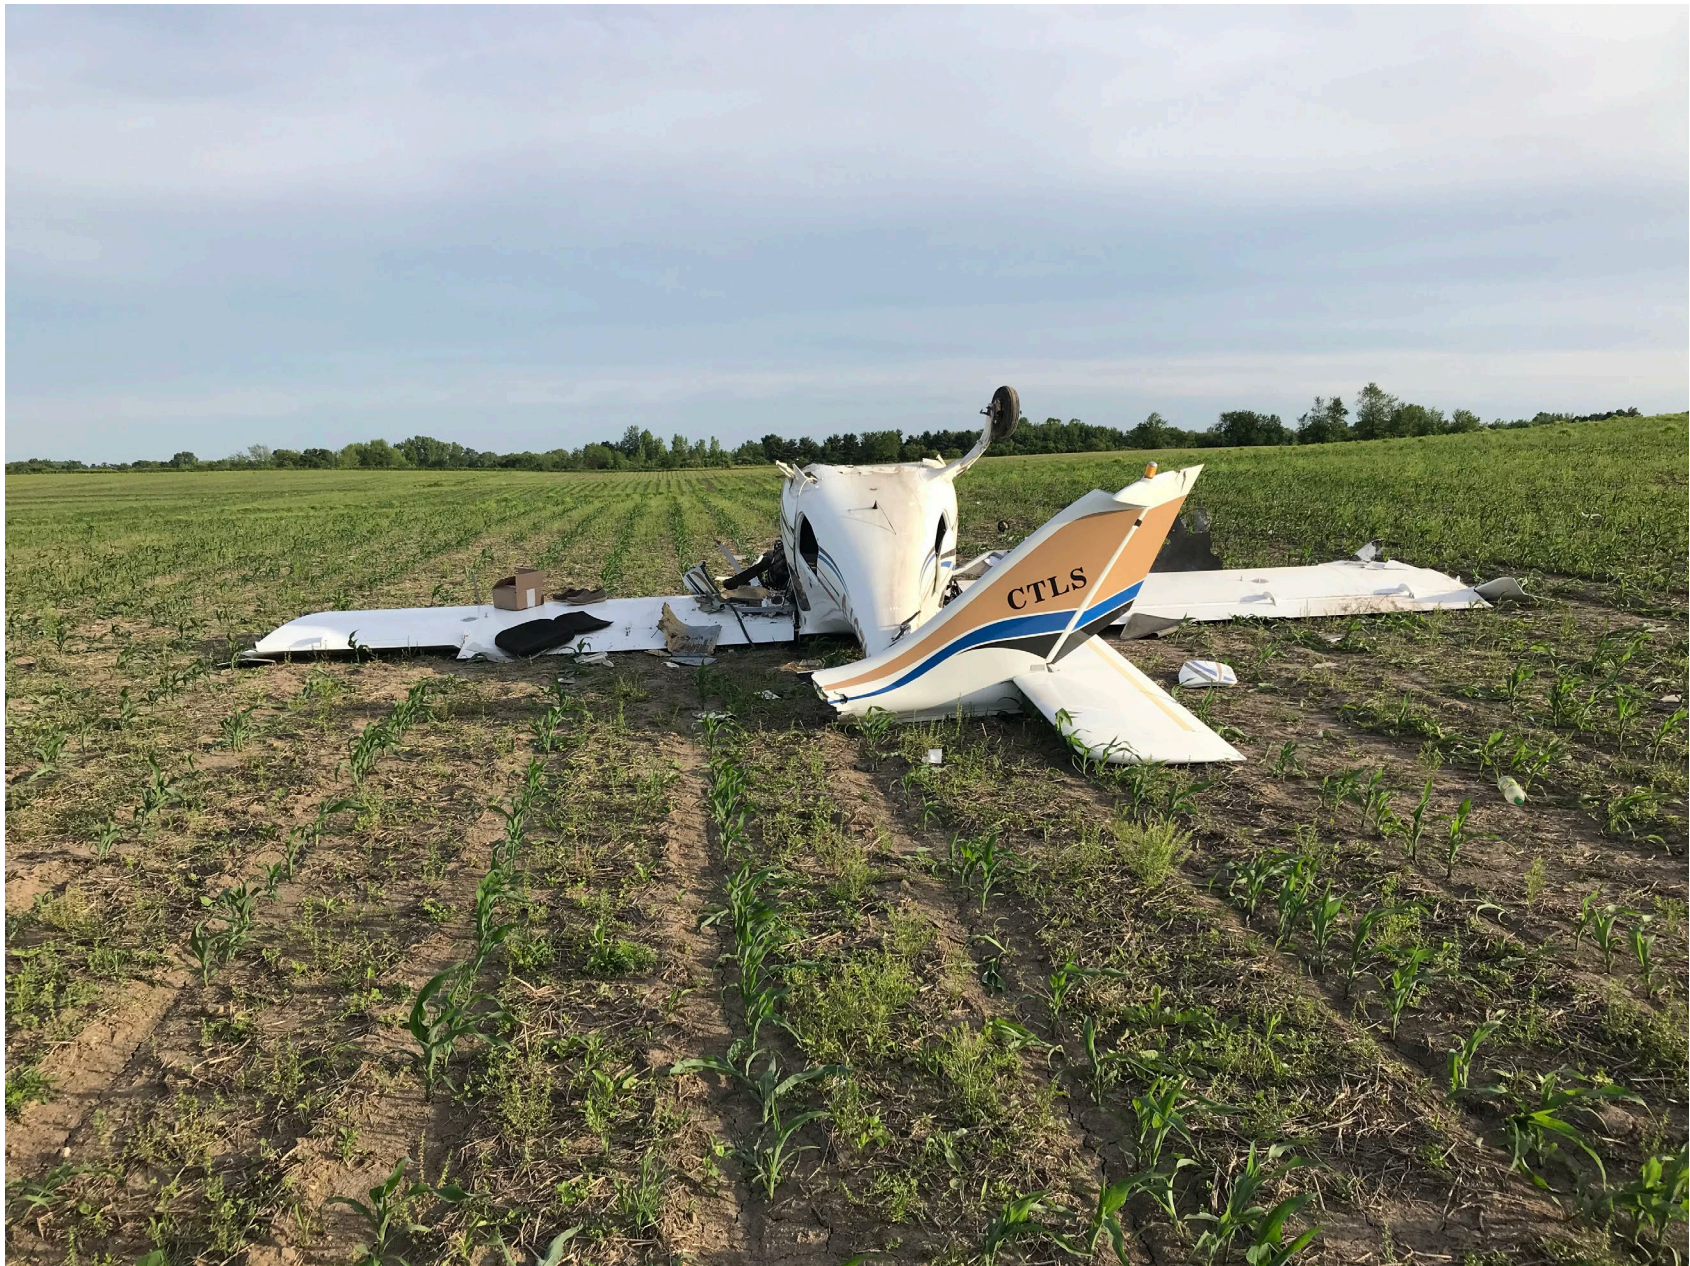
**Photo 2 – N257V at site viewed from its rear (NTSB Photo)**

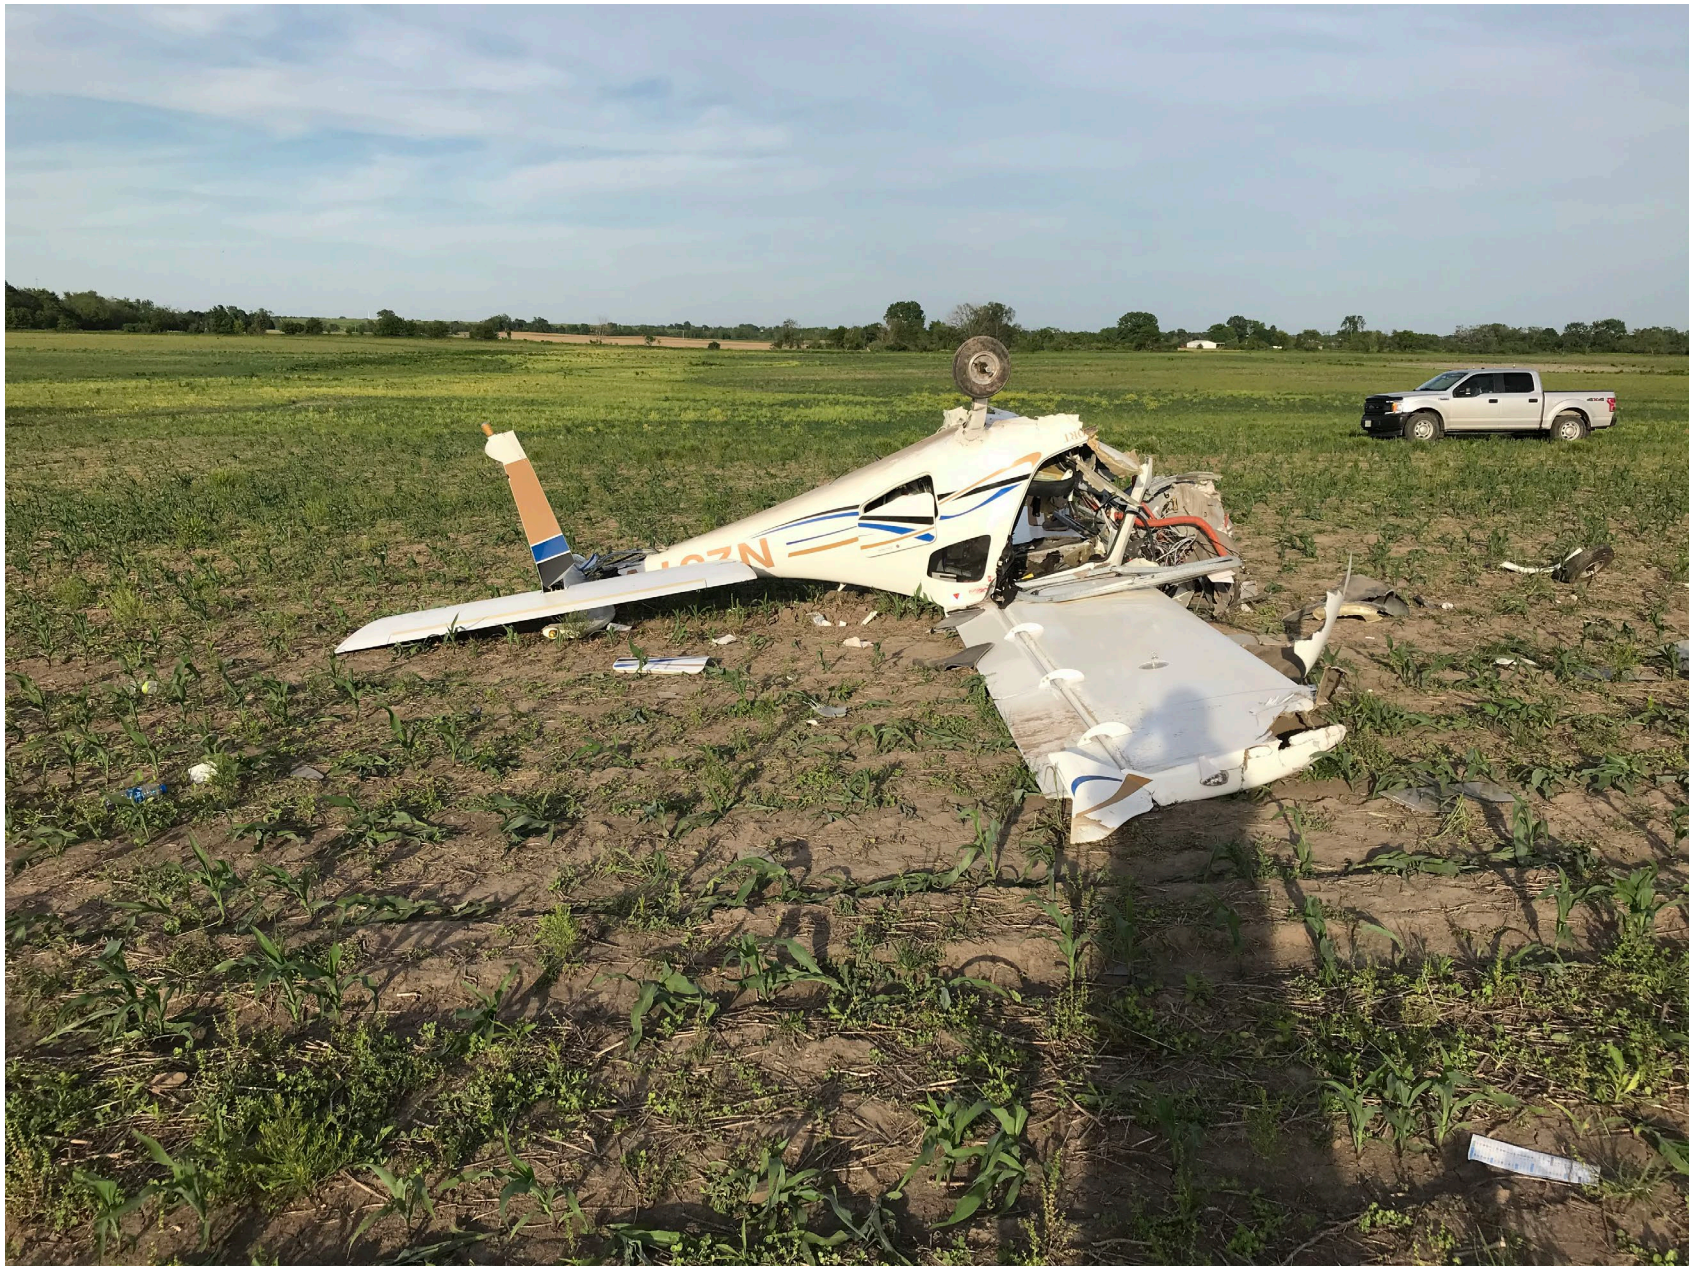
**Photo 3 - N257V at site viewed from its left side (NTSB Photo)**

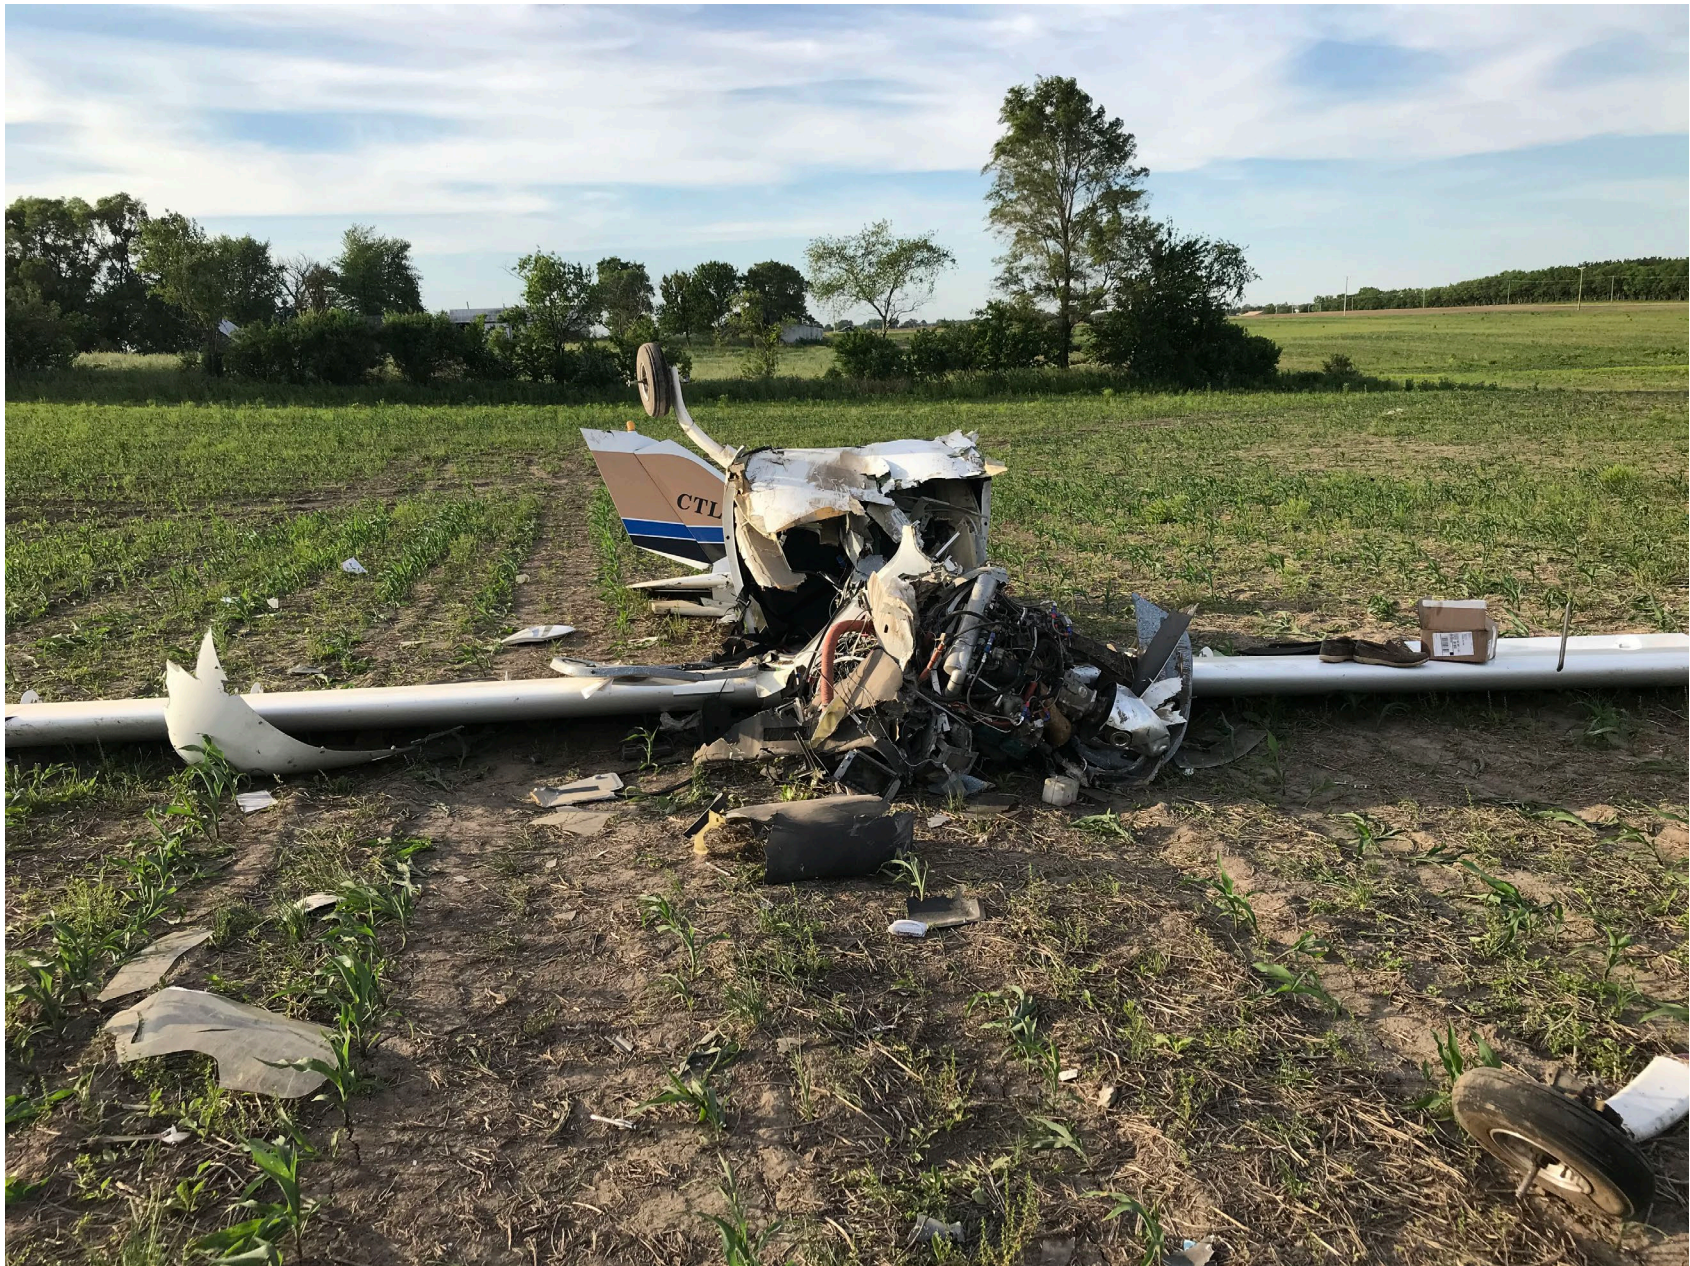
**Photo 4 - N257V at site viewed from its front (NTSB Photo)**

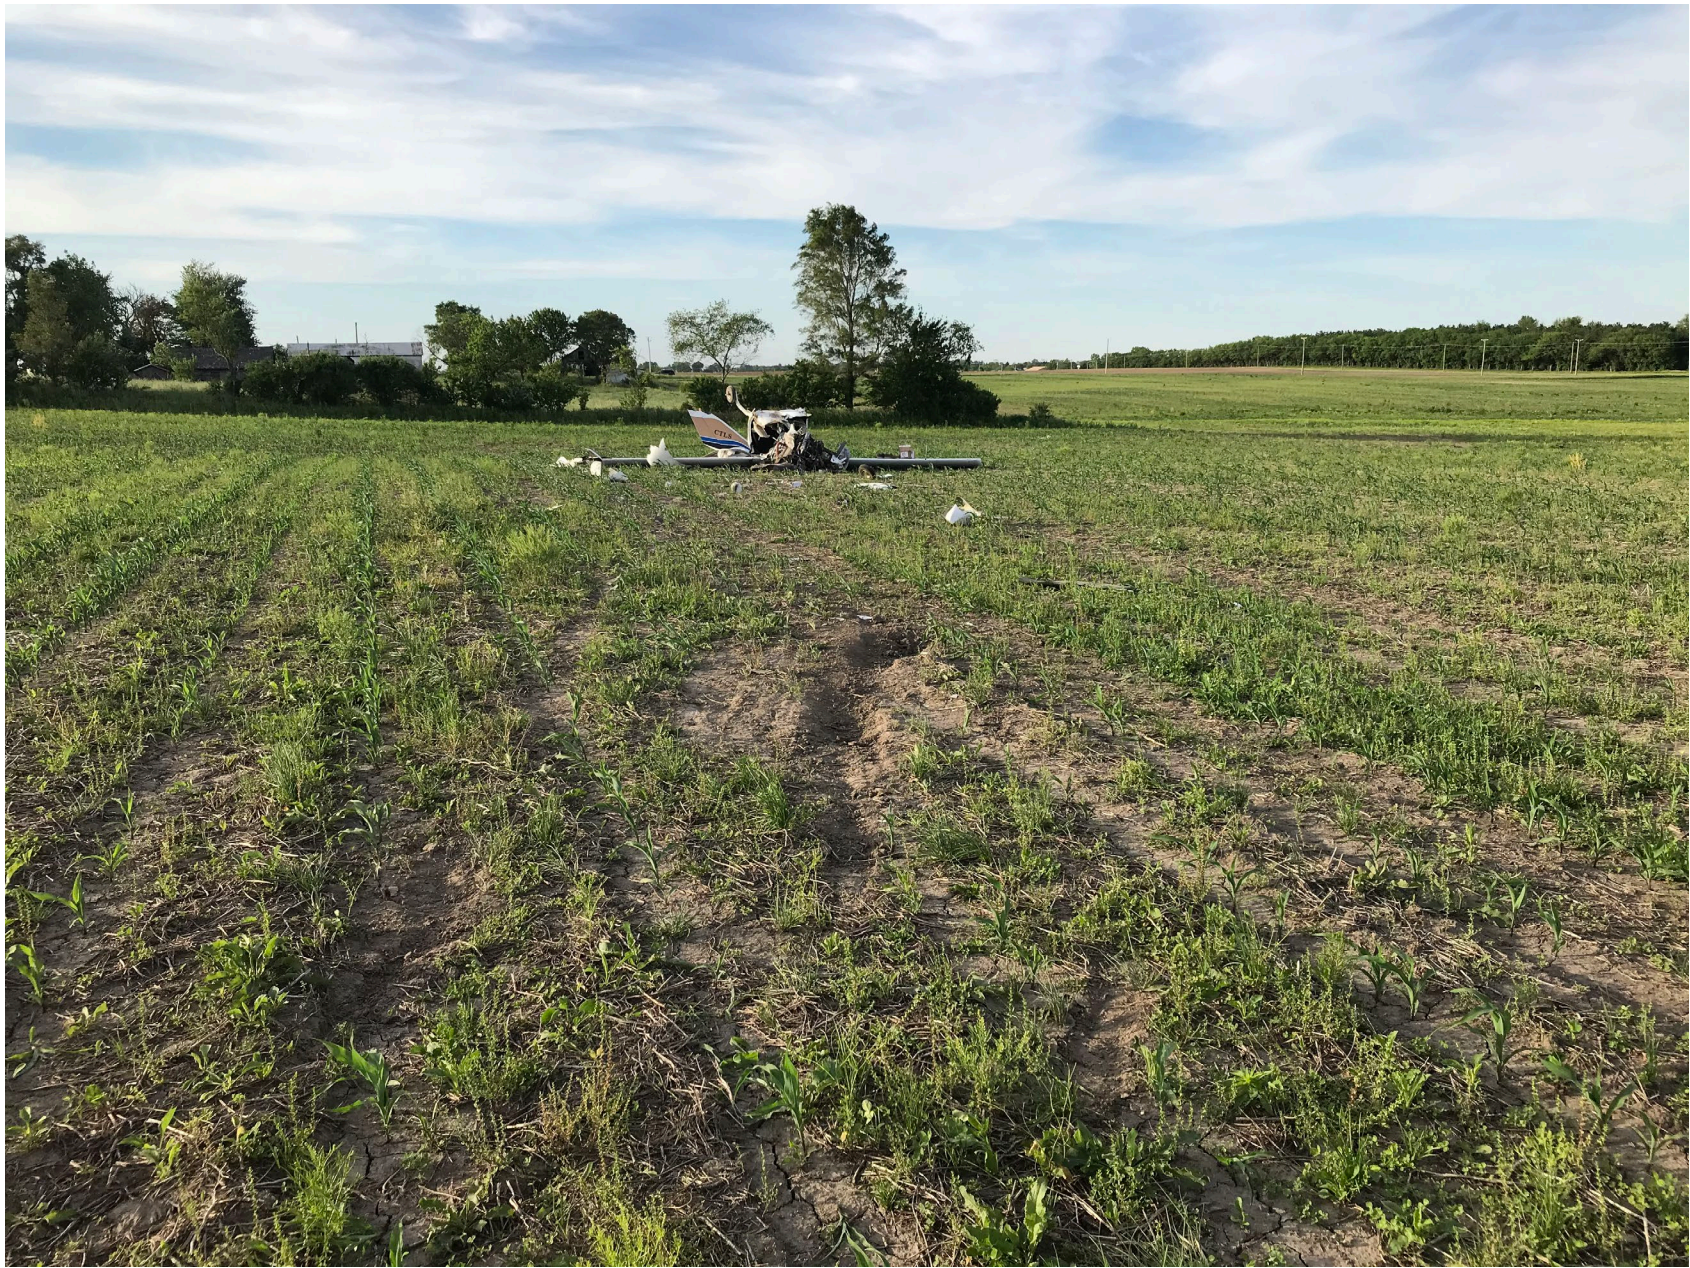
**Photo 5 – Accident site viewed from initial impact point (NTSB Photo)**

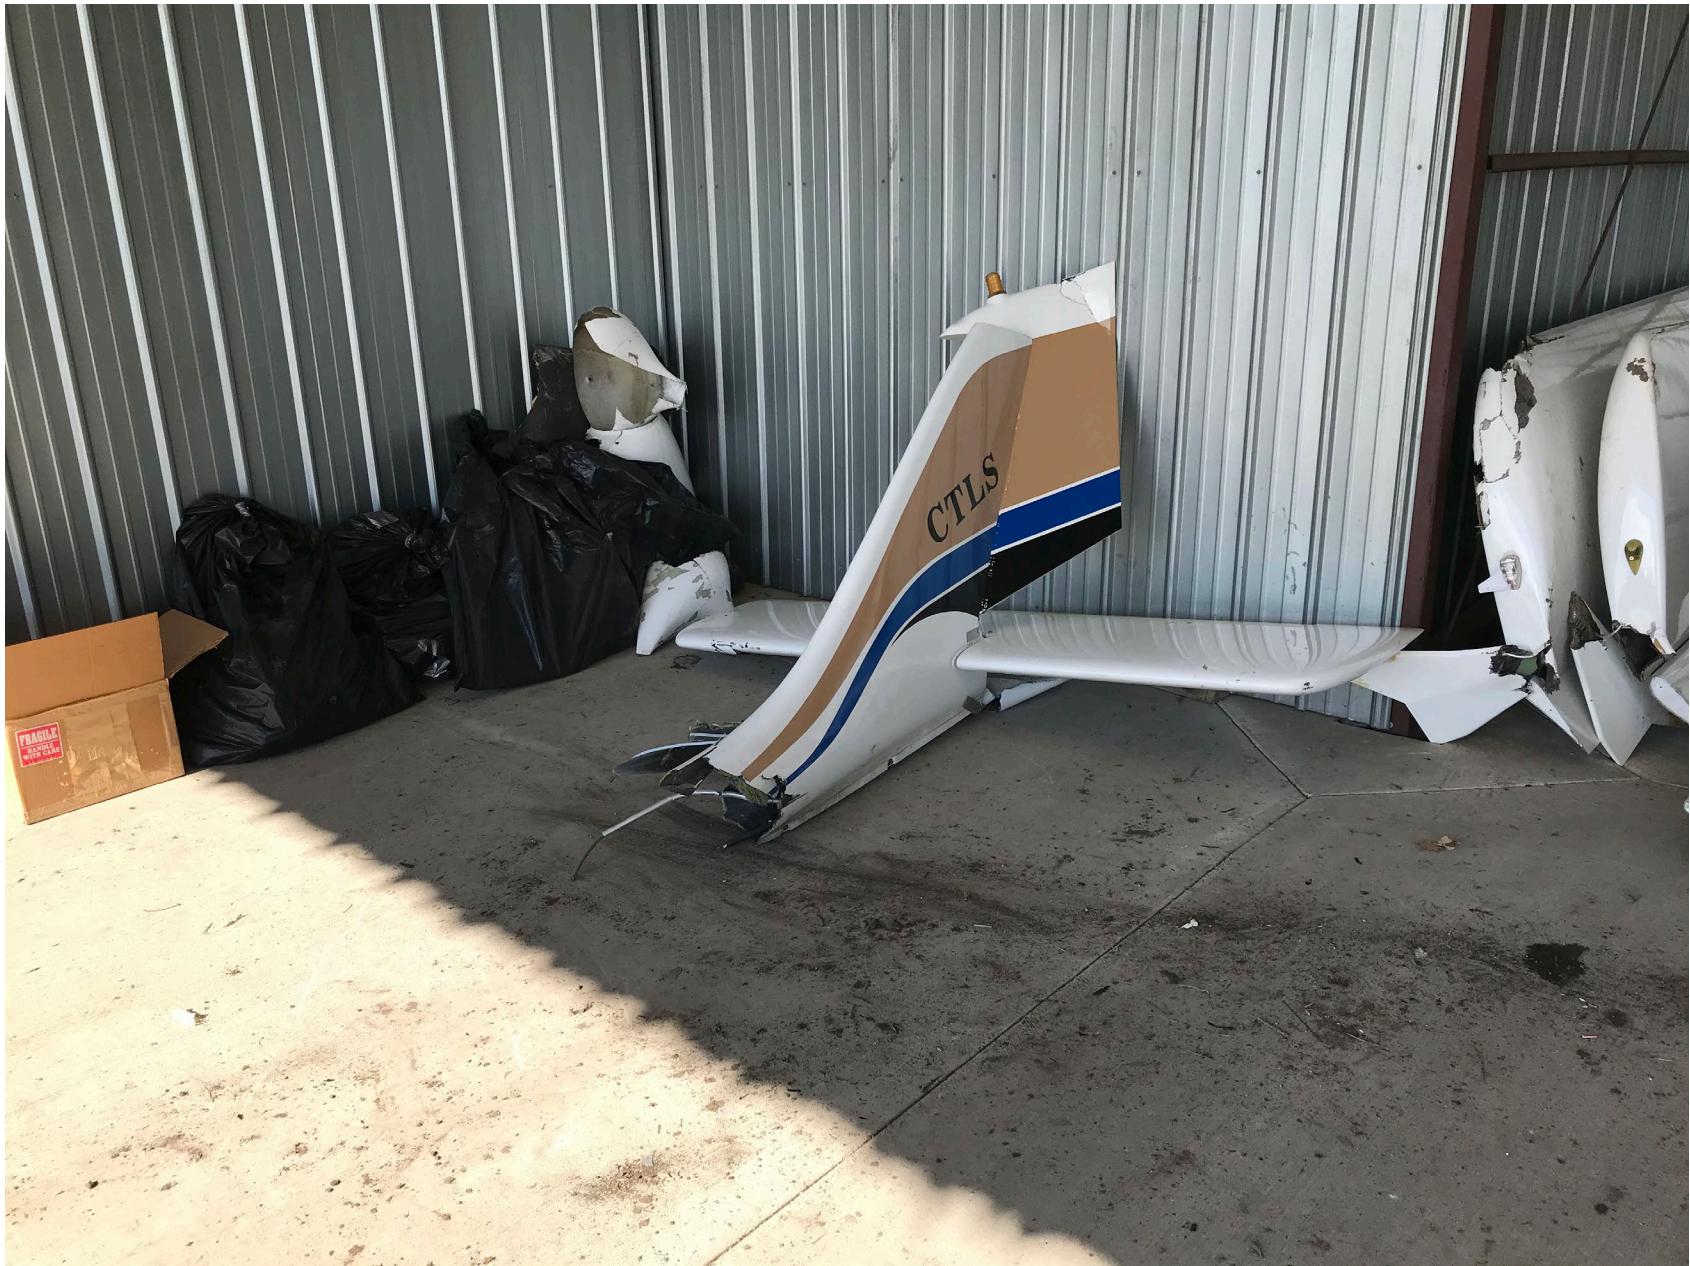
**Photo 6 – Airplane tail during postaccident examination (NTSB Photo)**

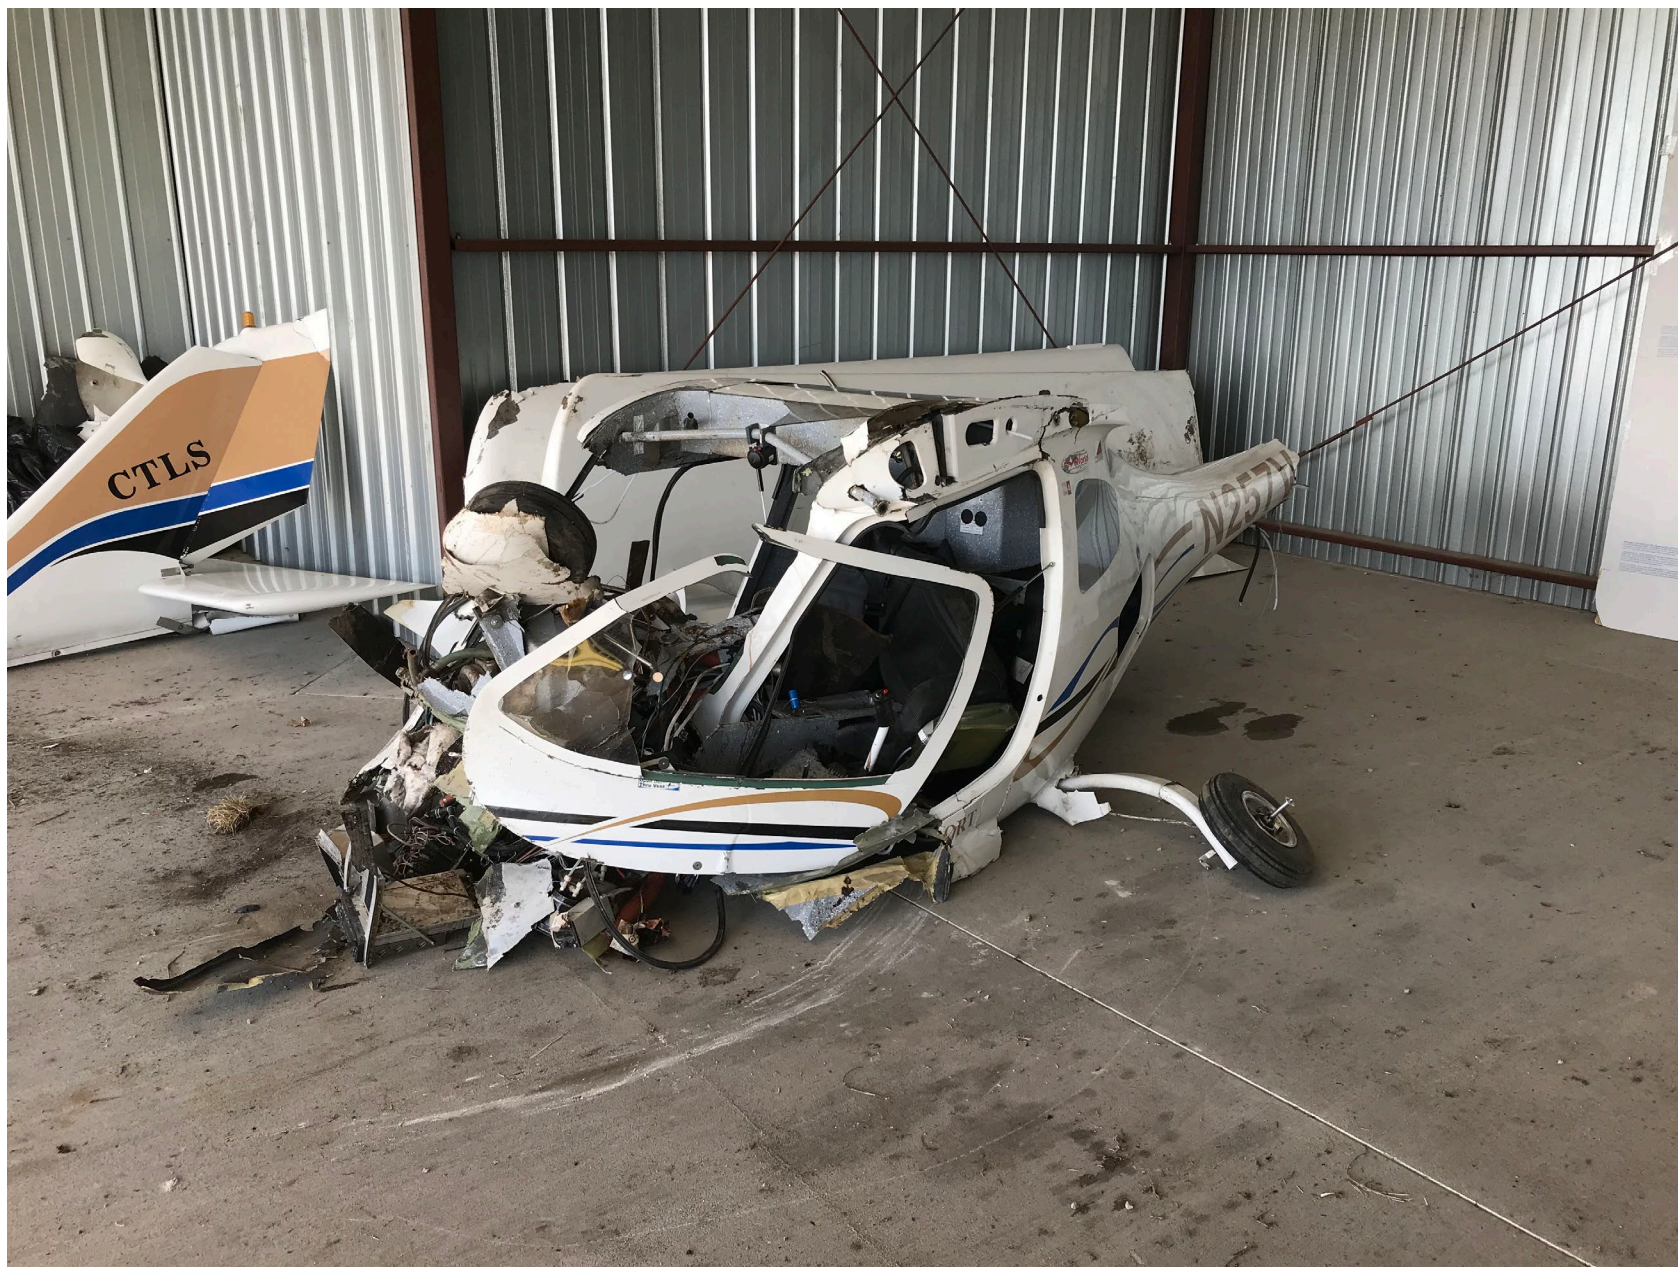
**Photo 7 - Airplane fuselage during postaccident examination (NTSB Photo)**

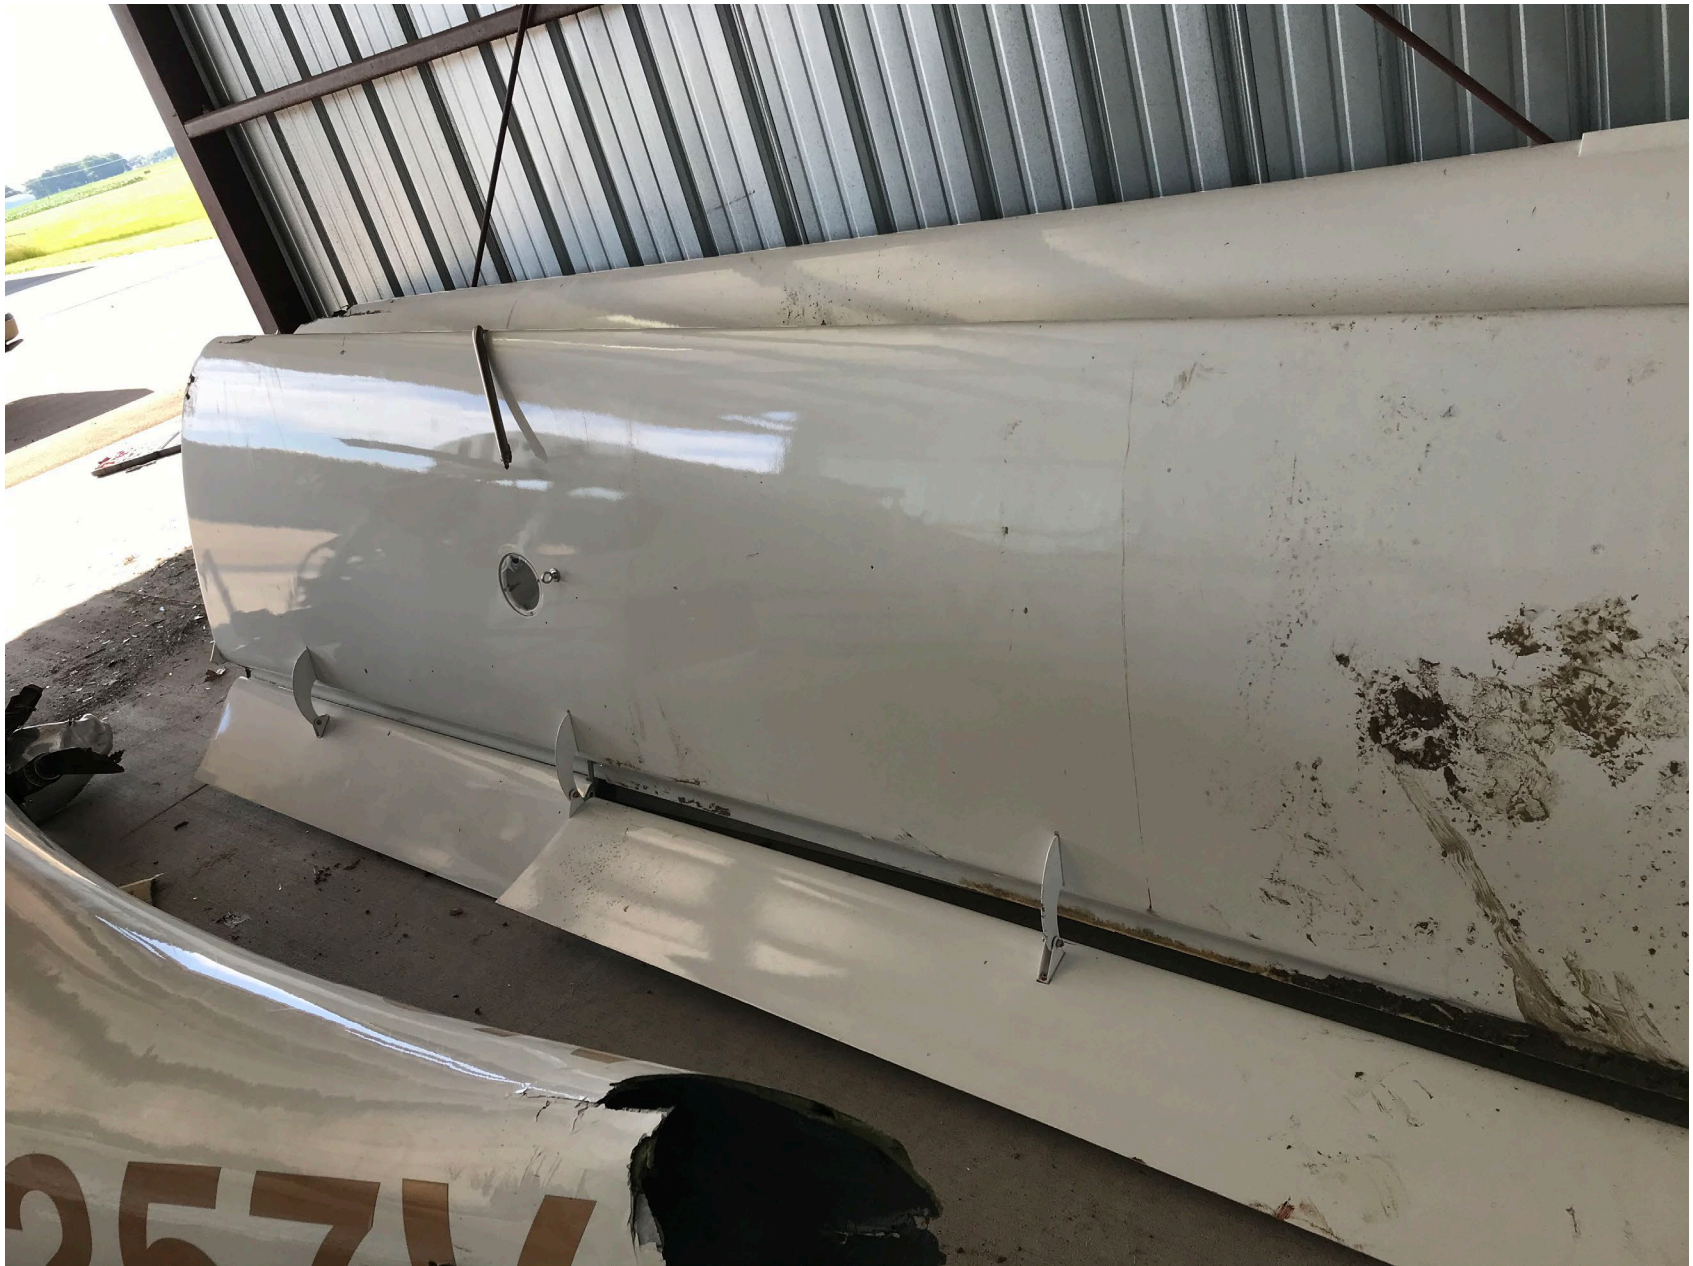
**Photo 8 - Airplane wings during postaccident examination (NTSB Photo)**

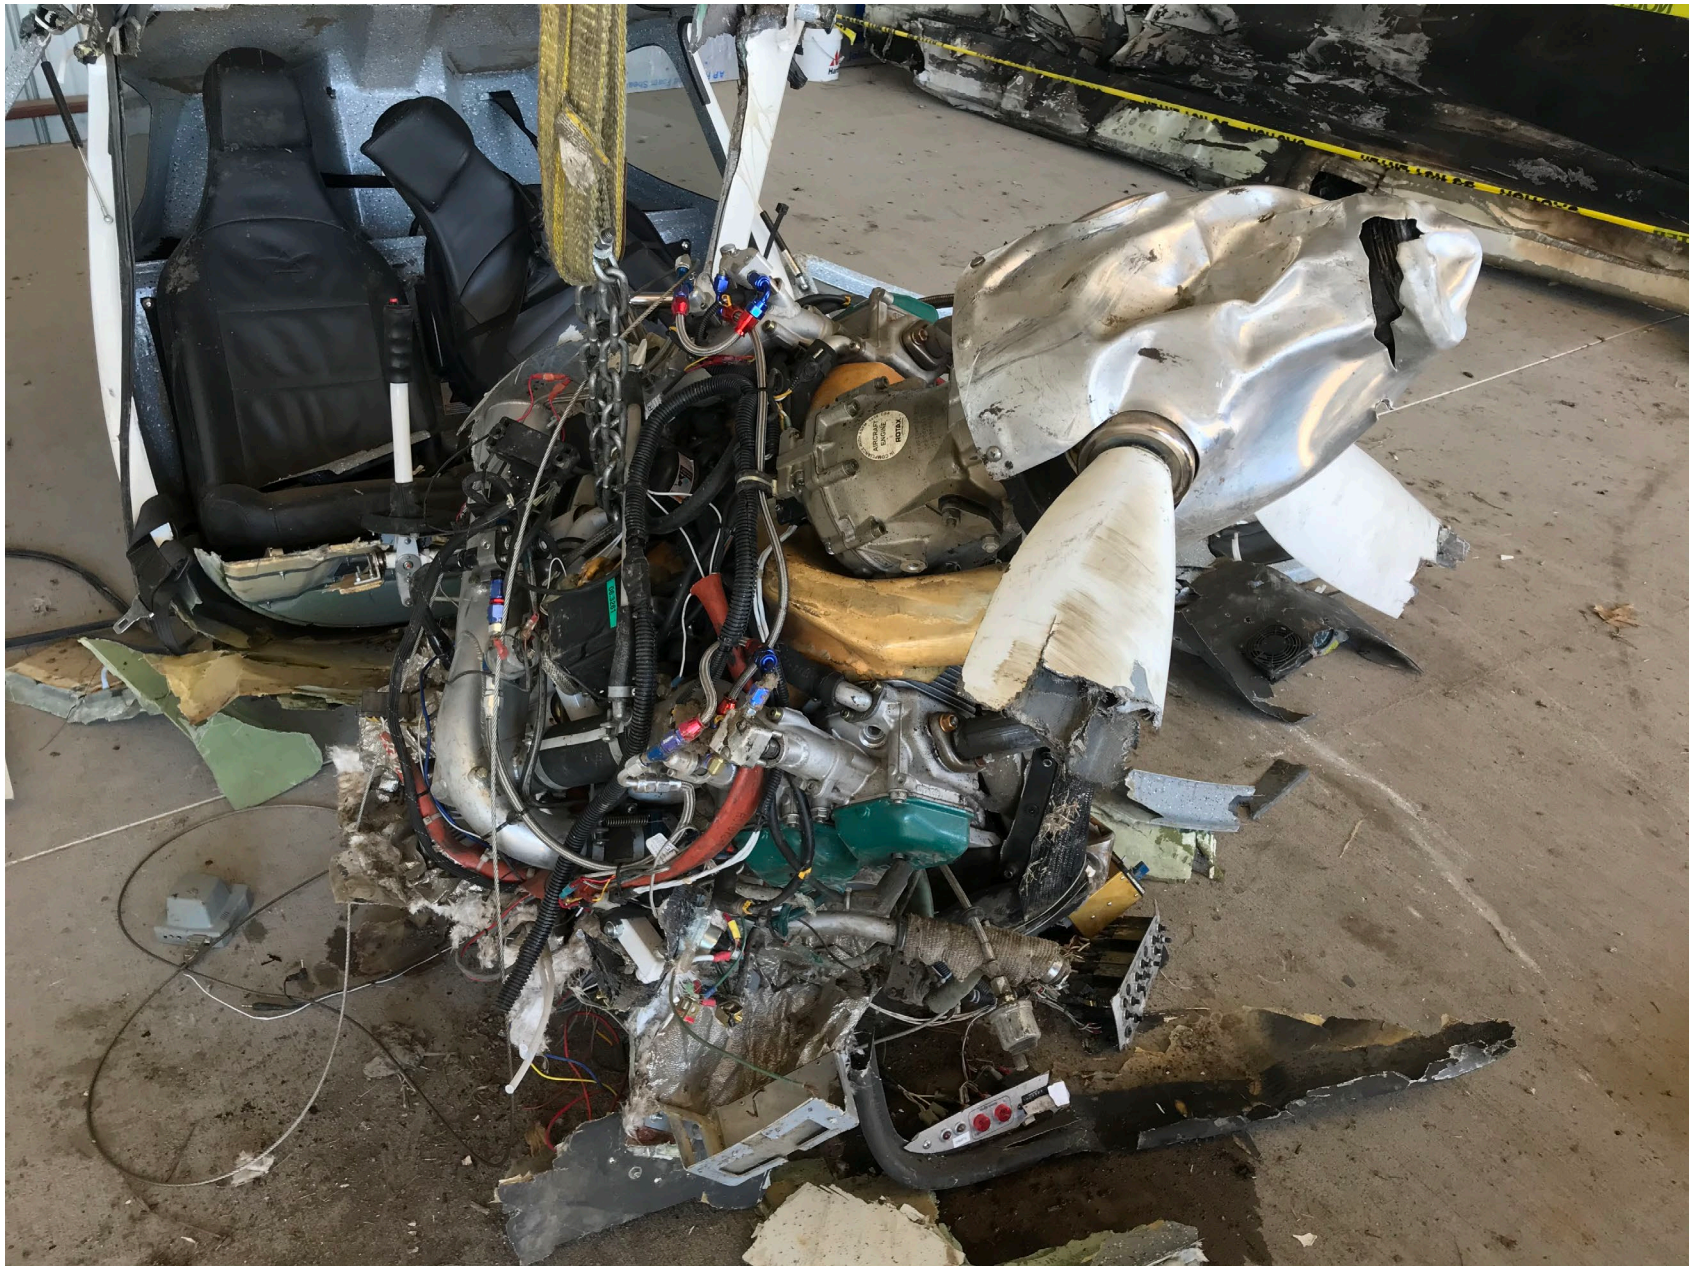
**Photo 9 - Airplane engine during postaccident examination (NTSB Photo)**

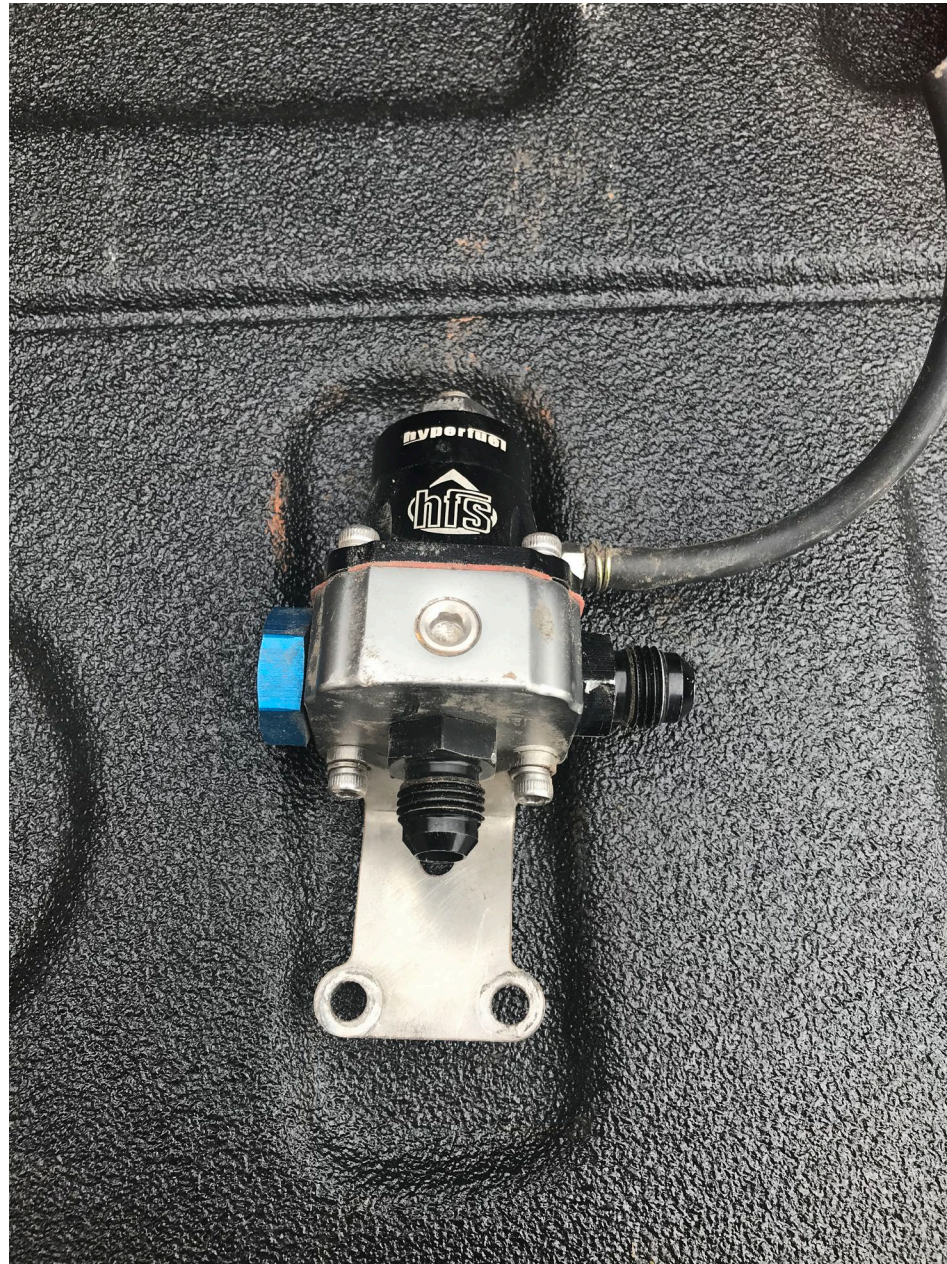
**Photo 10 - Airplane fuel pressure regulator during postaccident examination (NTSB Photo)**

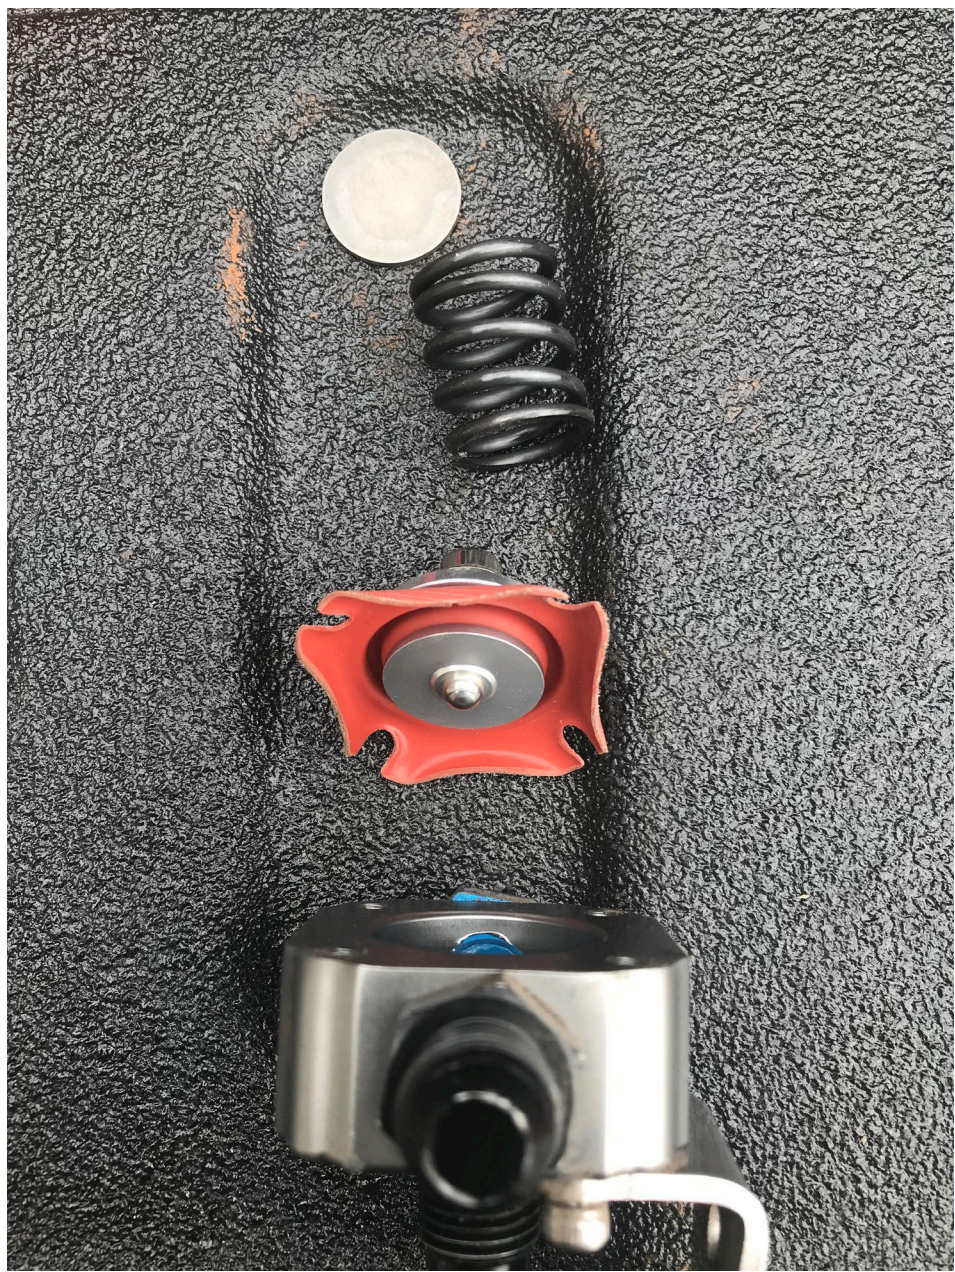
**Photo 11 – Disassembled fuel pressure regulator (NTSB Photo)**
